# **Drilled Shaft Construction**

## **MDT Project Case Studies**

## **Introduction**

This document provides some examples of problems that have occurred with drilled shafts on MDT projects and discusses general construction methods that may help avoid recurrence of the problems. It will be updated periodically.

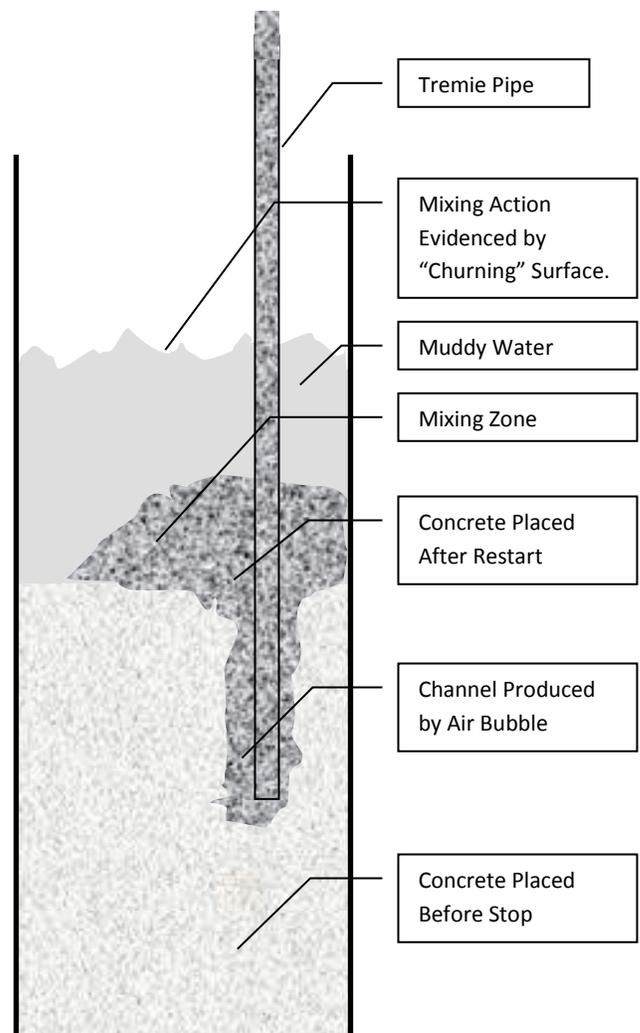
It is thought that the expelled air created a path for the newer concrete to travel through, allowing the concrete to bypass the zone of laitance and leave it deposited within the shaft.

This illustration to the right shows what may have happened when the column of air was allowed into the tremie pipe. Crosshole sonic logging did not indicate any problems in this area of the shaft however.

Possible condition shortly after restarting concrete placement

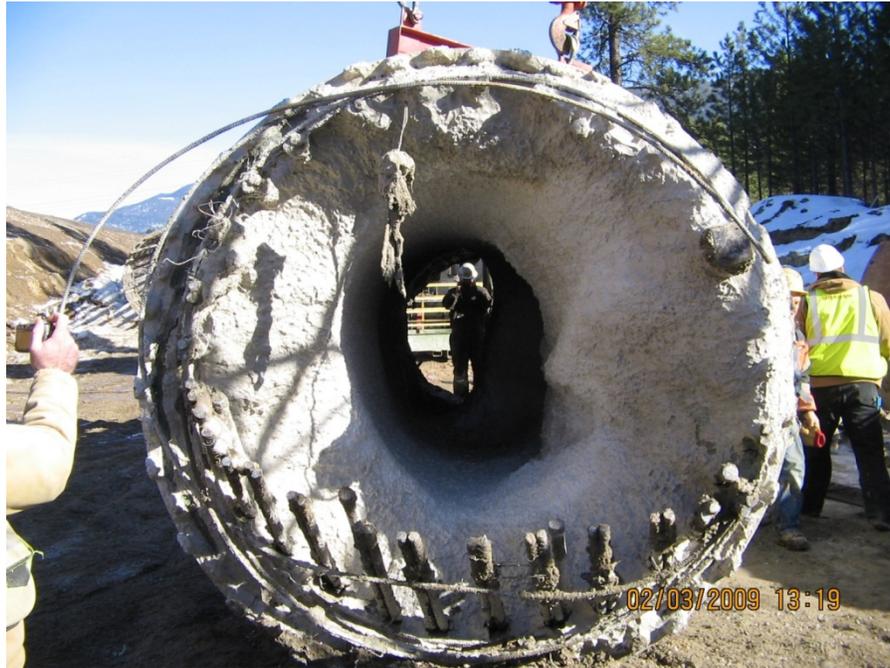
Figure 3. Excavated Shaft - MDT Photo.

Loss of workability during the placement can be the result of an improper concrete mix or excessively long placement times. The shaft shown in Figure 3 had to be removed due to loss of workability resulting from an improper concrete mix.

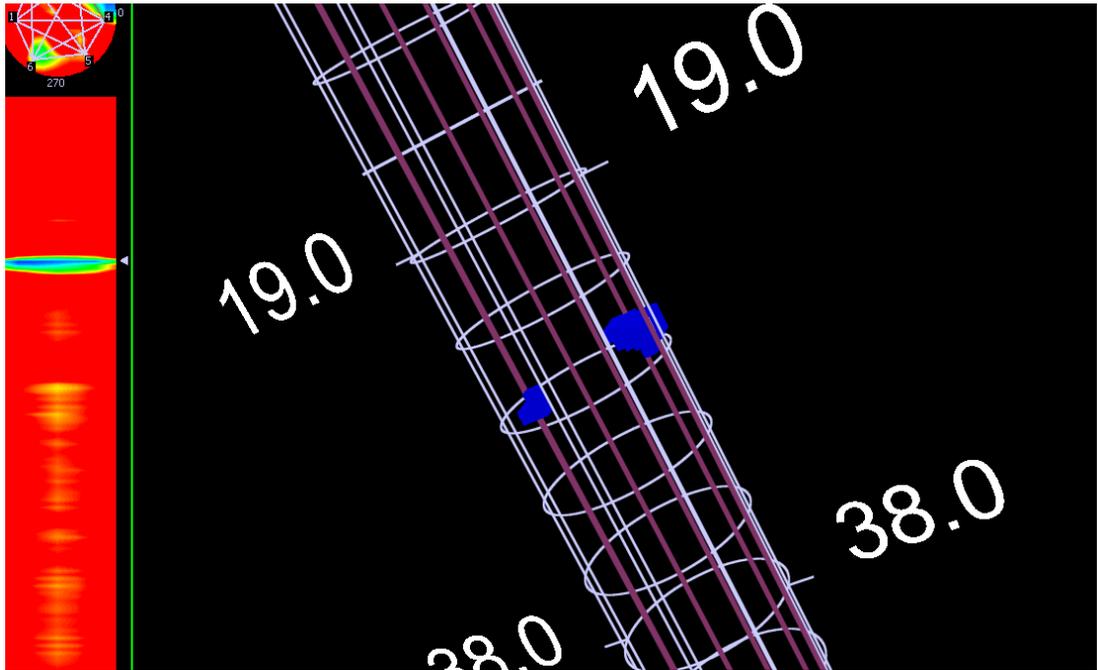
Figure 5. Tomographic Image of drilled shaft showing anomalies. MDT Image.

Figure 5 shows three dimensional imagery of the drilled shaft with anomalies that were detected by Crosshole Sonic Log testing (CSL). The anomalies were confirmed to be defects when the shaft was later cored, (Figures 6 and 7) and were found to be areas of segregated concrete.

The defective area of the shaft was cleaned out using high pressure water jetting then repaired by grouting.

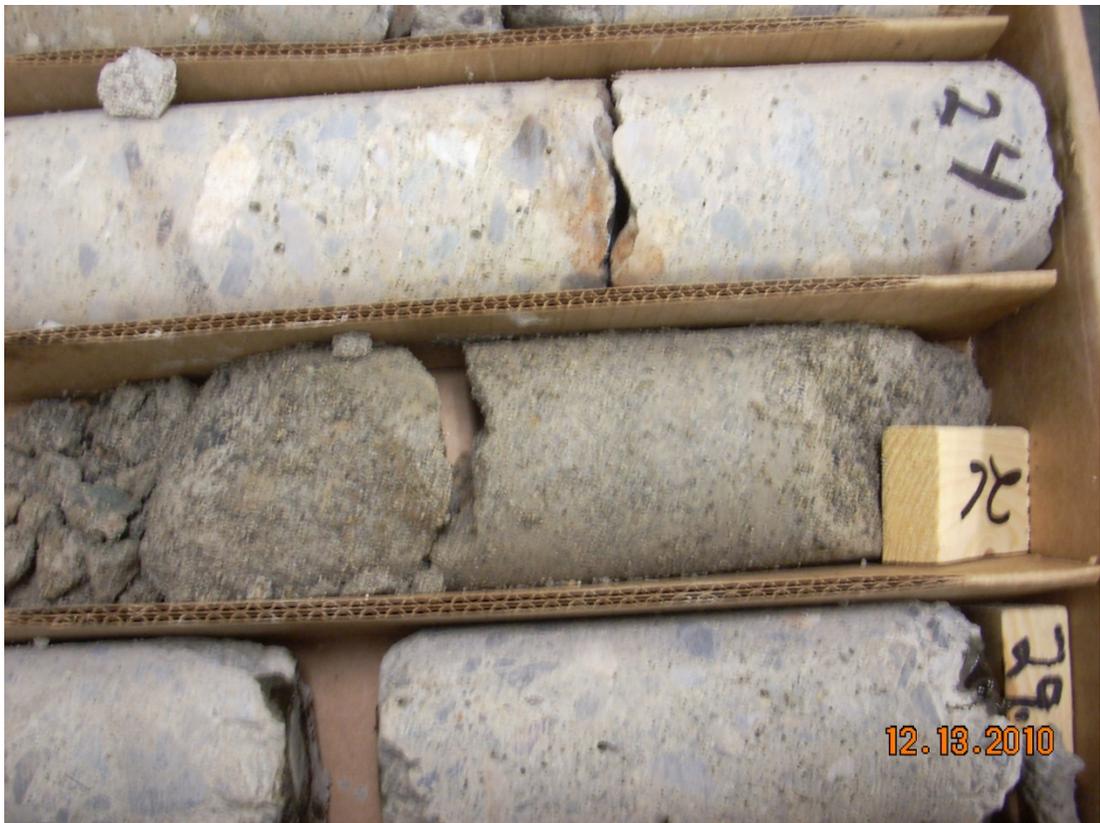
Figure 6. Core showing cemented sand without aggregate. MDT photo.

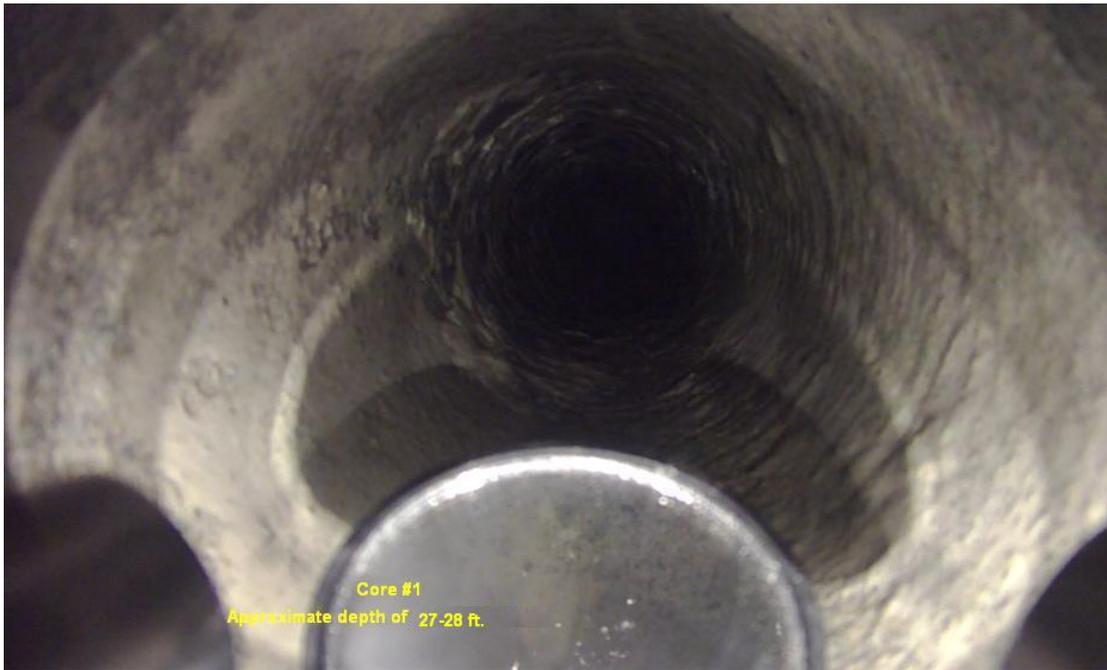
Figure 7. Image from within core shows cemented sand above weakly cemented aggregate. MDT photo.

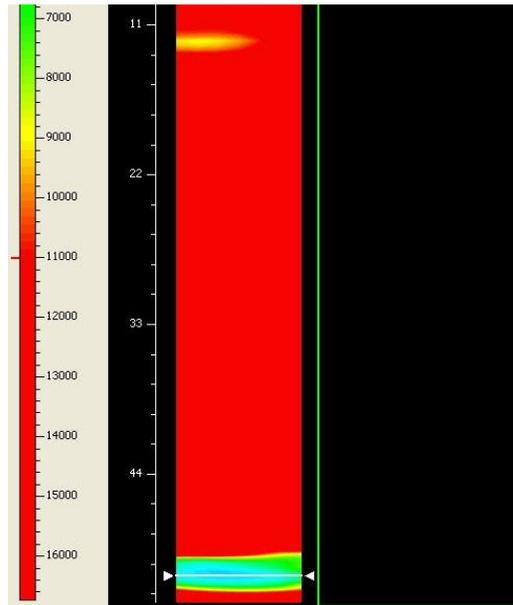
**Figure 8. Tomographic Image of Anomaly at Shaft Bottom. Coring confirmed sand filled toe ranging from 1-2 feet thick.**

It is not unusual for a Contractor to perform a “final cleanout”, immediately sound the bottom of the shaft with a weighted tape to verify the hole is sufficiently clean and then proceed to place the rebar cage and start concrete placement. It is possible that flowing sand or other material may be slowly intruding into an excavation and could build up during the time it takes to place the rebar cage, cut away excess rebar, add cage spacers, connect tremie, etc. It is recommended that the hole be inspected multiple times after cleanout to verify that the hole has remained clean between the time cleanout was performed and concrete placement is started.

Other than the cleanout buckets, other non-rotary tools may be very useful for removing cuttings and debris from the base of the shaft. Most common is some type of pump to lift cuttings for removal such as an air lift or a hydraulic lift. Hydraulic pumps are more controllable than the airlift system in that the volume and velocity of pumping can be regulated more easily. Airlifts tend to remove larger particles than pumps. Note that while pumping systems are probably the most effective means of removing loose cuttings or debris from the base of a wet hole, the aggressive use of these tools in cohesionless soils can advance the shaft excavation. The effectiveness of shaft base cleanout tools and techniques in wet holes can best be evaluated using a down-hole camera. It may be necessary to circulate clean water into the hole to improve visibility.<sup>1</sup>

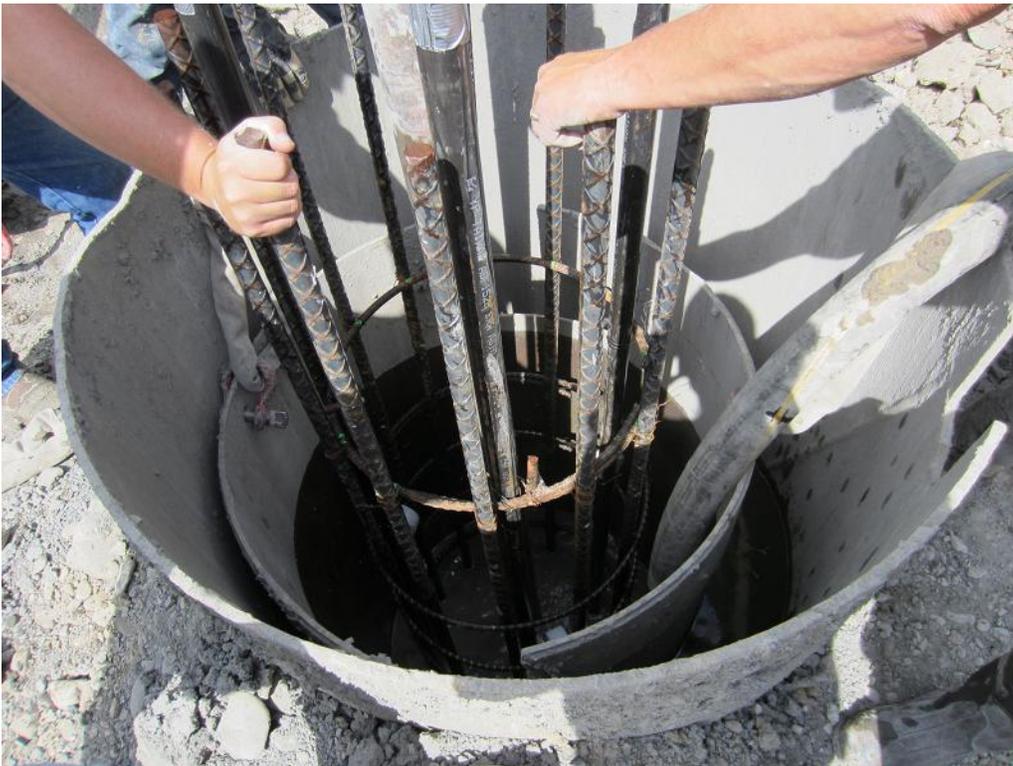
Note the level of water between the two casings in the photo below is higher than the water level inside the inner casing. Before starting the concrete placement, the Contractor pumped water from within the inner temporary casing. Dewatering in this manner created a differential pressure head with positive pressure outside the casing. This probably led to intrusion of silt under the casing. Rather than dewater the inner casing, the Contractor could have added water to maintain a positive pressure head within.

**Figure 9. Dewatering inside casing creates adverse pressure head.**

When this was observed by MDT, the Contractor was made aware of the concern. The Contractor chose to move the pump intake to the space between the casings and continued placing concrete.

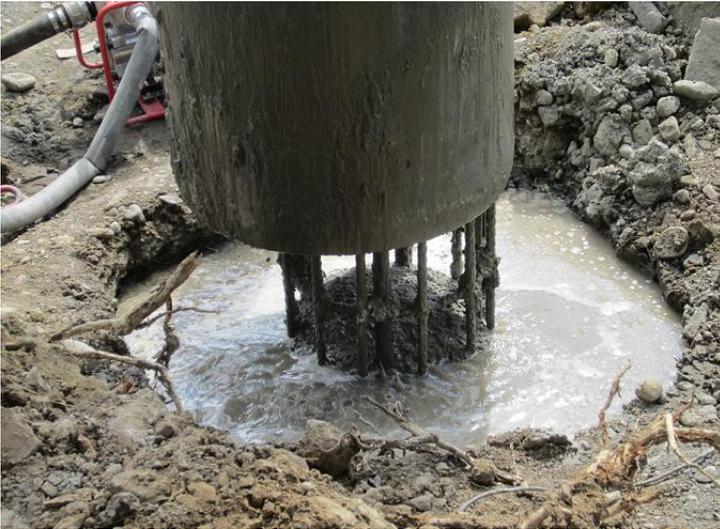
While pulling the casing, a positive head of concrete was not maintained within the casing which created another opportunity for soil or water intrusion into the shaft. In addition, there was an inadequate volume of concrete within the casing to displace any laitance and the surface water:

The Contractor pumped off the excess water, reinserted the tremie pipe and placed the remainder of the concrete.

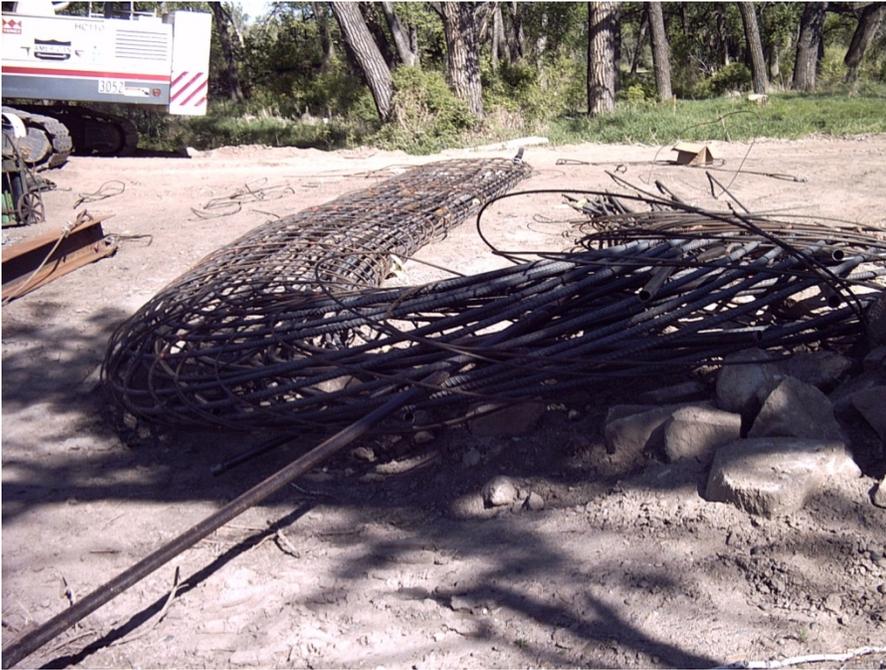
This reinforcing cage collapsed under its own weight when being picked by a crane.

Figure 10. Reinforcing cage collapse. MDT photo.

The method for bracing and lifting the reinforcement cage must be carefully planned in order to prevent collapse or permanent distortion of the cage.

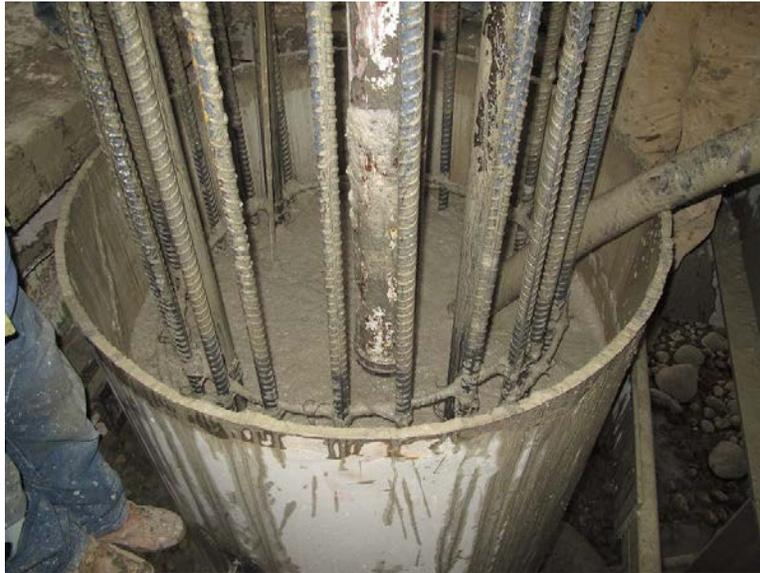
Figure 12 Attempting to Dewater and Retrieve Pipe

Concrete placement started about 1:30 PM. At 3:30 PM, while concrete was still being placed, it became apparent that one of the couplings in the placement tube had failed which had allowed some volume of concrete to be dropped through the standing water within the shaft. The contractor stopped placement and dewatered the shaft in an attempt to retrieve the disconnected section of pipe. This was unsuccessful and the contractor finally decided to abort the placement and attempt to remove the reinforcing cage. Even though the concrete had not taken set, the contractor was unable to hoist the cage.

Use bolted couplers or welded connections for joining sections of tremie pipe.

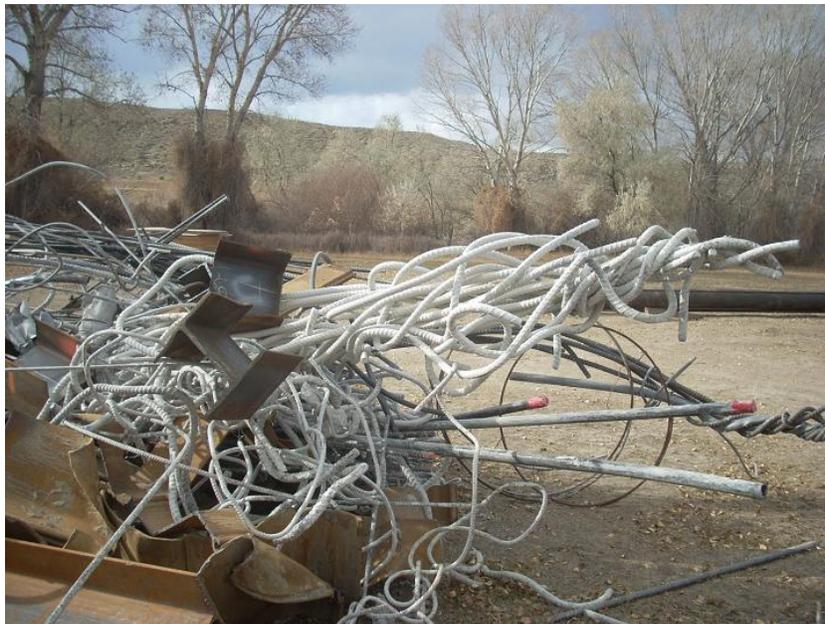
Over the course of several days, the contractor excavated the concrete and removed the reinforcing cage. The cage was destroyed during removal so a new cage was ordered with an additional 1.2 m of length in case additional excavation (depth) would be required by MDT.

Figure 13 Destroyed Reinforcing Cage

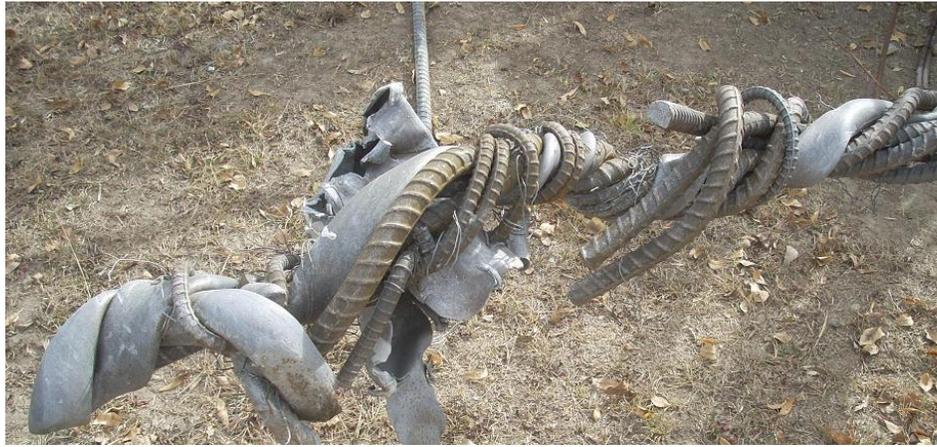
Figure 14 Twisted Rebar, CSL pipe, and Tremie Tube

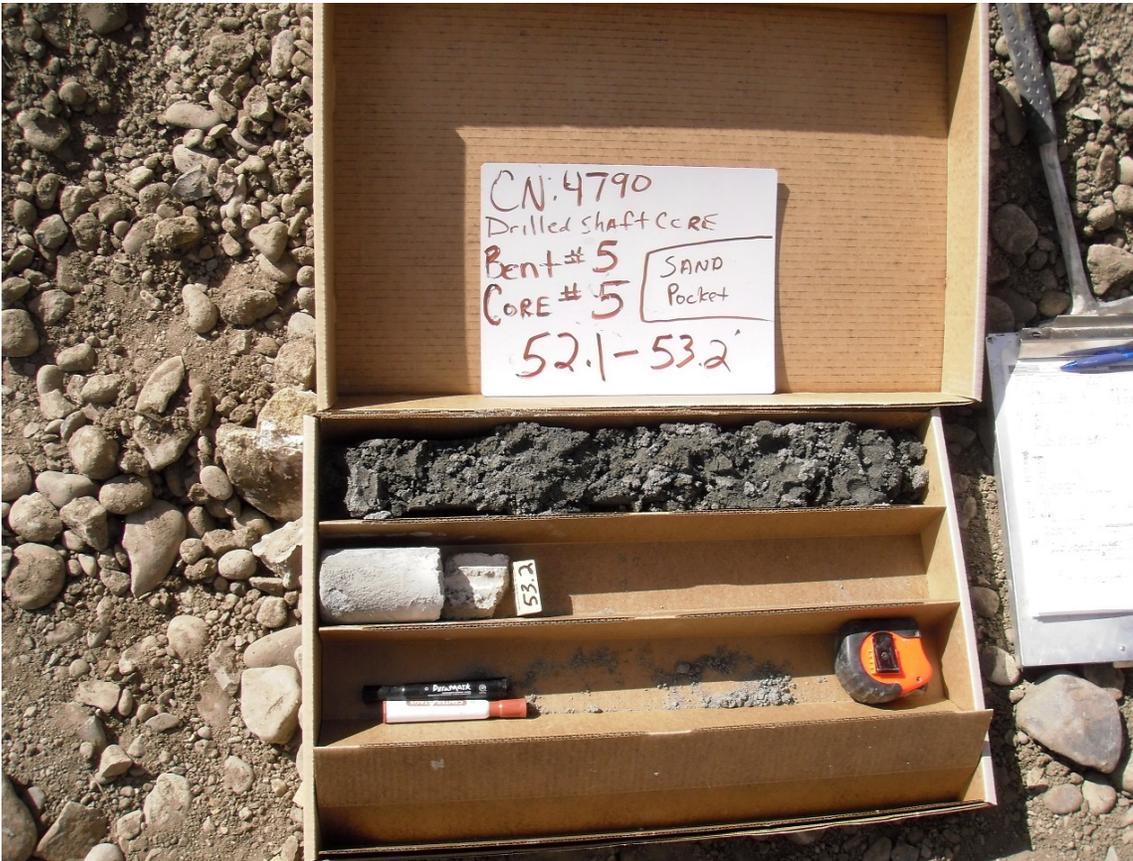
Measurements taken after drilling found that sand had entered several of the tubes. Two of the tubes had as much as 10 feet of sand. In addition water was applied at low pressure to each of the tubes, in turn, to see what the effects would be. Tubes 5 and 7 produced water when water was applied to tube 6 indicating connectivity there. By comparing the static water level outside the permanent casing and the water level in the tubes after some time, it was thought that there was likely connectivity between the void and the groundwater. All of this information was taken to indicate that a defect was likely present around the perimeter of the base of the shaft so two more cores were drilled. Sand pockets were found at a depth of approximately 52' and at the shaft bottom. Dave Cunningham of MDT Geotech was on site for several days assisting the project staff with logging the cores.

Core and Recovered Sand from the Bent 5 Shaft

The contractor elected to repair the bent 5 shaft first. They submitted a flush and grout repair procedure that was used on a previous project along with a grout mix design. After some MDT comment and information requests, a revised plan was ultimately accepted by MDT.

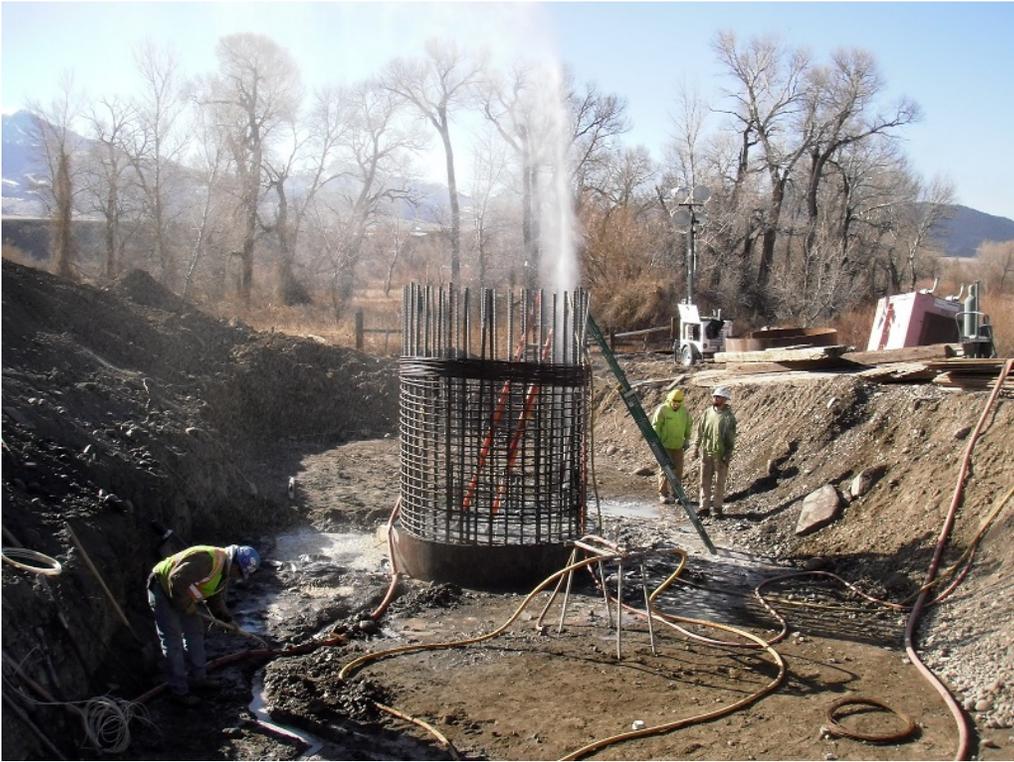
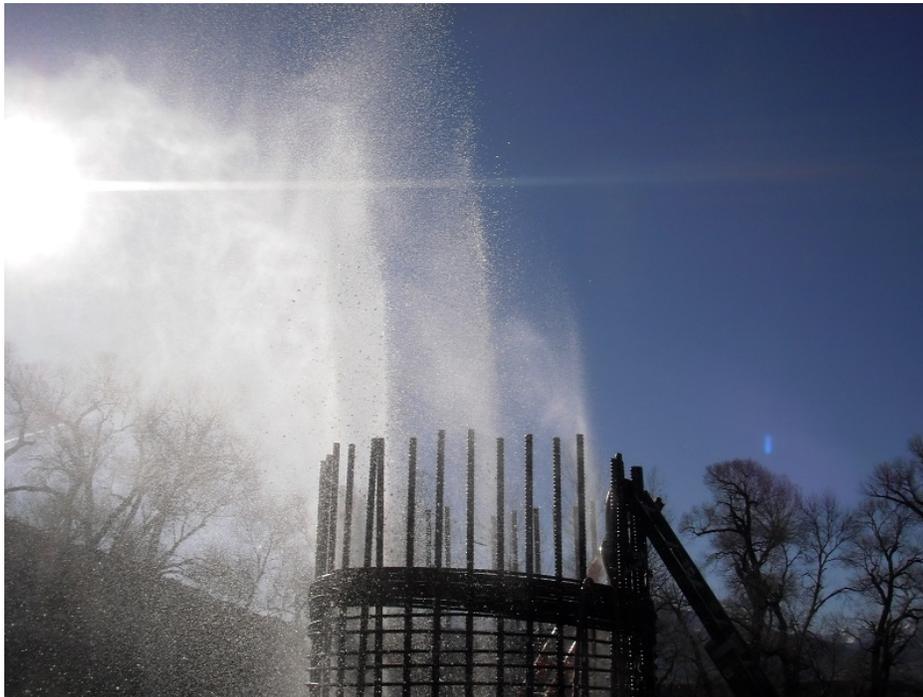
Flushing Sand from the Bent 5 Shaft

The contractor was able to effectively flush the sand from the shaft using compressed air. An air line was inserted down into the hole and when air was applied, groundwater along with sand was blown out. Connectivity was observed between the core holes and the CSL tubes, indicating that the void system was interconnected and relatively extensive.

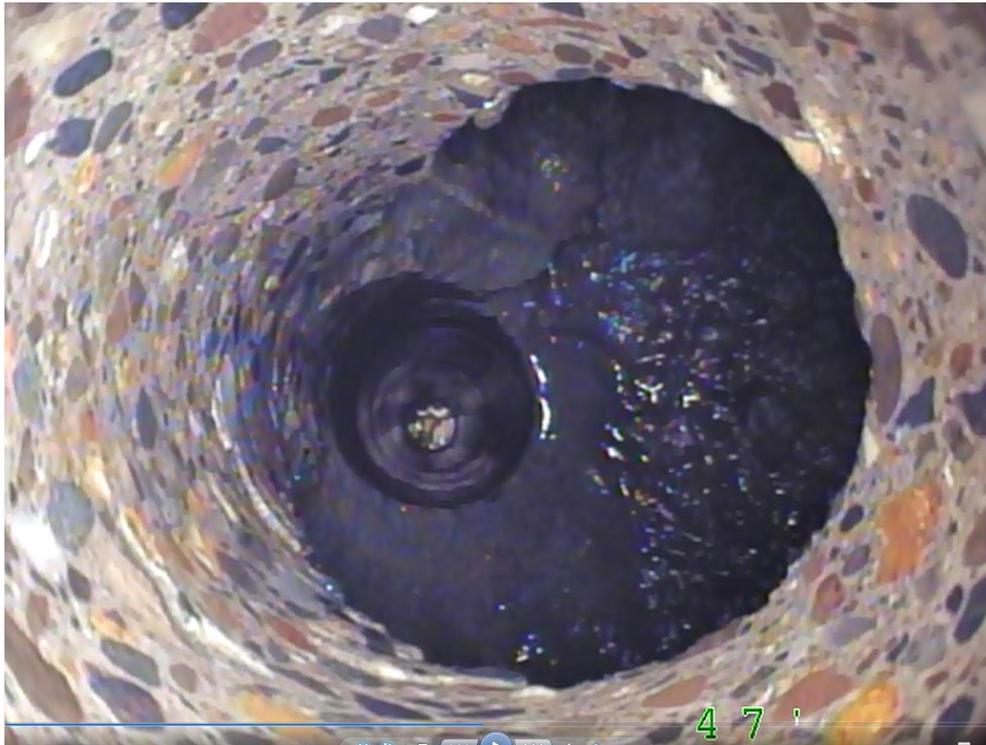
The Contractor hired a plumber with a sewer camera to inspect the core holes. The photo below is taken from a video clip of the inspection of one core hole and shows a substantial void in the shaft concrete at a depth below 47 feet. Note that the diameter of the core hole is approximately 3.5 inches.

It was not possible to view the defect at the shaft bottom due to the presence of water there.

The Bent 5 shaft was repaired on 4/2/2013. The general procedure was as follows: (condensed)

1. Flush sand from holes while adding water to maintain a positive or neutral head of water within the voids/holes.
2. Insert tube into lowest part of the void system and pump grout in, displacing water upward.
3. When any tube or core hole starts producing grout, cap that hole to force the grout to fill the other areas.
4. After all tubes/holes are filled, cap them and pressurize the system for 10 minutes.

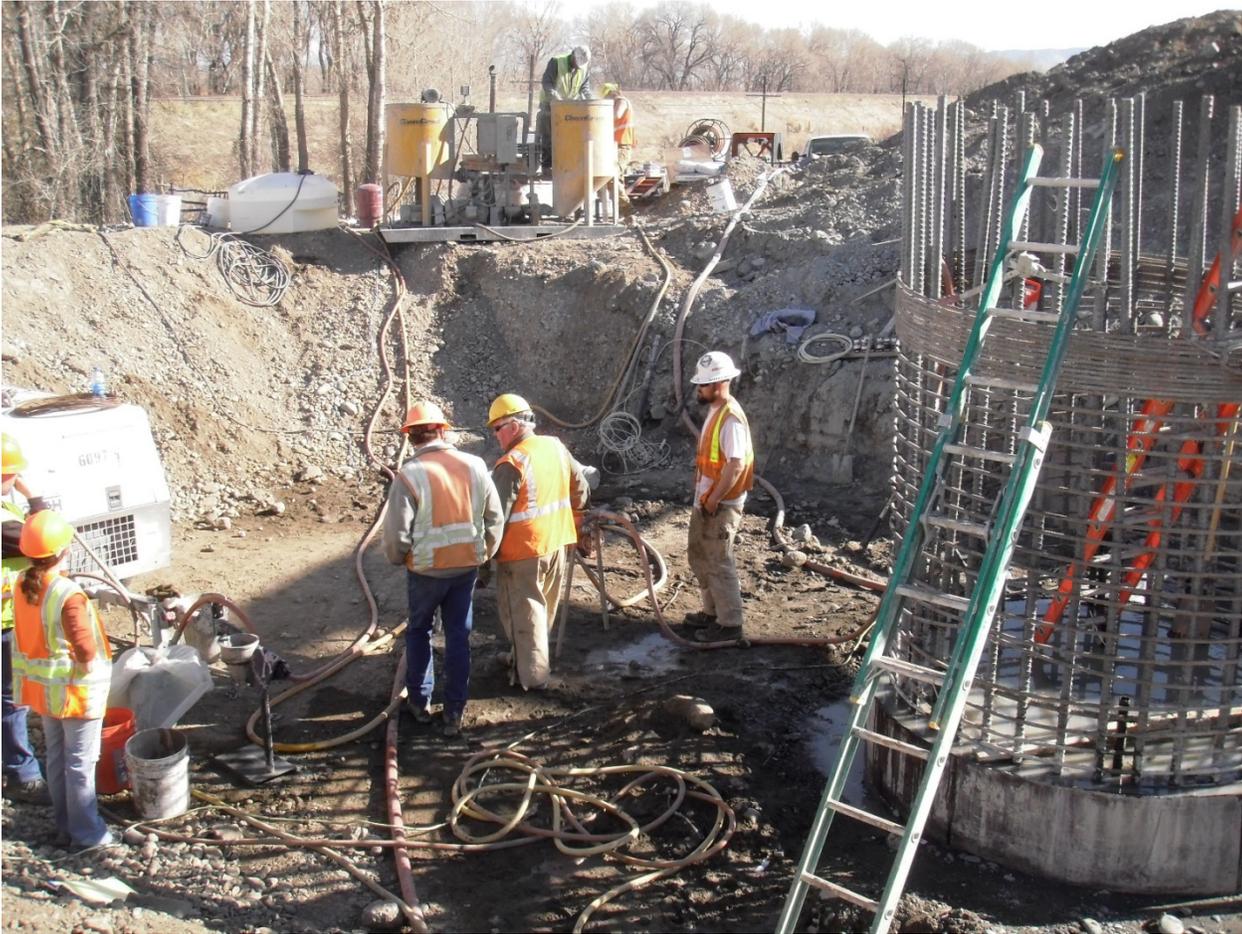
Grout Repair of Bent 5 Shaft

Based on grout flow measurements it was estimated that approximately 1.9 cubic yards of grout was used in total. The estimated volume needed to fill the tubes and core holes was calculated to be .55 cubic yards. Based on this approximately 1.36 cubic yards went to fill void spaces with some potentially lost to the surrounding soil.

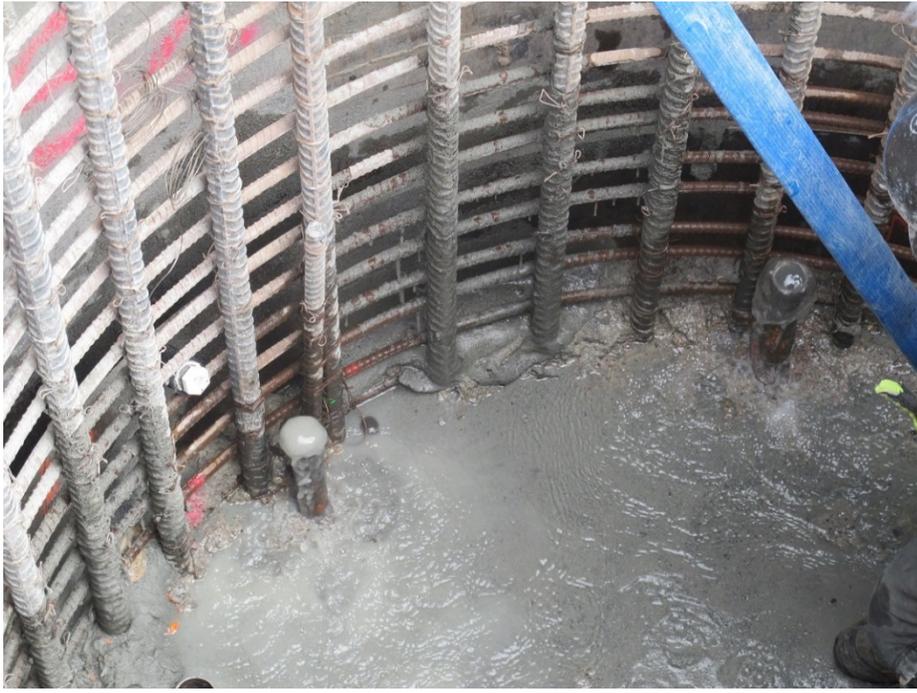
Flushing Sand from Voids with Water

4/10/2013: A similar procedure was used for repair of the Bent 4 shaft. However, using compressed air to clean the voids was not effective for this shaft due to inflow of new sand. Flushing the voids with water while maintaining a full head of water within the void system appeared to be effective at removing much of the sand. The Bent 4 shaft required approximately 6 cubic yards of grout and the grouting process took approximately 6 hours to complete.

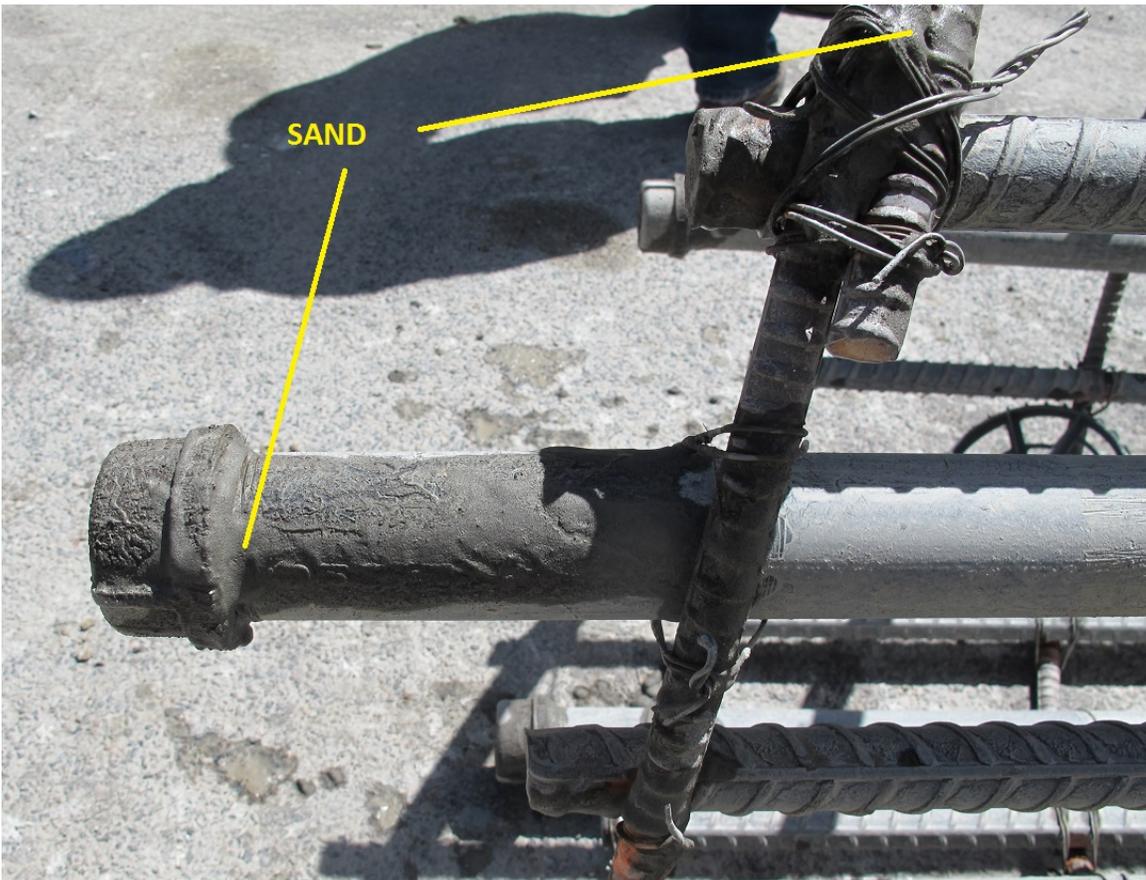
Shaft 4 was sounded a second time, after the reinforcing cage was placed, and it was determined that the bottom was no longer clean. The contractor removed the cage and performed additional cleanout. The presence of sand was observed on the bottom hoop of the cage, indicating sand was present in the excavation to a depth of at least 8 inches.

Figure 17 Shaft 4 Reinforcing Cage / CSL Tube

After additional cleanout the excavation was sounded again and thought to be clean. The cage was replaced and concrete was cast.

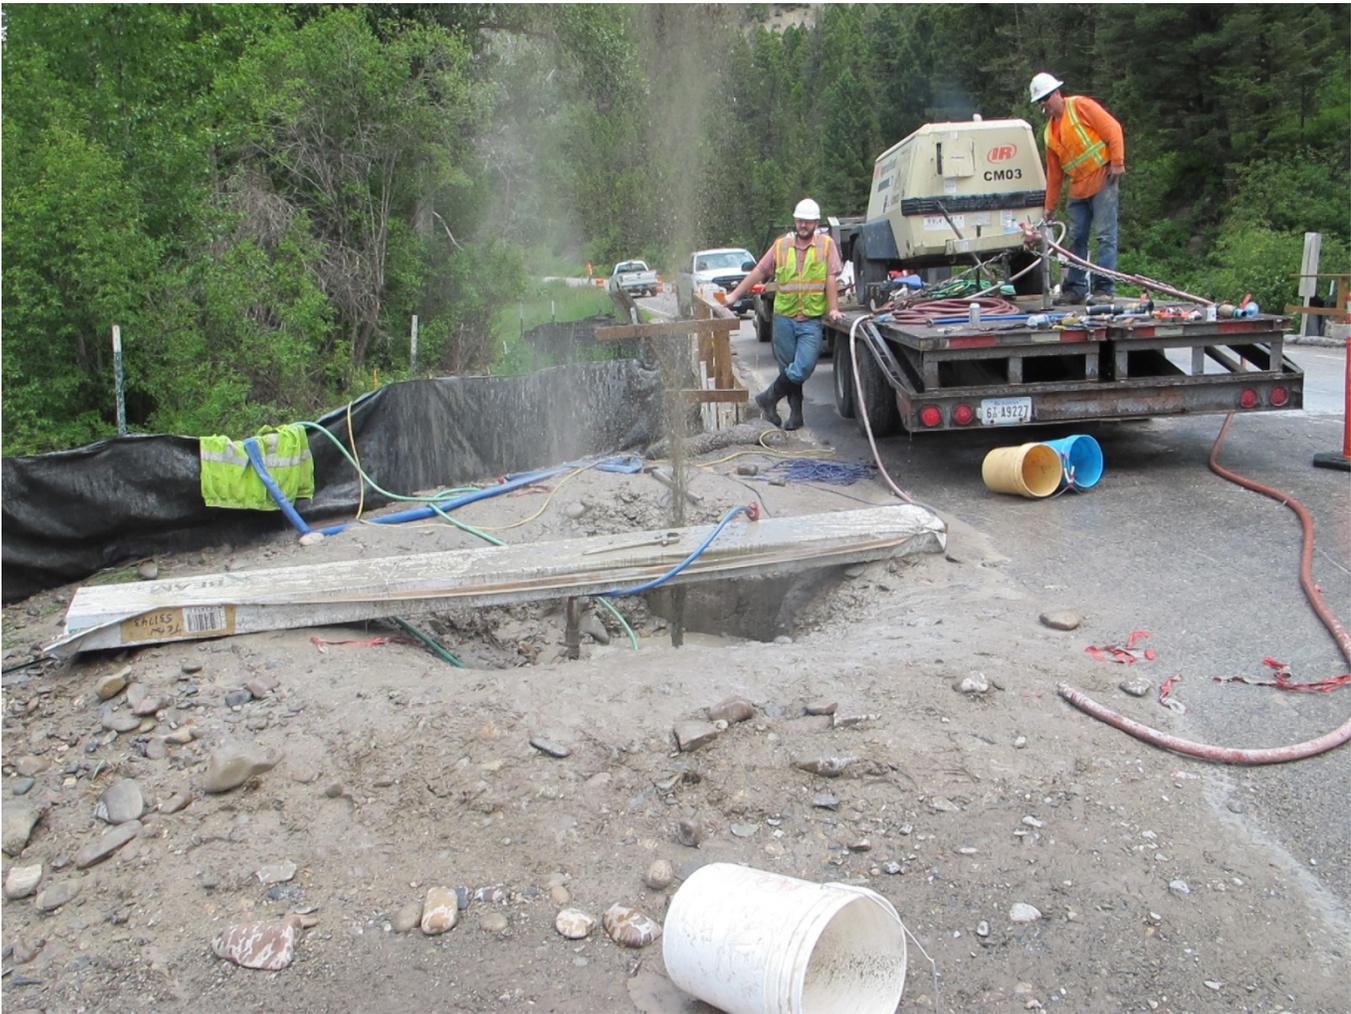
Figure 20 Air Lifting to Clean Out Shaft Toe

After the presence of sand/gravel was confirmed, the contractor used air lifting to flush the void clean. The illustration below shows a typical system. Note that this system has been used on several repairs and is has proven to be a very durable and effective system for removing loose material from within a drilled shaft. Plumbing fittings are arranged to allow the operator to alternately inject water and compressed air into the shaft at the toe. The PEX pipe is easily inserted to the shaft bottom in a core hole or a punctured CSL pipe. To operate, the tube is initially filled with water (water valve open, air valve closed). Next, the water valve is closed and the air valve is opened. A burst of compressed air lifts out loose material that is small enough to exit the annular space between the CSL pipe and PEX pipe. The process is repeated many times in each hole until the void is sufficiently clean. Note that the PEX line must be secured to the CSL tube or rebar cage prior to pressurizing with air. An effective method for doing this
