# MONTANA DEPARTMENT OF TRANSPORTATION STREAM MITIGATION MONITORING REPORT

*Lolo Creek  
Missoula County, Montana*

**YEAR 2013**

USACE Permit Number: NOW-2009-01903-MTM-Lolo Creek

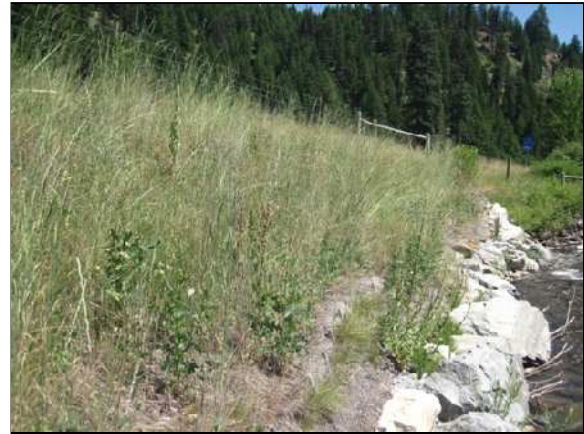
**Photo 4**  
**Description:** Downstream extent of riprap and coir.  
**Compass:** 40 (Northeast)

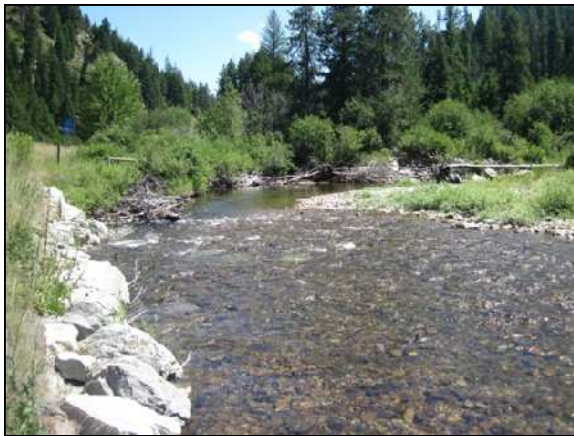
The lower (eastern) j-hook vane is approximately 26 feet long from the toe of the slope to the vane tip. This vane was installed at an upstream angle approximately 30 degrees from the stream bank, which falls within the range of angles specified in the typical design drawings. This vane was constructed with a 1.5% slope from the toe of the bank

to the tip of the vane. A pool has developed downstream from this vane; however it is difficult to determine whether this pool formed as a result of the vane placement or due to scour against a woody debris jam along the bank.

**Photo 2**  
**Description:** Looking at downstream j-hook vane.  
**Compass:** 90 (East)

The lower j-hook vane has been installed at a proper angle to the bank (30%), and at a 1.5% slope, comes close to meeting the specified range of 2-7% specified in the design. This vane appears to be functioning well, with a scour pool developing downstream.

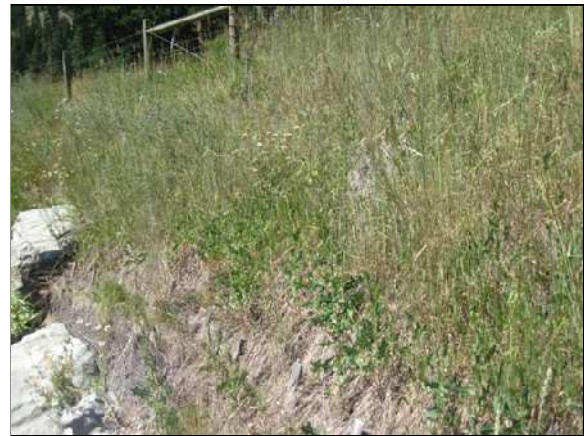
Evidence of planted woody vegetation included one row of willow stems below the riprap revetment. Plant survival success was low (13%), with approximately 6 live, and 47 dead willow stems observed (Table 1).

**Photo 5**  
**Description:** Coir and bank vegetation establishment.  
**Compass:** 330 (North-Northwest)

Prior to installing rock riprap, it is recommended to place cuttings in a key trench, allowing their tips to point upward and extend above the water surface as flood discharges recede. It is also recommended to place several layers of cuttings within the rip-rap as it is installed to generate a greater variety of planting elevations. If cuttings are installed during riprap installation, placing topsoil over each layer of cuttings prior to placing the next layer of riprap is suggested to improve root/soil contact. Large, interstitial spaces often exist between layers of riprap, which can result in desiccation of the cuttings or washing away during high flow events. Filling the riprap voids with unsorted gravels following installation of the rock will fill these interstitial areas, provide better soil contact with the cuttings, and improve cutting survival.

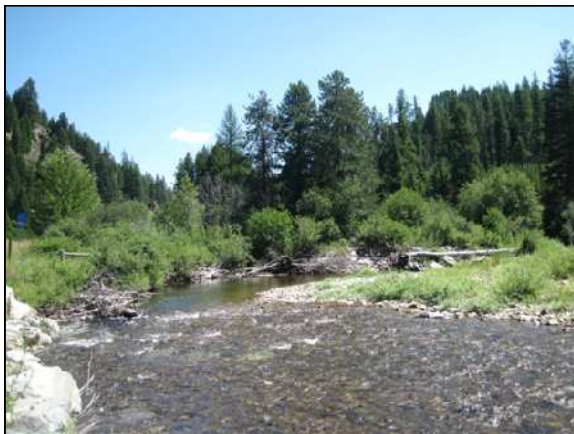
**Photo 3**  
**Description:** Looking at downstream j-hook vane.  
**Compass:** 90 (East)

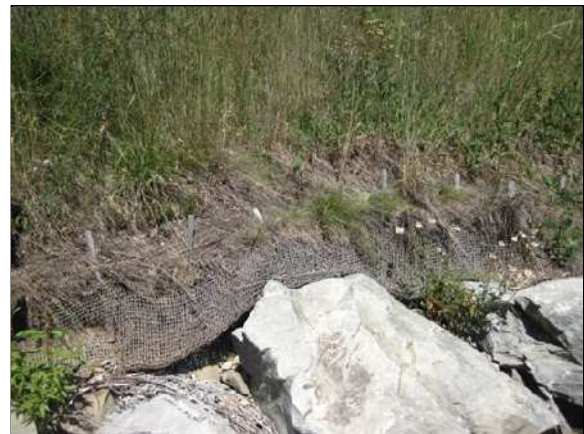
**Photo 6**  
**Description:** Coir fabric above riprap.  
**Compass:** 0 (North)

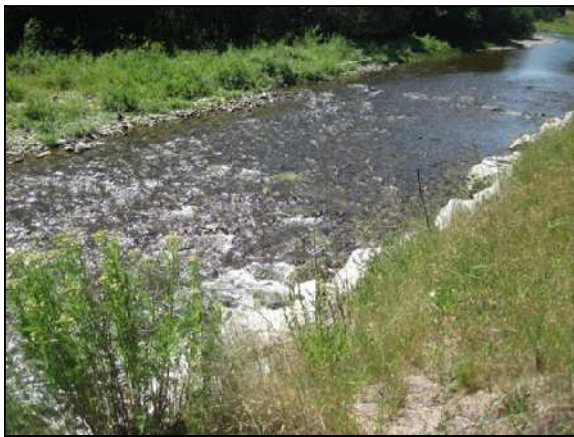
**Photo 7**  
**Description:** Upstream view of both j-hook vanes.  
**Compass:** 230 (Southwest)

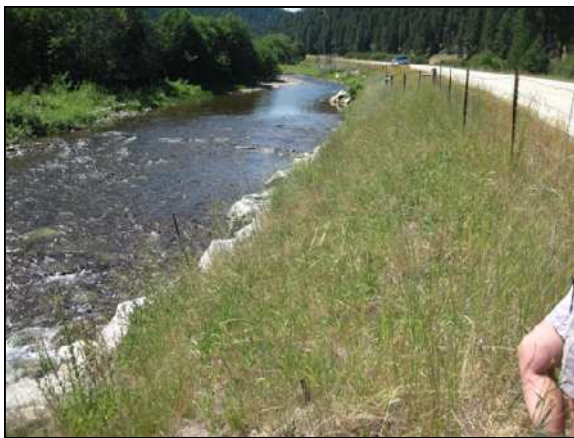
The upper (western) j-hook vane is approximately 22 feet long from the toe of the bank to the vane tip. This vane was installed at approximately a 60 degree angle from the stream bank (0 degrees being parallel, 90 degrees being perpendicular to the bank). The slope of the vane from the toe of the bank to the tip of the vane is nearly flat, with a positive slope of 0.33% (sloping downward toward the bank). The configuration of this j-hook varies from the typical design detail drawing, which specifies placing the rock at a 20-30 degree angle to the bank, and a 2-7% slope from the bank out to the tip of the vane.

**Photo 8**  
**Description:** Upstream j-hook vane.  
**Compass:** 270 (West)

Rock vanes are most effective at preventing erosion when installed at an upstream angle between 20-30 degrees from the bank and at a downward slope of 2-7%. The upper vane has been installed at a 60 degree angle to the bank and an inverted slope of 0.3%. It is unclear if the rock vane was installed at this slope, or if the rock has settled following the latest runoff event. The configuration (bank angle) and elevations of rock near the bank toe of this j-hook vane vary from the typical design figures. The configuration and elevations of this vane would not typically halt erosion in its vicinity; however, large riprap has also been placed along the toe of bank downstream of this vane for approximately 100 feet, preventing bank erosion between the two vanes. Given the additional rock placement is preventing erosion between the j-hooks and no erosion was observed upstream of the upper j-hook, no corrective actions are recommended at this time.

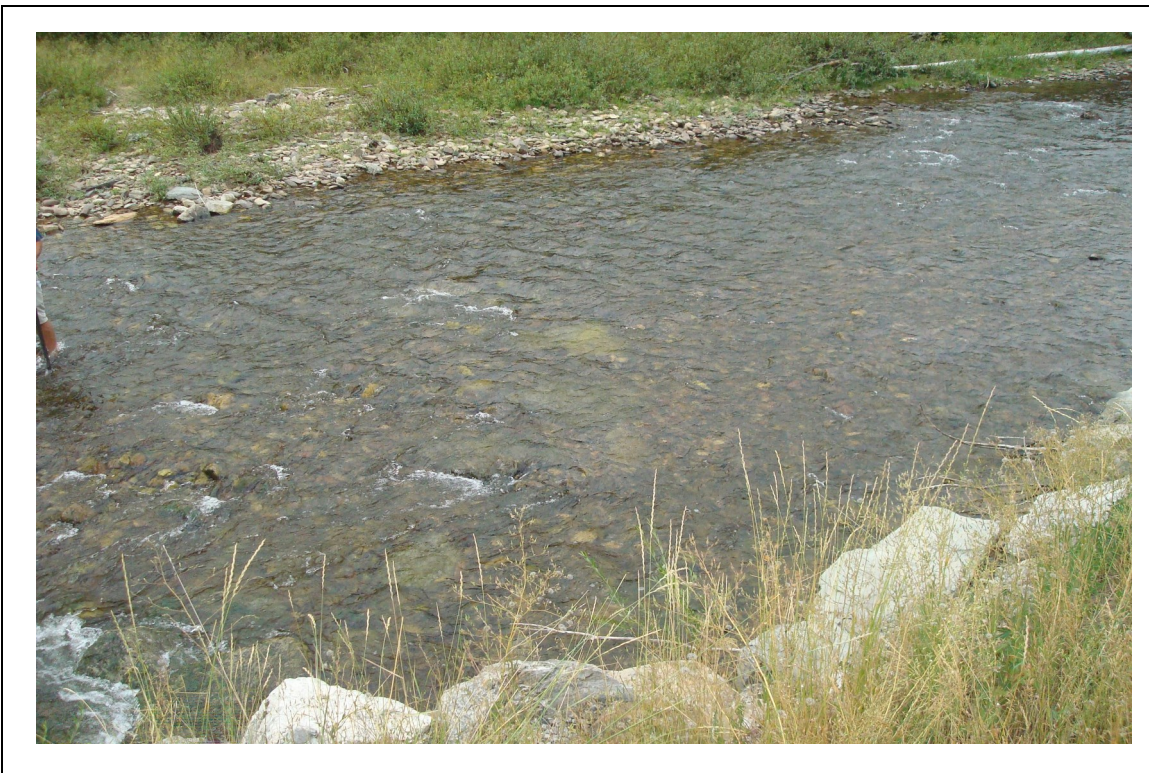
Lower J Hook in Channel  
A-5

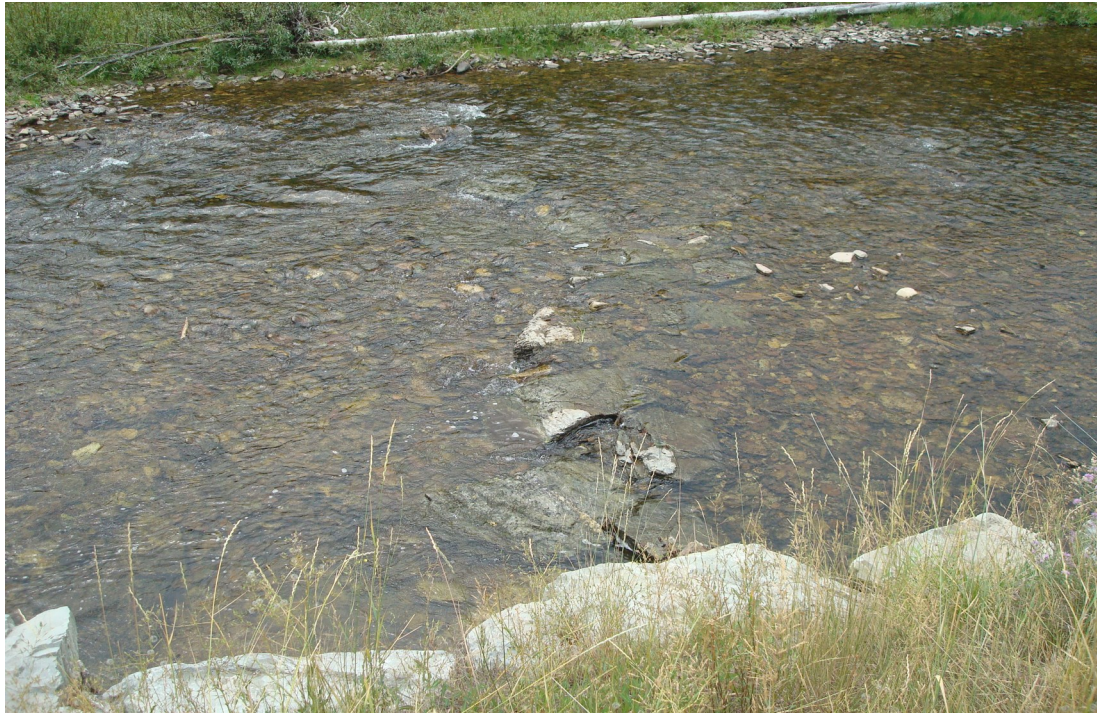
Upper J Hook in Channel
