# MONTANA DEPARTMENT OF TRANSPORTATION STREAM MITIGATION MONITORING REPORT

*Clark Fork River  
Granite County, Montana*

*Project Completed: 2013  
Monitoring Report #2: December, 2014*

Permit No.  
MFWP: SPA MDT R2-14-2012  
USACE: NWO-2012-00831-MTH

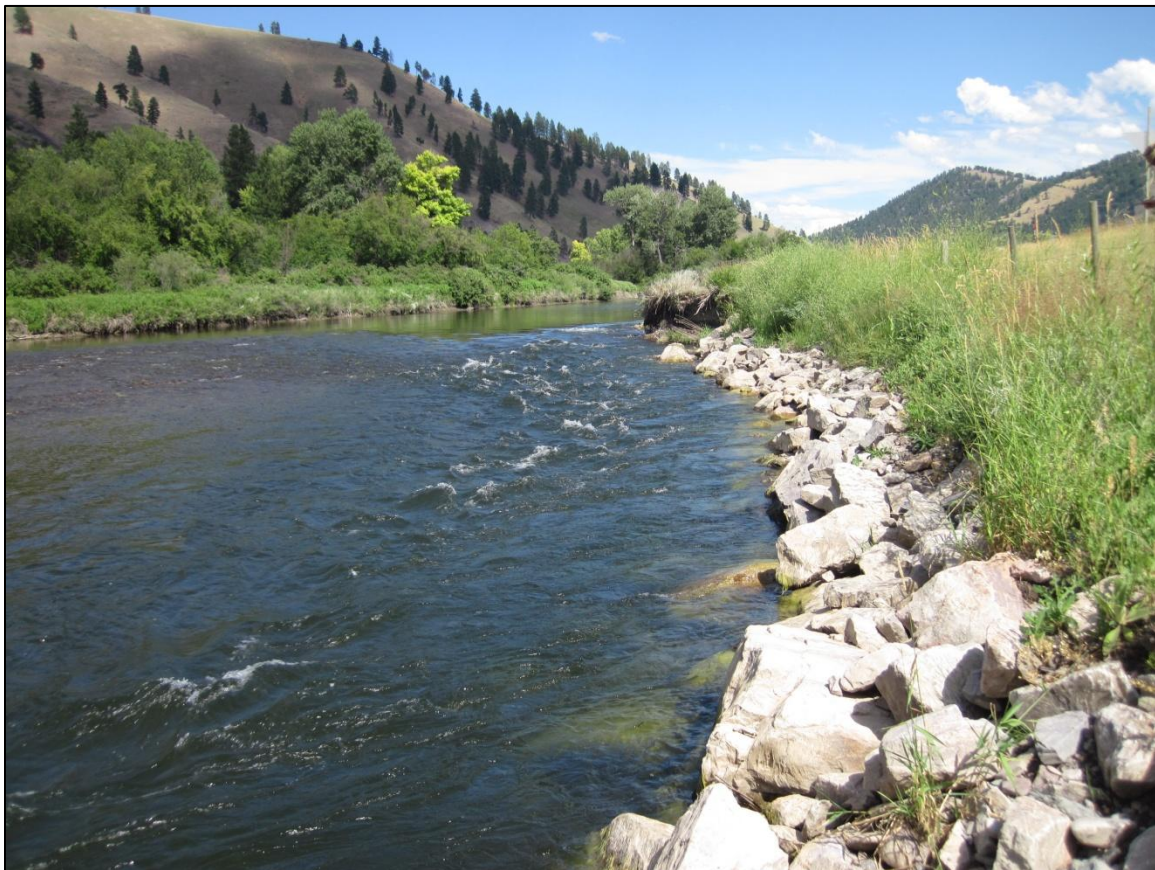
Cover. View of Clark Fork River with riprap and willow plantings looking East (upstream).

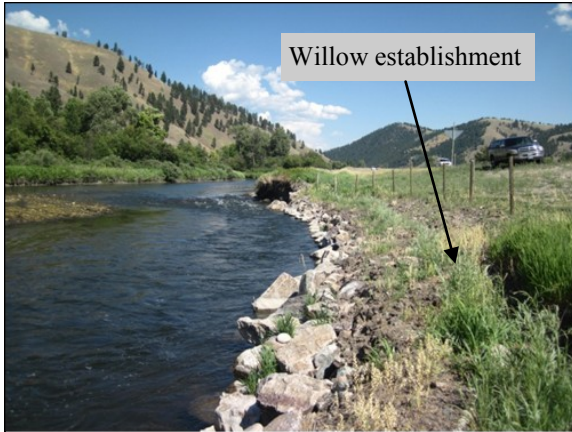
**Photo 1**  
**Description:** View upstream looking at revetment.  
**Taken in 2013**

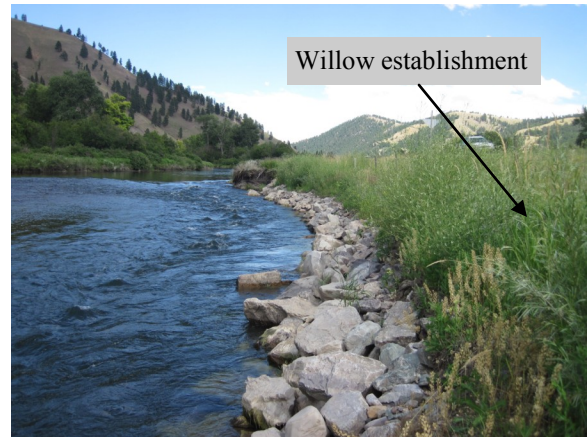
**Photo 1**  
**Description:** View upstream looking at revetment.  
**Taken in 2014**

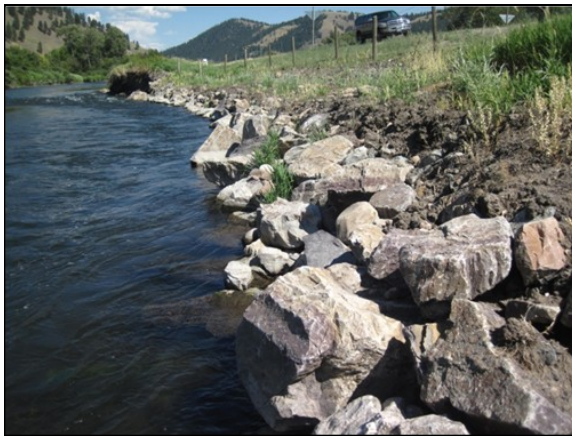
**Photo 2**  
**Description:** Toe of revetment looking upstream.  
**Taken in 2013**

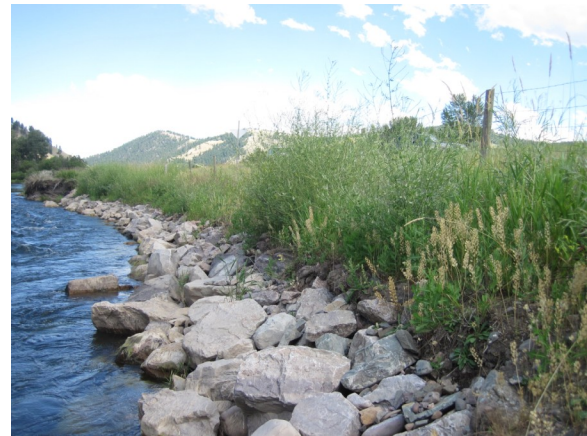
**Photo 2**  
**Description:** Toe of revetment looking upstream.  
**Taken in 2014**

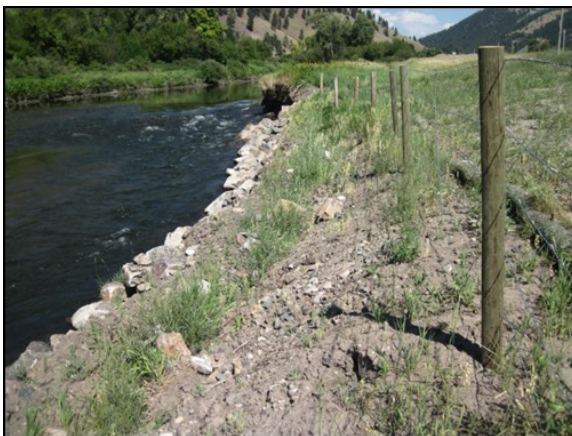
**Photo 3**  
**Description:** Middle of revetment looking upstream.  
**Taken in 2013**

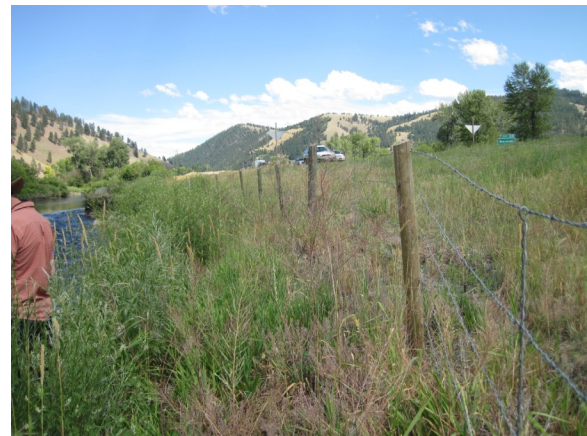
**Photo 3**  
**Description:** Middle of revetment looking upstream.  
**Taken in 2014**

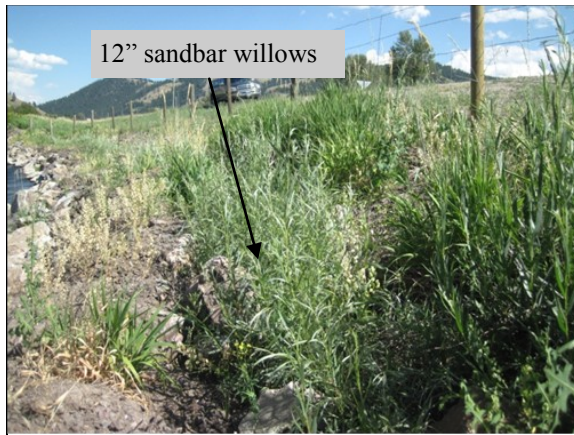
**Photo 4**  
**Description:** Willow growth at top of revetment.  
**Taken in 2013**

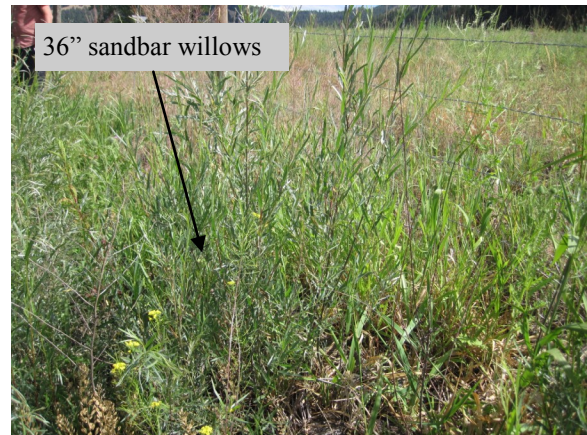
Willow stems approximately 36 inches tall were observed growing along the top of the riprap bank just above the uppermost layer of rock (See photos of willow establishment in Appendix A). These willows are approximately 24" taller than observed during the 2013 monitoring event, and indicate successful establishment. Dead willow stems were observed in 2013, but were not in 2014; presumably due to desiccation and decay two years following installation. Although no dead stems were observed in 2014, the number of dead stems estimated from 2013 has been included in the survival count to provide a more accurate result of survival (Table 1).

**Photo 4**  
**Description:** Willow growth at top of revetment.  
**Taken in 2014**

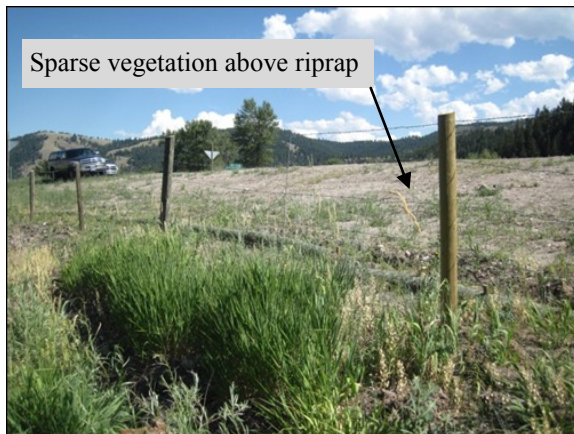
**Photo 5**  
**Description:** Weedy streambank/work area.  
**Taken in 2013**

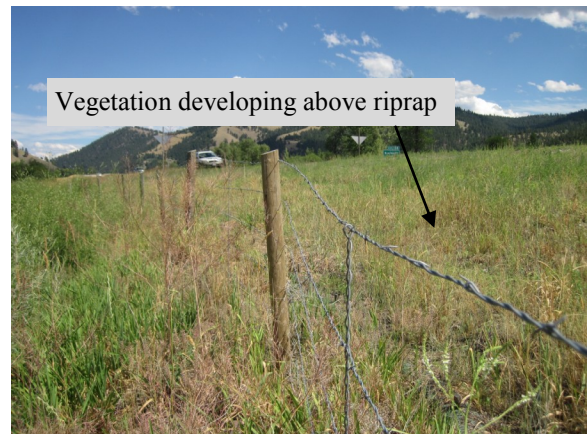
2014 monitoring indicated vegetation has become better established between the north edge of the highway and the stabilized bank (see Photos 5 and 6 in Appendix A). This area was likely used for equipment staging, and was poorly vegetated in 2013. Although vegetation is more established in this area, many of the observed species were weeds and undesirable species.

**Photo 5**  
**Description:** Weedy streambank/work area.  
**Taken in 2014**

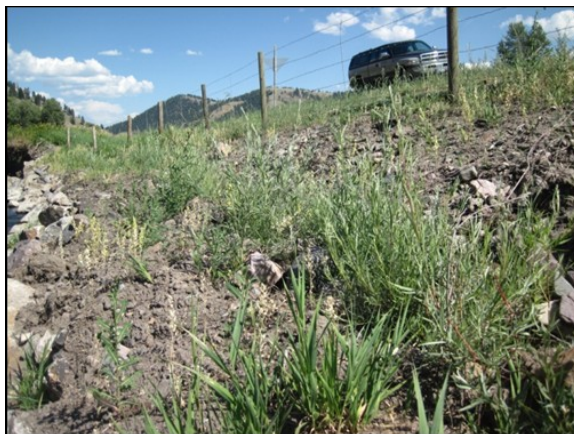
**Photo 6**  
**Description:** Sandbar willow growth and bare ground.  
**Taken in 2013**

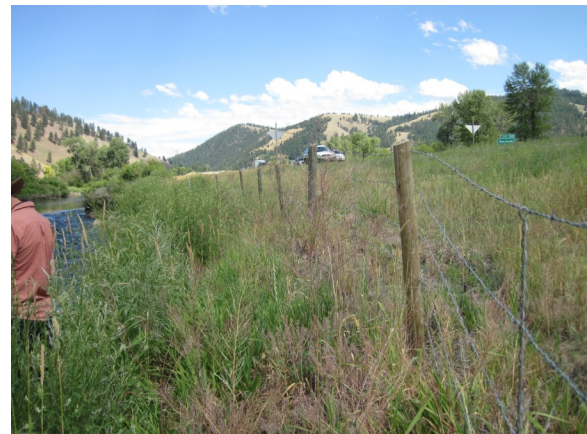
**Photo 6**  
**Description:** Sandbar willow growth and bare ground.  
**Taken in 2014**

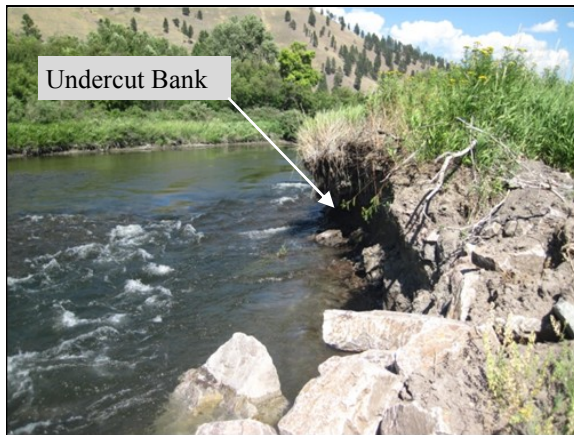
**Photo 7**  
**Description:** Eroding streambank at upstream extent.  
**Taken in 2013**

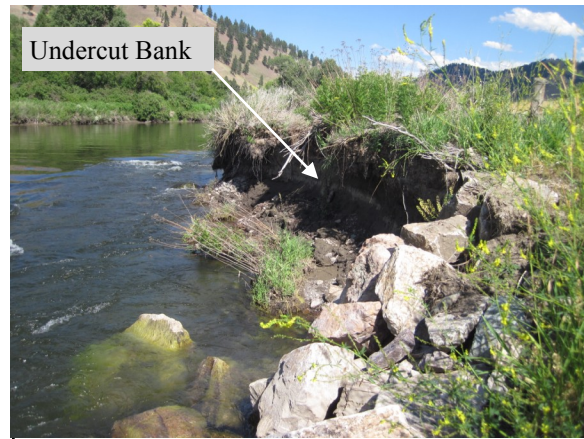
Bank erosion was observed just upstream of the riprapped bank in 2013. Monitoring in 2014 indicated the erosion extended approximately 15 feet further upstream and 3-4 feet laterally to the south (See Photo 7 in Appendix A). The upstream extend of the riprap has been keyed in approximately 15-20 feet further into the bank, and as a result, the erosion is not currently threatening to cut behind the riprap.

**Photo 7**  
**Description:** Eroding streambank at upstream extent.  
**Taken in 2014**

Upstream of the project area is an eroding bank approximately forty-five feet in length (Photo 7, Appendix A). This bank does not currently appear to threaten the project area; however the eroding streambank should be monitored to determine if it becomes a threat to the stabilized streambank or the Interstate. If the bank continues to erode, placement of additional riprap may be recommended to maintain protection of the highway. If necessary, the extent of additional riprap installation should be evaluated based on anticipated erosive activity, flow direction, bar formation, existing bank materials, and vegetative composition.

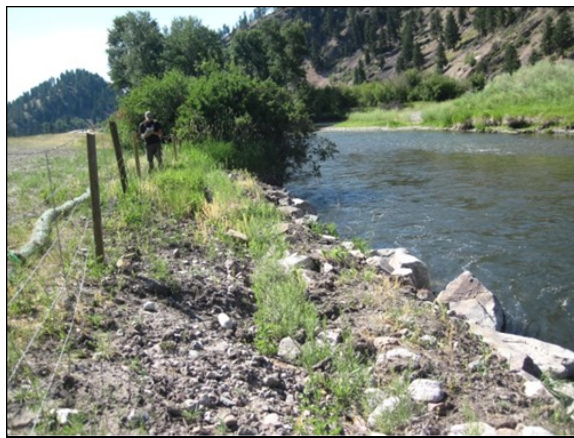
**Photo 8**  
**Description:** Middle of revetment looking downstream.  
**Taken in 2013**

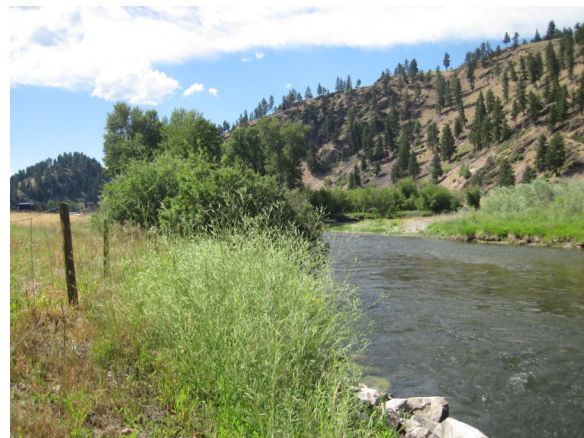
**Photo 8**  
**Description:** Middle of revetment looking downstream.  
**Taken in 2014**

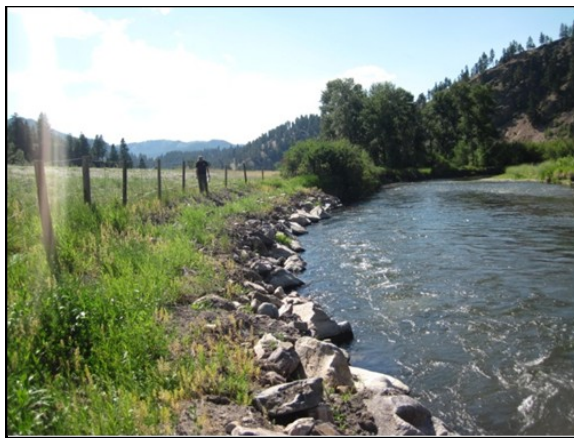
**Photo 9**  
**Description:** Looking downstream at revetment.  
**Taken in 2013**

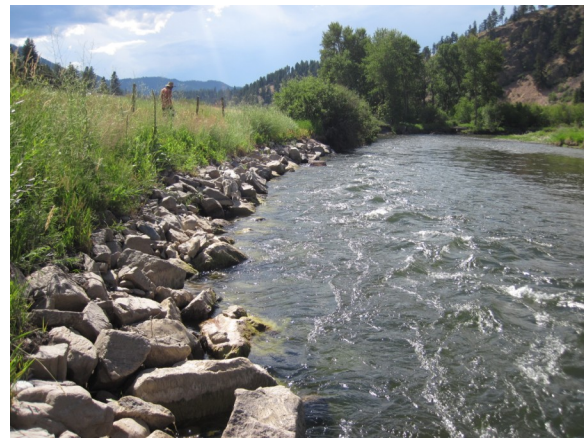
**Photo 9**  
**Description:** Looking downstream at revetment.  
**Taken in 2014**

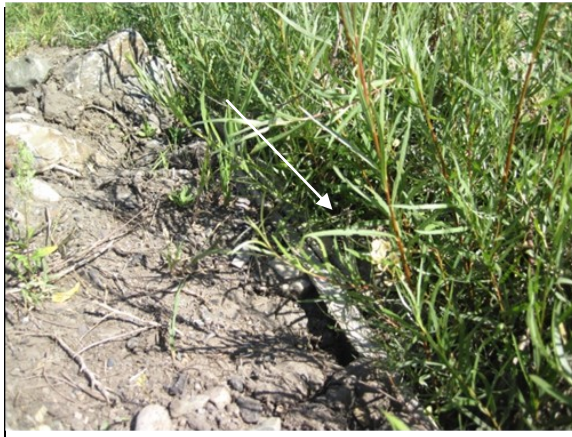
**Photo 10**  
**Description:** Close-up of sandbar willow growth.  
**Taken in 2013**

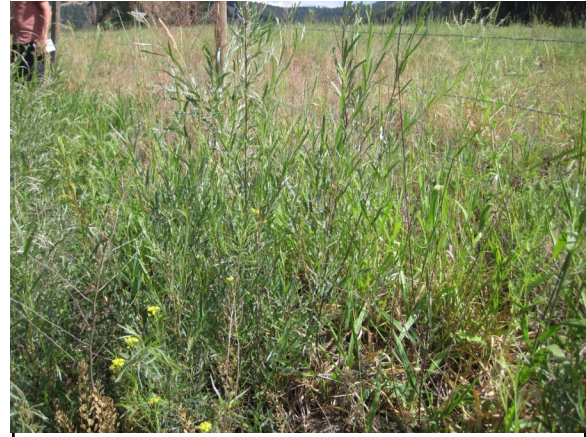
**Photo 10**  
**Description:** Close-up of sandbar willow growth.  
**Taken in 2014**

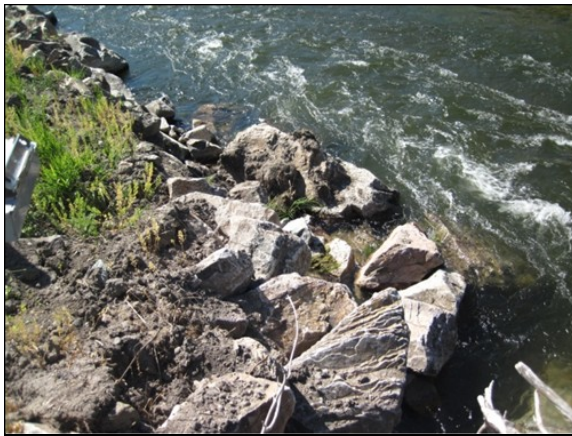
**Photo 11**  
**Description:** Upstream extent of rip-rapped stream-bank.  
**Taken in 2013**

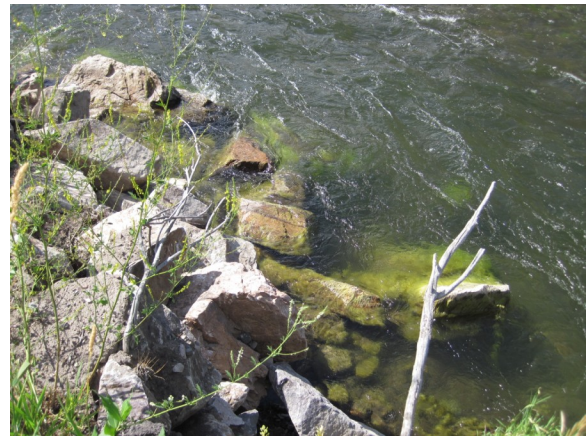
**Photo 11**  
**Description:** Upstream extent of rip-rapped stream-bank.  
**Taken in 2014**

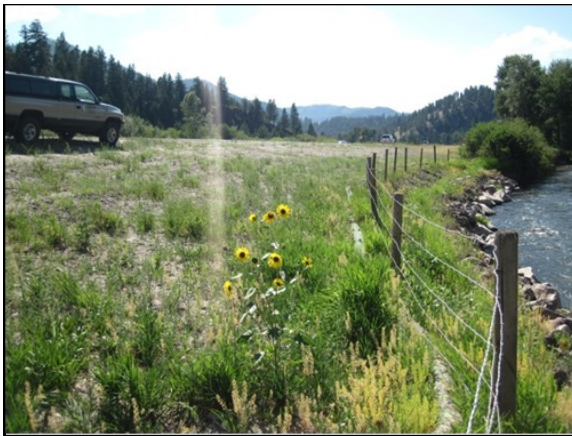
**Photo 12**  
**Description:** Weedy and bare re-sloped work area.  
**Taken in 2013**

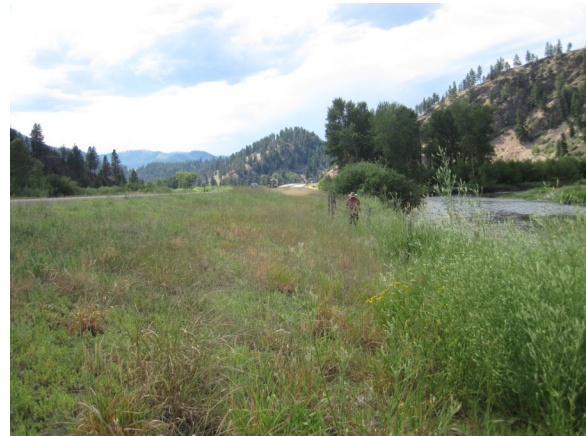
The upper streambank area and project staging area contained a large amount of weedy and undesirable species and approximately 30% bare ground (Photo 12, Appendix A). The majority of this area lies within the roadway clear zone, which is regularly mowed and used for maintenance activities. As such, this area is expected to take additional time to establish desirable species as compared to undisturbed areas. Weed control efforts along the roadway clear zone is suggested to prevent additional weed colonization.

**Photo 12**  
**Description:** Weedy and bare re-sloped work area.  
**Taken in 2014**

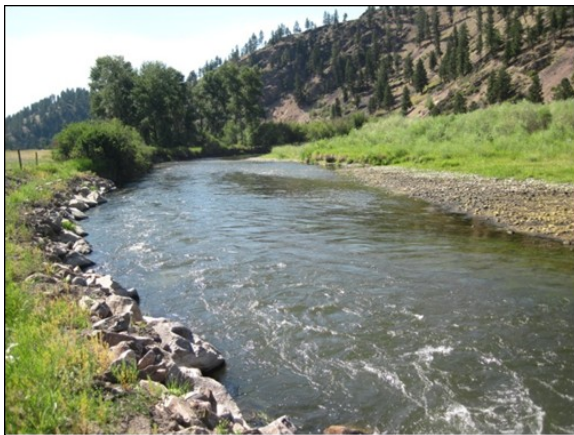
**Photo 13**  
**Description:** Looking downstream at revetment  
**Taken in 2013**

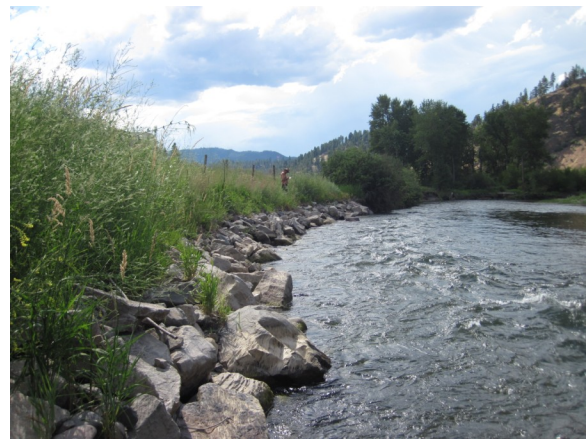
**Photo 13**  
**Description:** Looking downstream at revetment.  
**Taken in 2014**
