# MONTANA DEPARTMENT OF TRANSPORTATION STREAM MITIGATION MONITORING REPORT

*North Fork Bear Creek  
Ravalli County, Montana*

*Year Project Completed: 2011  
Monitoring Report #2: Submitted December, 2014*

MDT Project Number: NH-7-1(114)56  
Control Number: 2015 003

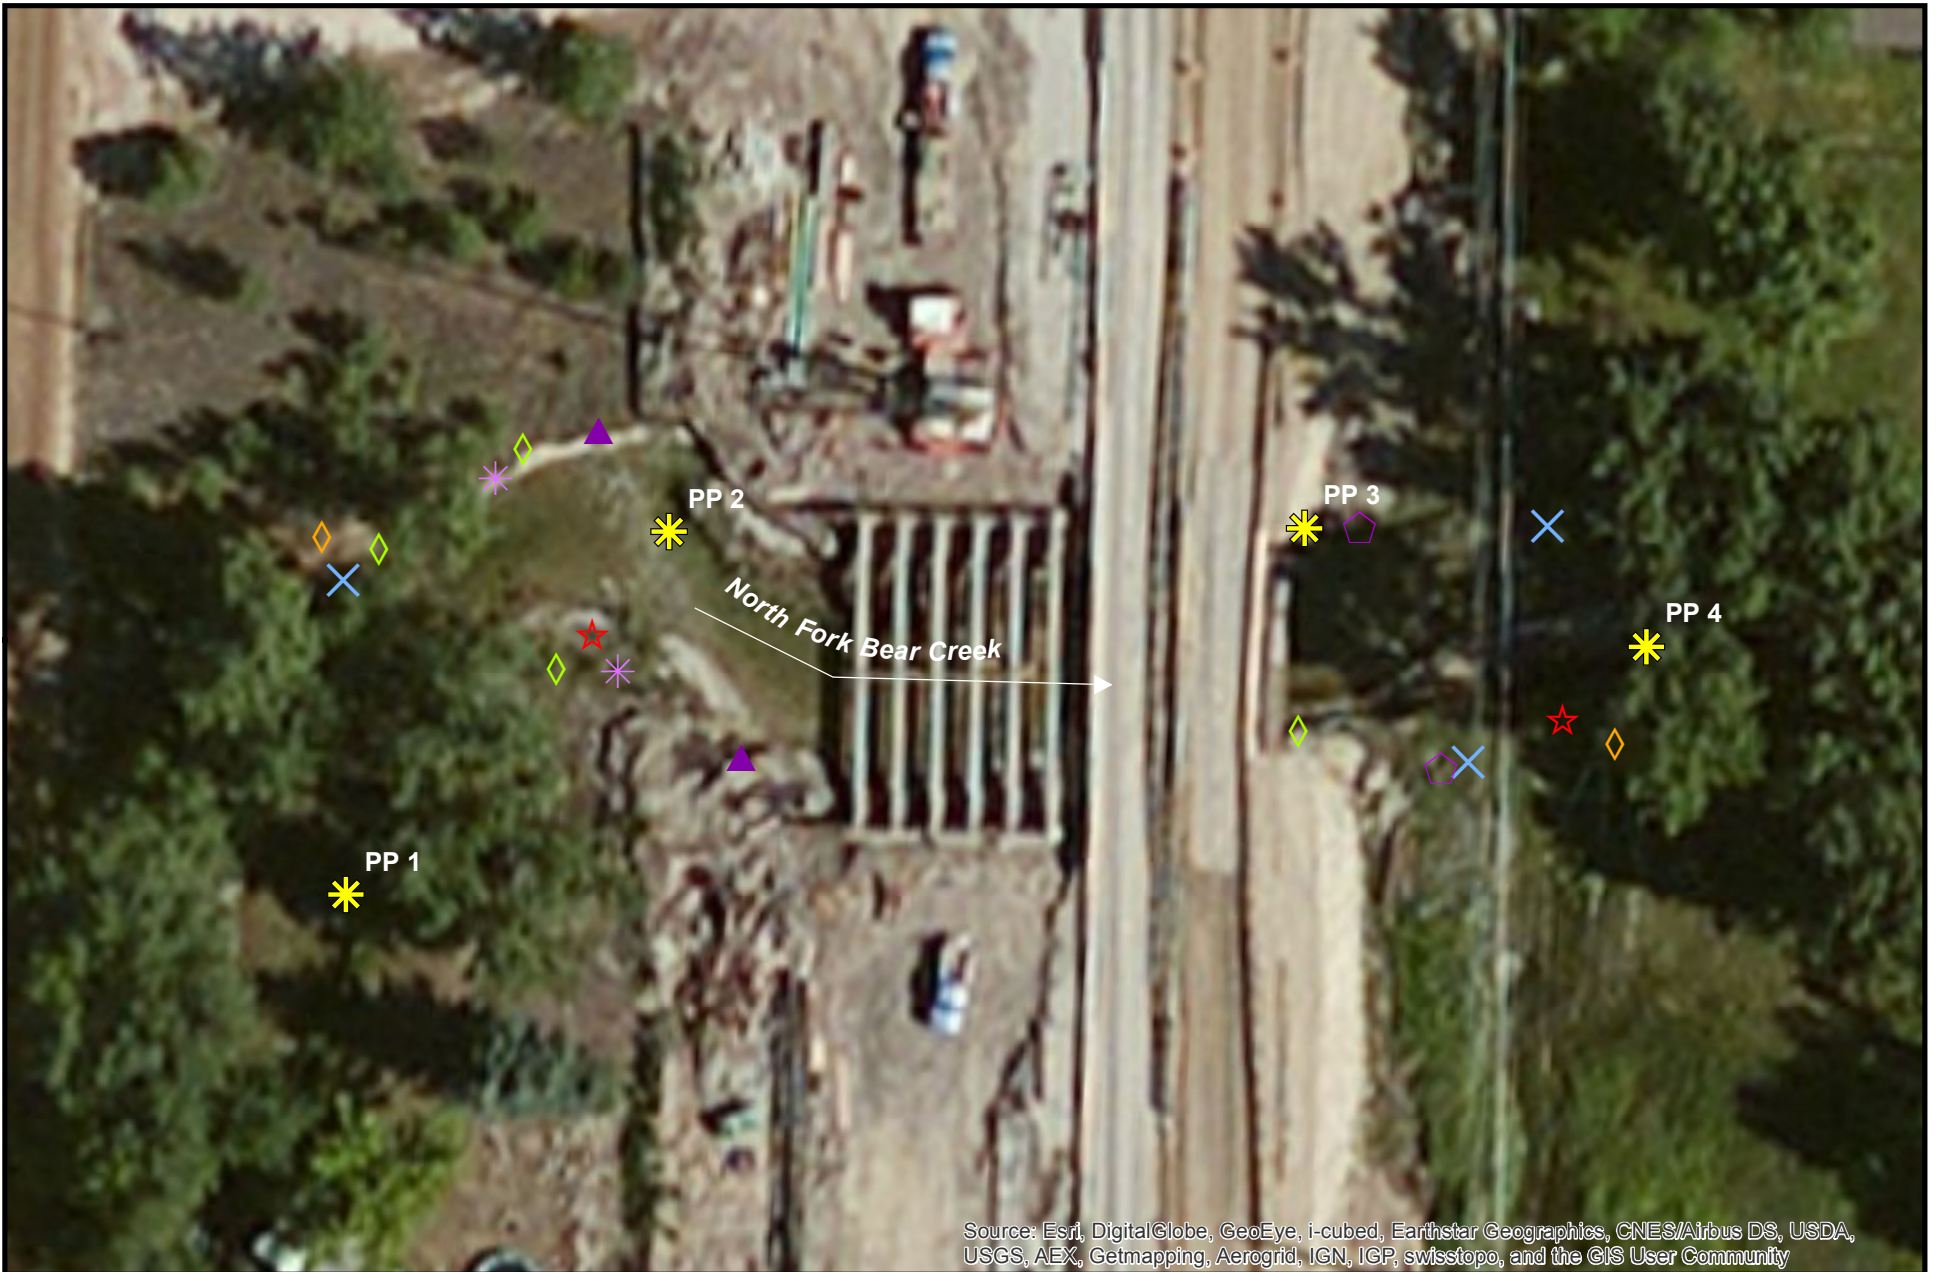
Noxious weeds were estimated at 35% areal coverage of the project site, which does not meet the performance standard of less than 10% areal coverage. Three additional noxious weeds were observed in 2014 as compared to the 2013 monitoring event, bringing the total number of noxious weed species observed to eight. Identified noxious weeds include knotweed complex, broad-leaf pepperwort, spotted knapweed, Canadian thistle, field bindweed, gypsy-flower (houndstongue), oxeye daisy, and common tansy. Noxious weeds were observed along both banks of the project reach, and were primarily concentrated upstream of the Highway 93 Bridge.

Monitoring events in both 2013 and 2014 documented relatively high occurrences of noxious weeds within the project site, resulting in an overall decline in the percent cover of desirable species. Implementation of a weed control plan at this project site would improve the likelihood of achieving the performance standards established for total vegetative cover of desirable species, and noxious weed cover. Noxious weeds were observed on both banks, and were primarily concentrated on the upstream side of the

Highway 93 Bridge. Locations of specific weed infestations are included on Figure 2 in Appendix A.

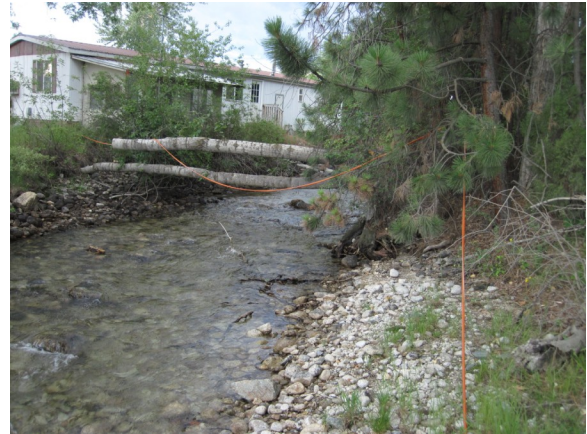
**Photo Point 1.4—2014**  
**Description:** View of dry channel looking upstream.  
**Compass:** 230 (Southwest)

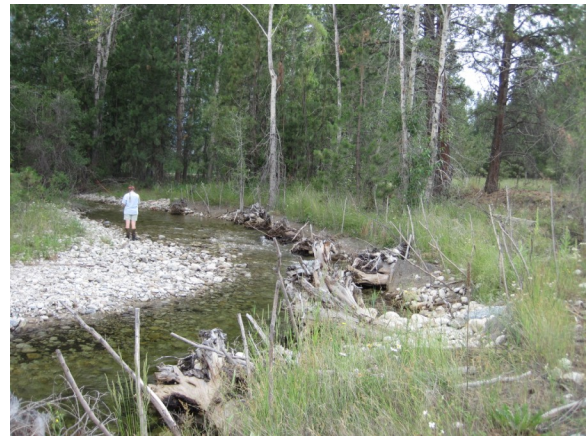
**Photo Point 2.1—2014**  
**Description:** View upstream of root wads on north bank.  
**Compass:** 225 (Southwest)

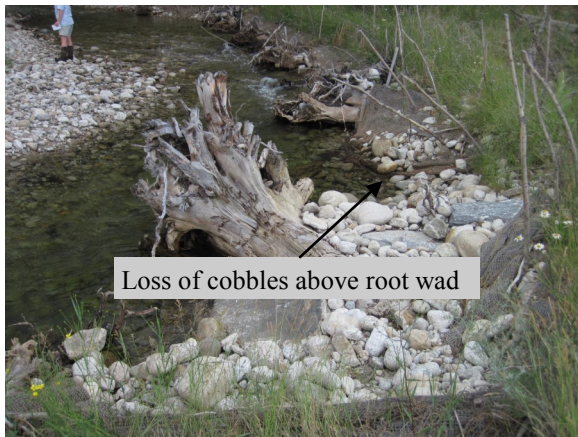
Loss of cobbles above root wad

**Photo 1**  
**Description:** Root wads upstream of bridge.

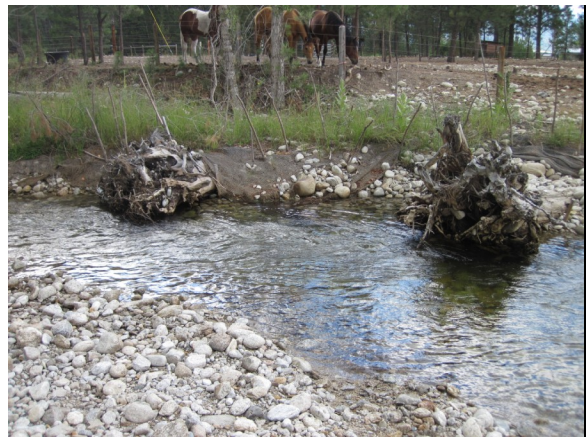
The trunk of one root wad installed upstream of Highway 93 appeared more exposed from the year prior (see Photo 2 in Appendix B). The exposure of this trunk appears as a result of the loss of cobble material placed on the upper six inches of the bank during high flows in 2014. Cobble materials placed over this root wad were covered with a layer of topsoil and coir fabric during construction; however, the fabric has peeled back from the top of the bank and is no longer providing protection of the upper bank. If additional cobbles adjacent to this root wad mobilize during subsequent high flows, the root ball may create a scouring hydraulic against the bank, reducing the ability of the

root wad to provide bank protection. Although the bank is not currently considered eroding due to the lack of lateral channel movement, continued monitoring is highly recommended to determine whether this segment of the project reach becomes more susceptible to erosion.

No streambank erosion was noted along the reconstructed banks within the North Fork Bear Creek Stream Mitigation Site. Root wads placed along the north bank appear to be mostly stable, with upper bank scour observed adjacent to one of the root wads. No lateral bank retreat was observed, and as a result, no measures are currently warranted to improve bank stability within the project reach. Monitoring of the exposed root wad is recommended to determine if that bank segment becomes unstable following future high water events.

**Photo 2**  
**Description:** Root wad upstream of bridge showing scour.

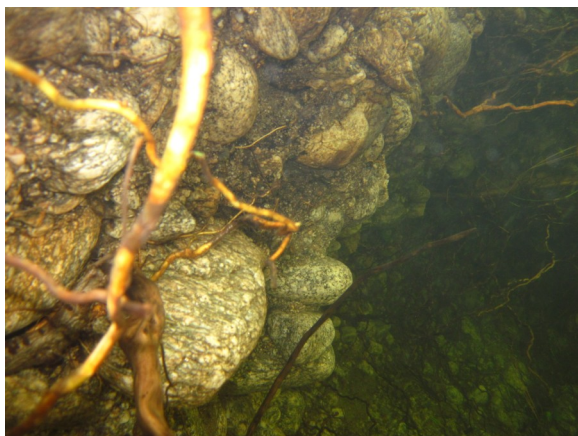
**Photo 3**  
**Description:** Underwater photo of large hole downstream of project site.

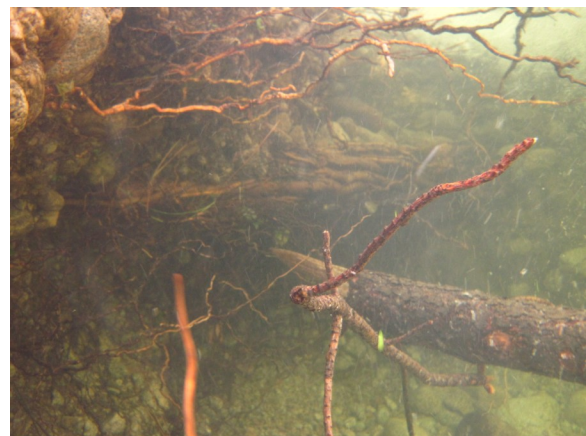
**Photo 4**  
**Description:** Underwater photo of large hole downstream of project site.

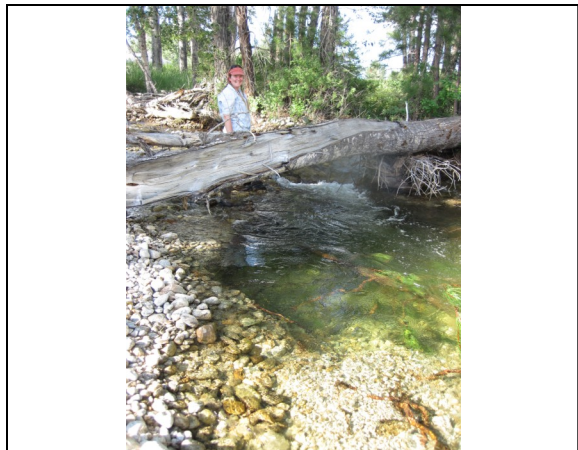
**Photo 5**  
**Description:** Large hole downstream of project site.
