MONTANA DEPARTMENT OF TRANSPORTATION STREAM MITIGATION MONITORING REPORT

*Clark Fork River
Granite County, Montana*

*Project Completed: 2013
Monitoring Report #3: December, 2015*

Permit No.
MFWP: SPA MDT R2-14-2012
USACE: NWO-2012-00831-MTH

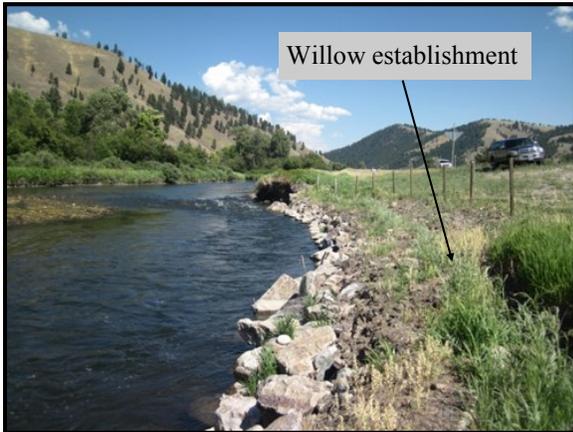
Photo 1
Description: View upstream looking at revetment.
Taken in 2013

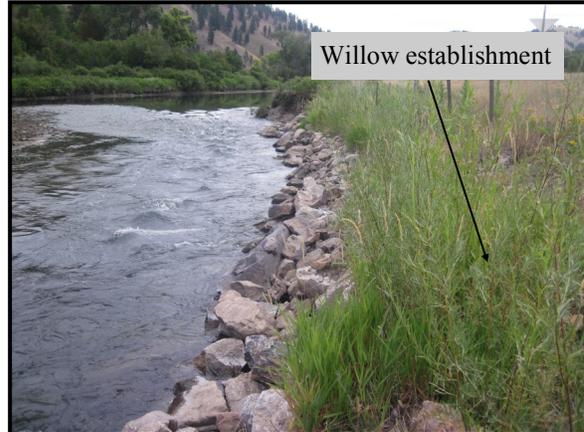
Willows stems ranging from three to seven feet tall were observed along the top of the riprap bank just above the uppermost layer of rock (See Photo 1 and Photo 4 of willow

establishment in Appendix A). These willows are approximately 24” taller than observed during the 2014 monitoring event, and indicate successful establishment three years following their placement. Planted willow cutting survival rates were determined by dividing the number of live willows observed (67) by the total number of willows observed above the riprap (101). Using this method, the success rate of willows planted above the riprap is 66% (Table 1). If the number of surviving willows above the riprap (67) is compared to the total number of willow shoots inspected above the riprap in 2013 (345), the survival rate is 19%.

Photo 1
Description: View upstream looking at revetment.
Taken in 2015

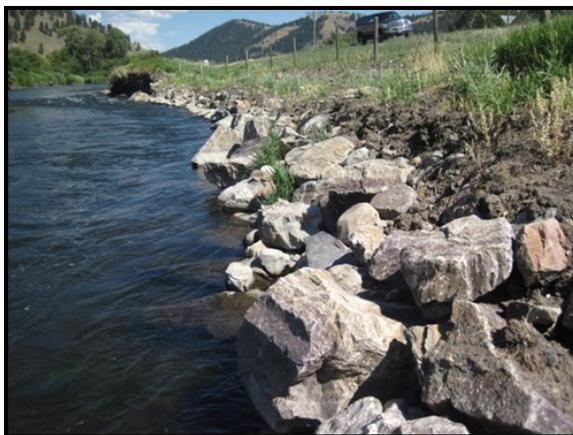
Photo 2
Description: Toe of revetment looking upstream.
Taken in 2013

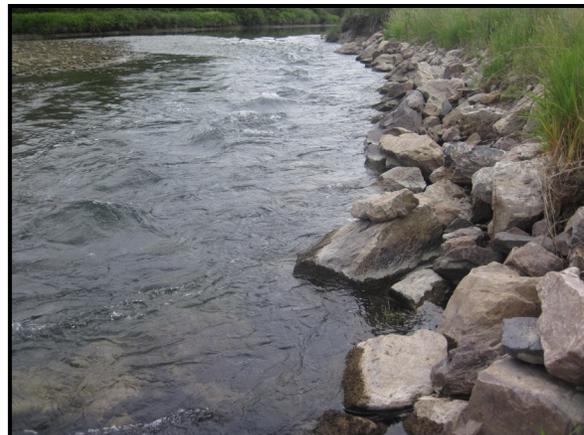
Willow cuttings planted beneath the riprap have largely been unable to successfully establish (See Photos 2 and 9 in Appendix A). In 2015, 11 willow stems were observed sprouting through the riprap, while an additional 39 dead stems were found in the voids between rock layers. It is possible some woody roots have established beneath the riprap and have yet to produce stems. To date, the survival rate of willows planted beneath the riprap is 22%. The overall survival rate of willows observed beneath and above the riprap is 52% (Table 1).

Photo 2
Description: Toe of revetment looking upstream.
Taken in 2015

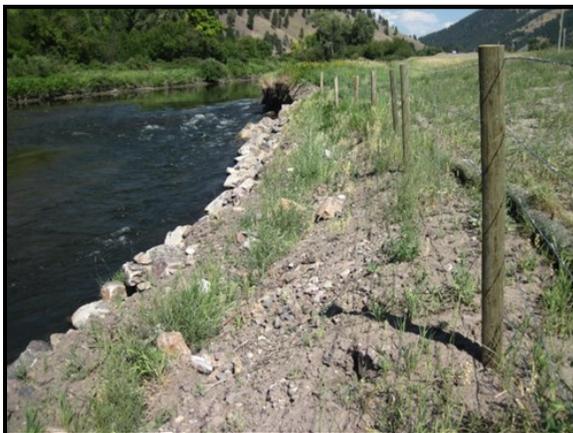
Photo 3
Description: Middle of revetment looking upstream.
Taken in 2013

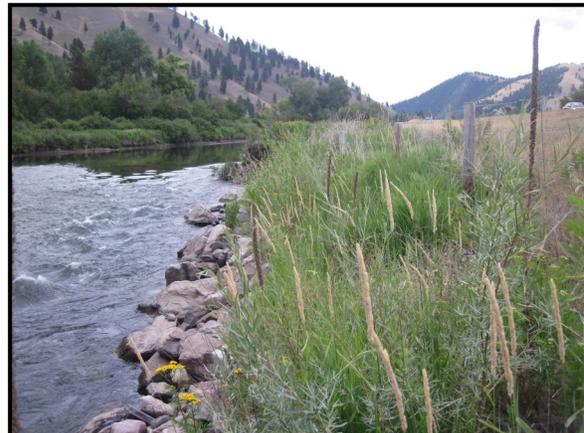
Photo 3
Description: Middle of revetment looking upstream.
Taken in 2015

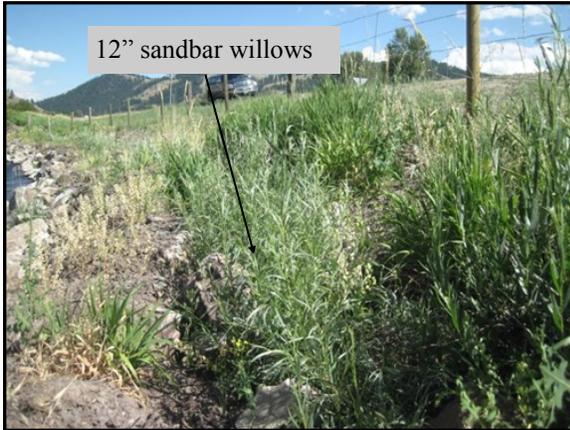
Photo 4
Description: Willow growth at top of revetment.
Taken in 2013

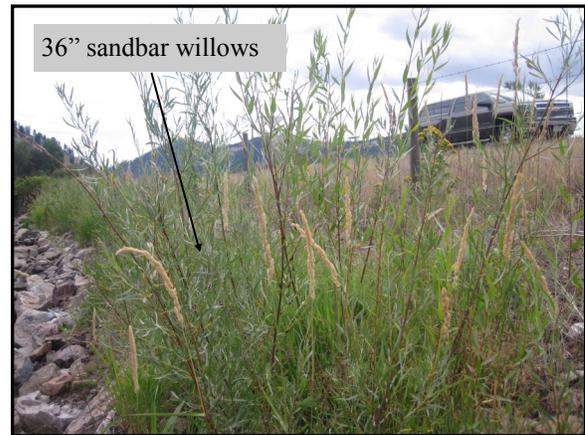
Photo 4
Description: Willow growth at top of revetment.
Taken in 2015

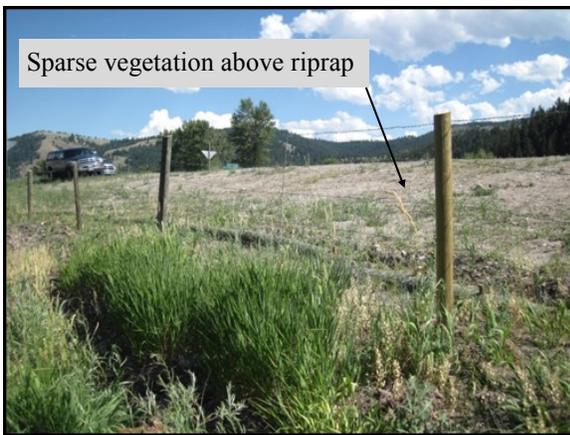
Photo 5
Description: Highway embankment / access area.
Taken in 2013

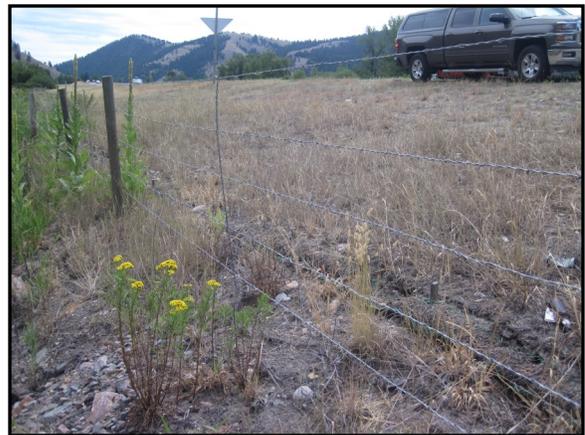
Vegetation has continued to establish between the north edge of the highway and the stabilized bank (see Photos 5 and 12 in Appendix A), although dry conditions during the growing season in 2015 appears to have limited the overall percent cover of this area. Two additional species of noxious weed species were noted in 2015, bringing the total number of species observed to five. Noxious weed species observed are summarized

Photo 5
Description: Weedy streambank/work area.
Taken in 2015

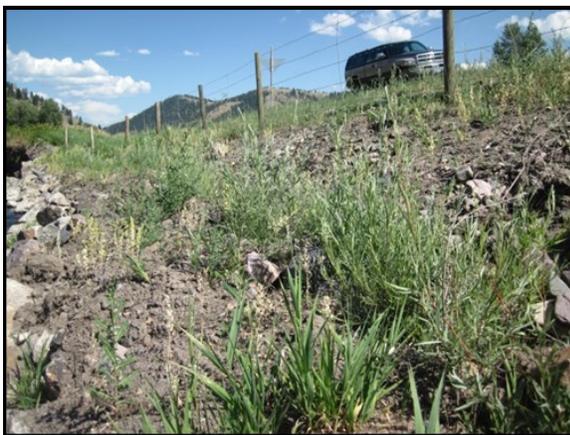
Photo 6
Description: Sandbar willow growth and bare ground.
Taken in 2013

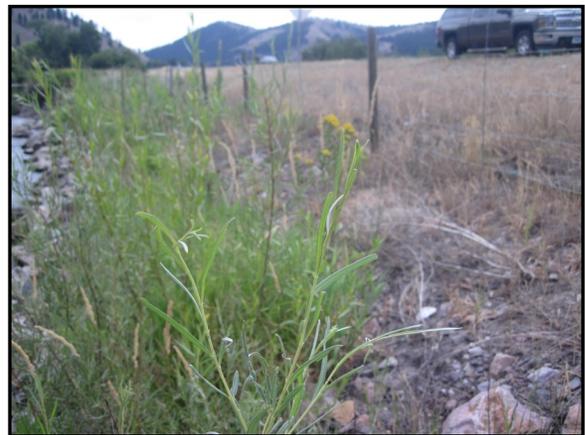
Photo 6
Description: Sandbar willow growth and bare ground.
Taken in 2015

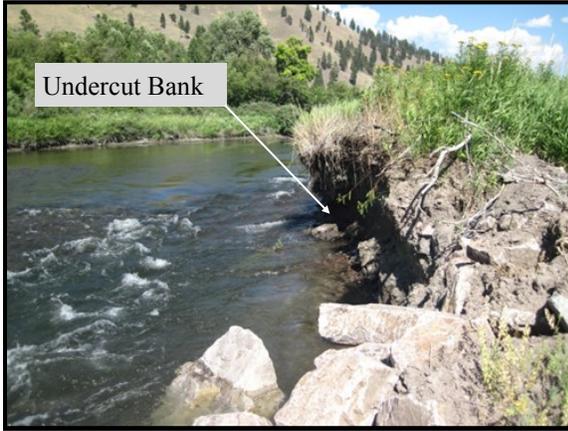
Photo 7
Description: Eroding streambank at upstream extent.
Taken in 2013

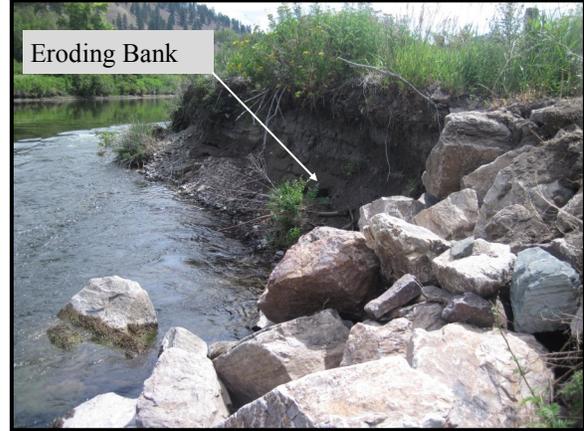
Bank erosion was noted in 2014 immediately upstream of the placed riprap. This bank eroded further in 2015, and has exposed approximately six additional linear feet of the riprap that was keyed in to the bank during construction (See Photo 7 in Appendix A). Although the erosion noted to date has yet to threaten the stability of the bank, additional observations may be warranted to ensure the riprap is not flanked over time.

Photo 7
Description: Eroding streambank at upstream extent.
Taken in 2015

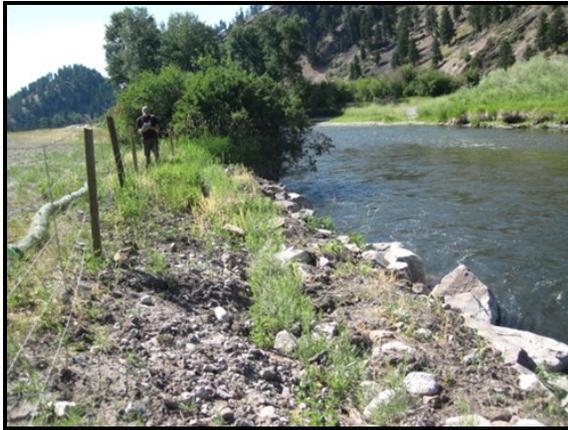
Photo 8
Description: Middle of revetment looking downstream.
Taken in 2013

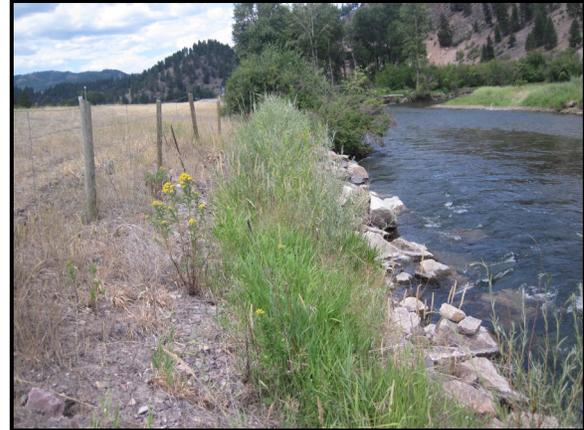
Photo 8
Description: Middle of revetment looking downstream.
Taken in 2015

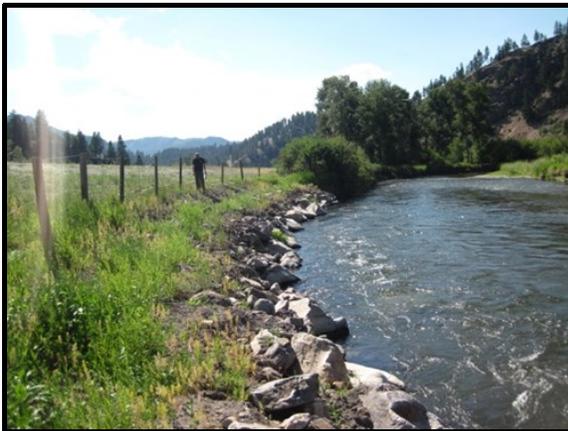
Photo 9
Description: Looking downstream at revetment.
Taken in 2013

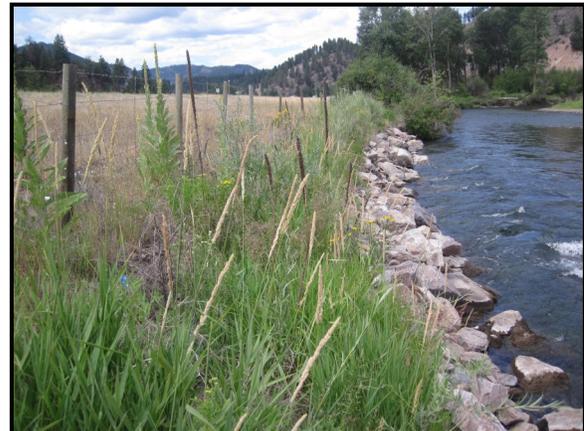
Photo 9
Description: Looking downstream at revetment.
Taken in 2015

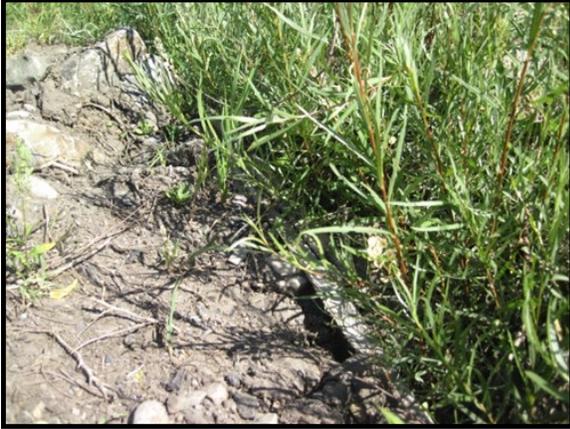
Photo 10
Description: Close-up of sandbar willow growth.
Taken in 2013

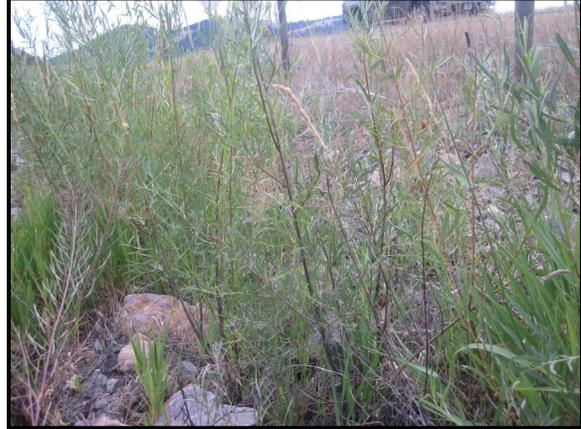
Photo 10
Description: Close-up of sandbar willow growth.
Taken in 2015

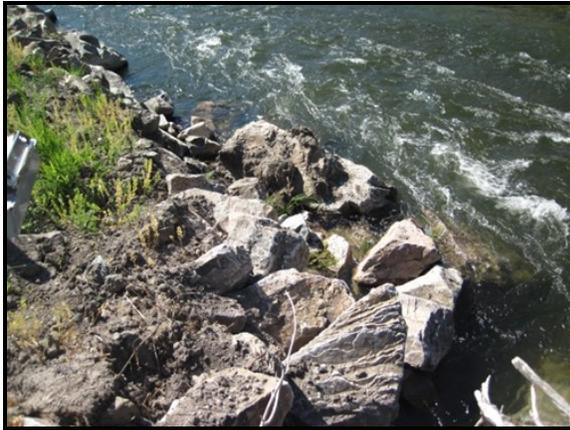
Photo 11
Description: Upstream extent of rip-rapped stream-bank.
Taken in 2013

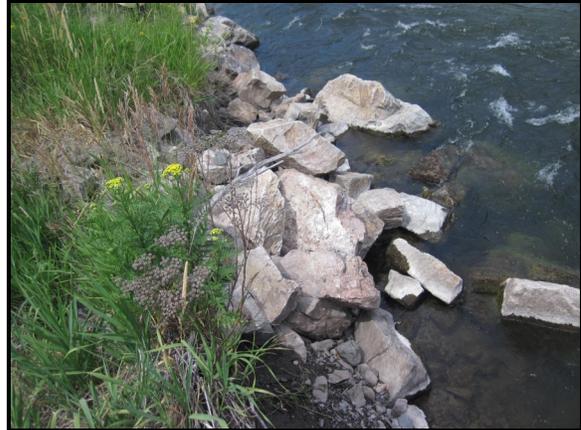
Photo 11
Description: Upstream extent of rip-rapped stream-bank.
Taken in 2015

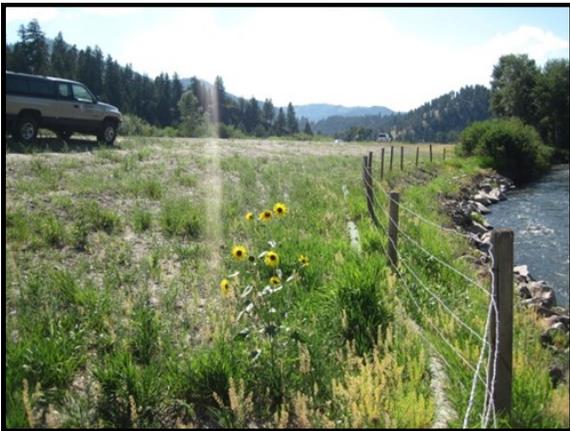
Photo 12
Description: Highway embankment adjacent to bank.
Taken in 2013

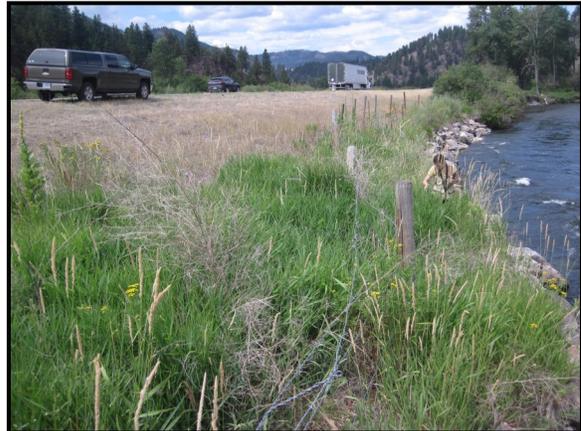
The upper river bank area and highway embankment exhibits a large amount of weedy and undesirable species and approximately 15% bare ground (Photo 12, Appendix A). The majority of this area lies within the roadway clear zone, which is regularly mowed and used for maintenance activities. As such, this area is expected to take additional time to establish desirable species as compared to undisturbed areas.

Photo 12
Description: Highway embankment adjacent to bank.
Taken in 2015

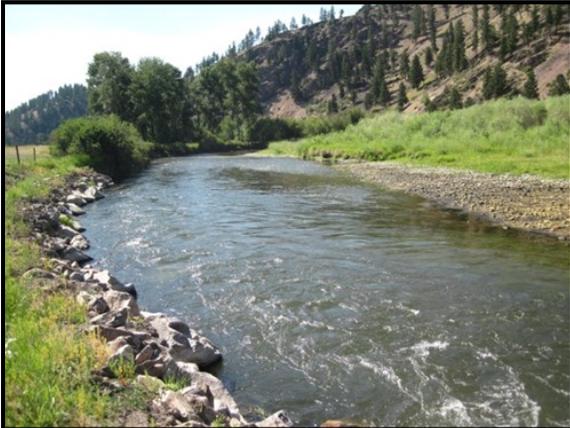
Photo 13
Description: Looking downstream at revetment
Taken in 2013

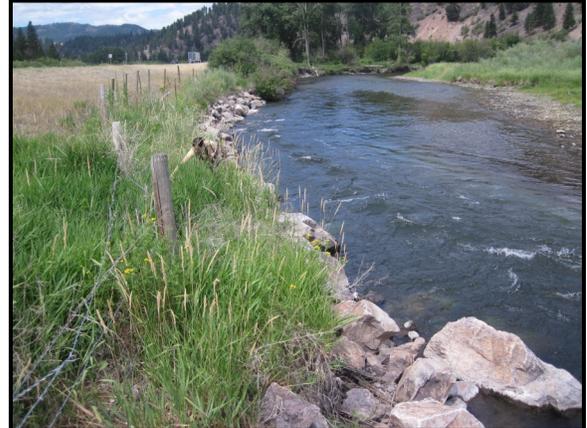
Photo 13
Description: Looking downstream at revetment.
Taken in 2015

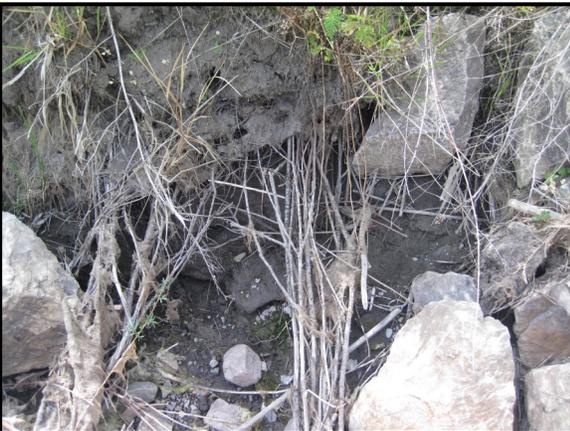
Additional Photo
Description: Dead willows in revetment
Taken in 2015

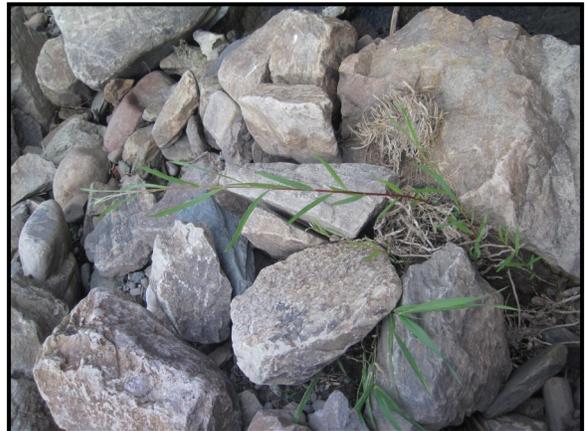
Additional Photo
Description: Willow growing in revetment
Taken in 2015
