MONTANA DEPARTMENT OF TRANSPORTATION STREAM MITIGATION MONITORING REPORT

*Clark Fork River
Granite County, Montana*

*Project Completed: 2013
Monitoring Report #4: December, 2016*

Permit No.
MFWP: SPA MDT R2-14-2012
USACE: NWO-2012-00831-MTH

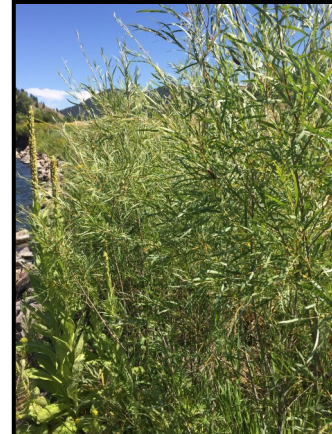
Photo 4
Description: Willow growth at top of revetment.
Taken in 2016

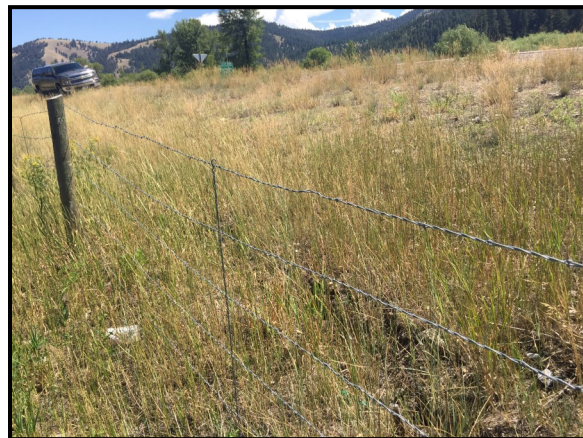
Vegetation has continued to establish between the north edge of the highway and the stabilized bank (see Photos 5 and 12 in Appendix A). The same five noxious weed species observed during the 2015 monitoring event were identified during the 2016 monitoring event and are summarized in Table 3. All noxious weed species were identified in trace to low amounts, which is defined as infestations covering less than 1% and 1-5% of the inspected area, respectively.

Photo 5
Description: Weedy streambank/work area.
Taken in 2016

The area above the riprap has been reclaimed by seeding and sprigging woody cuttings through a layer of topsoil. This area exhibits woody and herbaceous establishment as indicated by maturation of surviving willows and forbs. Weed management efforts should reduce the potential for colonization by new species and spread of those currently inhabiting the site.

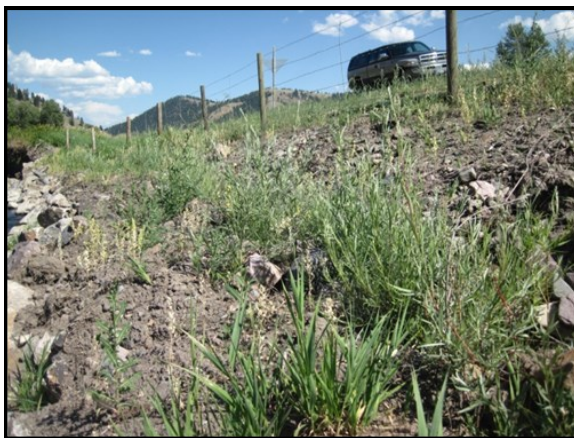
Photo 6
Description: Sandbar willow growth and bare ground.
Taken in 2013

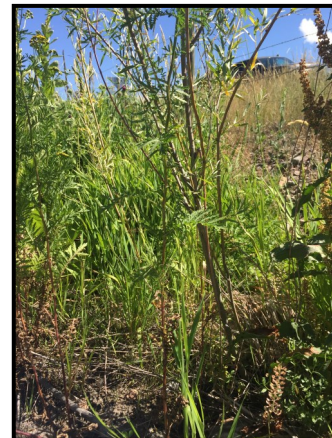
Photo 6
Description: Sandbar willow growth .
Taken in 2016

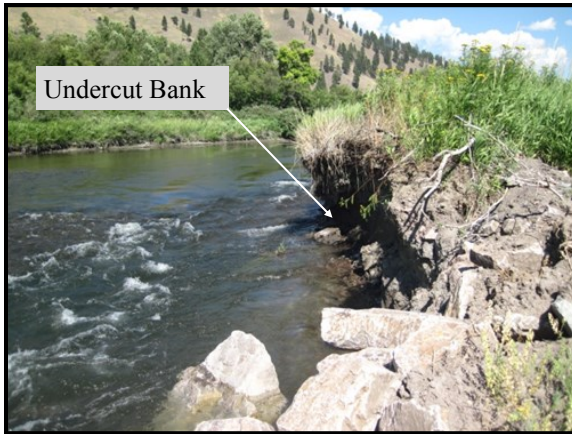
Photo 7
Description: Eroding streambank at upstream extent.
Taken in 2013

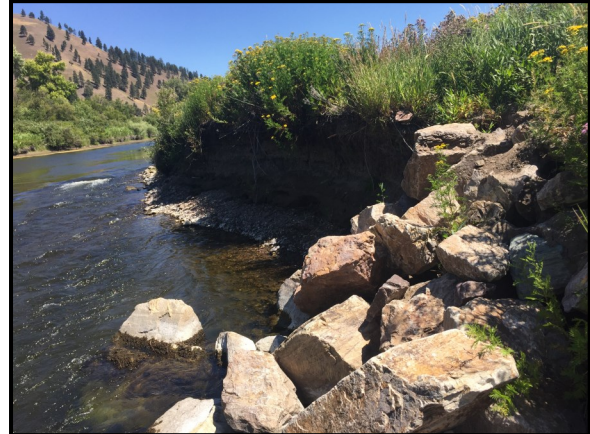
Bank erosion was noted in 2014 and 2015 immediately upstream of the placed riprap. Observations in 2016 noted the bank has eroded approximately 4' further southward in the past year, exposing additional rock installed within a keyway trench (See Photo 7 in Appendix A). While the extent of the keyway into the bank is unknown, continued erosion southward at this location may eventually result in the riprap being flanked from the upstream end.

Photo 7
Description: Eroding streambank at upstream extent.
Taken in 2016

materials along the top of the bank. Erosion immediately upstream of the stabilized bank has continued to expose the rip rap installed at the upper end of the project reach, and should be observed to ensure the rock is not flanked by the river. If the bank continues to erode, placement of additional riprap may be recommended to maintain protection of the highway. If necessary, the extent of additional riprap installation should be evaluated based on anticipated erosive activity, flow direction, bar formation, existing bank materials, and vegetation composition.

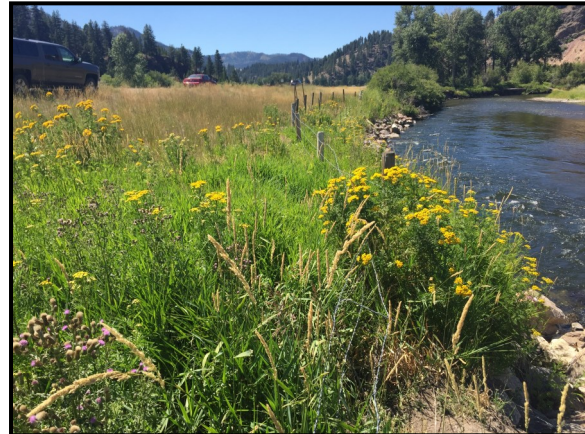
Photo 12
Description: Highway embankment adjacent to bank.
Taken in 2016

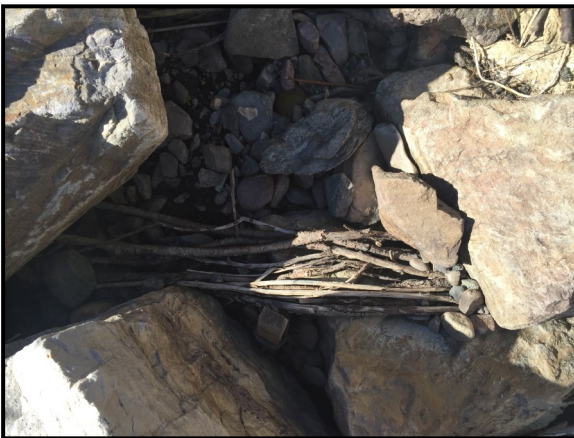
Observations of live willows establishing from beneath the rip rap have increased over the past four monitoring events; however have thus far shown very limited survival overall. A total of 16 willow shoots were observed growing out of the rock layer in 2016, all of which are growing along the western (downstream) half of the bank (see additional photo #2 in Appendix A). No sprigs have produced leafy stems along the eastern (upstream) half of the bank. Many dead willow sprigs were observed in the rock voids, which did not appear to have adequate topsoil for roots to establish (see Additional Photo 1 on Page 5 of Appendix A). While the exact cause of high mortality rates is unknown, the low survivability willows installed beneath the riprap could be due to long inundation periods during high flows, desiccation within the riprap voids, or not having enough soil contact with roots during the first growing season.

Additional Photo 1
Description: Dead willows in revetment
Taken in 2016

Although the site has not met the performance standard for woody survival, the justification of installing additional woody plantings within the rock revetment should be weighed against the potential for destabilizing the bank. Specialized willow planting equipment such as stingers exist that is capable of installing willow sprigs in previously placed riprap (NRCS 2007); however caution should be taken while using this type of equipment to prevent the destabilization of the rock layer. If this technique is implemented, a qualified contractor with experience installing plants in riprap is recommended.

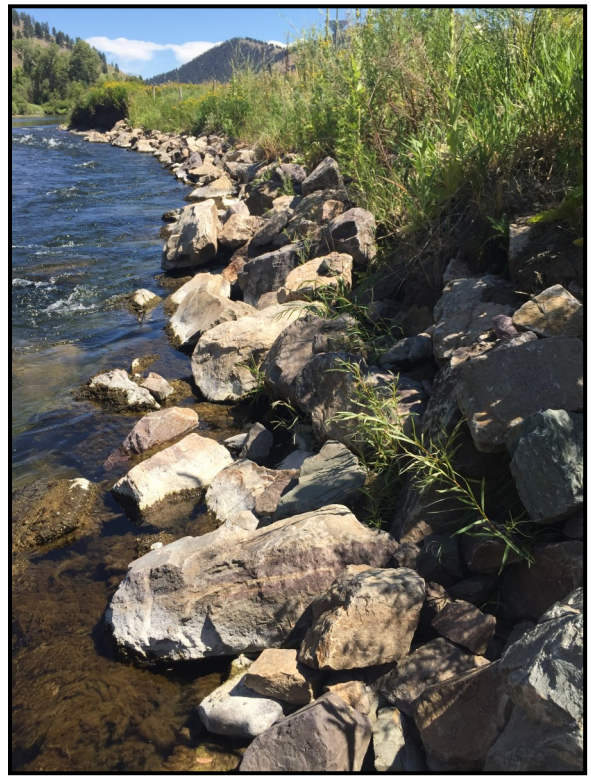
Additional Photo 2
Description: Willow growing in revetment
Taken in 2016
