MONTANA DEPARTMENT OF TRANSPORTATION STREAM MITIGATION MONITORING REPORT

*North Fork Bear Creek
Ravalli County, Montana*

*Year Project Completed: 2011
Monitoring Report #4: Submitted December, 2016*

MDT Project Number: NH-7-1(114)56
Control Number: 2015 003

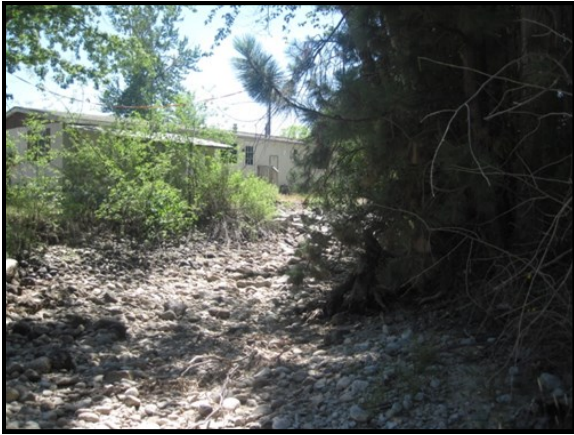
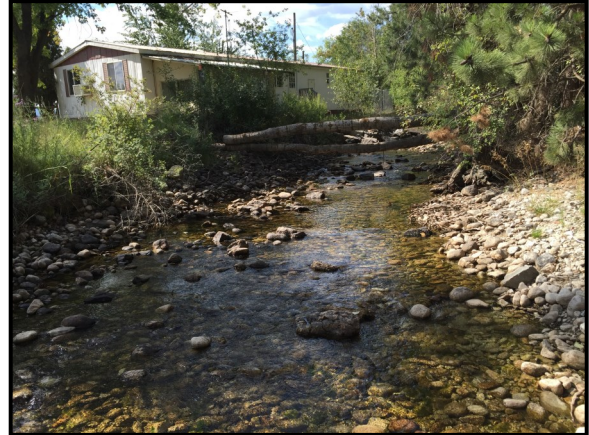
Photo Point 1.4—2013
Description: View of dry channel looking upstream.
Compass: 230 (Southwest)

Photo Point 1.4—2016
Description: View of wetted channel looking upstream. **Compass:** 230 (Southwest)

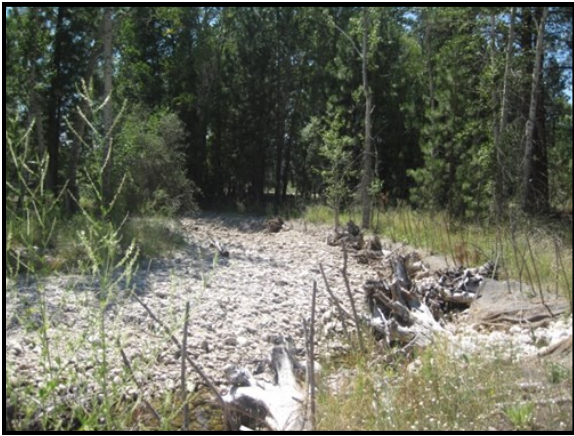
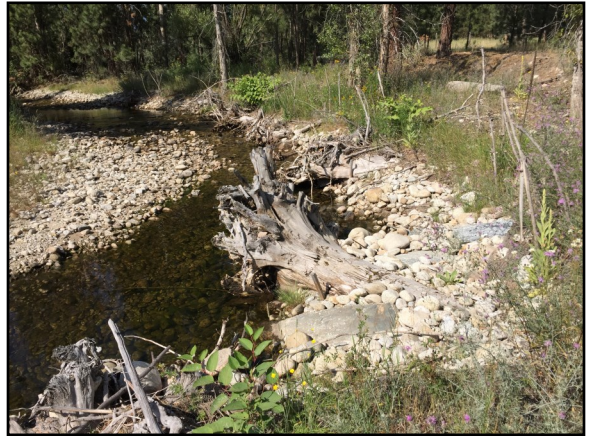
Photo Point 2.1—2013
Description: View of root wads on north bank.
Compass: 225 (Southwest)

Photo Point 2.1—2016
Description: View upstream of root wads on north bank. **Compass:** 225 (Southwest)

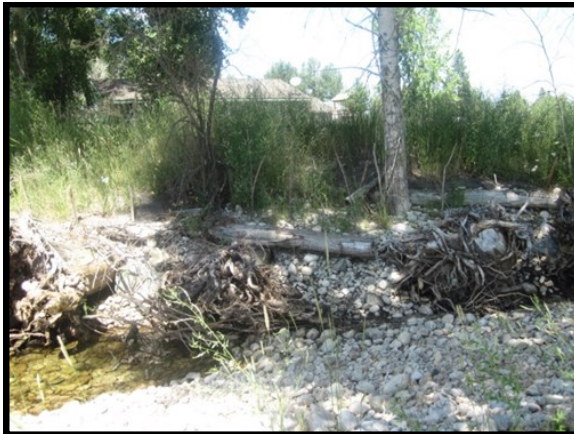
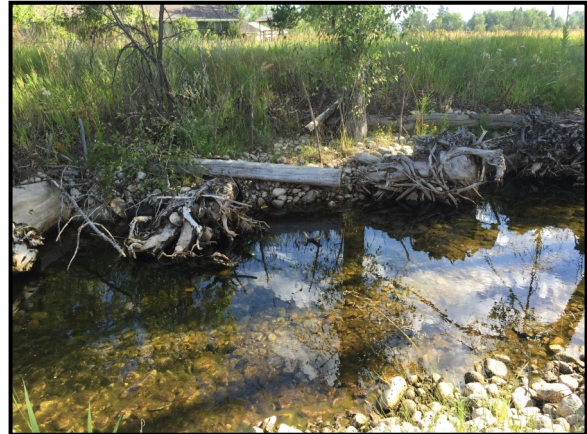
Photo Point 4.2—2013
Description: View of root wads on north bank downstream of bridge. **Compass:** 0 (North)

Photo Point 4.2—2016
Description: View of root wads on north bank downstream of bridge. **Compass:** 0 (North)

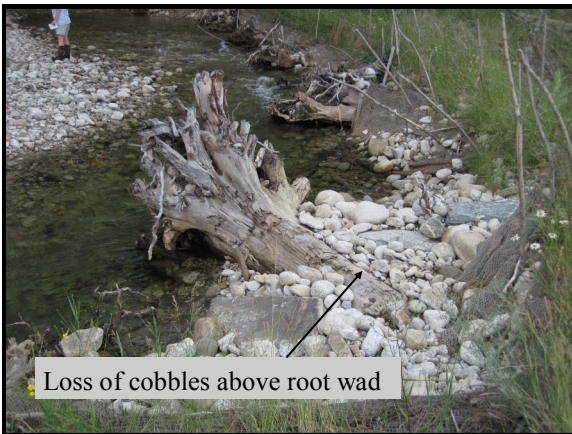
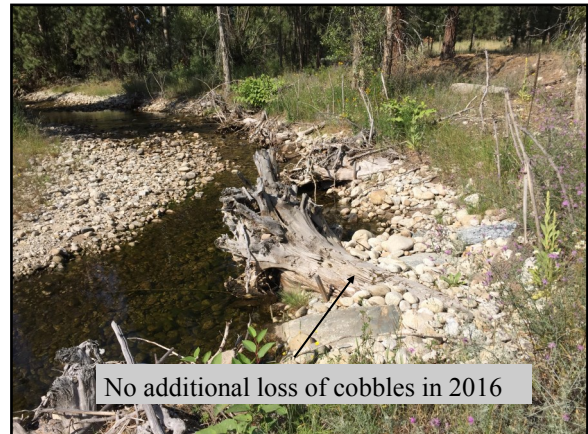
During the 2014 monitoring event, the trunk of one root wad installed upstream of Highway 93 appeared more exposed than the year prior (see Additional Photo 1 in Appendix B). The following is an excerpt from the monitoring report from this site (CCI, 2014):

The exposure of this trunk appeared as a result of the loss of cobble material placed on the upper six inches of the bank during high flows in 2014. Cobble materials placed over this root wad were covered with a layer of topsoil and coir fabric during construction; however, the fabric has peeled back from the top of the bank and is no longer providing protection of the upper bank. If additional cobbles adjacent to this root wad mobilize during subsequent high flows, the root ball may create a scouring hydraulic against the bank, reducing the ability of the root wad to provide bank protection. Although the bank is not currently considered eroding due to the lack of lateral channel movement, continued monitoring is highly recommended to determine whether this segment of the project reach becomes more susceptible to erosion.

The 2015 and 2016 monitoring events revealed no additional loss of cobbles or other bank materials in the vicinity of this root wad and tree trunk. The bank has not further destabilized, and no corrective actions are warranted at this location. No evidence of high water debris deposits or drift lines were noted, indicating the North Fork of Bear Creek likely did not experience an out of bank flow event during spring runoff periods during the past two years.

Additional Photo 1—2014
Description: Root wads upstream of bridge.

Additional Photo 1—2016
Description: Root wads upstream of bridge.

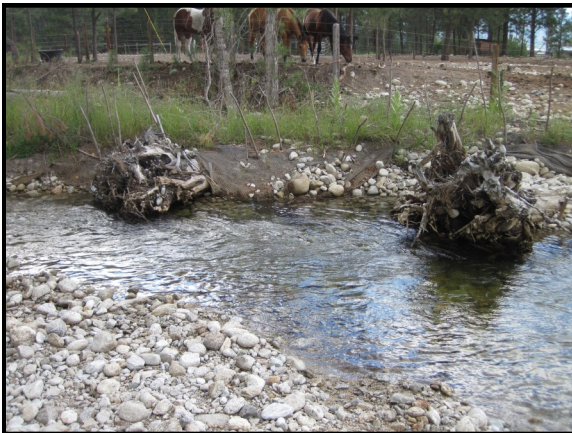
Additional Photo 2—2014
Description: Root wad upstream of bridge showing scour.
