# MONTANA DEPARTMENT OF TRANSPORTATION STREAM MITIGATION MONITORING REPORT

*Clark Fork River  
Granite County, Montana*

*Project Completed: 2013  
Monitoring Report #5: December, 2017*

Permit No.  
MFWP: SPA MDT R2-14-2012  
USACE: NWO-2012-00831-MTH

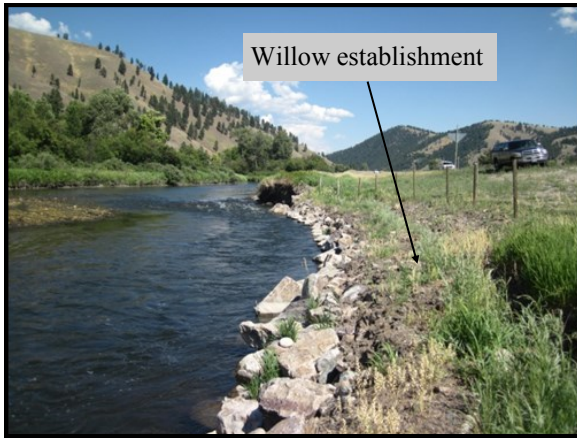
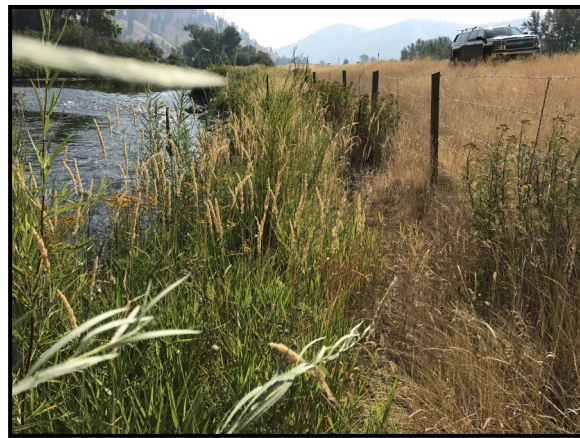
**Photo 1:** View upstream looking at revetment.

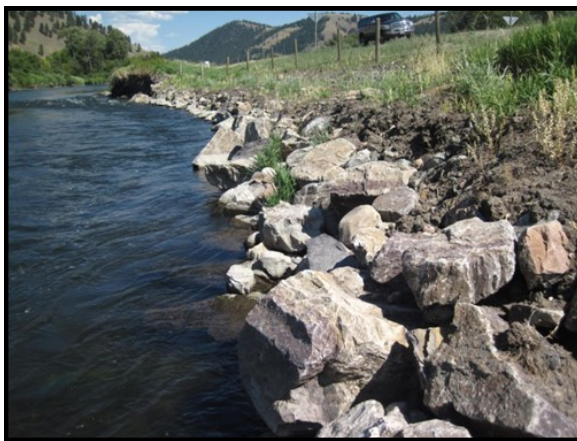
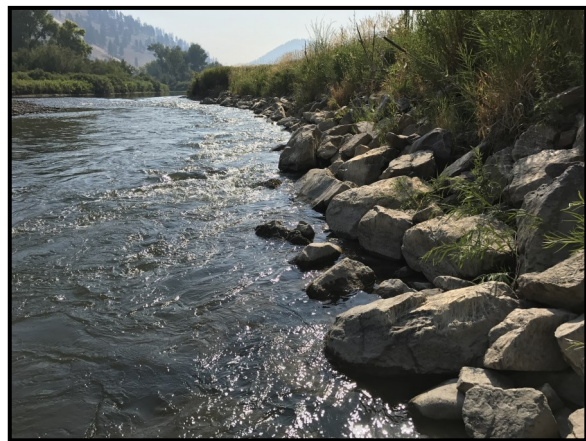
**Photo 2:** Toe of revetment looking upstream.

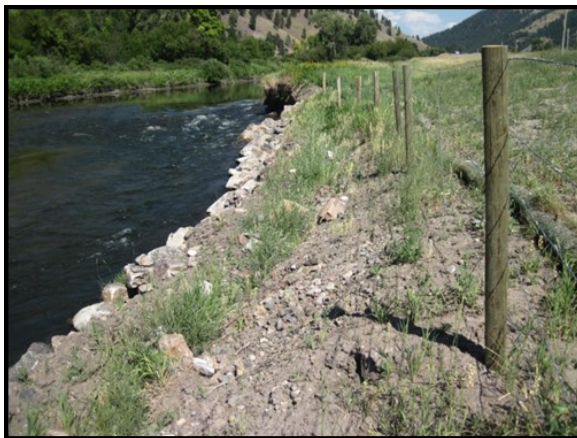
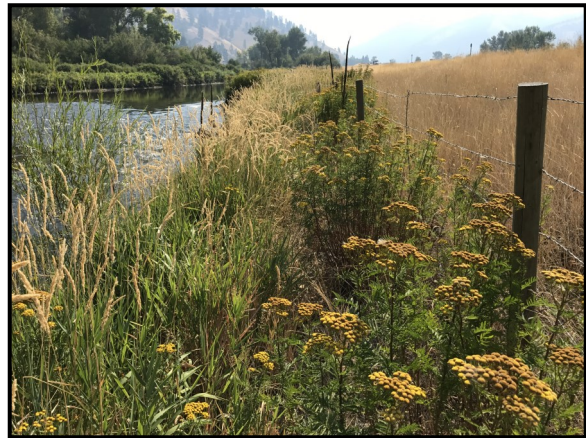
**Photo 3:** Middle of revetment looking upstream.

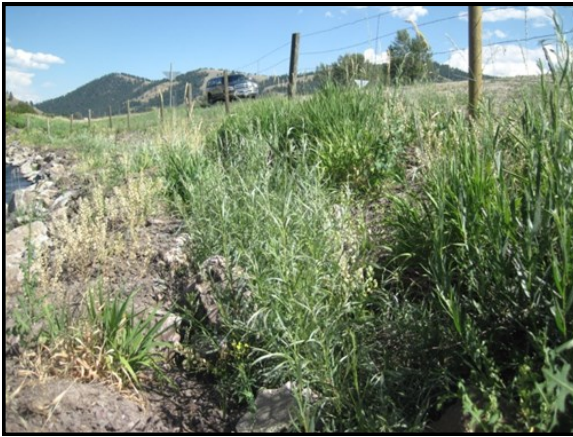
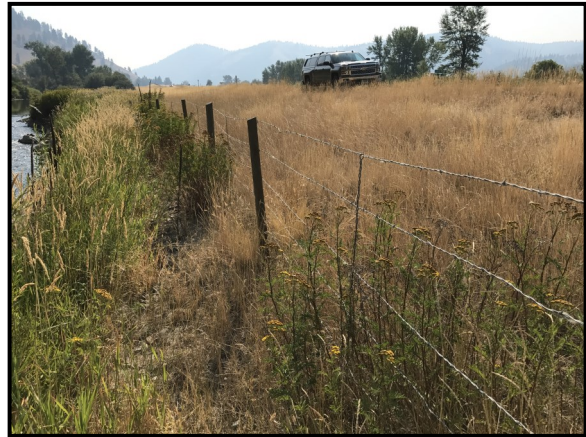
Willows placed along the top of the rock were installed as vertical, unrooted sprigs. Willow sprigs along the eastern (upstream) 75 feet of the stabilized bank have shown limited survival and have developed into a sparse stand of shrubs spaced approximately 20-30 feet apart. The few willows that have survived along the eastern 75 feet of project reach since construction four years ago are maturing, have multiple stems, and have grown to a height of 6-8 feet. Along the western (downstream) 75' of the stabilized bank, many of the sprigs have successfully colonized and developed into a relatively tall stand of willows ranging from 5-10 feet in height. It is unclear what factors led to more successful willow generation of the sprigs installed along the downstream end of the project reach.

Photo 4: Willow growth at top of revetment.

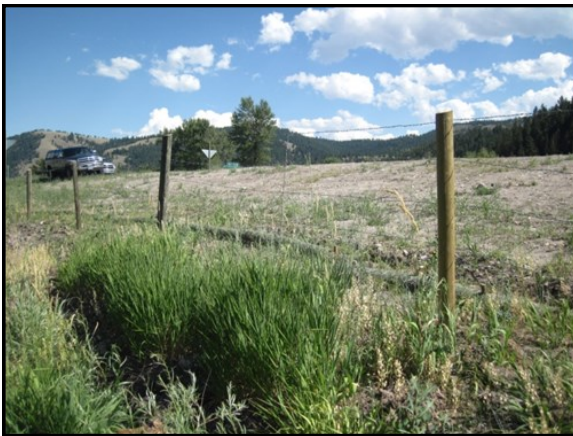
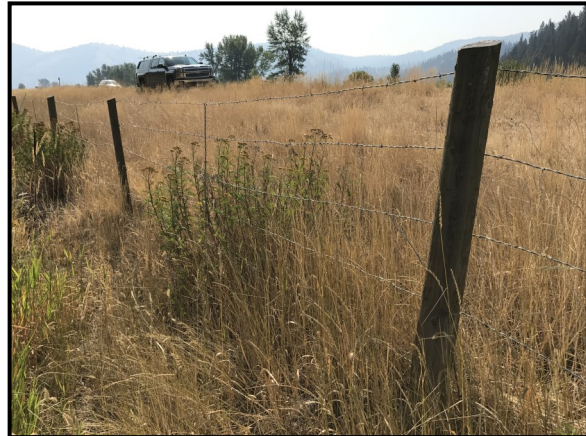
Vegetation has continued to establish between the north edge of the highway and the stabilized bank (see Photos 5 and 12 in Appendix A). In 2017, *Polygonum cuspidatum* (Japanese knotweed) was identified for the first time, in addition to the five noxious weed species observed during the 2016 monitoring event (Table 3). All noxious weed species, with the exception of *Tanacetum vulgare* (common tansy), were identified in trace to low amounts, which is defined as infestations covering less than 1% and 1-5% of the inspected area, respectively. In the past year, the percent cover of common tansy has increased and was assigned a moderate cover class (6-25% of the inspected area). The visual estimates of percent cover provided for noxious weeds may have been influenced by a combination of factors, including, but not limited to, previous herbicide applications, differences in annual precipitation and temperature, calibration training completed by field staff, and other unknown factors that make it difficult to determine the exact cause(s) for increases or decreases in coverage.

Photo 5: Highway embankment / access area.

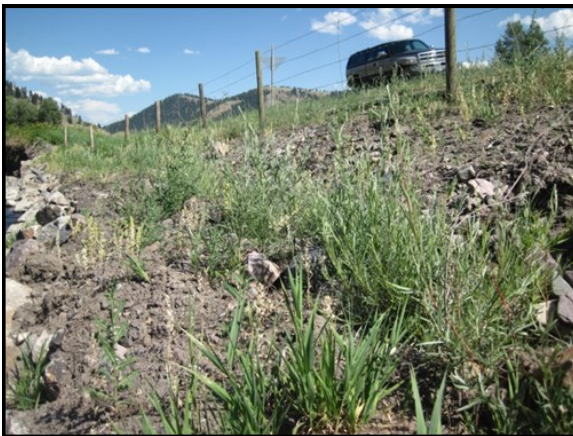
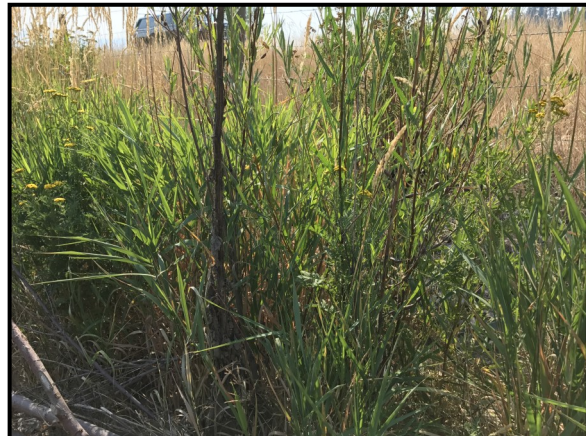
Photo 6: Sandbar willow growth along upper bank.

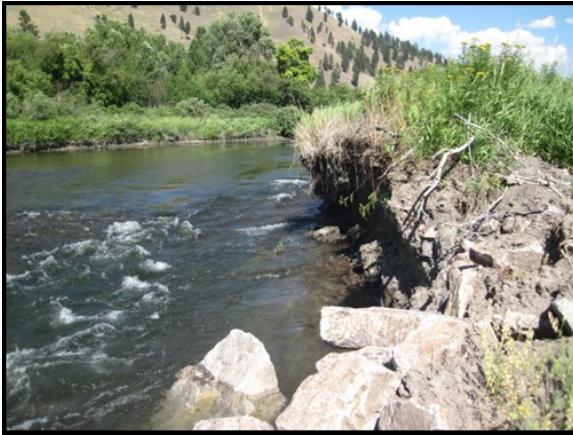
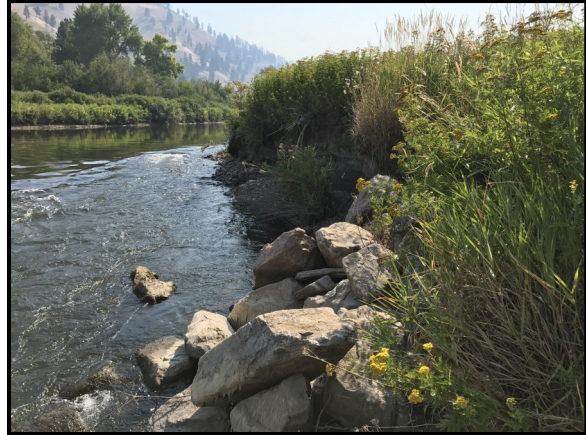
Bank erosion was initially noted just upstream of the riprap in 2014 with approximately 4 feet of additional bank loss observed in 2016. Continued monitoring of this bank has indicated less than a foot of additional bank loss in the past year (See Photo 7 in Appendix A) and no additional exposed riprap along the keyway. At this time, no additional stabilization measures are warranted at the upstream end of the stabilized bank.

**2013** **2017**  
**Photo 7:** Eroding streambank at upstream extent of stabilized bank

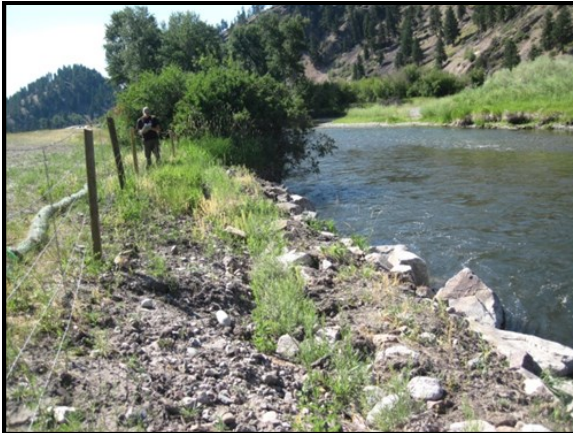
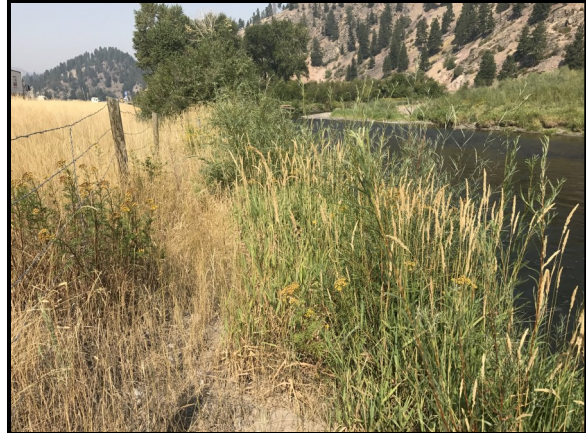
**2013** **2017**  
**Photo 8:** Middle of revetment looking downstream

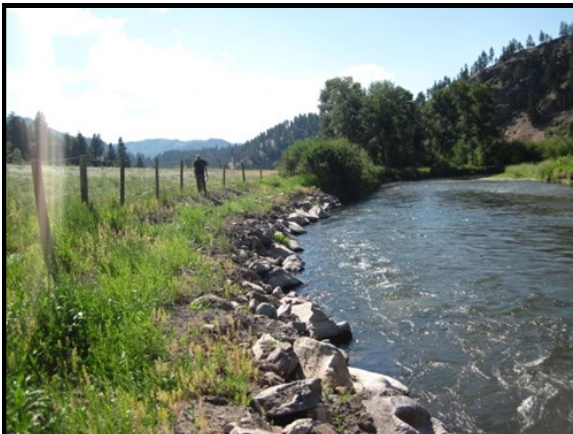
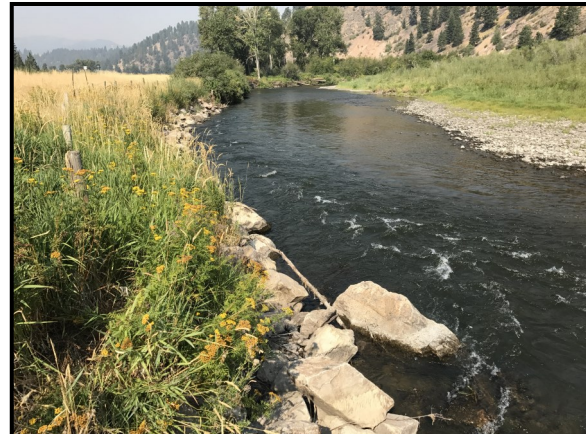
**2013** **2017**  
**Photo 9:** Looking downstream at revetment from upstream extent of stabilization.

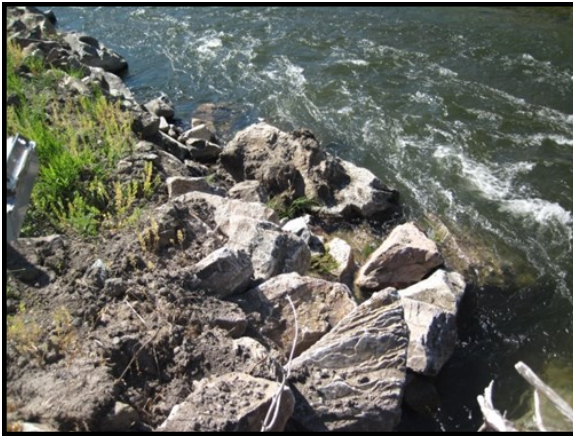
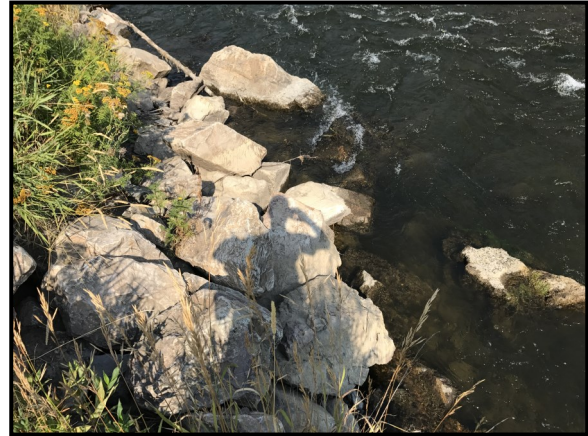
**2013** **2017**  
**Photo 10: Upstream extent of riprapped stream bank.**

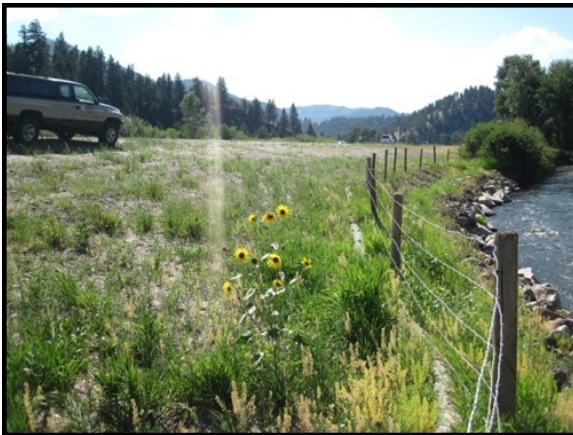
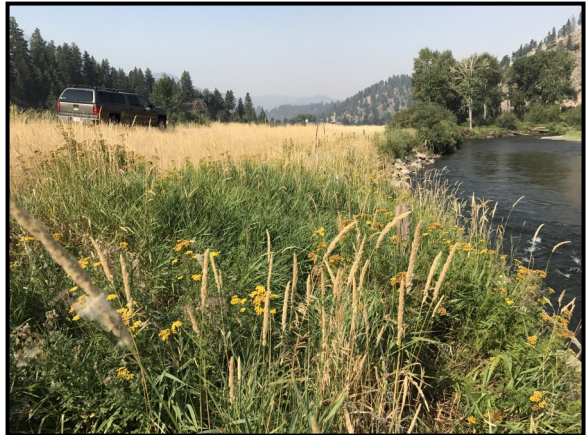
**2013** **2017**  
**Photo 11: Highway embankment adjacent to bank.**

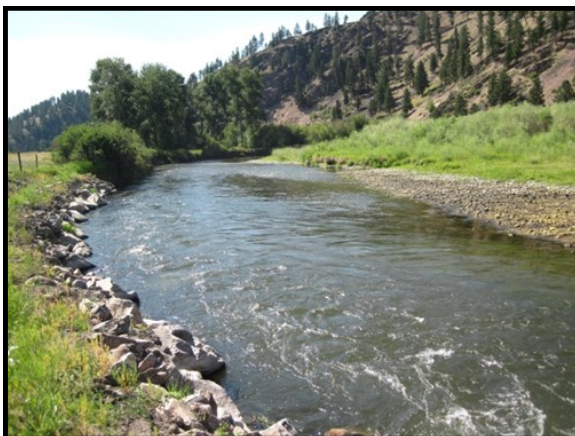
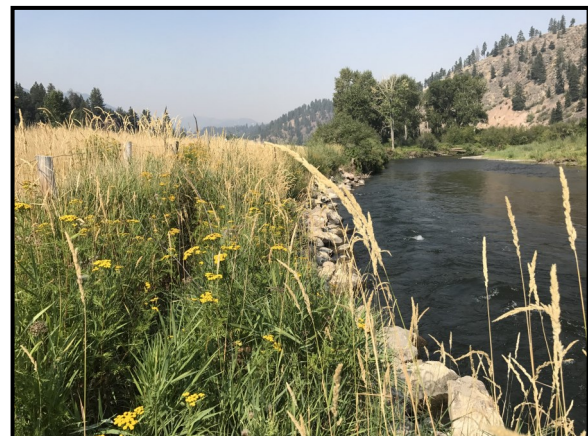
**2013** **2017**  
**Photo 12: Looking downstream at revetment**

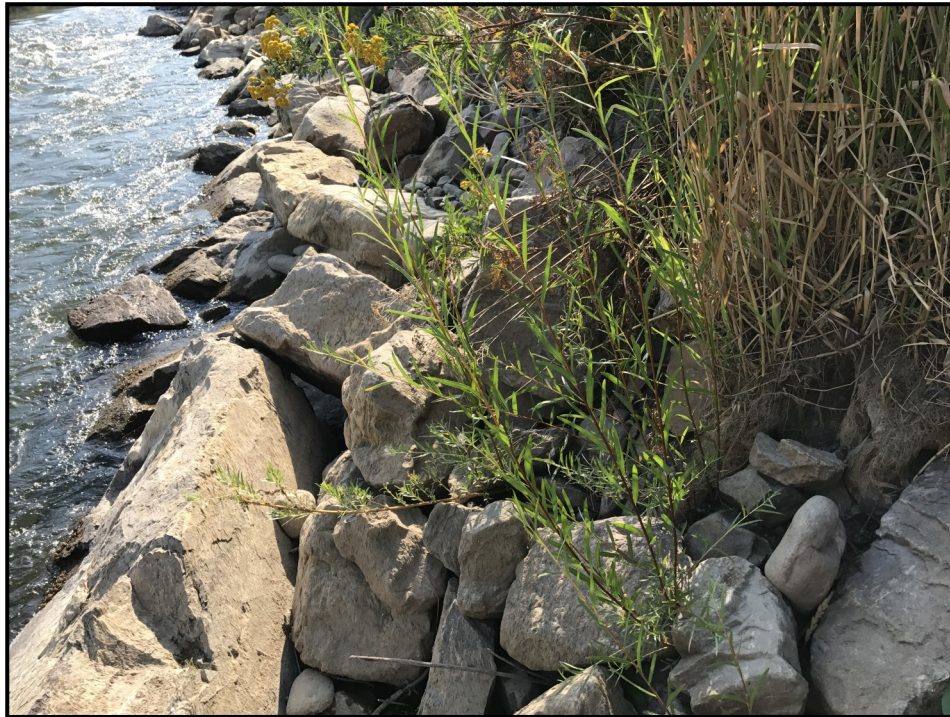
**Additional Photo 1**  
**Description: Willow growing in revetment**  
**Taken in 2017**

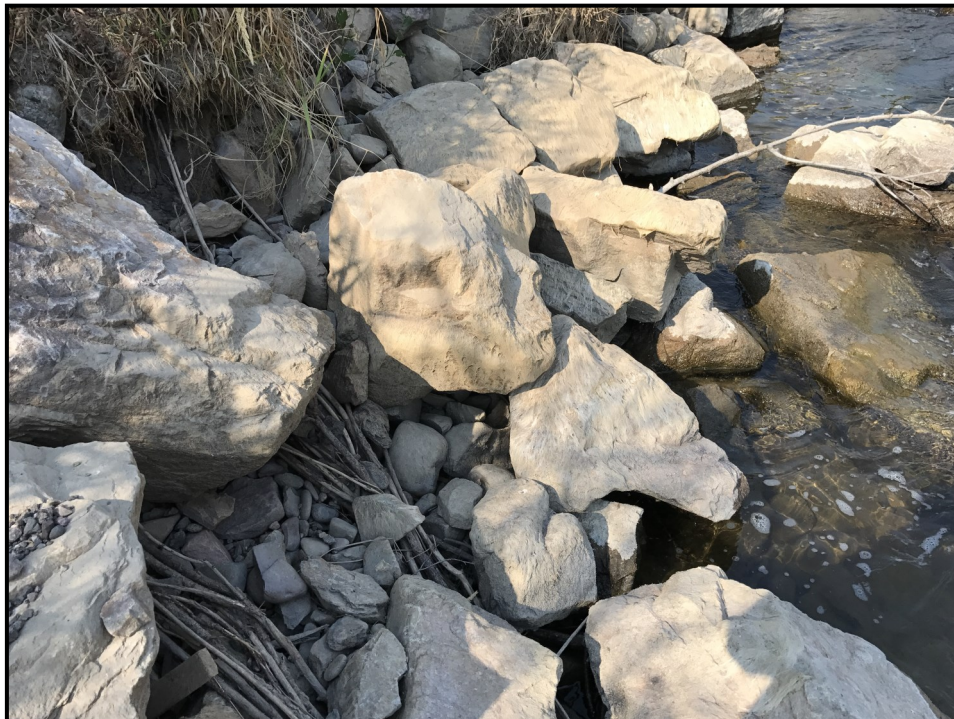
Observations of live willows growing from beneath the riprap indicated very limited survival following their installation in 2013. A total of 15 willow shoots were observed growing out of the rock layer in 2017, all of which occur along the western (downstream) half of the bank (see Additional Photo #2 in Appendix A). No sprigs have produced leafy stems along the eastern (upstream) half of the bank. Many dead willow sprigs were still visible within the rock voids, which did not appear to have adequate topsoil for roots to establish (see Additional Photo #1 on Page 5 of Appendix A). While the exact cause of high mortality rates is unknown, the low survivability of willows installed beneath the rip-rap could be due to long inundation periods during high flows, desiccation within the rip-rap voids, or not having enough soil contact with roots during the first growing season.

**Additional Photo 2**  
**Description: Dead willows in revetment**  
**Taken in 2017**

Although the site has not met the performance standard for woody survival, the justification of installing additional woody plantings within the rock revetment should be weighed against the potential for destabilizing the bank. Specialized willow planting equipment such as stingers exist that is capable of installing willow sprigs in previously placed rip-rap (NRCS 2007); however caution should be taken while using this type of equipment to prevent the destabilization of the rock layer. If this technique is implemented, a qualified contractor with experience installing plants in rip-rap is recommended.
