# MONTANA DEPARTMENT OF TRANSPORTATION STREAM MITIGATION MONITORING REPORT

*Project Completed: 2010  
Monitoring Report #5: December, 2017*

*Bowser Creek  
Flathead County, Montana*

MDT Project Number: NH 15(93)  
Control Number: 2038-011

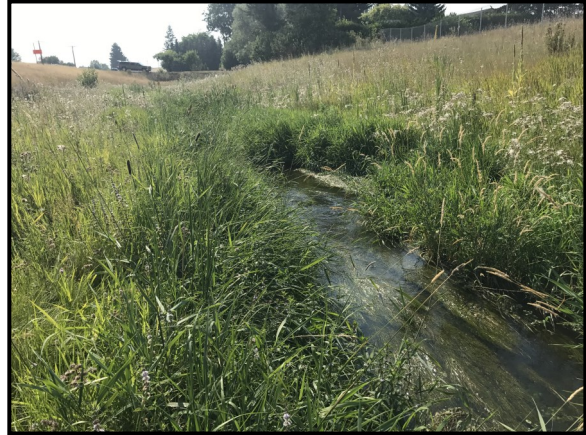
**Additional Photo 1:** Prolific watercress growth shown in 2013 was less prevalent in 2017.

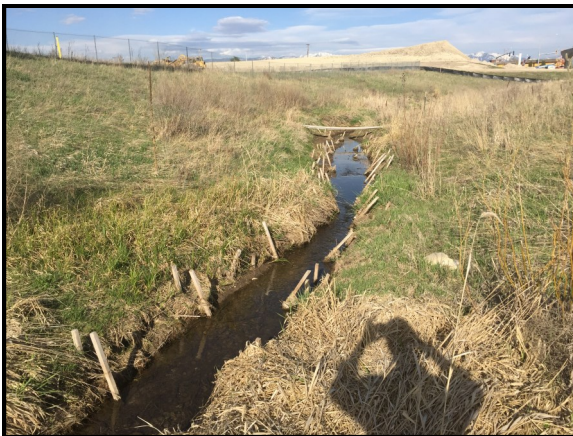
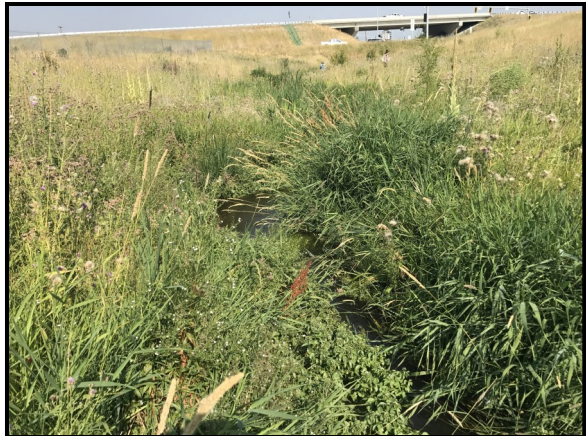
Eroding bank EBL3 was identified in 2015 as a newly eroding bank segment. Erosion along this bank was evident from the wood stakes that were used to construct the outside edge of the bank, which were 2 to 3 feet away from the edge of the bank. The channel is approximately 12 feet wide at this location, which is 6.5 feet wider than the design width of 5.5 feet. As noted above, erosion along EBL3 is associated with bank saturation and seeps entering Bowser Creek caused by the adjacent retention pond. Vegetation along this bank is dominated by Canada thistle, bull thistle, and smooth brome. The majority of the bank does not appear to be actively eroding; however, a seep observed near the downstream end of EBL3 is continuing to cause some bank calving. As a result of these factors, bank erosion along EBL3 is considered low.

**Additional Photo 2:** Eroding bank EBL3.

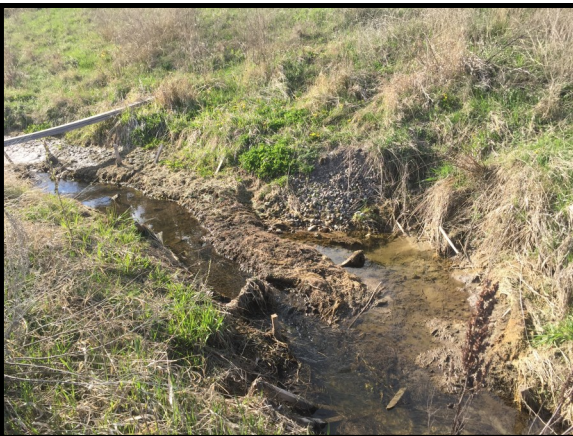
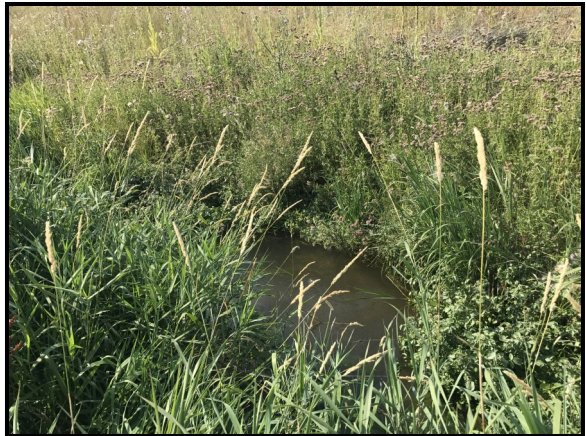
- Bank erosion along the left (north) side of the channel does not appear caused by scour during high flows as is typical of snowmelt driven streams.
- A retention pond has been constructed approximately 100 feet north of Bowser Creek. It appears the pond is elevated as compared to Bowser Creek, causing water to seep from the pond into Bowser Creek.
- The seepage of water from the retention pond toward Bowser Creek is causing bank saturation and instability where the seeps daylight along the north side of the stream channel.
- Saturated, fine grained materials along the north bank of Bowser Creek are transported downstream during high water events, resulting in bank retreat in locations where seeps enter Bowser Creek (including EBL2, EBL3, and EBL4 as shown on Figure 3 in Appendix A).

**Additional Photo 3:** Eroding bank EBL4.

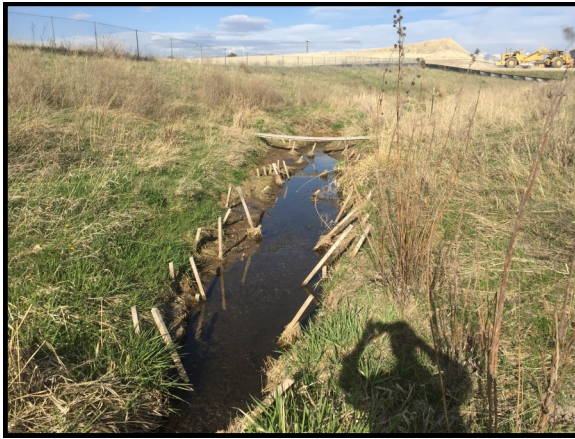
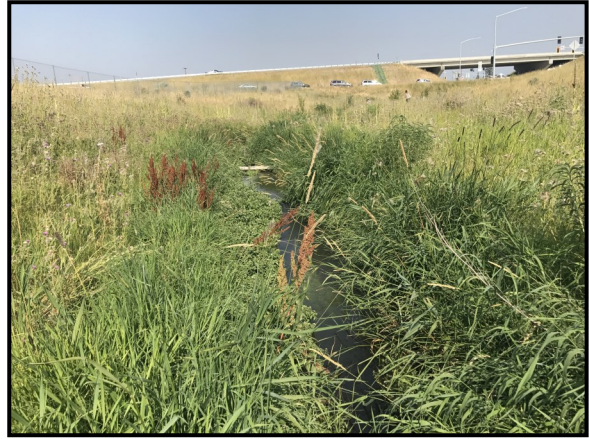
Two perpendicular cross section transects were surveyed at pools and two at riffles, with maximum depth and bankfull width for each indicated in Table 9 (plots for each transect included in Appendix B). In 2017, maximum bankfull depths ranged from 1.7 to 3.0 feet and bankfull widths ranged from 6.3 to 13.5 feet. Over the past five years, the channel indicates segments that are wider than the design width of 5.5 to 6.5 feet, which can be attributed to the decay of coir logs placed along both banks. The loss of bank structure following the natural biodegradation of the logs has resulted in portions of the channel as wide as 13.5 feet. Bank structure has been compromised by seepage from the adjacent retention pond, and is causing segments of the north bank to slump. These channel segments are unlikely to recover back to the design dimension due to the unnatural hydrology and continuous saturation caused by seepage from the retention pond; however they provide a diversity in channel form and are not continuing to degrade or erode. Based on the vast majority of the reconstructed channel performing as intended, attempts to narrow the channel through these relatively short, over-wide segments is unwarranted.

**Additional Photo 4: Widened channel segment.**

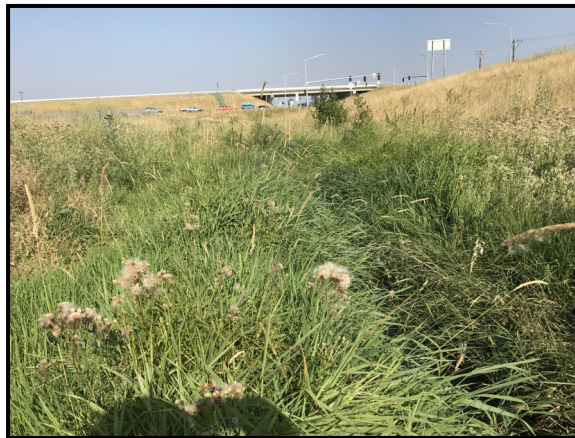
The stream bank vegetation inventory identified 40 plant species along the banks of Bowser Creek (Table 6). Reed canary grass comprised 21-50% cover along both stream banks in 2017 (see additional photo #5 in Appendix C). The Winward stability ratings are based on vegetation communities rather than individual species; therefore, a vegetation community was assigned to each stream bank based on one or more dominant species (Winward 2000). Vegetation community Type 2 – *Phalaris arundinacea* was the dominant vegetation community observed along the stream banks, with an associated Winward stability rating of 9.

**Additional Photo 5: Dense reed canarygrass along upper segment of Bowser Creek**
