MONTANA DEPARTMENT OF TRANSPORTATION STREAM MITIGATION MONITORING REPORT

North Fork Bear Creek Ravalli County, Montana

Year Project Completed: 2011 Monitoring Report #6: Submitted December, 2018

MDT Project Number: NH-7-1(114)56 Control Number: 2015 003

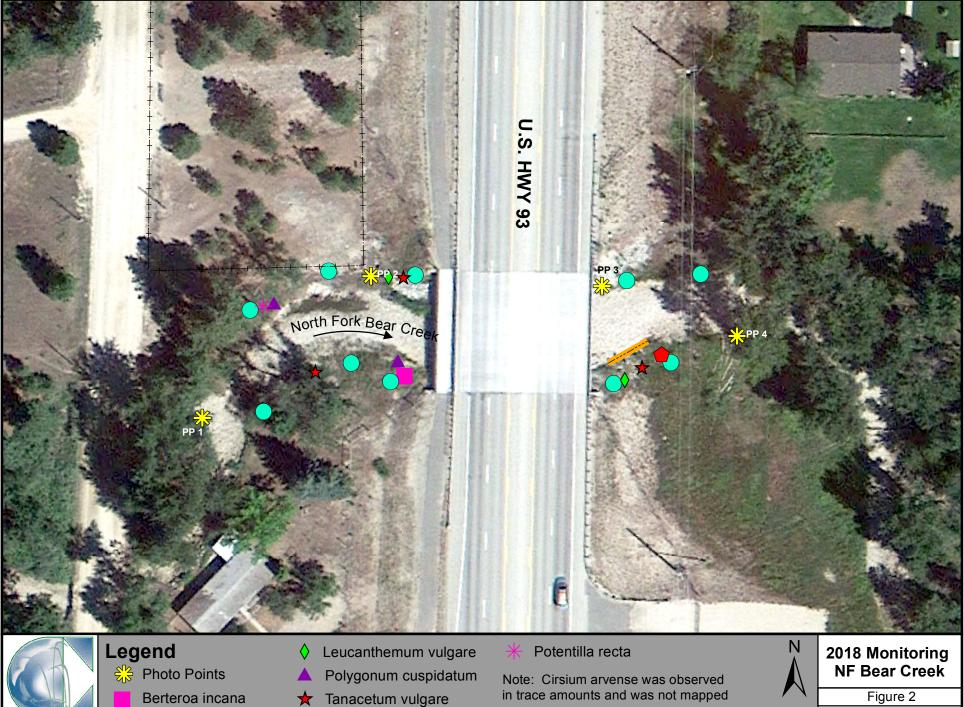
Eighteen infestations of Montana Listed Priority 2B noxious weeds were observed within the project area, all of which were classified as low cover class (1-5%). Two infestations of Priority 1B noxious weeds were found within the riparian corridor and were also considered low cover class (Table 3 and Figure 2, Appendix A). Cheatgrass (Bromus tectorum), a Montana Priority 3 regulated weed species was also observed across the site. Two noxious weed species originally observed in 2014 (Convolvulus arvensis and *Cynoglossum officinale*) have not been observed during the past four monitoring events. and as a result, they are no longer considered present within the reach.

One eroding bank was identified within the project reach, which occurs just downstream of the highway bridge along the right (south) bank. Erosion along this 25-foot long bank segment was initially observed in 2017. Over the past year, the bank has continued to erode laterally and captured a camera tower installed by MDT to record wildlife use in the area. The bank consists of cobble and gravel material and is vegetated with a mixture of herbaceous and woody species including common yarrow (*Achillea millefolium*), narrow-leaf cottonwood (*Populus angustifolia*), Woods' rose (*Rosa woodsii*), and spotted knapweed (*Centaurea stoebe*). Based on photo documentation, it appears the bank has retreated by approximately 3 feet in the past year and 4-5 feet in the past two years (see photo points 3.2 and 3.3 in Appendix B).
