Montana Department of Transportation Stream Mitigation Monitoring Report

BOWSER CREEK MITIGATION SITE

Monitoring Year: 2020

Monitoring Dates: July 31-August 1, 2020

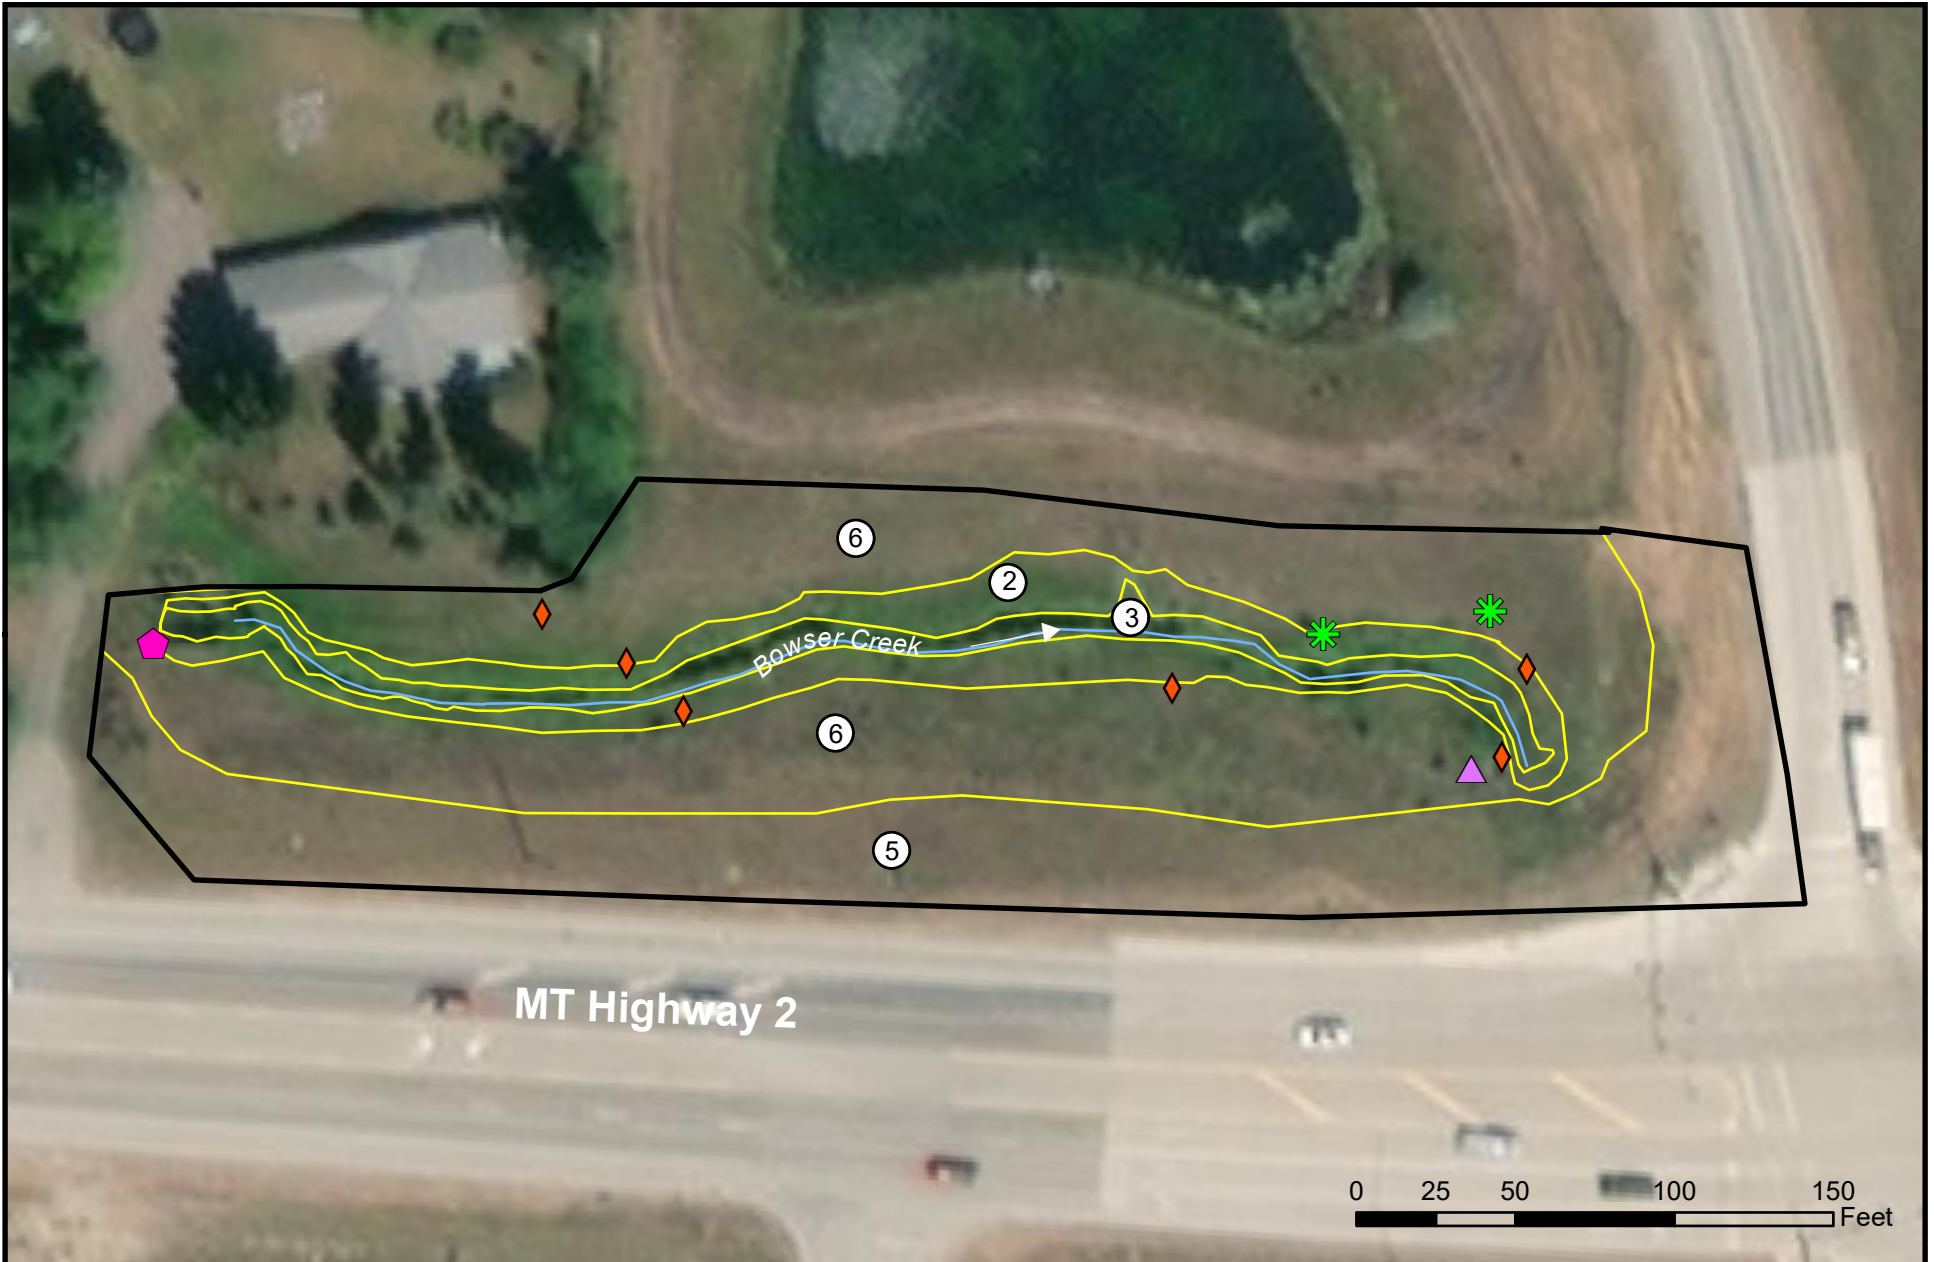
**Bowser Creek - 2020
Noxious Weeds and
Vegetation Community**
Figure 3
Date: 10/22/2020
Bowser_monitor2020.mxd

Dominant species recorded along the riparian and stream bank transects were combined with visual observations in other areas to develop a vegetation community map (Figure 3, Appendix A). Four vegetation community types were observed in 2020 and are included in Table 3.

Vegetation community Type 6 – *Elymus* spp./*Bromus inermis* was observed for the first time in 2019 due to a shift in dominance from the noxious Canada thistle and nonnative bull thistle to patchily distributed bare ground and an increase in the nonnative smooth brome (*Bromus inermis*). This community expanded in 2020 into areas previously identified as community type 5.

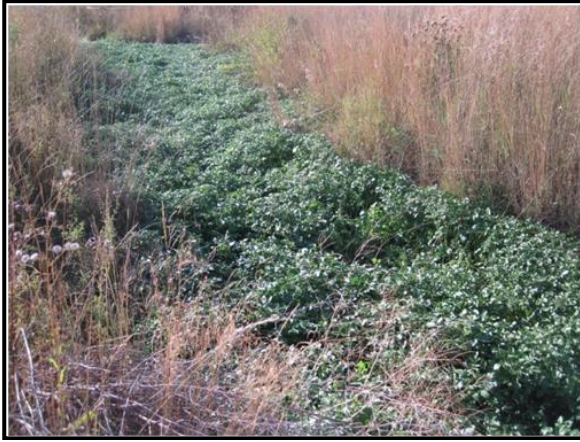
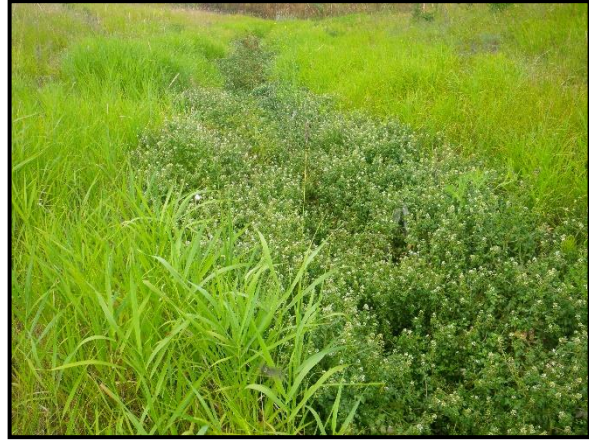
Vegetation community Type 3 – *Nasturtium officinale* was identified within the channel. Watercress dominated this community type with more than 50% cover growing in the channel bed and 6 to 10% cover along both stream banks. This community has been consistently observed in dense stands along the stream bed during the growing season and has expanded to both stream banks between the 2017 through 2020 monitoring events.

Additional Photo 1: Prolific watercress growth shown in 2013 was less prevalent in 2020.

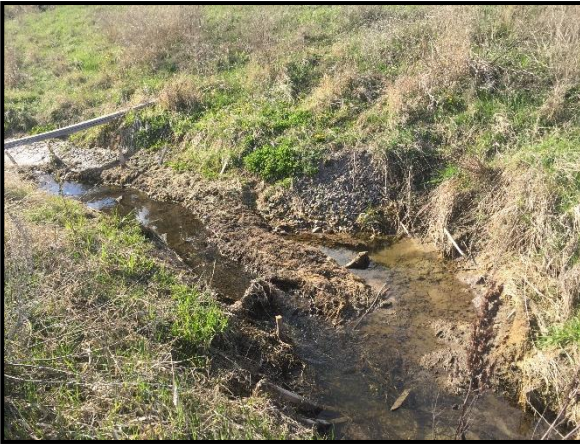
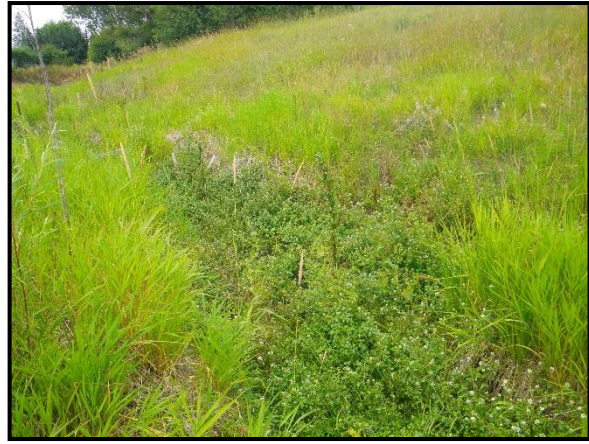
No eroding banks were observed at Bowser Creek in 2020, and the banks were 100% stable. One eroding bank had previously been documented at the mitigation site along a 15-foot segment of the left (north) bank. This eroding bank was caused by a seep that emerges from the north side of the channel and saturates the bank. Bank erosion was noted in this location

from 2017 through 2019, in the form of minor bank sloughing. In 2020, the eroding bank has stabilized by wetland vegetation and therefore was removed from the eroding bank inventory.

Additional Photo 2: Eroding bank EBL3.

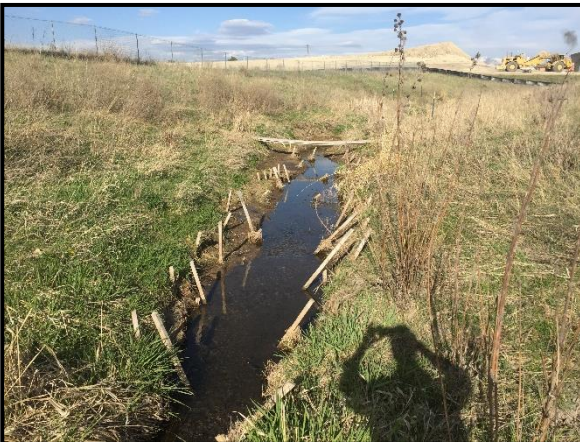
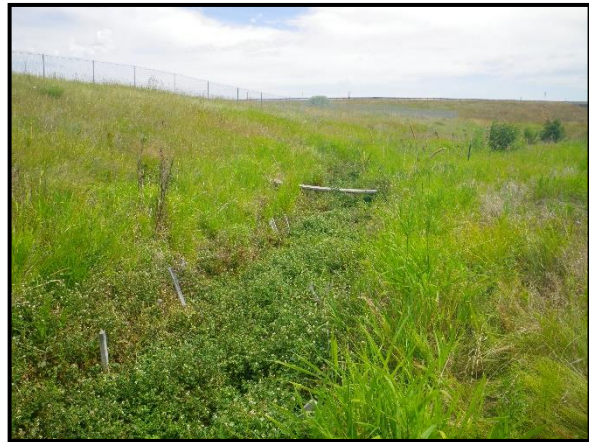
Transect data indicates that the bankfull width of the channel has also remained quite stable through the monitoring period, with the exception of Transect #3. The bankfull channel at Transect #3 has widened and become shallower by almost one foot since 2019. As no bank erosion was observed at this location, the observed channel widening is not considered to be problematic and may be due to survey discrepancies.

Additional Photo 3: Widened channel segment.

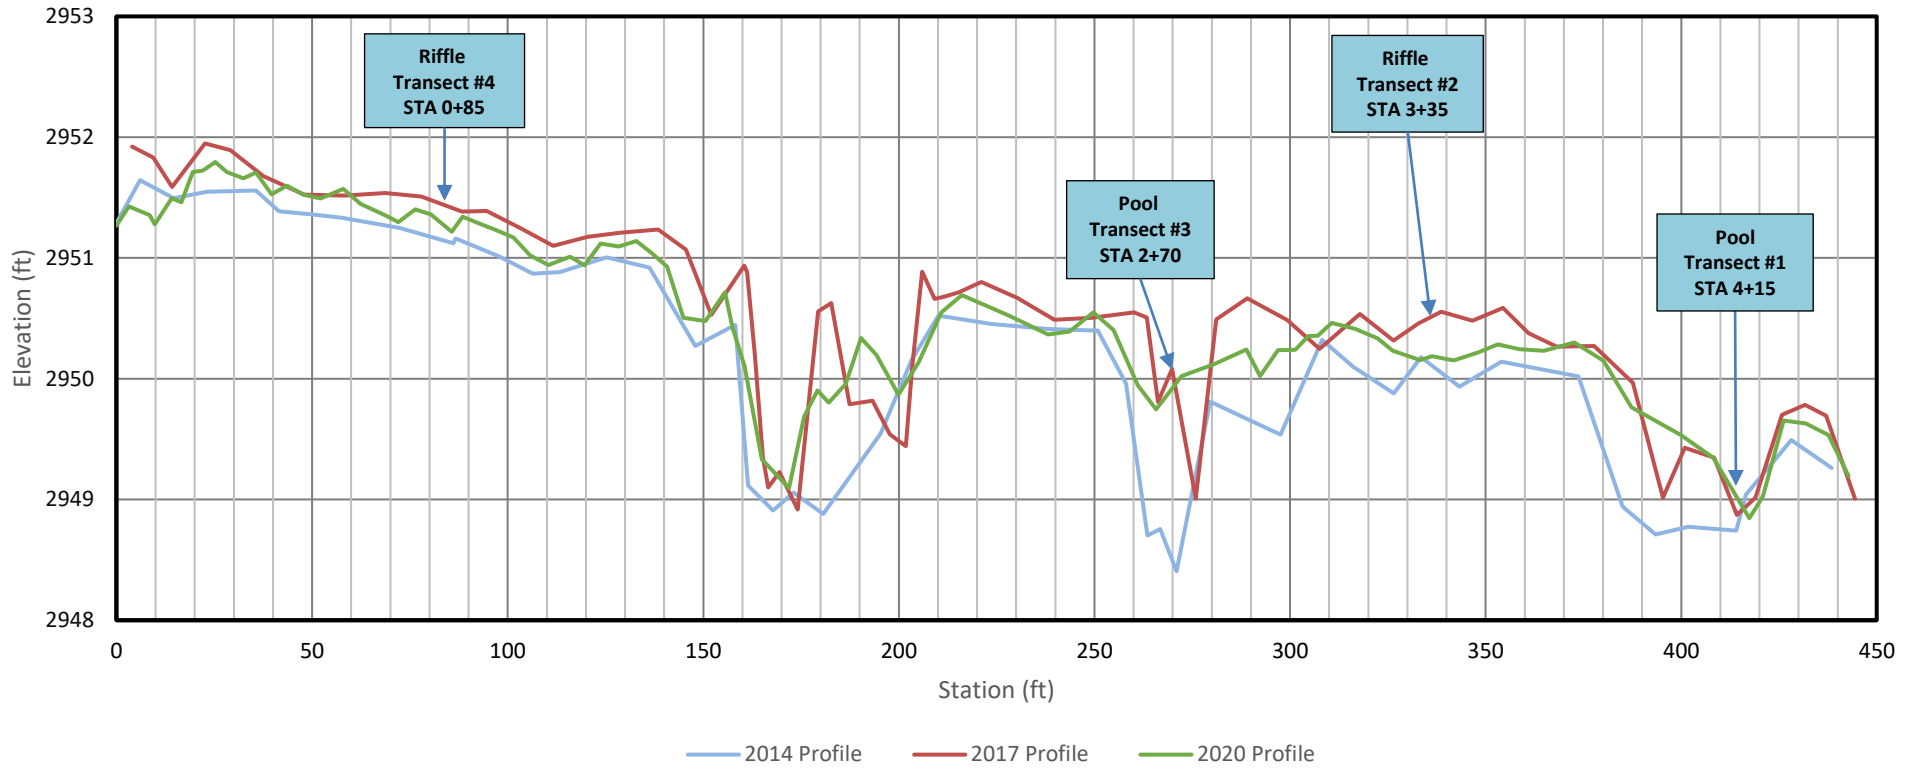
Bowser Creek Longitudinal Profiles

The annually surveyed longitudinal profiles and cross-sectional transects indicate Bowser Creek has remained relatively stable throughout the monitoring period. Three riffles and two pools have been maintained since 2014, although the pools located at Transect #1 and between stations 1+52 and 2+10 have partially filled, and the pool located at Transect #3 has filled in by approximately one foot (Table 5, Appendix E). The change in pool dimensions observed within the project reach are the result of sediment inputs either from upstream sources or as a result of channel widening. At this point, the severity of this problem is low and may correct itself over time. No corrective action is recommended at this time.
