Montana Department of Transportation Stream Mitigation Monitoring Report  
**FOY'S BEND FISHERIES CONSERVATION AREA NH\_MT5-3(50)109F UPN #: 2038013**

**Monitoring Year:** 2021

**Monitoring Conducted By:** Confluence Consulting Inc.

**Monitoring Dates:** August 13th-14th, 2021

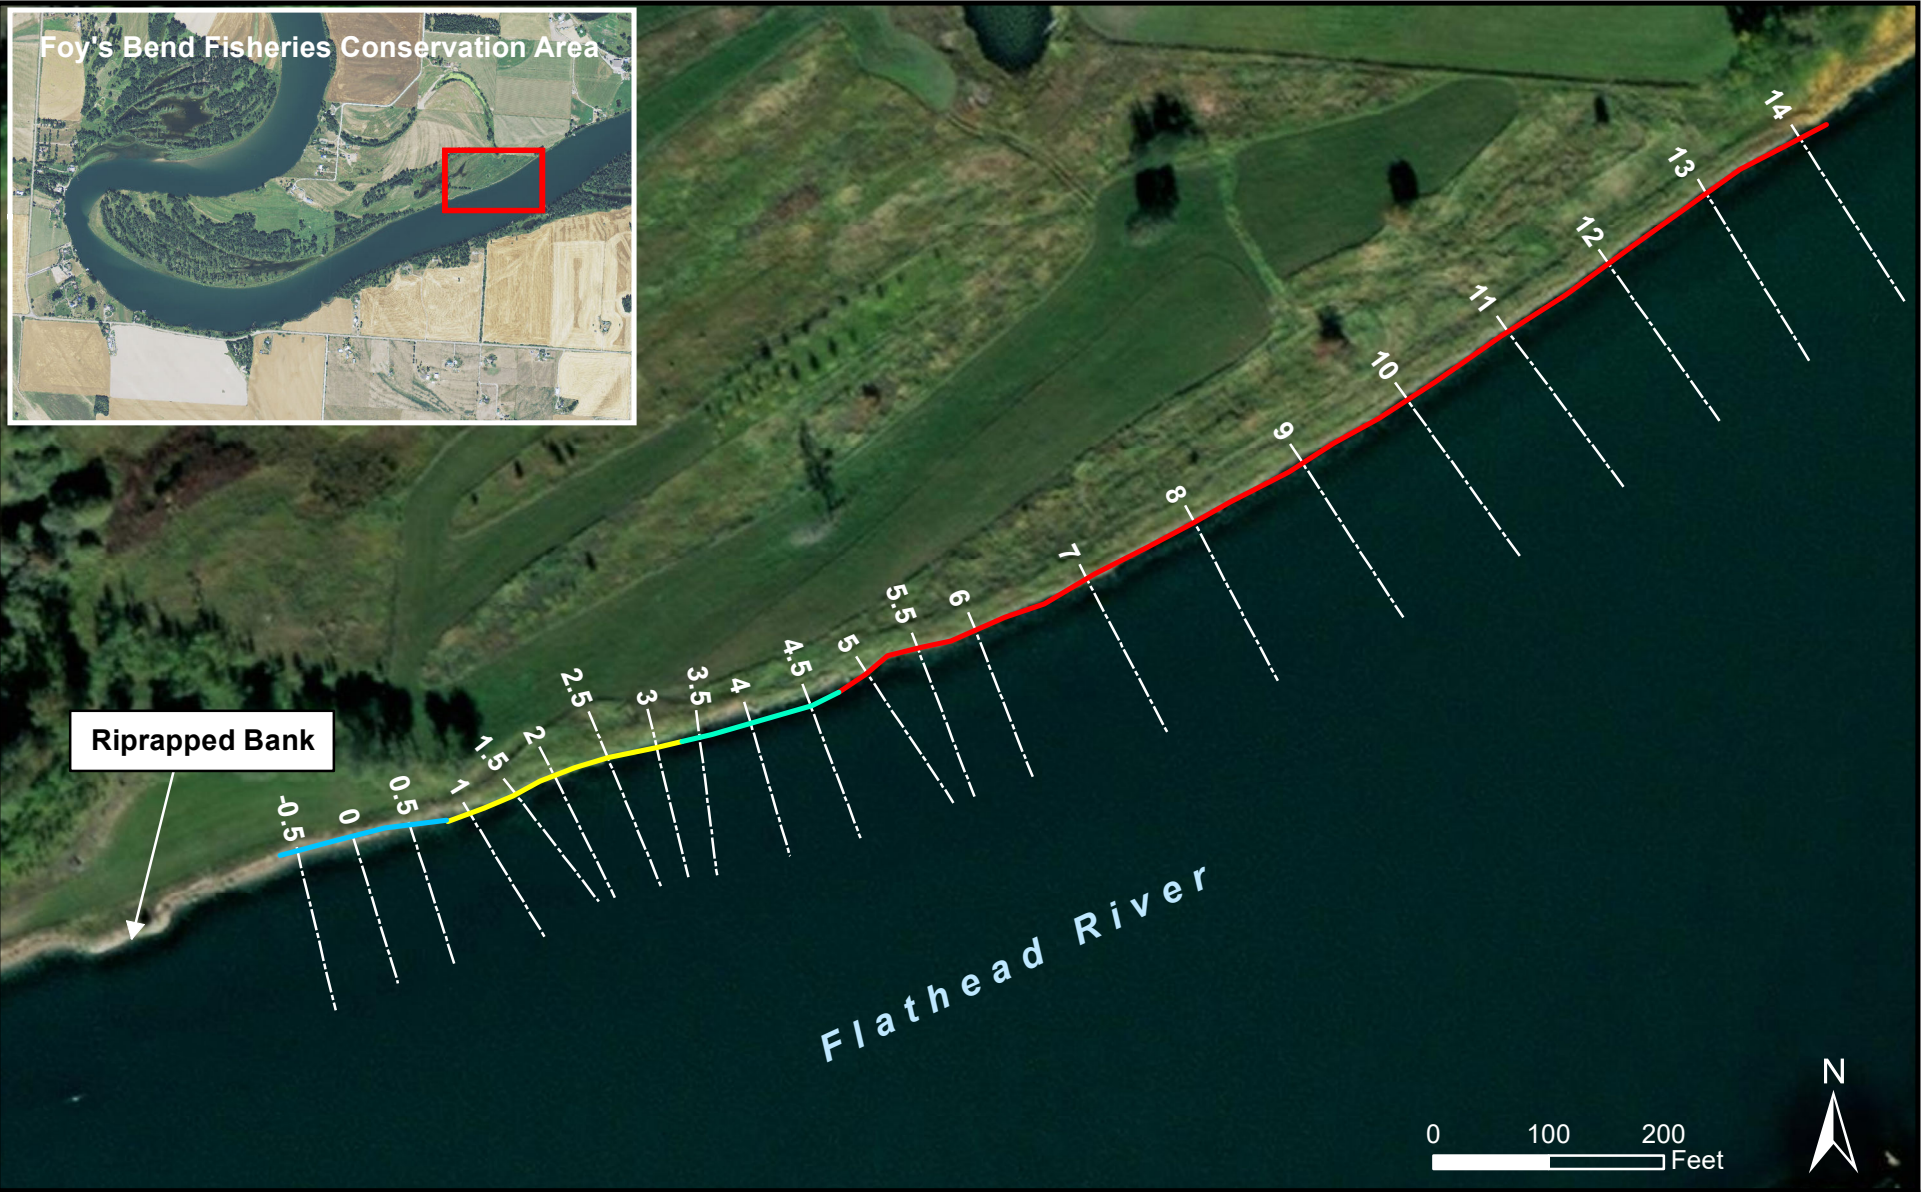
<b>Foy's Bend 2021 Surveyed Bank Transects</b>
Figure 2
Date: 10/29/2021
<i>2021 Bank Surveys.mxd</i>

*Reach 2* – Reach 2 is 135 feet long and is represented by Transects 3.5 through 4.5 (Appendix A, Figure 2). Between 2013 and 2017, severe bank erosion beneath the woody fascines was observed in Reach 2, and the woody fascine eventually became detached from the bank. The elevation of the fascine in Reach 2 has continued to drop over the past four years and as of April 2021, the fascine had washed away and could no longer be identified (Table 7). Due to the loss of bank protection from the fascines, the bank has eroded more rapidly over the past four years. Extended transect surveys indicate that the submerged toe of the bank has moved northward approximately 5 feet between 2016 and 2021 and is therefore likely contributing to the soil loss beneath the bank treatment in Reach 2 (Appendix G, pages G-19, G-21, & G-23). The lower banks have eroded enough to begin to affect the upper portions of the bank, especially at Transect 4 where 3-6 feet of the upper bank has slumped off (Additional Photo 4, Appendix B; Appendix G, page G-20). The leading edge of the bank has retreated by average of 12.7 feet since monitoring began in 2013 (Table 7).

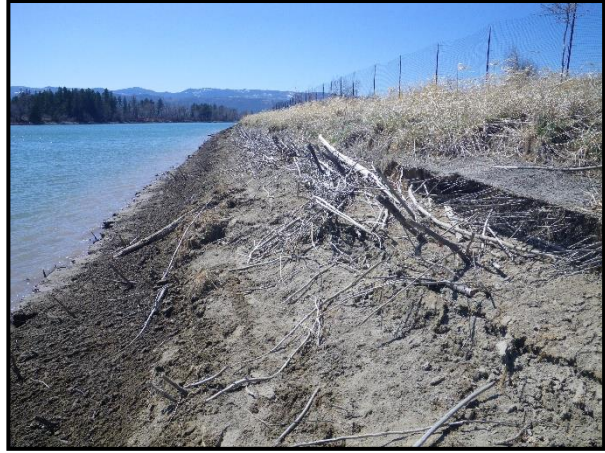
**Additional Photo 6:** Looking upstream at exposed, degrading fascine and unprotected bank exposed to erosion near T-13.

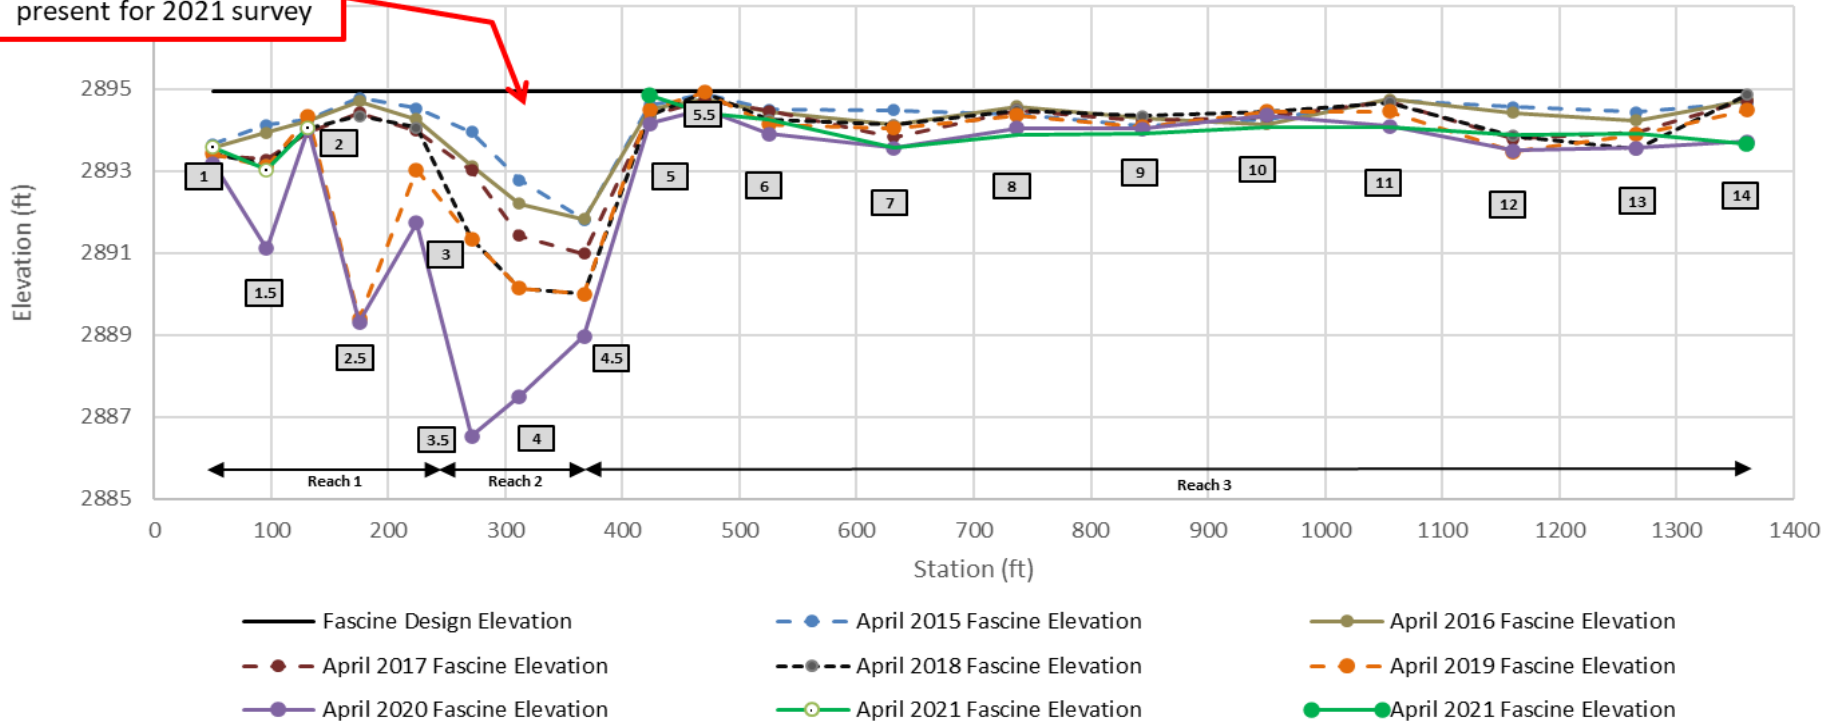
# Foy's Bend Fascine Profile

Fascine no longer present for 2021 survey
