Montana Department of Transportation Stream Mitigation Monitoring Report

**MILL CREEK MITIGATION SITE**

**MDT Project Number:** NH7-1(114) 59 / UPN # 201500

**Monitoring Year:** 2021

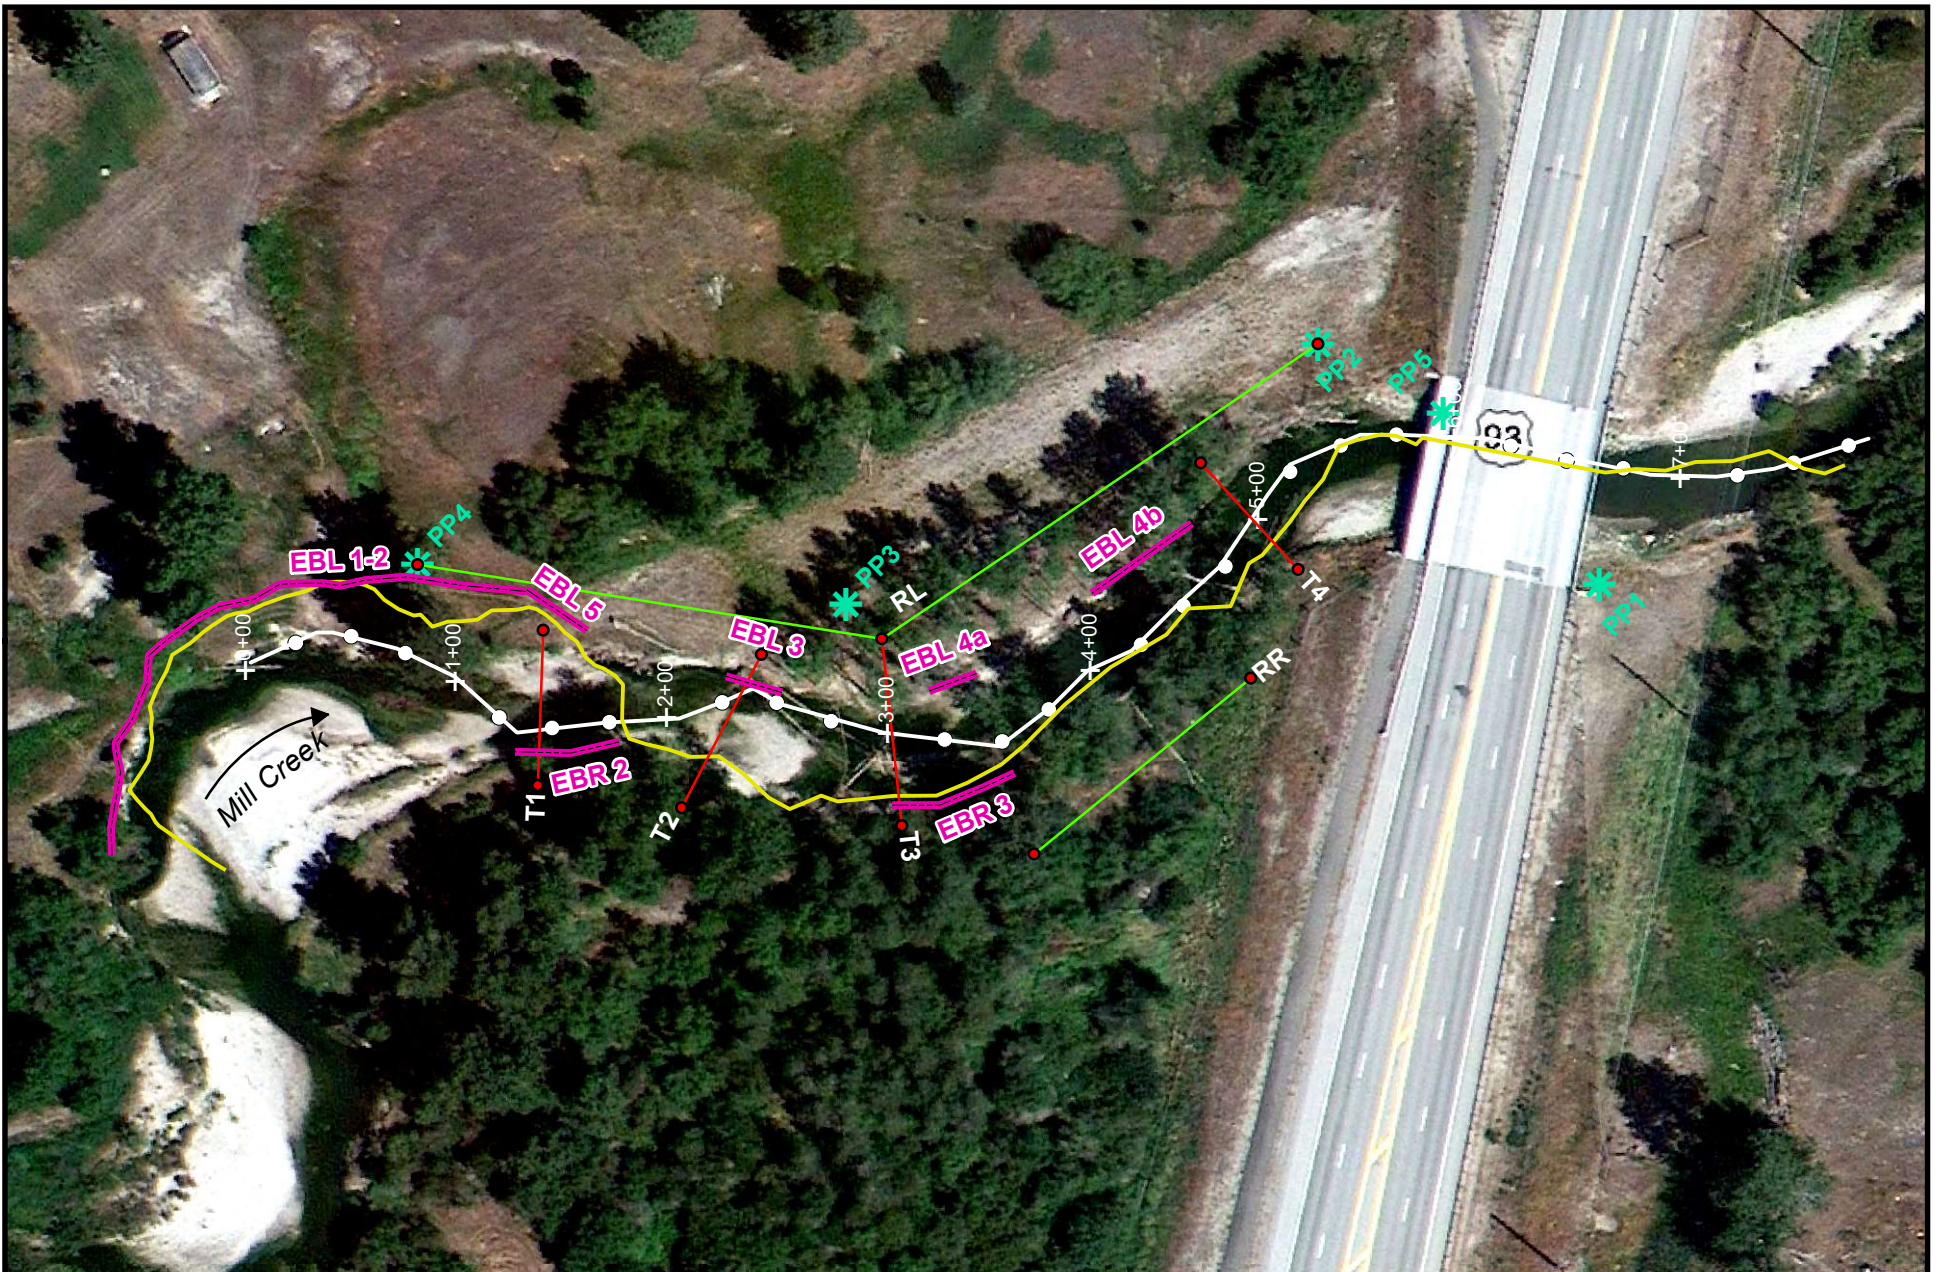
In 2021, continued bank erosion was noted in five locations (Table 4) within the project reach and has continued along a sharp meander bend immediately upstream of the project reach. Descriptions of erosion along these banks are provided below, while locations are illustrated on Figure 2 in Appendix A.

When the project reach is viewed from above (Figure 2, Appendix A) it is apparent that the thalweg has laterally shifted, thus changing the bank locations subject to erosive forces (See Bank Erosion Inventory discussion above).

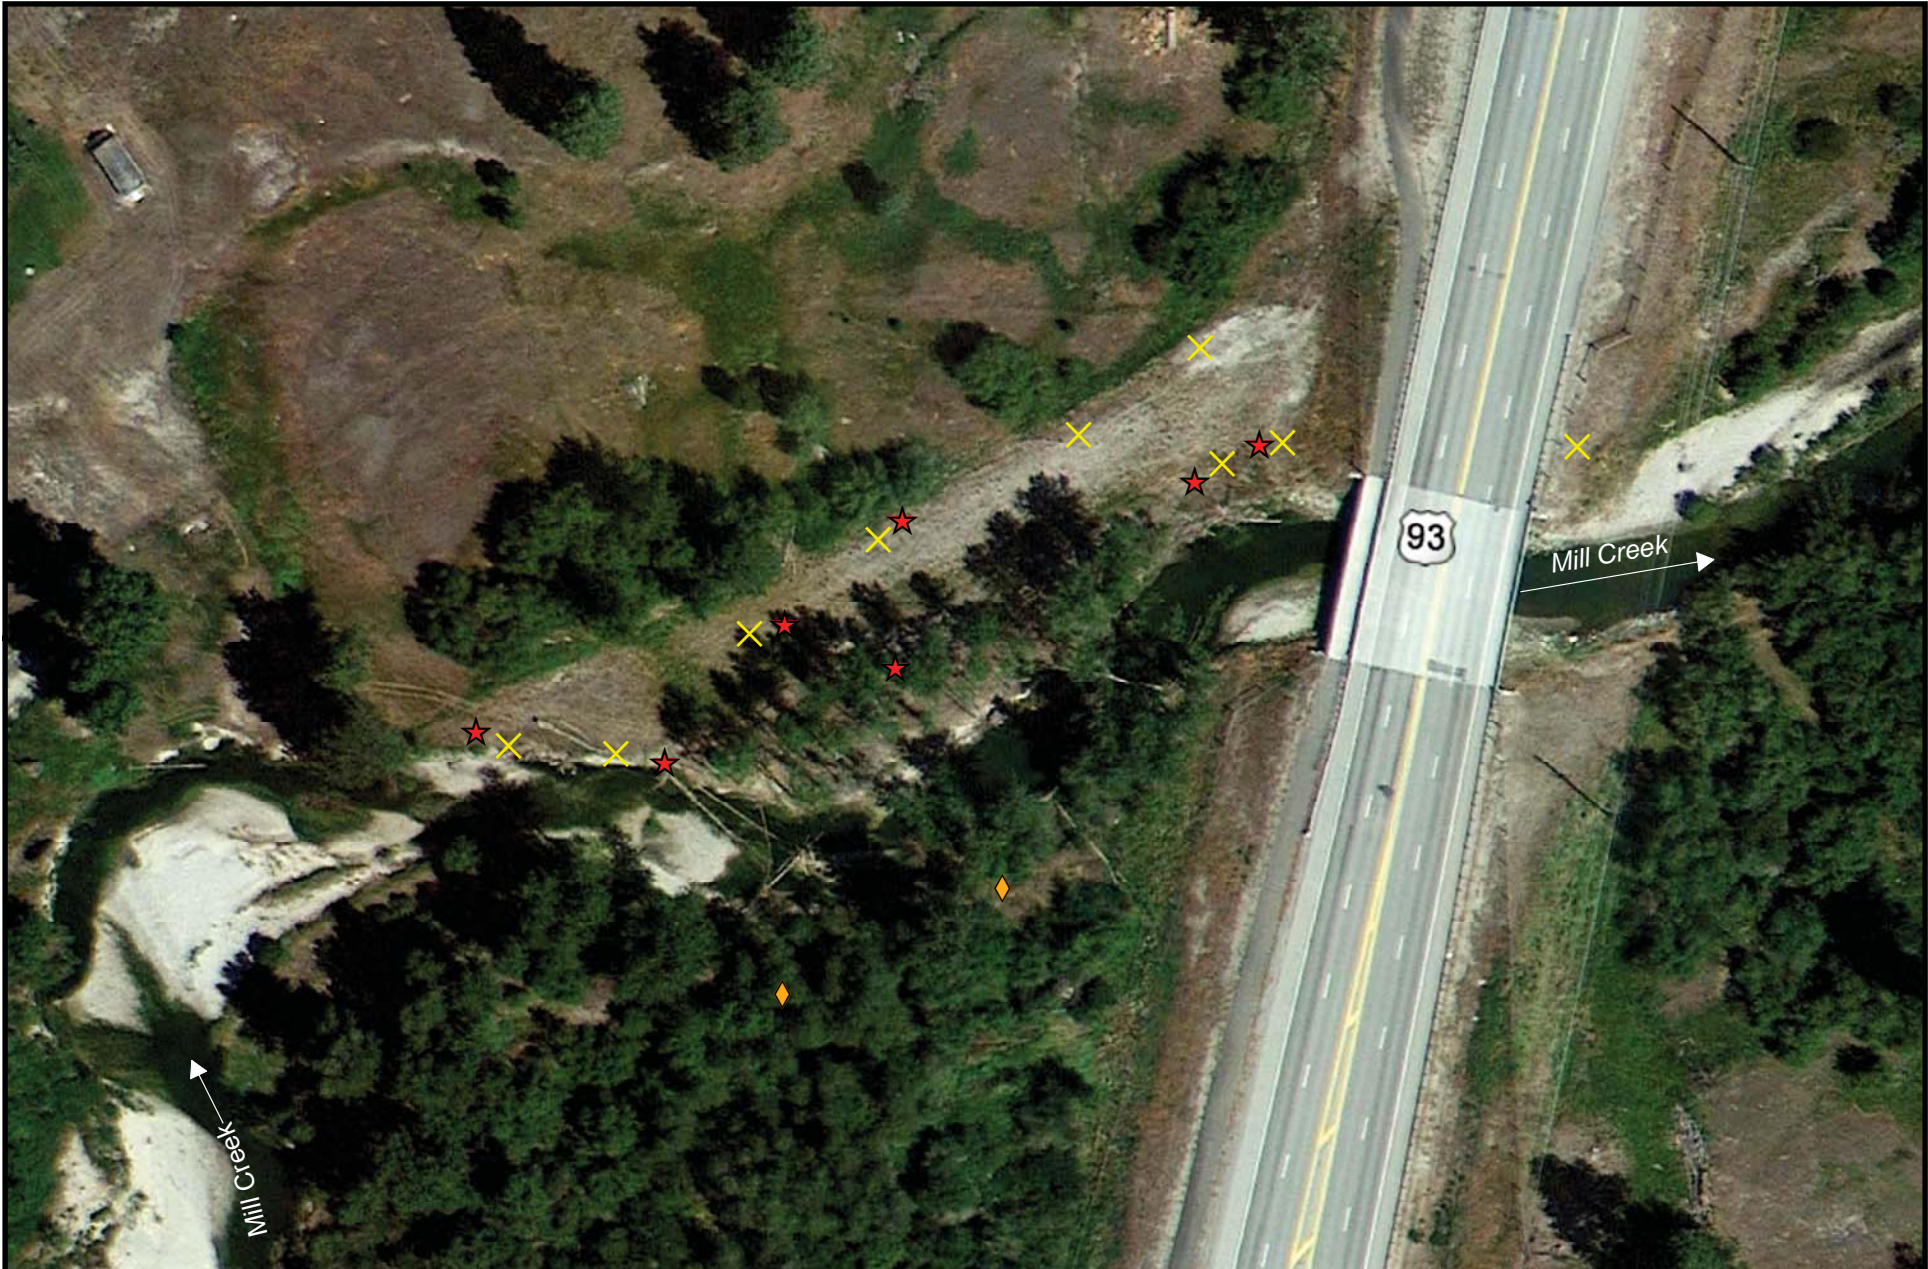
The vegetation inventory along Mill Creek identified eight noxious species (Table 3). Isolated occurrences of houndstongue (*Cynoglossum officinale*), St. Johnswort (*Hypericum perforatum*), leafy spurge (*Euphorbia esula*), ox-eye daisy (*Leucanthemum vulgare*), and hoary alyssum (*Berteroa incana*) were observed in trace amounts within riparian transects but were not mapped. Noxious weed infestations mapped within the project area were within the trace (less than 1 percent) and low (1 to 5 percent) cover classes. Locations of all noxious weed infestations, with the exception of isolated weed occurrences, are shown on Figure 3 of Appendix A. Many of these infestations occur on private properties outside of the road right-of-way (ROW) and are therefore inaccessible to MDT weed control contractors without landowner permission.

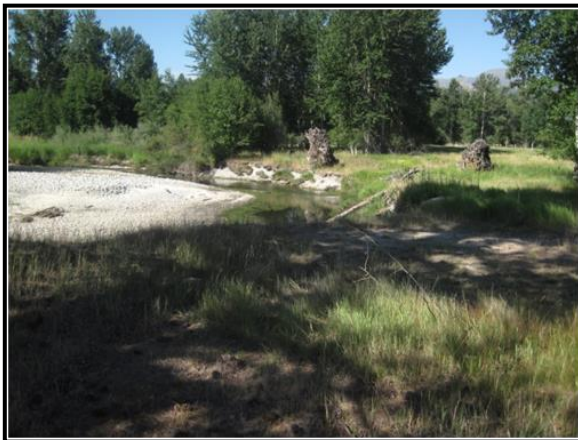
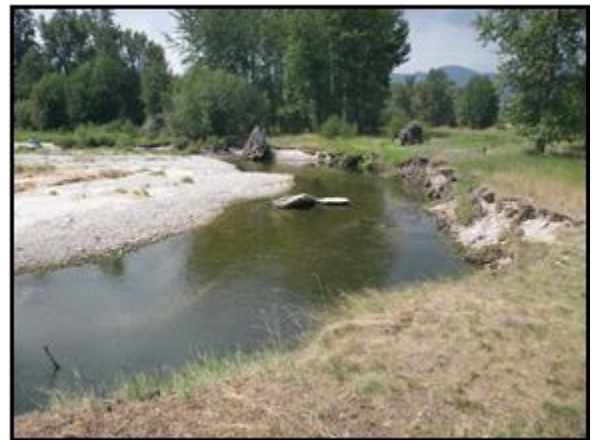
**Photo Point 4.3:** Looking upstream at point bar formation along the right bank. **Compass:** 225° (Southwest)

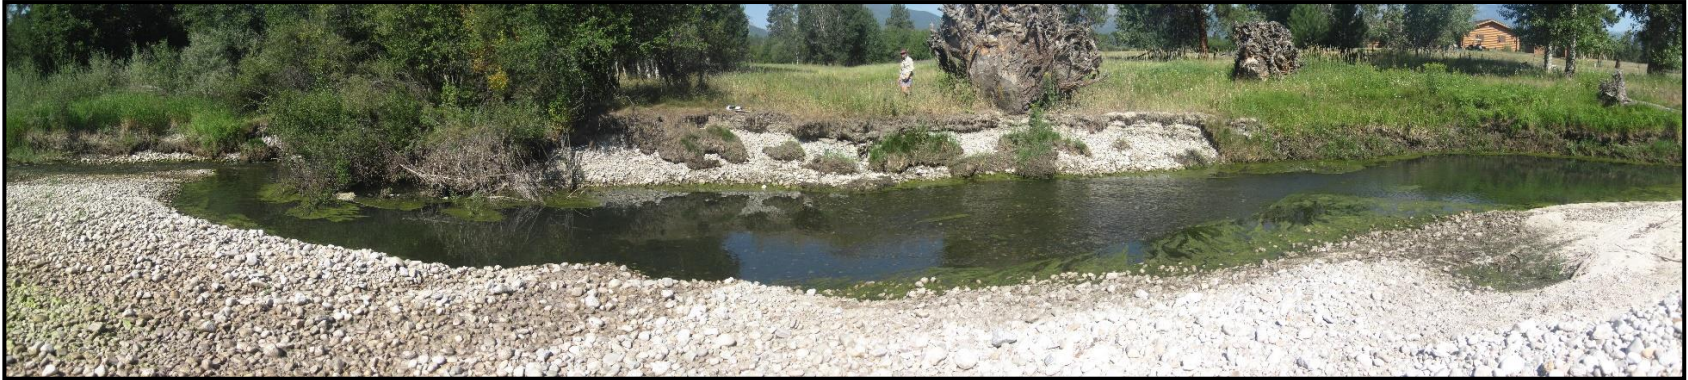
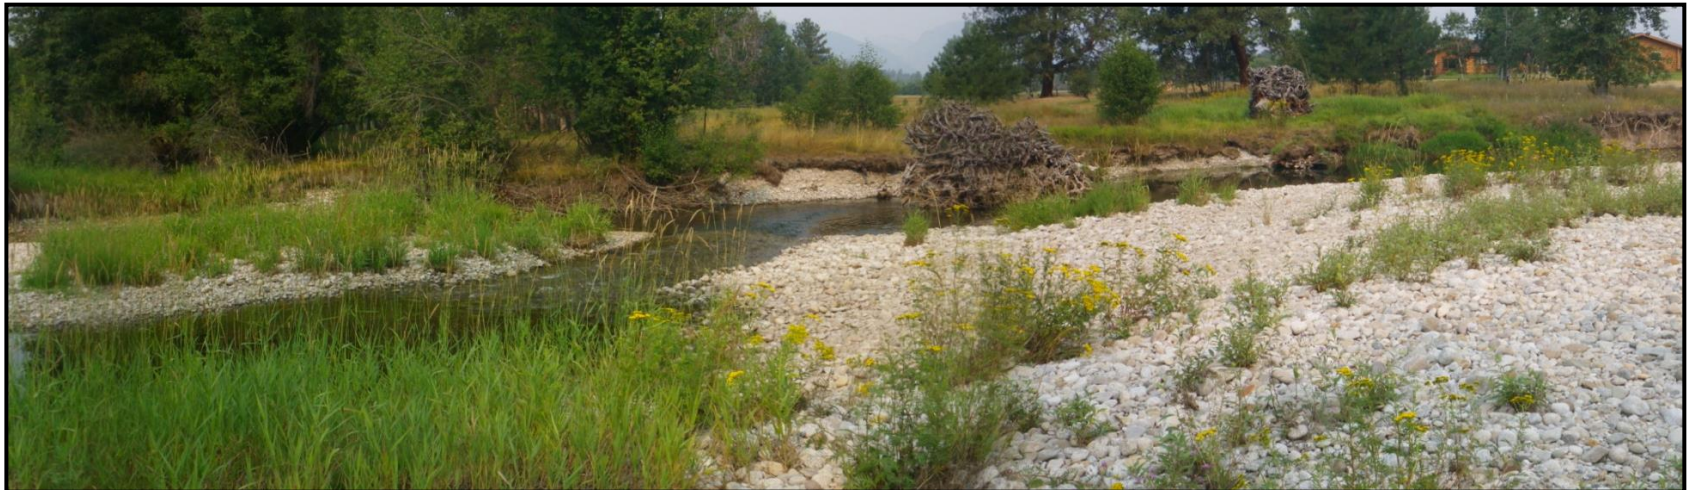
*Bank erosion upstream of the project reach* - Lateral migration has been noted along the north bank above the project reach since 2013 (Figure 2, Appendix A). Eroding bank segments, EBL1 and EBL2, were documented on the north side of the channel as two separate eroding bank segments in 2013 but were combined into one 247-foot-long eroding bank in 2014 (herein referred to as EBL1-2). This eroding bank occurs on private land upstream and outside of the MDT project reach but has been monitored since 2013 due to the potential of continued erosion that may affect the project reach. The upper 150 feet of EBL1-2 has shown relatively little change over the past five years with a bank retreat rate of between 0.2 and 0.6 feet per year (Additional Photo 1, Appendix B), and a short segment of bank between the upper and lower portions of the bank appears to be stabilizing. The lower 100 feet of the bank has migrated northward at a more rapid pace than the upper bank segment, especially in the vicinity of a large ponderosa pine tree that fell into the channel in 2016. This tree was removed from the river in 2020, as was a second large ponderosa pine that was growing on the bank. This bank segment has migrated to the north at a rate of 6-8 feet/year for the past five years (Additional Photo 2, Appendix B). Root wads and large rocks that were placed on, but not keyed into the toe of the banks are now in the middle of the right side of the channel (Additional Photos 1 & 2, Appendix B) and are causing increased scour against the bank. Severity of the erosion along EBL1-2 is considered very high.

EBL1-2 is eroding due to extensive gravel deposition just upstream of and across the channel from the eroding bank. Mid-channel bars and an advancing point bar on the right bank are forcing the thalweg up against the exposed north bank, which runs along this relatively sharp meander bend. Additionally, the substrate on the bank is highly unstable as it is primarily comprised of historic alluvial deposits consisting of unconsolidated gravel and cobble.

**Additional Photo 1:** Upper end of eroding Bank EBL1-2.

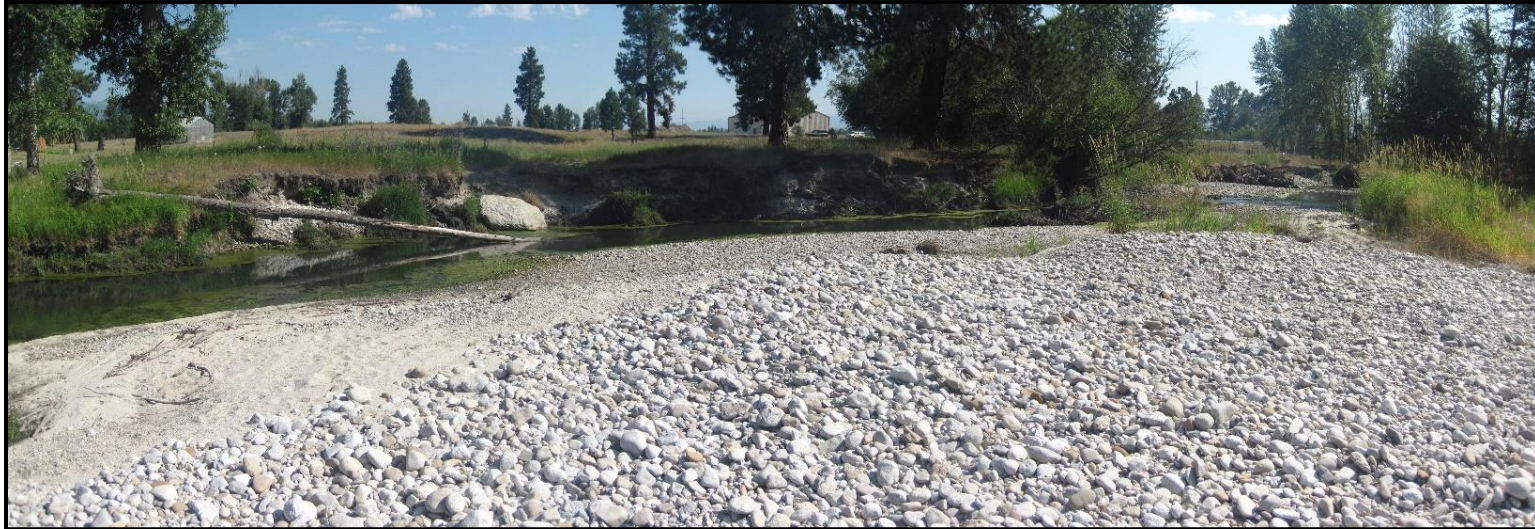
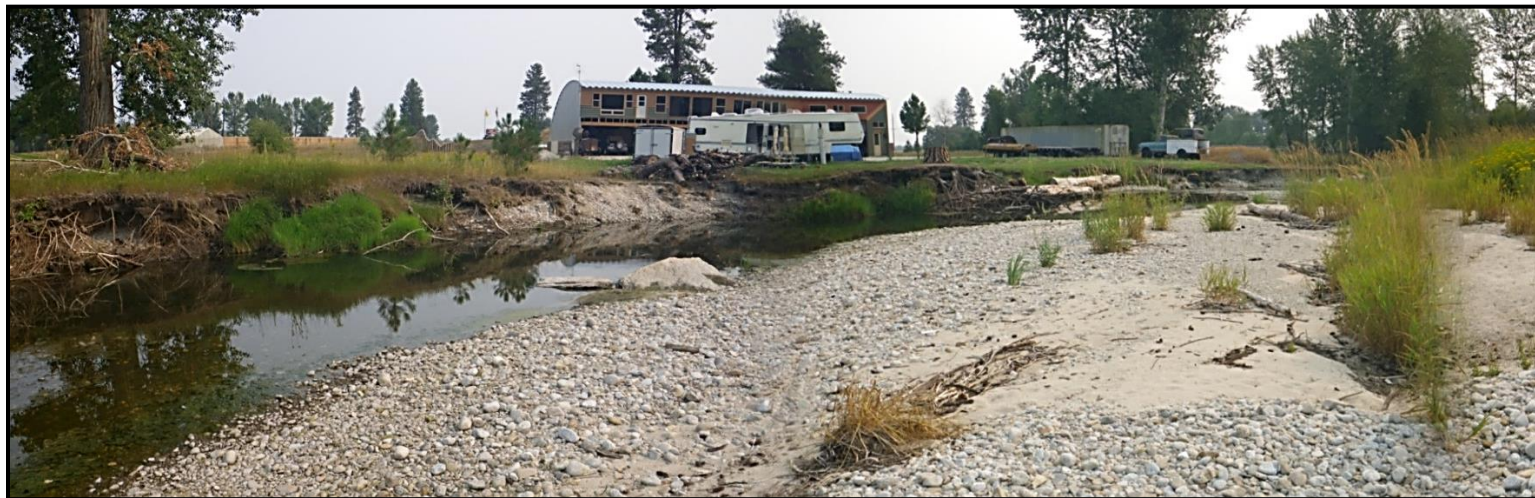
**Additional Photo 2:** Lower end of eroding Bank EBL1-2.

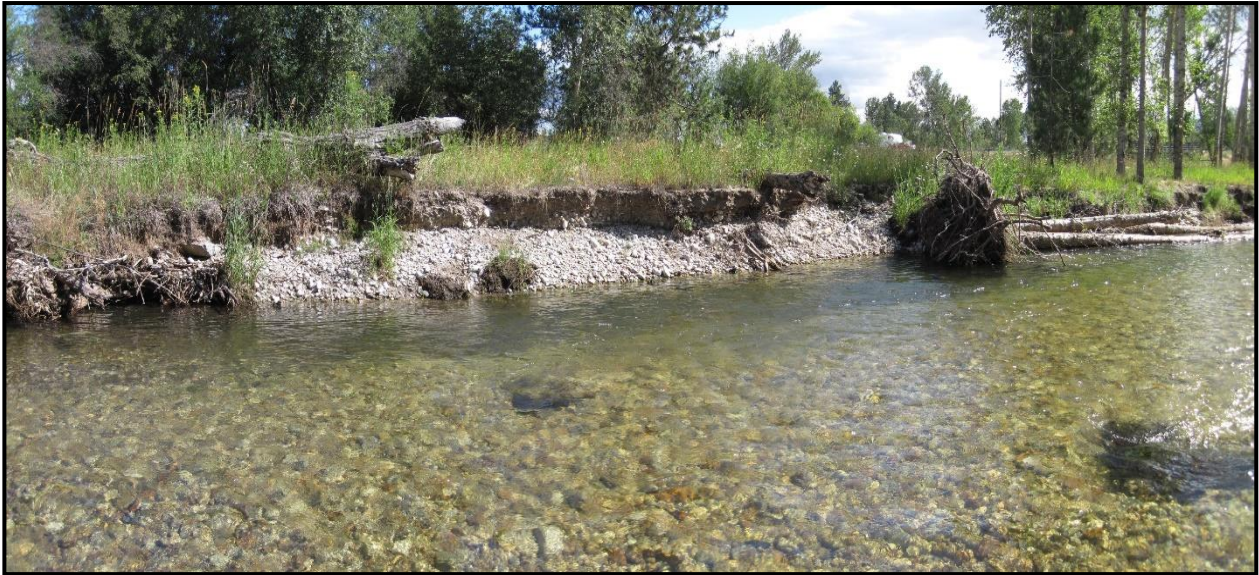
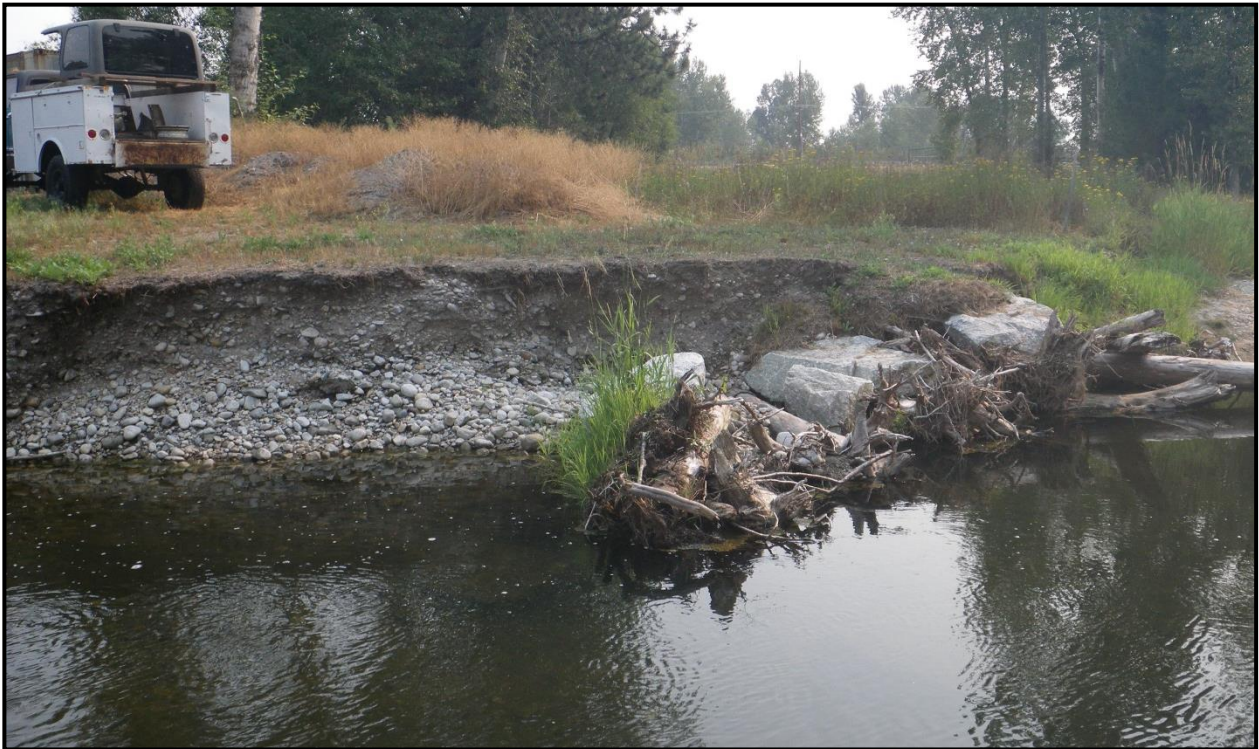
Erosion has been observed just downstream of EBL5 in a location previously numbered as EBL3. This eroding bank was originally observed in 2014 but was removed from the eroding bank inventory in 2019 because it had stabilized following the development of a gravel deposit adjacent to the bank. In 2020, this gravel deposit was washed away during the high flow events and EBL3 was again eroding. In 2021, a gravel bar had begun to develop at the upstream end of EBL3 and the bank had once again begun to stabilize. The length of EBL3 was thus reduced by approximately 30 feet in 2021.

**Additional Photo 3:** Upper section of Eroding Streambank EBL3.

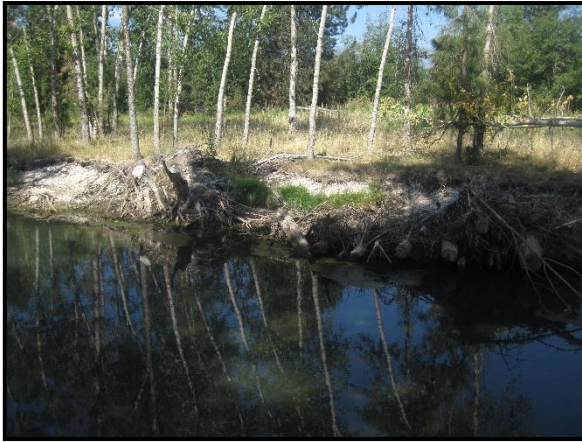
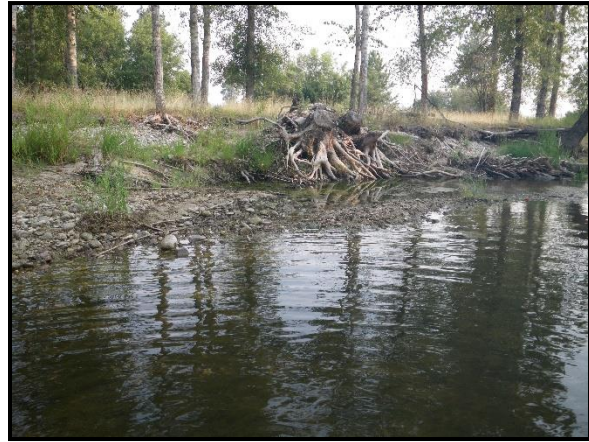
Lateral erosion at bank EBL4 has been observed over the last five years, but in 2021 the middle section of this bank had begun to stabilize. Bank instability at EBL4 was potentially caused by natural channel adjustments and debris jams that formed following construction but the channel form in this location seems to have reached an equilibrium over the short term. The length of EBL4 was significantly reduced in 2021 and has now been separated into two separate segments (EBL4a & b). The middle section of this bank has stabilized by sediment deposits which are now being colonized by willow and perennial wetland vegetation including sedges and rushes.

**Additional Photo 4: Eroding streambank EBL4.**

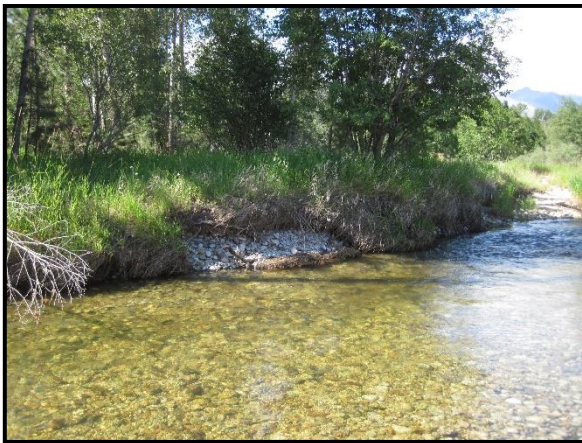
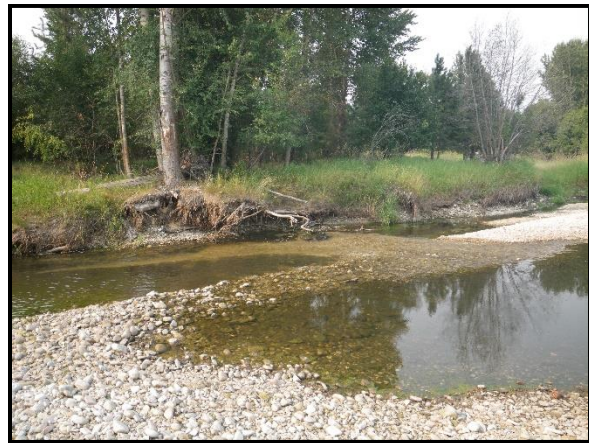
Erosion at EBR2 was originally noted in 2014 along 65 feet of the channel across from the head of the deactivated (backfilled) stream channel. Erosion at this location is tied to sediment deposition leading to channel adjustments, and scour along the outside of a meander. Additional erosion along this bank segment was not observed between 2015 and 2017; however, the bank showed signs of erosion again beginning in 2018, including undercutting, slumping sod mats, and root exposure. The eroding bank length increased from 40 to 80 feet between 2018 and 2019 and remained around 80 feet in length in 2020. In 2021, 30 feet of EBR2 had stabilized due to the development of a large point bar upstream of and adjacent to the bank. This point bar is forcing the stream away from the bank, resulting in a reduction of erosive forces and allowing it to stabilize (Additional photo 5, Appendix B).

**Additional Photo 5: Eroding streambank EBR2.**

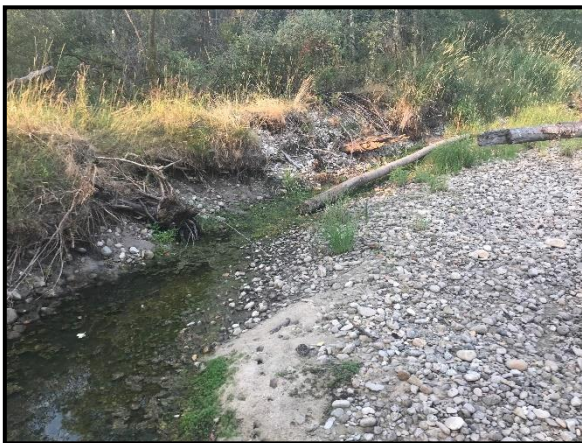
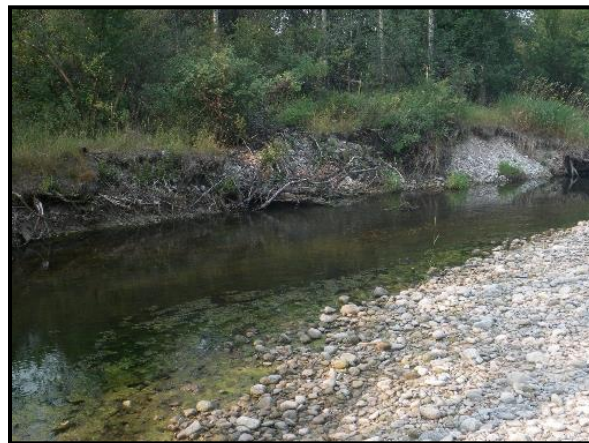
EBR3 was observed in 2013 adjacent to a woody debris jam on the right bank and was characterized by upper bank sloughing and toe scour. Very little change has been observed at EBR3 since that time and no changes were observed at during the 2021 monitoring event.

Vegetation along the upper bank includes reed canary grass, oxeye daisy, woods rose, wheatgrass, brome, small cottonwood saplings, and young willows, but the lower bank still does not support much vegetation (Additional Photo 6, Appendix B). During high flow events, the stream flows directly against this bank and has washed away the topsoil. The lack of topsoil combined with the steep slope of the bank are likely prohibiting bank stability.

**Additional Photo 6: Eroding streambank EBR3.**

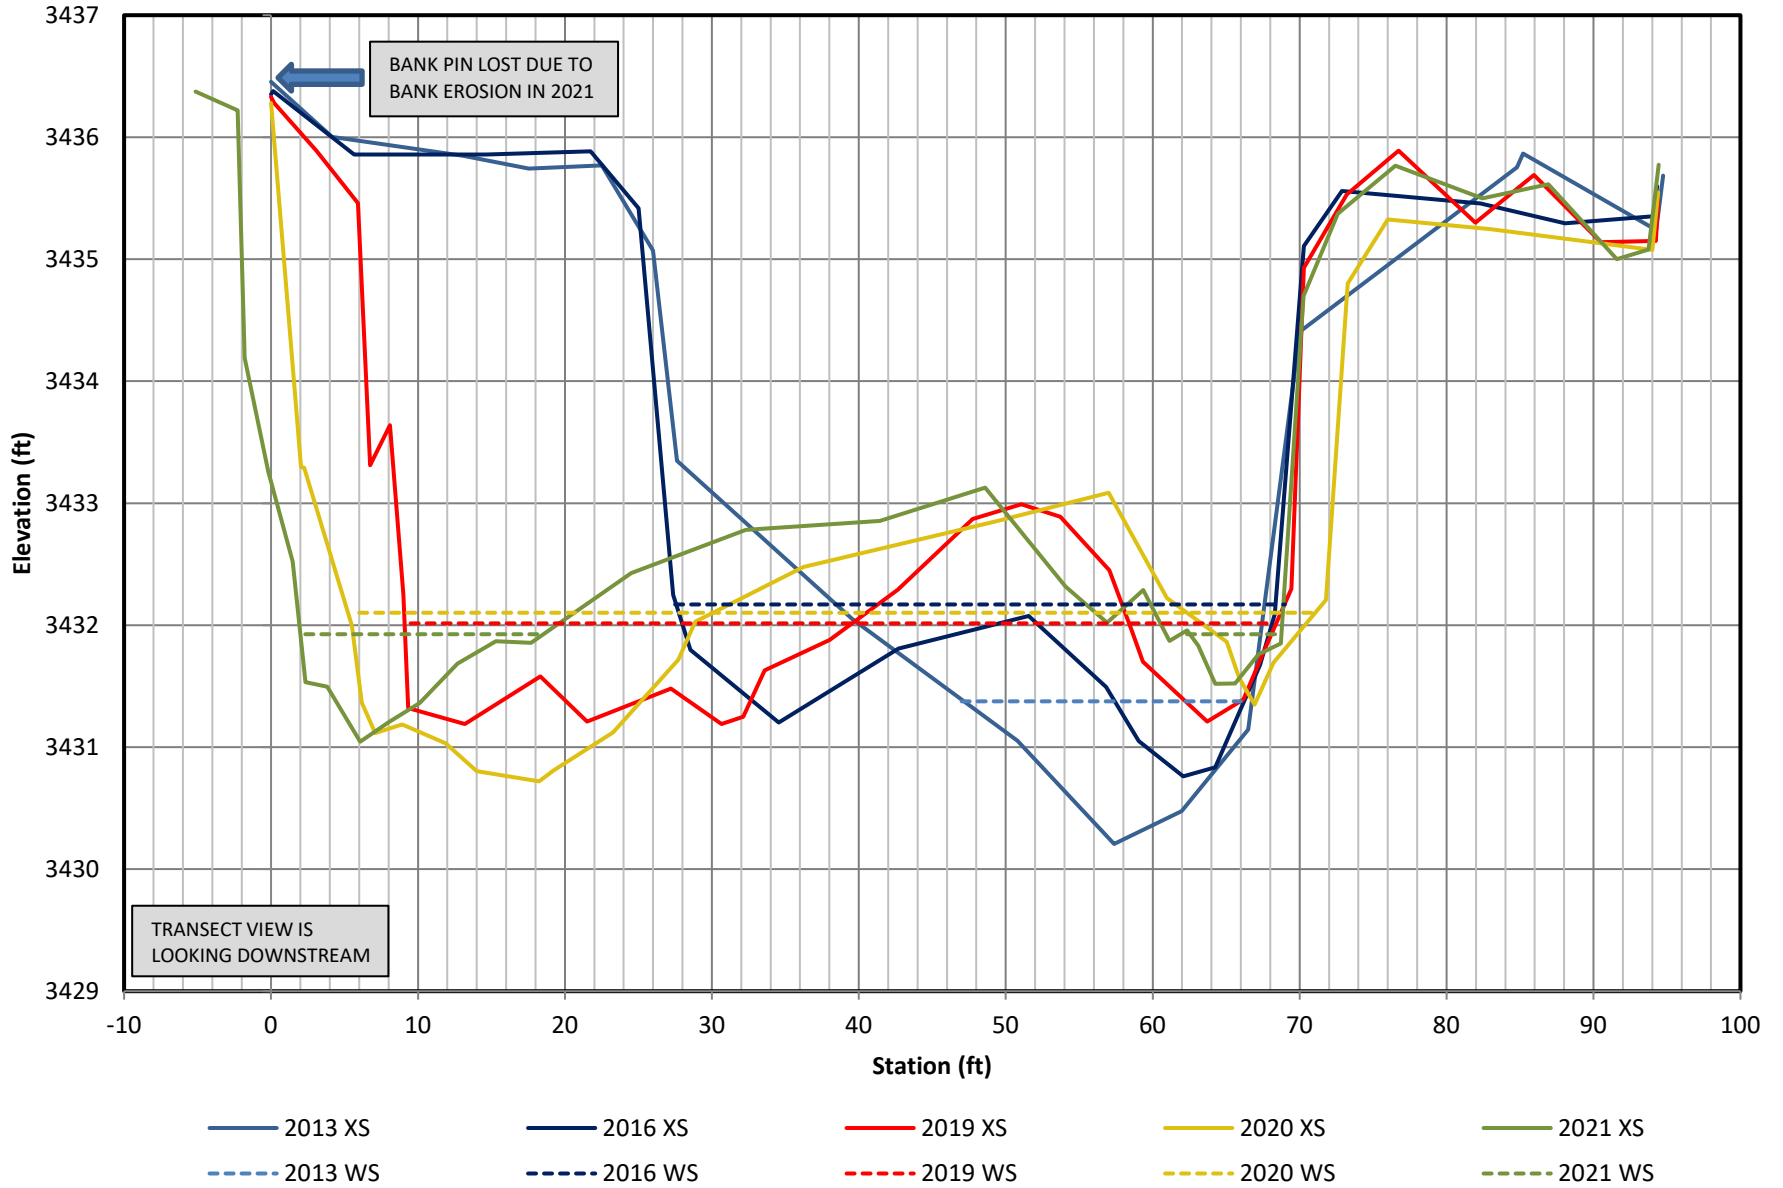
# Mill Creek Transect #1 - Riffle

While transect #1 (T1) was originally positioned at a riffle, survey data from 2013-2015 indicated that a pool had formed in this location; likely caused by point bar development on the right side of the channel just upstream of T1. Over the last 3-4 years, additional deposition on the right side of the channel has forced more flow against the bank, where the pool that intersects T1 now occurs. The channel width at T1 has increased annually by 4-5 feet as a result of erosion on the north bank (Appendix D).

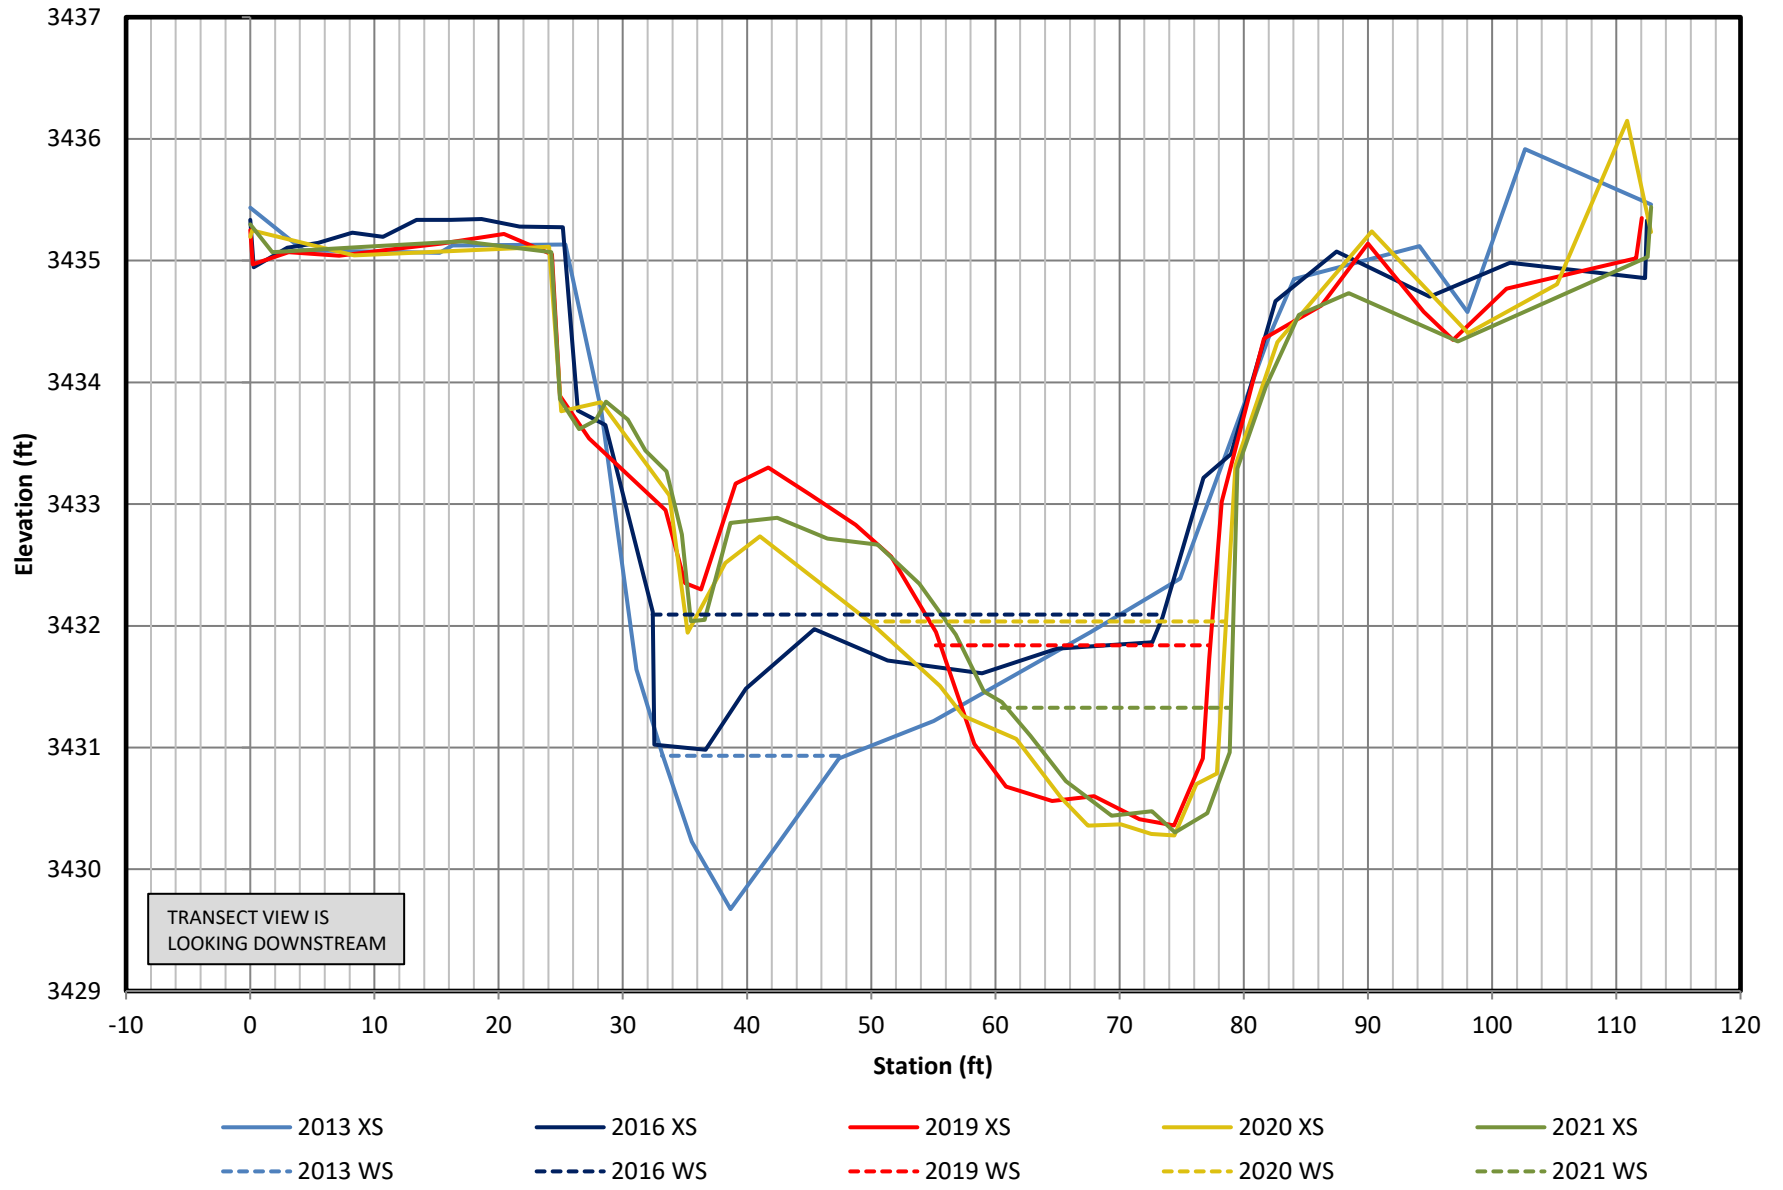
# Mill Creek Transect #2 - Pool

Transect #2 (T2) was originally established at a pool adjacent to a woody debris jam along the north bank. The debris jam has mostly washed away and since 2015, a gravel deposit has been observed adjacent to the north bank. This deposit has caused the thalweg and the pool to shift toward the right bank (see photos of Transect #2, Appendix B).

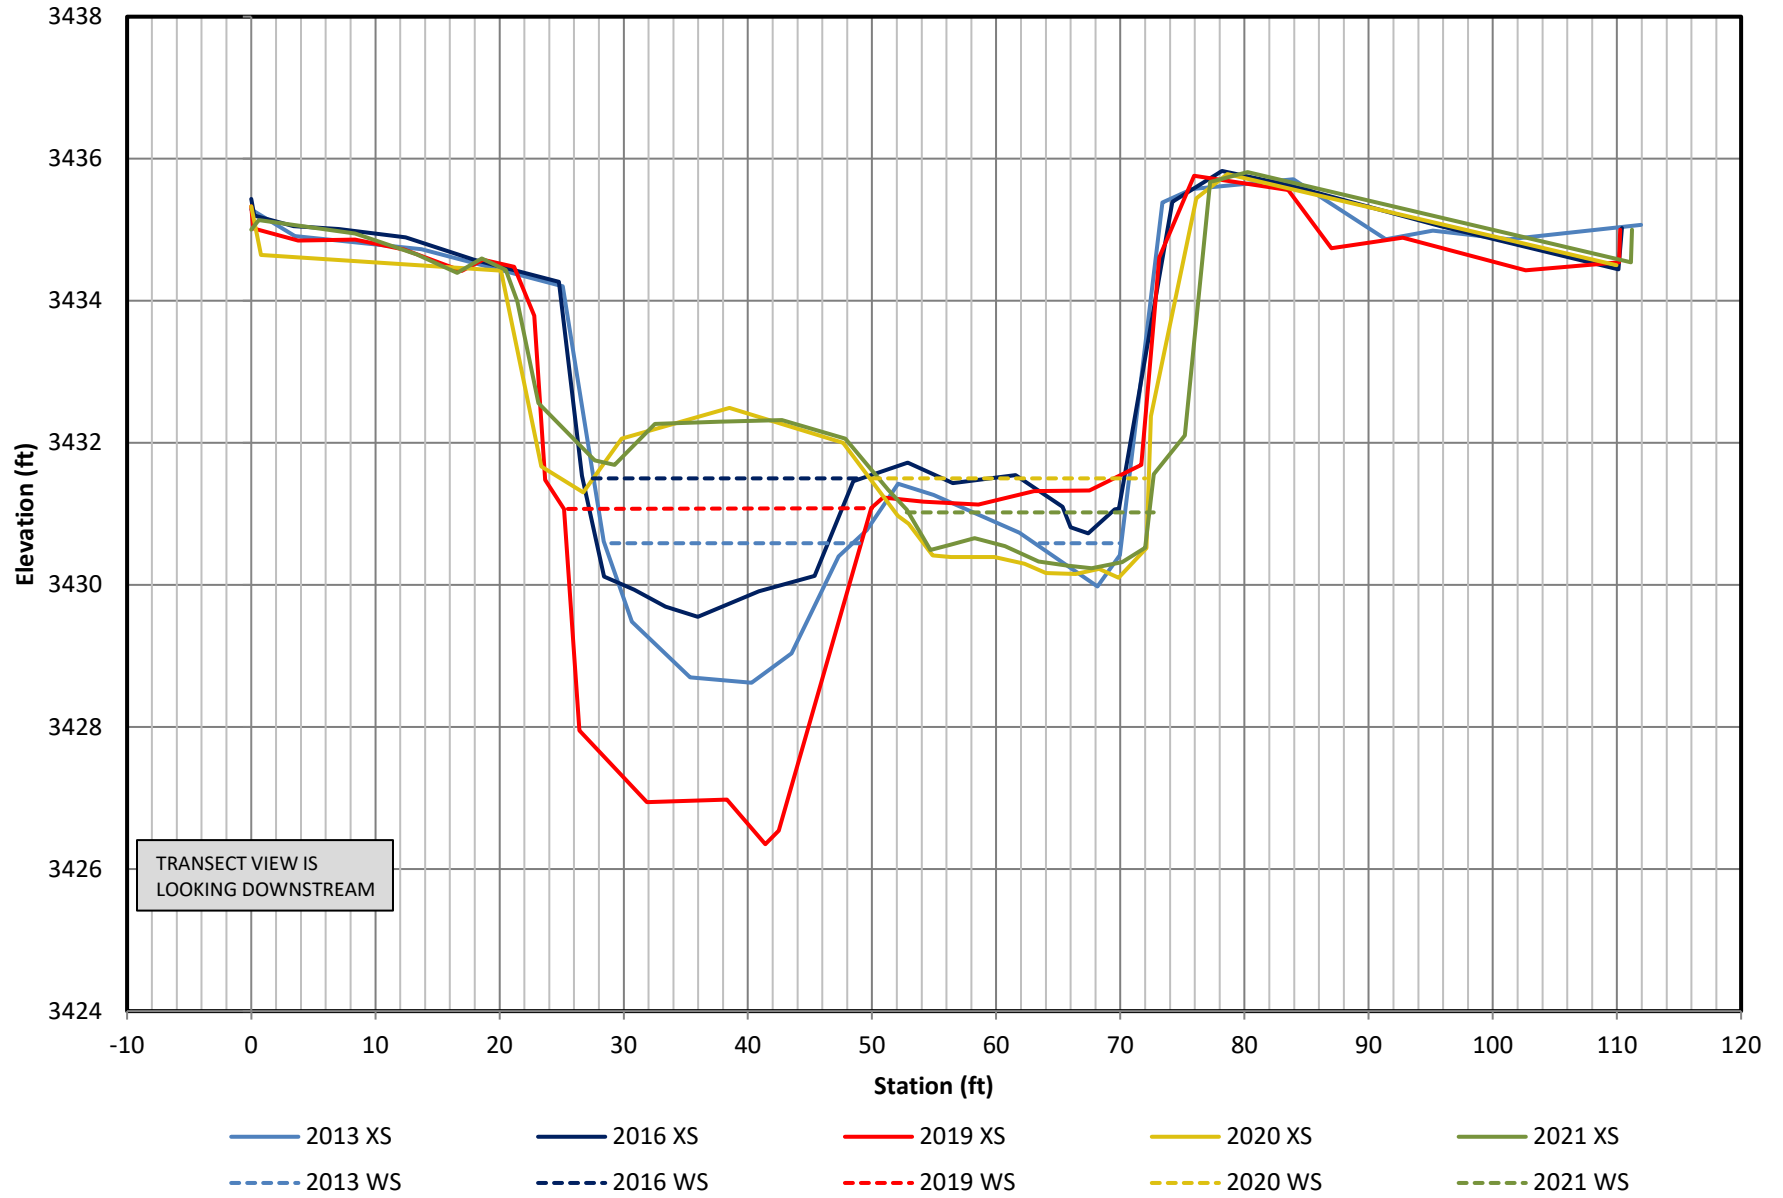
# Mill Creek Transect #3 - Pool

Transect #3 (T3) generally maintained the same geometry from 2013 to 2019, although increased pool depth was observed in 2019. However, between the 2019 and 2020 monitoring events, a large gravel bar developed along the north bank, forcing the thalweg and the majority of the flow to shift to the right side of the channel. The T3 cross-section no longer contains a pool and now represents a run. This change in channel form was maintained in 2021 (Appendix D).

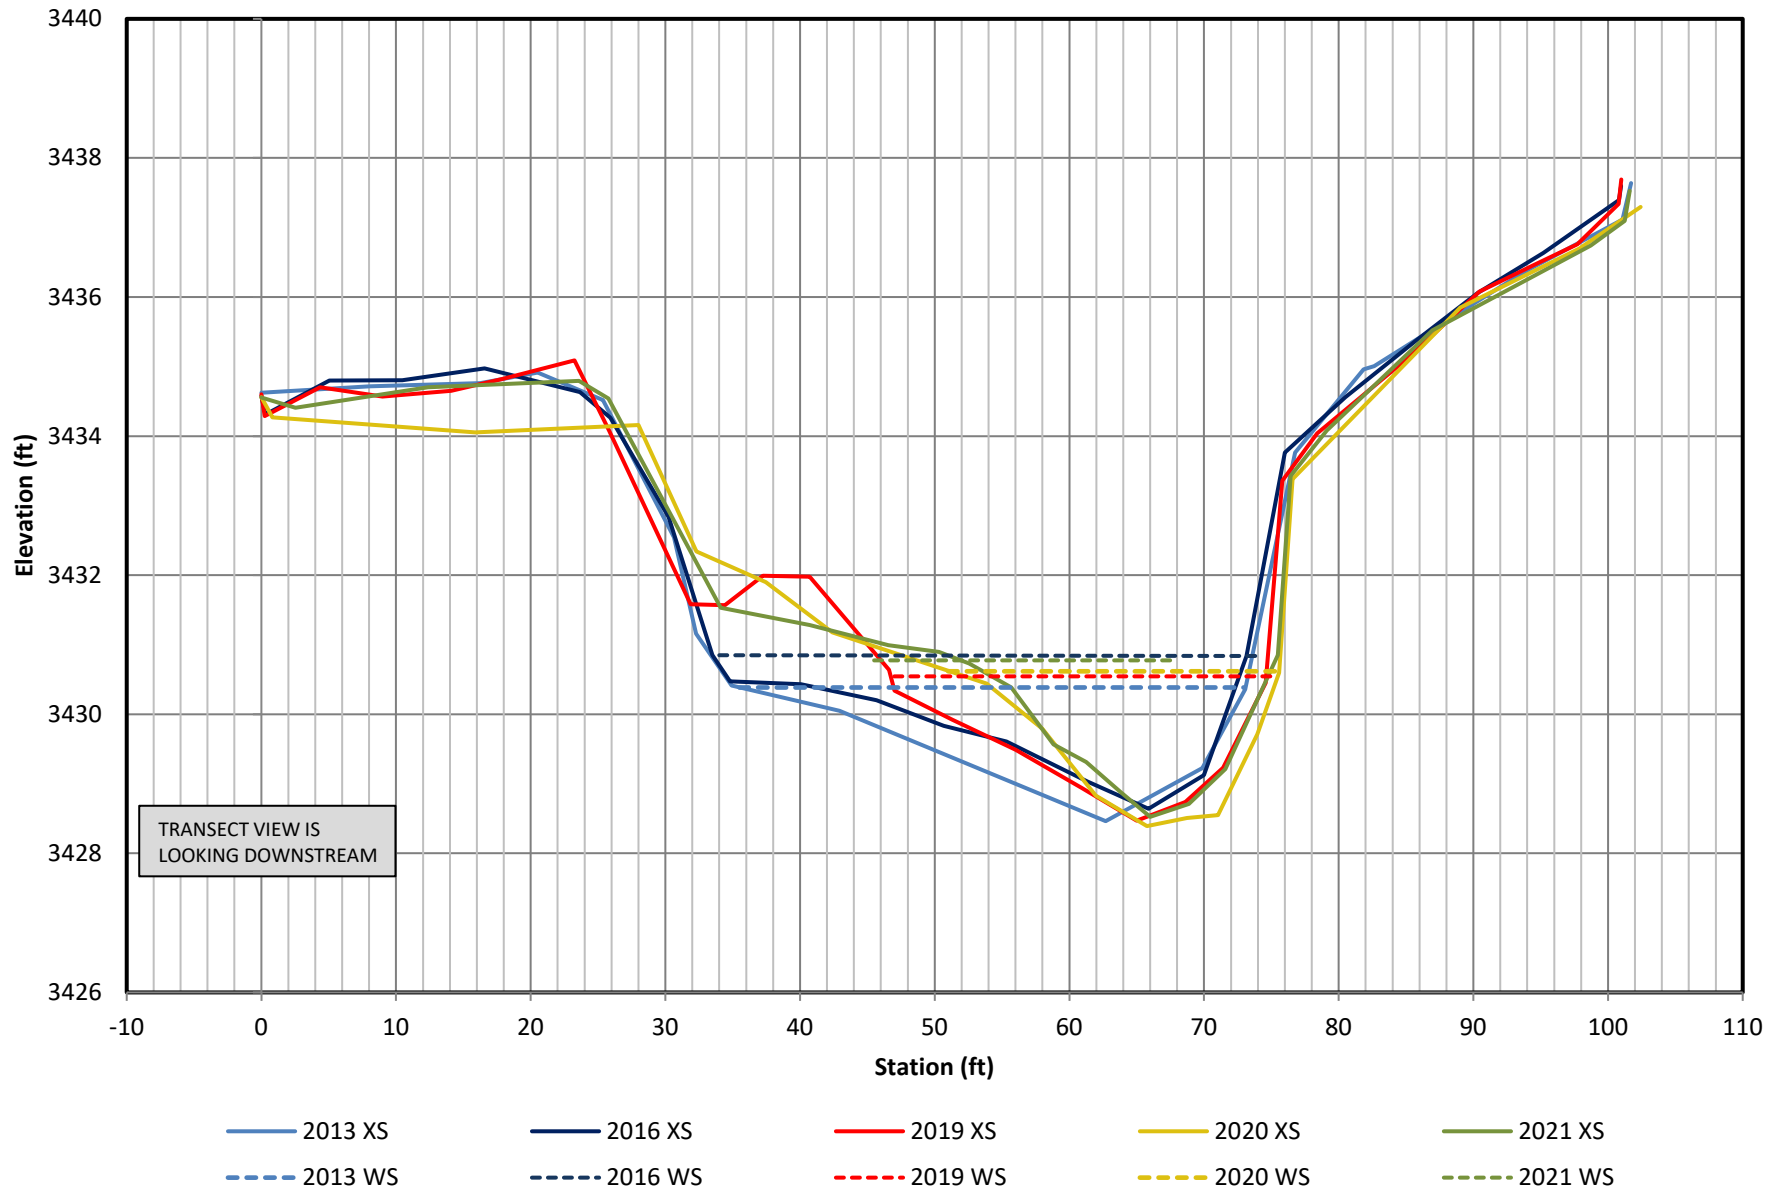
# Mill Creek Transect #4 - Riffle

Transect #4 (T4) is located at a riffle just upstream of the U.S. Highway 93 Bridge. Channel geometry has remained relatively consistent at this location since 2013. A point bar has gradually developed along the north bank, and the thalweg has moved closer to the right bank (Appendix D). Bar development along the north bank may eventually result in erosion along the right bank; however increased erosion has not been observed in the vicinity of T4 to date.
