Montana Department of Transportation Stream Mitigation Monitoring Report

**MILL CREEK MITIGATION SITE**

**MDT Project Number:** NH7-1(114) 59 / UPN # 201500

**Monitoring Year:** 2021

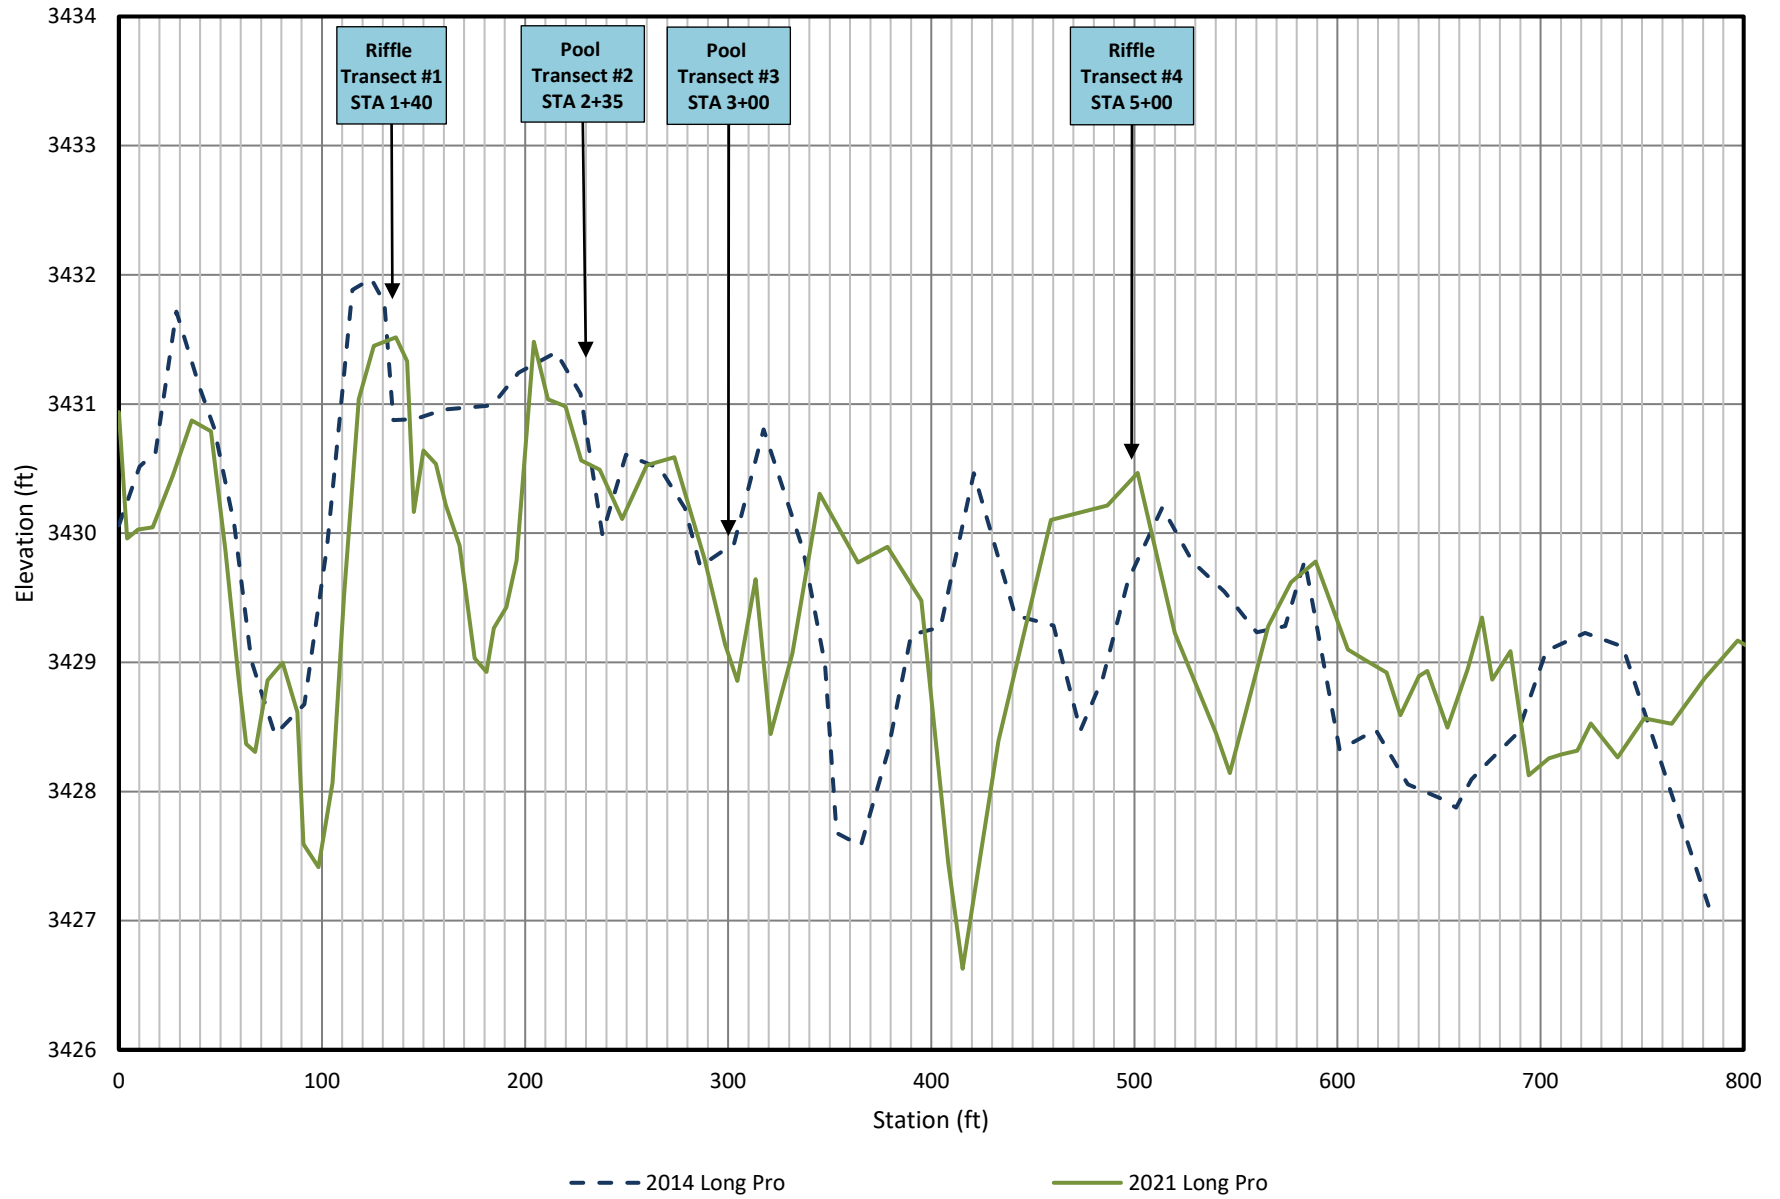
# Mill Creek Longitudinal Profiles: 2014 - 2021

*Longitudinal Profile* - The 2021 longitudinal profile indicates that, as would be expected in a highly dynamic system, pool and riffle locations have moved around quite a bit over the years as sediment is redistributed within the reach. In general, the number of pool-riffle sequences has remained relatively consistent over time (Appendix D). Six pools are being maintained with riffles between each pool, thus indicating that the mitigation reach is supporting a healthy diversity of aquatic habitat types. Based on riffle crest elevations, the longitudinal profile also indicates the bed profile of the reach is neither downcutting nor aggrading.
