Montana Department of Transportation Stream Mitigation Monitoring Report

**BOWSER CREEK MITIGATION SITE**

**MDT Project Number: NH-MT5-3(50)109F UPN #: 2038013**

**Monitoring Year:** 2022

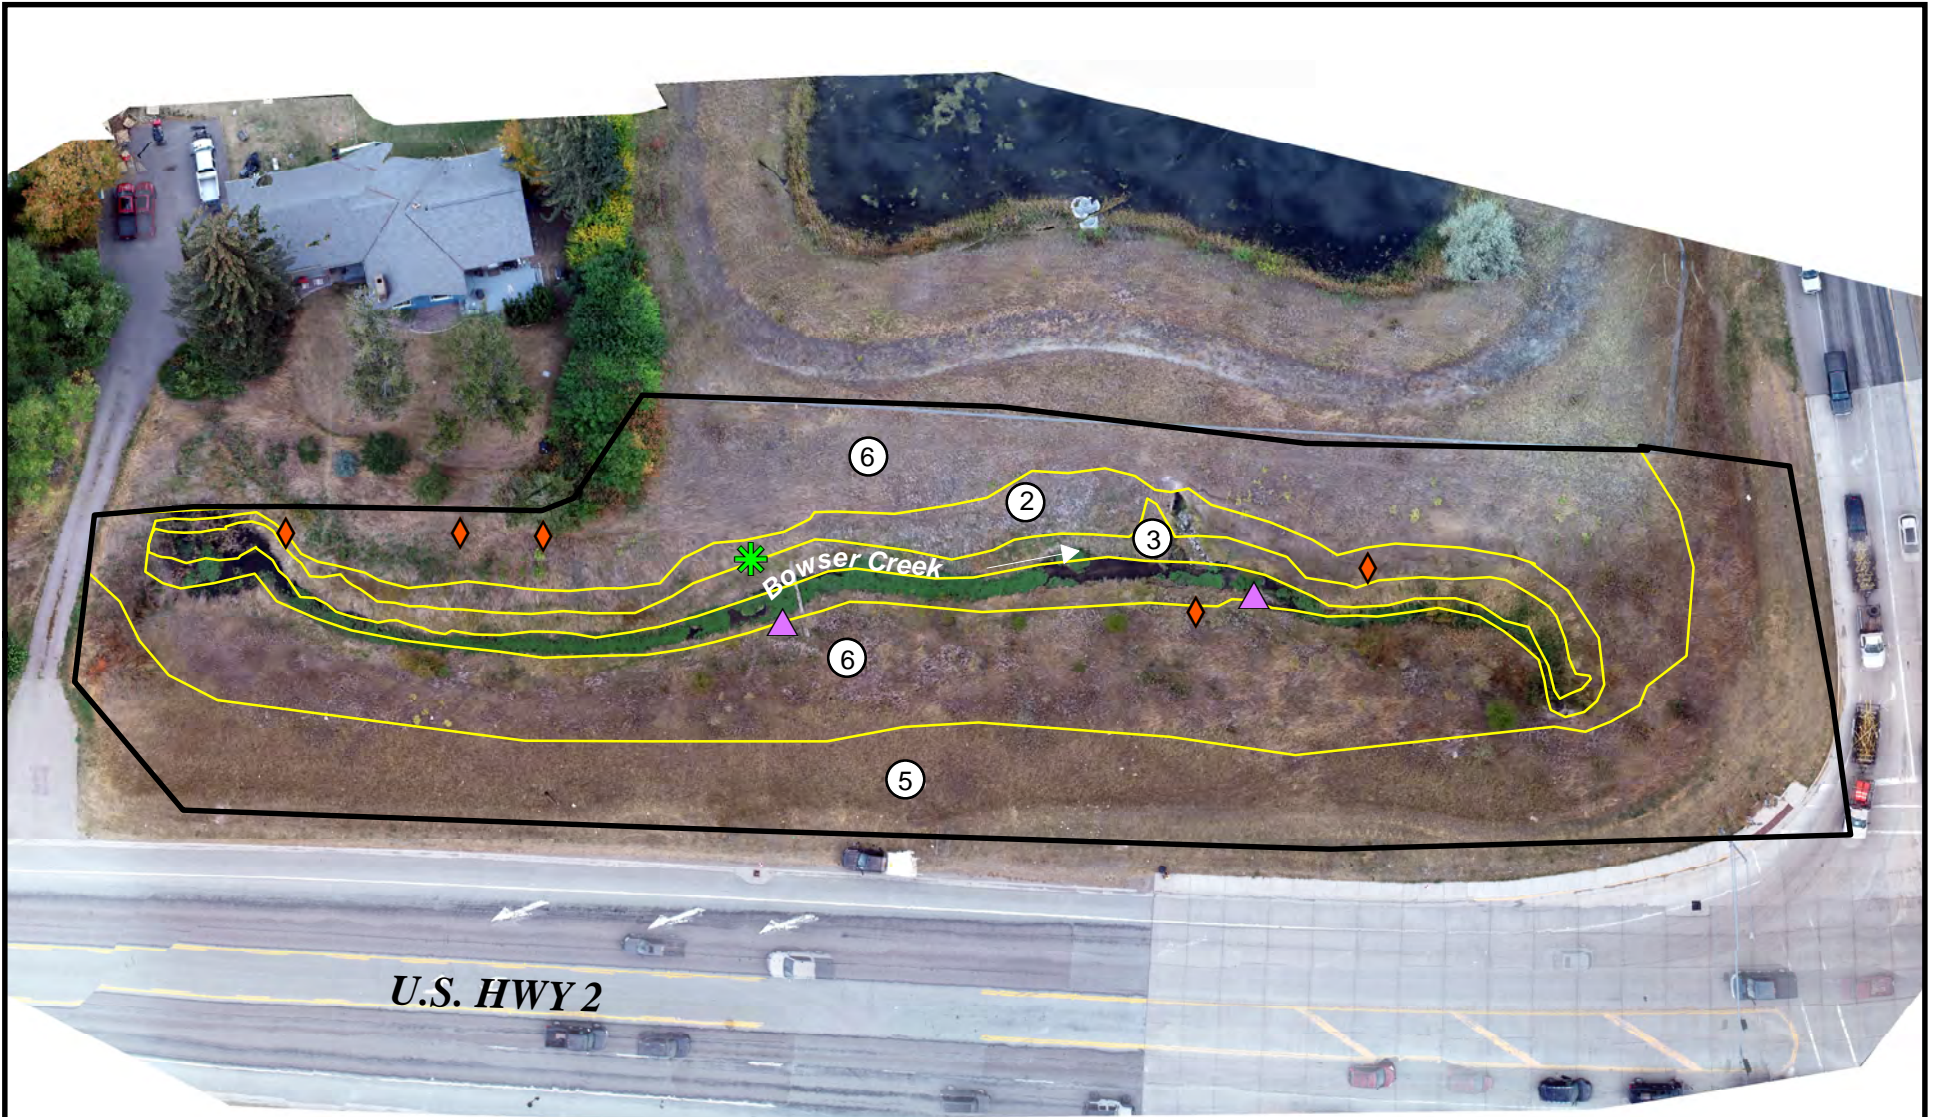
**Bowser Creek - 2022 Noxious Weeds and Vegetation Community**  
Figure 3

Dominant species recorded along the riparian and stream bank transects were combined with visual observations throughout the site to develop a vegetation community map (Figure 3, Appendix A). The four vegetation community types observed in 2022 are described below (

daisy (*Leucanthemum vulgare*), butter-and-eggs (*Linaria vulgaris*), and common tansy (*Tanacetum vulgare*) (MT Department of Agriculture, 2019). An estimated 3% of the project area was colonized by noxious weeds, representing a consistent level of infestation with 2021. A low cover class (1 to 5 percent) was assigned to all mapped weed occurrences within the project area in 2022. Canada thistle was the most prevalent noxious weed, with infestations located throughout the project area. Two infestations of butter-and-eggs previously mapped at the east end of the site were not observed in 2022, and two new infestations of oxeye daisy were recorded along the right bank of Bowser Creek. Locations of noxious weed infestations are provided on Figure 3 in Appendix A, with the exception of which include common tansy and houndstongue which were observed as isolated occurrences and in trace amounts.

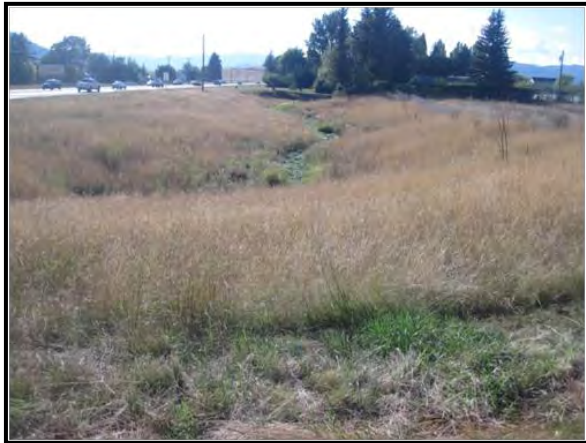
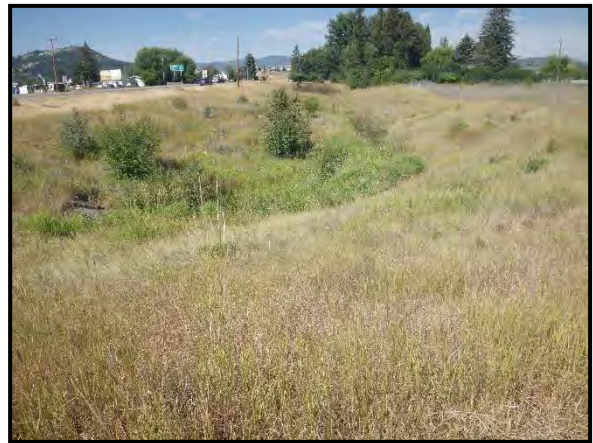
**Photo 1:** View looking west (upstream) of Bowser Creek.

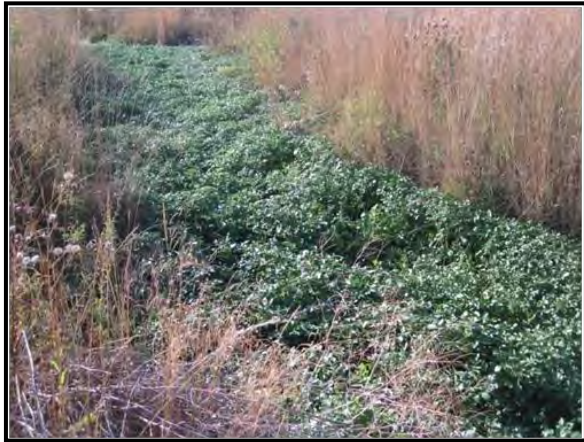
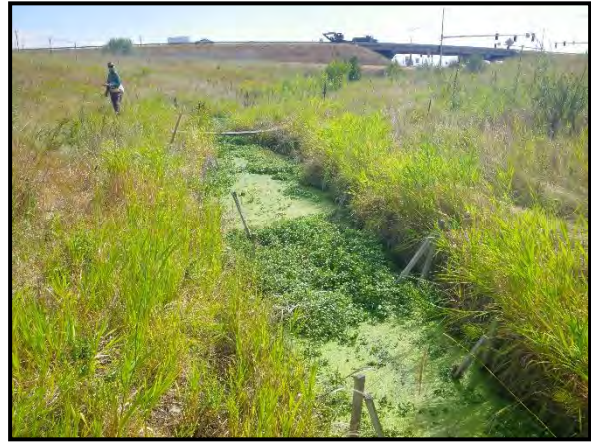
Vegetation community Type 3 – *Nasturtium officinale* (watercress) was observed within the channel. Watercress dominated this community type with more than 50% cover growing in the channel bed and 6 to 10% cover along both stream banks. This community has been consistently observed in dense stands along the stream bed and edges of stream banks since the 2015 monitoring event. In 2022, this community appeared to be diversifying and now includes common duckweed (*Lemna minor*), climbing nightshade (*Solanum dulcamara*), and true forget-me-not (*Myosotis scorpioides*), although in much lesser amounts than watercress.

**Additional Photo 1:** Prolific watercress growth shown in 2013 was less prevalent in 2022, and duck weed has moved into the plant community

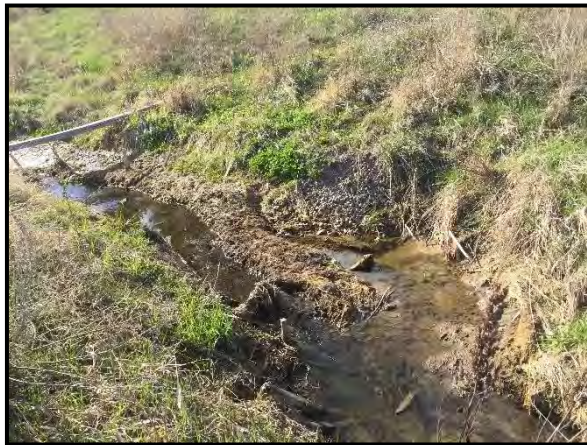
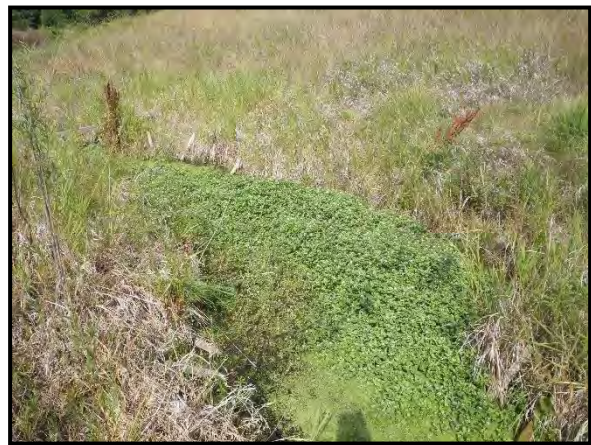
No eroding banks were observed within the Bowser Creek site in 2022. Only one eroding bank was observed in 2021, and in 2022 this bank had developed enough vegetation cover to no longer be considered eroding.

**Additional Photo 2:** Healed Eroding bank observed in 2013.

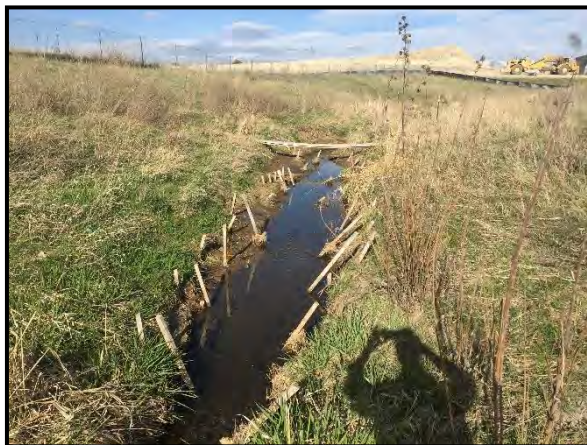
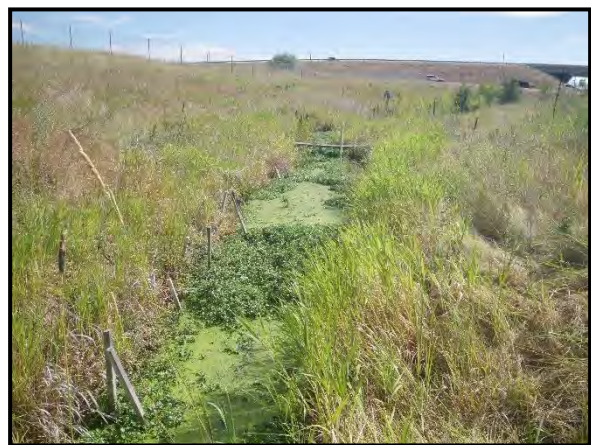
**Additional Photo 3:** Bowser Creek Channel showing abundant aquatic macrophyte growth in 2022.

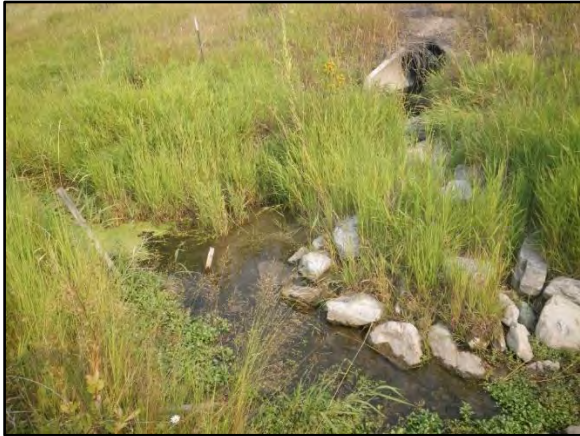
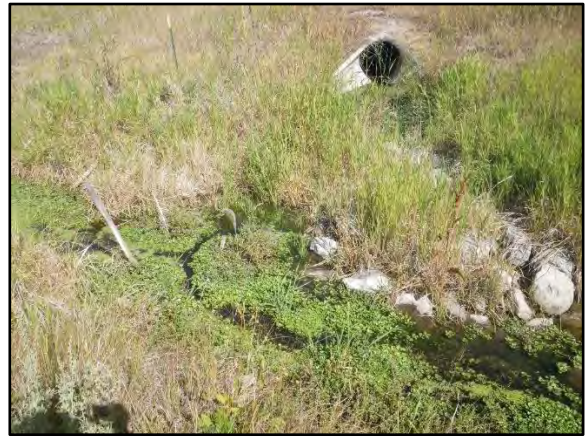
**Additional Photo 4:** Stormwater pond culvert and outflow confluence with Bowser Creek.

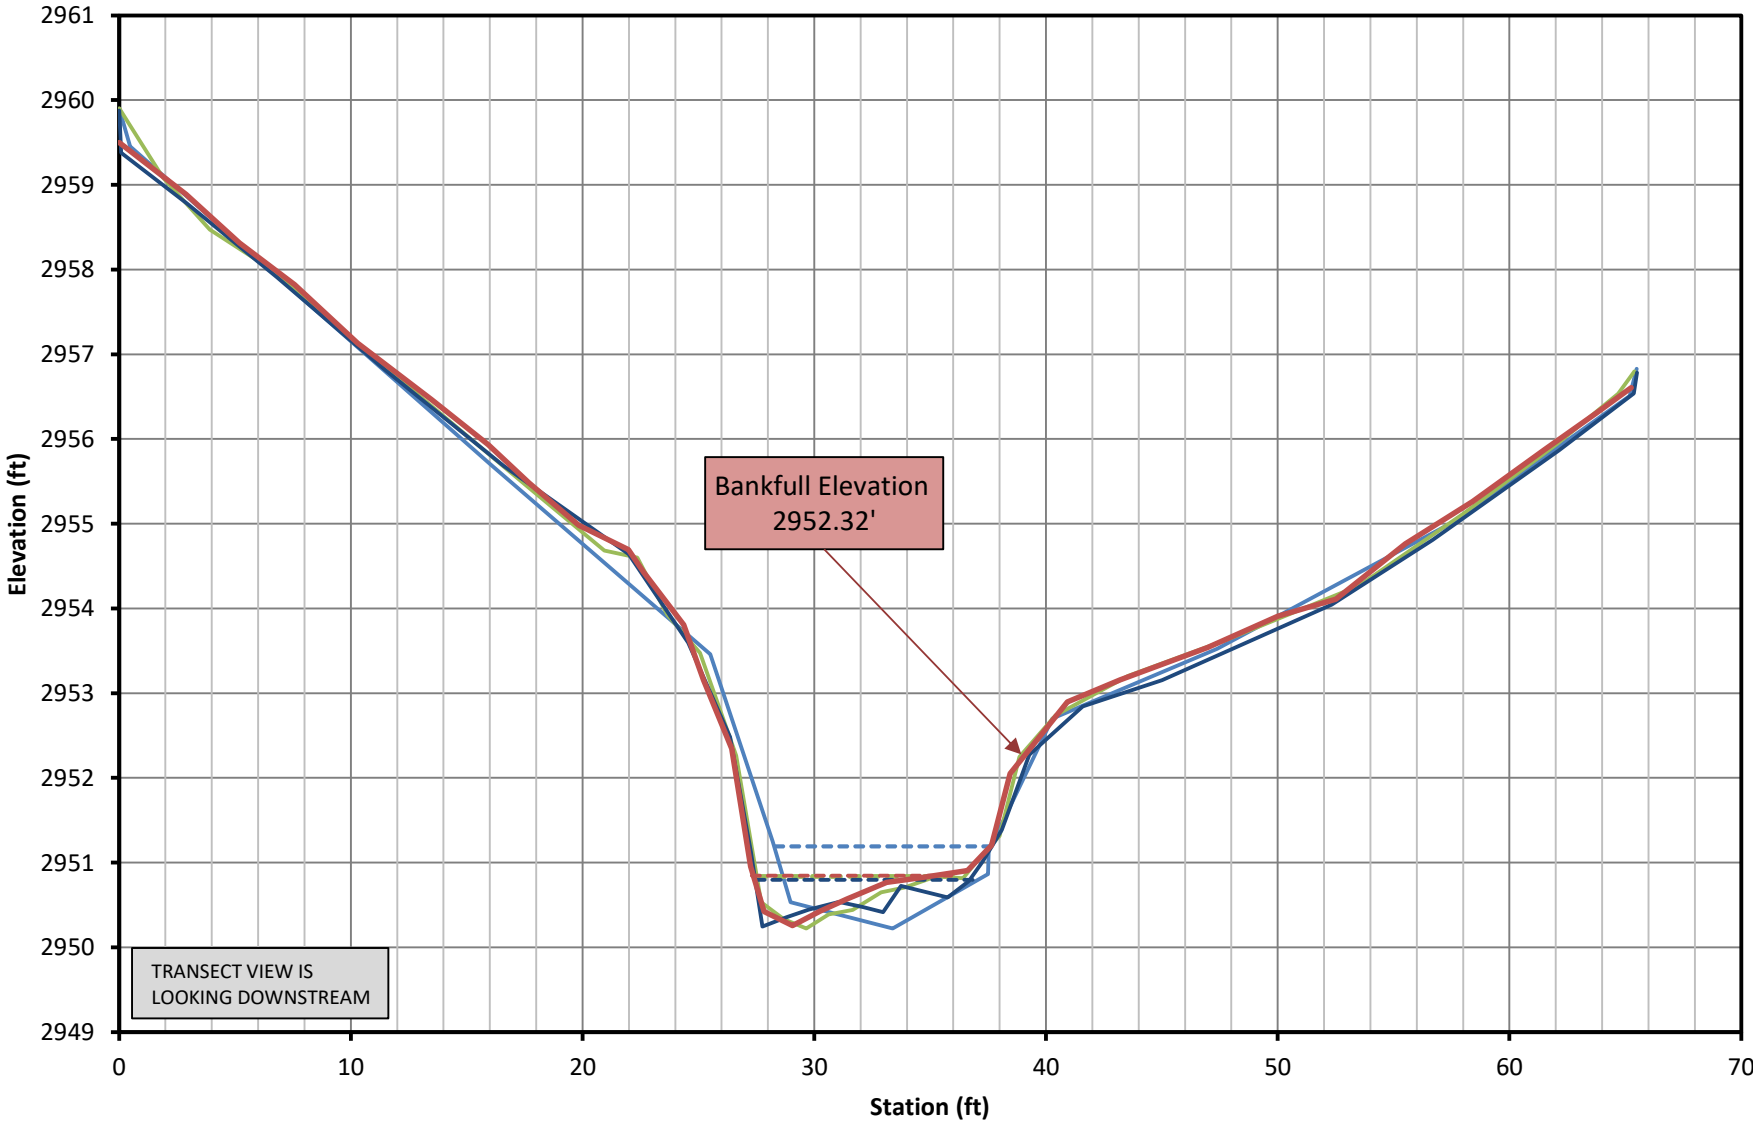
# Bowser Transect #2 - Riffle

The cross-sections (i.e. transects) of Bowser Creek surveyed in 2022 indicate that channel widths have remained stable since 2021 and did not show signs of lateral migration (Table 6).

Cross section data indicate the channel depths decreased slightly at three of the four cross-section locations since 2021. The 2022 longitudinal profile indicates an increased sediment load within the project reach since 2021. All three pools, which were maintained from 2014 to 2021, were largely filled-in during the 2022 monitoring event (Table 5; Appendix E). The decreased channel depths observed within the project reach are likely the result of upstream sediment inputs as no sediment sources are evident within the project reach. However, the longitudinal profile also indicates that the riffle elevations are being maintained, signifying that the reach as a whole is not aggrading (Appendix E).
