**Experimental Feature Final Report
 December 2022**

Experimental Feature:	Tencate-MIRIFI MPV400 Polypropylene Nonwoven Geotextile
Location:	Great Falls District, Cascade County, City of Great Falls, U-5201 Smelter Ave. NW – 5 th St NW to 1 st St NW
MDT Project Name:	Smelter Ave – 1 st to 5 th St NW
MDT Project Number:	UPP 5201(24)
Experimental Project Number:	MT-17-03
Principle Investigator:	Chad DeAustin, Experimental Project Manager (ExPM)
Construction Date:	August 2017
Date of Inspections:	April 2018, April 2019, April 2020, September 2021, May 2022

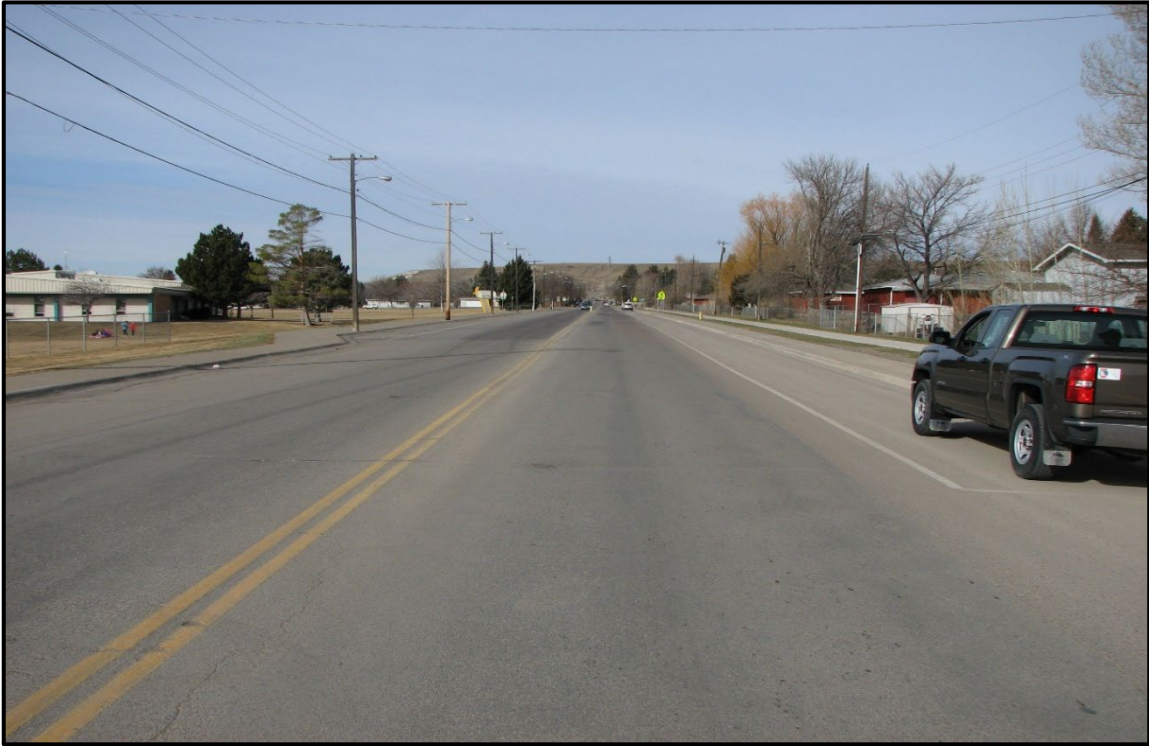
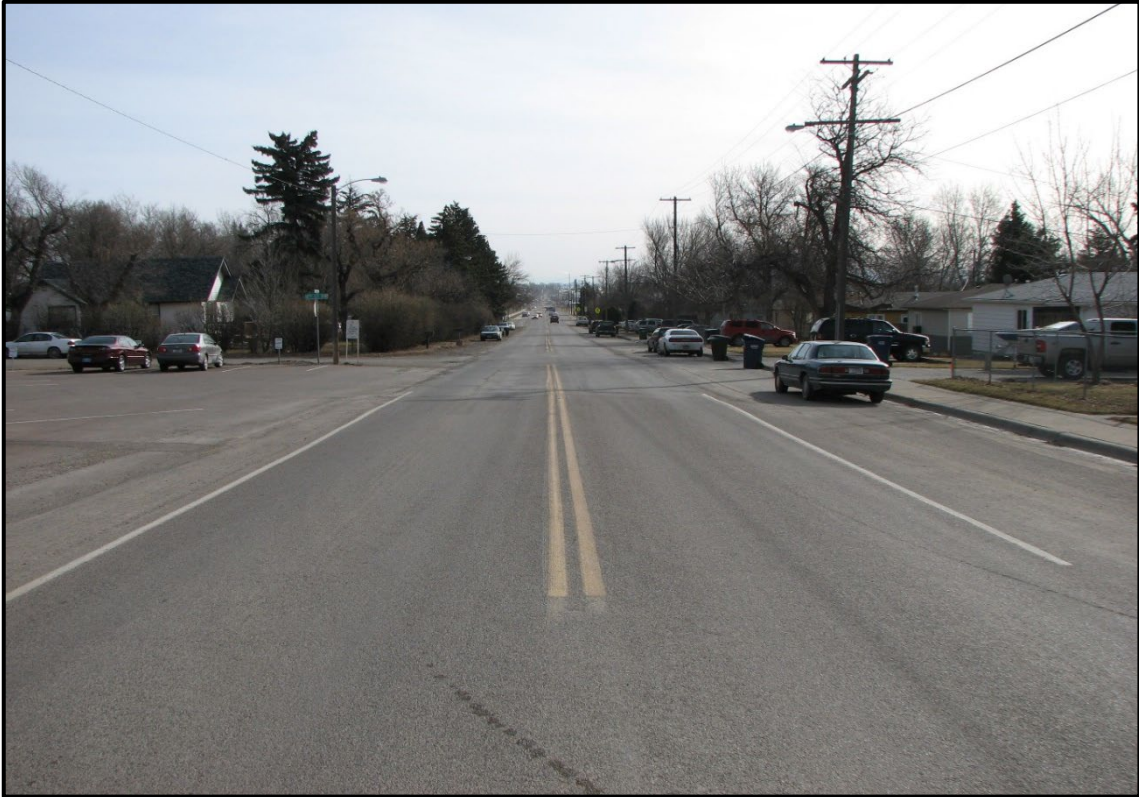
↕ Project section prior to milling phase; top picture is Smelter Ave & 1st NW, view west. Lower image Smelter Ave. & 5th St. NW, view east.

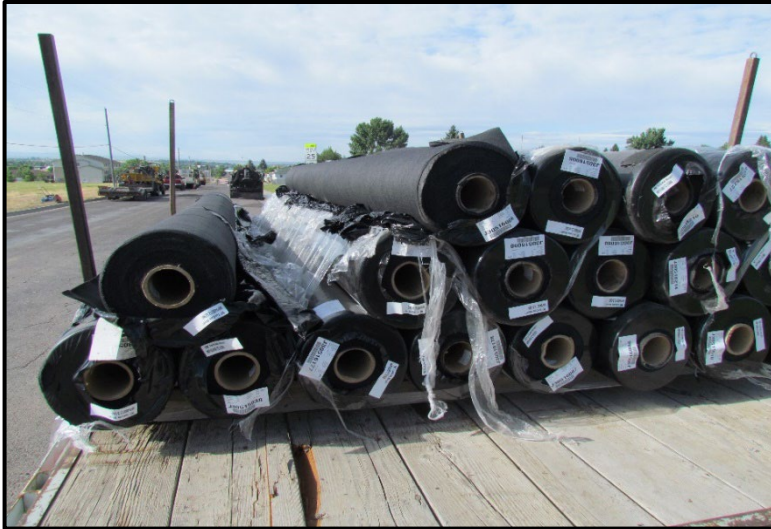
← Mirafi MVP400 ready for application to the prepared road surface.

Each roll is 360' (110m) in length and 12.5' (3.8m) in width.

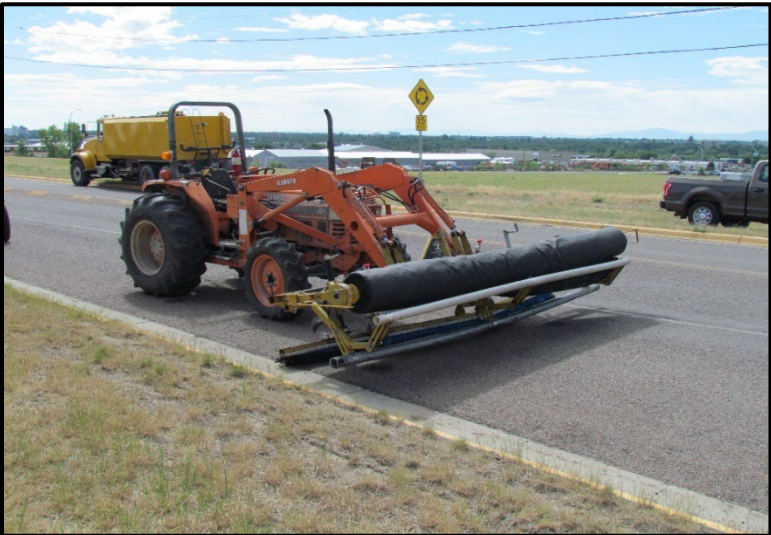
← The geotextile rolls are applied to the road surface using an applicator designed to fit on a front-loading tractor.

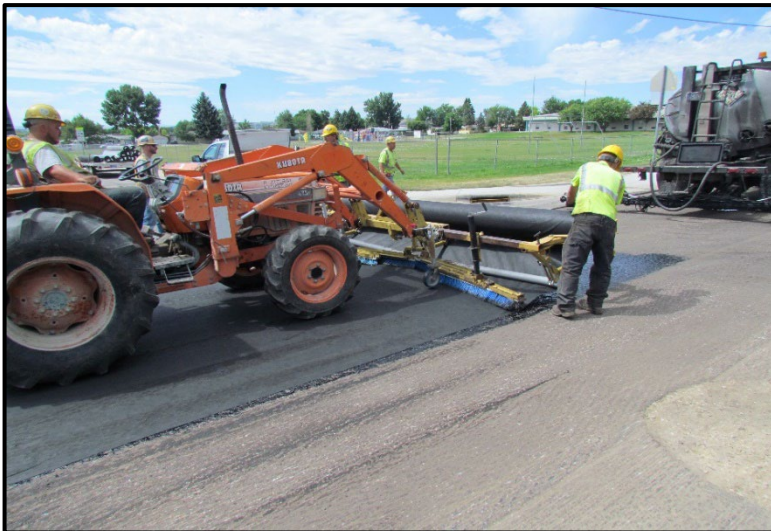
← As the tack coat is applied to the clean milled surface, the fabric is rolled out, properly tensioned, and prepared for the run.

The geotextile should be tight and without excess wrinkles and folds as it is placed.

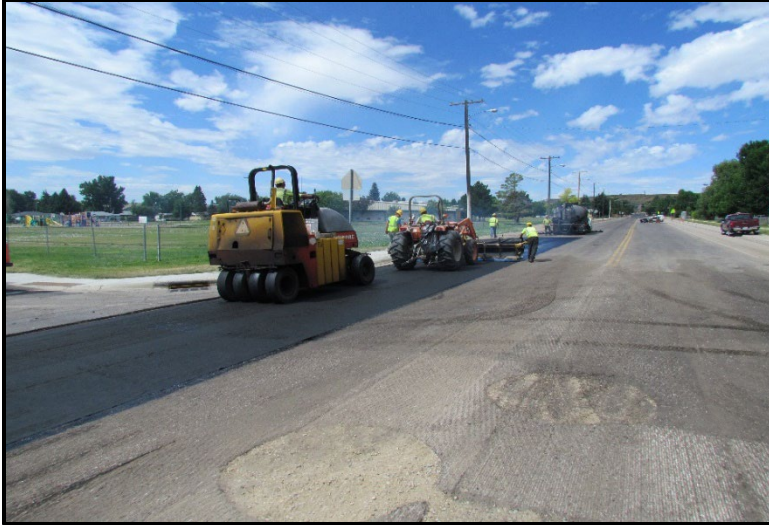
← As the first pass begins a pneumatic compactor 9-wheel roller follows close behind to insure good adhesion to the fabric, tack coat and underlying pavement.

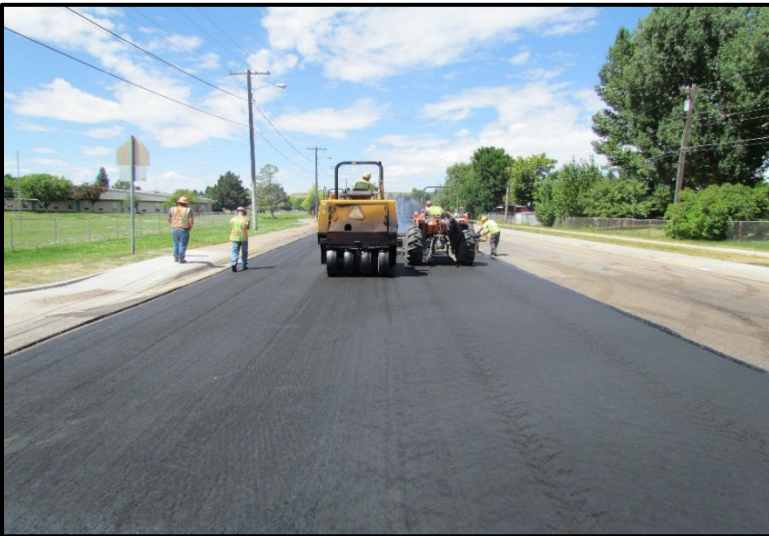
← The second pass of fabric being applied. Note the pneumatic roller insure a direct pass over the overlapping geotextile seam.

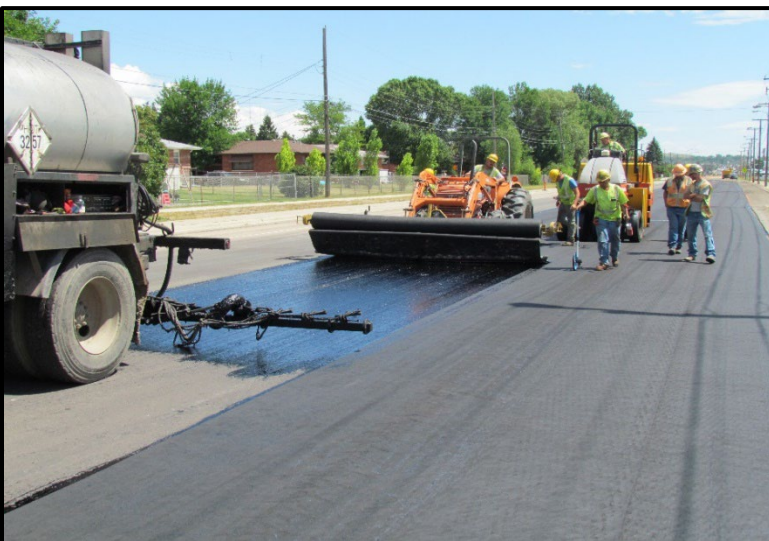
← View of fabric placement at front end of geotextile train.

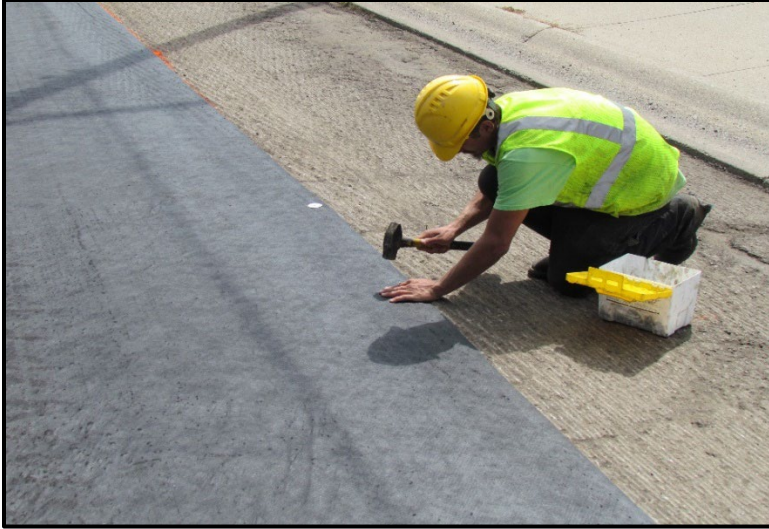
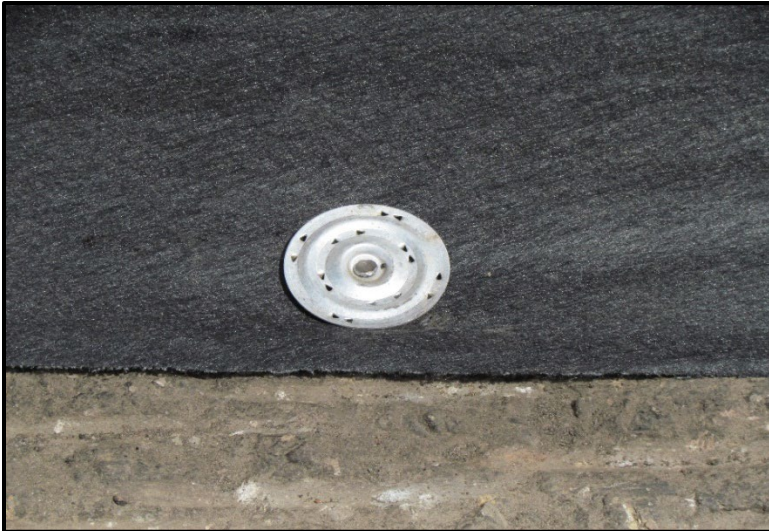
↙↘ To ensure the geotextile remains in place during the paving phase, galvanized fasteners (perforate metal disks), tacked at longitudinal and transverse seams are to ensure that the geotextile does not shift or fold before or during asphalt cement (AC) placement.

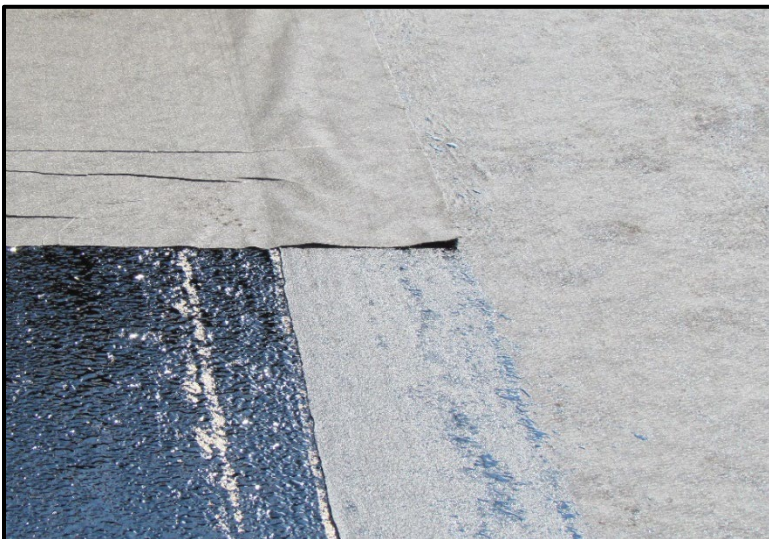
↙ Longitudinal seams were overlapped on adjacent panels on average eight (8") inches.

Transverse panels seams averaged twenty-four (24") inches in overlap.

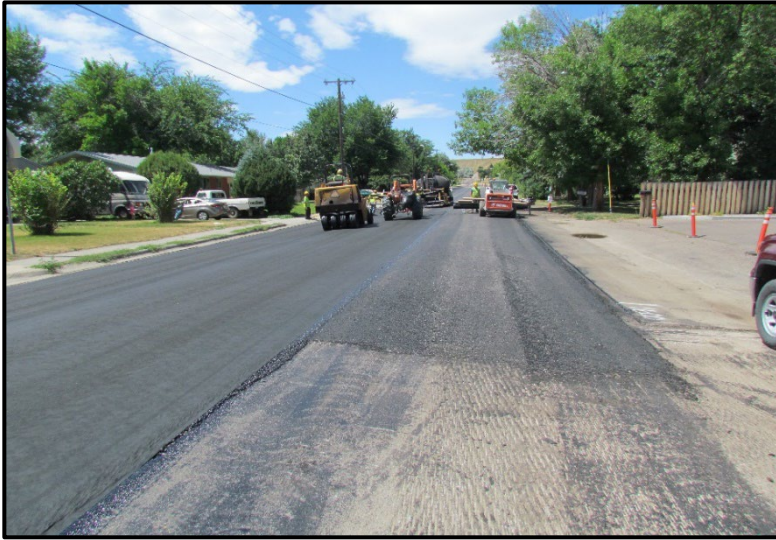
← Note that on the west end of the project (approximately 5th St. NW to 2nd St. NW), the condition of the milled pavement required a 1/2" leveling course of AC prior to the placement of the geotextile.

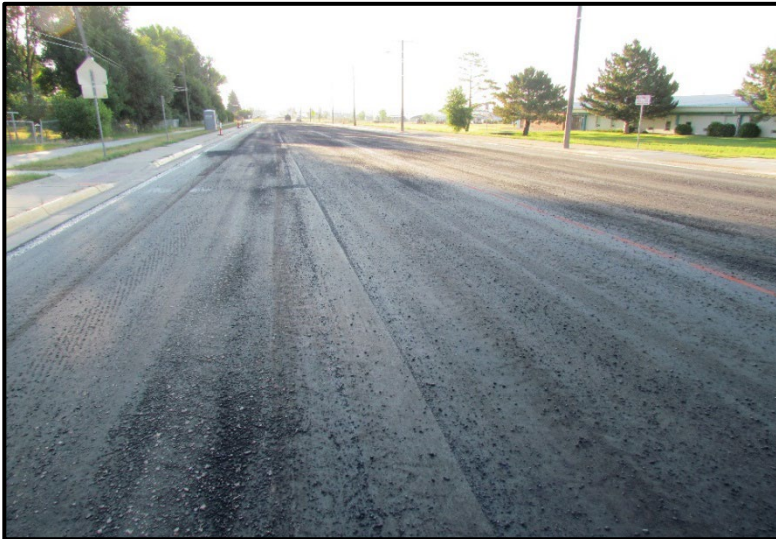
← The application of the geotextile is complete and now ready for paving.

A standard practice for this contractor is to broadcast a topical layer of milled AC aggregate to protect the fabric tearing or shearing from moving equipment during the paving process.

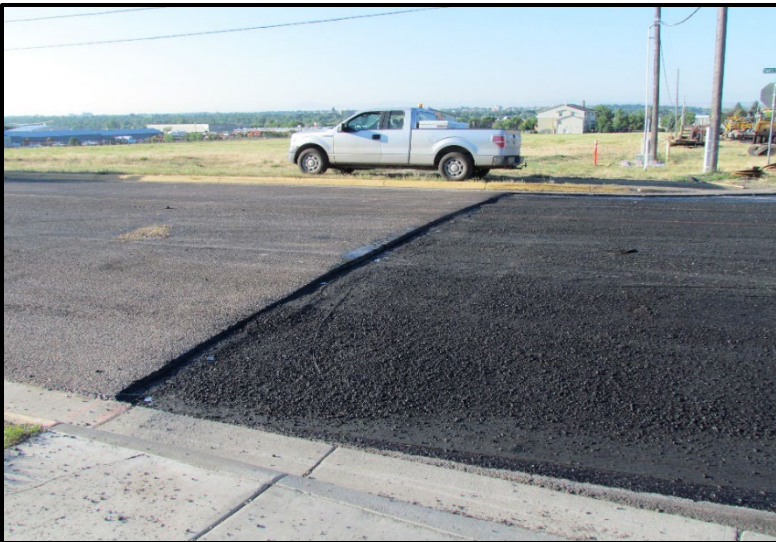
← Image of east end of project transition prior to paving.

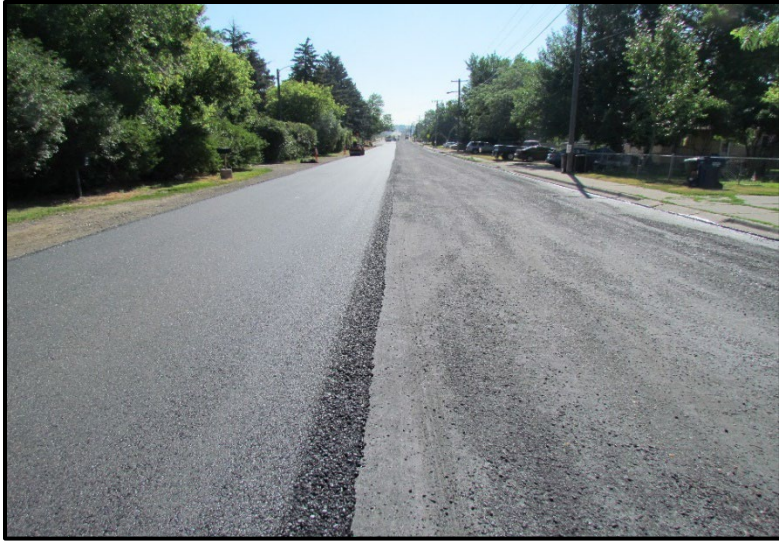
← Representative image of completed paving pass, view west.

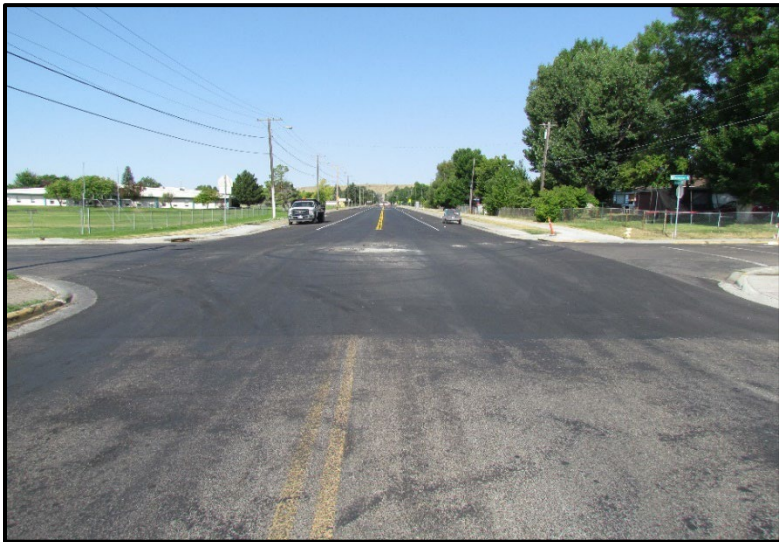
← Completed project, east end, view west.

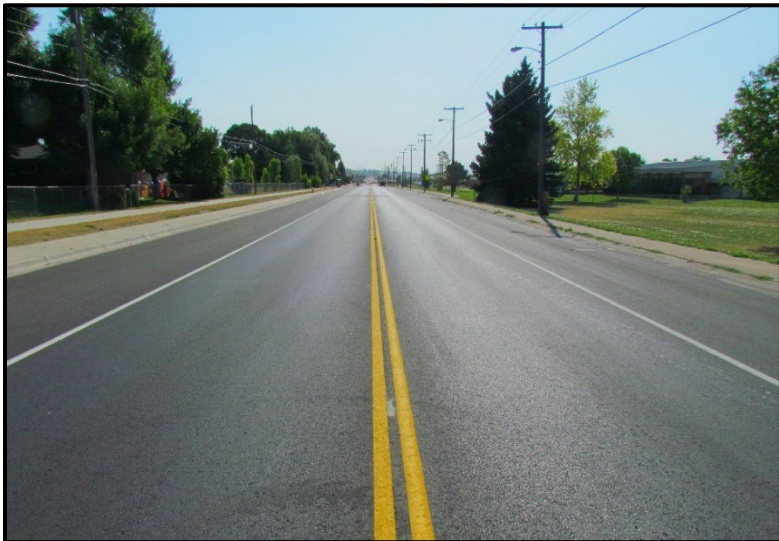
← Completed project, west end, view east.

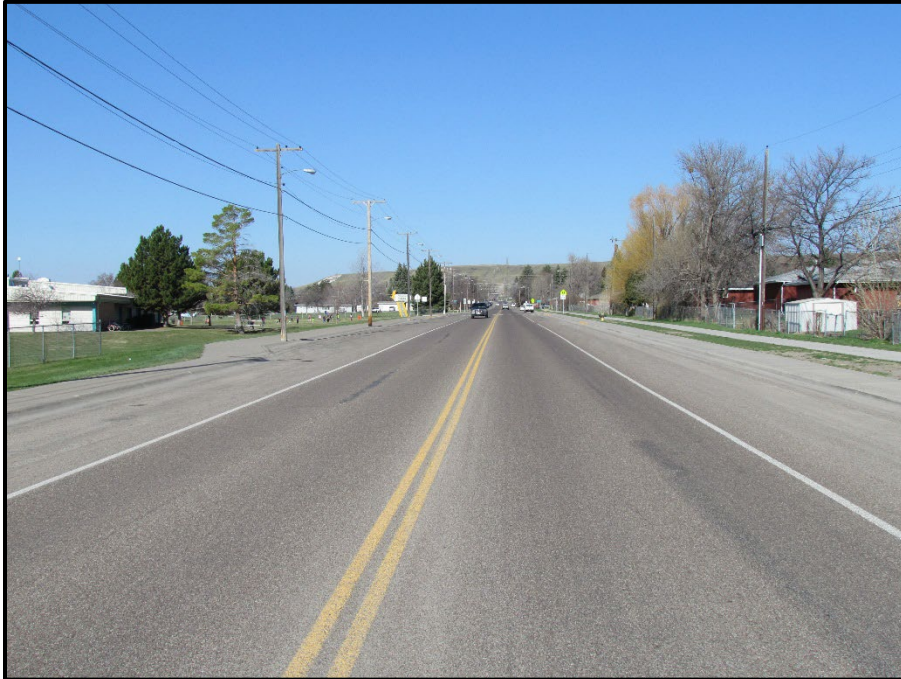
← East end of project;
view west.

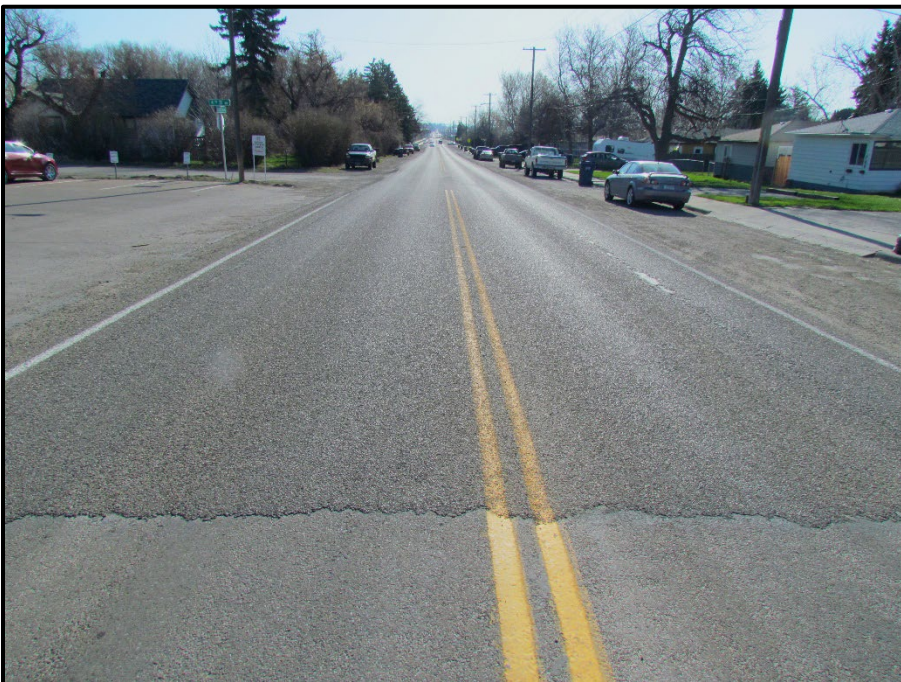
← West end of project;
view east.

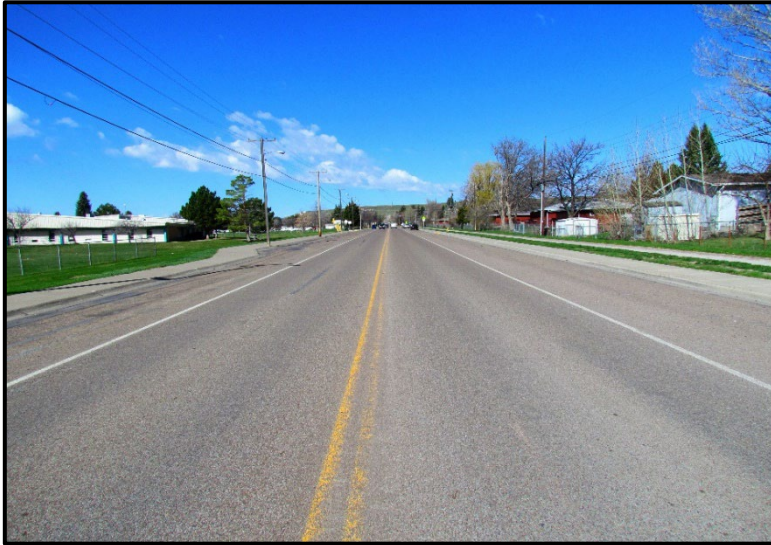
← East end of project; view west.

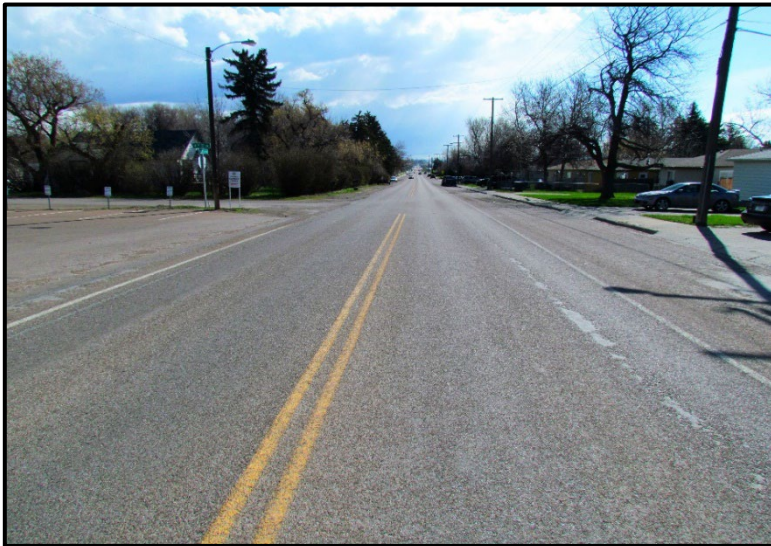
← West end of project; view east.

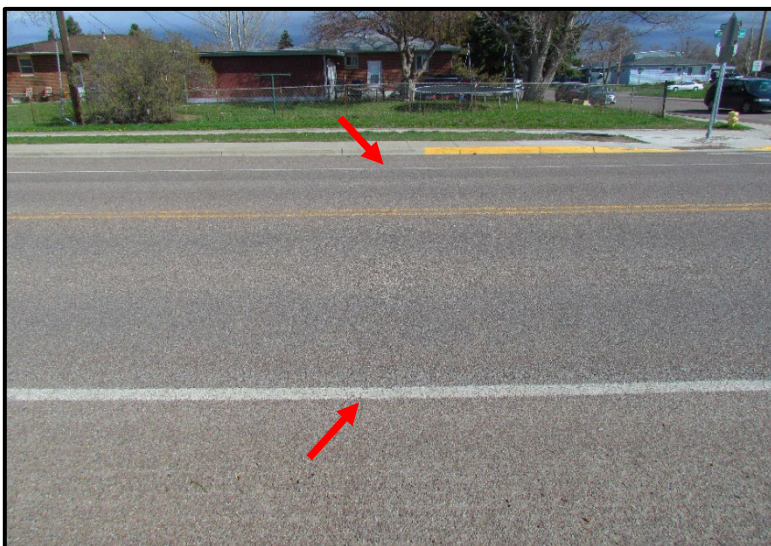
← Although difficult to see in this image; one low-severity longitudinal crack has appeared on the project near Riverview Blvd intersection (red arrows).

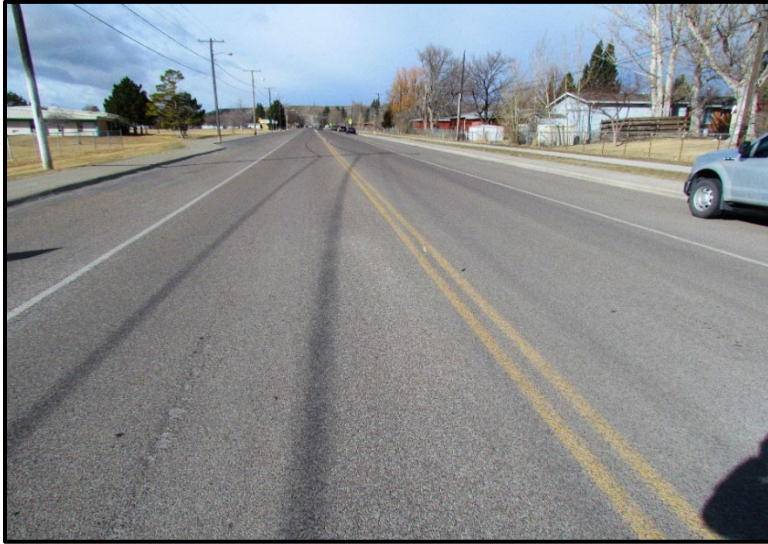
← East end of project; view west.

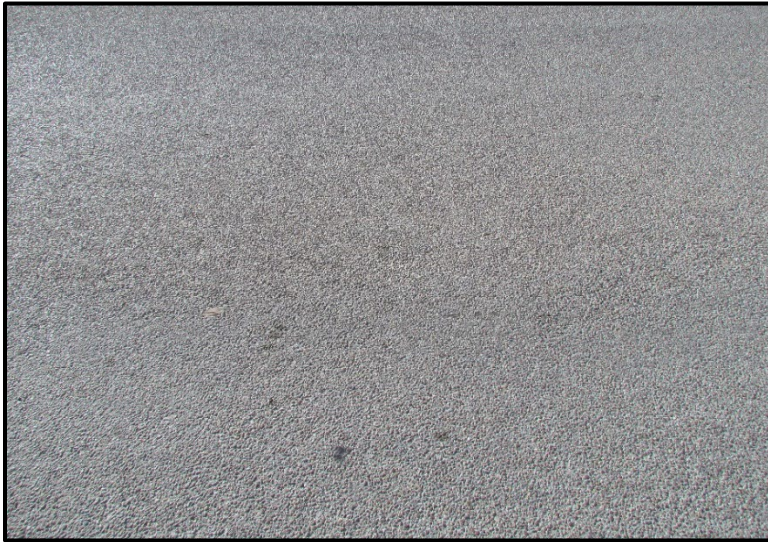
← Example of pavement surface condition.

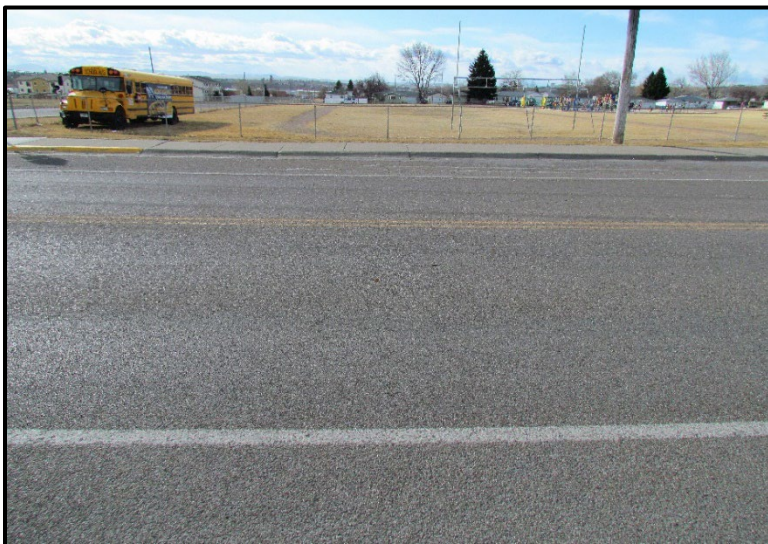
← Transverse view of pavement.

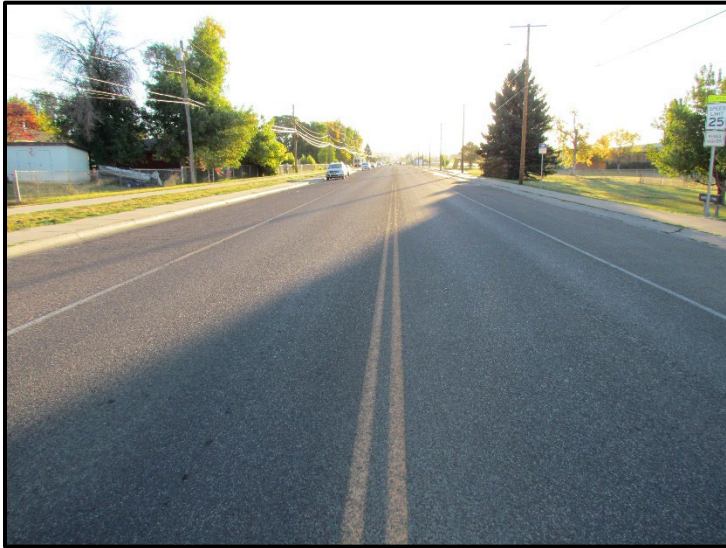
← Image of Smelter Ave near intersection with Riverview Blvd view east.

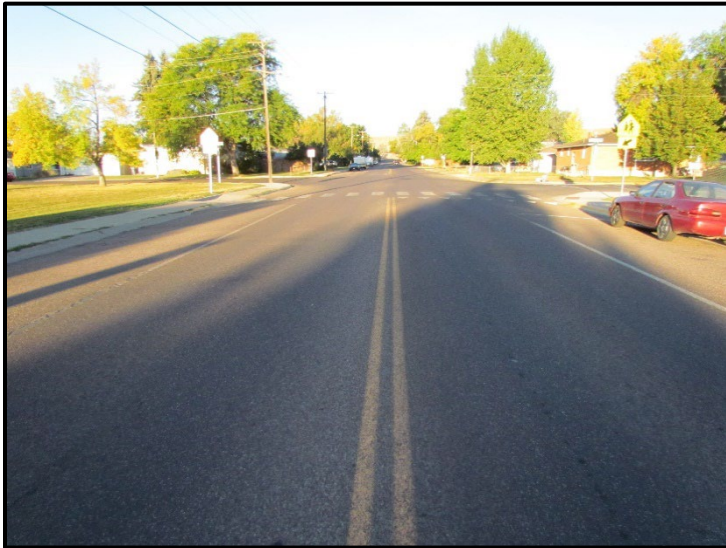
← Image of Smelter Ave near intersection with Riverview Blvd view west.

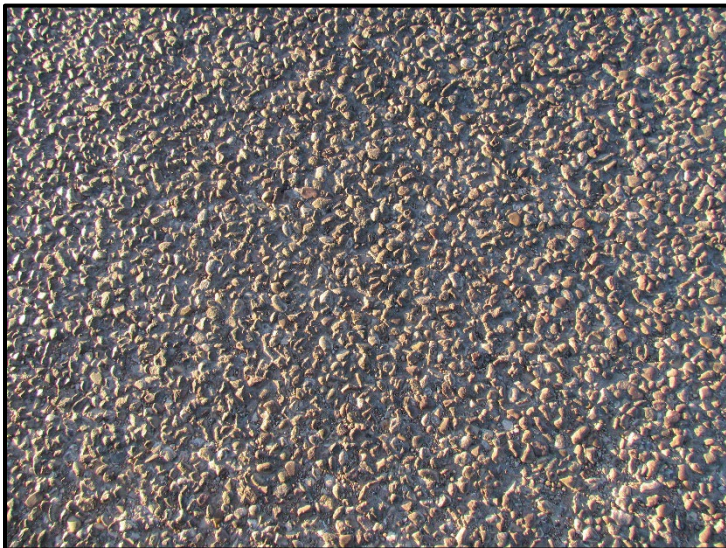
← View of current surface of PMS with chip seal on the roadway.

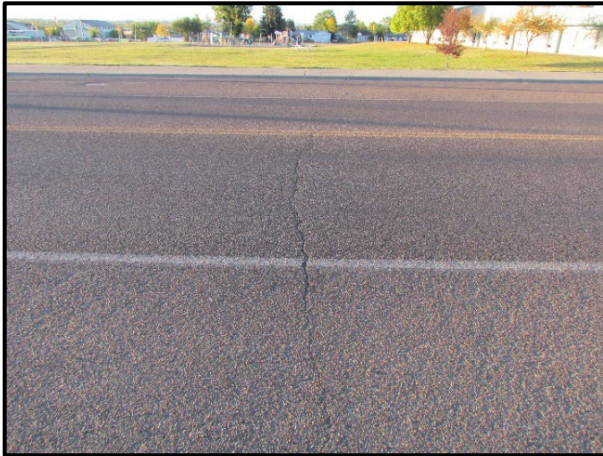
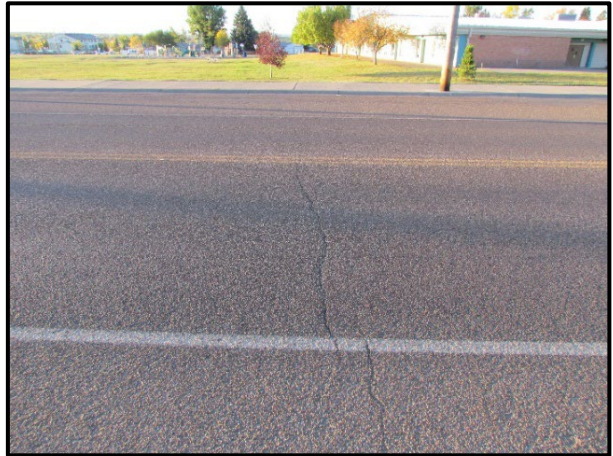
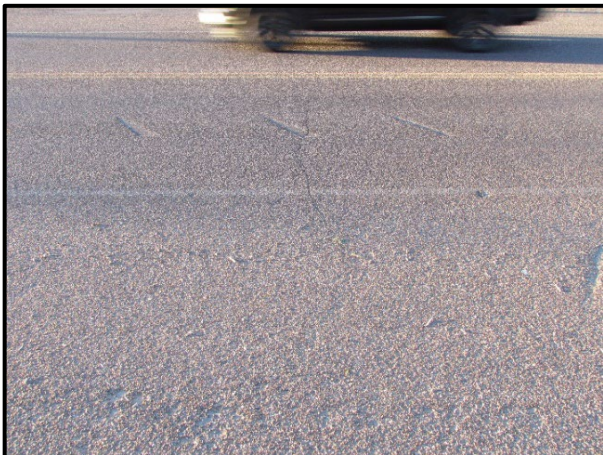
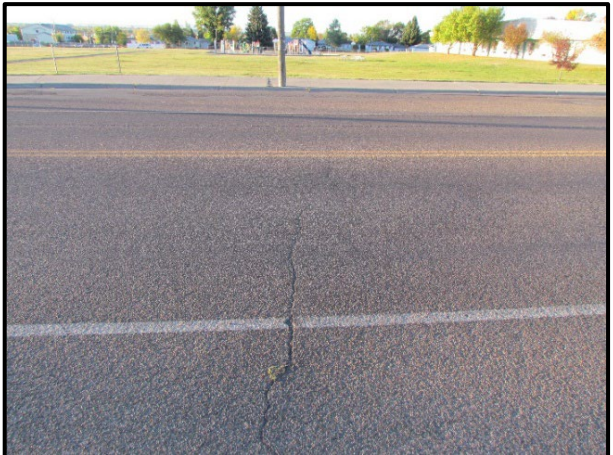
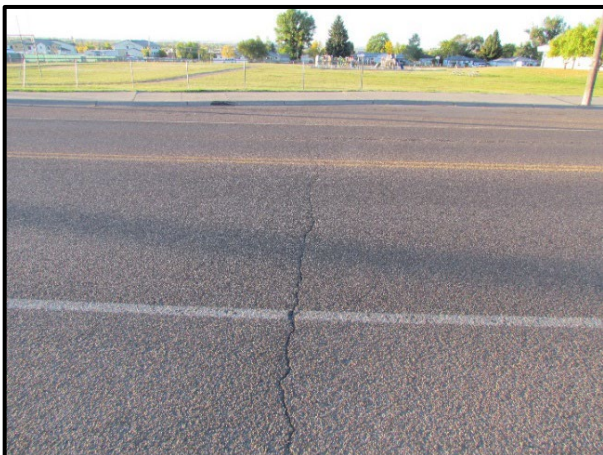
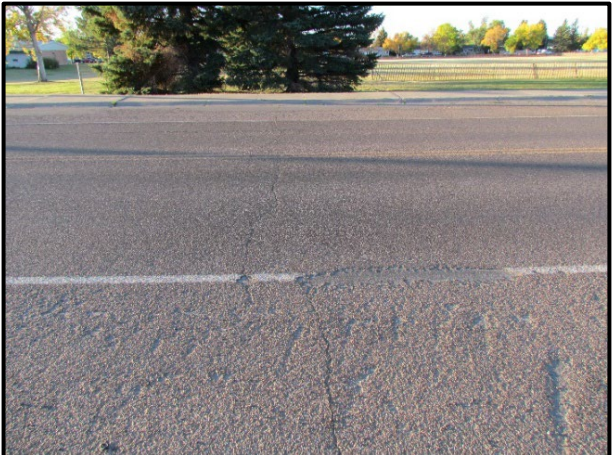
↓ Below are some images of the increased distress seen in 2021.

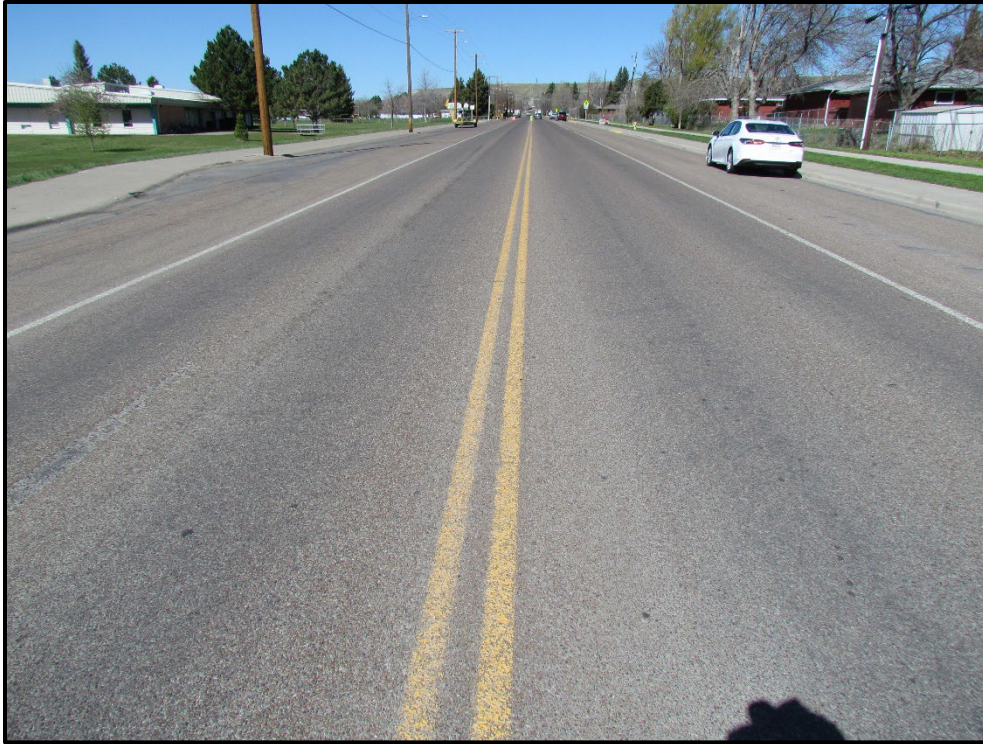
↑ 1st Street NW, view west.

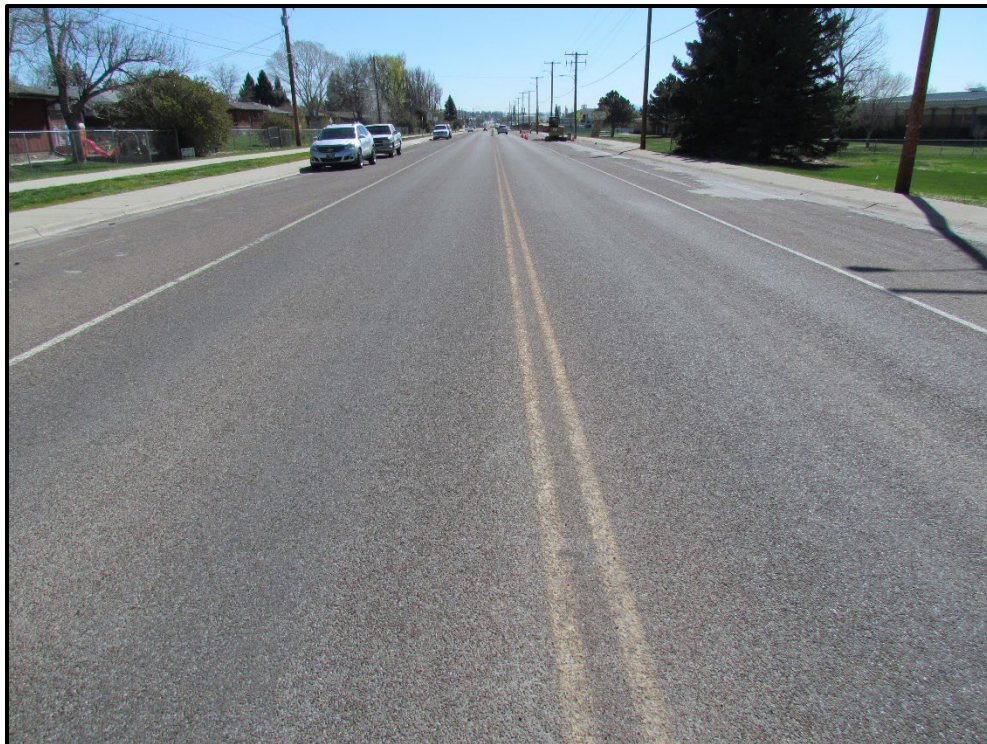
↑ Riverview Boulevard, view east.

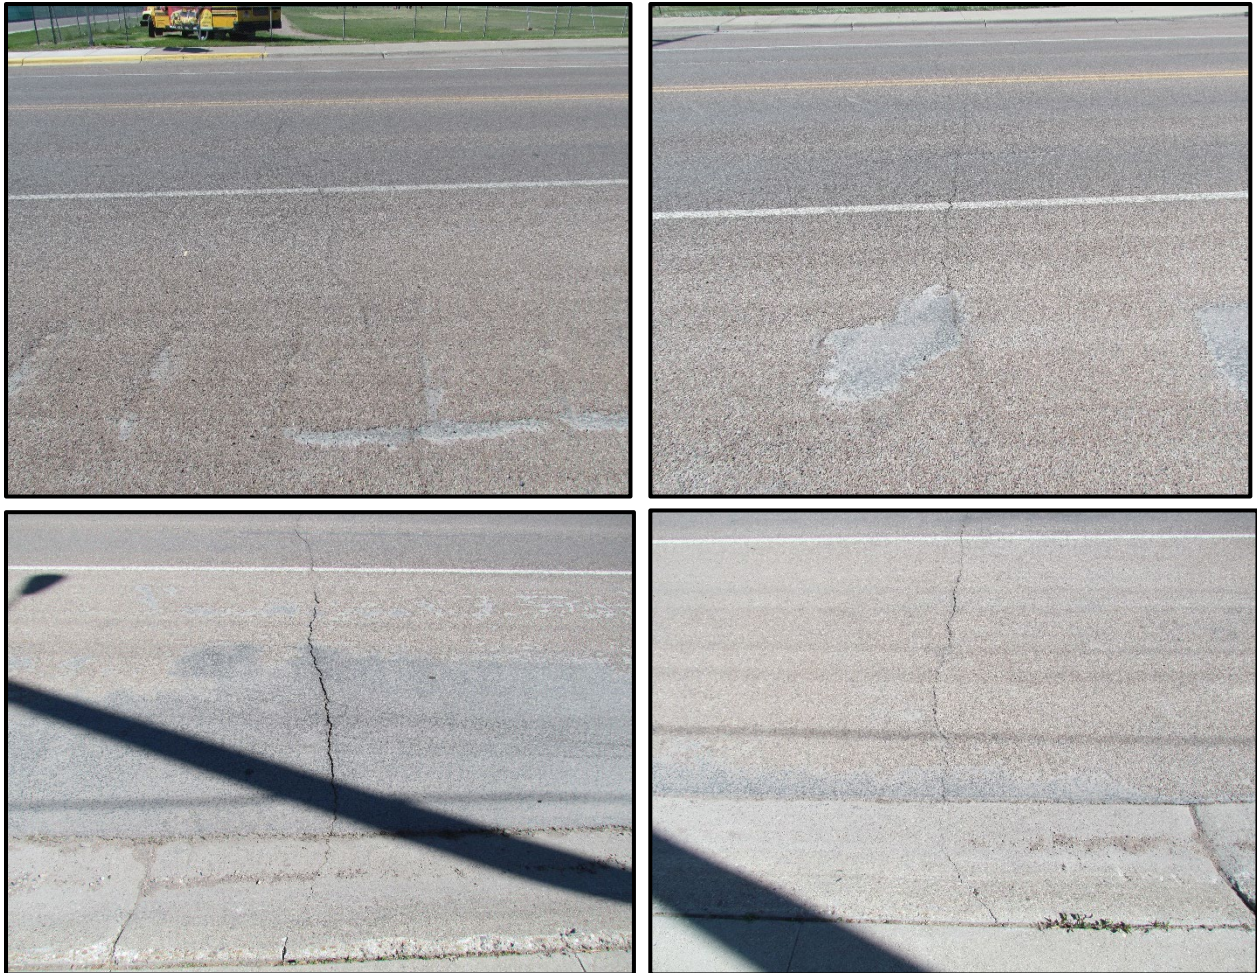
During the 2022 site visit, continued distress was noticed. There wasn't as significant of an increase as seen in 2021 and most of the distress is located from 1st Street NW to the front entrance sidewalk in front of Riverview Elementary, see below.

↑ This distress was noticed near the Riverview Boulevard intersection and are being highlighted because of how the crack continues from the plant mix into the concrete, suggesting an issue in the base.

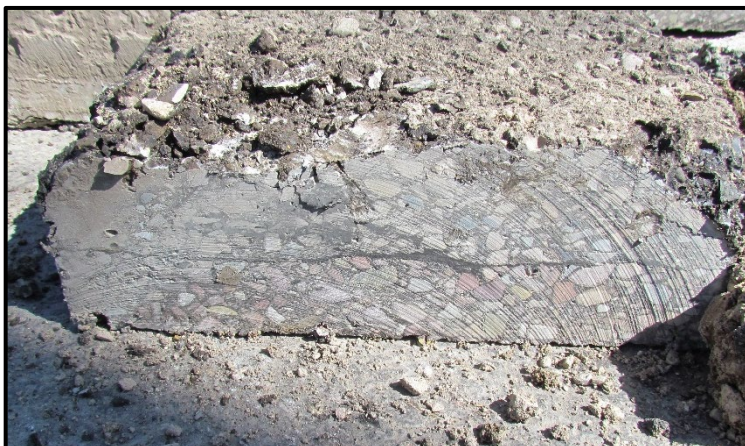
← During the 2022 visit, Rocky Mountain Contractors was doing some utility work which provided the opportunity to see a cross section of the plant mix, notice the distinct layer of the paving fabric.
