EXPERIMENTAL PROJECTS FINAL REPORT

CONTECH® A-2000 POLYVINYL CHLORIDE (PVC) PLASTIC PIPE

Project Name: Checkerboard - Martinsdale (CN 4803000)

Project Number: STPP 14-2(20)63

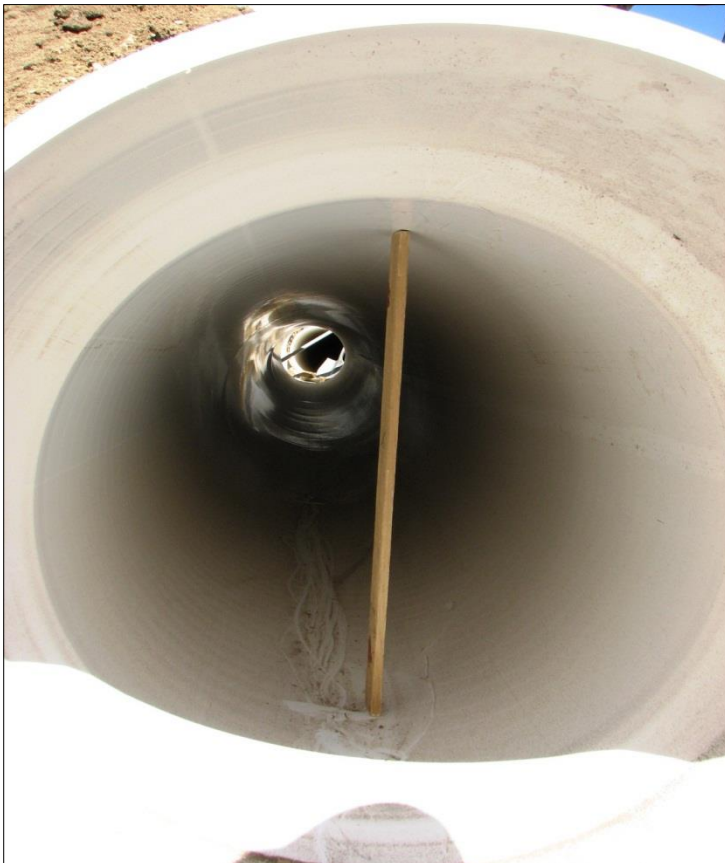
← This section of survey stick was cut to approximate 18" and run through the pipe in the same manner as indicated in the previous image. No visual deflection was observed.

Note: This was a very simplistic method to test for deflection and representative of a very small fraction of the entire length of the pipe layout and may not be indicative of current or long-term performance of the pipe in this application.

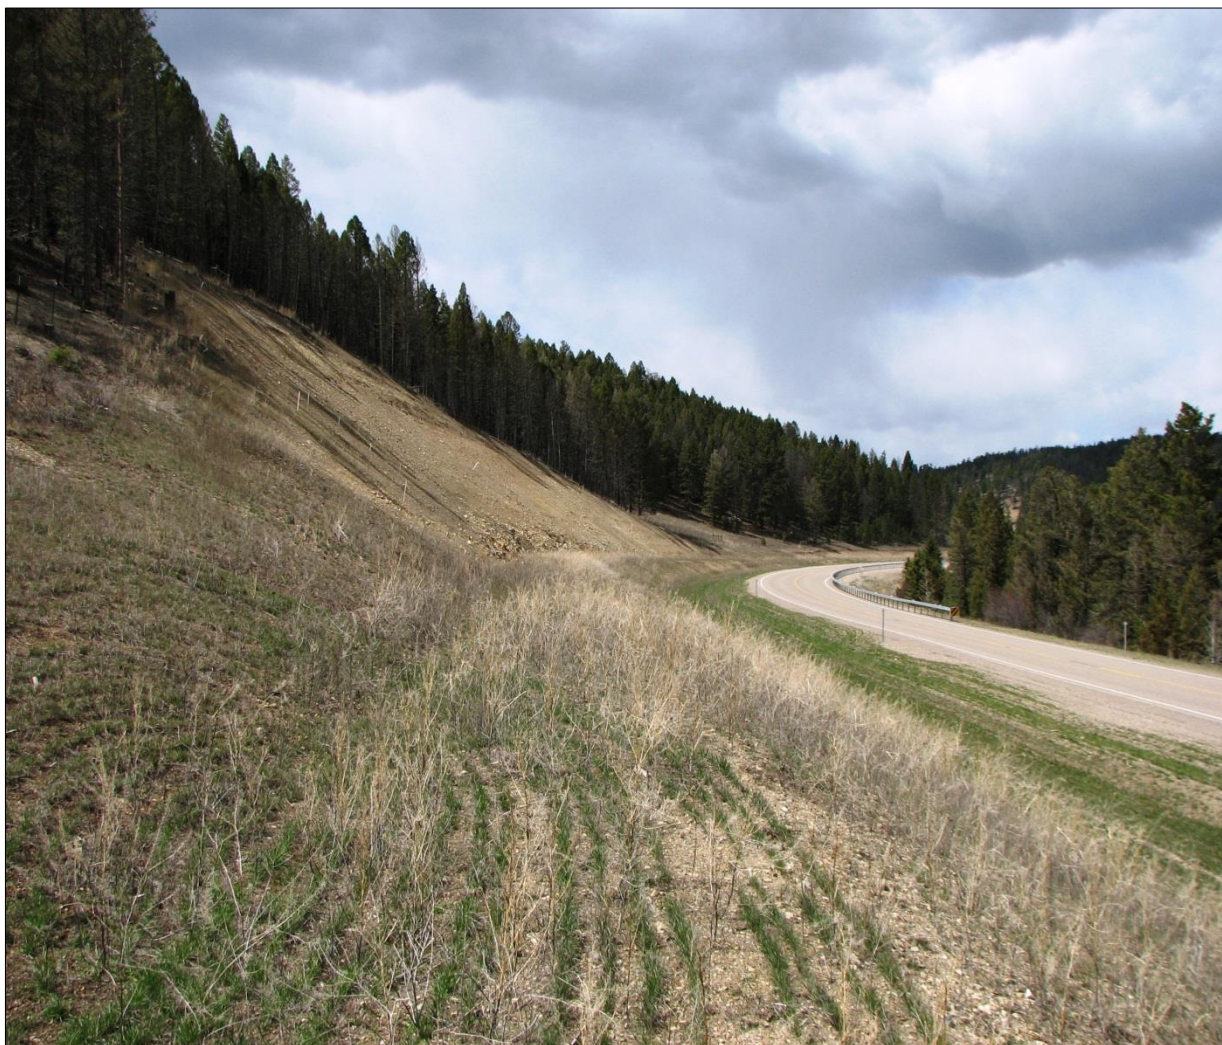
A site inspection of the 18" (46 cm) A-2000 was conducted on May 15, 2014 by research staff. A walk through of the approximately 2084 ft. length section showed no evidence of visual disturbance on the surface or surrounding area of the irrigation line or the manhole connections. Page 20 of this report has representative image of the 2014 inspection. District staff has reported no incident involving pipe performance since installation.

↑ View west: Start of approximate location at the east end of the 18" A-2000.

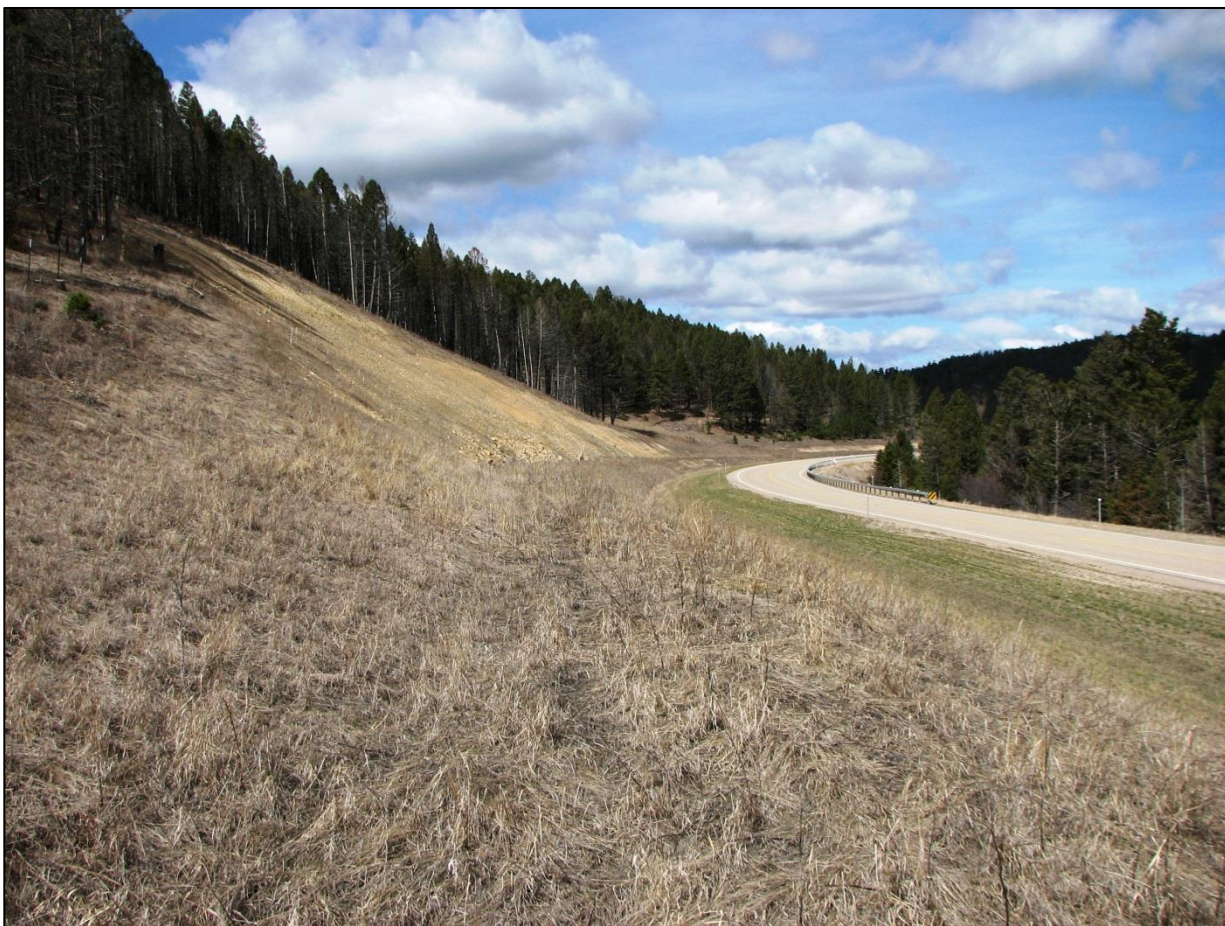
Same report as stated in May 2015. Page 22 of this report has representative image of the 2015 inspection. District staff has reported no incident involving pipe performance since installation.

↑ View west: Start of approximate location at the east end of the 18" A-2000.
