EXPERIMENTAL PROJECTS CONSTRUCTION AND EVALUATION REPORT

CENTERLINE CONTRAST STRIPING AND THE ADDITION OF HIGH-VISIBILITY STRIPING MATERIAL FOR ADDED CONSPICUITY IN NIGHTTIME AND WET DRIVING CONDITIONS

Location:	Missoula/Missoula County: North Reserve St. Highway 93 (N 92) – Reference Point 0.0-5.4
Project Name:	Pavement Markings – Reserve St.
Project Number:	NH 92-1(12)0
Experimental Project No.	MT-14-07
Type of Project:	Enhanced Pavement Markings
Principal Investigator:	Craig Abernathy: Experimental Project Manager (ExPM)
Technical Contact:	Gabe B. Priebe, P.E.: Traffic Project Engineer
Date of Installation:	September 2015

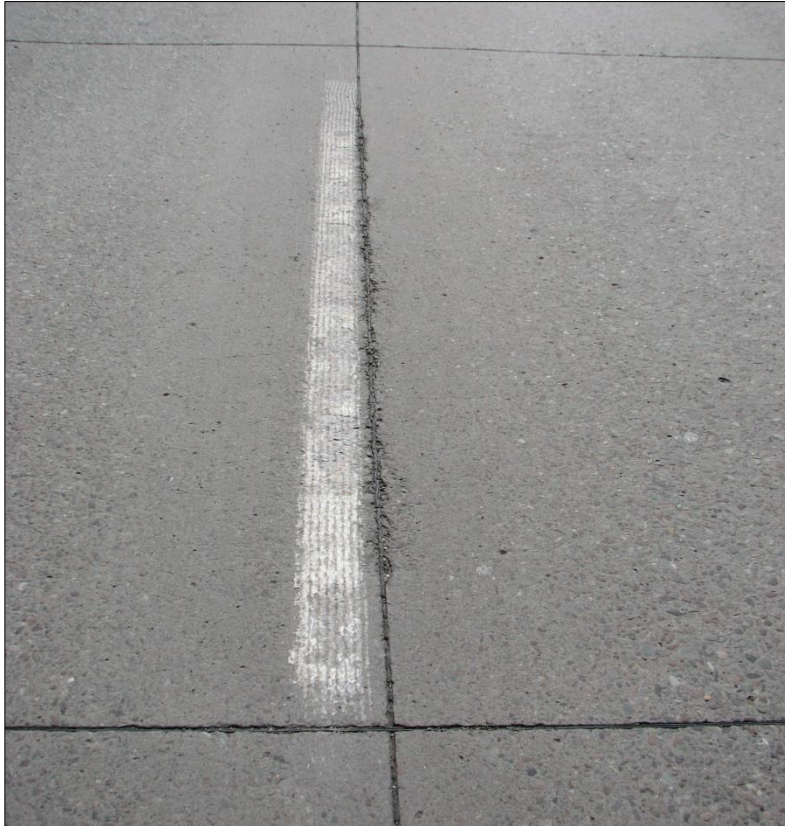
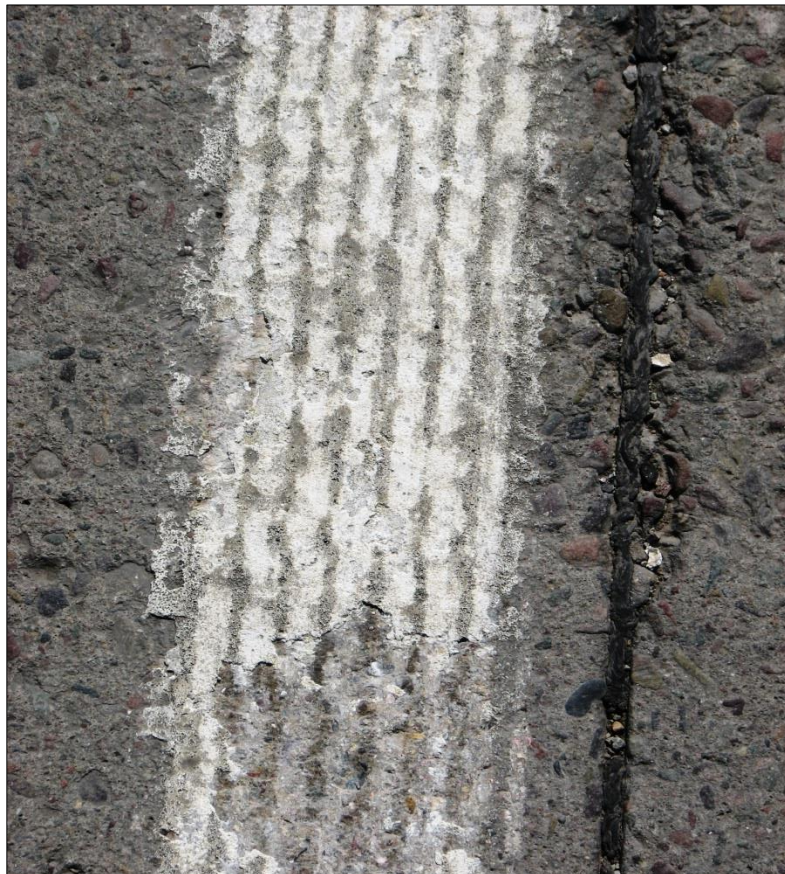
↙↓ Representative images of the existing stripe after the grinding phase.

Consistency of the amount stripe removed from pavement varied throughout the project.

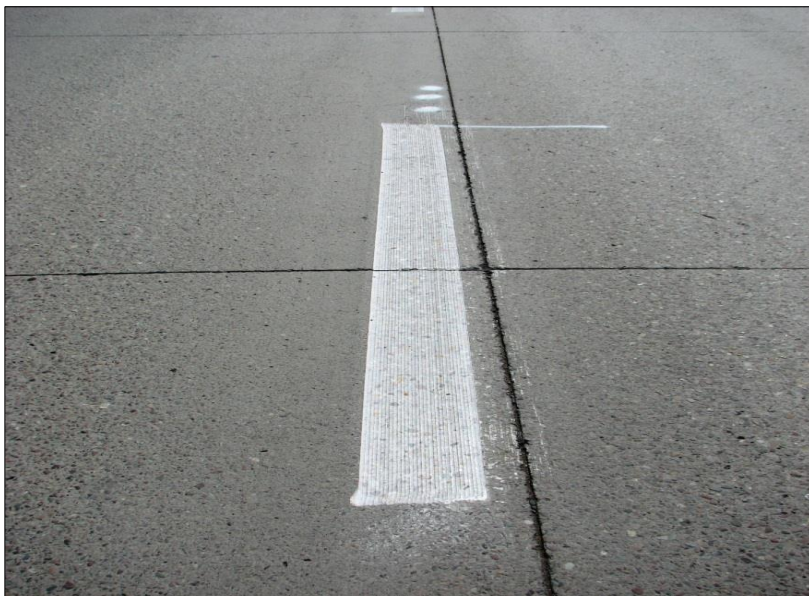
← Representative image of completed diamond grind groove.

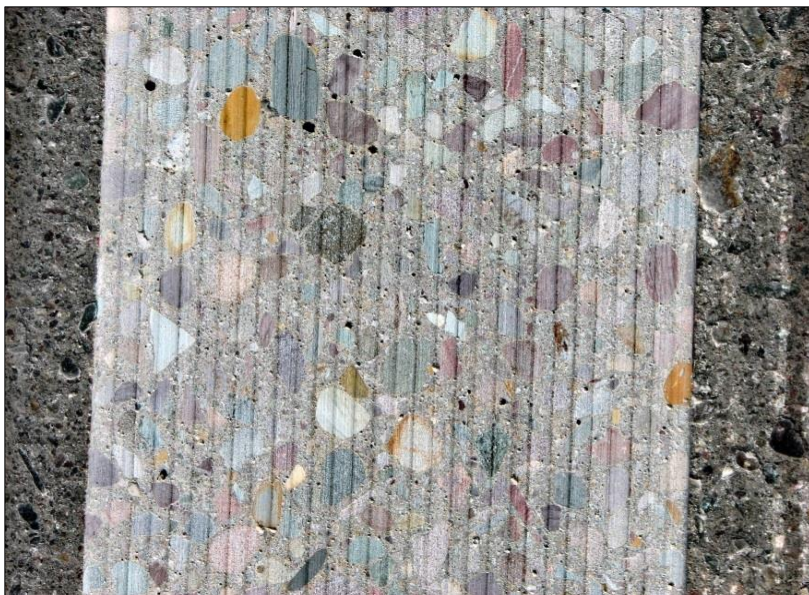
← Close-up of diamond grind. Groove relief represents a quality cut and clean definition.

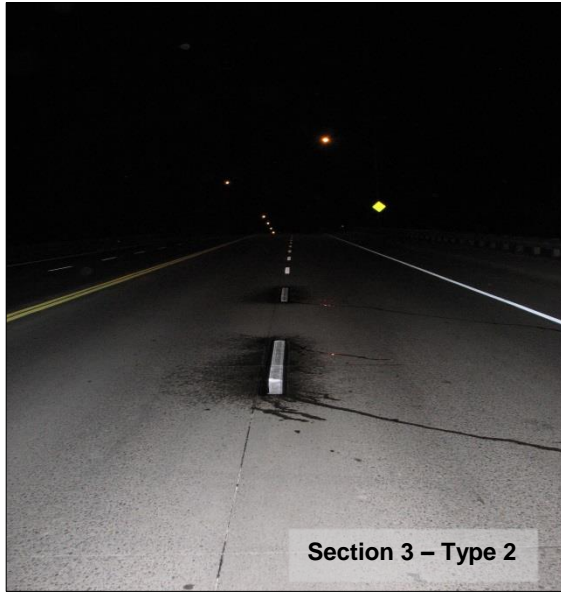
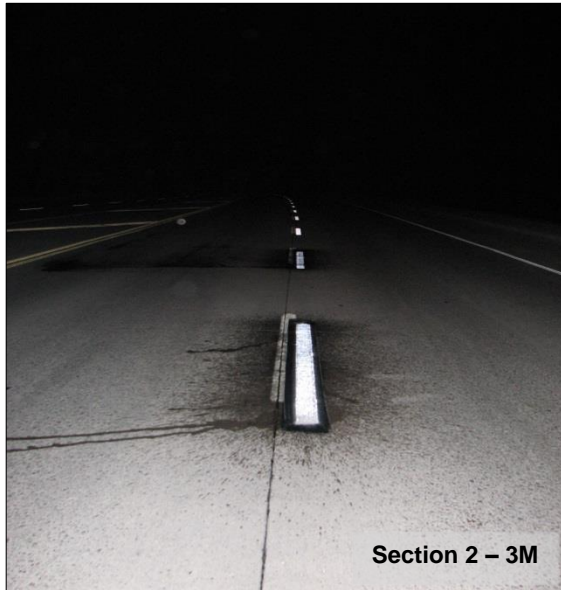
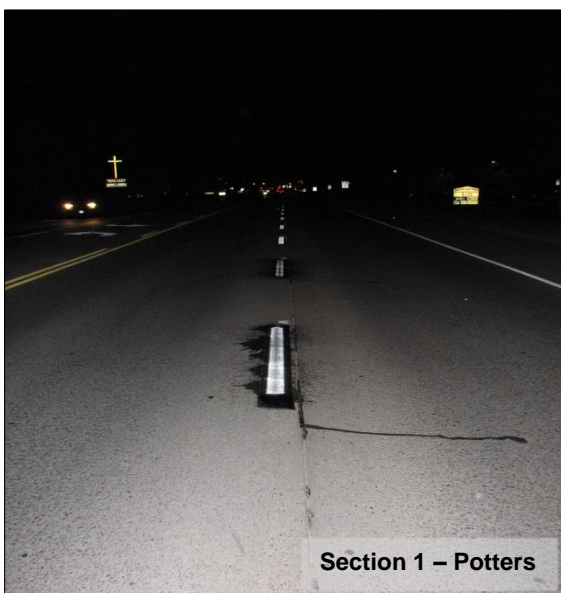
The top image is section 3 using only type 2 glass beads. A coating of water on type 2 beads has a reduced effect on retroreflectivity.

Although subjective, sections 2 & 1, with the added wet reflective material, appear visually to have greater luminescence than the control section 3.

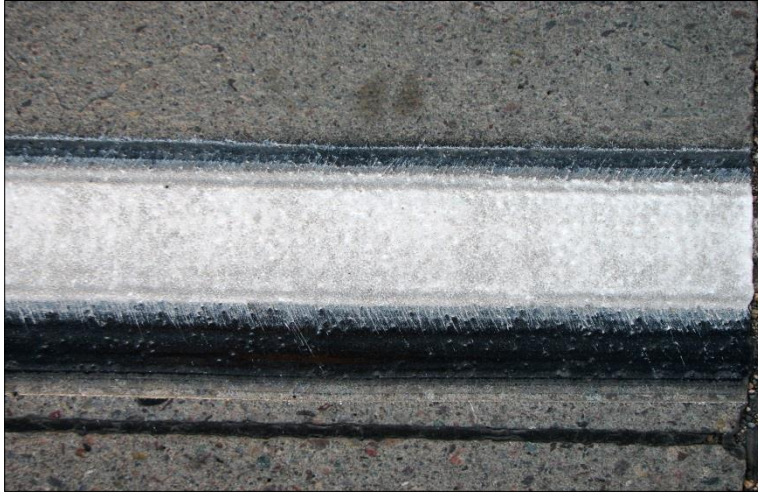
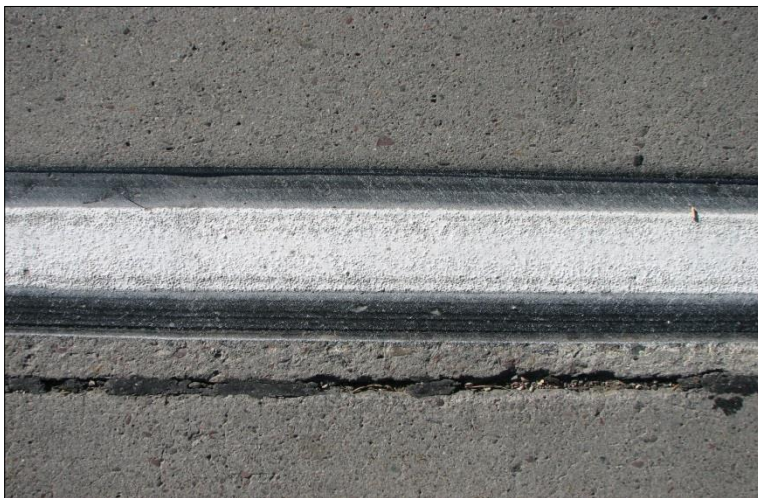
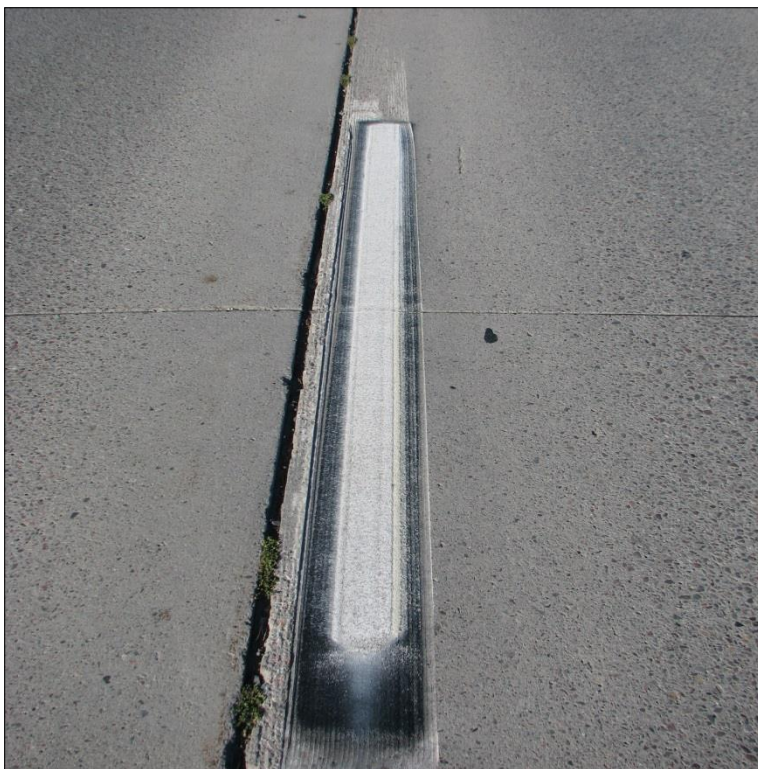
Installation Issue: White Epoxy Overspray

↙↓ Representative images of overspray of the white stripe to underlying black stripe which may reduce clarity of the contrasting colors.

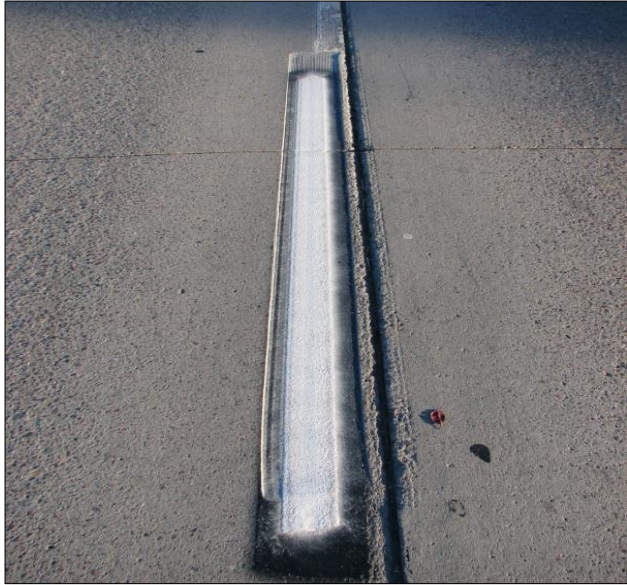
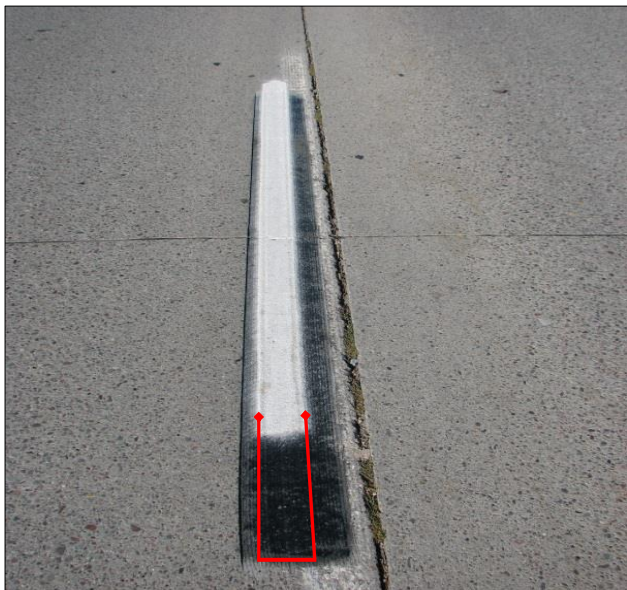
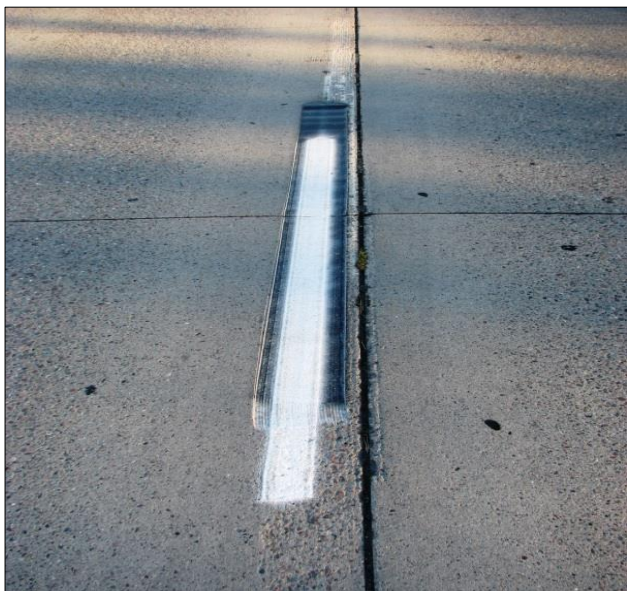
Installation Issue: Poor Pavement Marking Alignment to Prepared Groove

↔ Sample images of poor calibration during striping phase.

Some installations both stripes missed the recessed groove and in other skips the white stripe extended beyond the groove.

In addition, the contractor had a difficult time keeping the top stripe aligned equal side distance on the base stripe (center image example).

As compared to the total number of skip markings to the project, these anomalies of practice are statistically small but to a level of occurrence that requires documentation.

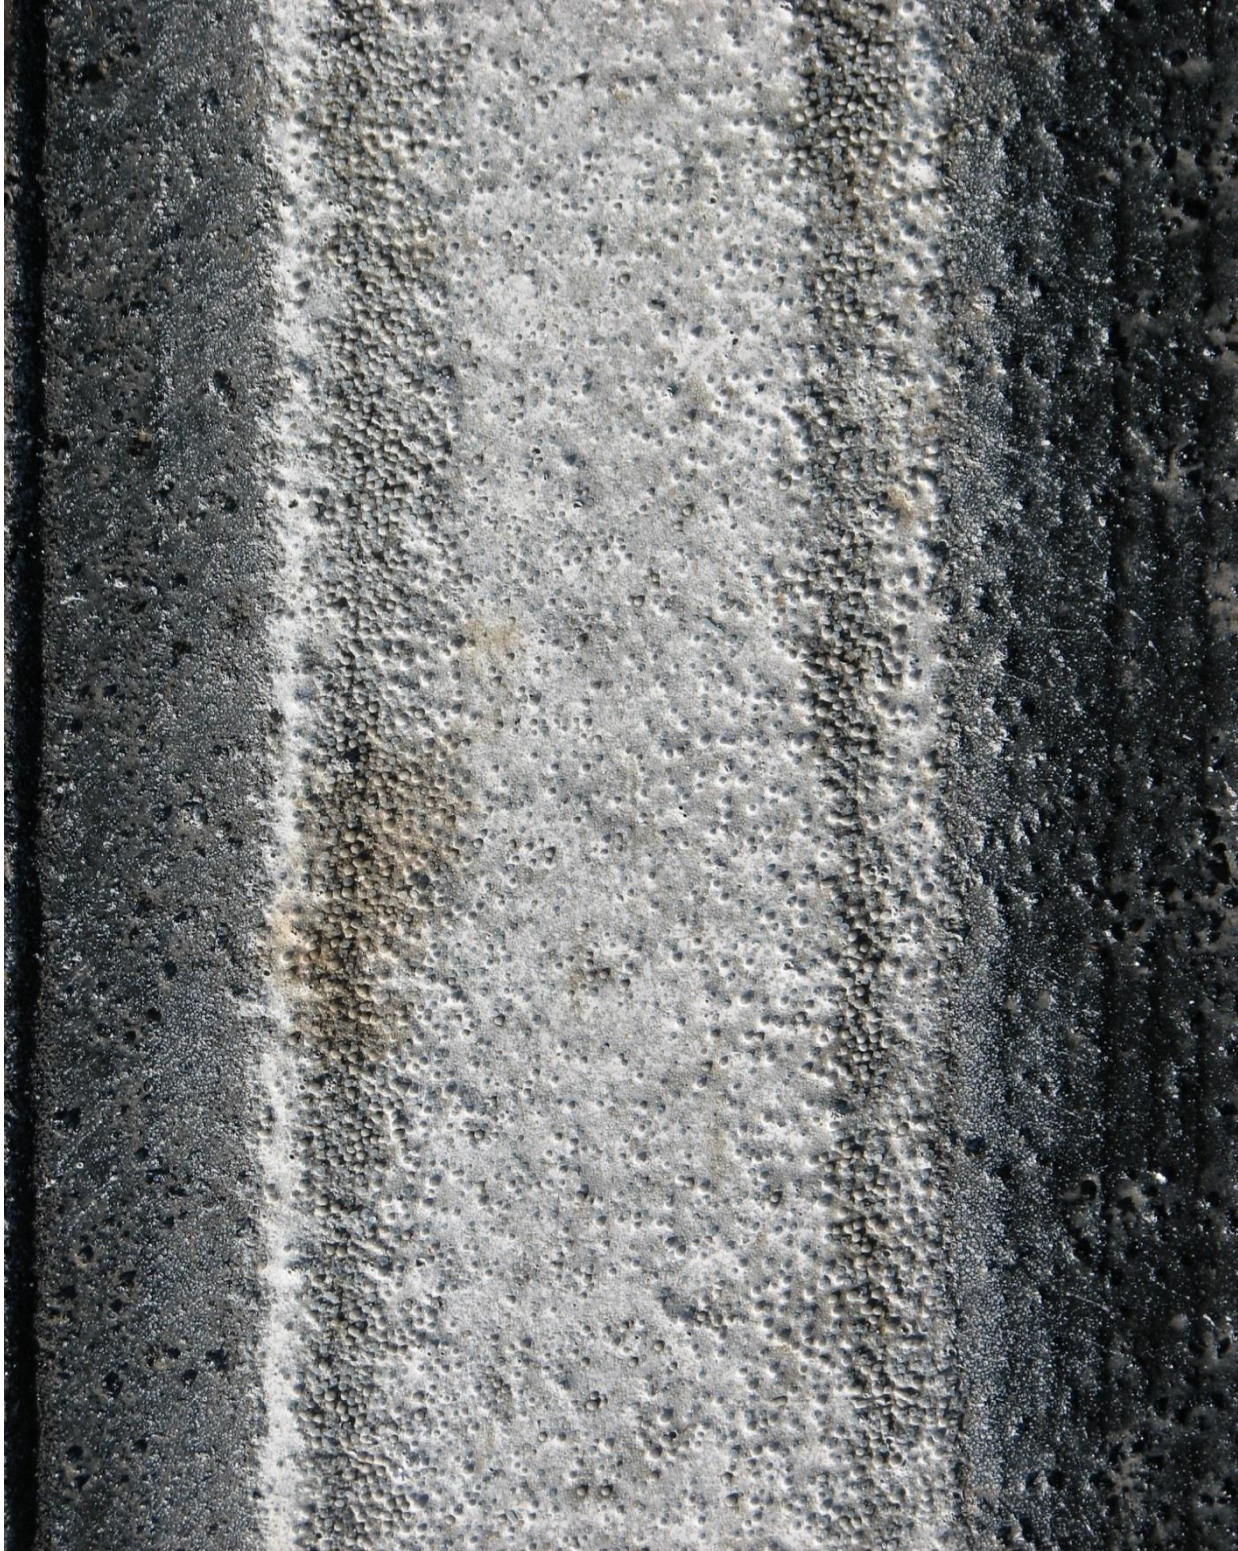
Installation Issue: Inadequate Bead Distribution - Potters Visimax: Section1

↑ By visual examination, Visimax bead population distribution was applied at a higher percentage near the edges of the stripe than the interior. Also, due to this edge clustering, may not have adequately embedded the bead to the binder and possibly will be a performance issue in the future.

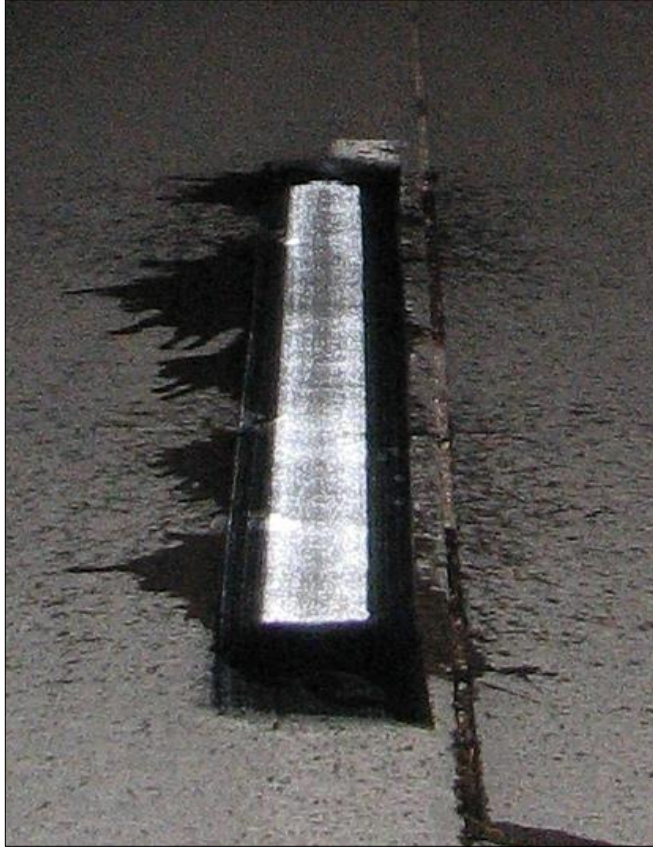
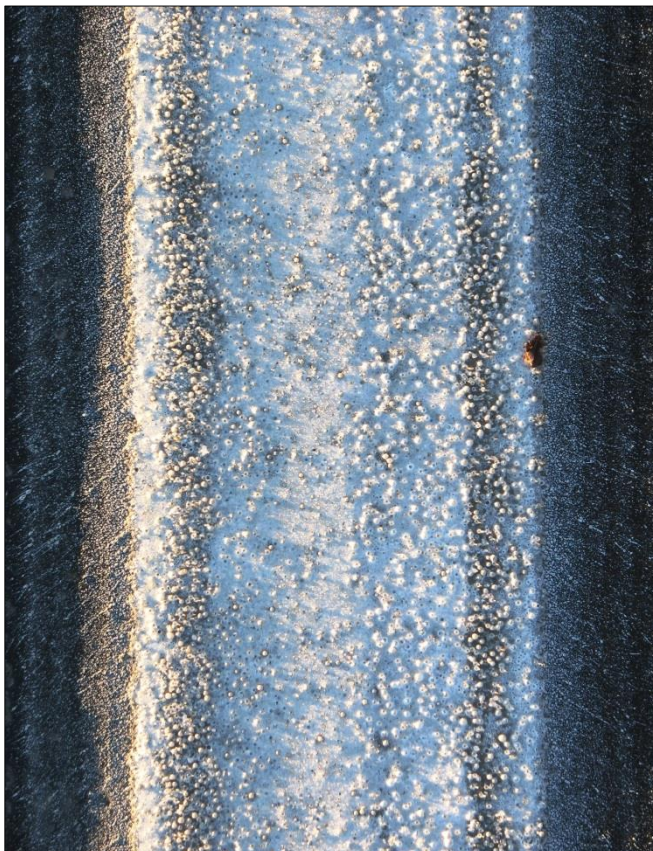
↙↓ **Section1-Potters Visimax:** The top image was a skip line taken at night with water poured within the recessed groove.

As shown, the darker shade, predominantly through the center of the white stripe, is due to an inadequate distribution of the Visimax beads. This is compared to the edges of the stripe, which display greater luminosity.

The lower image is a sample of the bead distribution within the stripe.

This may be an indication of improper calibration of the bead gun.

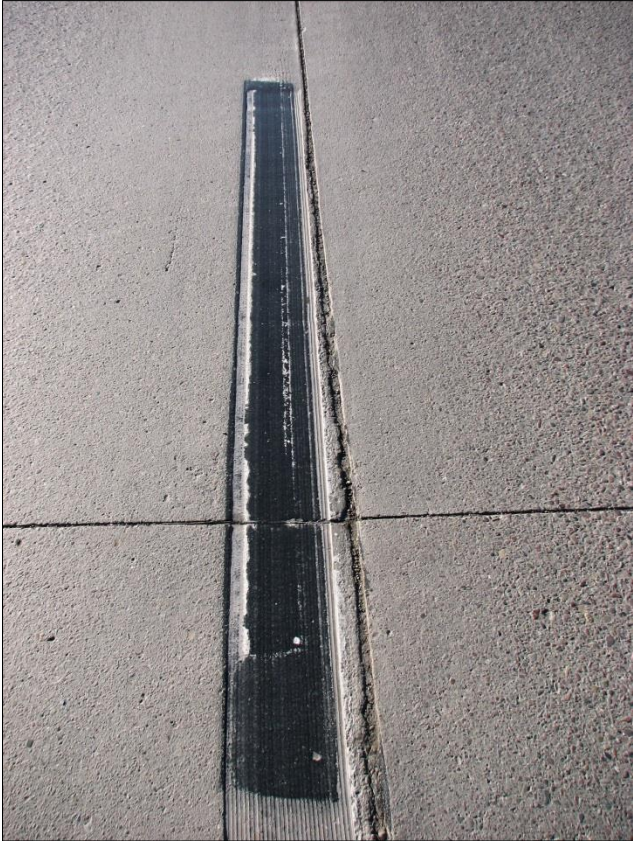
← Representative image of the contrast stripe with almost 100% of the top white stripe removed.

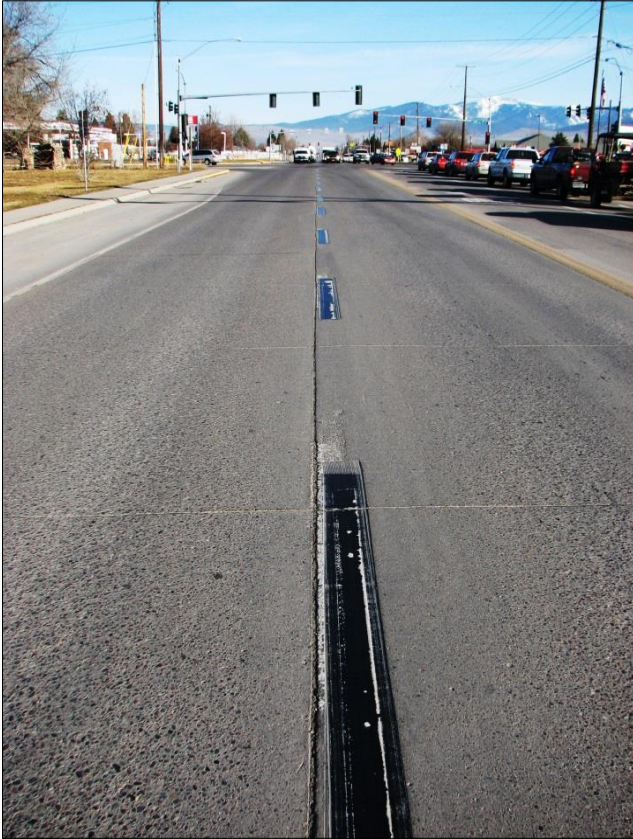
← Southbound of South St. – View North: About 14 skips lacking white stripe.

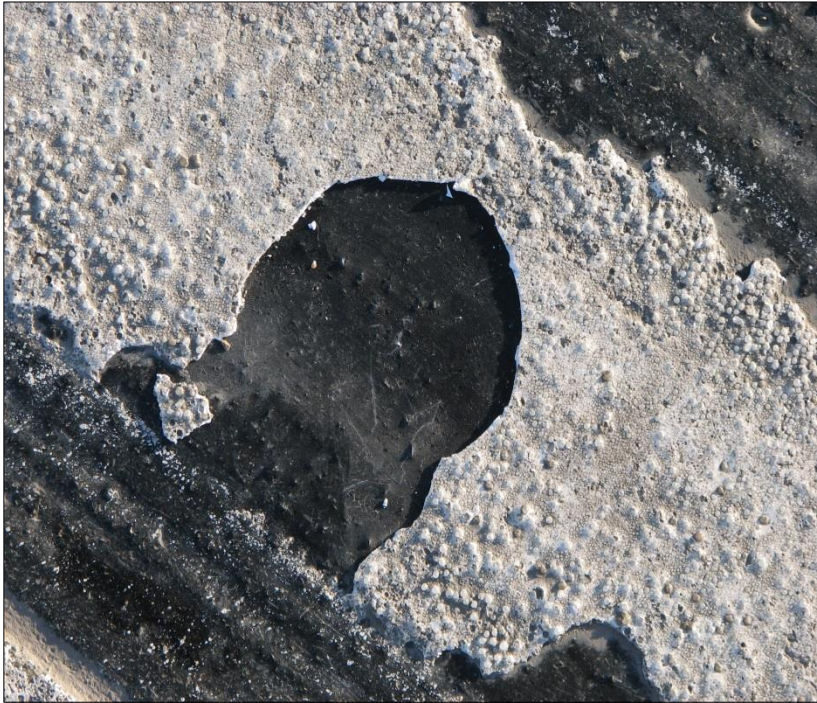
← Close up of partial white to black epoxy binder delamination.

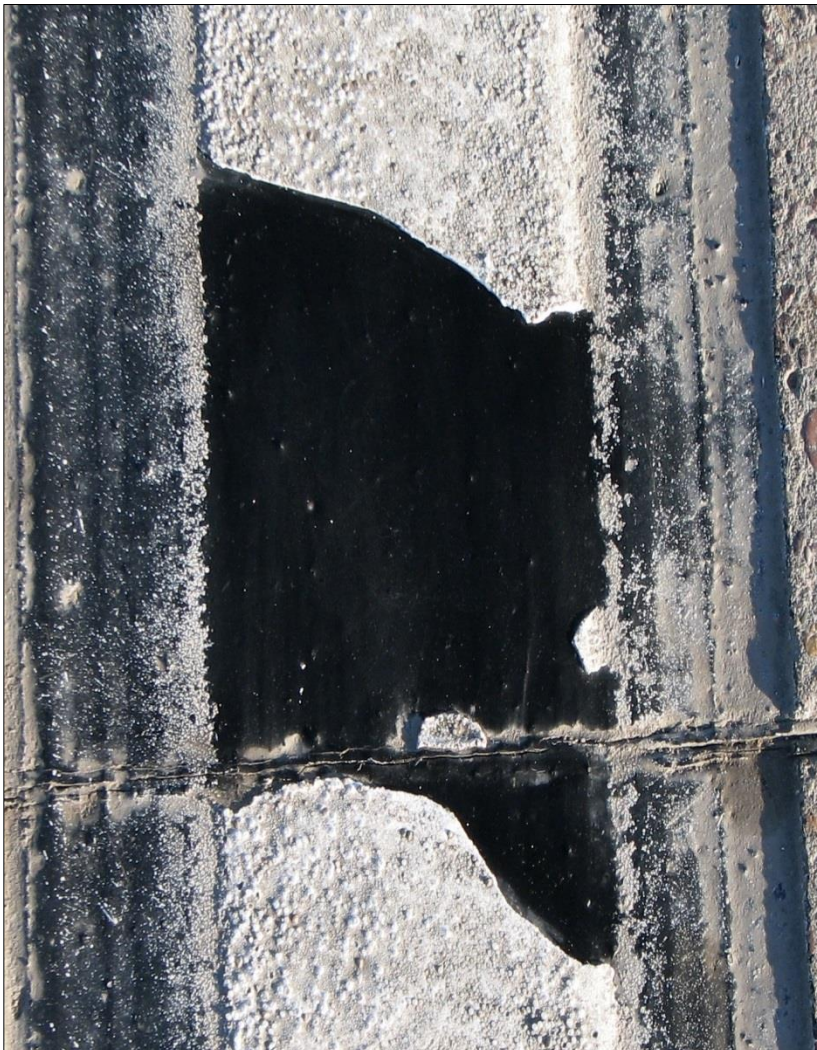
It was reported that the application time between the top and bottom layers averaged at twelve (12) hours. Others states' practice of employing contrast striping is to apply the top layer immediately after the bottom stripe is placed. Whether the break between layers may have introduced an element to deactivate the bonding process is difficult to quantify at this time.

← In observing actual traffic driving over the contrast striping, this section was seen to pop off as a vehicle tire drove over it.

The underlying black epoxy was smooth to the touch, as well as the underside of the white epoxy.

No indication of mechanical bond was evident.

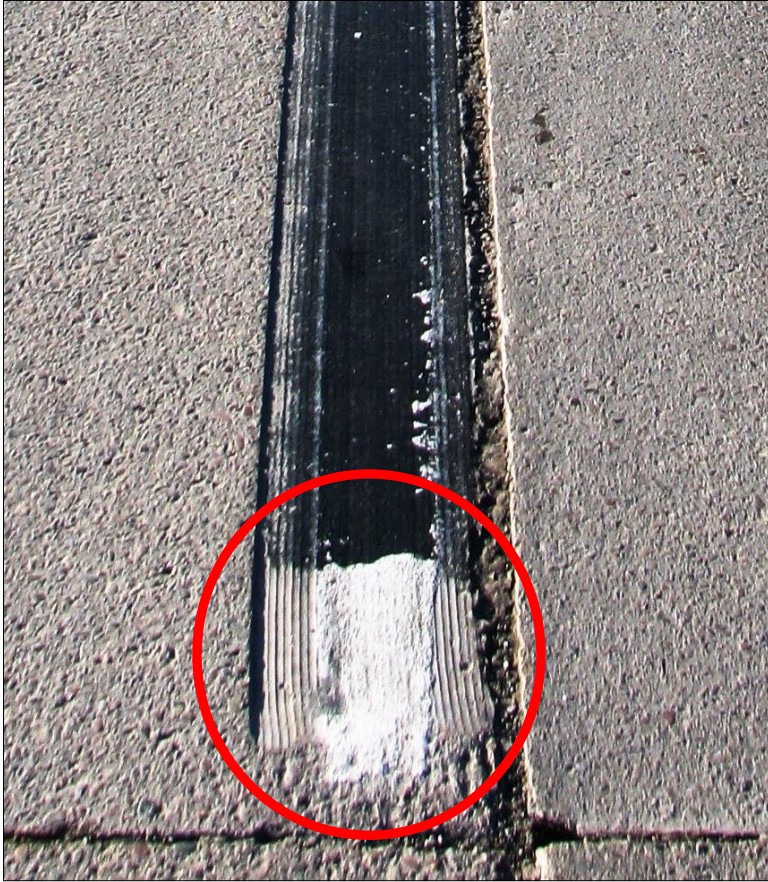
← Contrast stripe with complete removal of top layer, note the white epoxy remains adhered to the grooved pavement (red circle).

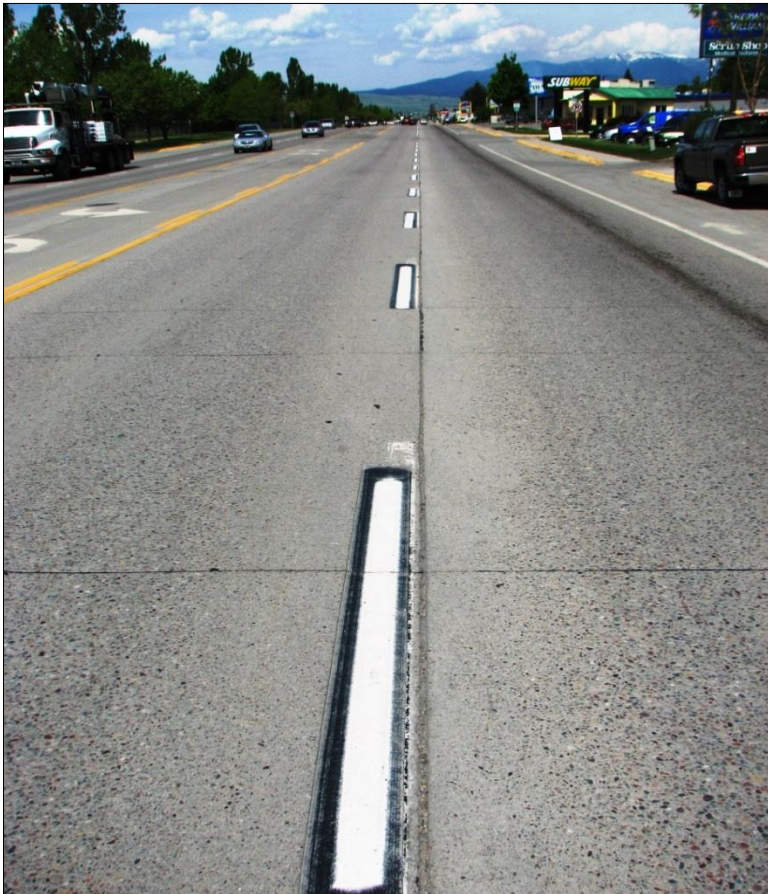
← As stated previously in the report, the majority of the project contrast striping is intact. However, due to the current performance trend the delamination issue may continue.

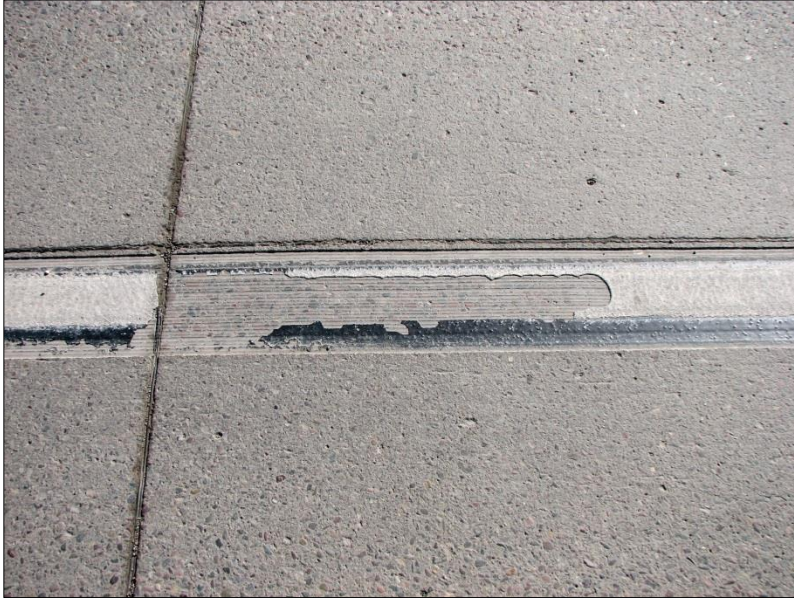
Location: Southbound lane; south of Schramm St. adjacent to the Marriot Courtyard Hotel.

← Image of pop-out of entire contrast stripe from grooved concrete pavement.

This was the only full removal of stripe located on the project as of March 2016.

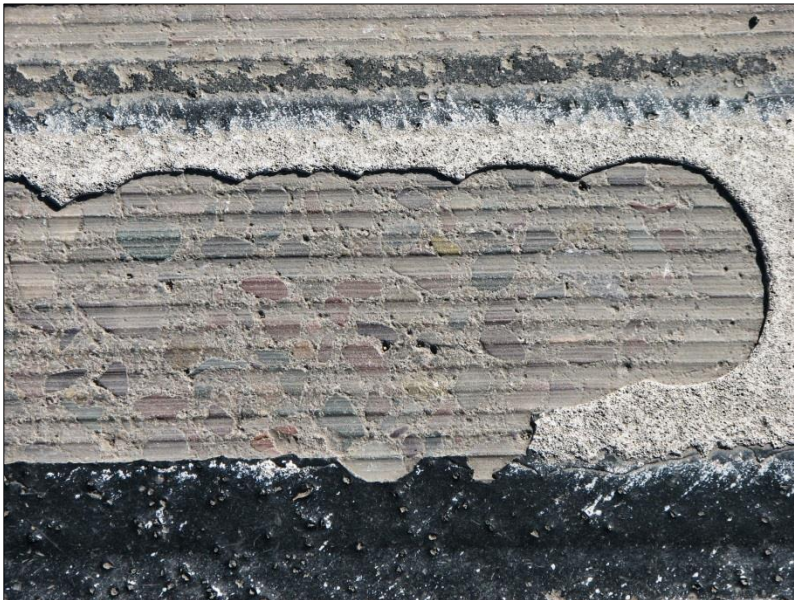
← Pop-out closer view.
