**EXPERIMENTAL PROJECTS CONSTRUCTION AND 2014 SITE INSPECTION
FINAL REPORT**

EVALUATION OF THE BREAK-OUT SQUARE POST BREAKAWAY SYSTEM

Project Name: Break-Out Square Post

Exp. Project Number: MT-12-08

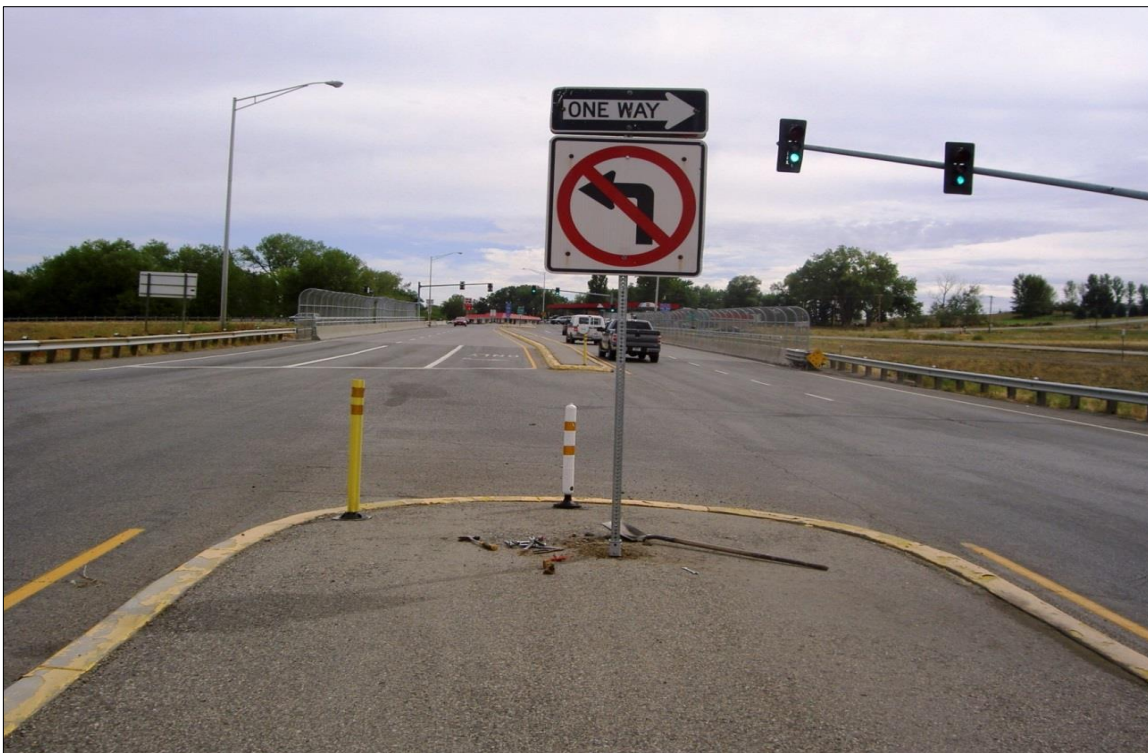
This installation was outside the scope of this report and Research was informed on September 2013 that the BOS post had been (assumed) snapped due to high winds (excess of 70mph) with a sign area of 3'X3' and 1'x3'.

The sign and post were still intact and undamaged. Reinstallation of the unit took approximately 30 minutes to put the sign back in service. The following image is the completed repair.

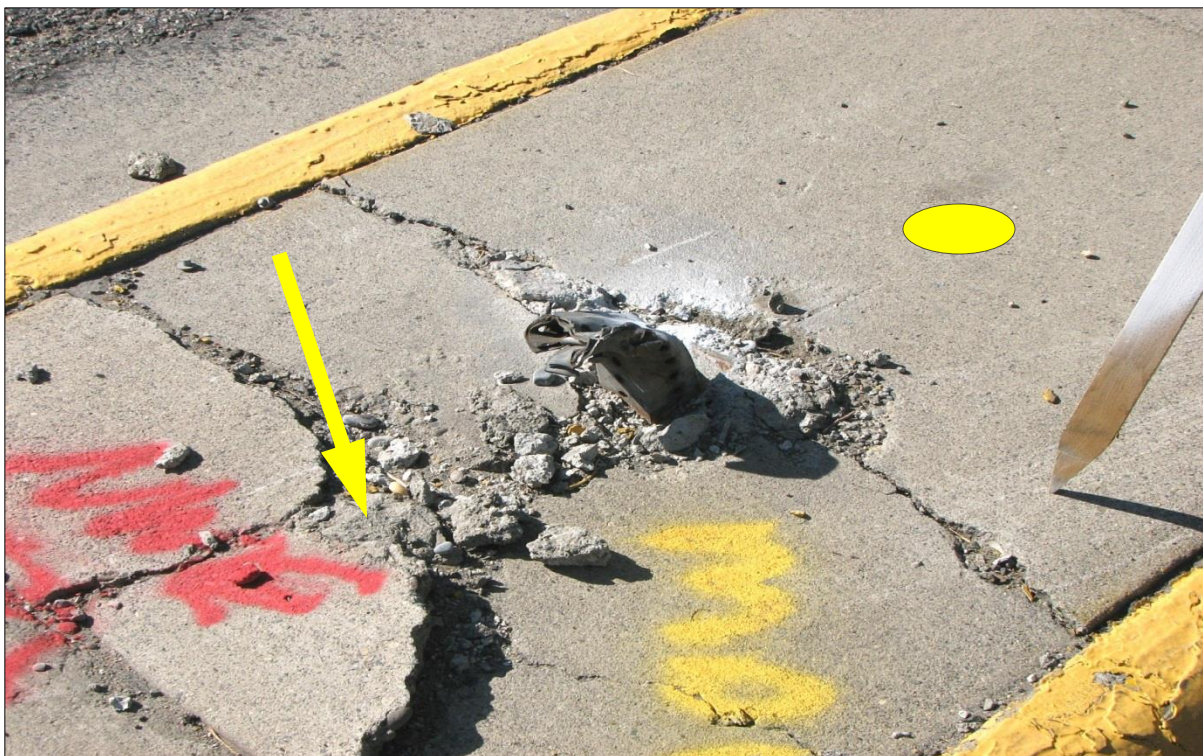
↑ ↓ Condition of the lane divider after two sign impacts. Location of the original sign placement (yellow arrow). Yellow circle will approximate location of new sign base.

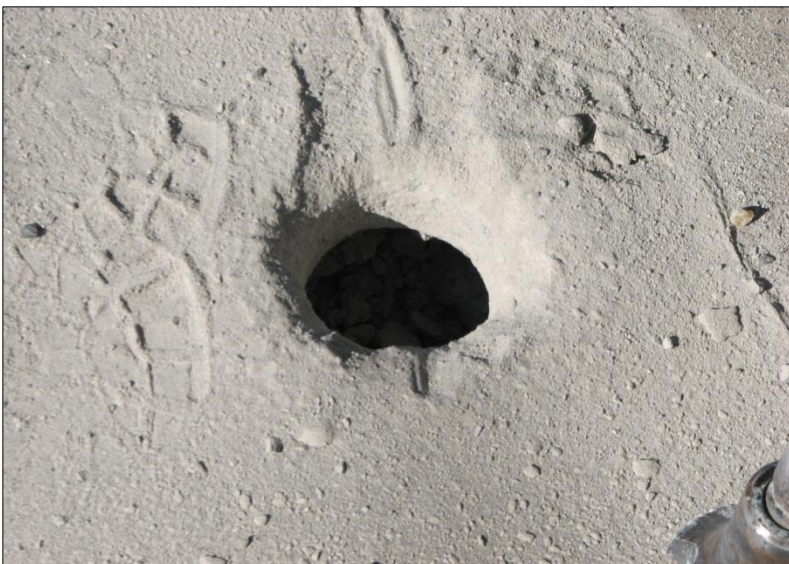
← Boring completed. It was found the depth of the concrete was approximately 2.5" (6.4 cm).

Normally for slabs less than 4" thick an extension is added to the anchor adaptor for added base support.

Since an extension was not supplied it was decided to use only the adaptor with this installation.

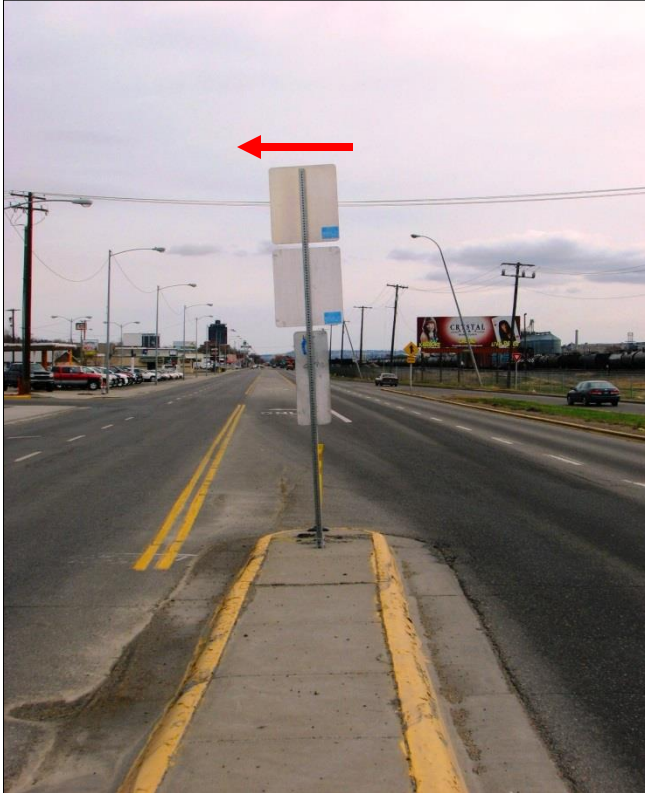
During this inspection it was found that the sign was leaning northwards about five degrees (5°) and leaning forward (easterly) about ten to fifteen degrees (10-15°).

← Upon inspection it was noticed that the sign post had a northern tilt as seen from the rear (view east).

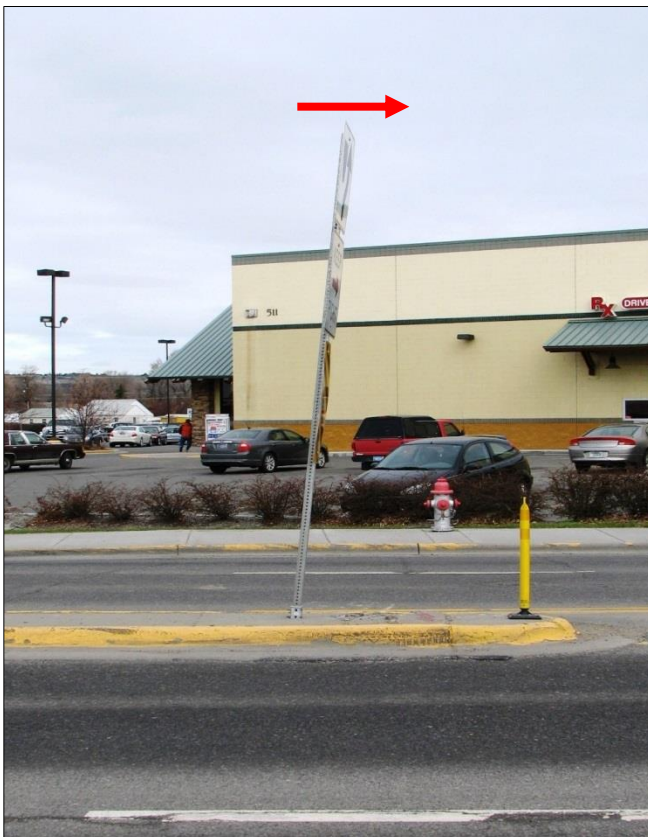
← From a side view (looking north) the sign post had a substantial forward lean.

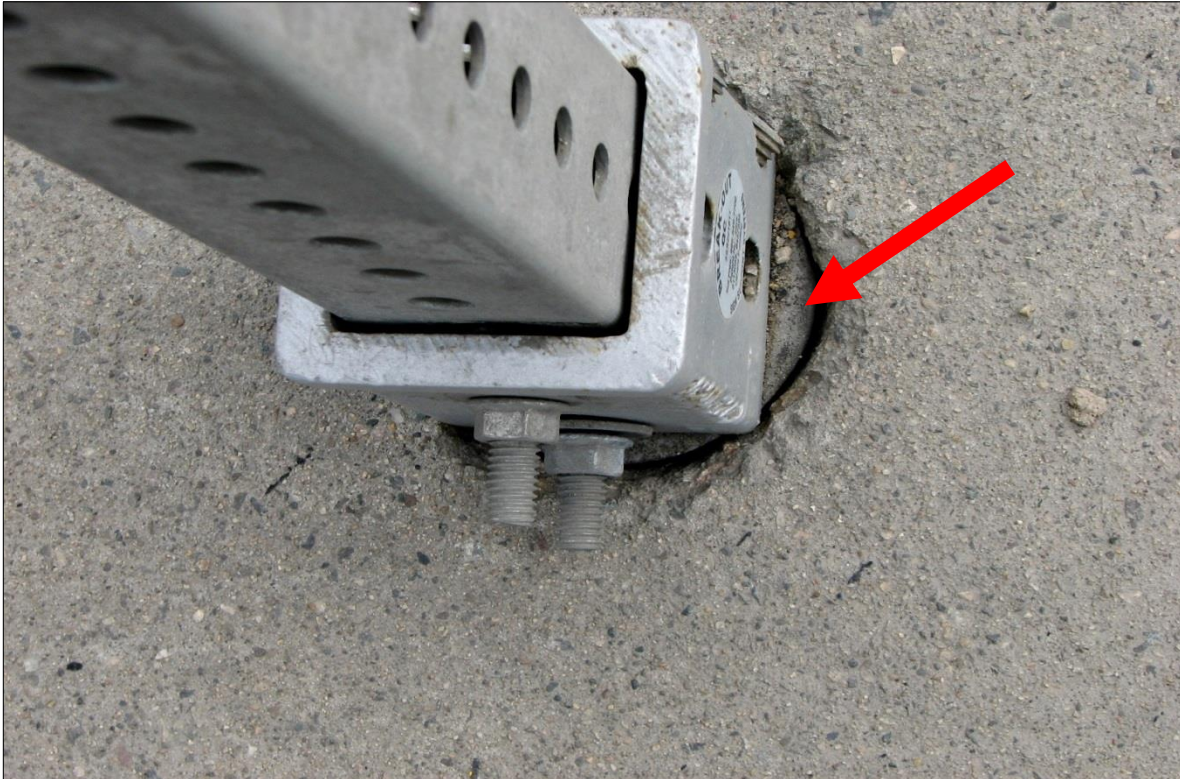
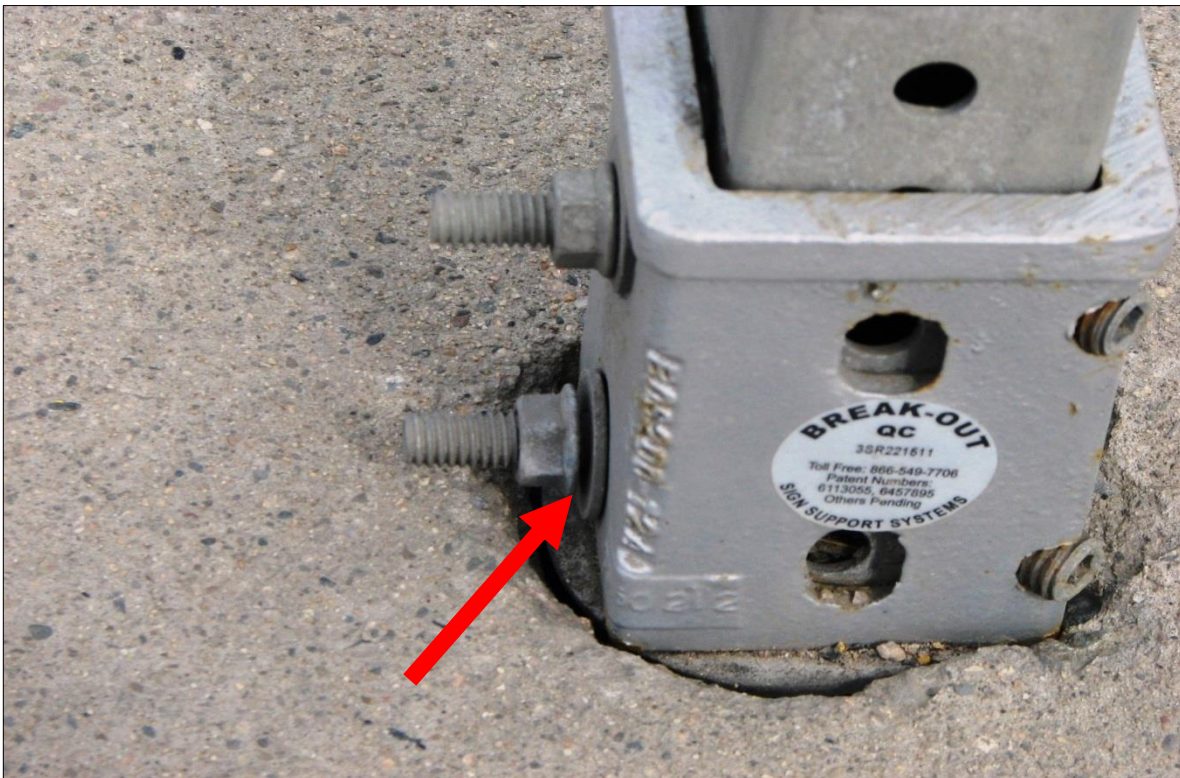
Several of the top coupler attachments (lower socket cap nut and corner hex screw) were loose. The anchor adaptor has depressed into the 3" drilled hole about ¼".

- ↑ The top coupler and wedge-lock unit appeared to be tight in the anchor base; however the anchor base was moveable in the drilled concrete.
- ↓ The rear lower base nut to socket cap attachment was loose. It could not be determined if the other socket cap nut attachment was tight or not.

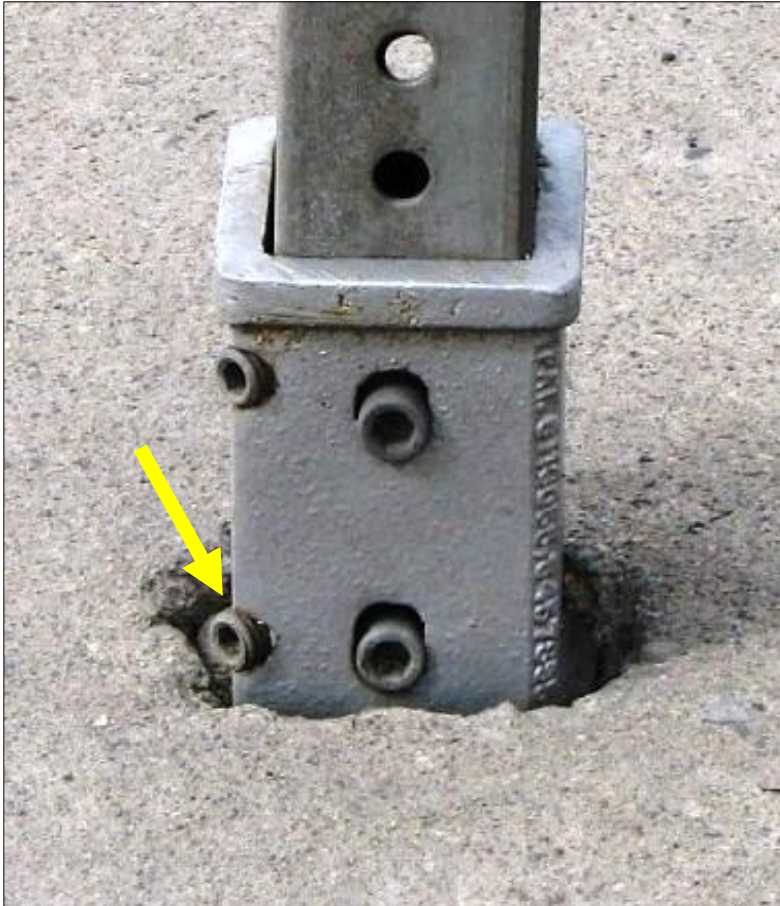
As stated above in the initial remarks, the concrete base thickness was less than 2.5" which to date, appears proven inadequate to support the anchor with sign; however the installation went ahead. In retrospect with the thickness of the base as it was, an anchor extension (which attaches to the anchor adaptor) may have kept the anchor to base a stable installation. These extensions range from twelve inches (12") to twenty-six inches (26"). Another option with the thinness of the PCCP base would have been to apply concrete (or mortar) to the interior in and around the hole to make a solid connection.

A current assumption is that wind-generated vibration has caused the above conditions but that is only speculation.

↙ In comparing the lower image taken in 2012 of the completed BOS unit, and the upper image taken during the April 2013 inspection, shows that the anchor (wedge) adaptor has recessed almost a half inch ($\frac{1}{2}$ ") into the concrete base.

Also note the corner hex screws (yellow arrows) appear to have reversed out of the top coupler hex attachment.

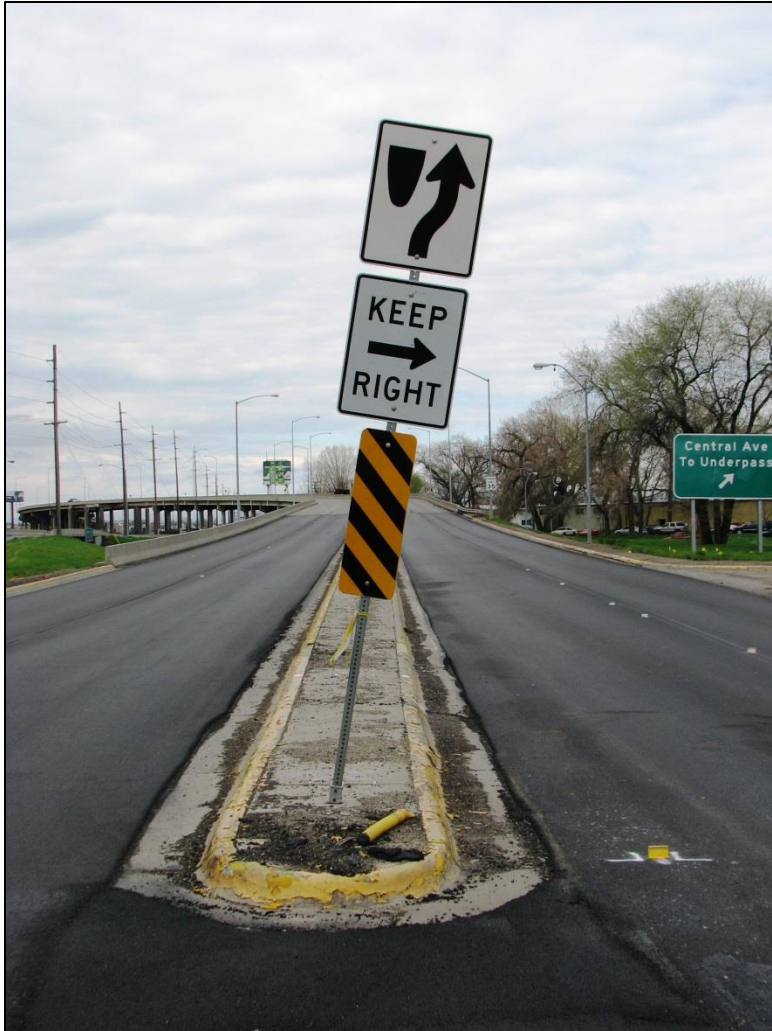
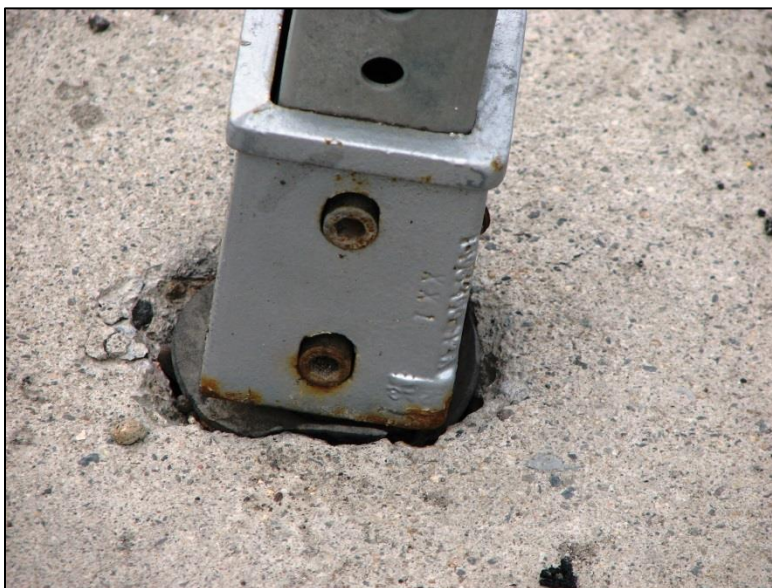
Condition of the sign is the same as reported on April 2013. The tilt and lean was more pronounced. See page 18.

↙↓ As compared to the image taken in April 2014 the sign incline has increased. Even at this severe angle and in shallow placement, the anchor adapter has held.

↓ Close-up of top coupler and anchor base.

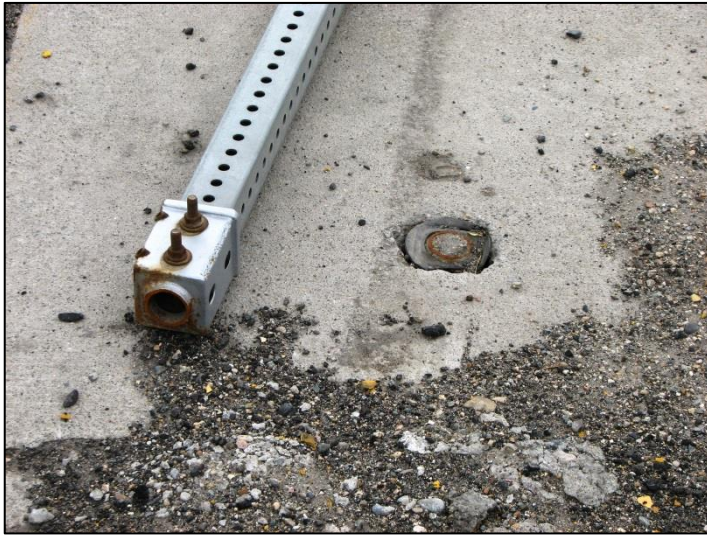
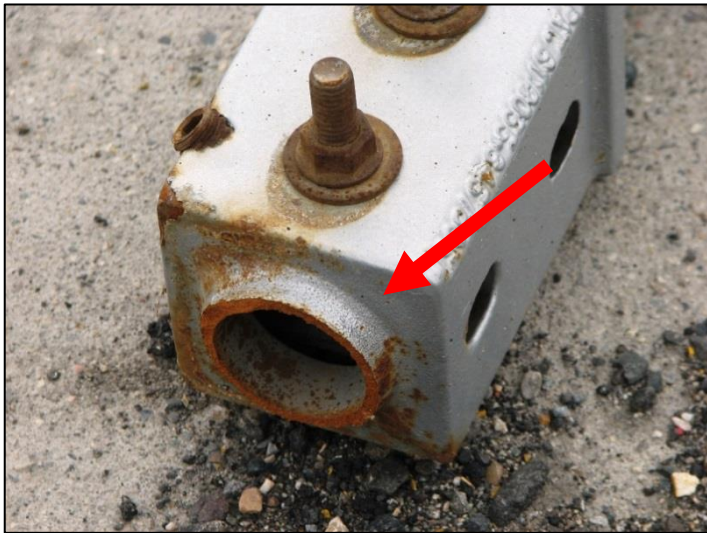
↙ The District notified Research that the Montana and Central Ave. Jct. sign unit had taken a vehicle hit in early May.

As these images show (even at the severe tilt of the base) the top coupler (red arrow) sheared cleanly from the 360° wedge-lock base insert (yellow arrow).

Note at the image at the bottom of the page, the round black deformed object is the seal washer (refer to page 7).

The impact did not affect the placement of the anchor base.

Conventionally, this design allows the wedge-lock to be removed from the anchor base by releasing and removing the tension bolt (in which sanding debris has covered – white arrow) to allow a new break-out unit to be reinserted into the anchor (refer to page 9).

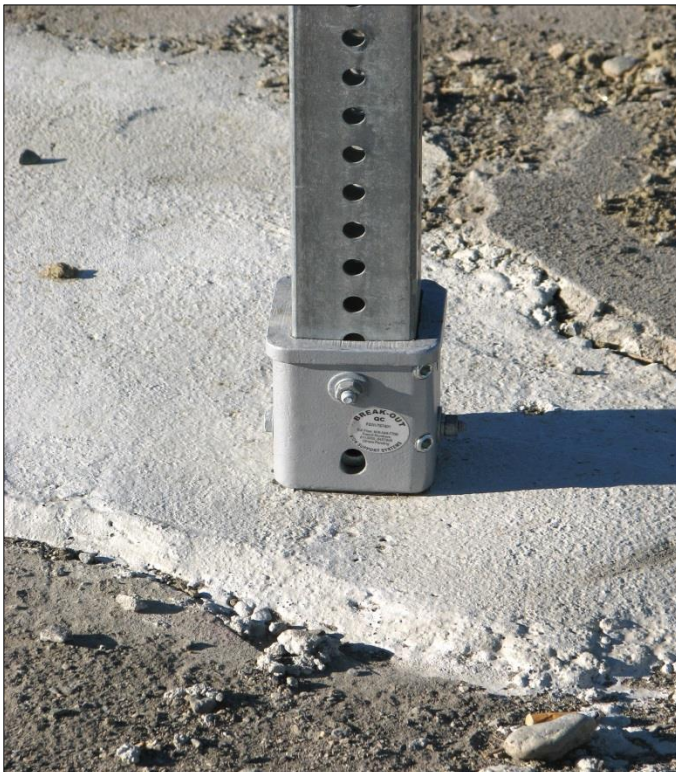
← New installation close-up of breakaway base.

Not confirmed; but it is assumed the original anchor adapter was reused.

Conventional hex bolts were used to affix the sign base to the break-out unit other than socket caps used in the original installation.

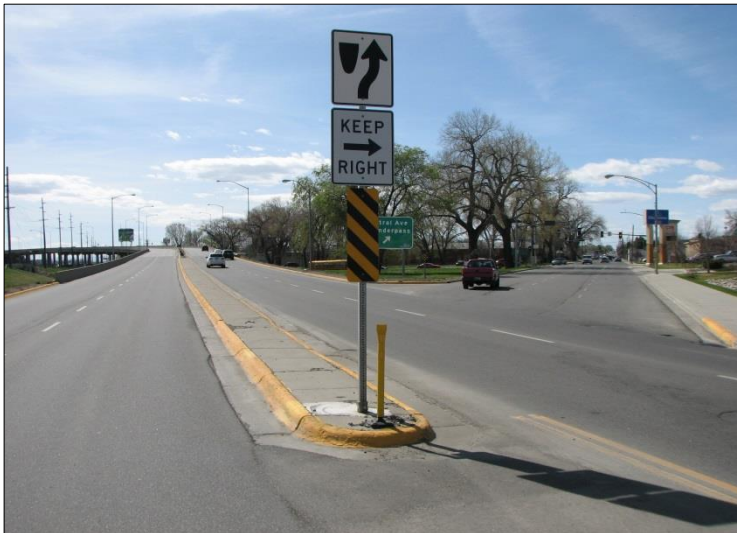
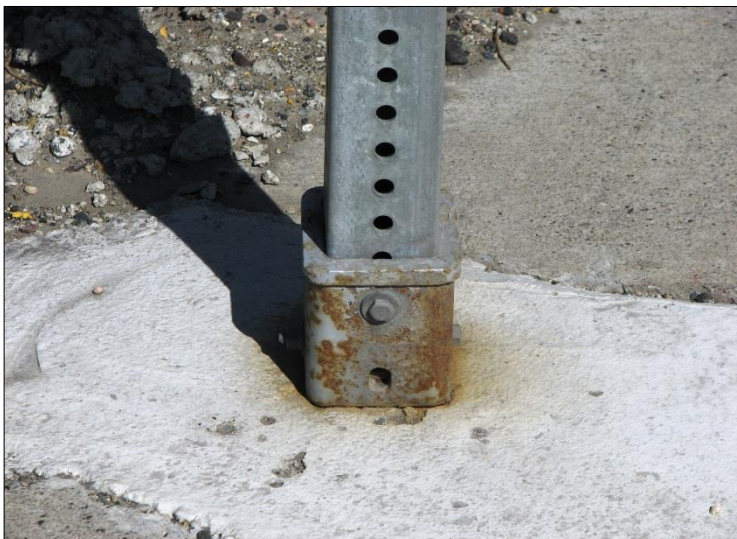
← Some bases were observed
developing rust or corrosion.
