**Montana Department of Transportation
Research Programs**

**EVALUATION OF CRACK-SEALING MILLED PAVEMENT IN THE EFFORT
TO REDUCE TRANSVERSE CRACKING**

Final Report 2018

Project Number: Dutton N & S IM 15-6(35)309

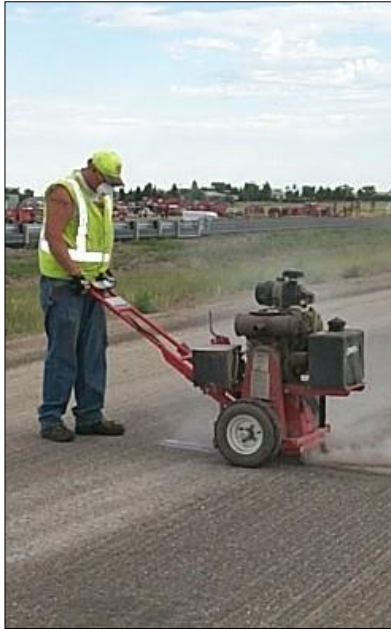
Grinding in process

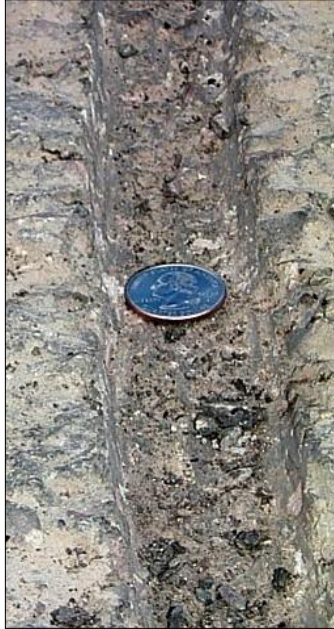
Depth and width of grind

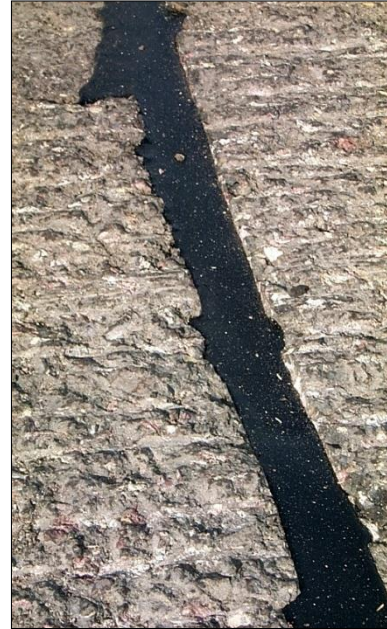
Sealed with Crafc
Hot-applied Modified
Asphalt Sealant

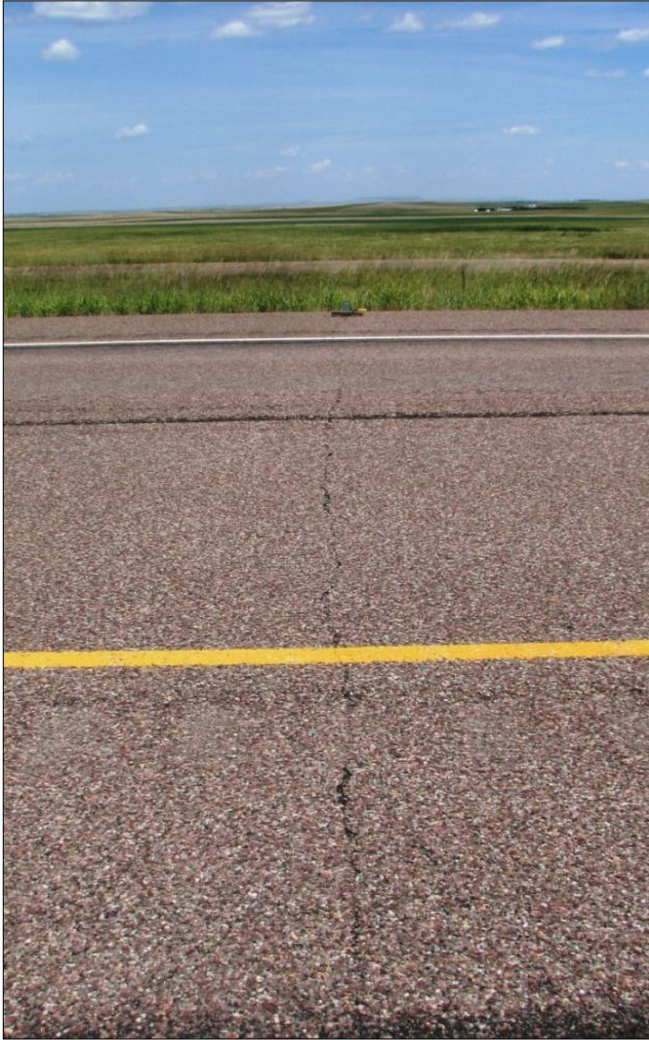
← Example of low-severity cracking on sealed north section (2009)

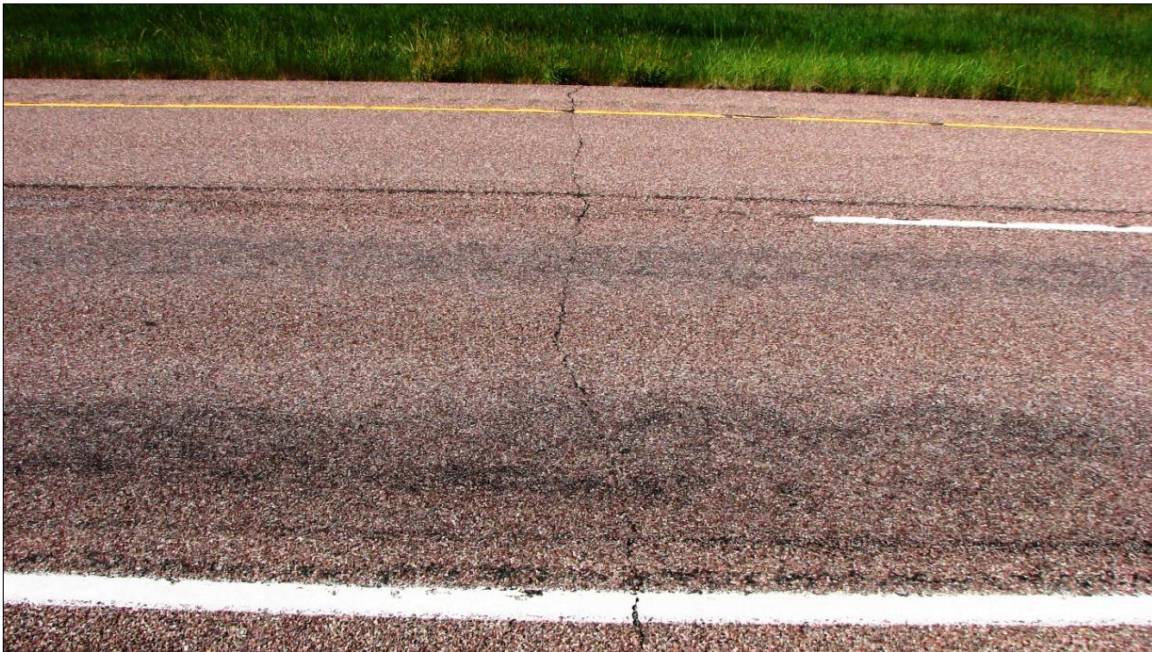
↓ Example of low-severity cracking on un-sealed south section (2011)

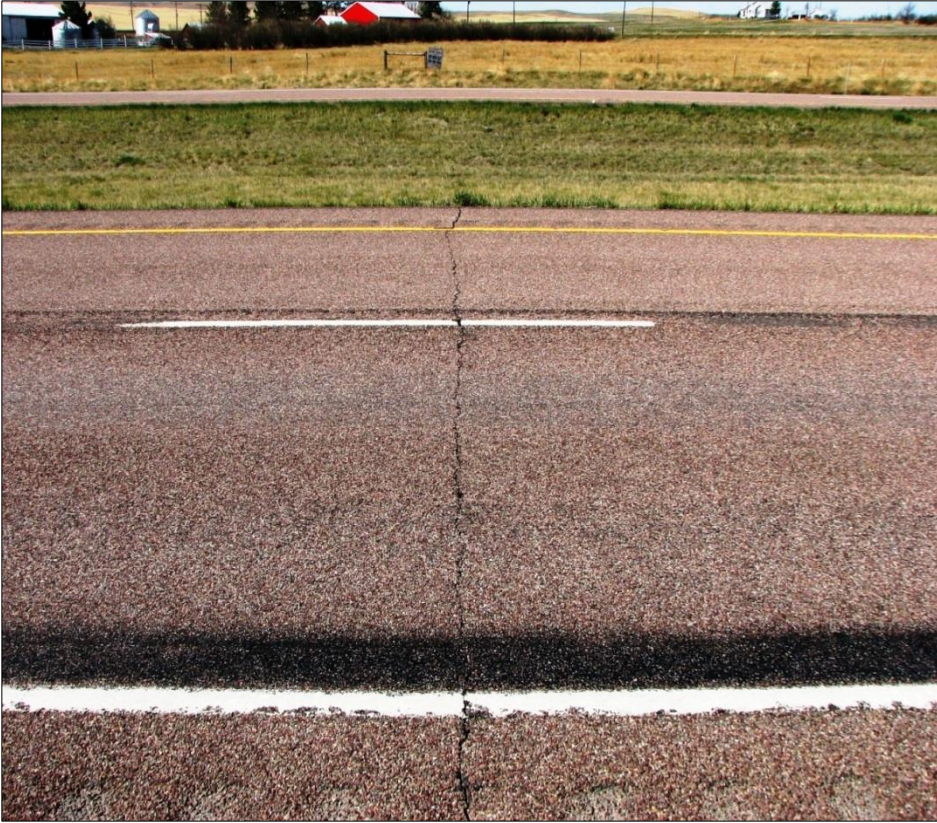
← Example of low-severity cracking on un-sealed south section (2012)

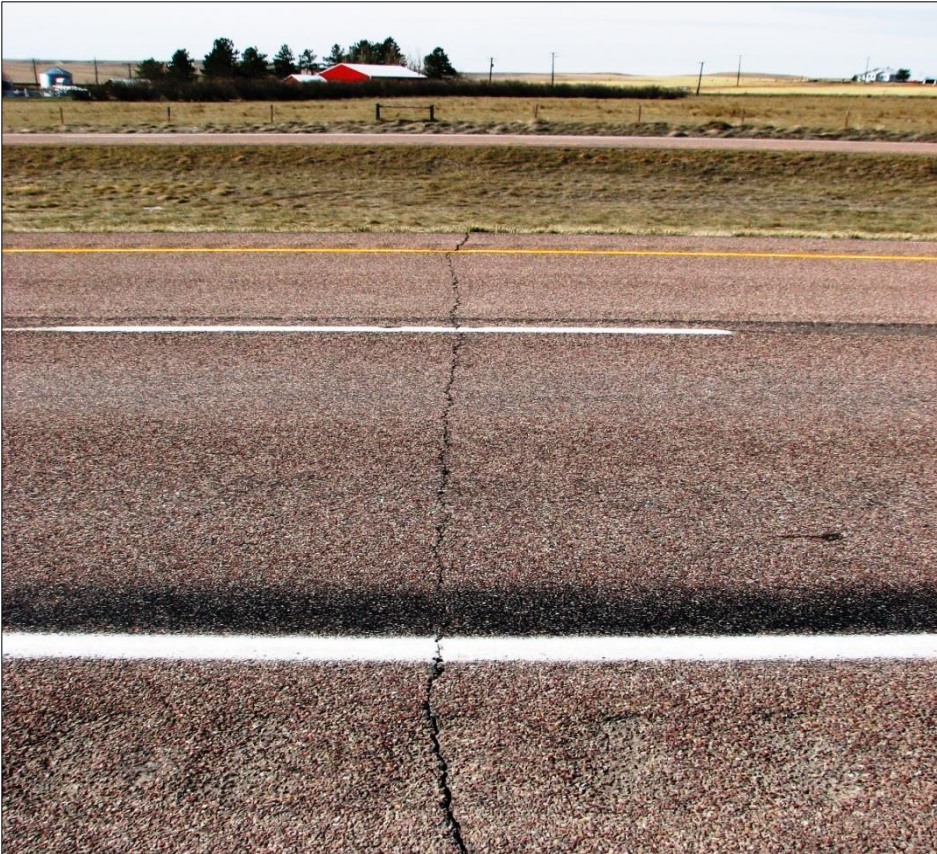
← Example of low-severity cracking on un-sealed south section (2013)

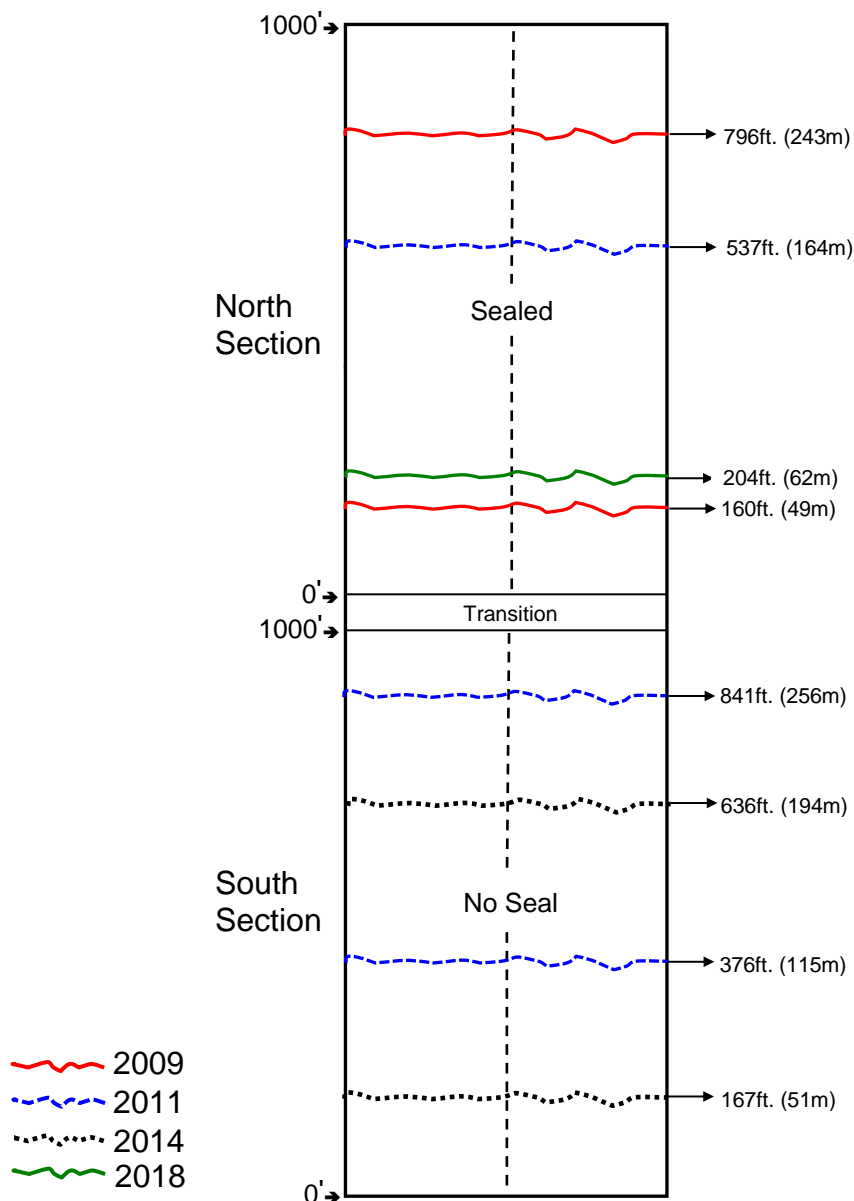
Documented Cracking – Interstate 15/Northbound lanes: Mile Point 312

The south and north sections were initially chosen due to the homogeneous condition and identical number of cracking on both sites. No transverse cracking occurred from construction date of 2005 to 2008. During the 2009 inspection the sealed north section had developed two low-severity cracks (red lines). The blue lines represent cracking to date (low-severity) documented with the 2011 site inspection; with two additional cracks appearing in the no-seal section between 2013 & 2014. To date all cracks on both sections have been crack sealed at the surface.

One additional low-severity transverse crack was documented in early 2018 in the sealed section of the project. The graph depicts the approximate location and distance from the start of each test section, (crack locations approximate; not to scale). No additional site inspections will occur since the section of interstate is being repaved.
