## EXPERIMENTAL PROJECTS FINAL REPORT

### EVALUATION OF THE METADOME TRUNCATED DOME USED IN EXISTING AND NEW ASPHALT APPLICATIONS

**Project Name:** ADA Asphalt DWD

**Project Number:** STPP-STPE 13-5(8)96

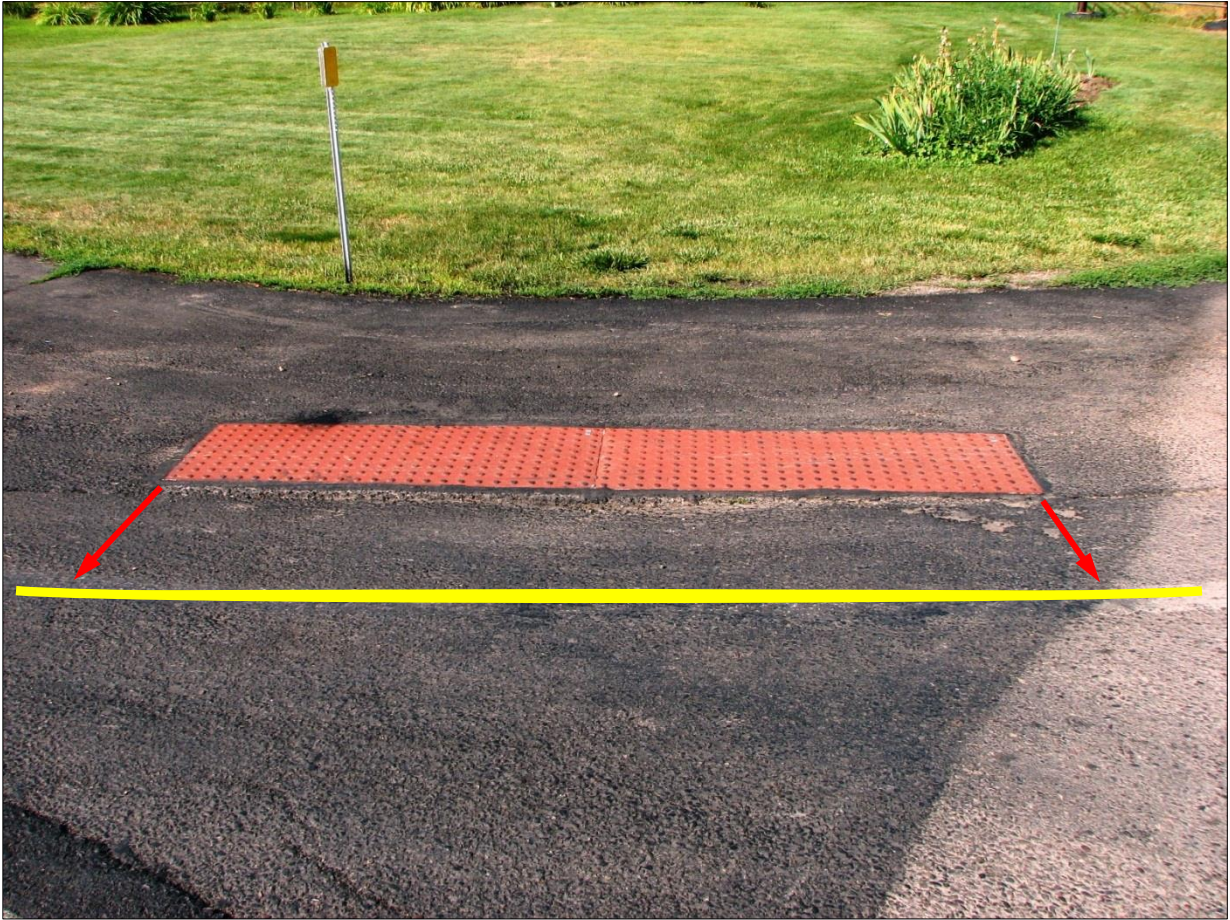
↑ The manufacturer's representative had a concern over the placement of the DWD located on the southwest corner at the intersection of North Ave. and Clements Rd.

As seen in the image above the panel is set on a radius within several feet of the white line (or fog line). The yellow line in the image is superimposed since sealing the bike path no longer made the stripe visible. The issue is the location of the panel may be prone to be plowed. Although the height of the panel lip to pavement is within ADA tolerance ( $< \frac{1}{4}$ " ), a plow blade hitting the panel at the right angle could damage the unit.

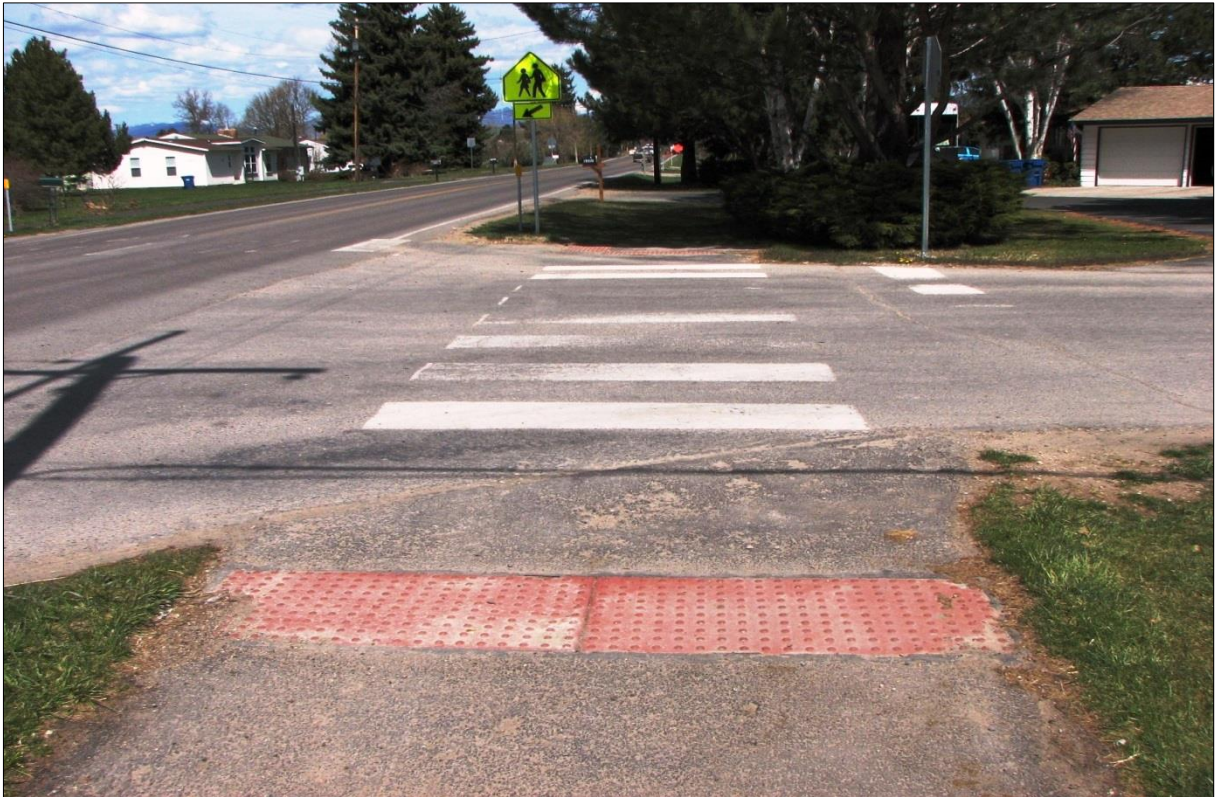
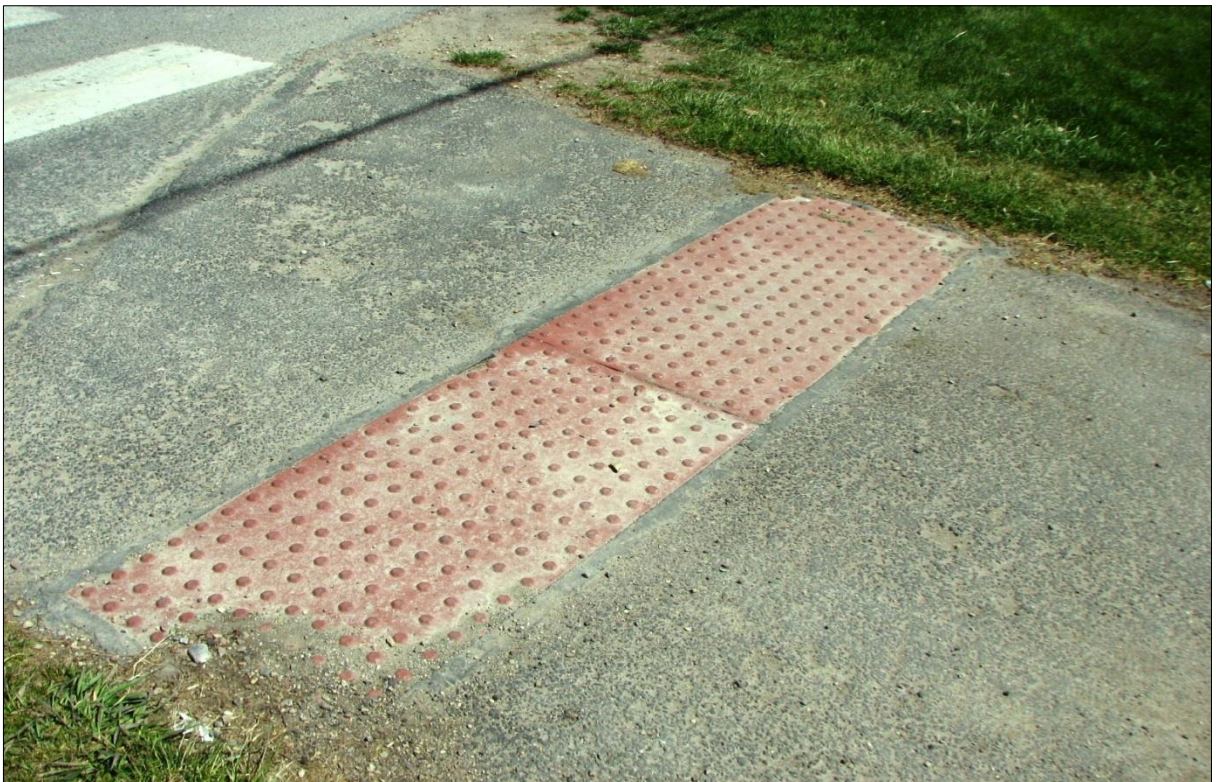
↑ ↓ Intersection of Mount Ave. and Clements Rd; east side of installation. The DWD's at this location were visually in good shape.

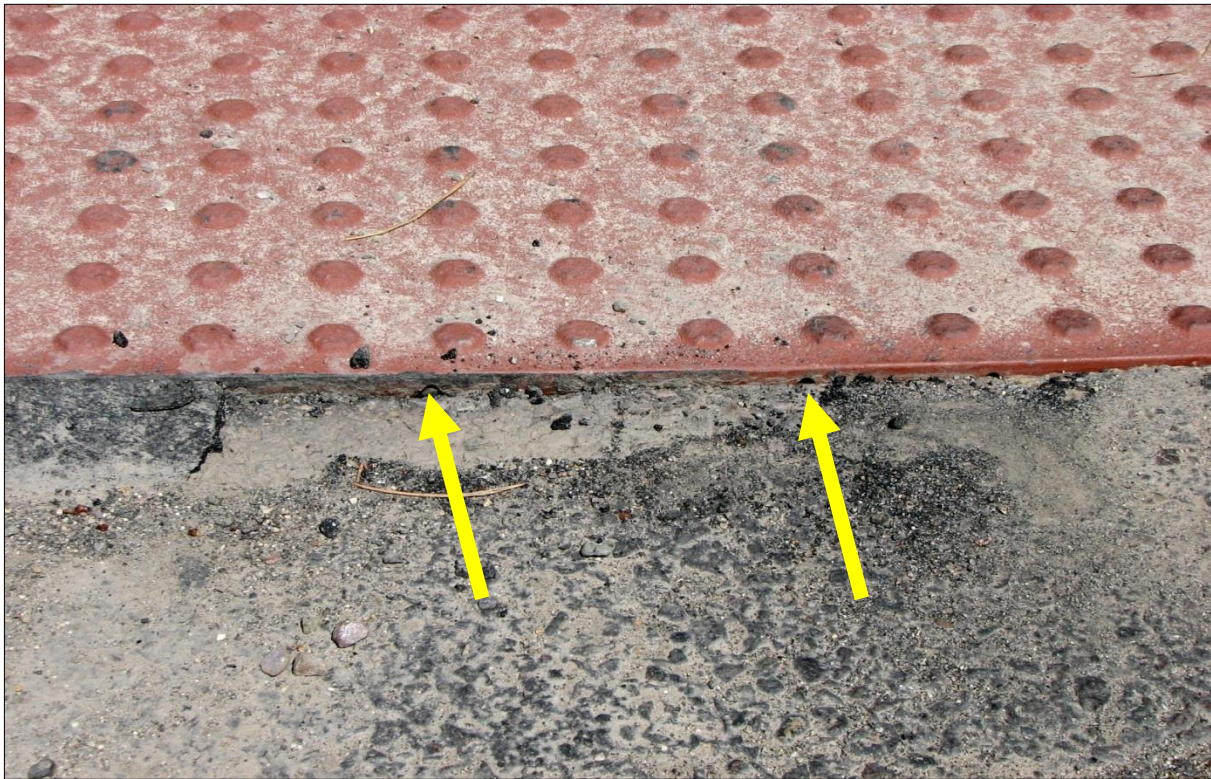
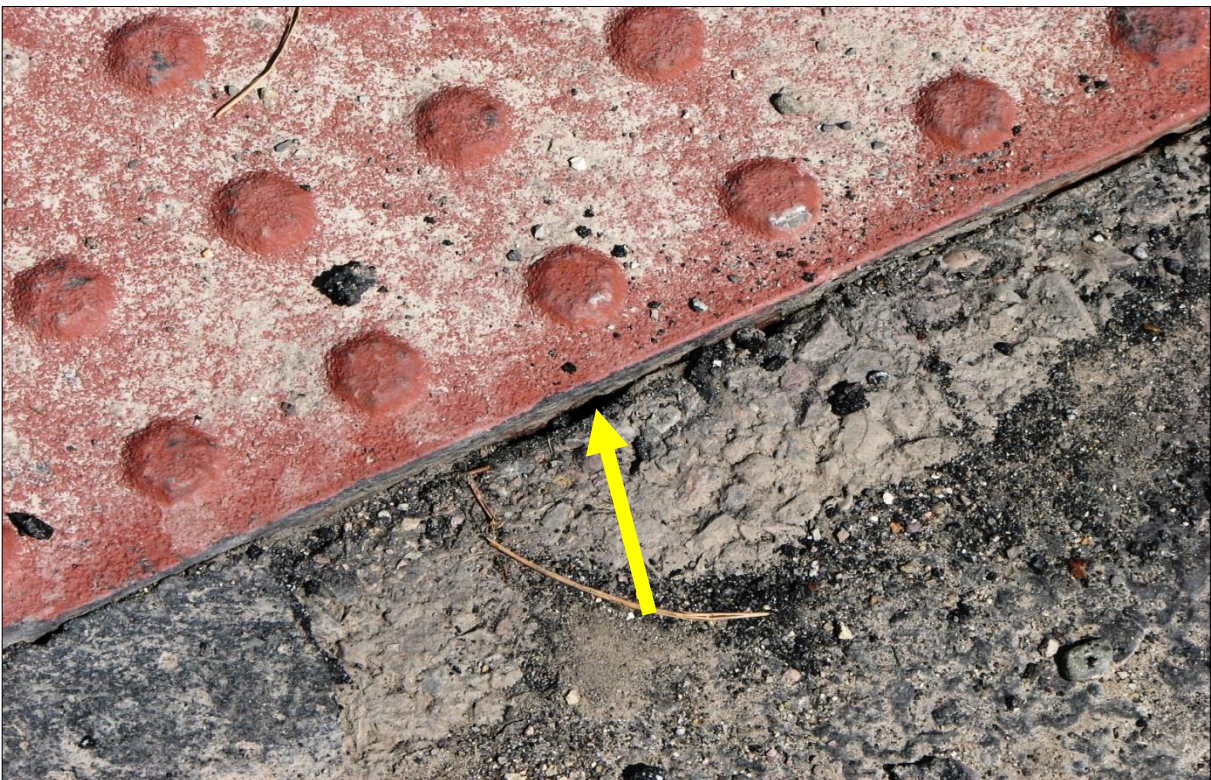
↑↓ The driveway patch used in the installation is beginning to crack and delaminate as seen in the above and below images. This is exposing the flange openings (yellow Arrow) to potential entry of moisture which may promote freeze/thaw activity.

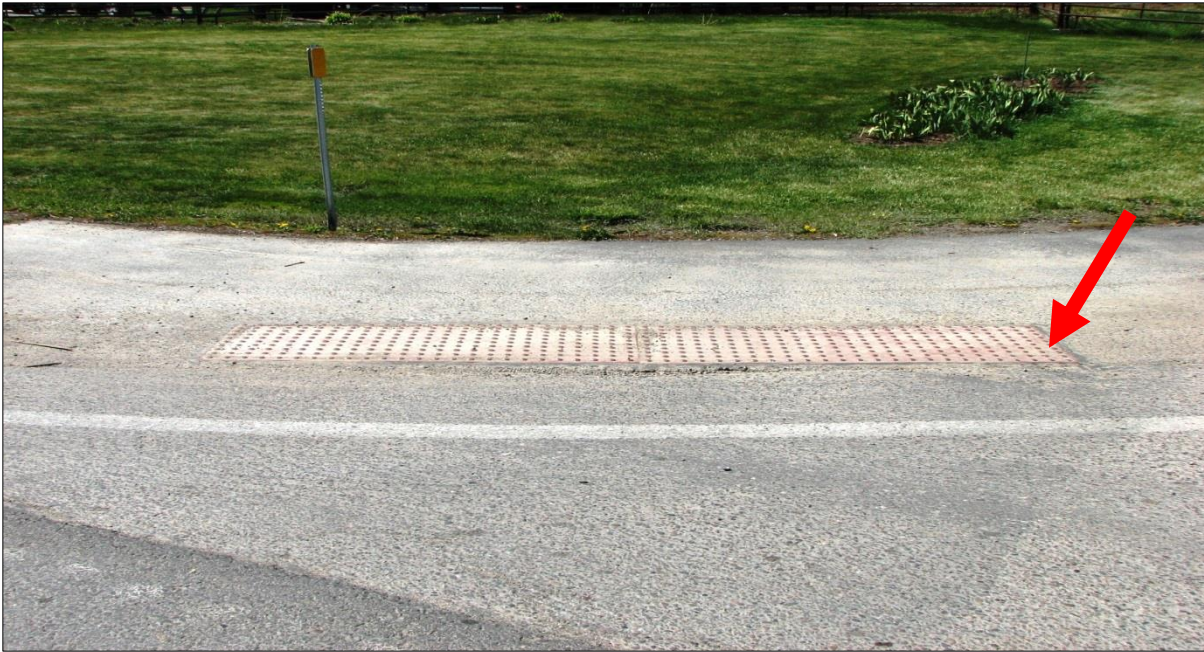
↑ Intersection of North Ave. and Clements Rd. View of DVD on west side of intersection.

← It was observed on the leading edge of the northeast corner (red arrow) of the DVD had visual plow damage of either the scraping off of the powder coating or actual depression of the domes.

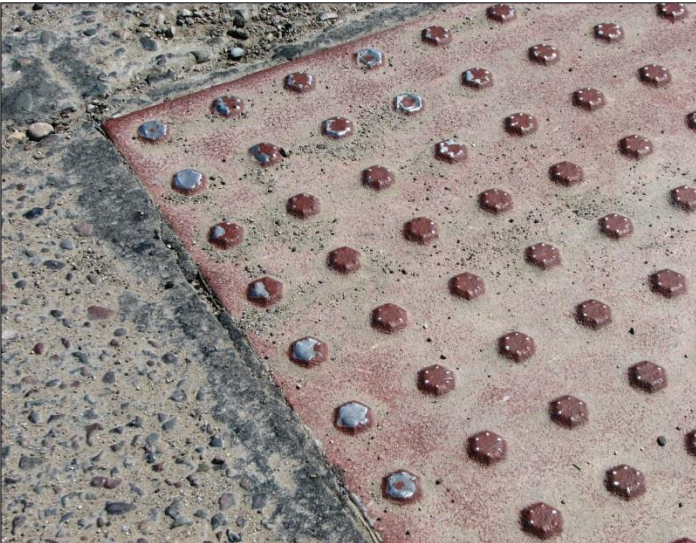
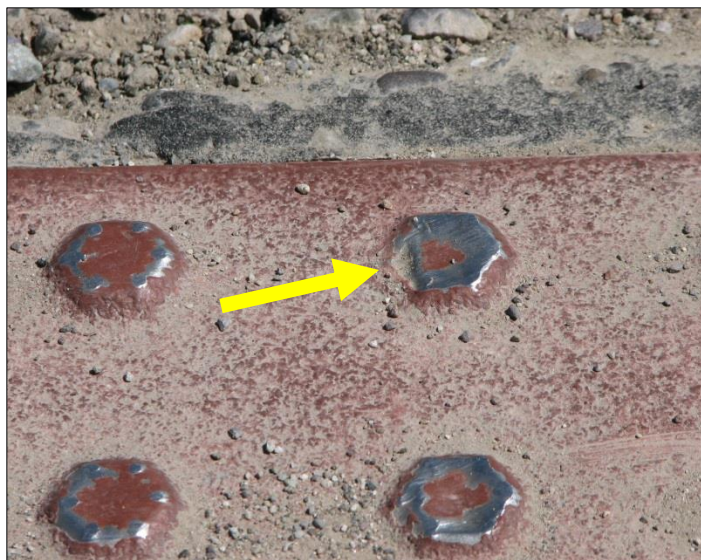
← A close-up of the damage done to the panel domes. The yellow arrow shows the direction of the hit.

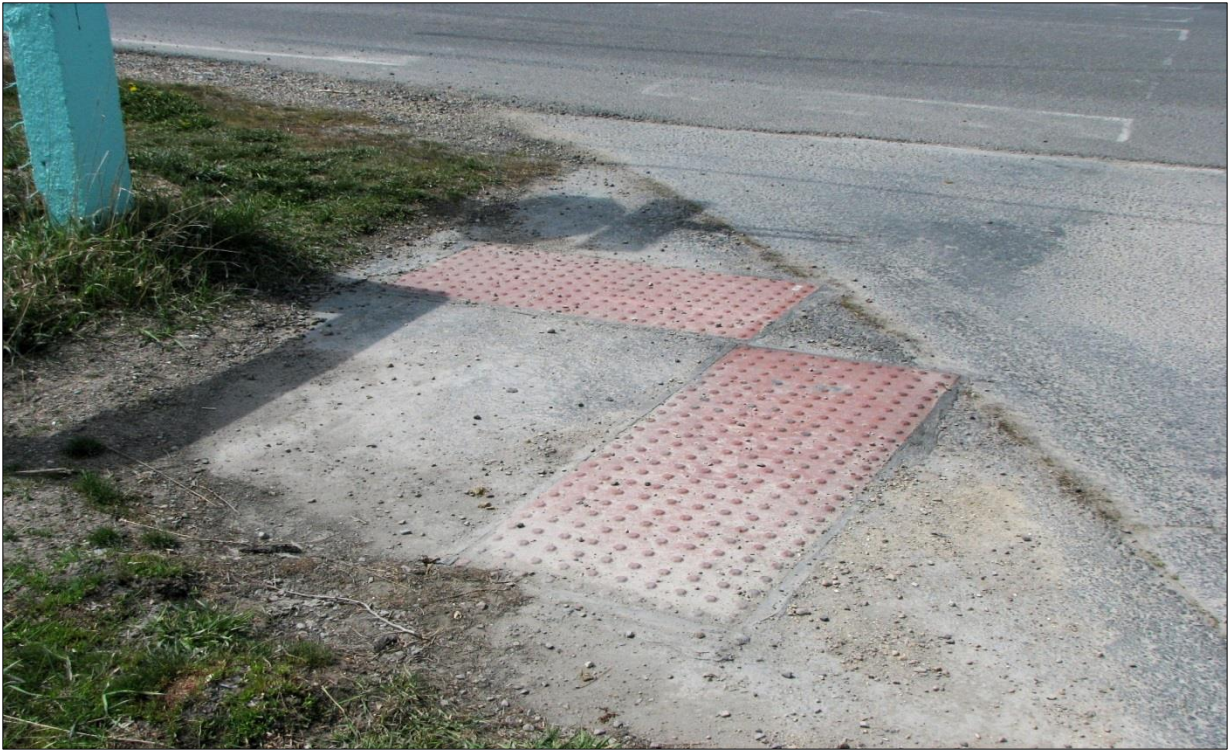
↑ Southeast DWD placement at intersection of North Ave. and Clements Rd. Panels are in good condition.

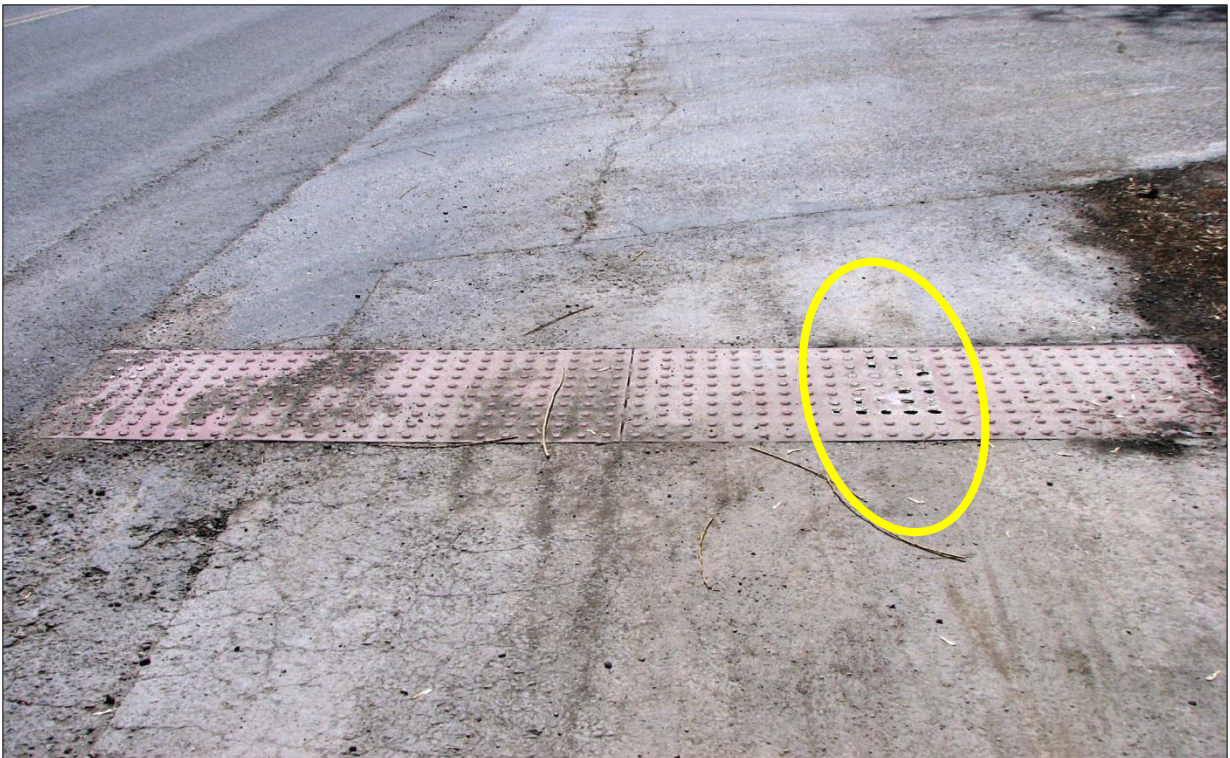
↓ **Intersection of Colonial Ave. and Clements Rd.** West panel placement has severe plow damage of sheared or flattened domes as defined in the area of the yellow circle.

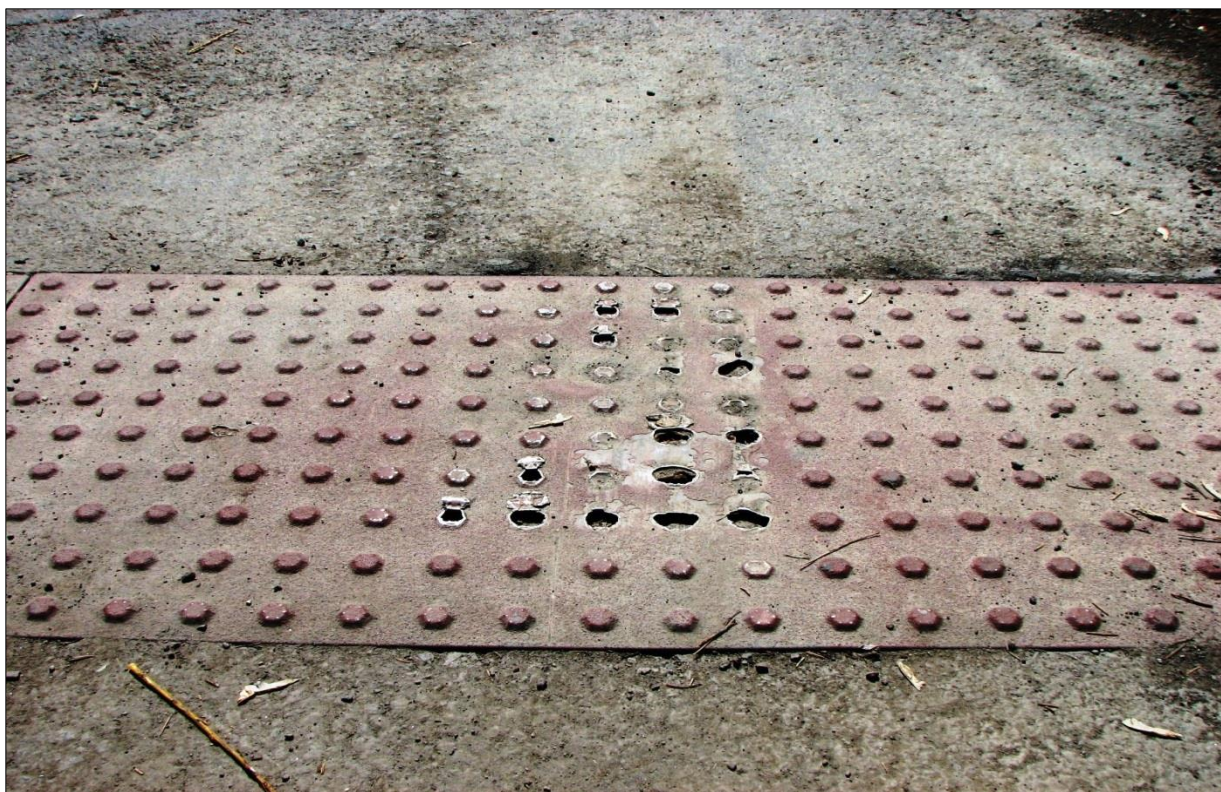
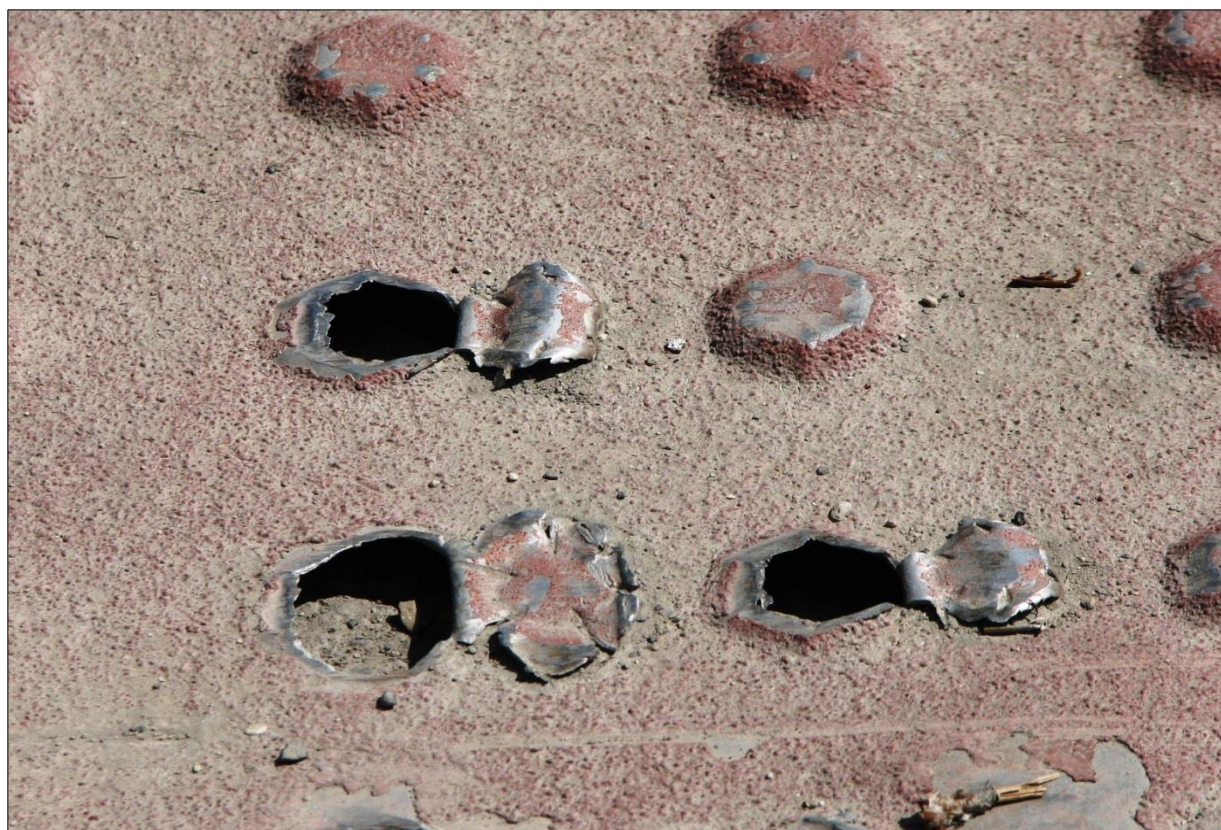
↑↓ Several close-ups of the damaged domes. Some domes were flattened; others completely removed or peeled back as seen in lower image. The peeled back domes may be a safety hazard since they are razor sharp to the touch.

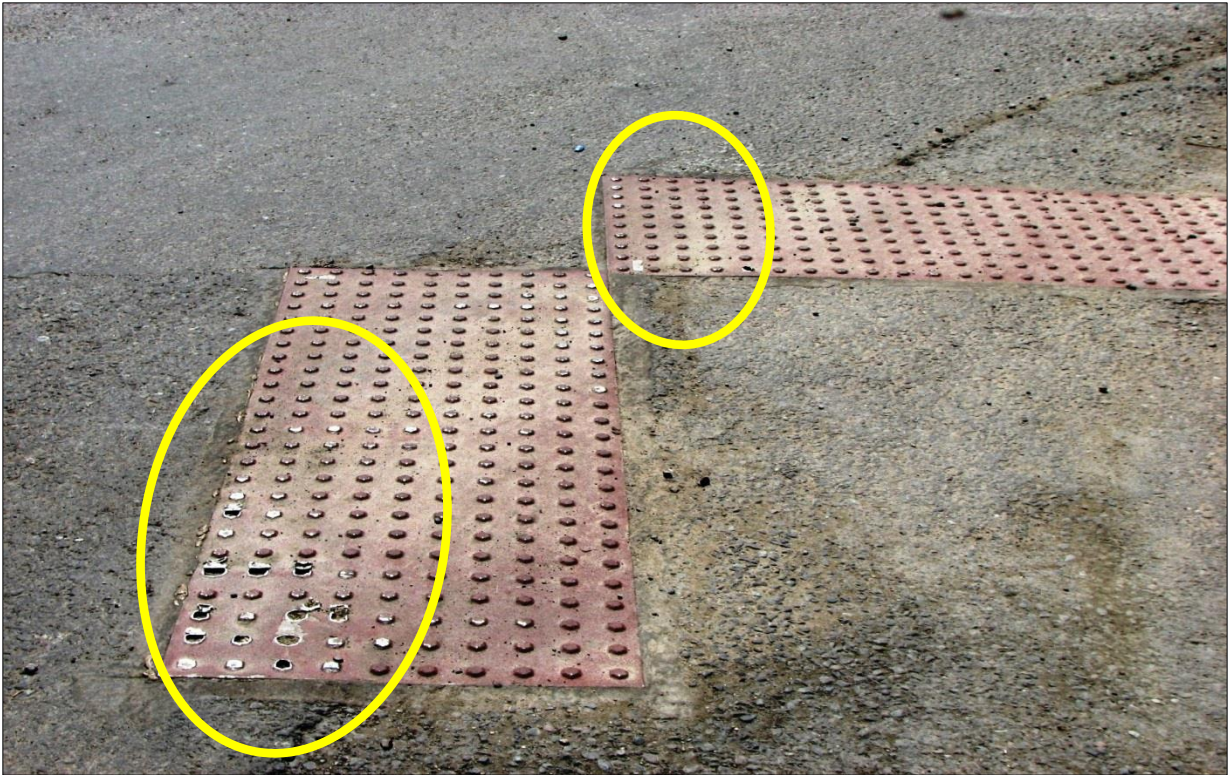
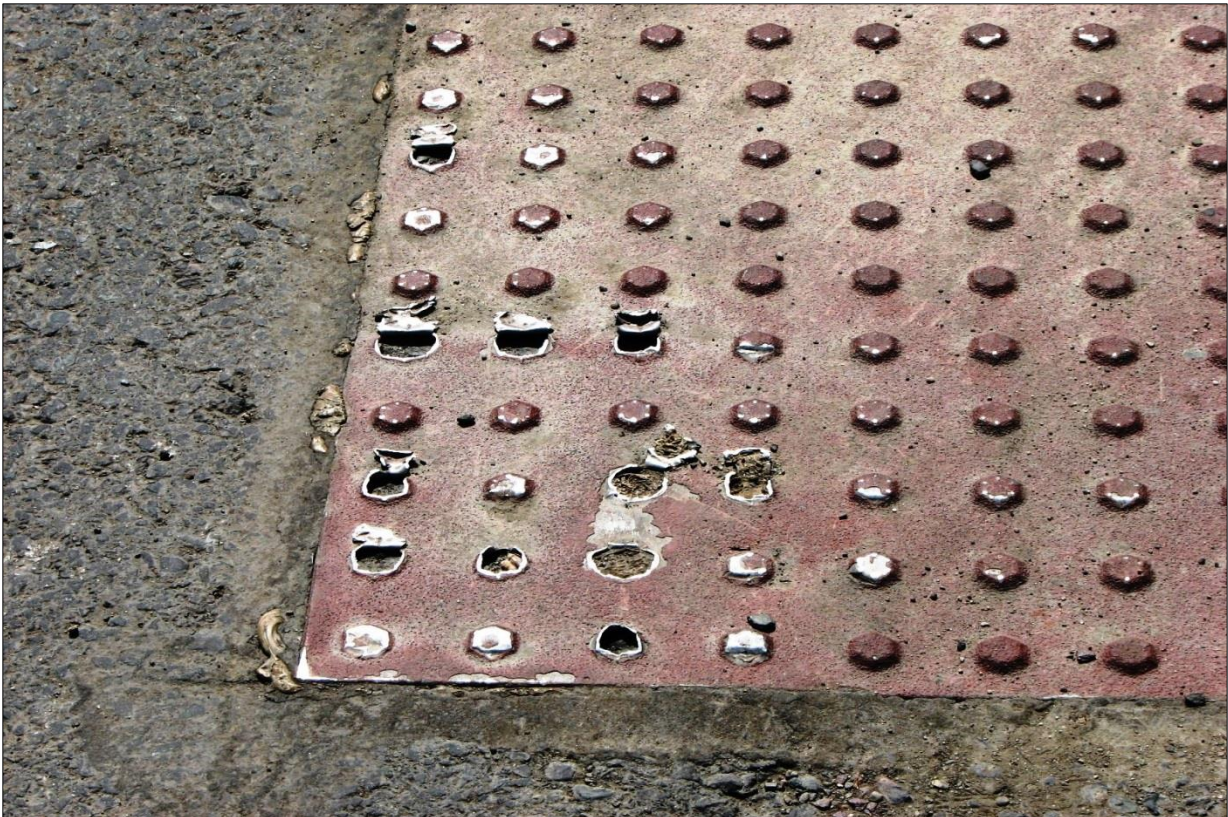
↑↓ **Intersection of South Ave. and Clements Rd – West placement:** Additional damaged panels by plow as defined in the area of the yellow circles. Lower image is a close-up of the damaged domes.

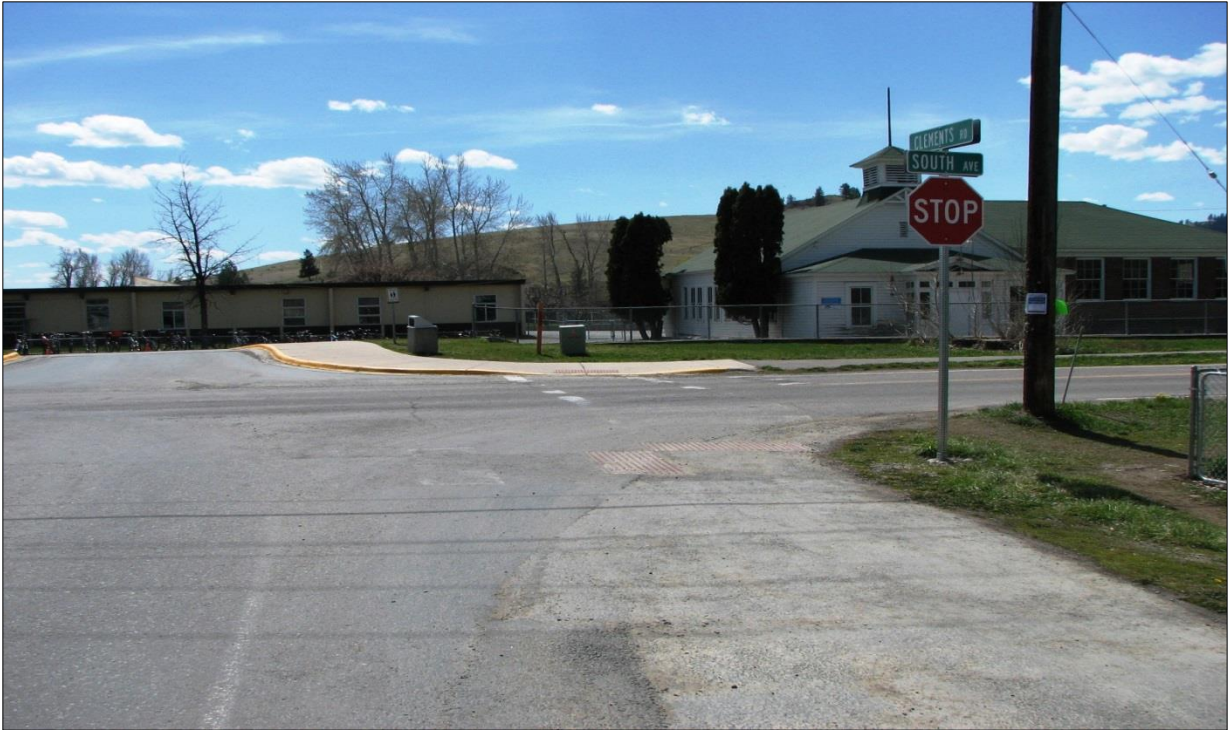
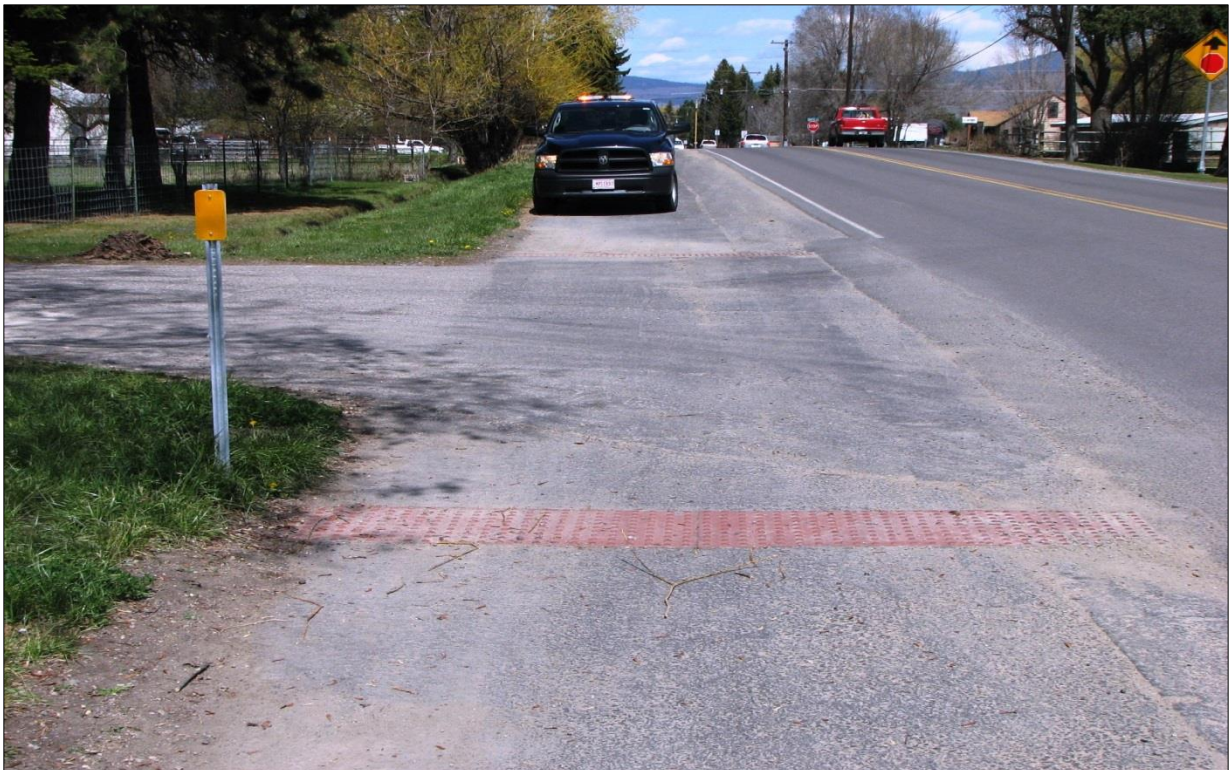
↑↓ All panels which exhibited damage from plowing activities were located on the west side of the project with the pedestrian/bike path essentially an extension of the roadbed as seen from these images. This allowed the plow truck to treat the path as an extended lane. The east side DWD installations is a basic widened sidewalk which to date has no visual damage since it can be assumed it was not cleared by fixed-blade.

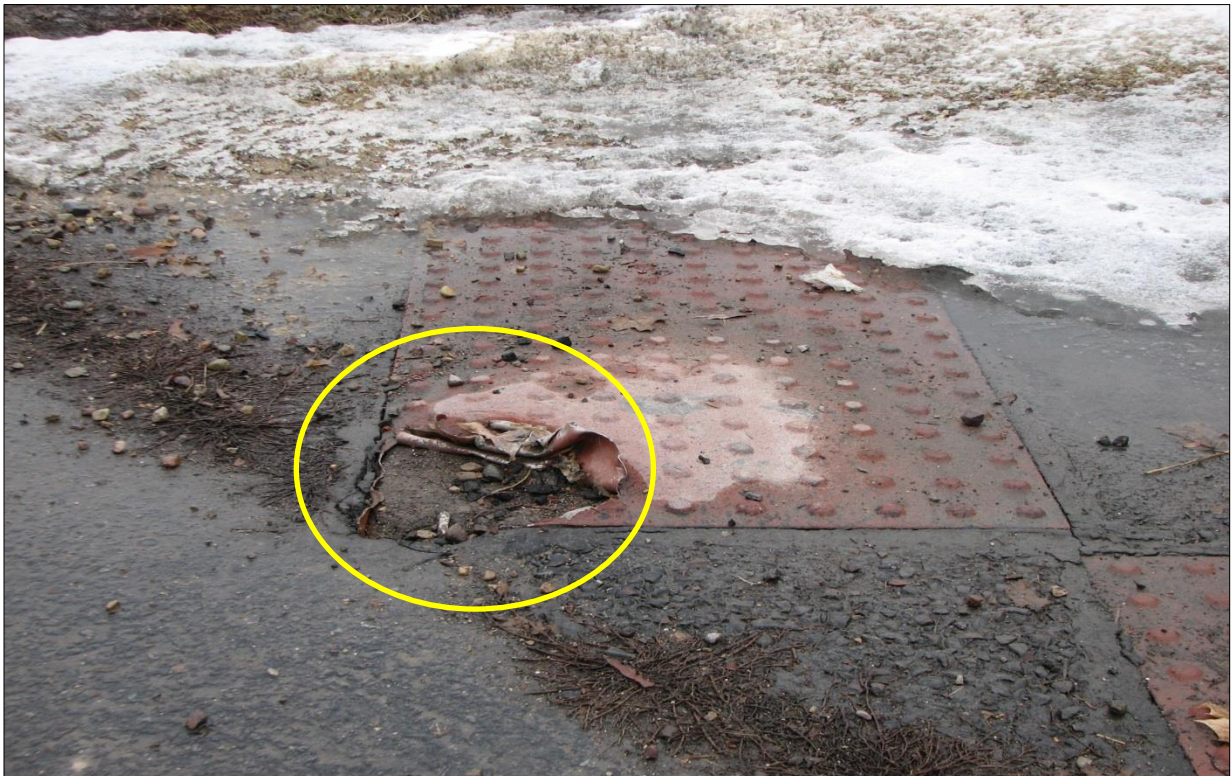
↓ **Intersection of North Ave. and Clements Rd – Southeast placement:** Original stainless steel DWD exhibiting heavy plow damage at the corner (yellow circle).

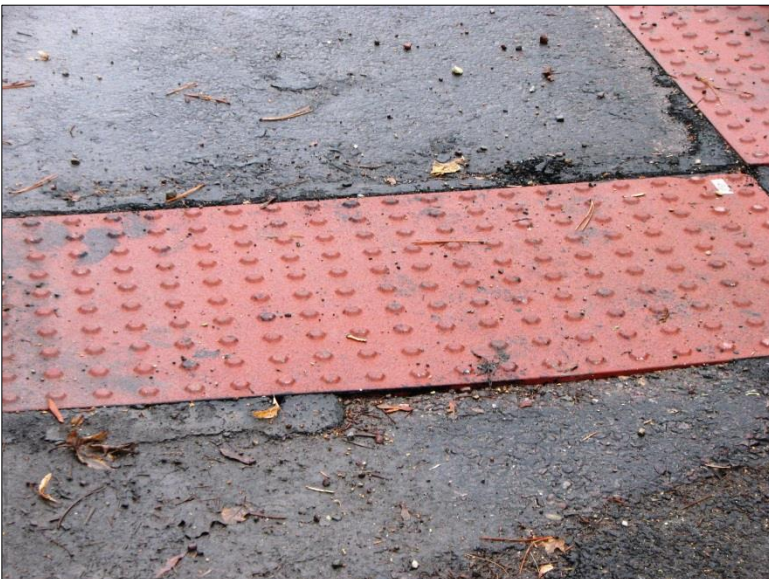
← This stainless steel DWD at the intersection of Spurgin and Clement has signs of slight plow damage and the asphaltic patch used to seal the perimeter has mostly deteriorated exposing the DWD lip.

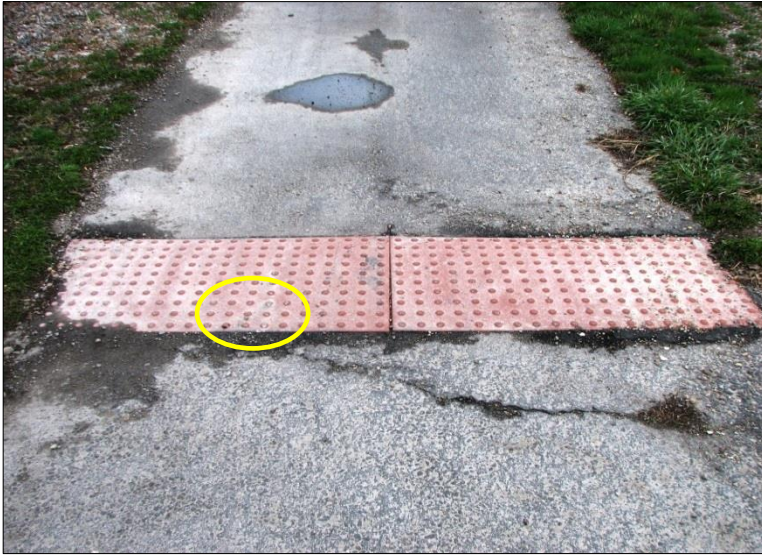
↙↘ General representation of condition of DWD's along Clements Rd.

This unit located at Spurgin Rd. road is in good shape but does have minimum plow damage indicated by the yellow arrow.

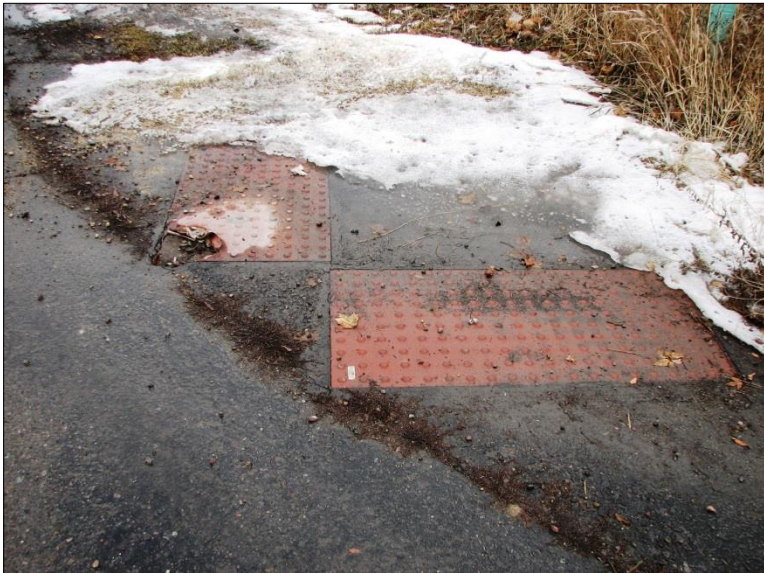
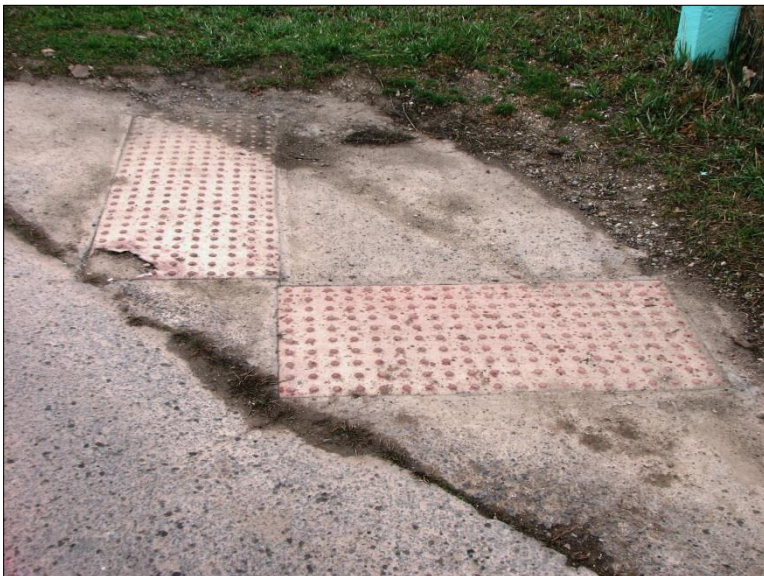
←↓ Intersection of Clements Rd. & North St.

Condition of plow damaged DWD as documented in February 2014.

The below image of the same DWD taken in April 2015.

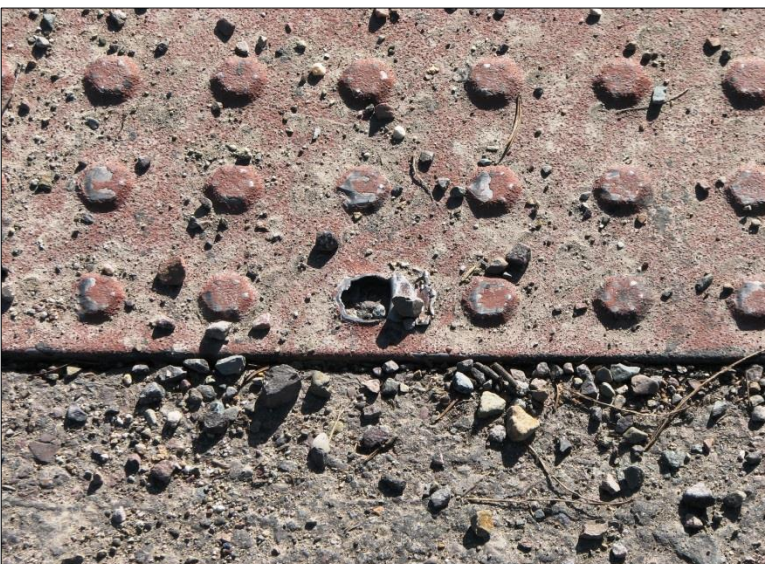
← Example of the type of distress seen on this project with stainless steel DWD apparently caused by snow plow maintenance.

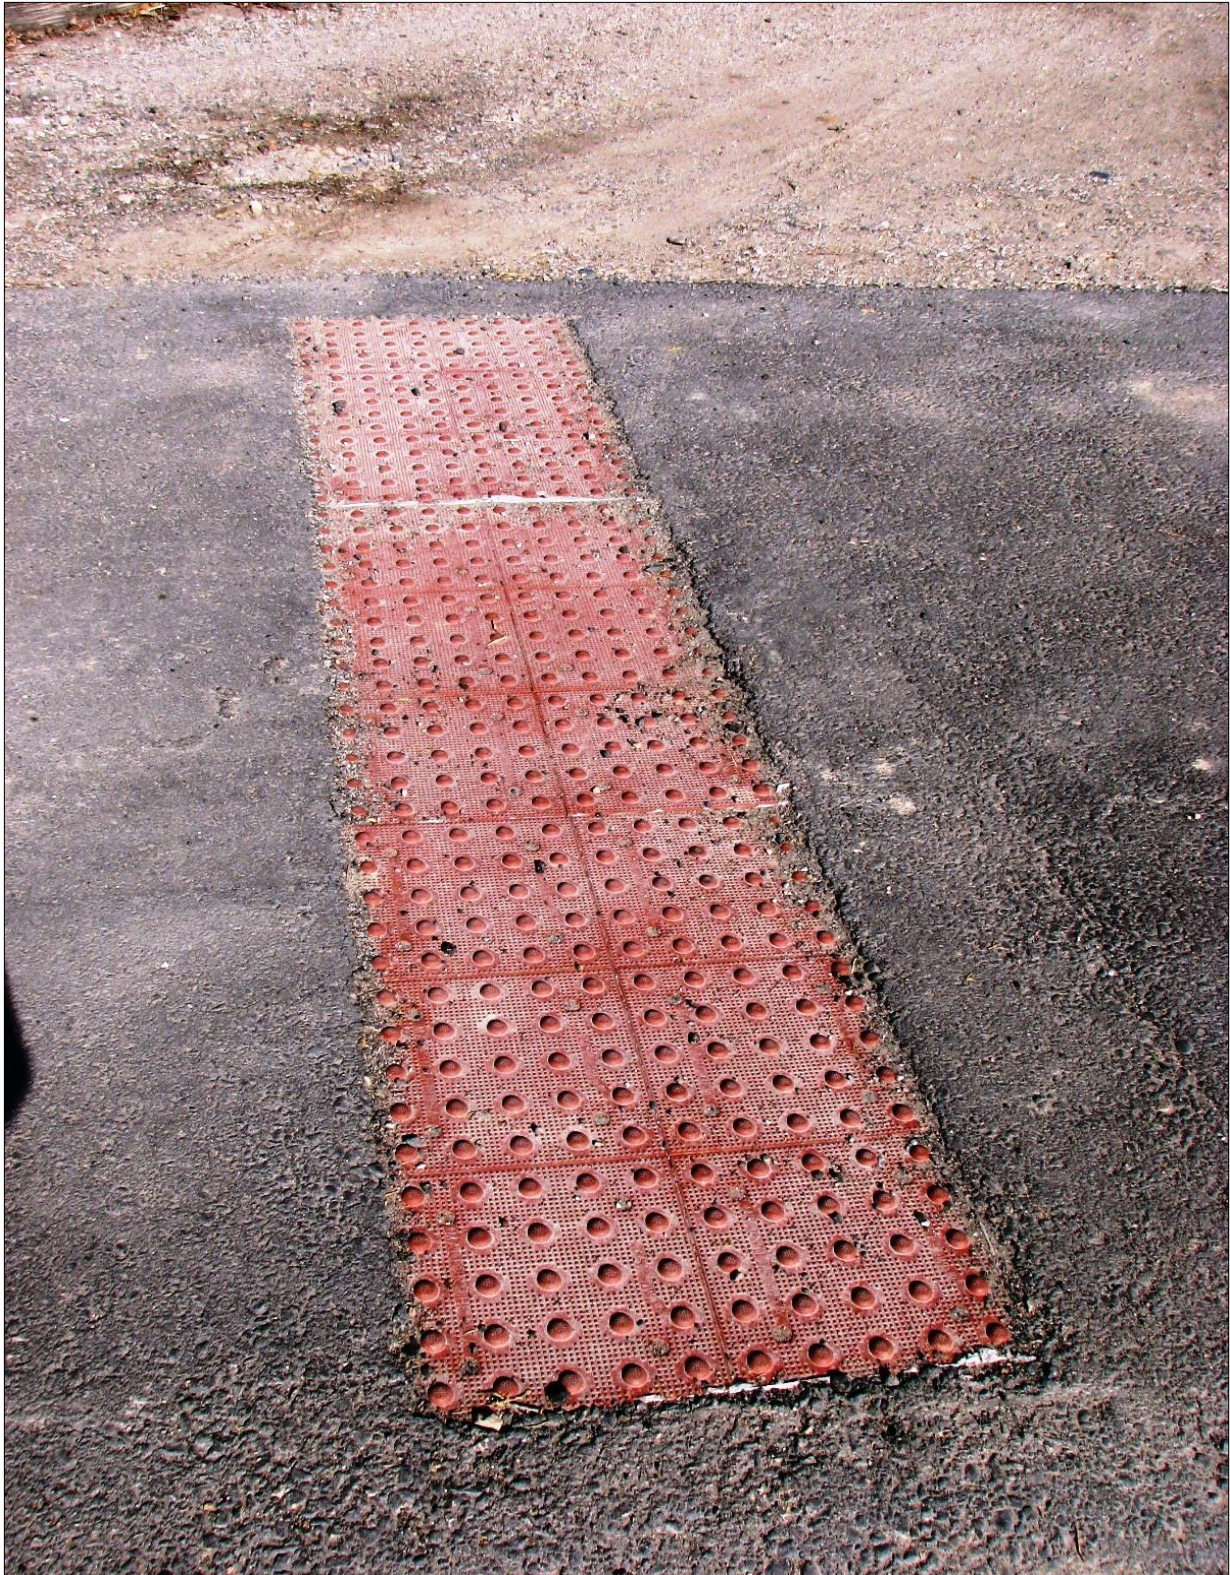
↑ Representative image of the cast-iron DWD placement. All sites exhibited no visual distress. All eleven (11) panels were in tight with no evidence of debonding or faulting with the asphalt cement (AC) base.

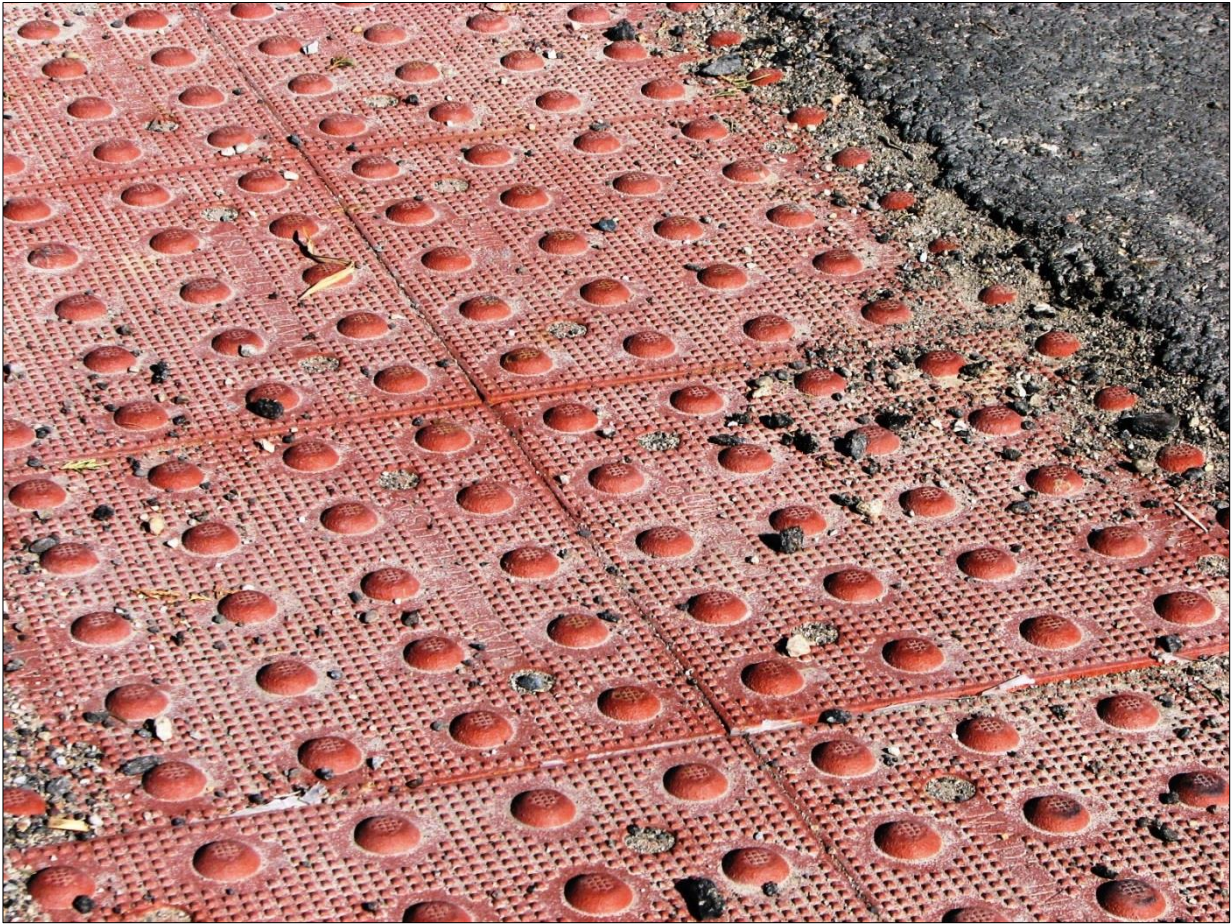
↑ Close-up of panel domes. It is unclear on how the Three Forks installation was maintained if not at all. The powder coating on all sites were undisturbed, if a fixed-blade had been used you may see some abrasion on the exposed domes.

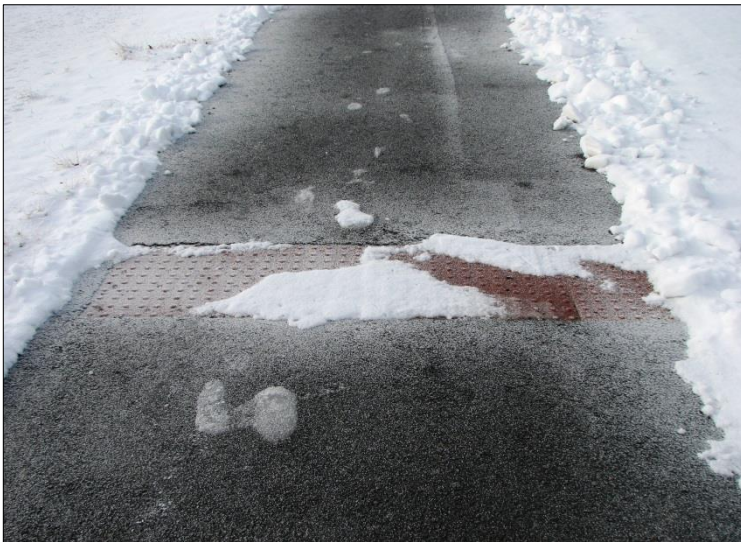
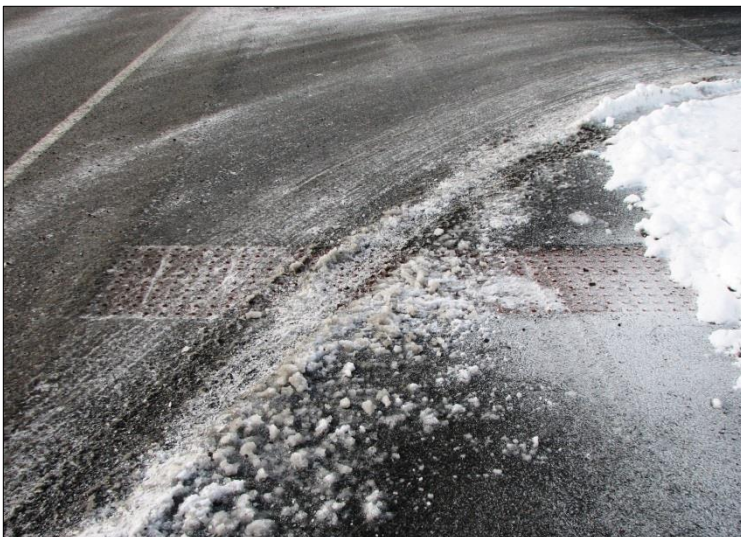
↩️ This is the DWD unit at the northwest corner of the entrance of the Three Forks Market on Jefferson River Rd.

As you can see this unit is actively being driven by vehicles entering the store's parking lot.

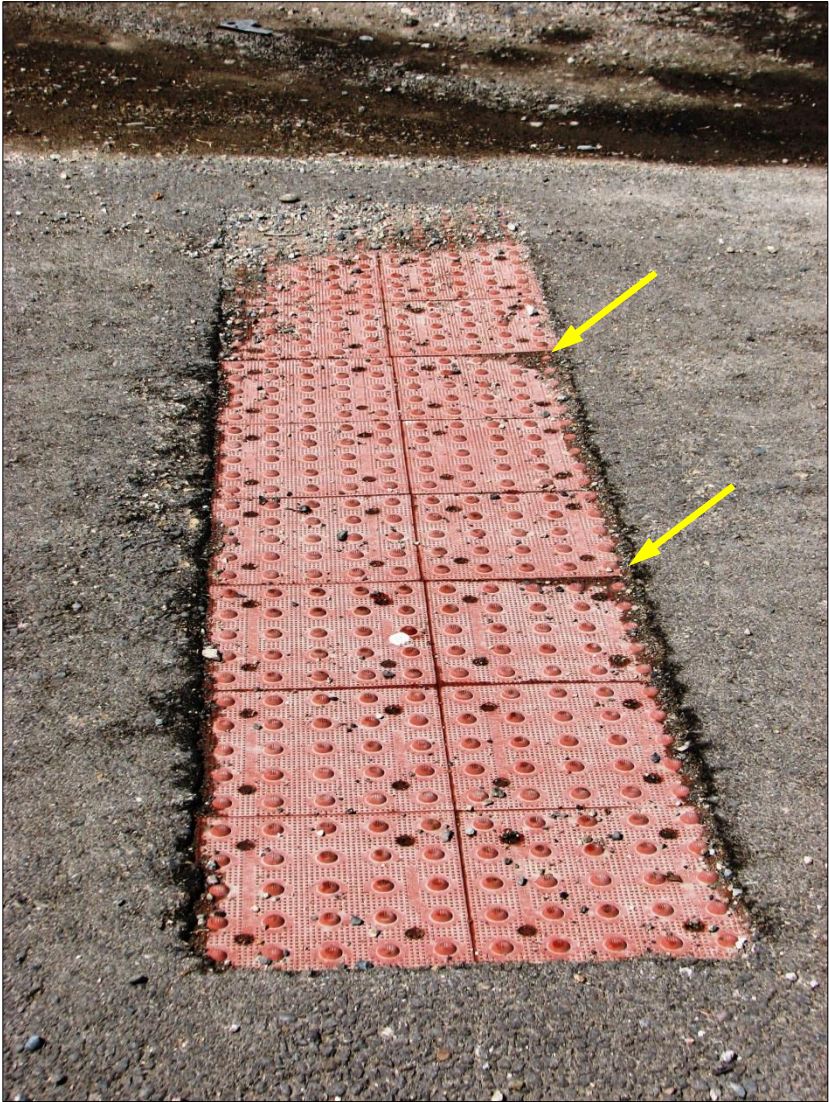
← One DWD unit had a noticeable depression (yellow arrows) at the edge of the connection plates.

Since snow removal is done by truck-mounted plow this apparent faulting may be the cause of the vehicle weight pushing the edge of the DWD down.

The unit plates are connected by male/female tabs (see page 25), which may limit the indent to the extent as seen in this image.
