## EXPERIMENTAL PROJECTS FINAL REPORT

### EVALUATION OF THE METADOME TRUNCATED DOME USED IN EXISTING AND NEW ASPHALT APPLICATIONS

**Project Name:** ADA Asphalt DWD

**Project Number:** STPP-STPE 13-5(8)96

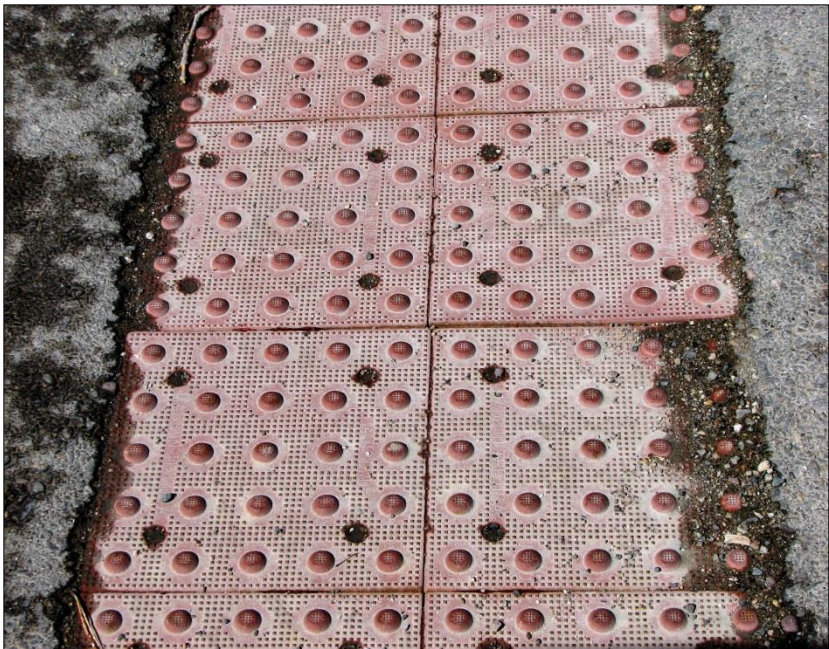
← Close-up in the shift of the cast-iron plates.
