Montana Department of Transportation
Research Program
October 2003

POST-CONSTRUCTION INITIAL EVALUATION REPORT

Detectable Warning Devices (Truncated Domes) for use by the Visually Impaired

Location: Great Falls, 6th St. N. W.
Project No.: STPU 5201(11)
Description: Baseline experimental evaluation of various detectable warning devices for sidewalk curb ramps
Evaluation Date: October 22, 2003
Participants: Craig Abernathy
Experimental Project Coordinator

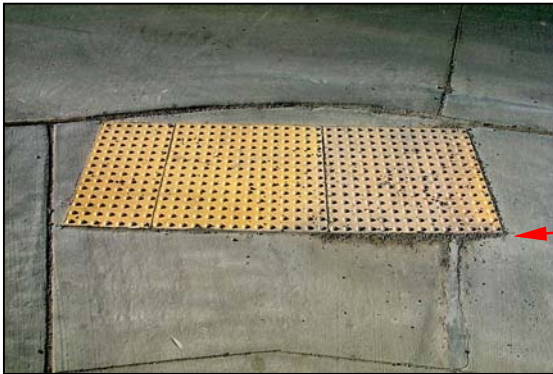
Installation 1A: Located on the northeast corner at the intersection of the east entrance to the Expopark adjacent to 5th Ave. N. W.

◆ Note the surface discoloration (right side of image) and collected debris from drainage across the mat.

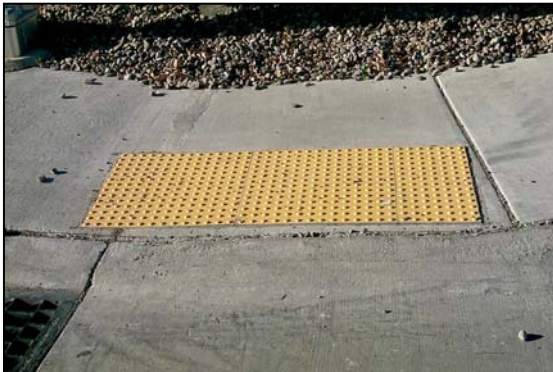
Installation 1C: Located on the southwest corner of the intersection 5th Ave. N. W. & 6th St. N. W. This treatment connects the east-west pedestrian walkway.

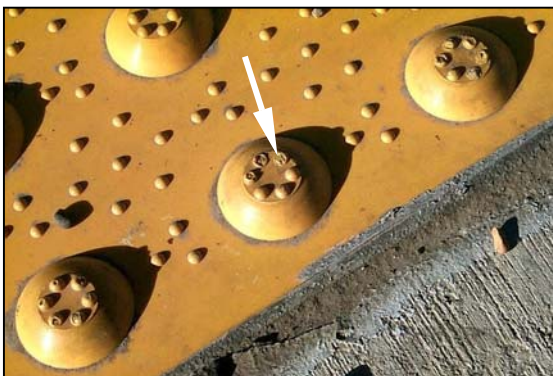
It was noticed that the skid-resistance texture atop the truncated domes were suffering from abrasion or shearing from wear. This was seen mostly around the perimeter domes of the mat.

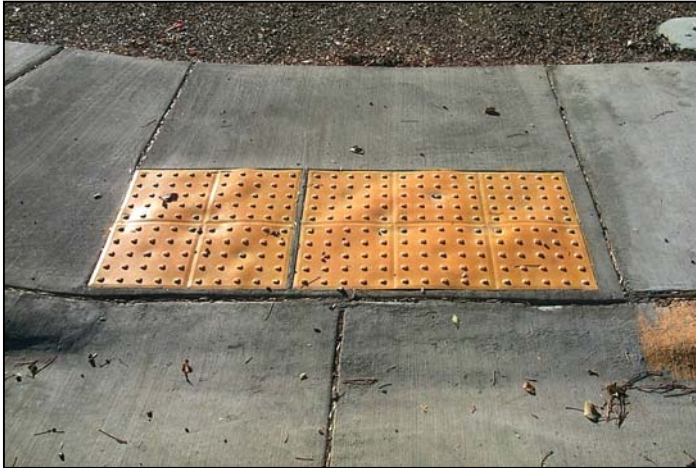
Installation 2: Located on the southwest corner at the intersection of 6th Ave. N. W. and 6th St. N. W.

This treatment appears in good condition since construction. As stated in the October construction report, the wrong adhesive application was used during installation. This caused the undulating surface texture of the mat. At this time it is unsure whether this will be a detriment to performance. It was noticed the plastic setting pins have pushed up slightly and are exposed above the dome. Most likely, they will eventually be broken off through use.

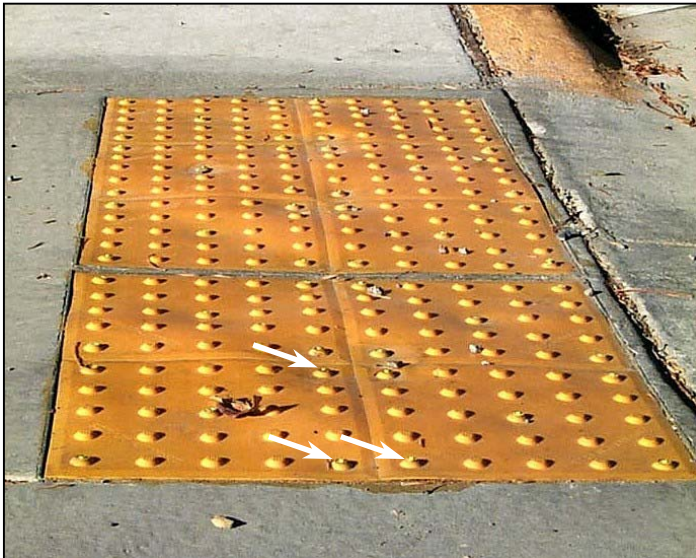
Installation 2: Side view looking east. Note the wavy texture of the mat.

Notice the setting pins pushed above the truncated domes (white arrows).

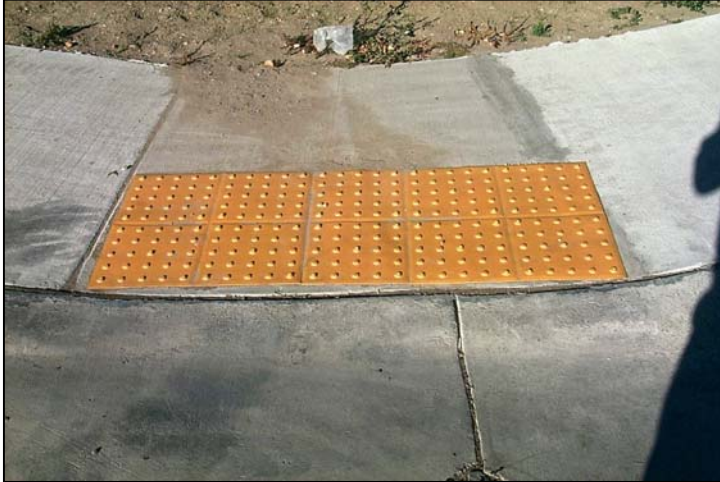
Installation 3A: Located on the northwest corner of the intersection of 5th Ave. N. W. and 6th St. N. W.

This treatment connects the north-south pedestrian walkway.

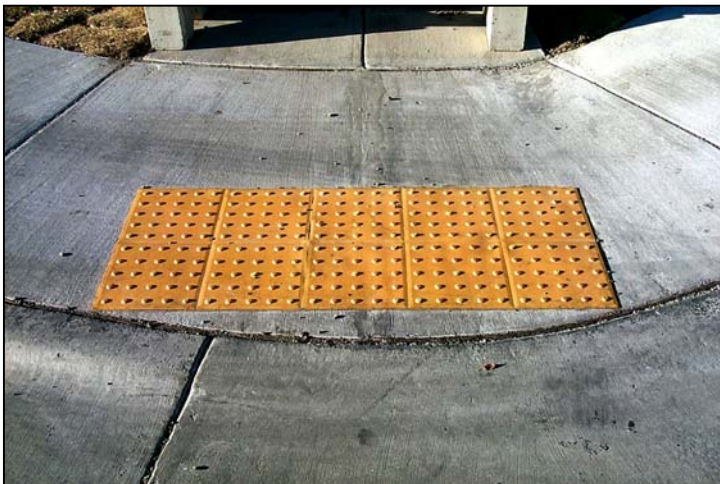
Installation 3B: Located on the southwest corner of the intersection of 1st Ave. N. W. and 6th St. N. W.

All installations were in good condition at the time of this inspection. No noticeable loss of adhesion or mat deterioration was observed. Some of the plastic setting pins have pushed up several millimeters from the dome attachment.

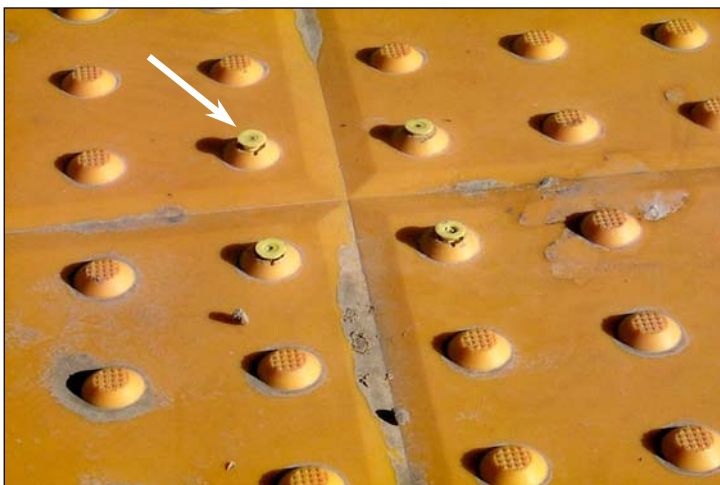
Note the setting pins exiting above the dome attachments. It is premature to determine if this will be a detriment to performance

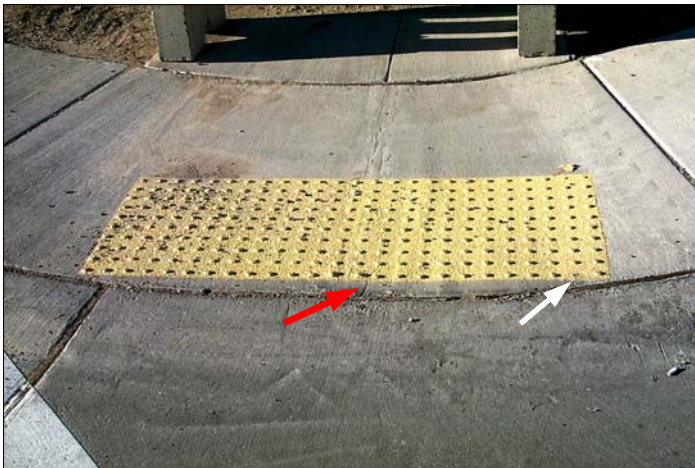
Installation 5B: Located at the southwest intersection of 3rd Ave. N. W. and 6th St. N. W.

This treatment has suffered the loss of one dome in the extreme northeast quadrant of the mat (white arrow) and has a reflective crack appearing through the base from the underlying mortar joint (red arrow)

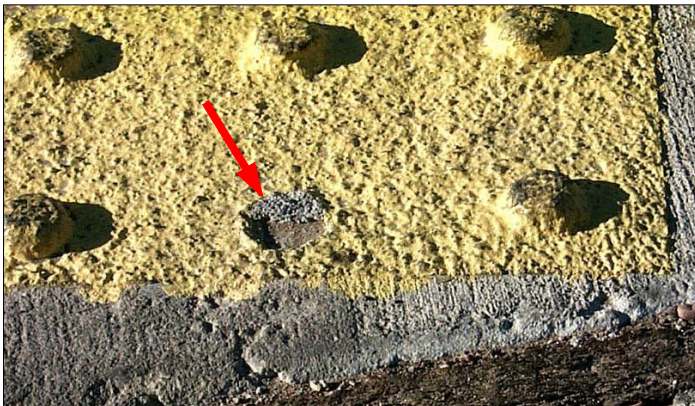
Installation 5B: Close-up of missing dome. It is unclear how this dome was lost; however there was evidence of heavy-lugged tire treads on top and around the mat. You can see the skid tracks on the top surface of the domes.

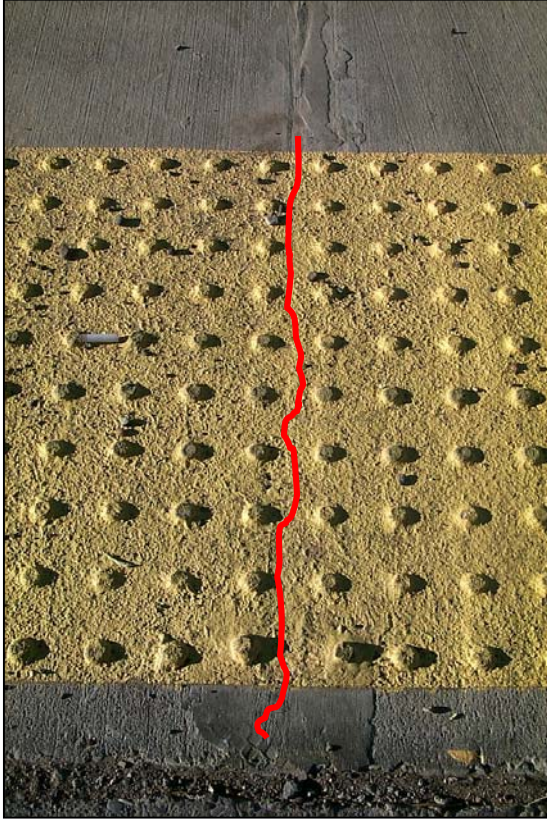
Installation 5B: Minor reflective cracking from the mortar joint. To better view the crack a line has been superimposed over the image where the crack is located on the mat.

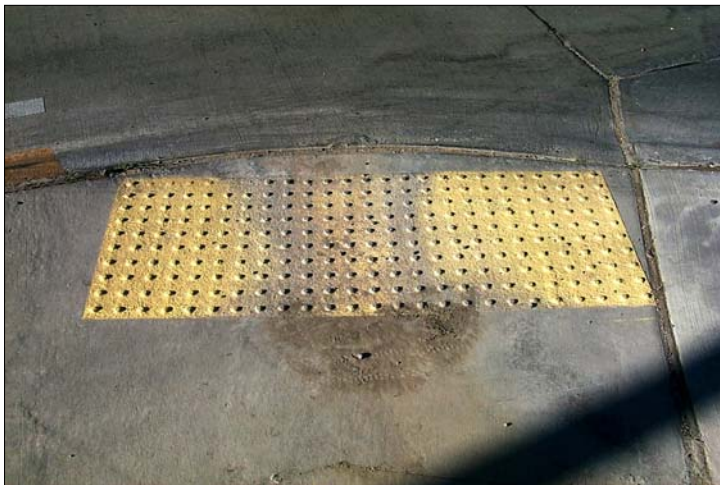
Installation 5C: Located on the southeast corner of the east Expopark entrance and 6th St. N. W.

Note the accumulation of debris from drainage.

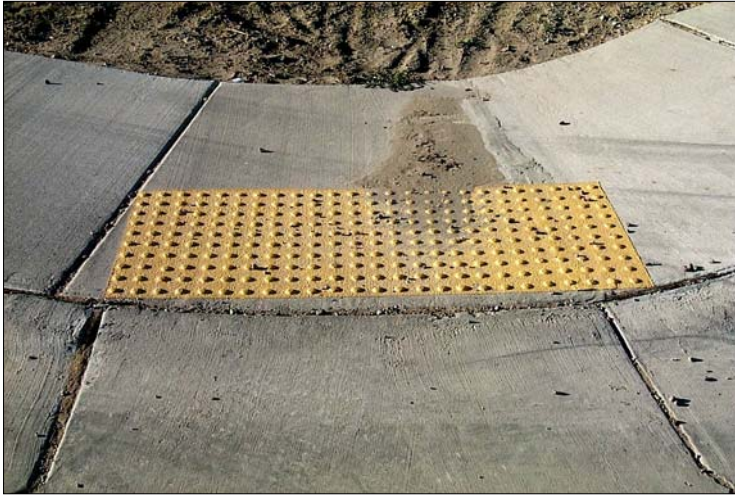
Installation 6A: located on the southwest corner of the intersection 2nd Ave. N. W. and 6th St. N. W.

Note the accumulated debris from drainage.

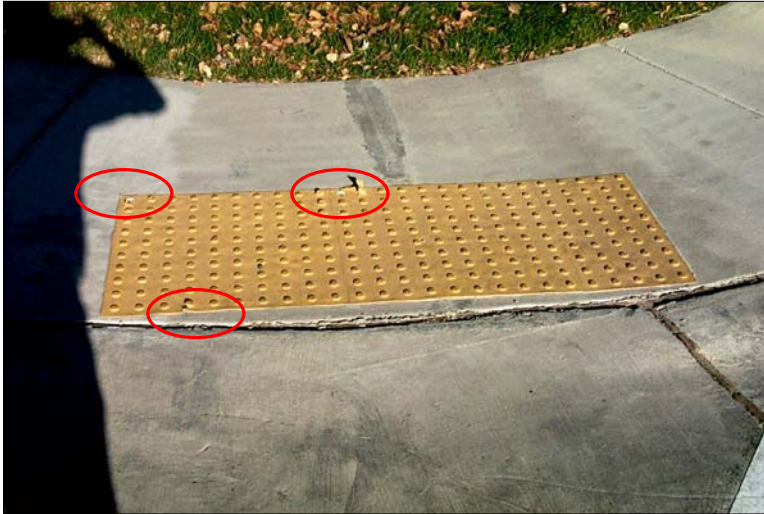
This treatment has suffered torn and loss domes. It is difficult to ascertain the reasons for this damage. It may be from tire damage since there are tread marks around the installation but earlier photos show these tracks were present before installation.

Installation 7: Located on the northwest corner of the intersection of 3rd Ave. N. W. and 6th St. N. W.

Areas of dome damage are circled in red.

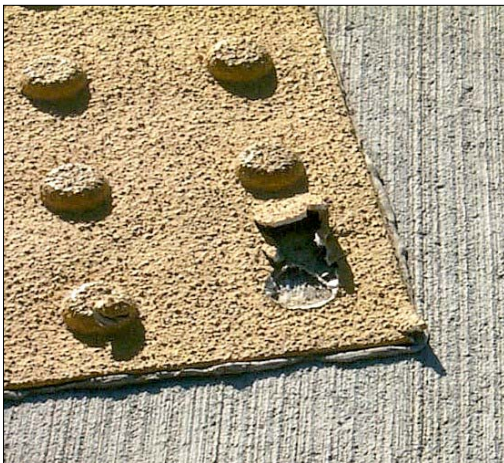
Installation 7: Close-up of damaged mat. Loss of dome and ripped mat. Extreme southwest quadrant of installation.

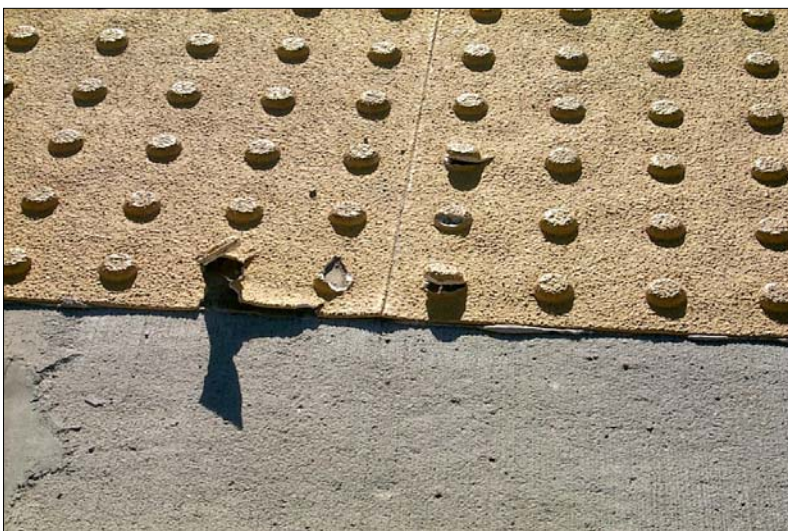
Installation 7: Additional close-up of damaged mat. Loss of dome and ripped mat. Mid-west quadrant of installation.
