Montana Department of Transportation Research Programs May 2011

### EVALUATION OF EDGE LINE RUMBLE STRIPS (INFORMAL)

### FINAL REPORT

Location:	Cascade County, Interstate 15, C000015; Approximate Mile Point 274
Project name:	Great Falls North & South
Project Number:	IM 15-5(101)270 (UPN 4041)
Type of Project:	Edge Lines on Rumble Strips
Principal Investigator:	Craig Abernathy Experimental Program Manager
Date Constructed:	Summer 2007
Evaluation Date:	June 2007-April 2011

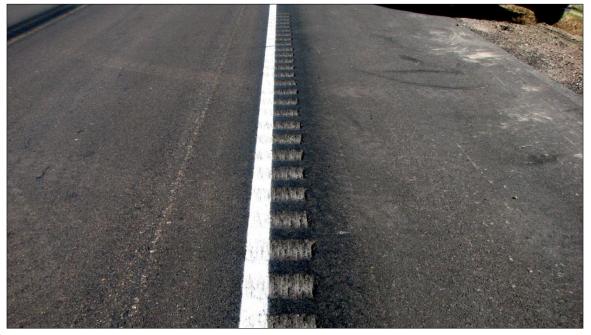
### June 2007

↑ Image of newly placed edge stripe with full coverage over rumble strip on inside travel lane

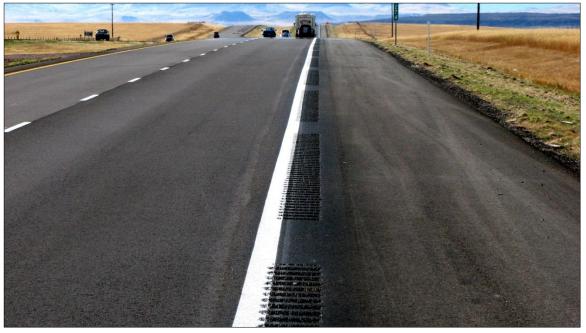
### June 2007

↑ Image of newly placed edge stripe with partial coverage over rumble strip on travel lane

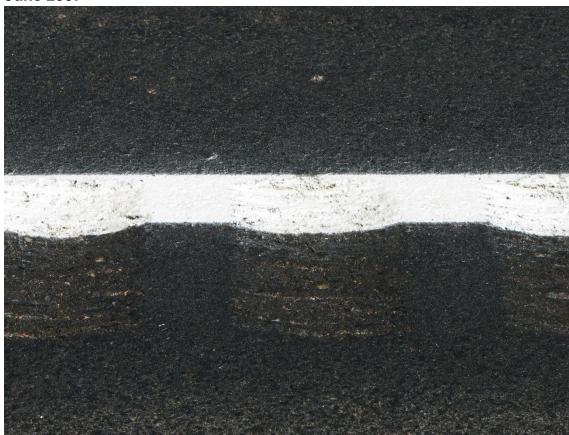
June 2007

↑ Close up of edge line on rumble strip

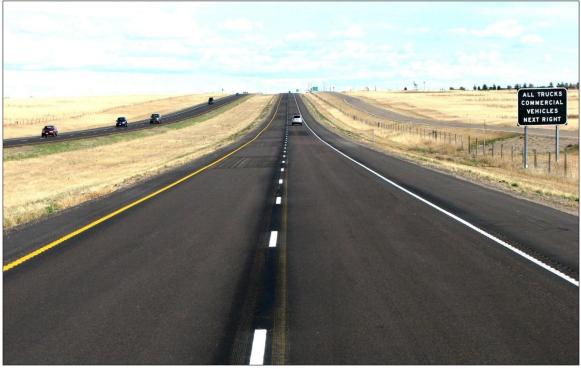
### June 2007

↑ Overview of full coverage edge line rumble strips – view north

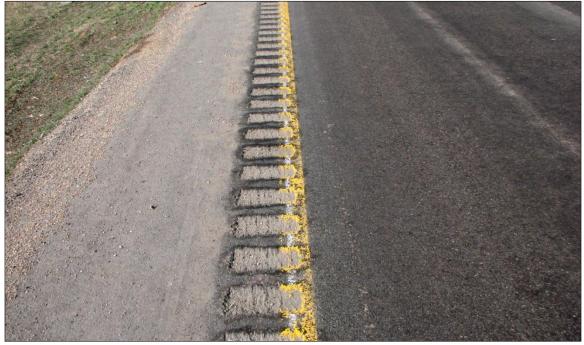
## May 2008

↑ Condition of outside passing lane rumble strip and edge line in spring of 2008

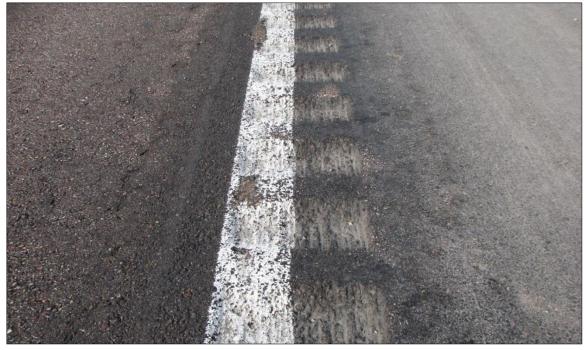
### May 2008

↑ Condition of edge line in the travel lane

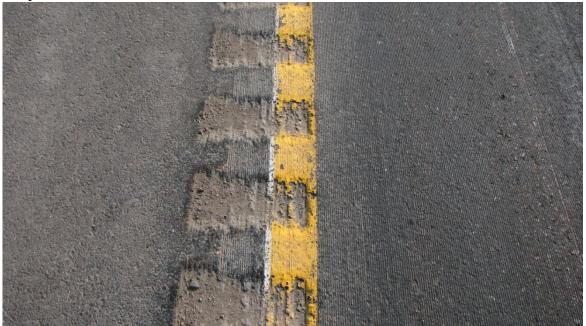
### May 2008

↑ This shows a section where the edge line paint within the rumble strip has popped out of the recess of the strip. It is unclear at this time what mechanism of debonding may have caused this condition.

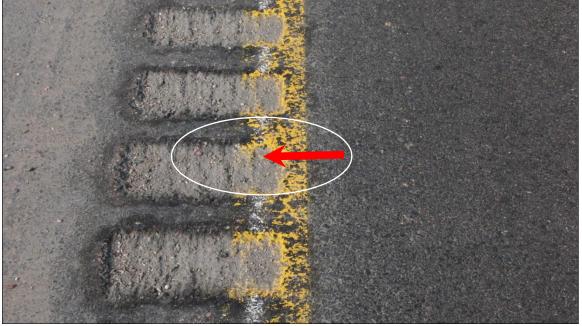
### May 2008

↑ The pavement stripe in the recess of the rumble strip is intact; however sediment has collected within the indent of the strip and may diminish the retroreflectivity of the paint on the peak side of the strip (red arrow)

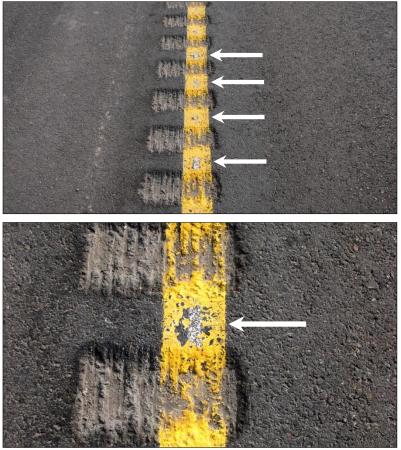
### May 2008

← These two images represent several areas where the paint is in fair condition relative to other locations, but have lost paint between the strips. As seen by the images on the left, the paint loss seems to be at or near the center of the stripe area between the strip lines (arrows). It is difficult to account for a reaction like this. Harmonics of the plow blade passing over the recessed area and then onto the painted pavement section may be a factor, or the frequency of plow passes has yet to degrade the rest of the area.

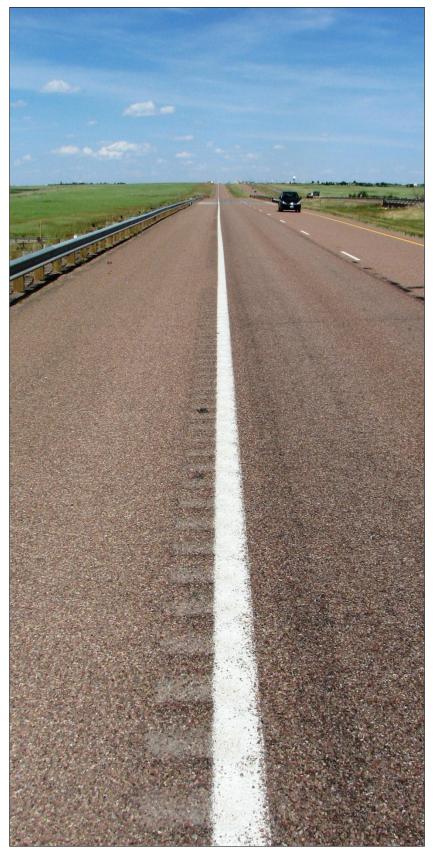
### <u>June 2009</u>

← Image shows the application of a seal and cover (chip seal) and the reapplication of the travel lane pavement stripe.

At the time of site visit, the overall condition of the travel line stripe is in good condition.

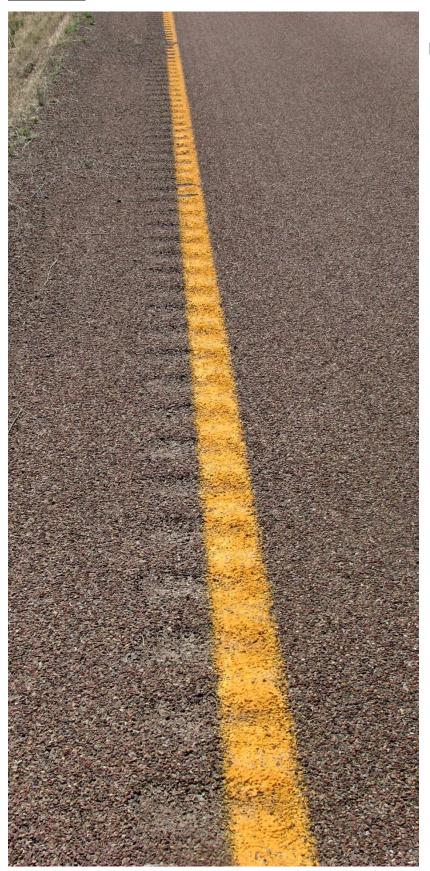
### June 2009

← Overall condition of the passing lane stripe.

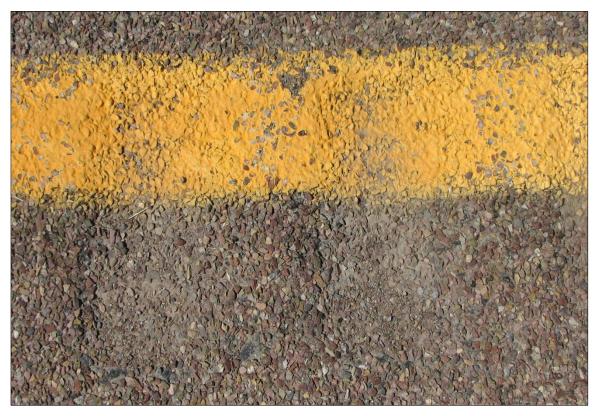
# <u>June 2009</u>

♠ Close-up image of passing lane strip/stripe.

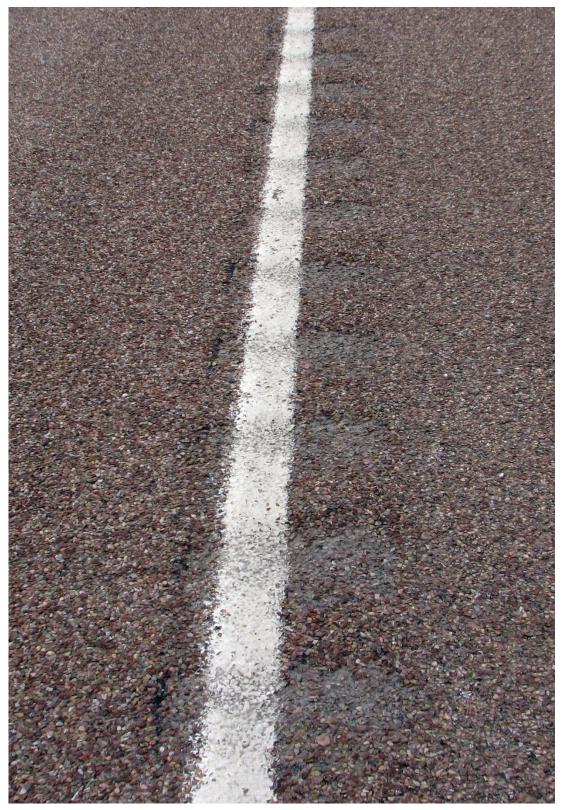
### <u>April 2011</u>

↑ Sample image of edge line over rumble strip travel lane. Note that debris/particulates accumulated in the recess of the rumble strip may reduce retroreflectivity.

One of reasons to place edge line over the strips is the potential for gained retroreflectivity due to the fact the edge line is on angle (or upward peak) within the strip facing toward oncoming traffic. Past research from other states has supported that supposition. However the debris and particulates that have accumulated in the recesses of the strips may diminish that potential added reflectivity. It should be noted that the travel lane strip indent had less accumulated particulates than the passing lane side. Possibly due to the majority of traffic using the travel lane versus the passing lane; with the action of passing traffic may assist in keeping the strip recess cleaner.

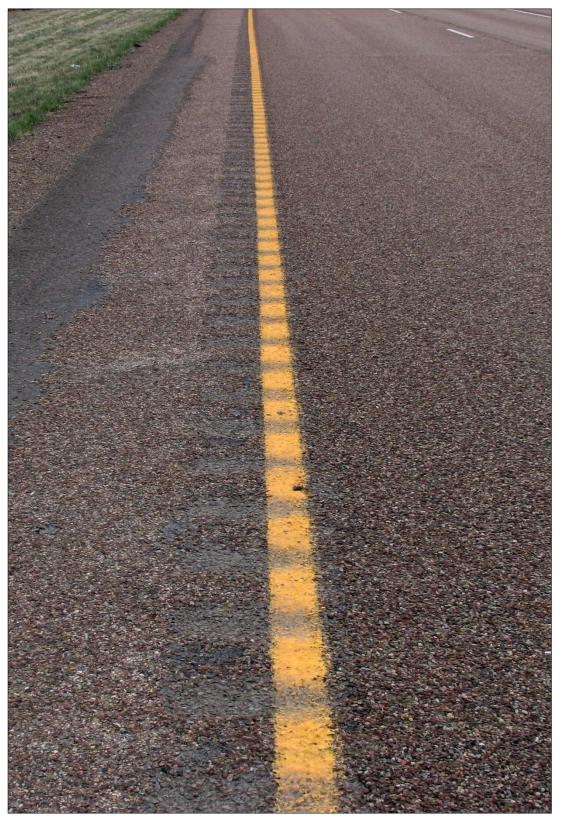
↑ Sample image of edge line over rumble strip passing lane. Note that debris/particulates accumulated in the recess of the rumble strip may reduce retroreflectivity.

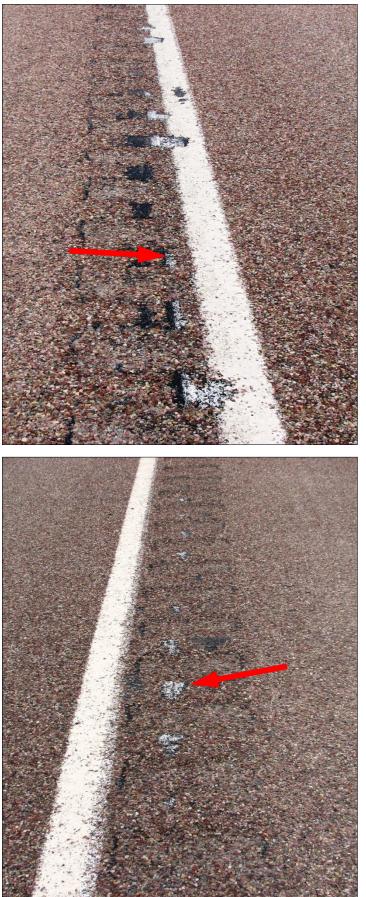
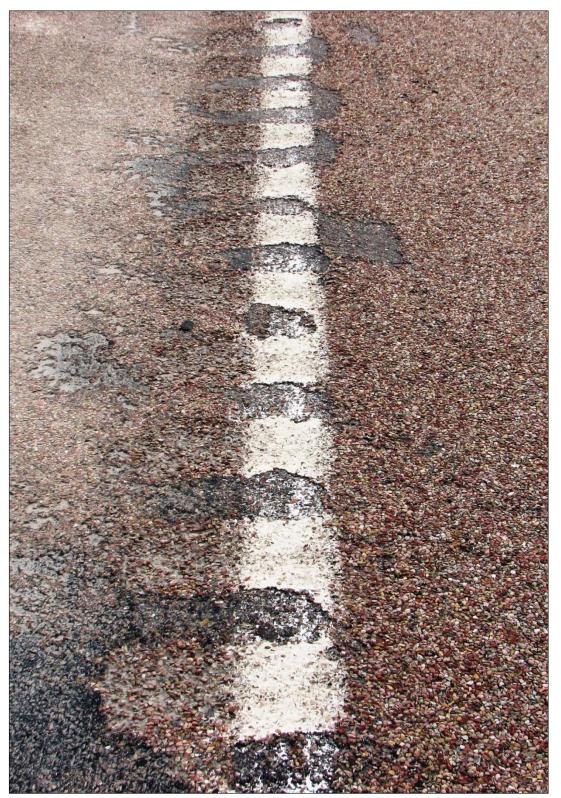
♠ Example image of areas where the pavement stripes have been scrapped off by plowing activity between the rumble indents.
