Montana Department of Transportation  
Research Program  
November 2007

**EXPERIMENTAL EVALUATION FINAL REPORT**

**Emulsified Asphalt Treated Aggregate (EATA)**

Project No.: Sportsman's Campground – East STPP 46-5(2)51; CN 2137

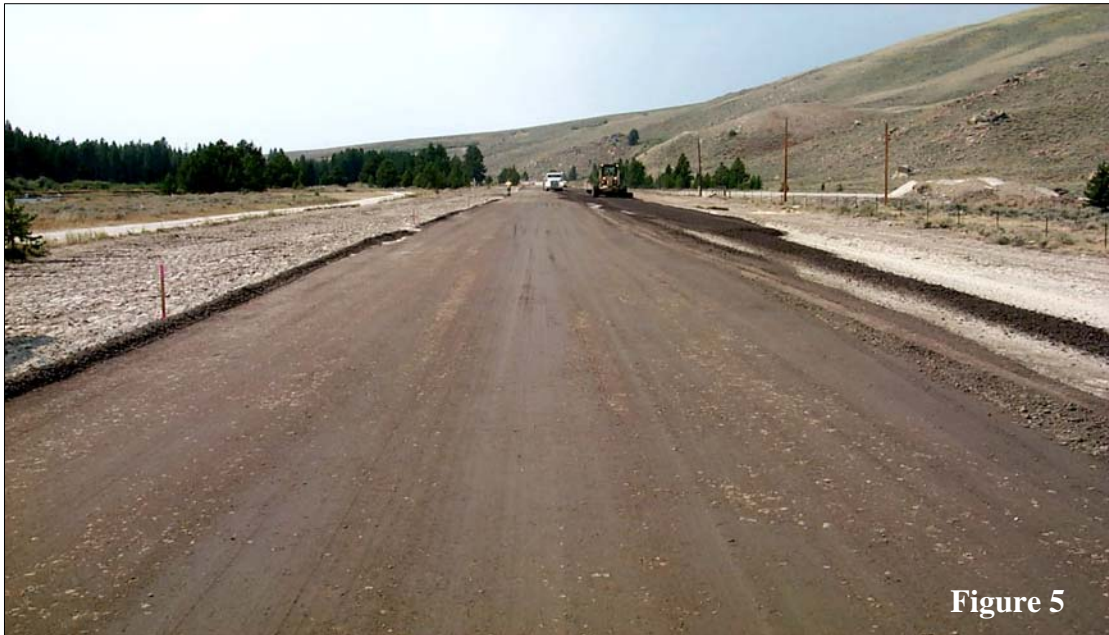
**Figure 5**

Once graded the EATA was compacted using steel drum rollers (figure 4). With the installation of the first test section (1.5% EATA at 100mm depth) did exhibit segregation (or raveling) at the surface predominately between the wheel paths and shoulders (figure 5). Over time as the treatment cured and as the loose aggregate was displaced or compacted by traffic the section began to display a more uniform appearance. All the test sections (with the exception of the gravel control) developed a more uniform appearance after a short cure time. The EATA sections had good workability and compacted easily. Once placement was finished, traffic and construction equipment had no visual effect on the material. The product did not track onto vehicle body or tires. The amount of moisture on the surface did not add to any tracking issues.

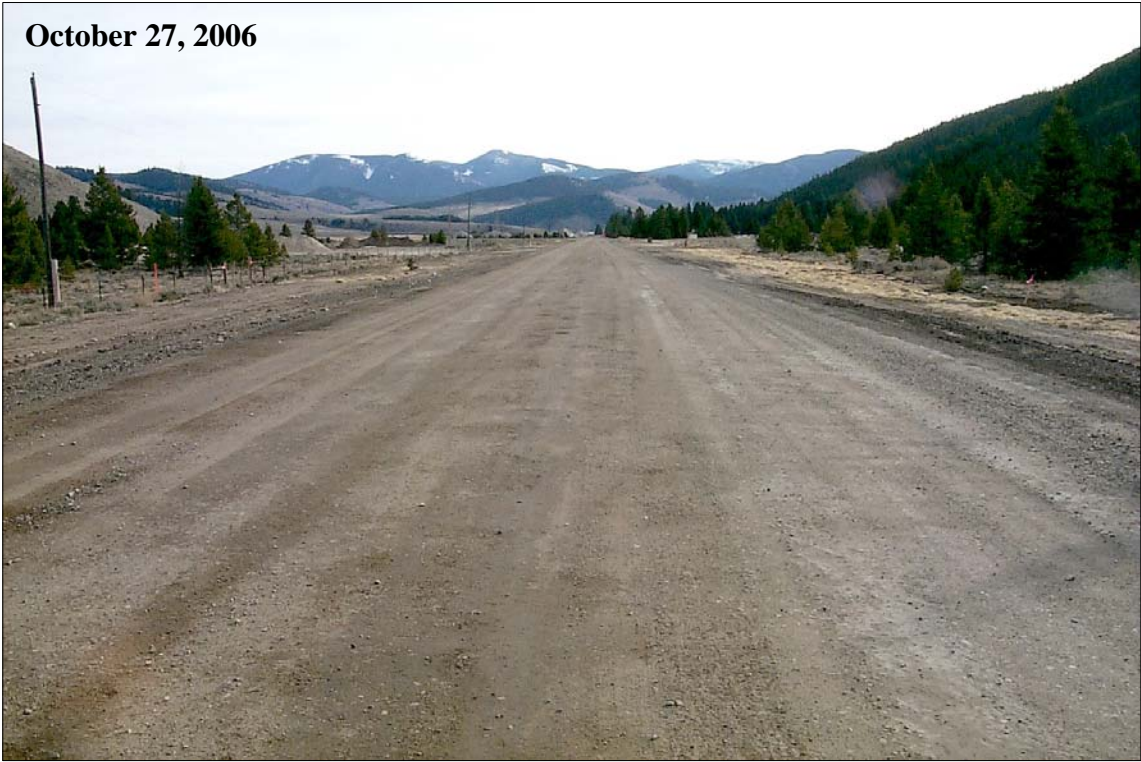
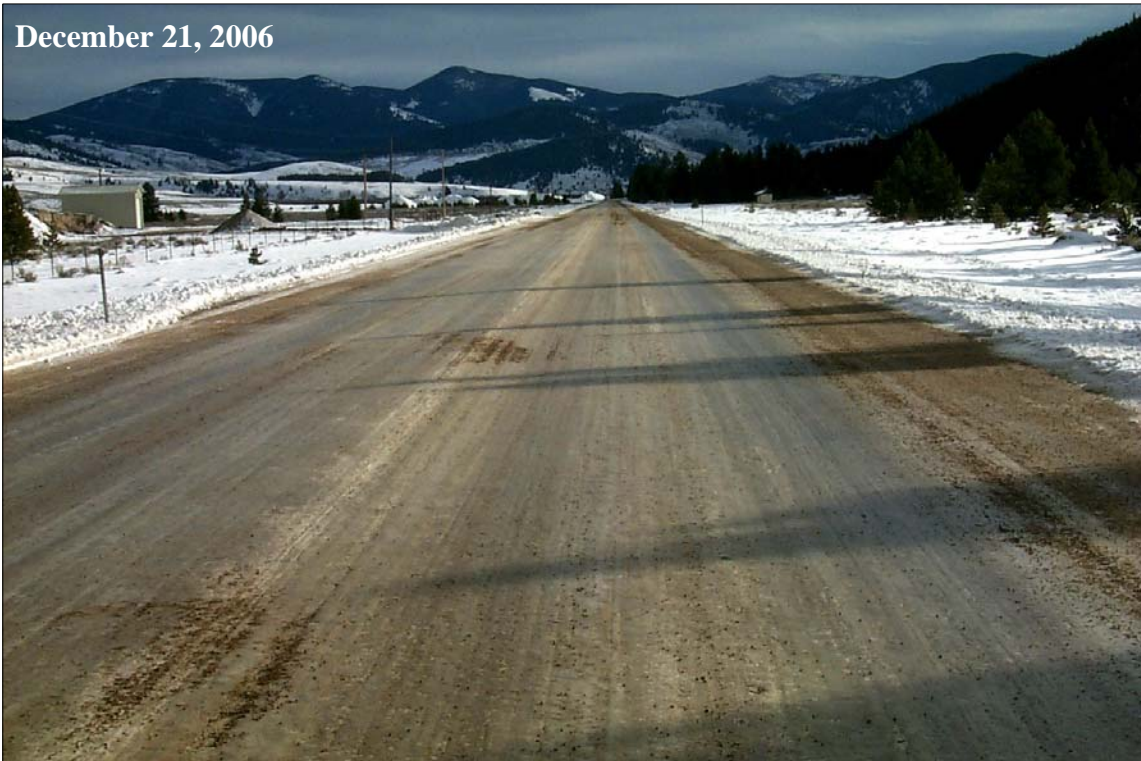
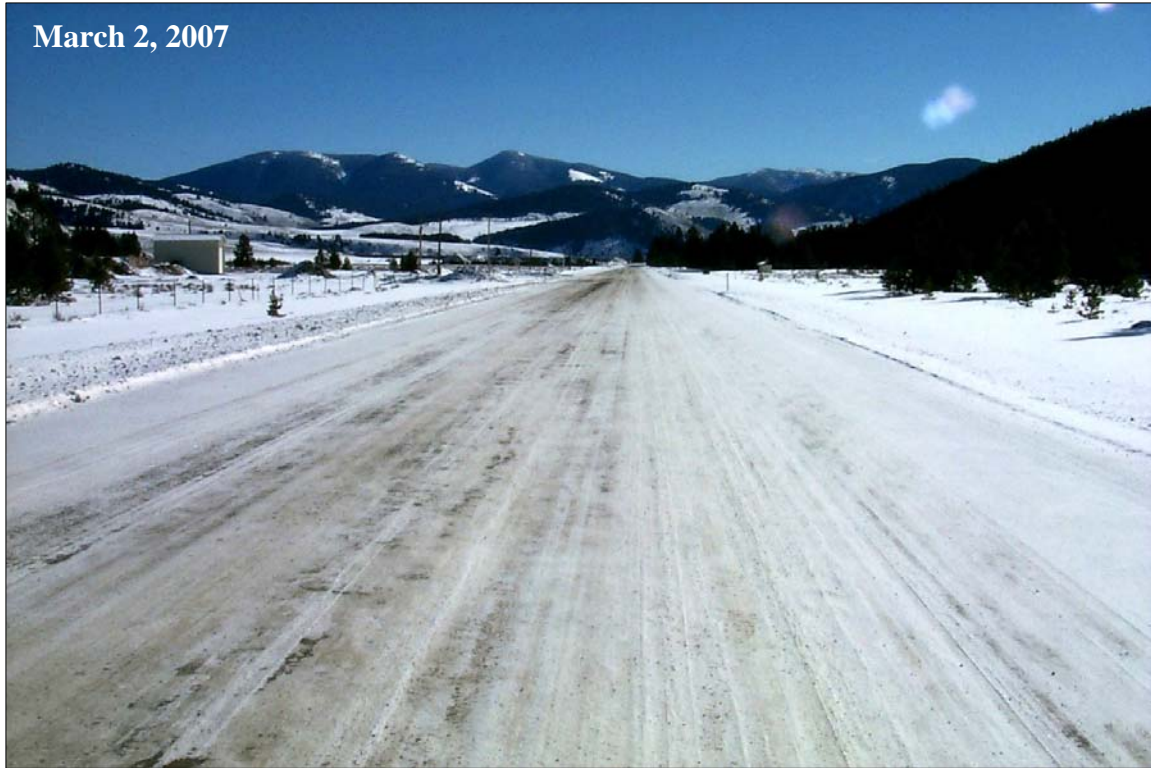
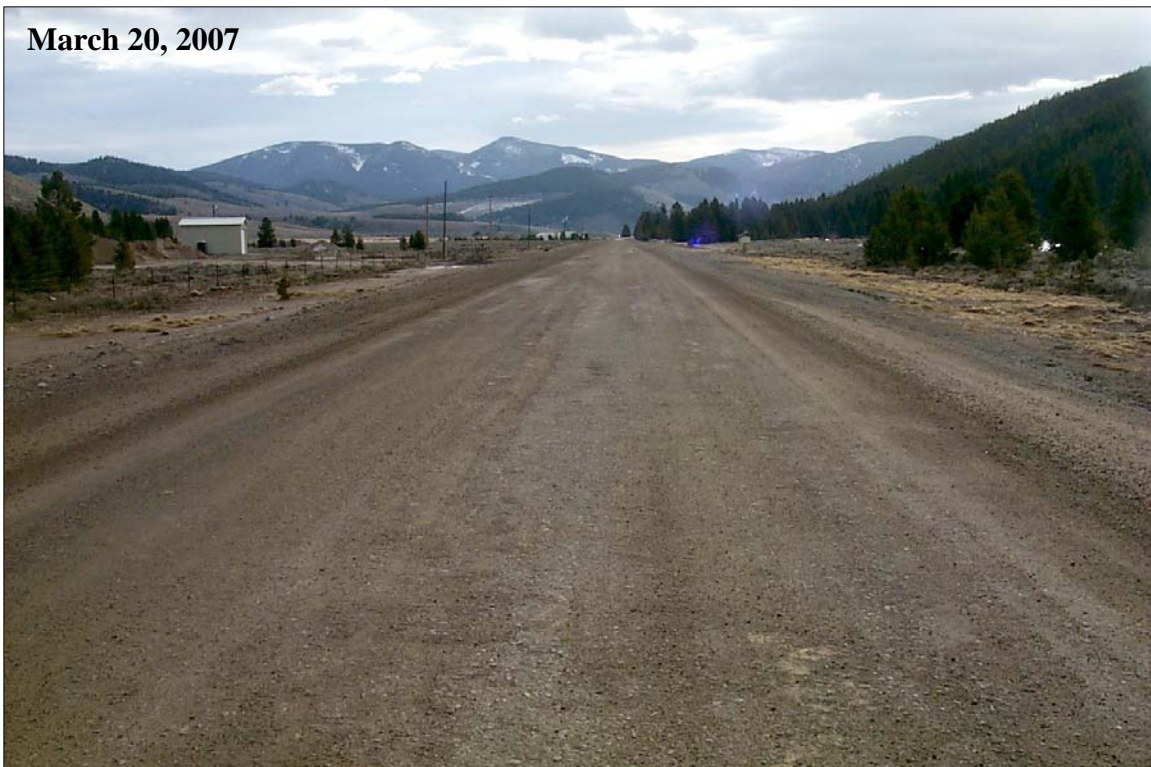
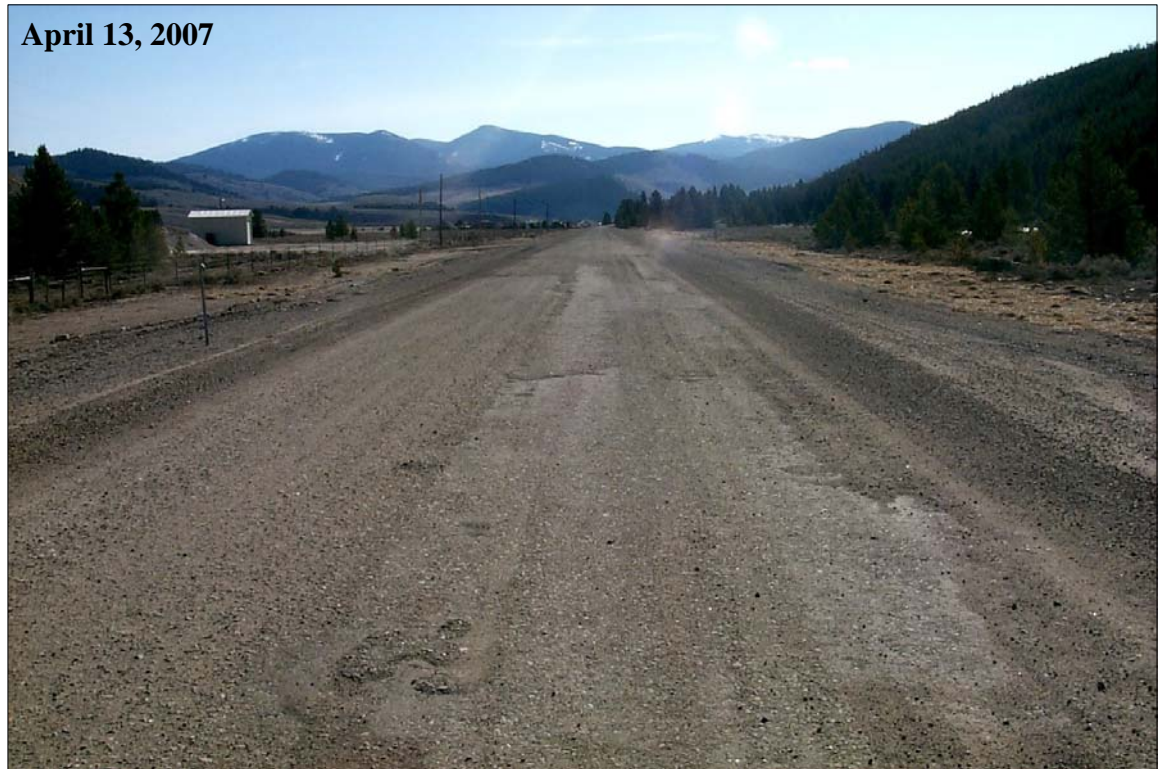
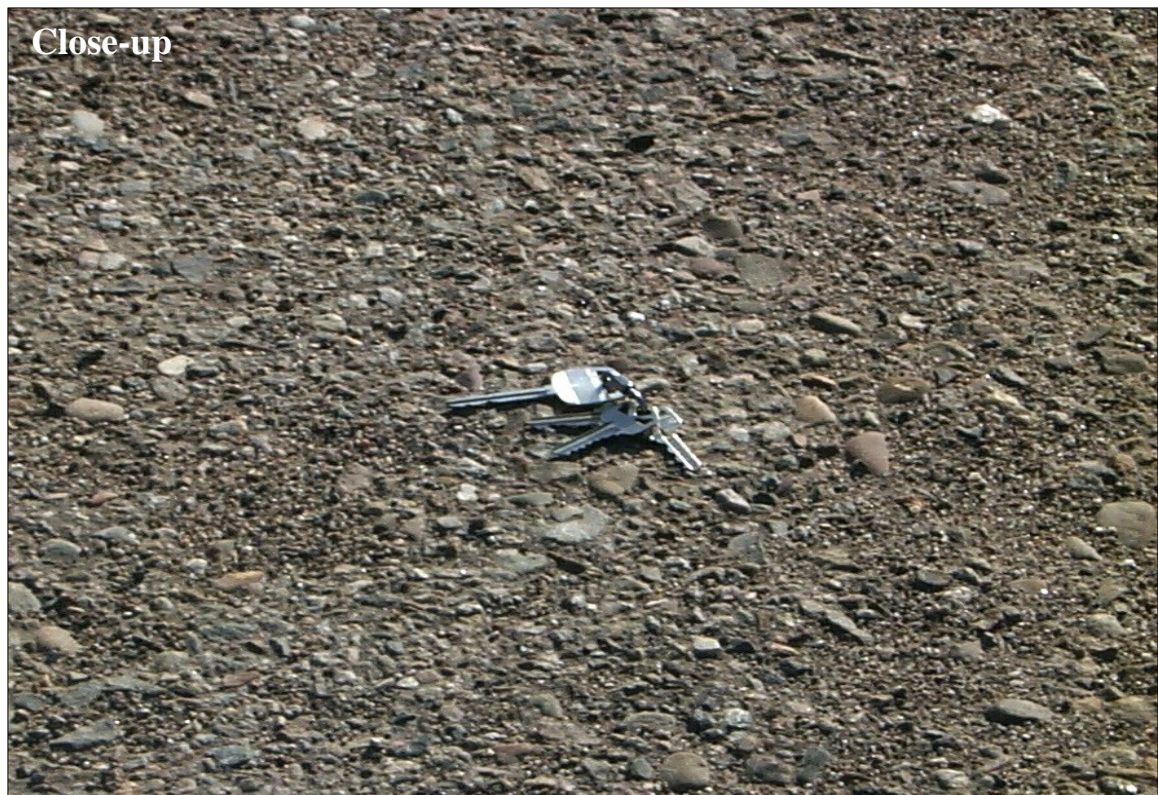
**Section 1: 1.5% EATA, 100mm**

The 1.5%, 100mm (section 1) displayed the most in raveling and traffic dust during the mild months. Pertaining to section 1, the crushed aggregate course (CAC) used in this project contained a high level of fines which would be difficult for a homogeneous coating of emulsion during the pug milling process. The lower the percentage of emulsion may attribute to more segregation and raveling with the higher percentage level of emulsion (or the higher amount of residual asphalt content after cure) functioning better. The 2.5% treatment (section 4) did achieve performance over the other test sites but it should be noted that the 2.0% sections performed almost as well as the 2.5% site. There was no discernable difference in function over the 100mm and 200mm depths. The gravel control section performed as expected, described as having the poorest ride quality based on severity of potholes, raveling, washboard and dust. The control section required routine surface maintenance due to conditions previously noted.

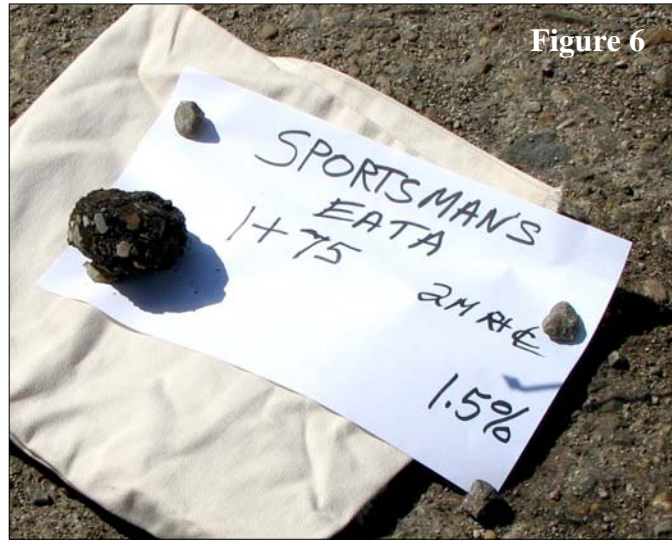
Figure 6

On May 18, 2007, the Butte District took core samples of the EATA test sites to see how the CSS-1H emulsion had incorporated into the aggregate. Cores were drilled approximately 100mm in depth. As predicted, due to the low emulsion content, most core samples fell apart during drilling. Section 1 (1.5% EATA at 100mm) did produce a nominal core which showed good cohesion of the aggregate (figure 6).

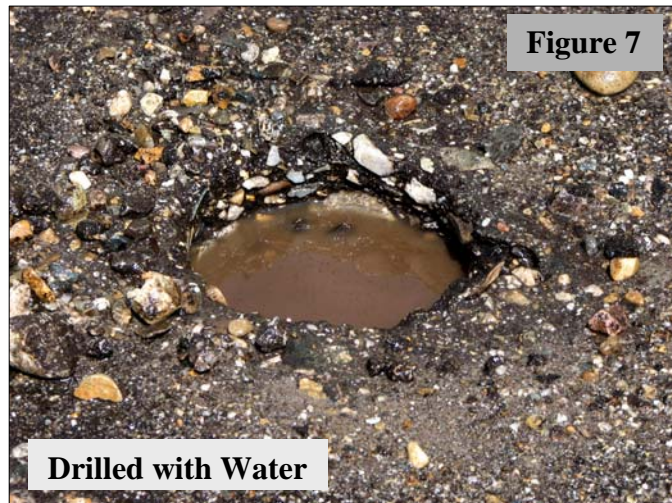
Figure 7 shows partially the interior of the core wall after the core was removed. Figure 8 shows another image of the condition of the core side walls. Notice the evidence of asphalt released during the coring. The side walls of these cores were relatively smooth and hard.
