EXPERIMENTAL PROJECTS CONSTRUCTION AND EVALUATION REPORT

Evaluation of Durable Traffic Pavement Marking Tape (PMT)

Project Name: Lyndale Intersections

Experimental Project: MT-14-02

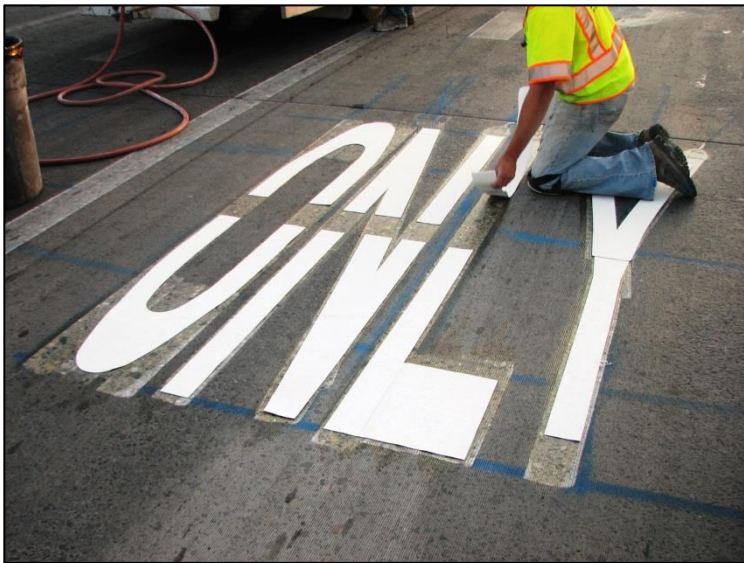
← The ONLY legends did not meet the Manual on Uniform Traffic Control Devices (MUTCD) requirements and had to be modified in the field.

Here you can see the gap in the letters needed to make the legend in compliance.

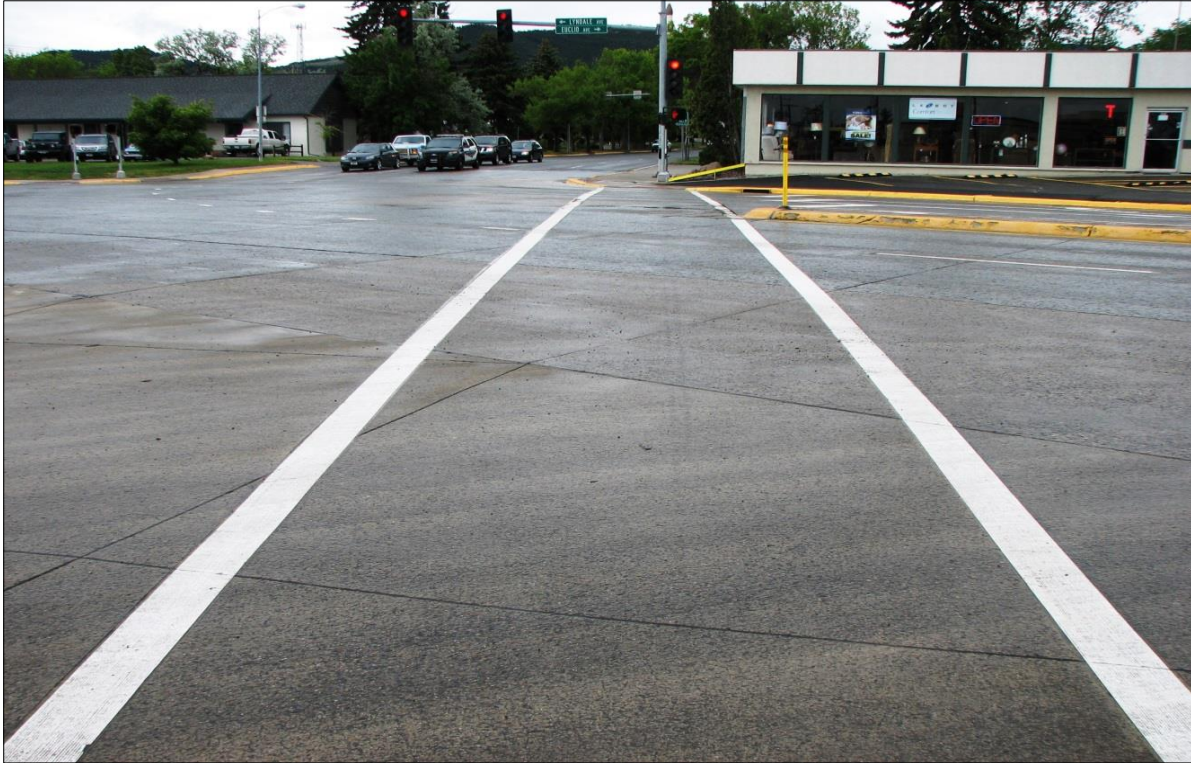
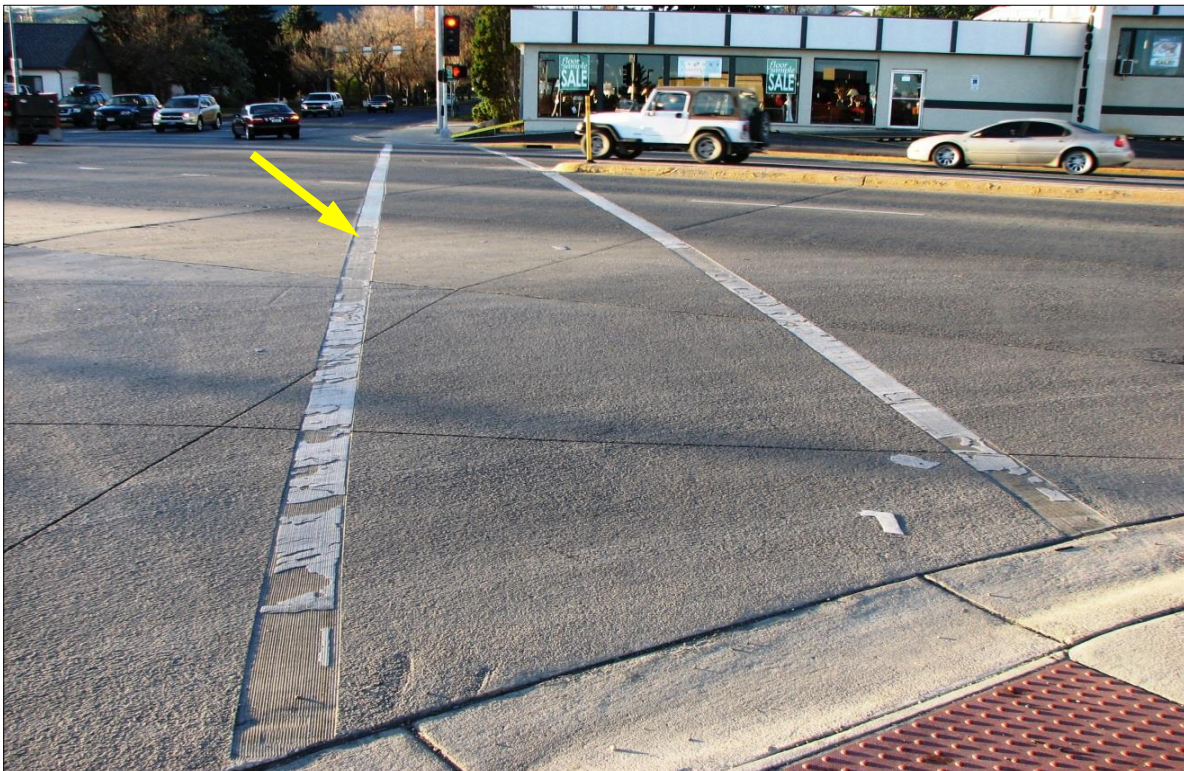
↑ Image of Euclid Ave: westbound, west side pedestrian lines shortly after installation.

↓ Same location approximately 4 months after installation. Initial tearing and delamination began in the travel lane (yellow arrow) and progressed to the curb.

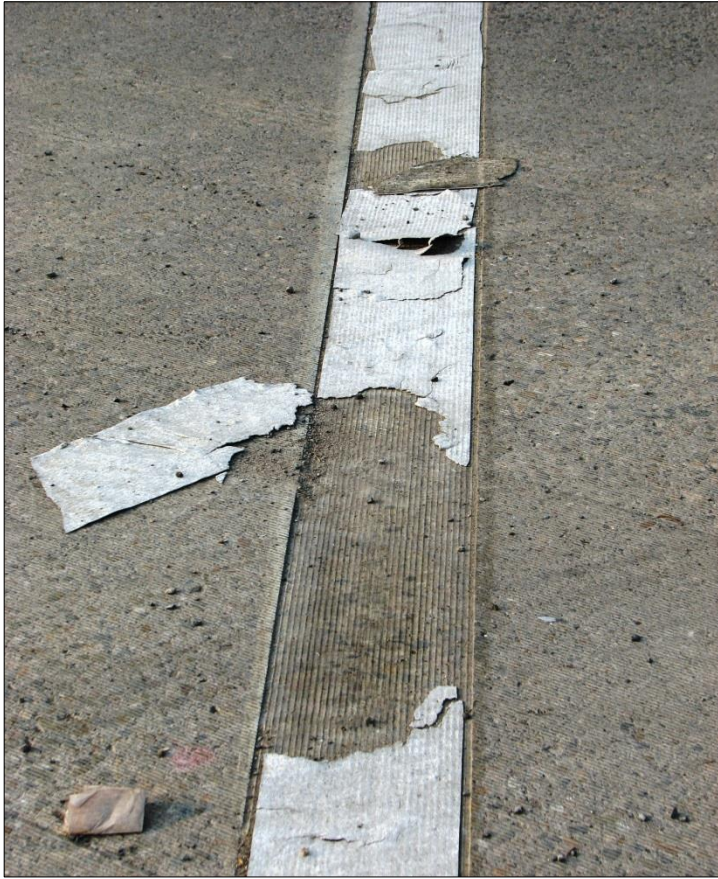
← A closer view of the pedestrian line tape damage.

Once the tape cracked or tore continuous vehicle traffic would eventually cause the tape to separate from the grooved pavement.

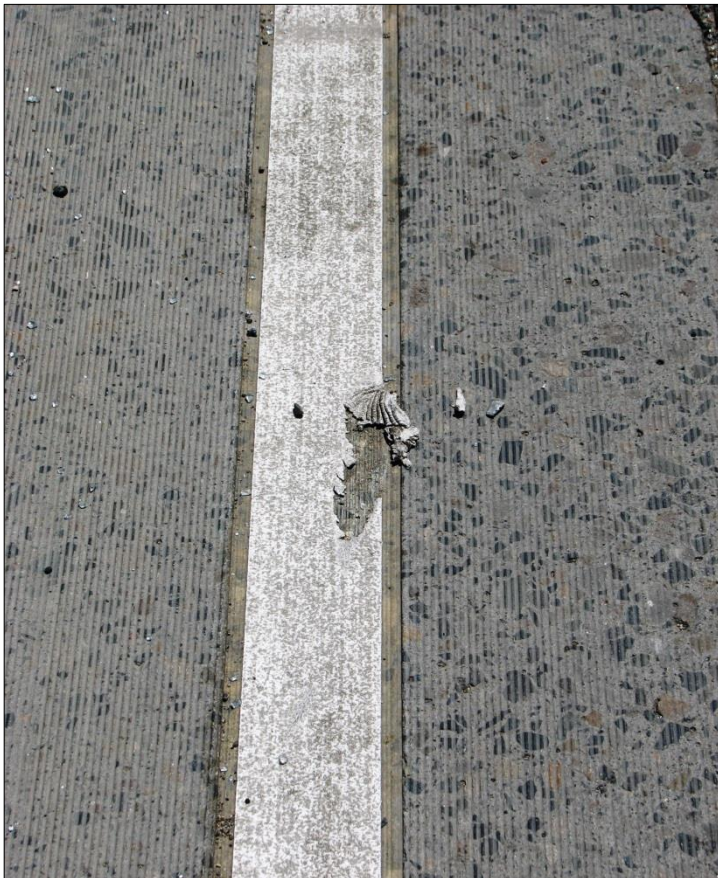
← An example of a torn section of tape on an edge line.

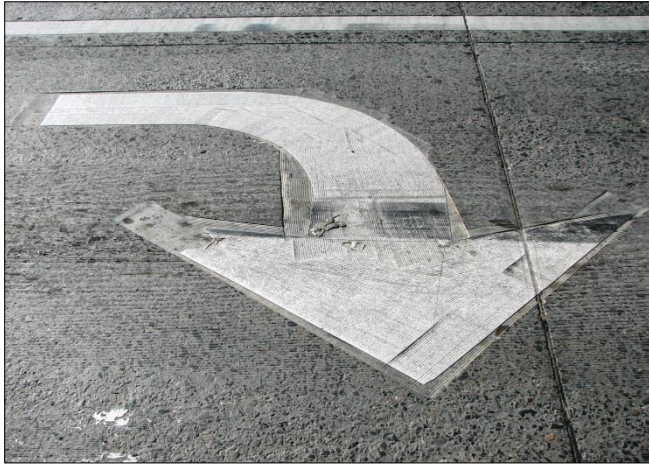
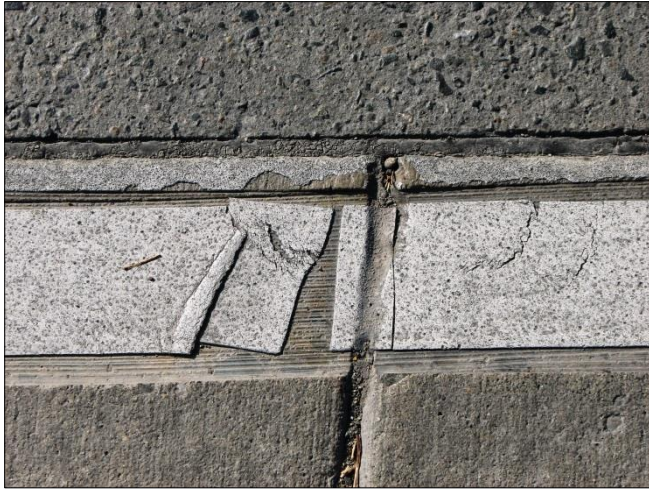
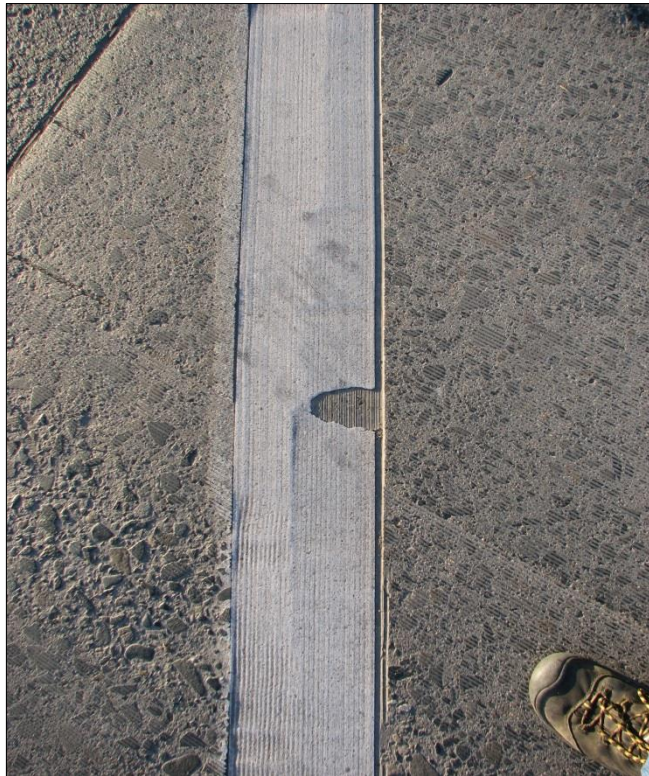
↩️⬇️ More examples of the type of tape distress with the Swarco project.

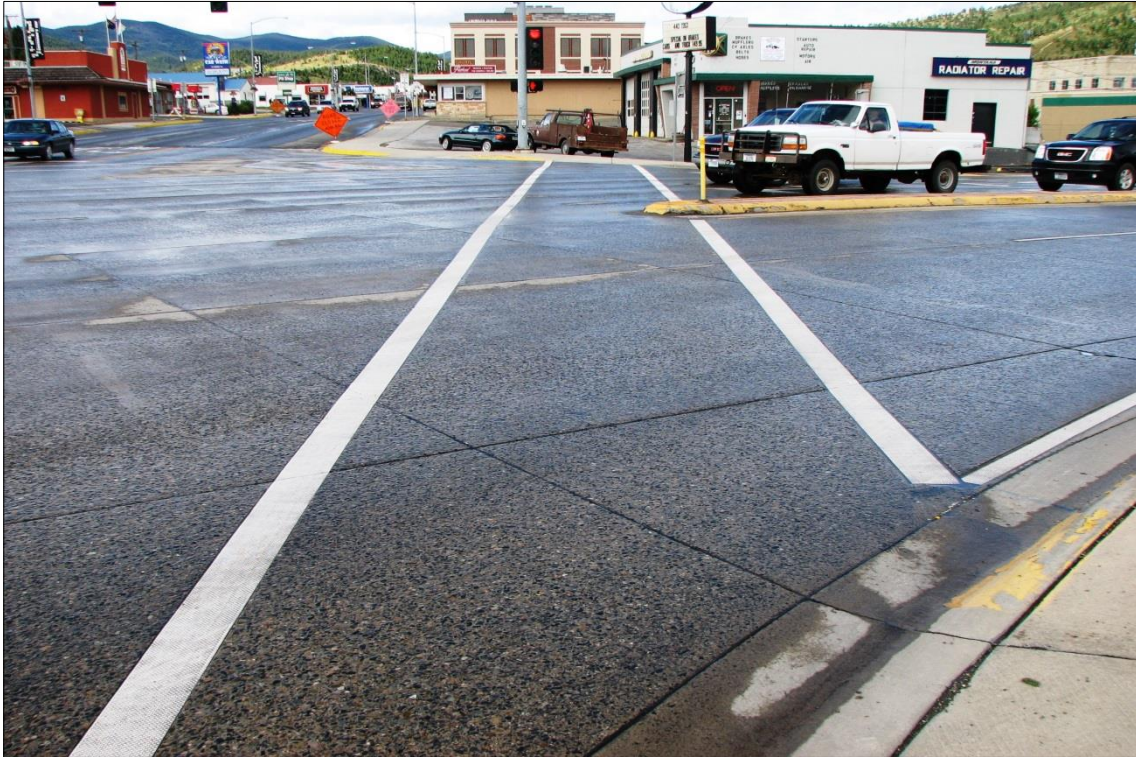
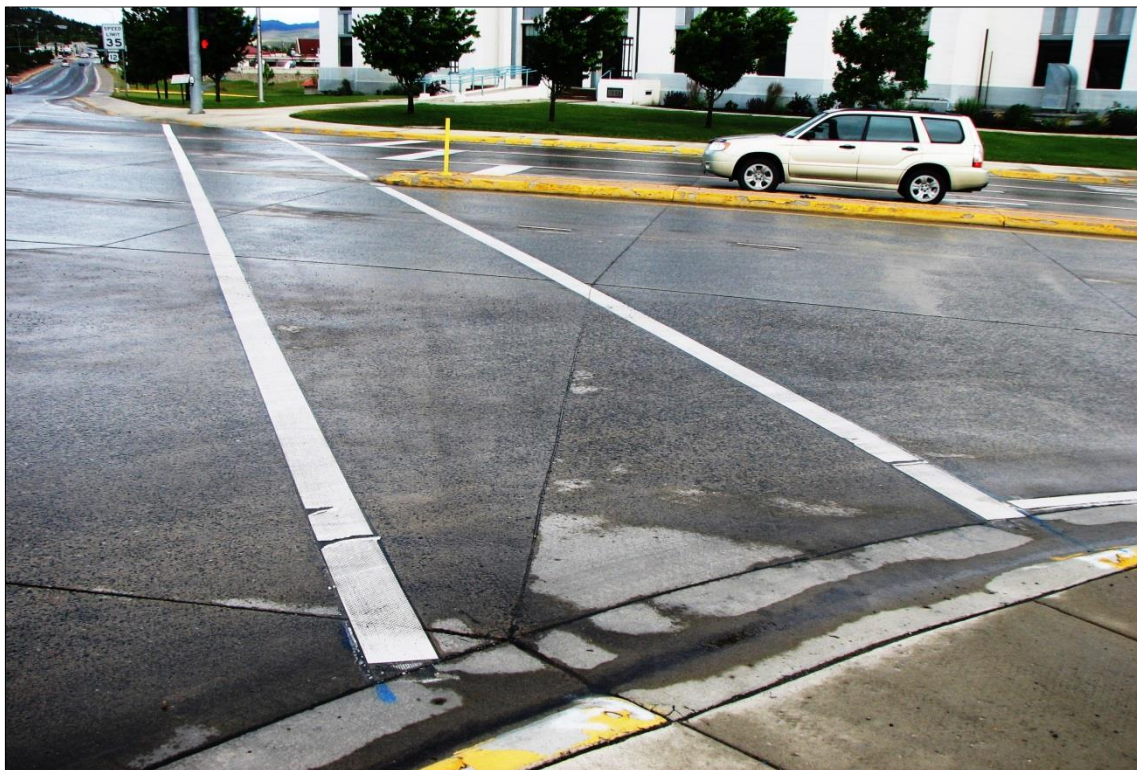
↑ Image of West Lyndale: westbound, west side pedestrian lines shortly after installation.

↓ Right turn from West Lyndale onto Last Chance Gulch: Turning movements are stretching and tearing the pedestrian lines.

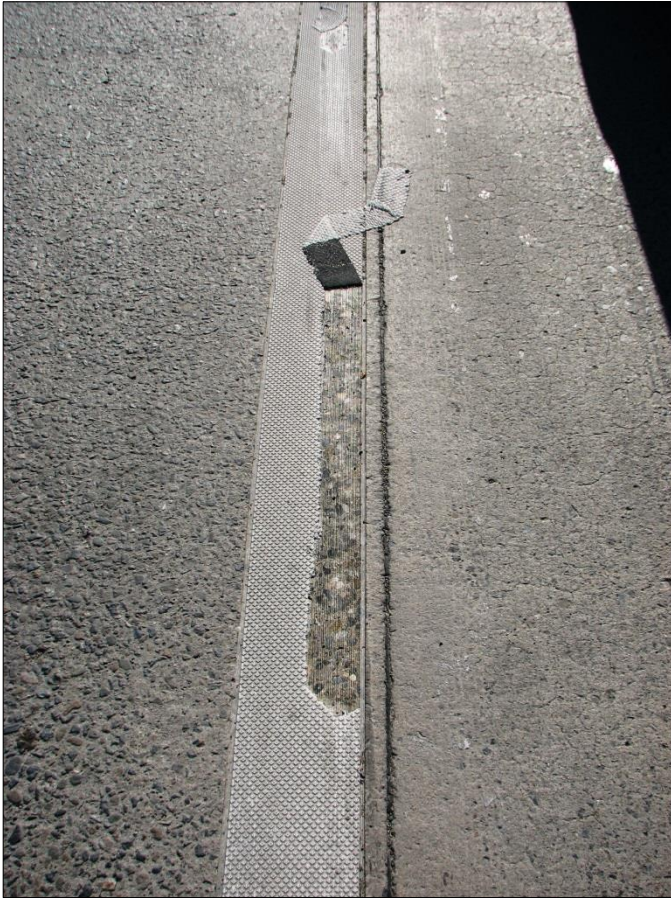
← Sample image of a friction tear most likely caused by sudden braking of a vehicle.

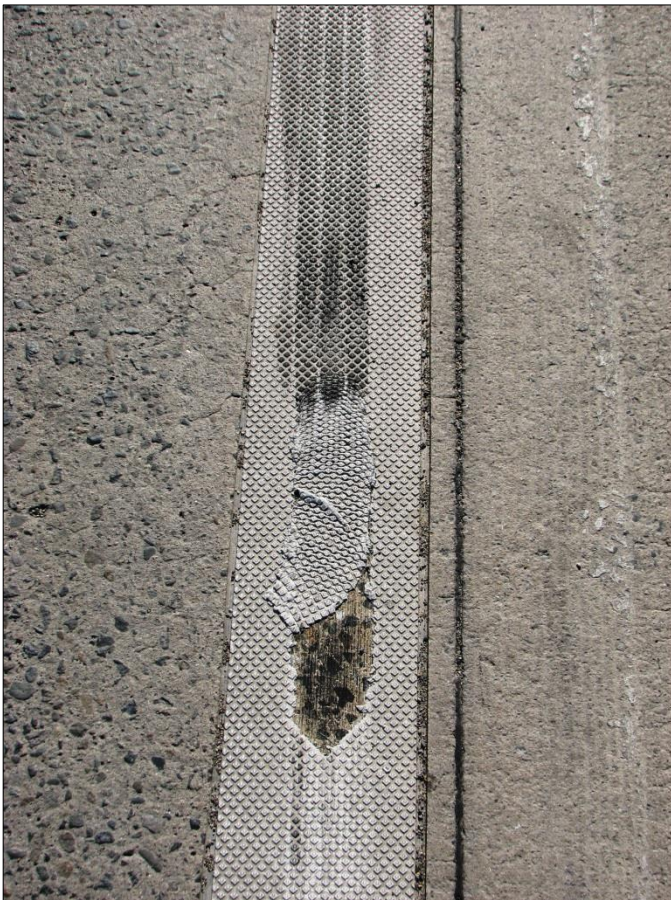
← Damaged caused by sudden braking by a vehicle is apparent in this image.

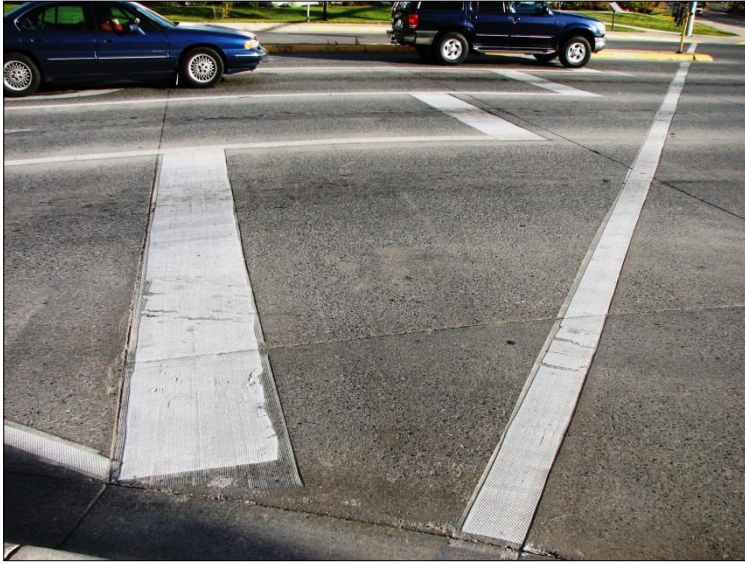
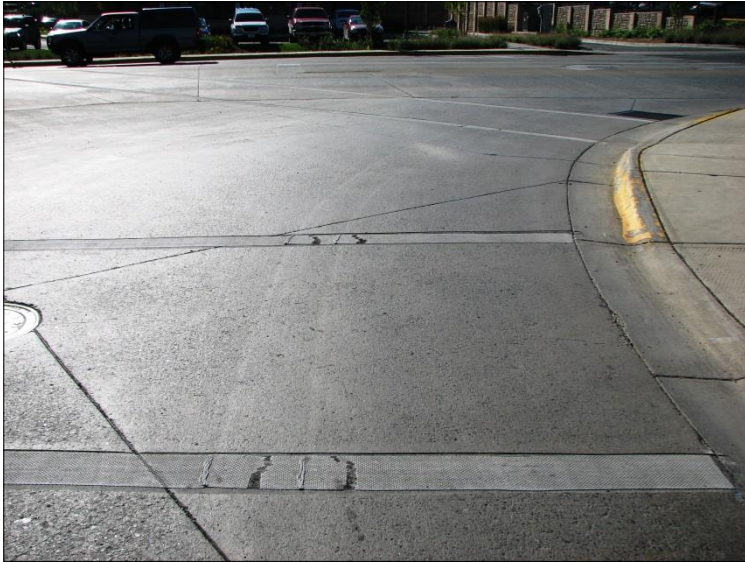
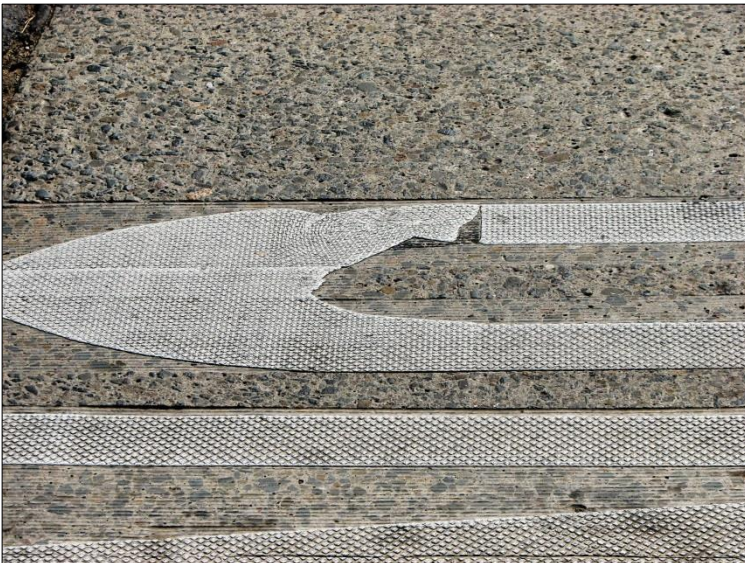
↙ More examples of the type of tape distress with the 3M Stamark project.

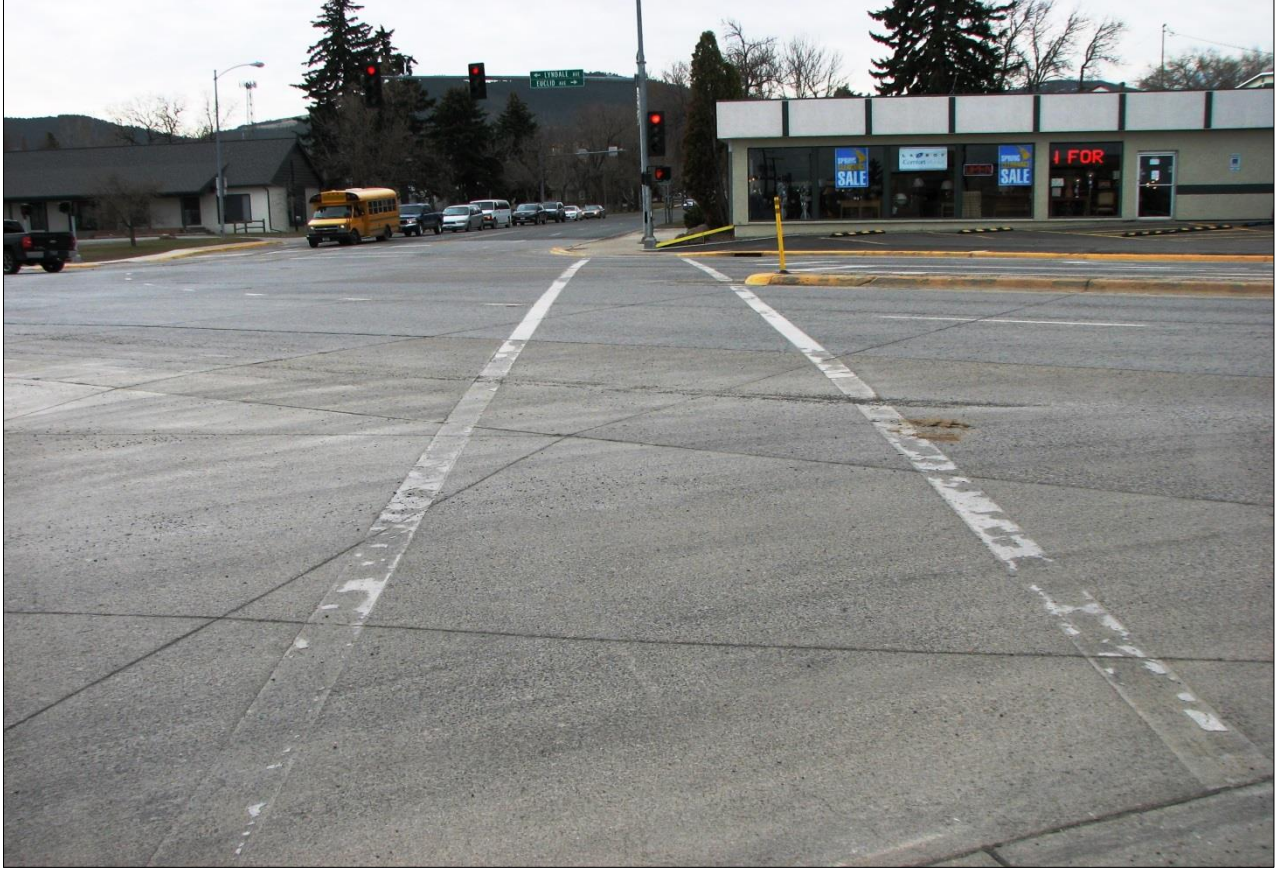
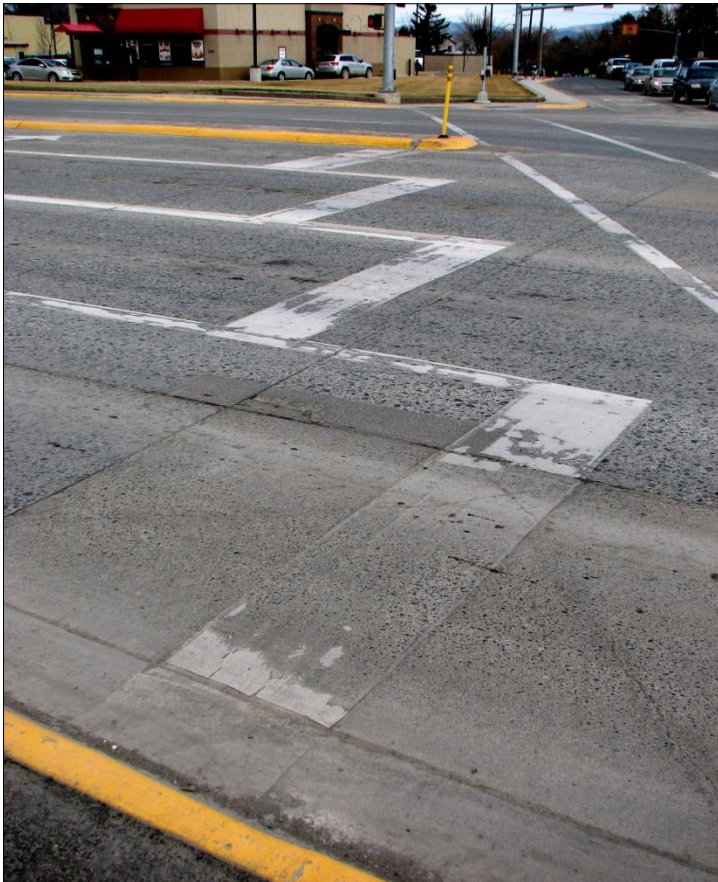
← ↑ As seen in earlier inspections, the pavement tape continues to degrade especially in areas with the most direct tire to tape contact.

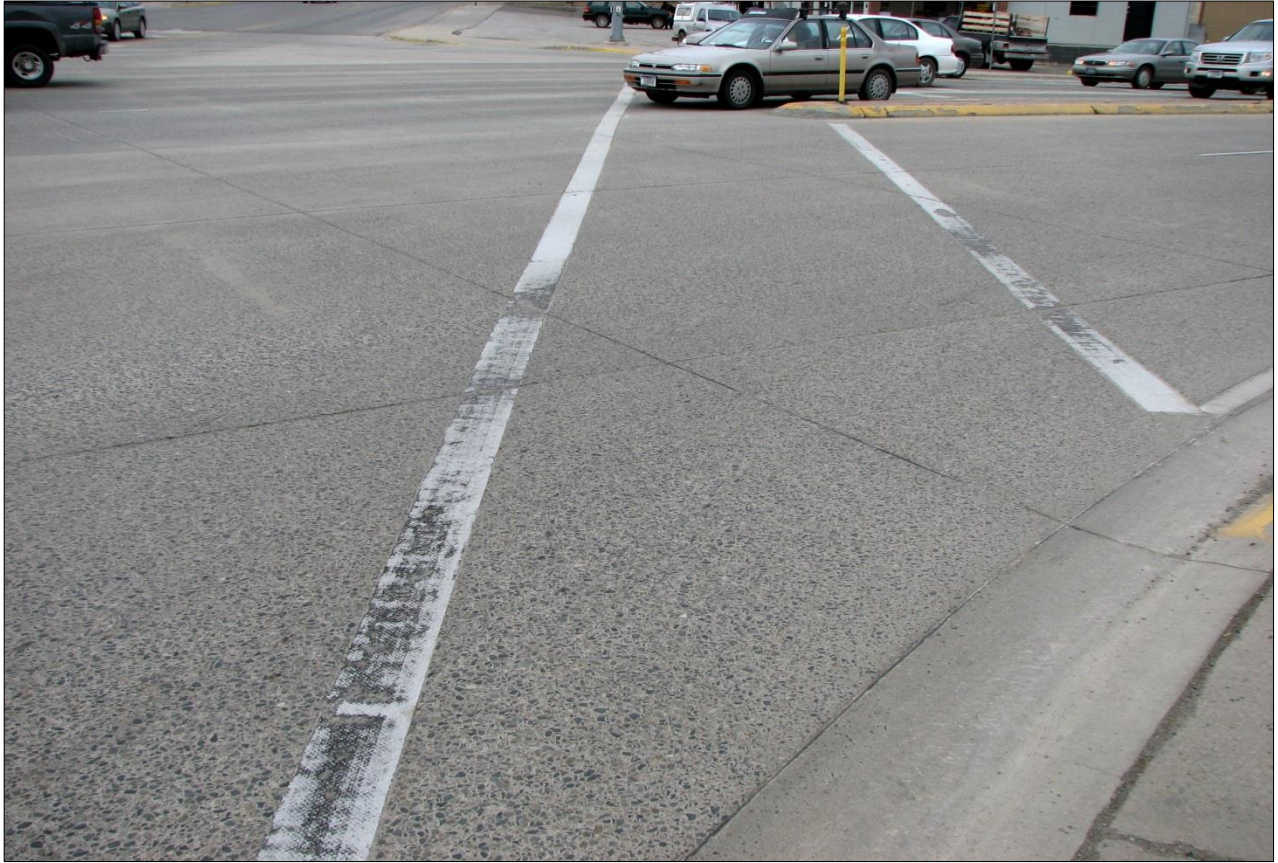
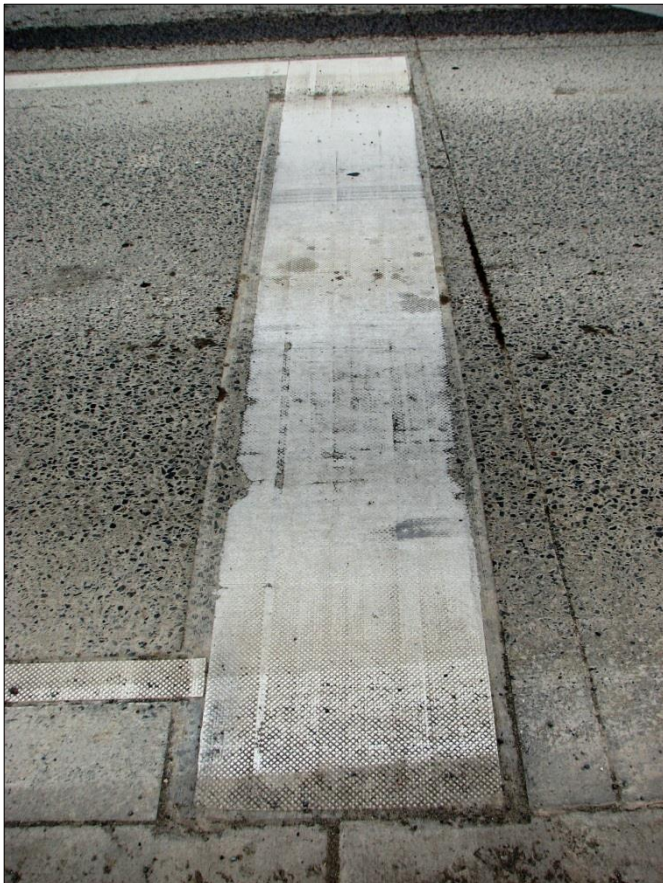
← ↑ General representation of continued pavement tape deterioration.

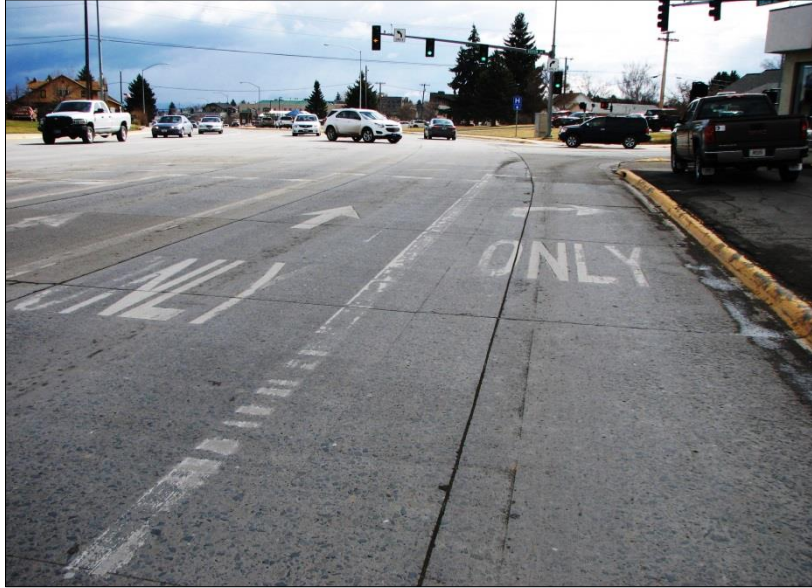
← Euclid Ave., eastbound – west end of intersection.

← General visual examples of the condition of the pavement marking at various areas of the intersection since installation in the summer of 2014.

Debonding (or delamination) of material is the most prevalent form of distress, secondary would be uneven tape wear.

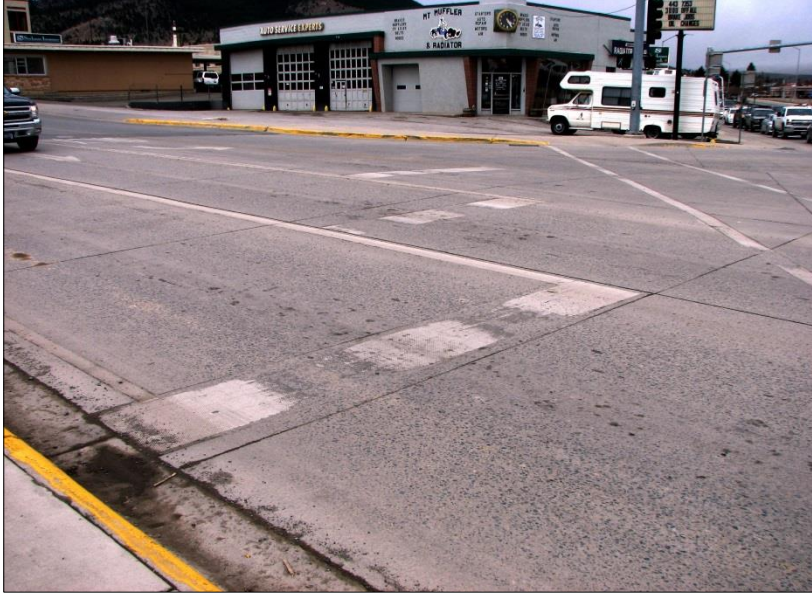
← N. Last Chance Gulch, northbound – south end of intersection.

← General visual examples of the condition of the pavement marking at various areas of the intersection since installation in the summer of 2014.

The main distress feature is direct wearing of the tape due to vehicle traffic.

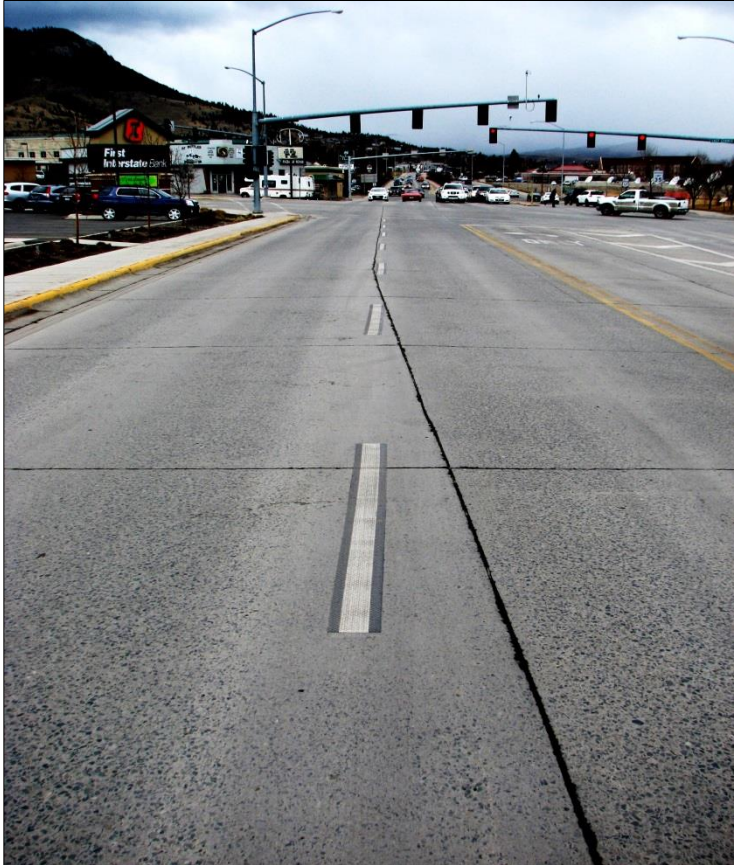
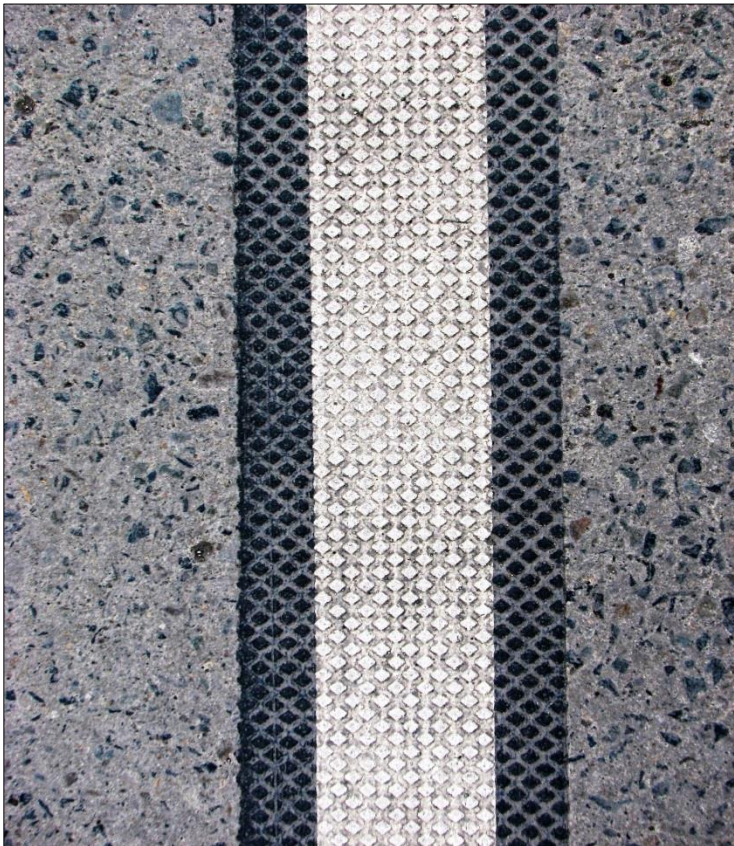
↙↘ 3M's contrast striping skip lines (or dotted lines) are in good condition since applied in the summer of 2014.

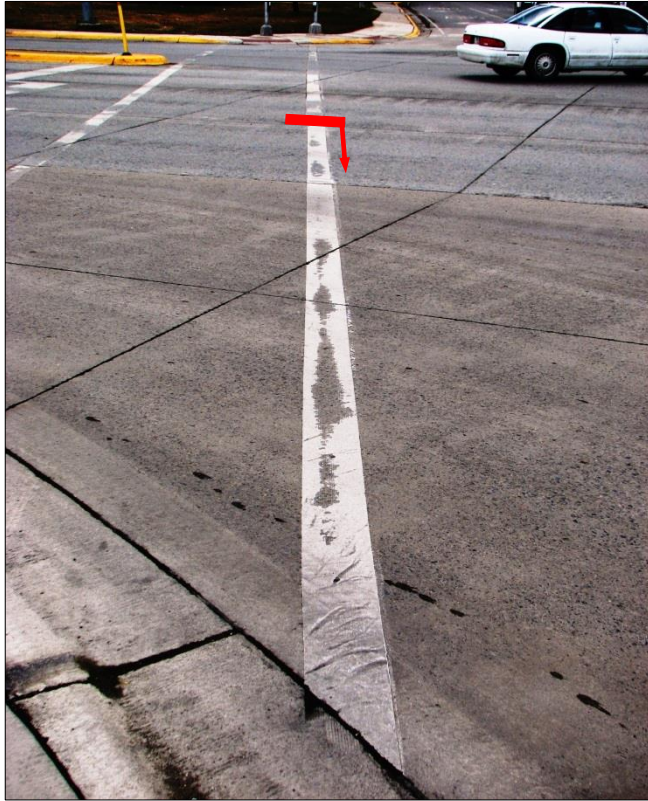
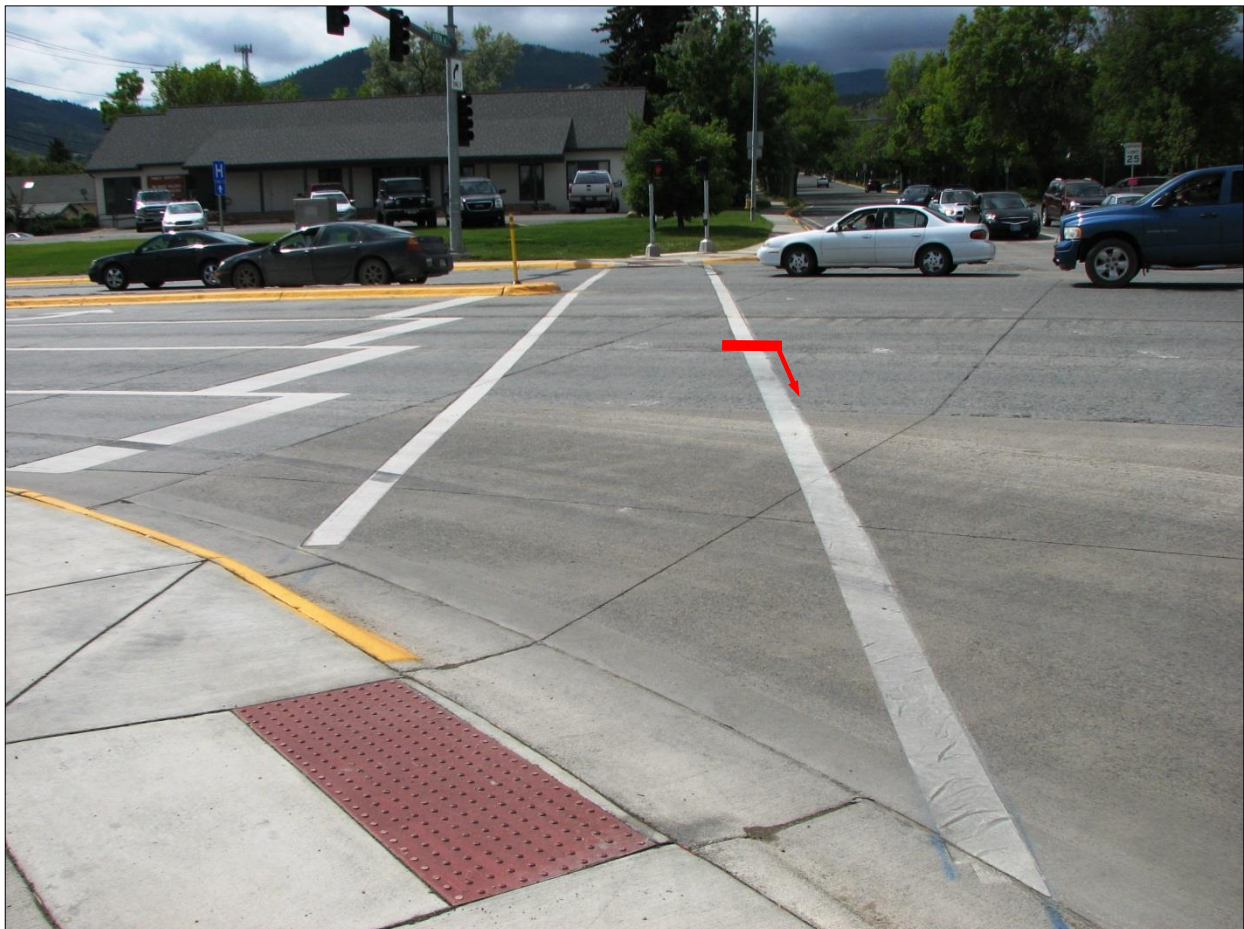
↙ West Lyndale Ave. – westbound,
east end of intersection:

During the Swarco installation the contractor elected to apply a section of Methyl Methacrylate (MMA) to the crosswalk bar.

The image below was taken in the summer of 2014. The image to the left was taken in the spring of 2016.

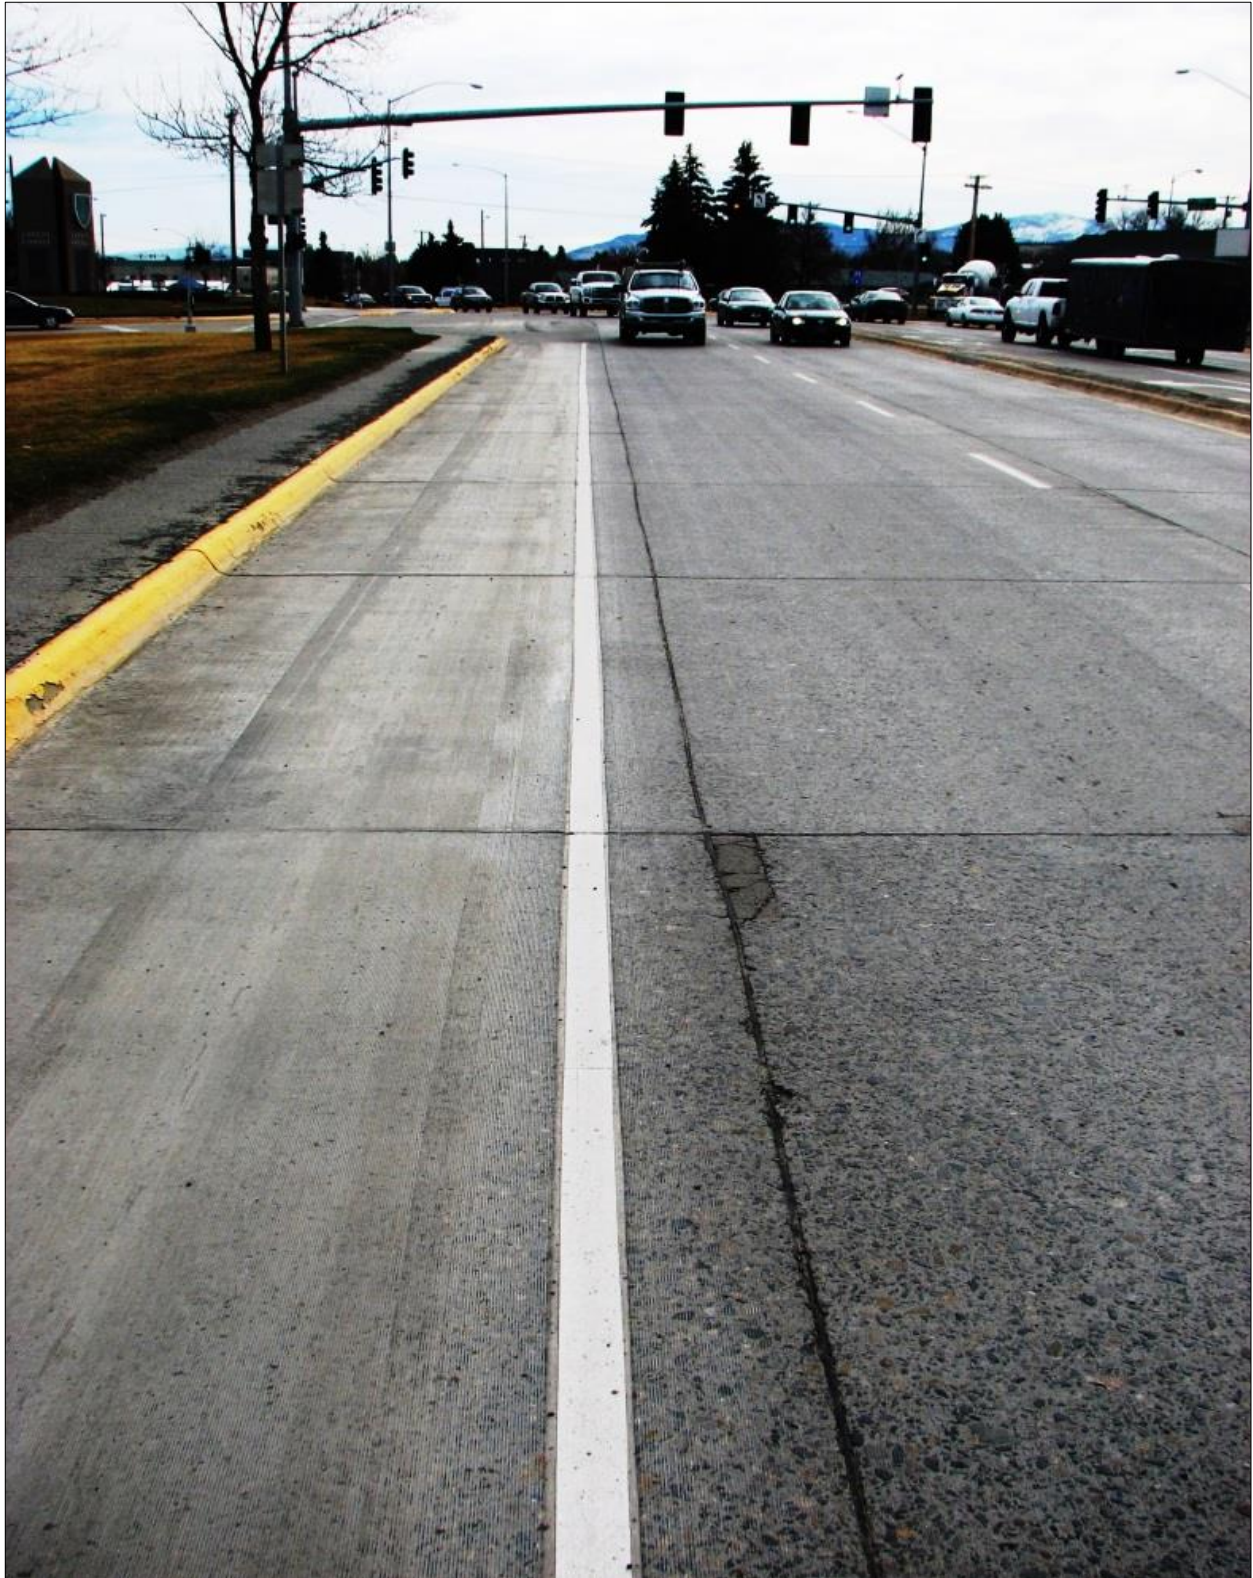
Pavement lines such as the example below of the 4" white edge line/broken lines Swarco tape (and as applicable with the 3M Stamark) where tire to tape contact is at a minimum, or not subjected to stop and start friction as related to the transverse markings; are generally in good condition at both project sites since installation in 2014.

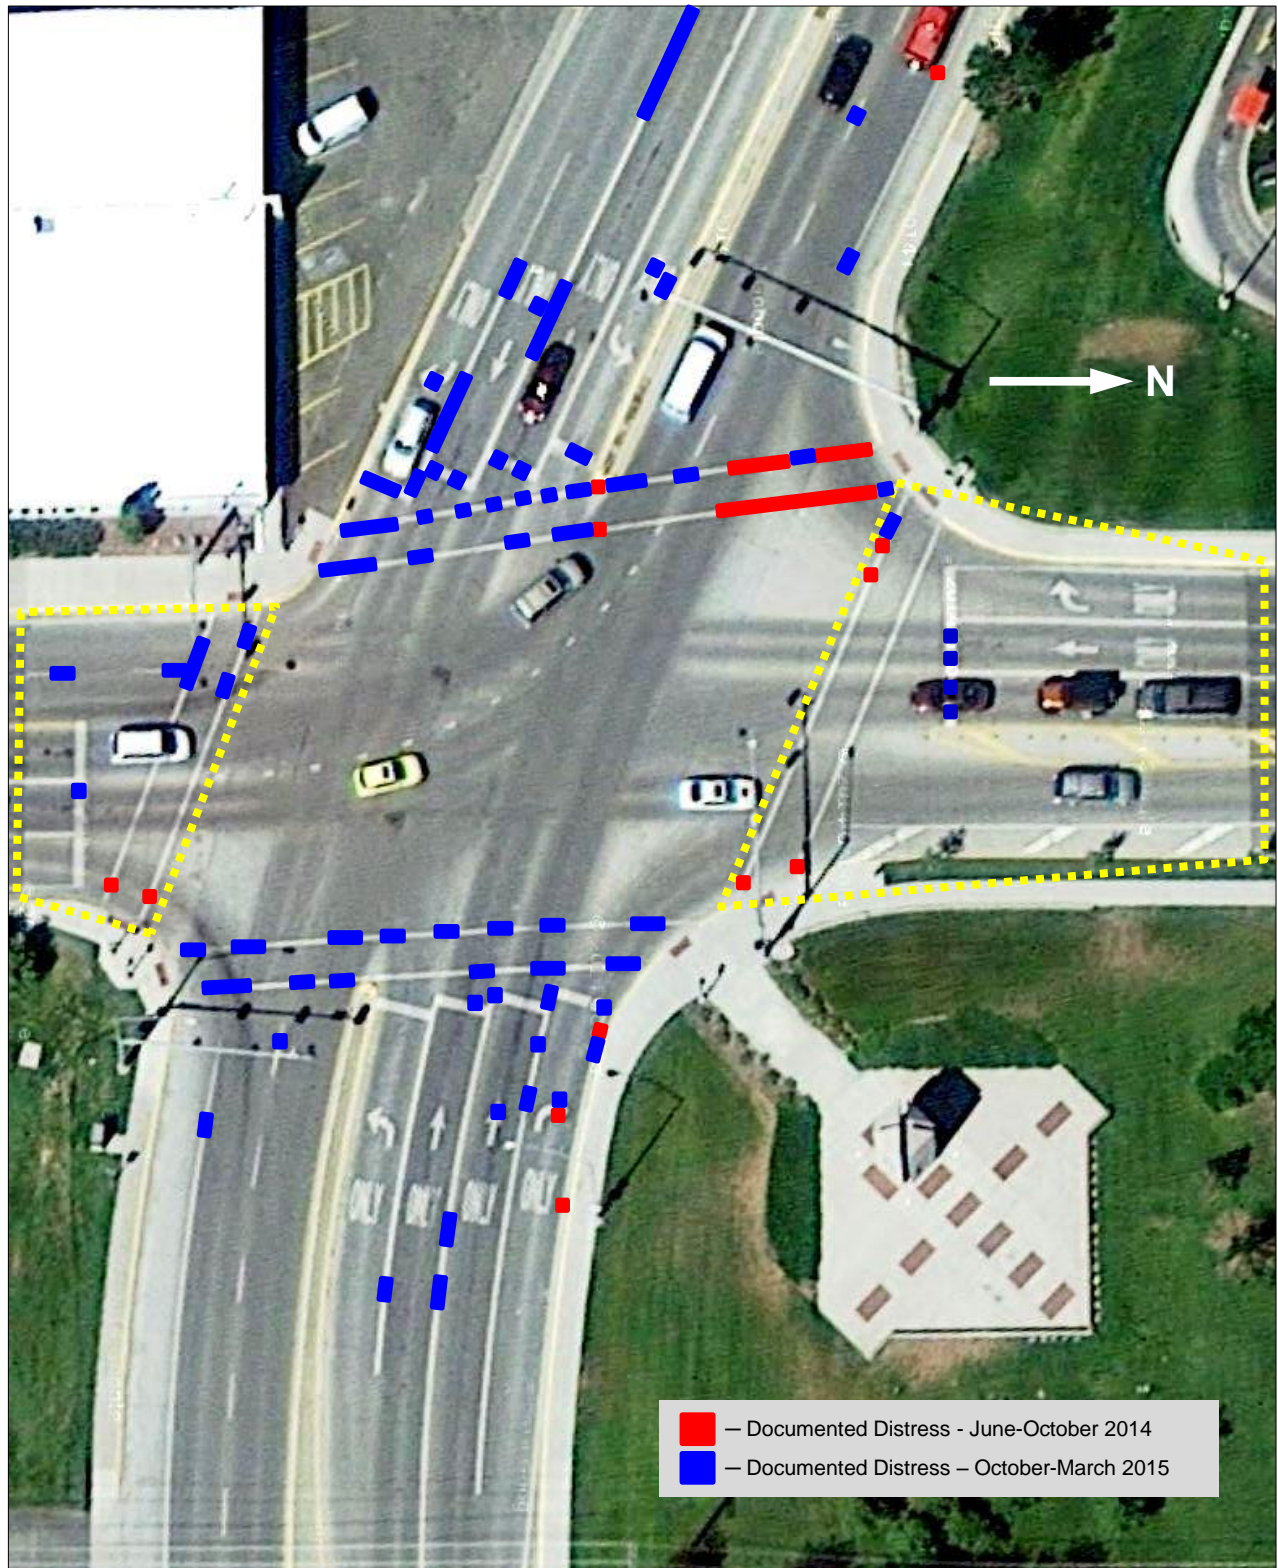
Swarco Director 25 Pavement Tape Defect Locations: West Lyndale & Euclid

Overview indicating areas where tape distress has been documented to date. Note the intersection area outlined in **yellow** (North Benton) received the 3M Stamark pavement tape. Locations are strictly for reference. This map is not to scale.

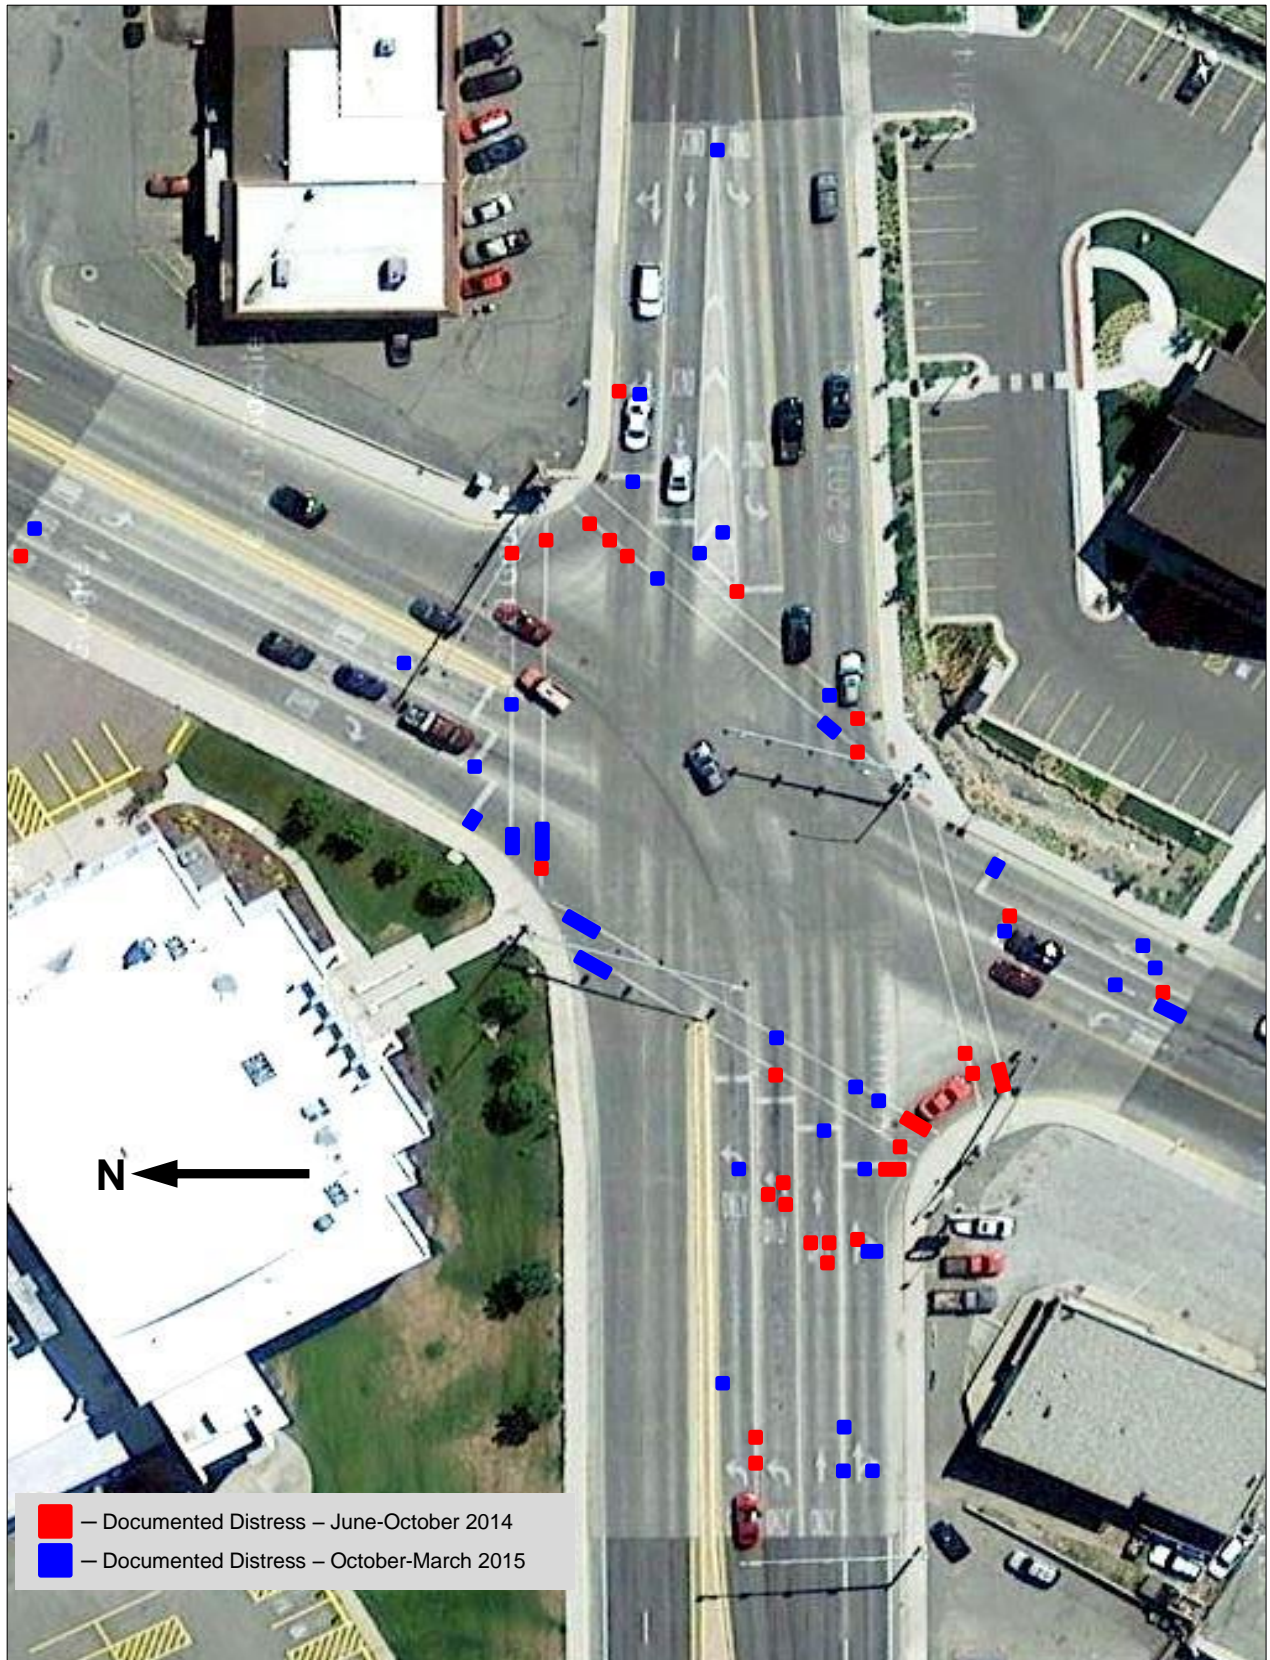
3M Stamark Pavement Tape Defect Locations: West Lyndale & Last Chance Gulch

Overview indicating areas where tape distress has been documented to date. Locations are strictly for reference. This map is not to scale.
