## FINAL REPORT

### PORTLAND CEMENT CONCRETE PAVEMENT (PCCP) REHABILITATION WITH DIAMOND GRIND AND PLANT MIX SEAL (PMS)

**Project Name:** Glendive East & West (EB/WB)

**Project Number:** IM 94-6(51)210

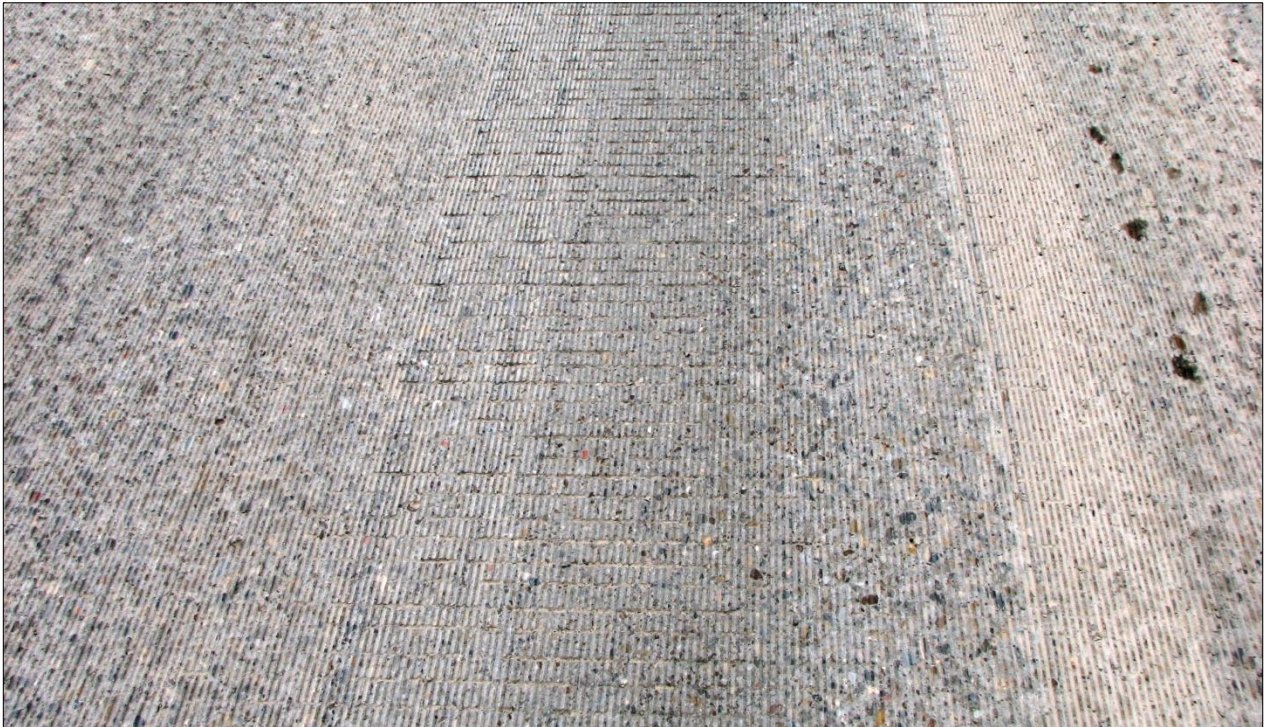
↑ Sample image of micro-grinding. As seen in the above image, based on a comparison of the condition of the eastbound grinding phase in 2011, the westbound displayed an inconsistent grind and coarser texture.

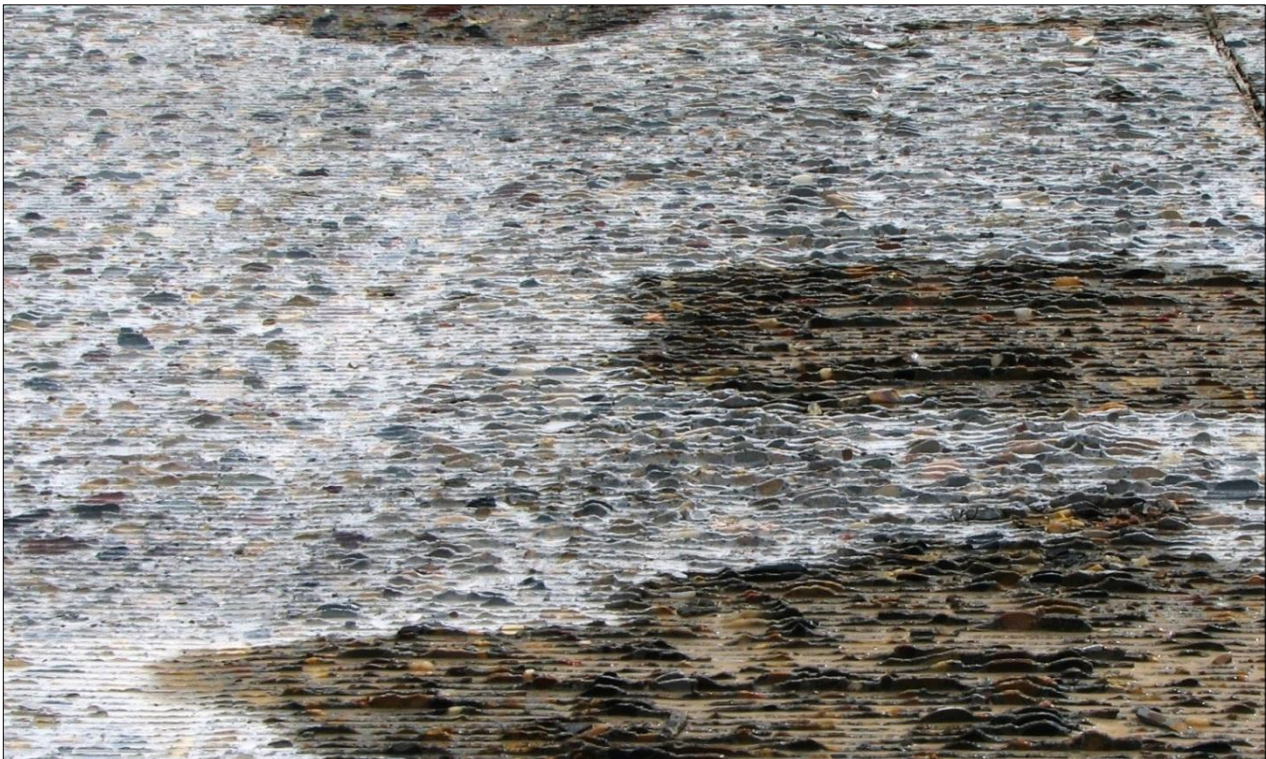
↓ The image below is a close-up of the PCCP after grinding. Initially it was determined to use a skid loader blade to even the relief of the grind prior to applying the PMS. The paving proceeded without any corrective action to the current grind.

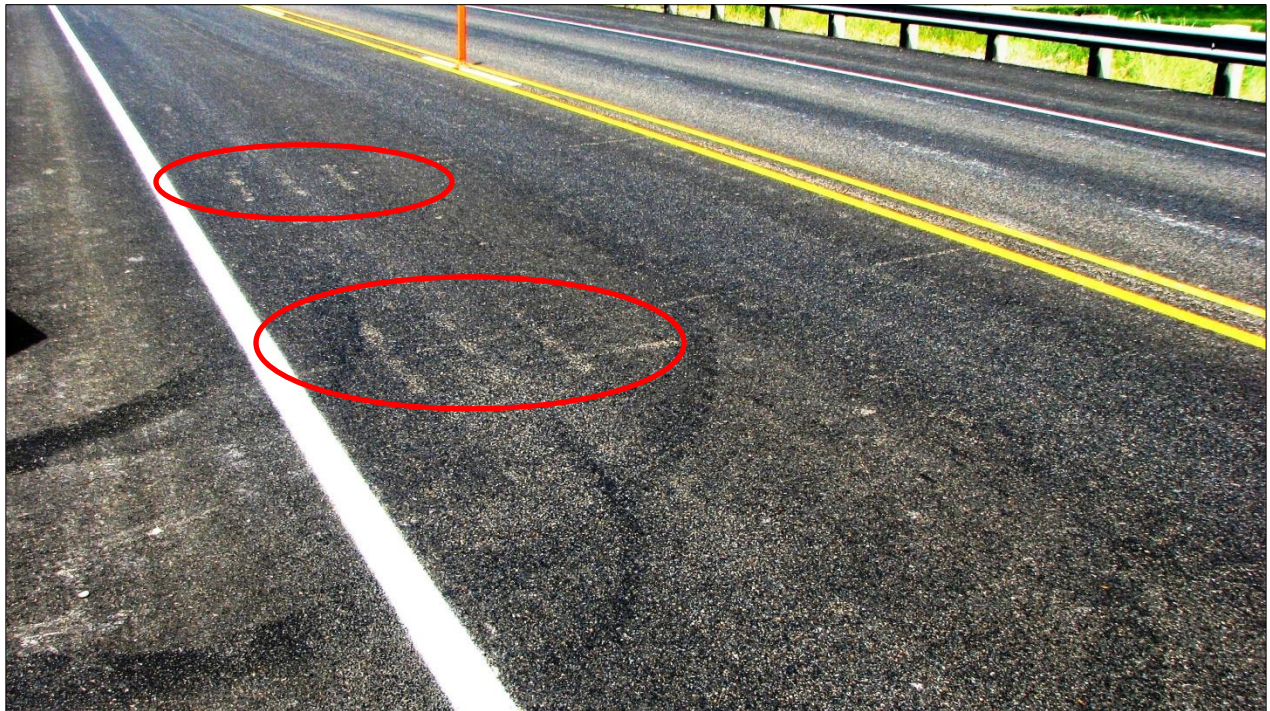
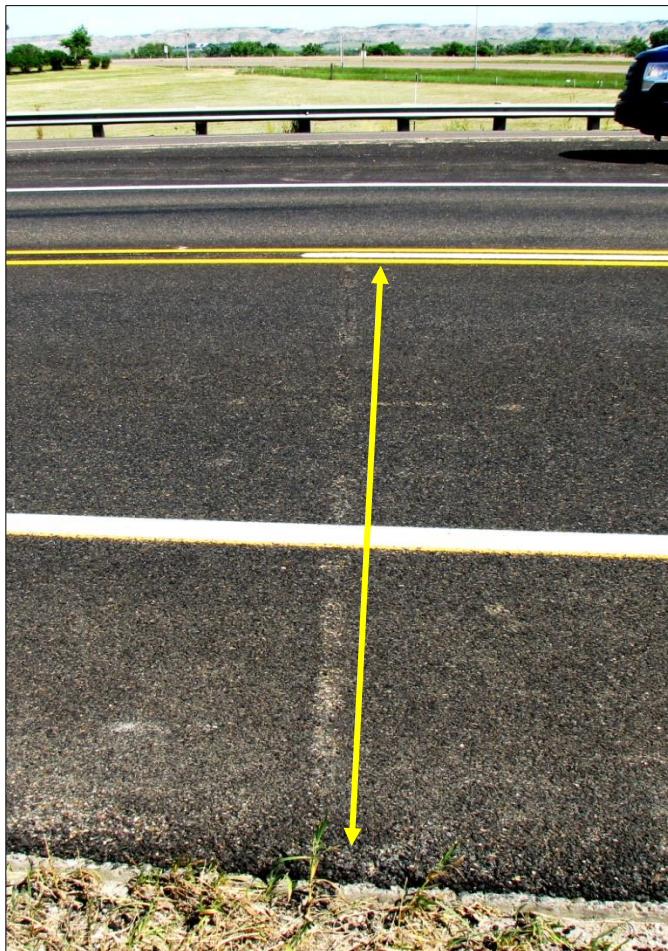
↙↗ During the July 2011 site visit the MDT Project Manager directed Research to the west end of the eastbound lanes (constructed in 2010) to document apparent shadowing of the dowel slots (red circle) and the slab joints (denoted by yellow line). This condition was predominately in the passing lane and (at this time) encompassed about 2000ft. (610m) starting at the west end of the project.

On close inspection it was observed that the asphalt cement (AC) had been scraped from the aggregate apparently by plow passes. An assumption to this anomaly may be movement of the slab joint due to heavy loads in which the grouted slots are pushed up to a relief higher than the surrounding AC; though this movement is only 1-2 millimeters. Research will continue to monitor this condition in future evaluations.

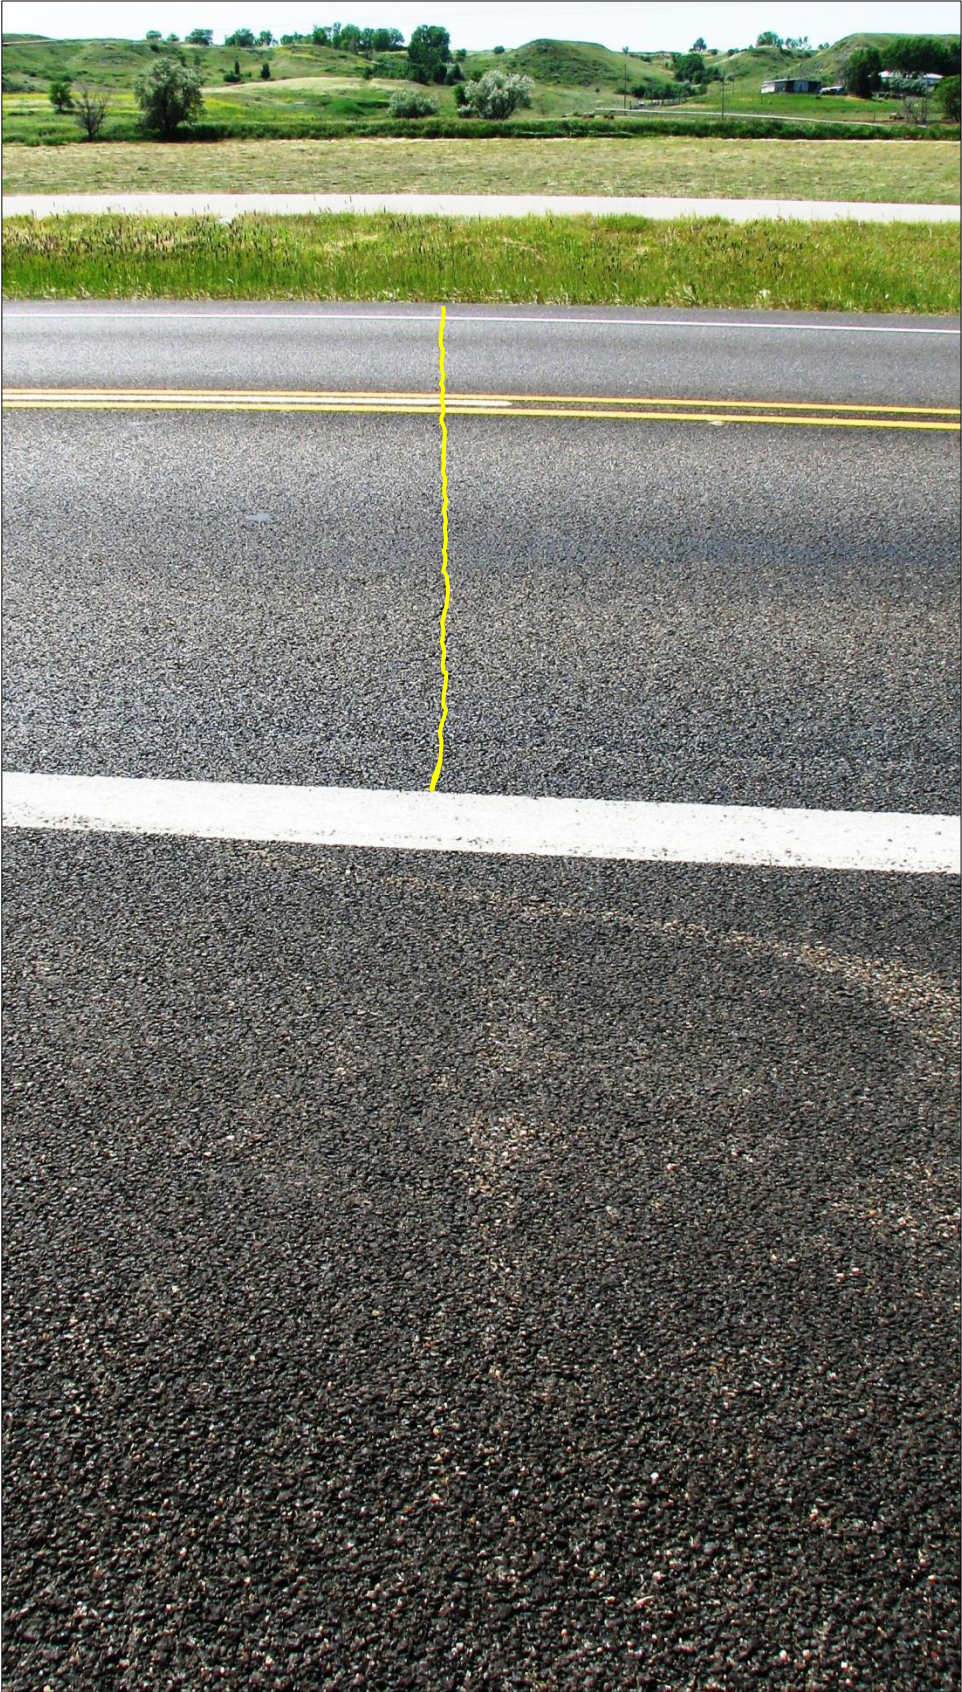
← The reflective joint crack in this image is difficult to see and is superimposed with a yellow line for better clarity. This crack is located at exit 210 just past the overpass. To date cracking is at a minimum and is rated as low-severity.

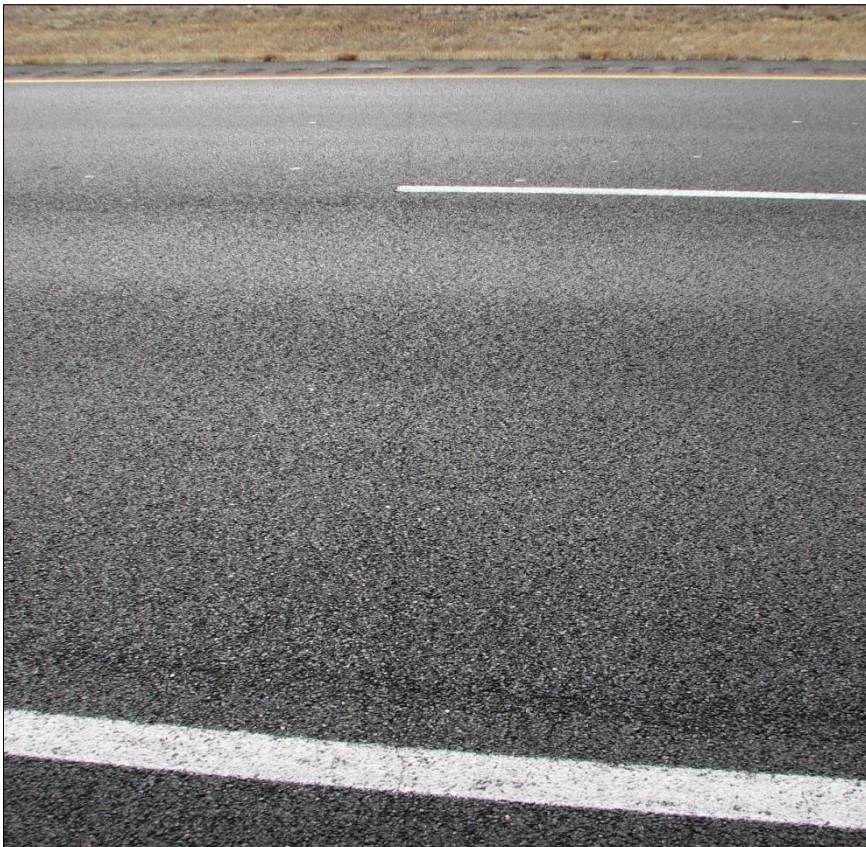
← Image of mat texture. Surface appearance is tight and uniform. No appreciable rutting was detected.

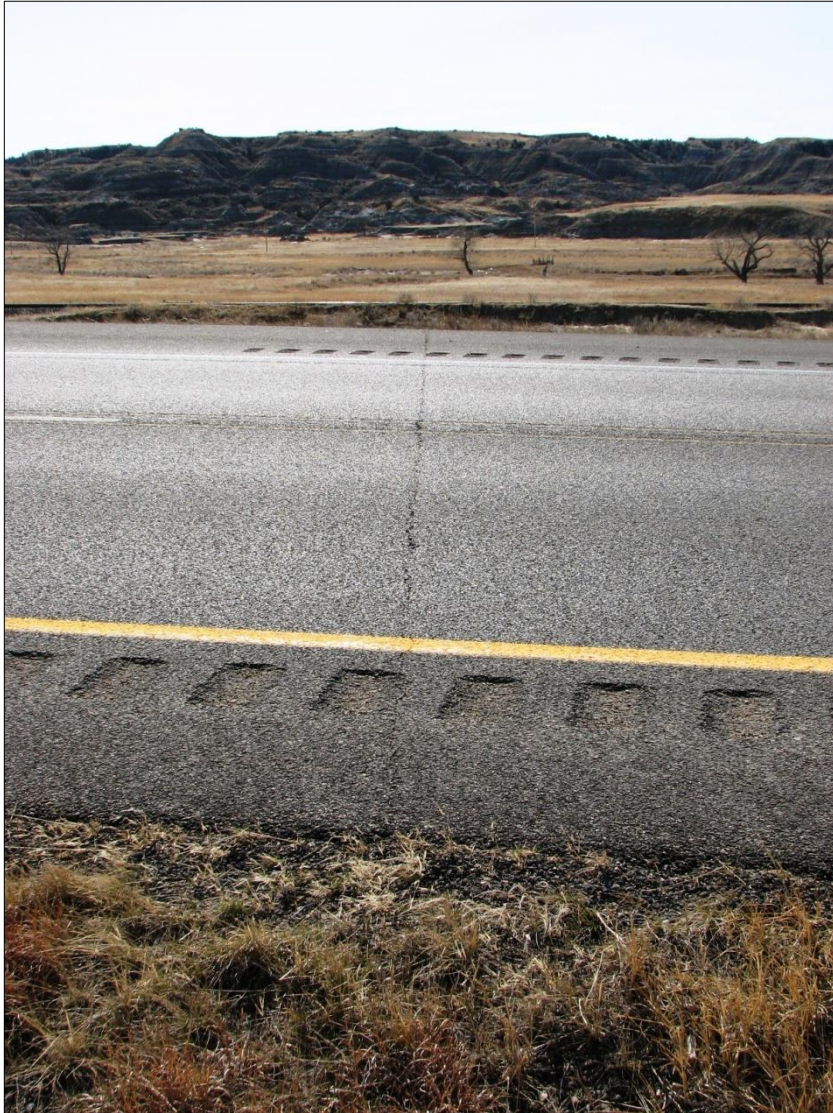
← Joint reflection cracking (the PCCP underlying joint) is seen through the PMS layer. This cracking is on all underlying PCCP dowel-retrofit joints on the east bound portion of the project.

The image on the left shows a sample of that cracking.

To date the west bound lanes also exhibits reflective cracking but the frequency is very minor.

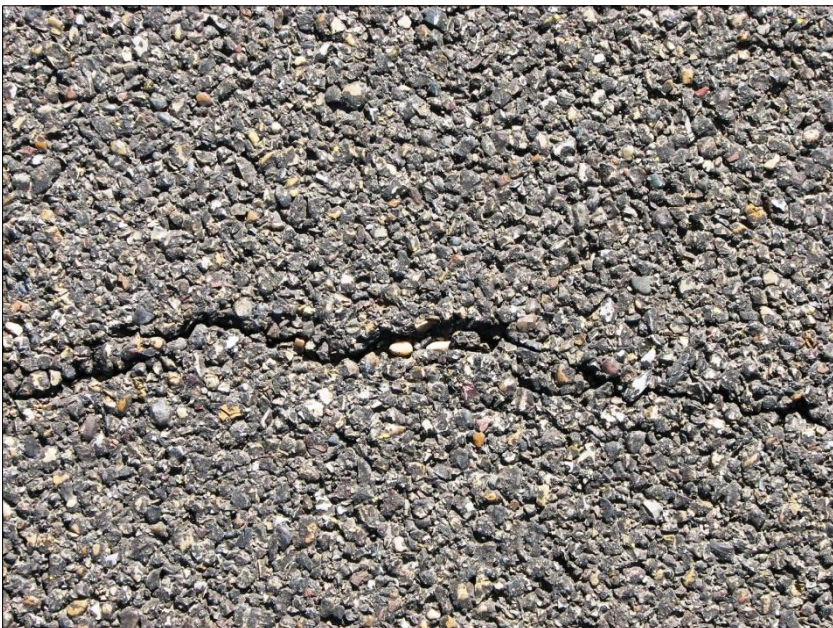
↓ The image below is a representative close-up of the reflective cracking. The crack is rated as low-severity (mean width of  $\leq 6\text{mm}/0.25\text{''}$ ).

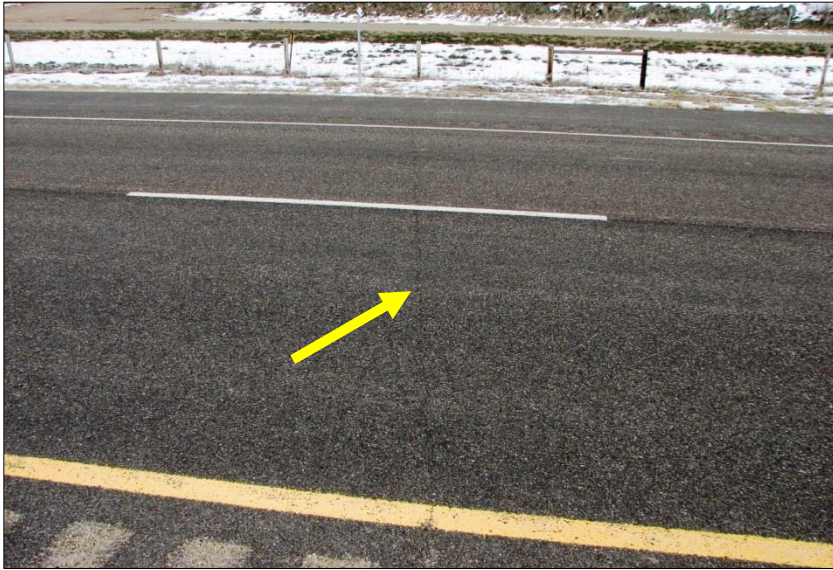
← Joint reflection cracking (the PCCP underlying joint) is seen through the PMS layer. This cracking is on all underlying PCCP dowel-retrofit joints on the west bound portion of the project as also seen on the eastbound lanes.

The image on the left shows a sample of that cracking.

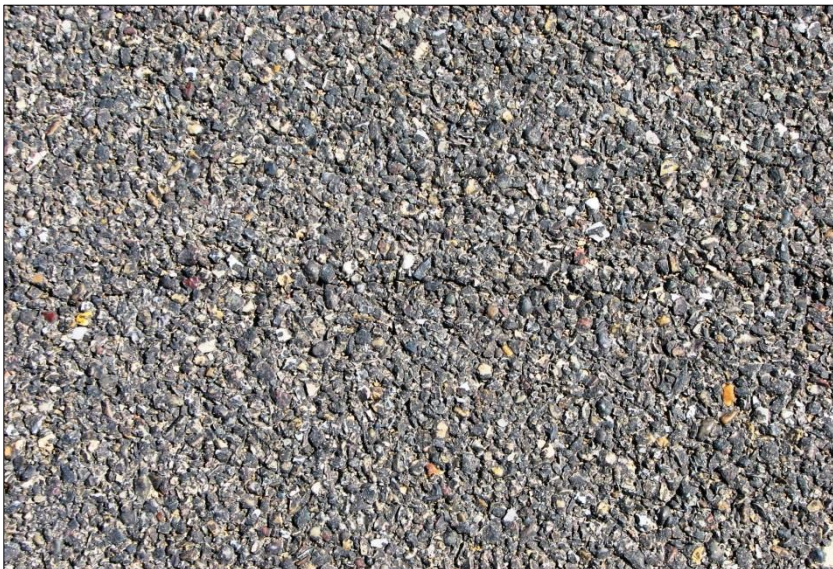
← A representative close-up of the reflective cracking in the westbound lanes. The crack is rated as low-severity (mean width of  $\leq 6\text{mm}/0.25''$ ).

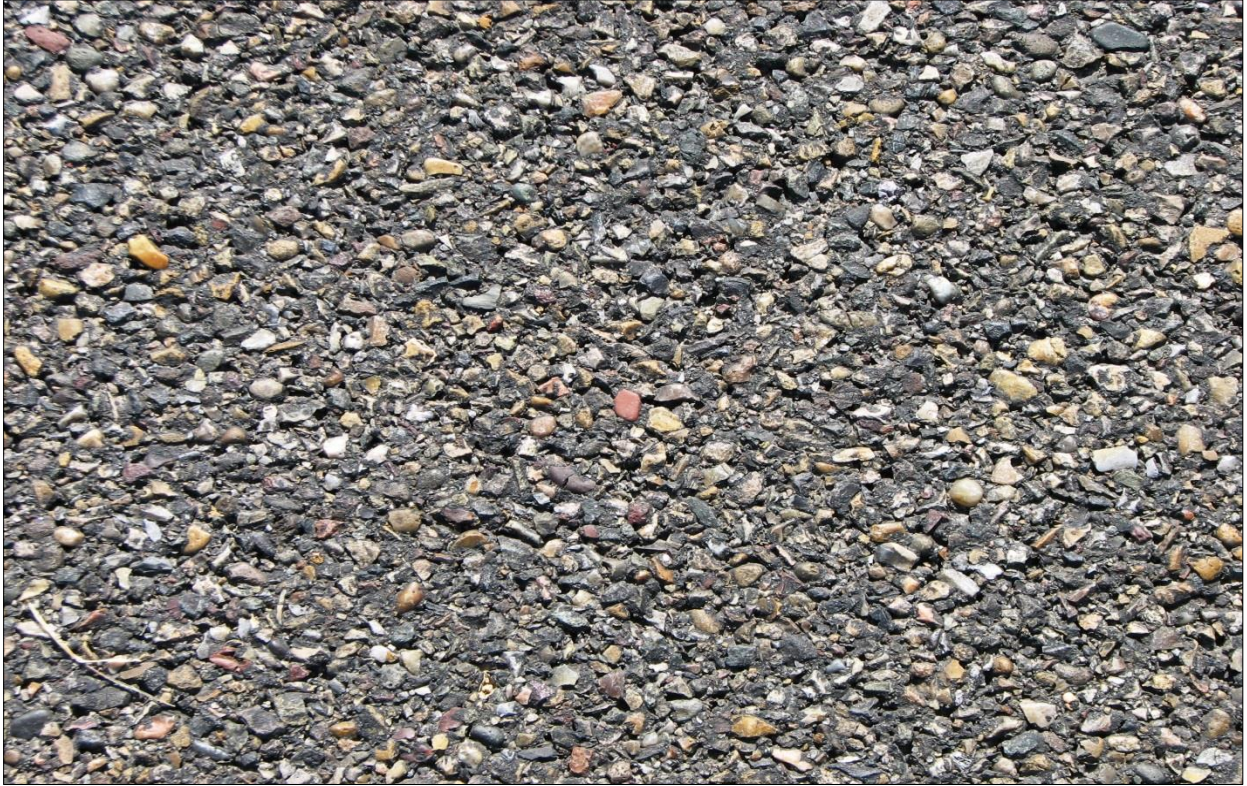
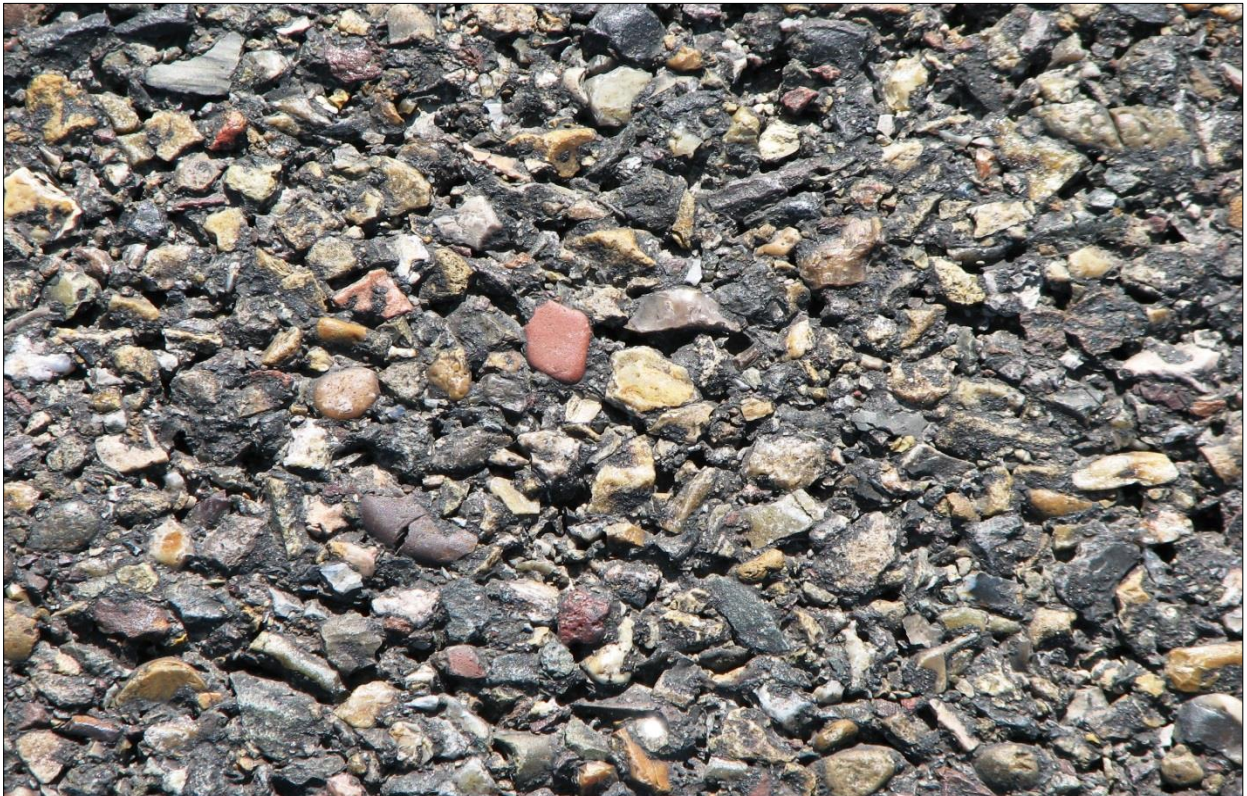
↑ ↓ Representative Images of PMS surface texture. No abnormal surface deformation noticed. No apparent bleeding or raveling is perceptible throughout the project. Polishing of aggregate minimum.

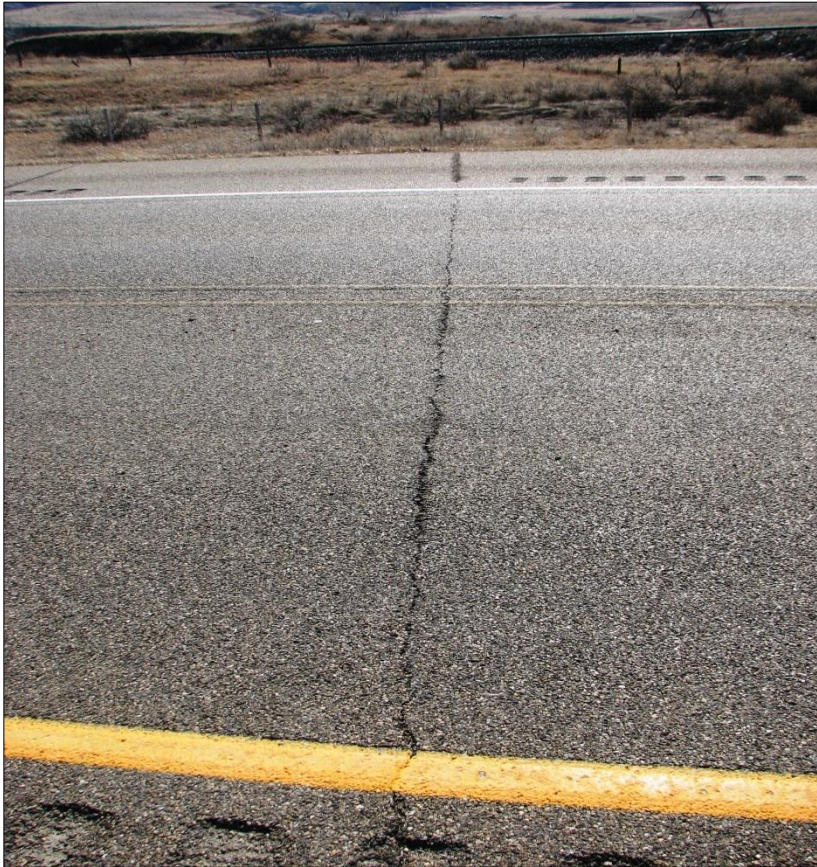
← Overlay surface joint reflection cracking on the project (which includes all PCCP underlying joints), is at low-severity.

The image on right depicts a crack typical on the project; on the low-end of severity cracking.

Reflective cracking at the pavement joints is considered normal for this type of project.

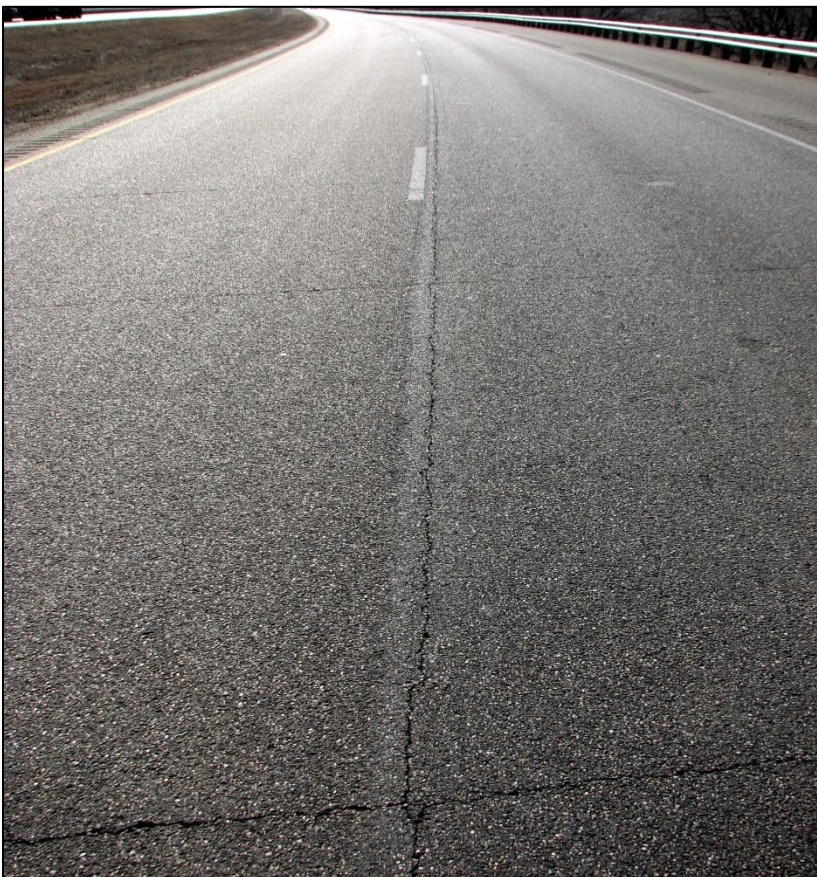
← Minor longitudinal reflective cracking is noticed during this inspection. Not predominant to the entire project.

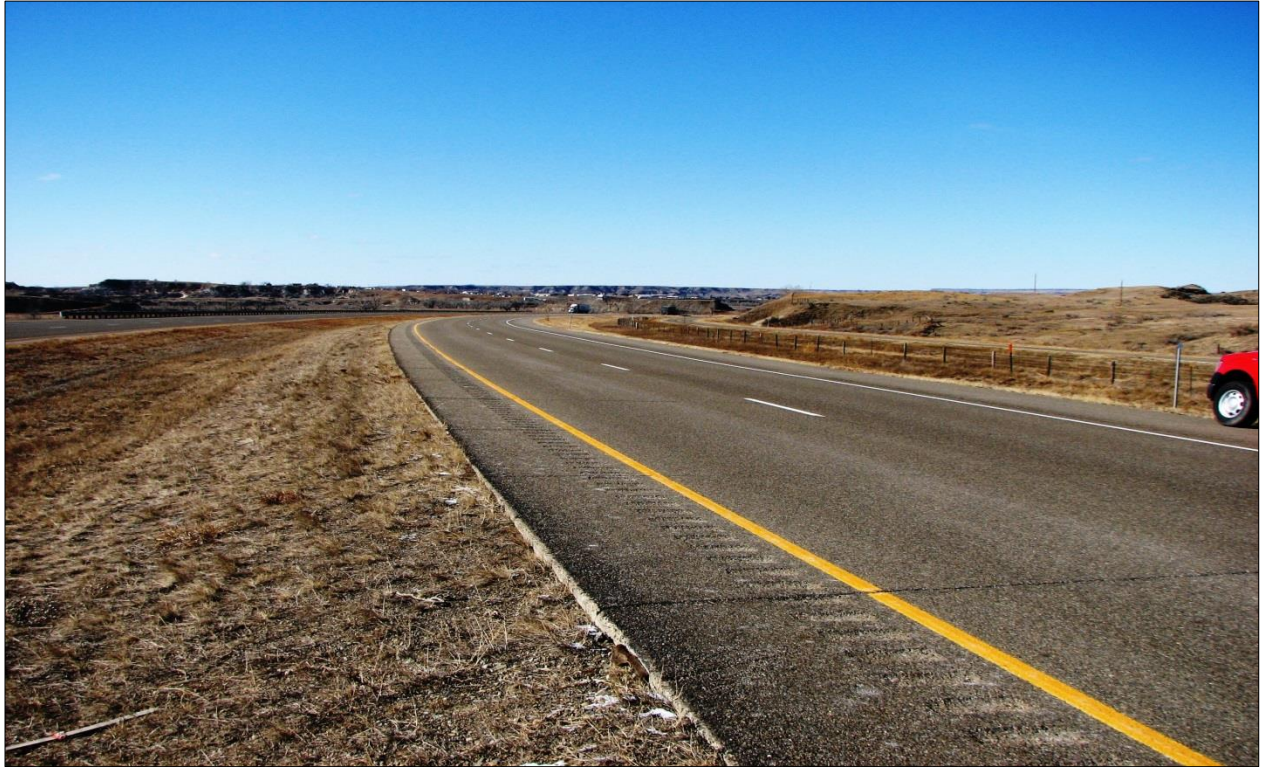
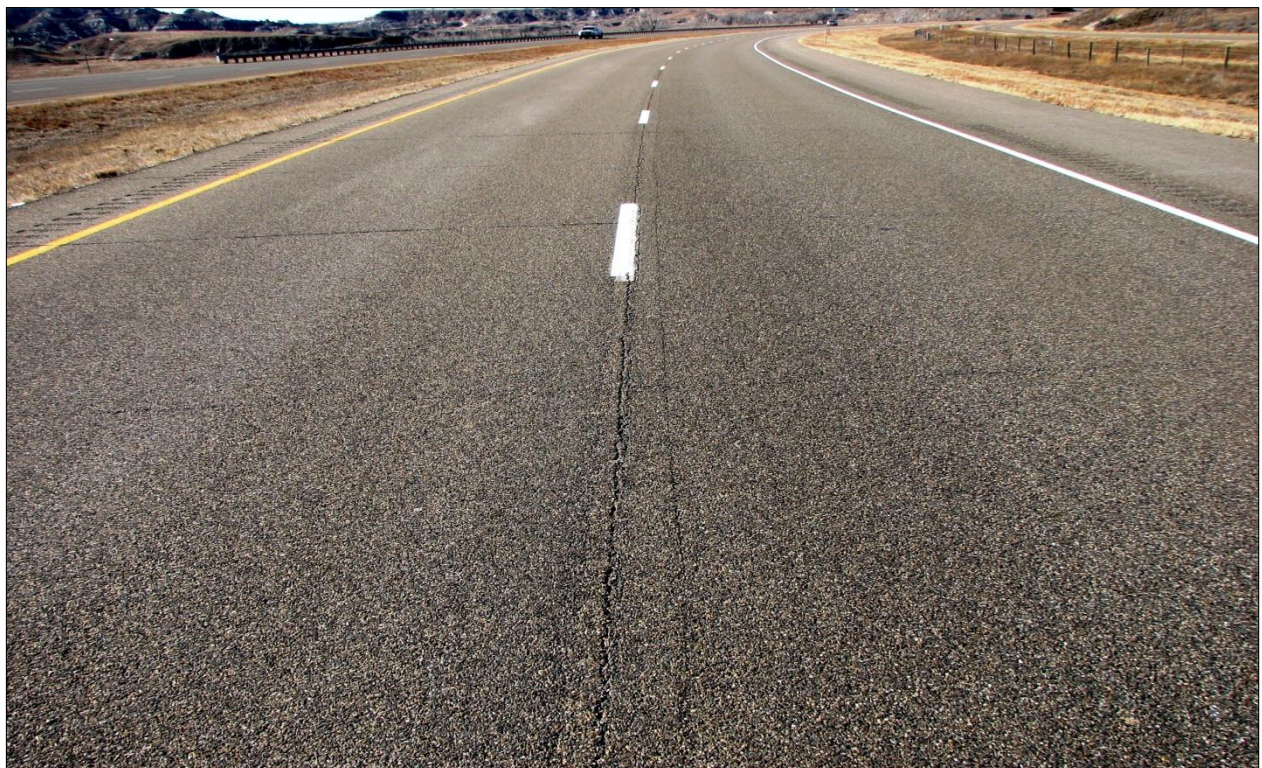
↑↓ East end of project looking west; westbound lanes. Visual inspection of the overall project supports the combined PMS application and PCCP dowel retro-fit treatments as performing well. Pavement mat is tight with minor evidence of raveling or bleeding. Rutting is also at a minimum. On average reflective joint cracking is rated at low-severity.

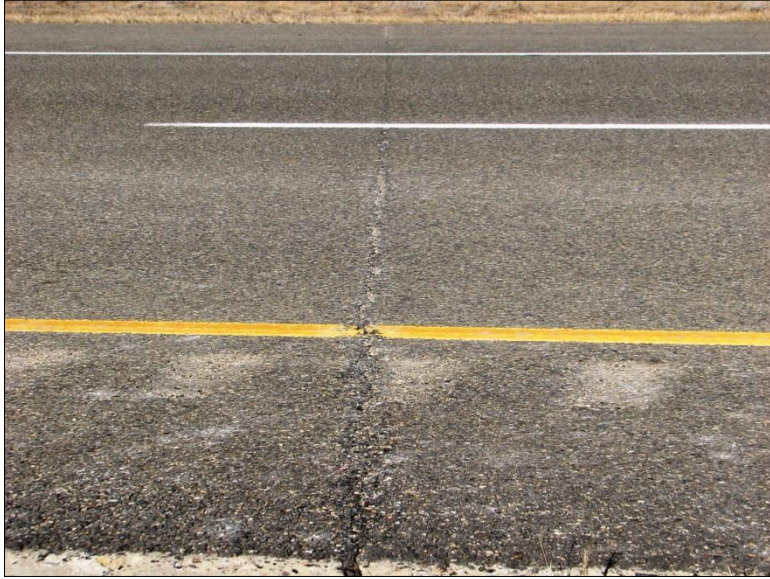
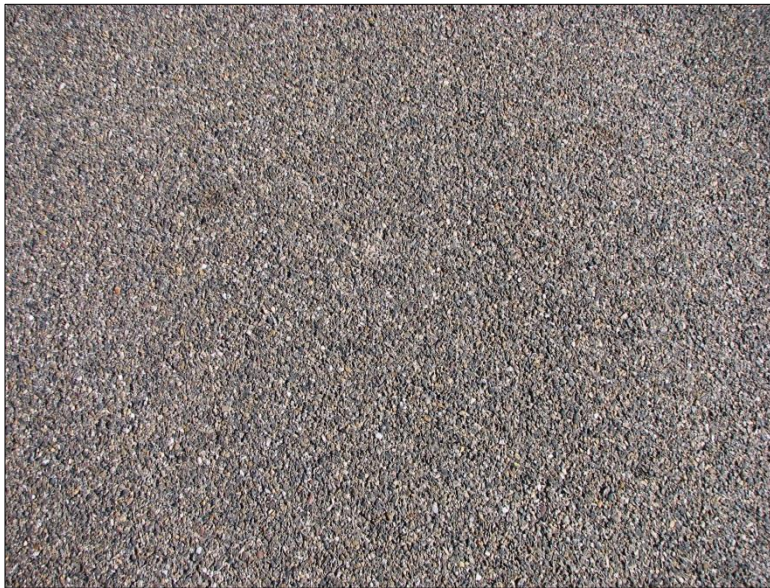
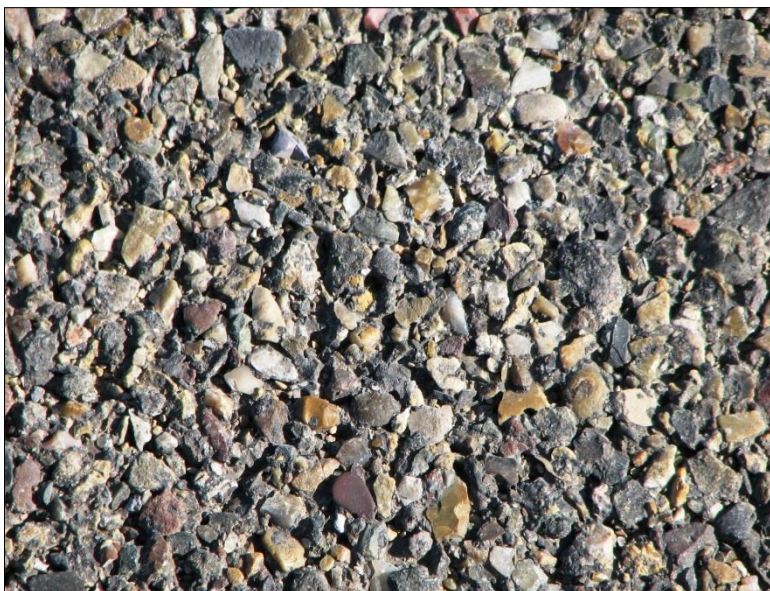
←↓ Representative images of pavement condition to reflective joint cracking and mat condition.
