EXPERIMENTAL FINAL REPORT

KWIK BOND 1121 POLYESTER POLYMER CONCRETE (PPC) OVERLAY

Location: Interstate 90/Stillwater County/Billings District: Three
Decks: SEP COUNTY ROAD (I00090391+00402),
BERRY CREEK (I00090400+03661),
BERRY CREEK (I00090400+03662)

Experimental Project: MT-13-05

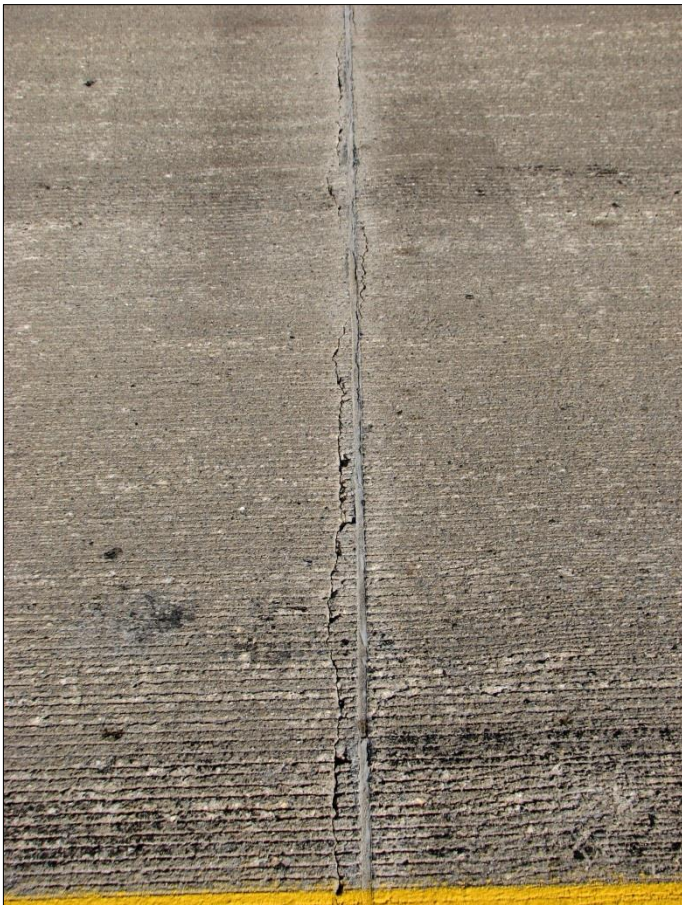
← Sep County Rd. structure: View of cracking along an expansion joint on the south side, east end of the westbound deck.

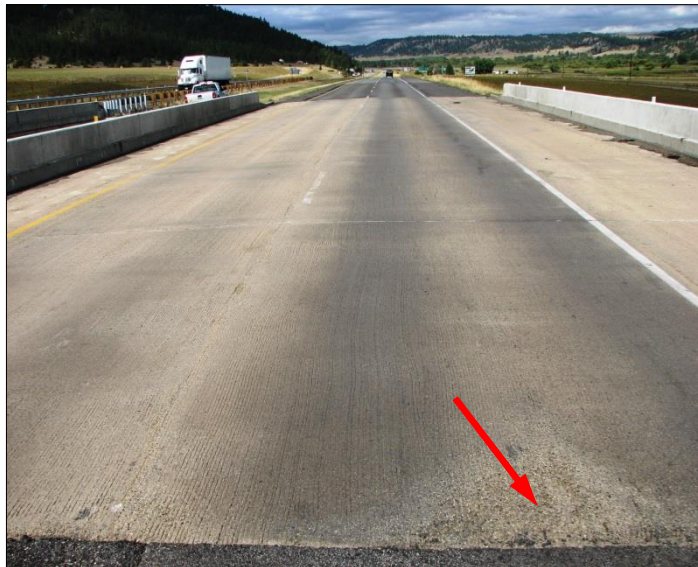
← Surface textures in both lanes appeared to be in good condition after the first year since installation.

Some shearing, assuming plow scrape, of the PPC may be seen at the pavement to deck transition travel lane (Red arrow).

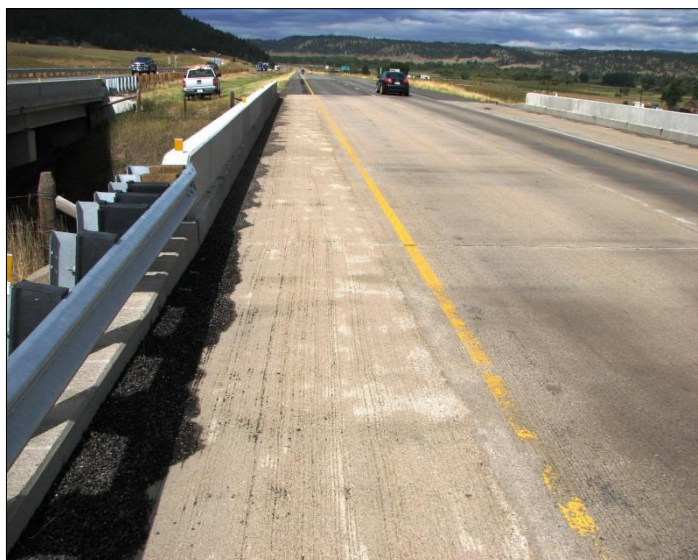
This abrasion or scraping of the PPC material is assuming to be undulations of the polymer due to inconsistencies during the paving process (possibly due to the manual screed and floating of the material after paving) which created varying thicknesses susceptible to plow scrape.

← Additional plow abrasion is apparent on the deck shoulder; predominately on the south side.

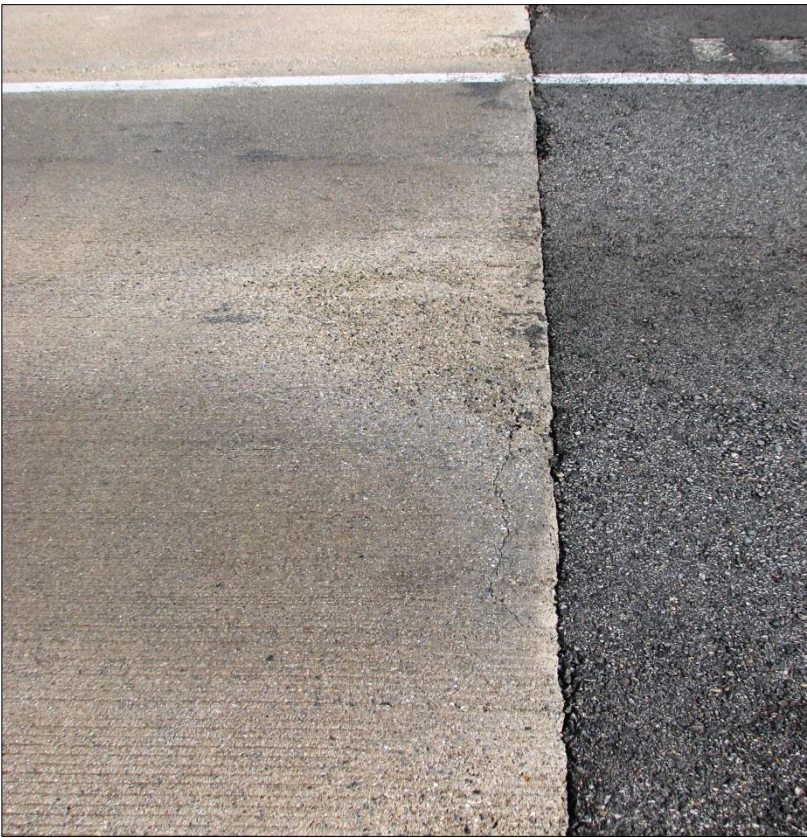
← Closer view of the plow scrapes on the PPC travel lane in addition to some localized stress cracking near the joint approach (red arrow).

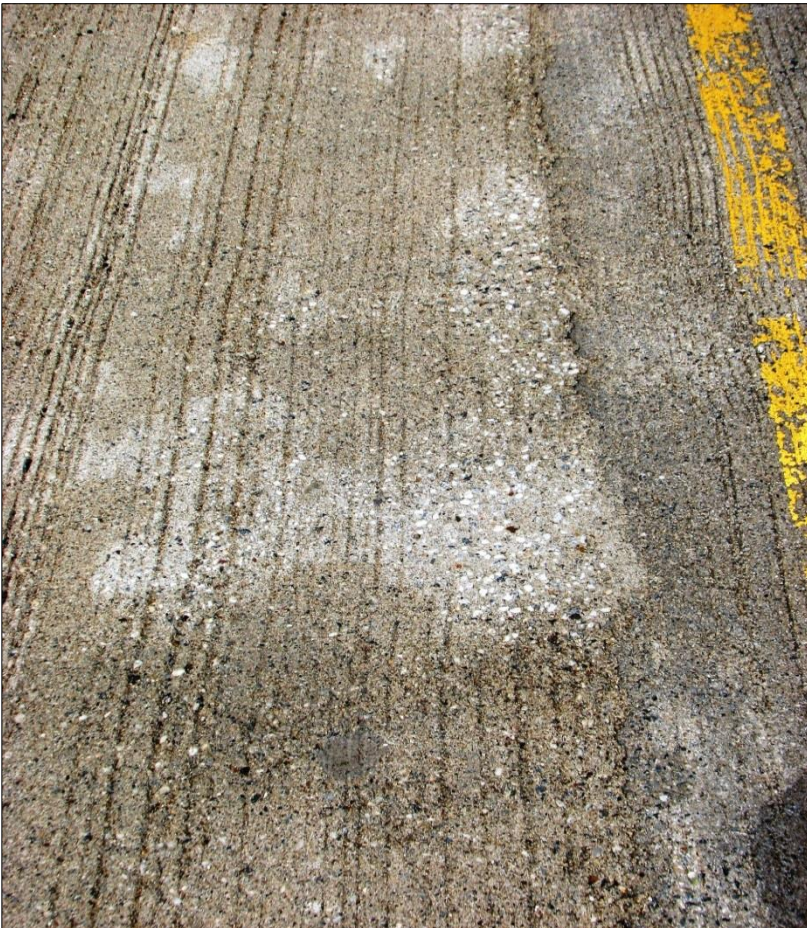
← Close-up of PPC abrasion by plow passes (south deck shoulder).

Future inspections will document if this trend continues.

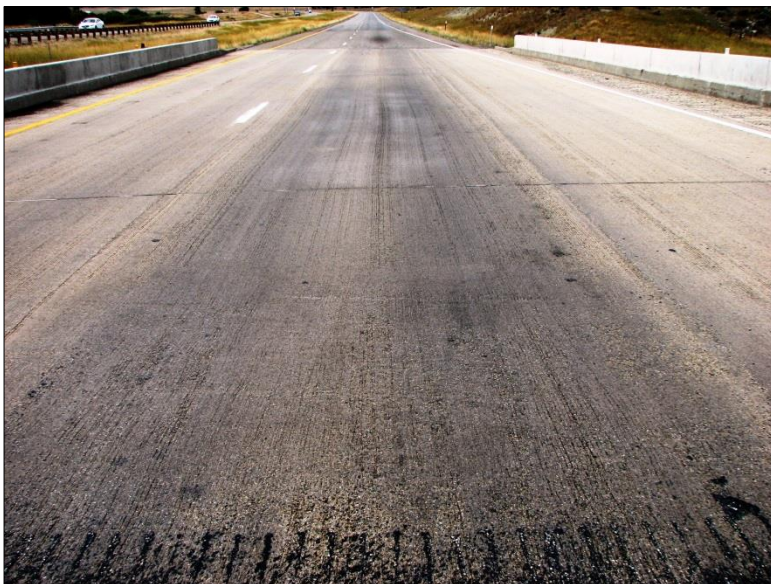
← Berry Creek Westbound:
Visually, both structures
surface texture appears coarse
with tining well pronounced as
initially placed in 2014.

No evidence of plow abrasion
on any area of the two decks
as seen on the Sep County
structure.

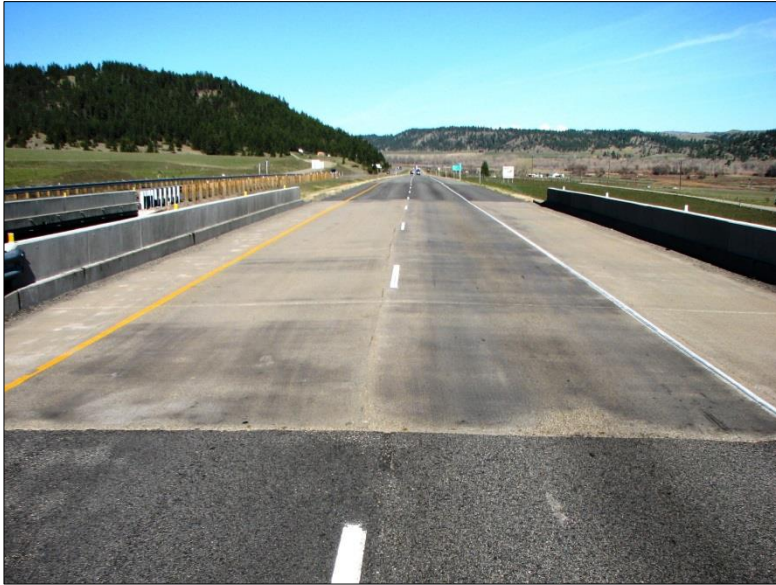
Slight abrasion of PPC at transition (red arrow).

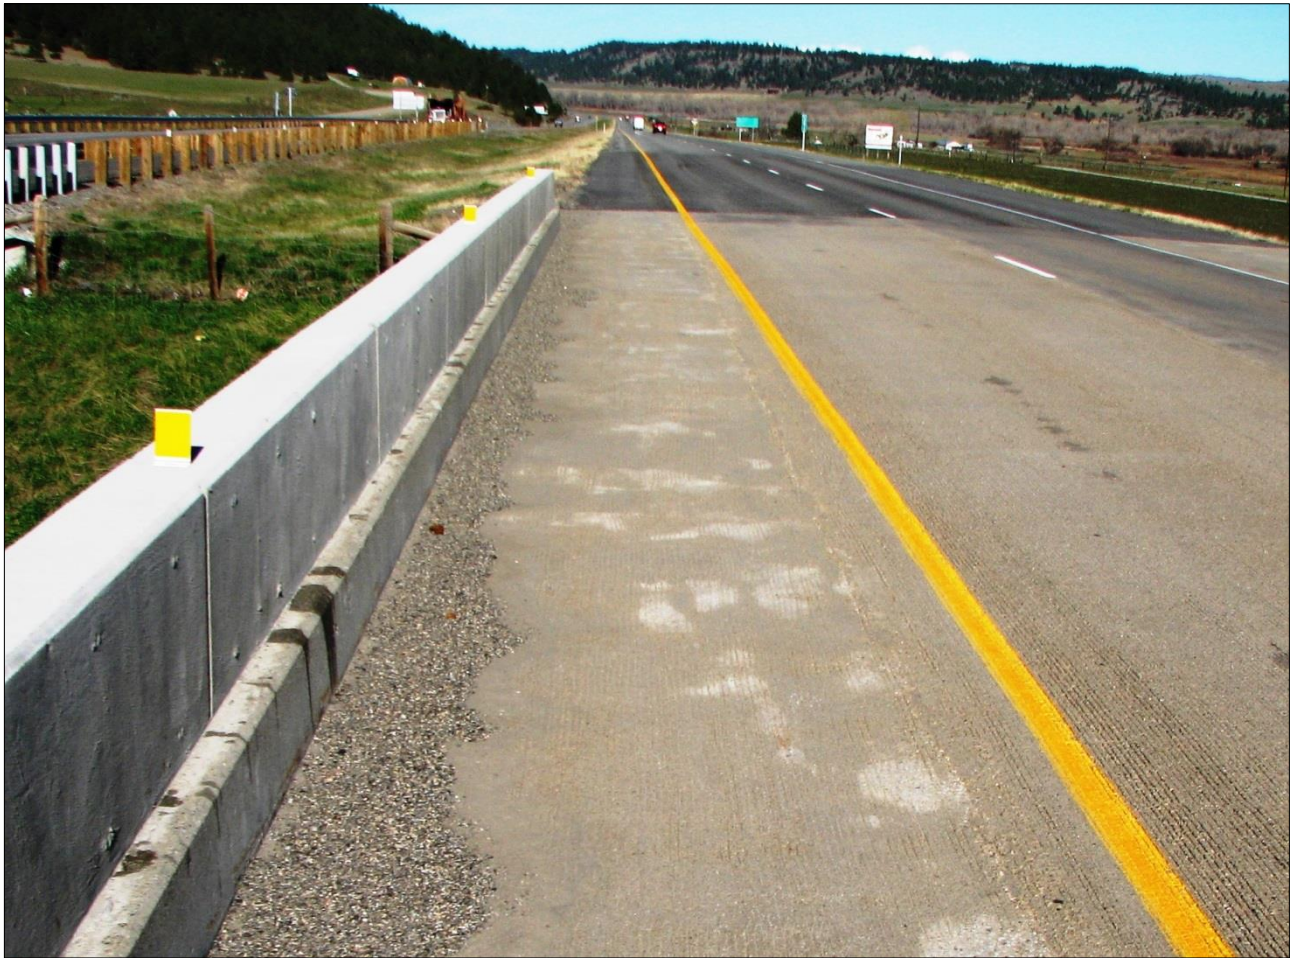
↑ Shoulder abrasion due to snowplow passes as documented in 2015; most likely due to an uneven application of PPC. To date not an indication of deficient performance.

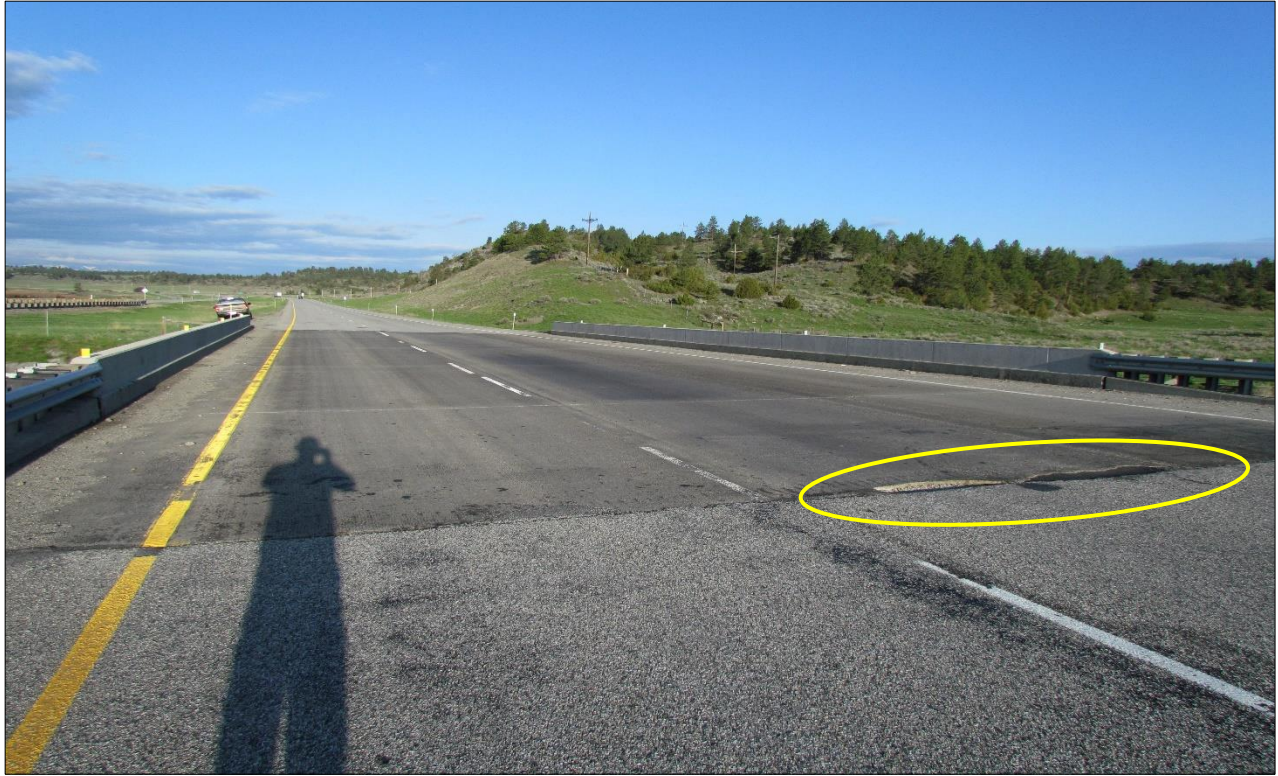
↑ East end of Berry Creek Rd. westbound structure (view west); circled area shows section of patched deck and segment of active delamination in the travel lane.

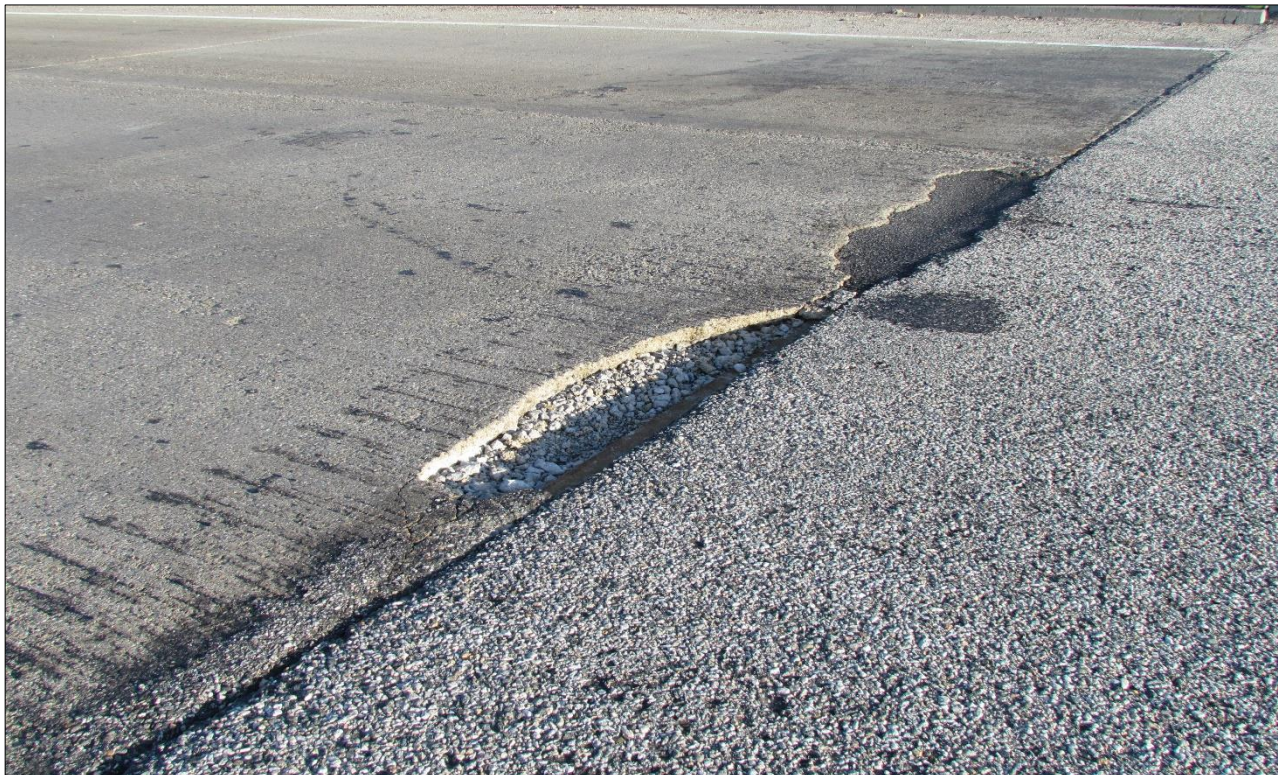
↓ Closer view of the damaged portion of deck at the transition of deck to pavement; the extent of the broken area is down to the top rebar layer and mainly in the wheel paths.

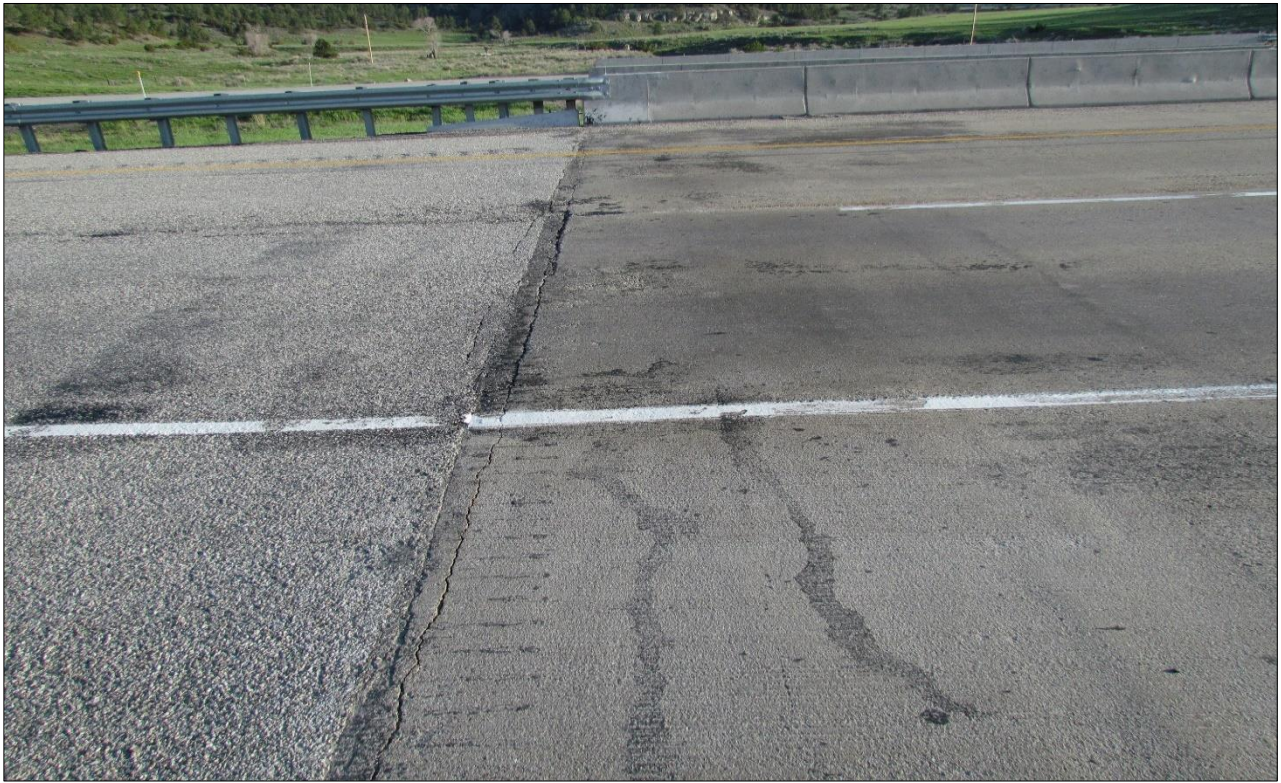
↓ East bound-East end transition joint of deck to pavement; transverse cracking apparent on the PPC which runs along the entire east span.

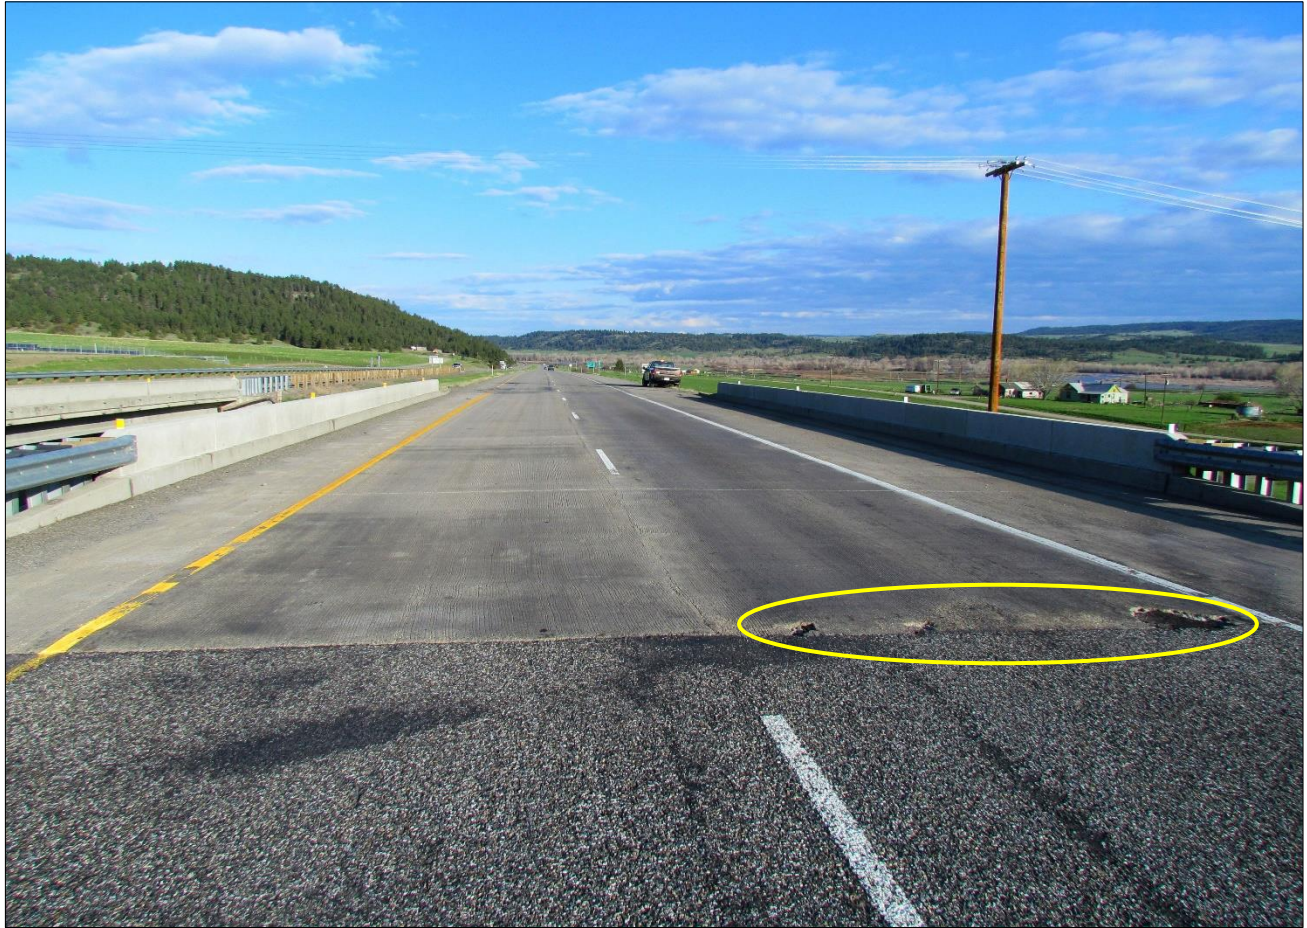
The Berry Creek and Sep County Road westbound structures are beginning exhibit distress similar to punchouts down to the first mat of rebar; mainly in the travel lane at proximity of the AC pavement and deck transverse joint. Some of the affected areas have previously been patched (see page 20).

↑ View west – east end of structure; circled area is uncontrolled cracking with a section of previous patch repair in the travel lane. Most of the damage is located in the wheel paths.

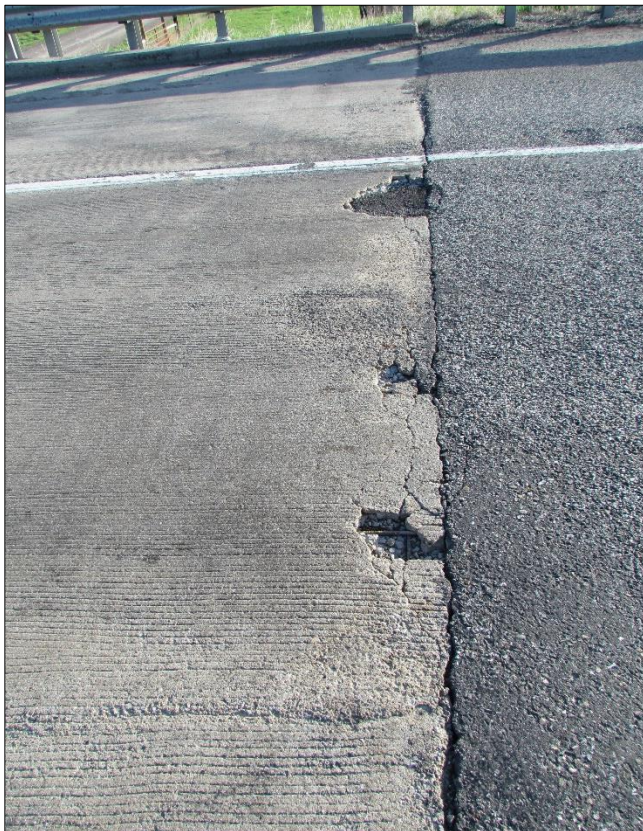
← Another view of the PPC overlay damage (view north).

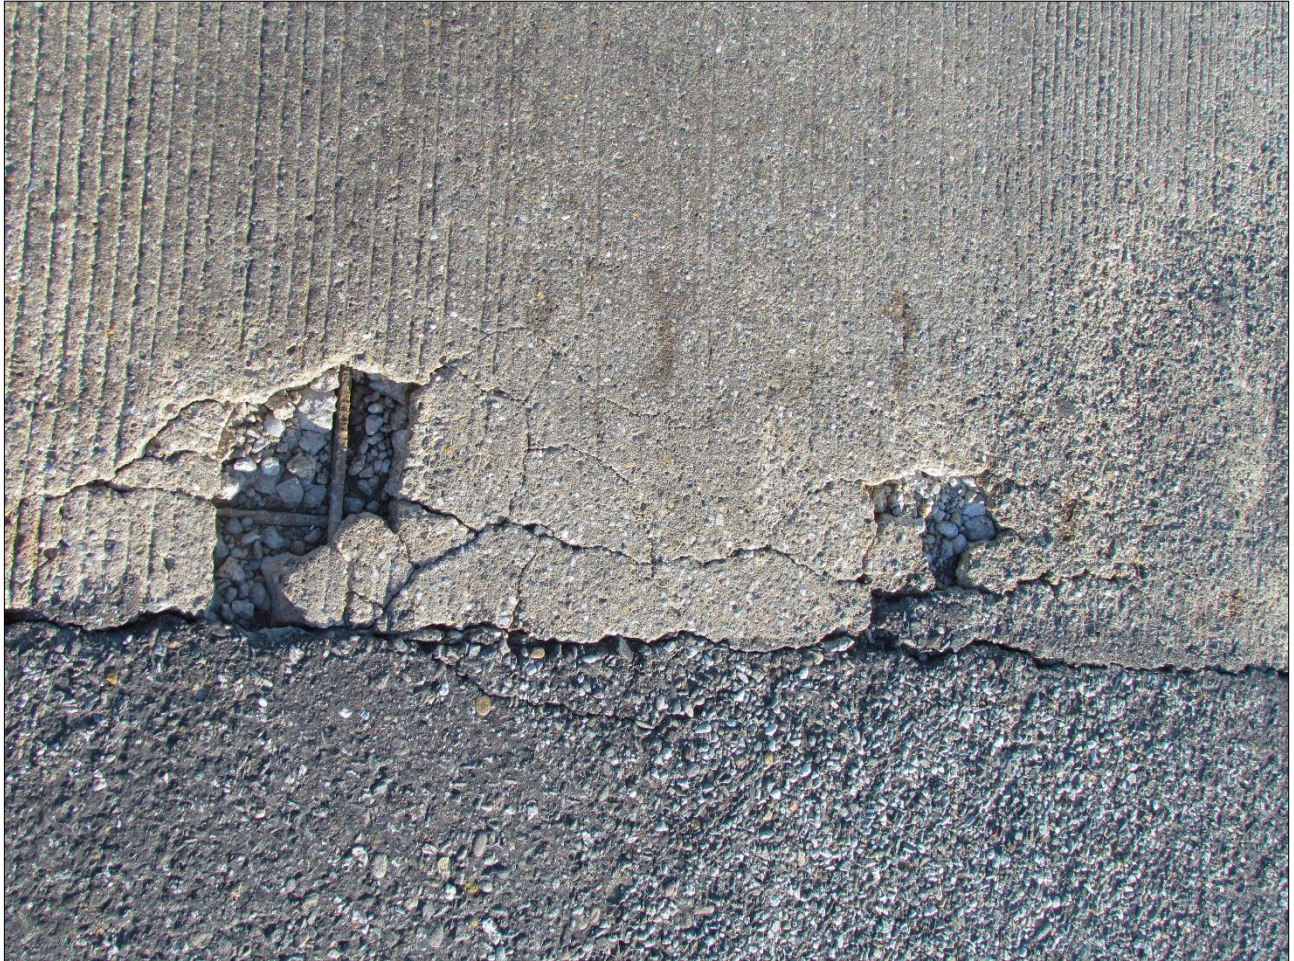
↑ Close-up of damaged deck section.

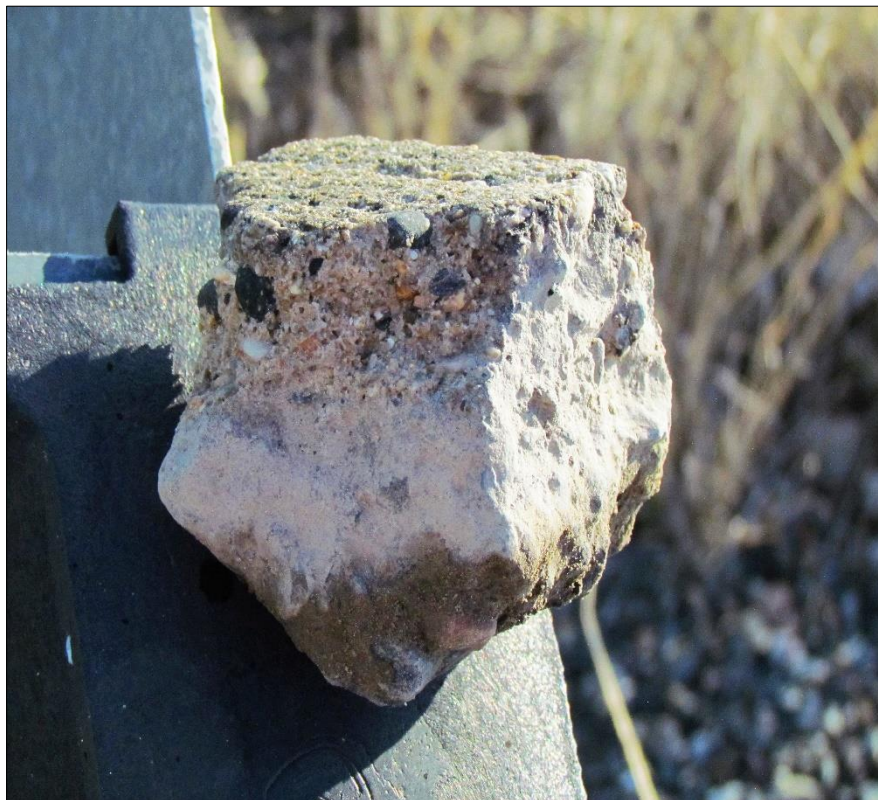
← Piece of the PPC and underlying PCCP; All sections of damaged deck such as seen here revealed no delamination of the PPC to PCCP layer.

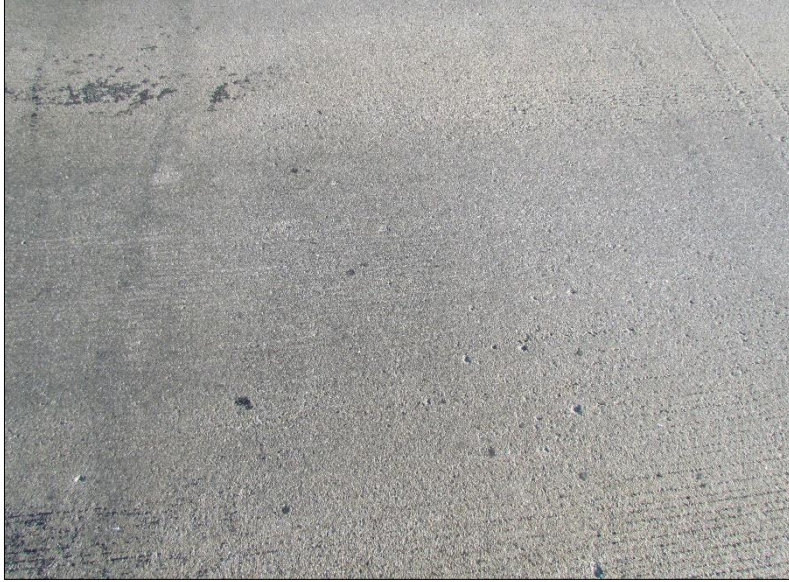
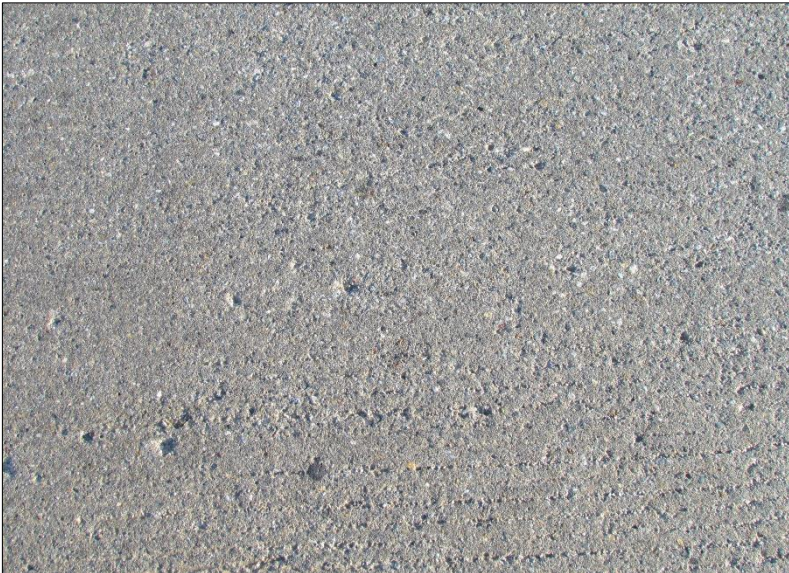
In addition, visually; the structures wheel paths are exhibiting wear not seen in past inspections. The Department may want to perform skid testing to determine if skid resistance is within a reasonable parameter (page 24).

← ↓ The top and center images are representative of the average (visual) wheel path surface texture on the three PPC structures as seen in 2018.

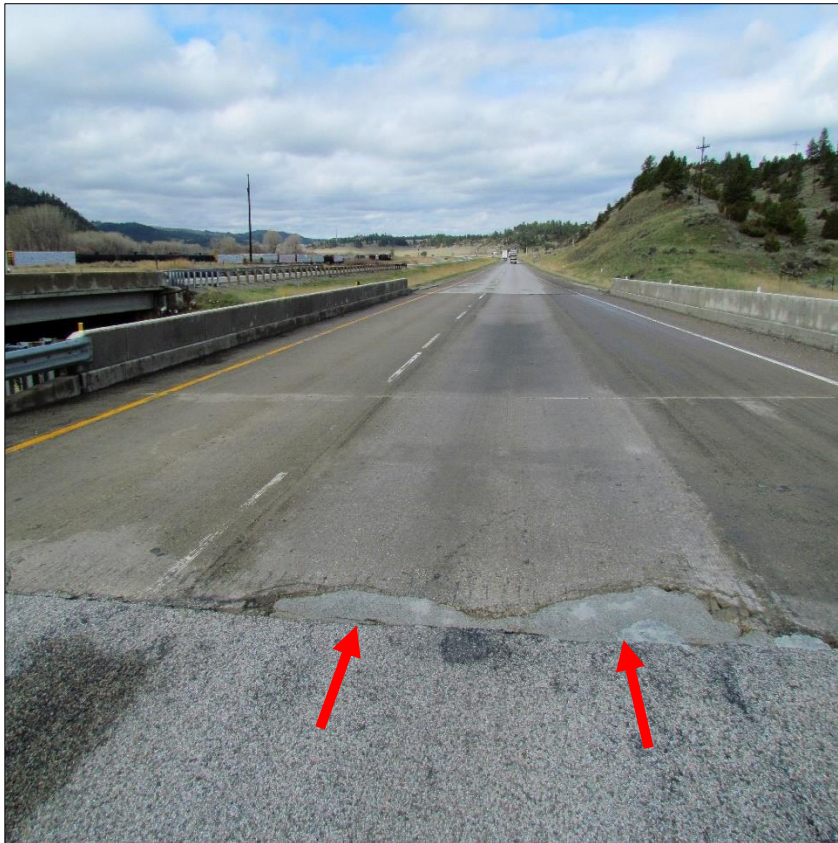
Note the patch repair at the deck edge predominantly in the travel lane wheel path (red arrows).

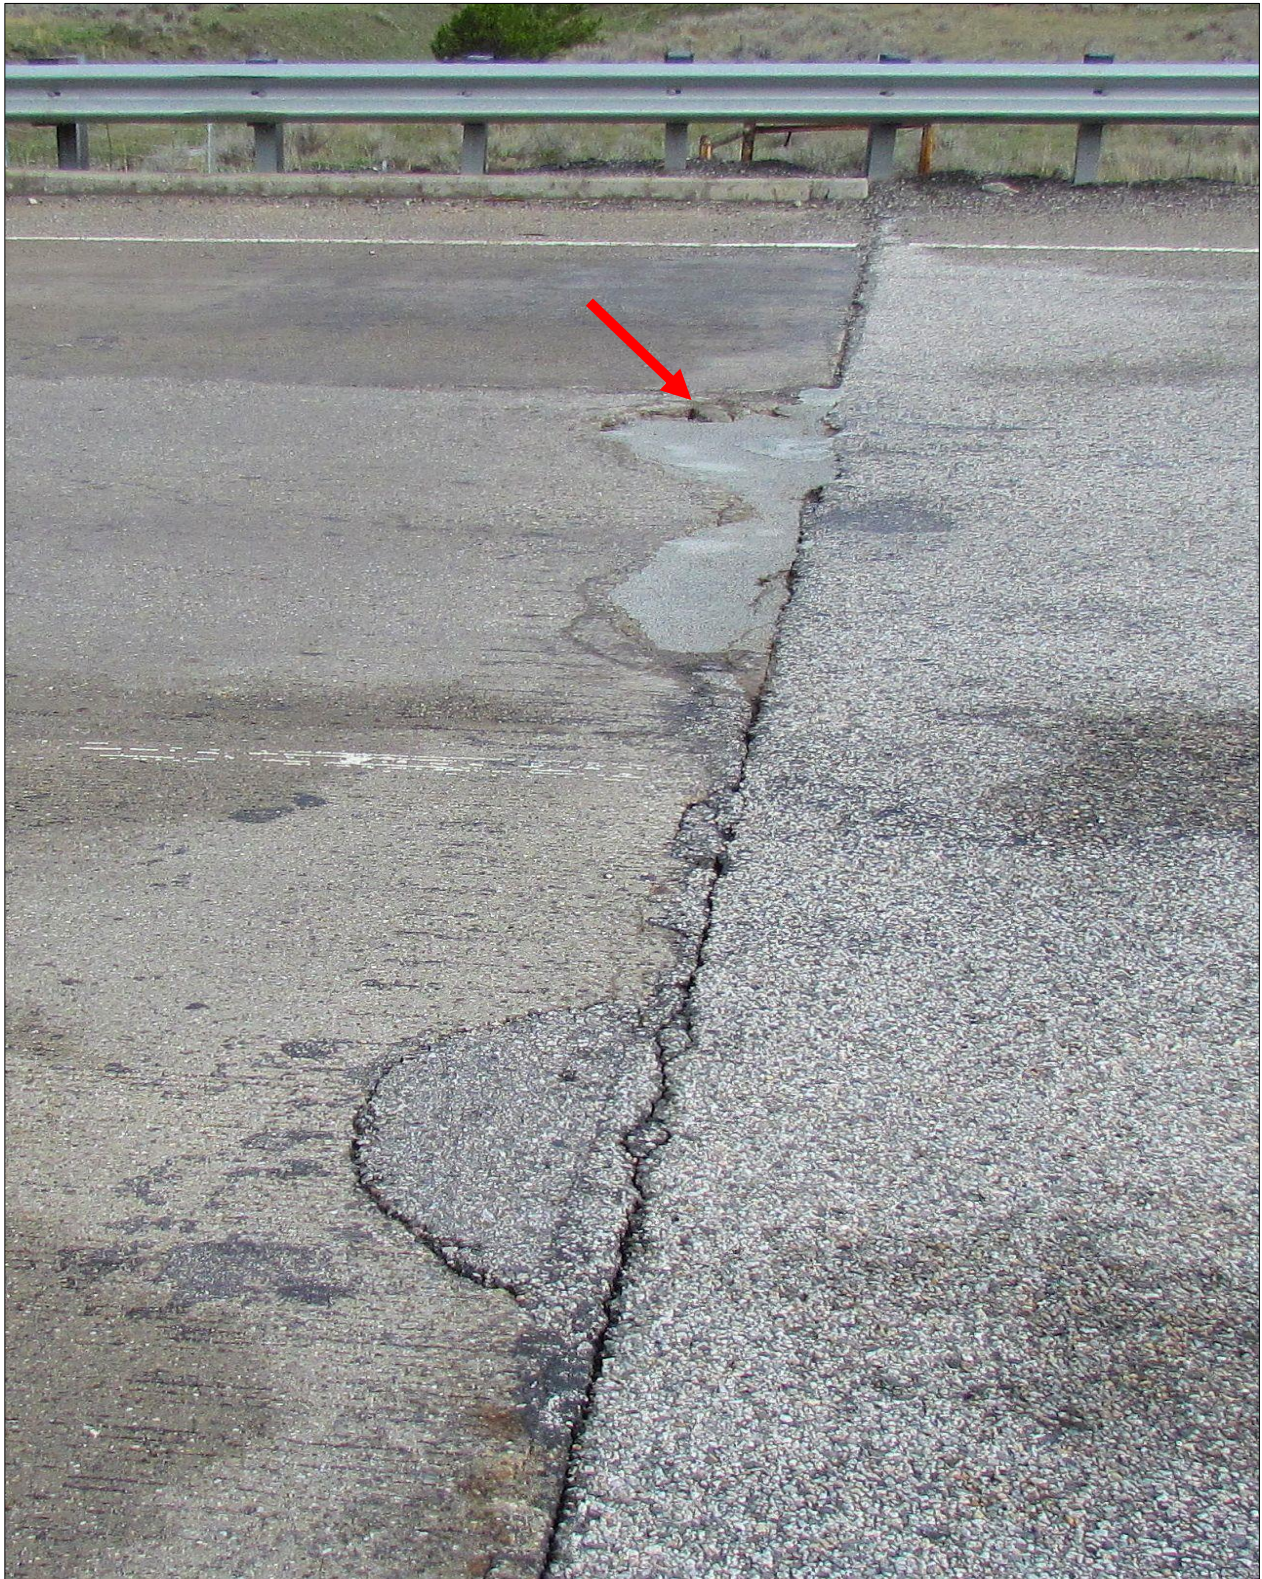
As stated in 2018 inspection; the Berry Creek and Sep County Road westbound structures continue to exhibit distress of cracking or spalling down to the first mat of rebar; mainly in the travel lane wheel paths at proximity of the AC pavement and deck edge joint. Some of the affected areas have previously been patched.

↑ Oblique view of deck patching at east end of westbound deck. An area of patch is also on the passing lane right wheel path.

Red arrow denotes continued spalling on right wheel path of travel lane.

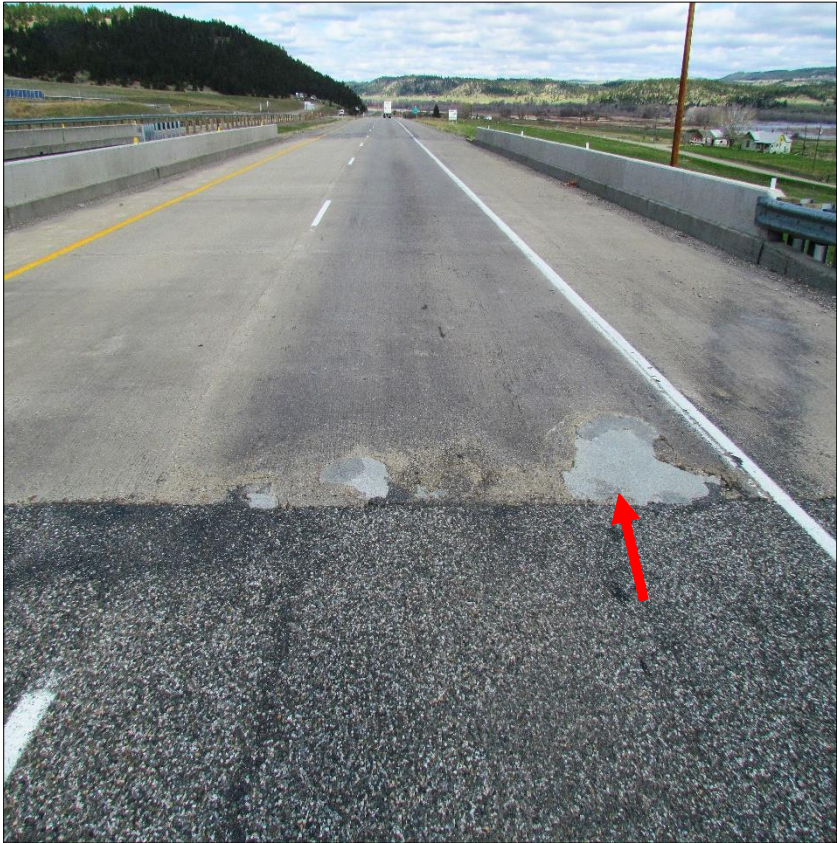
Areas of patched spalling, mainly in the wheel path (red arrow).

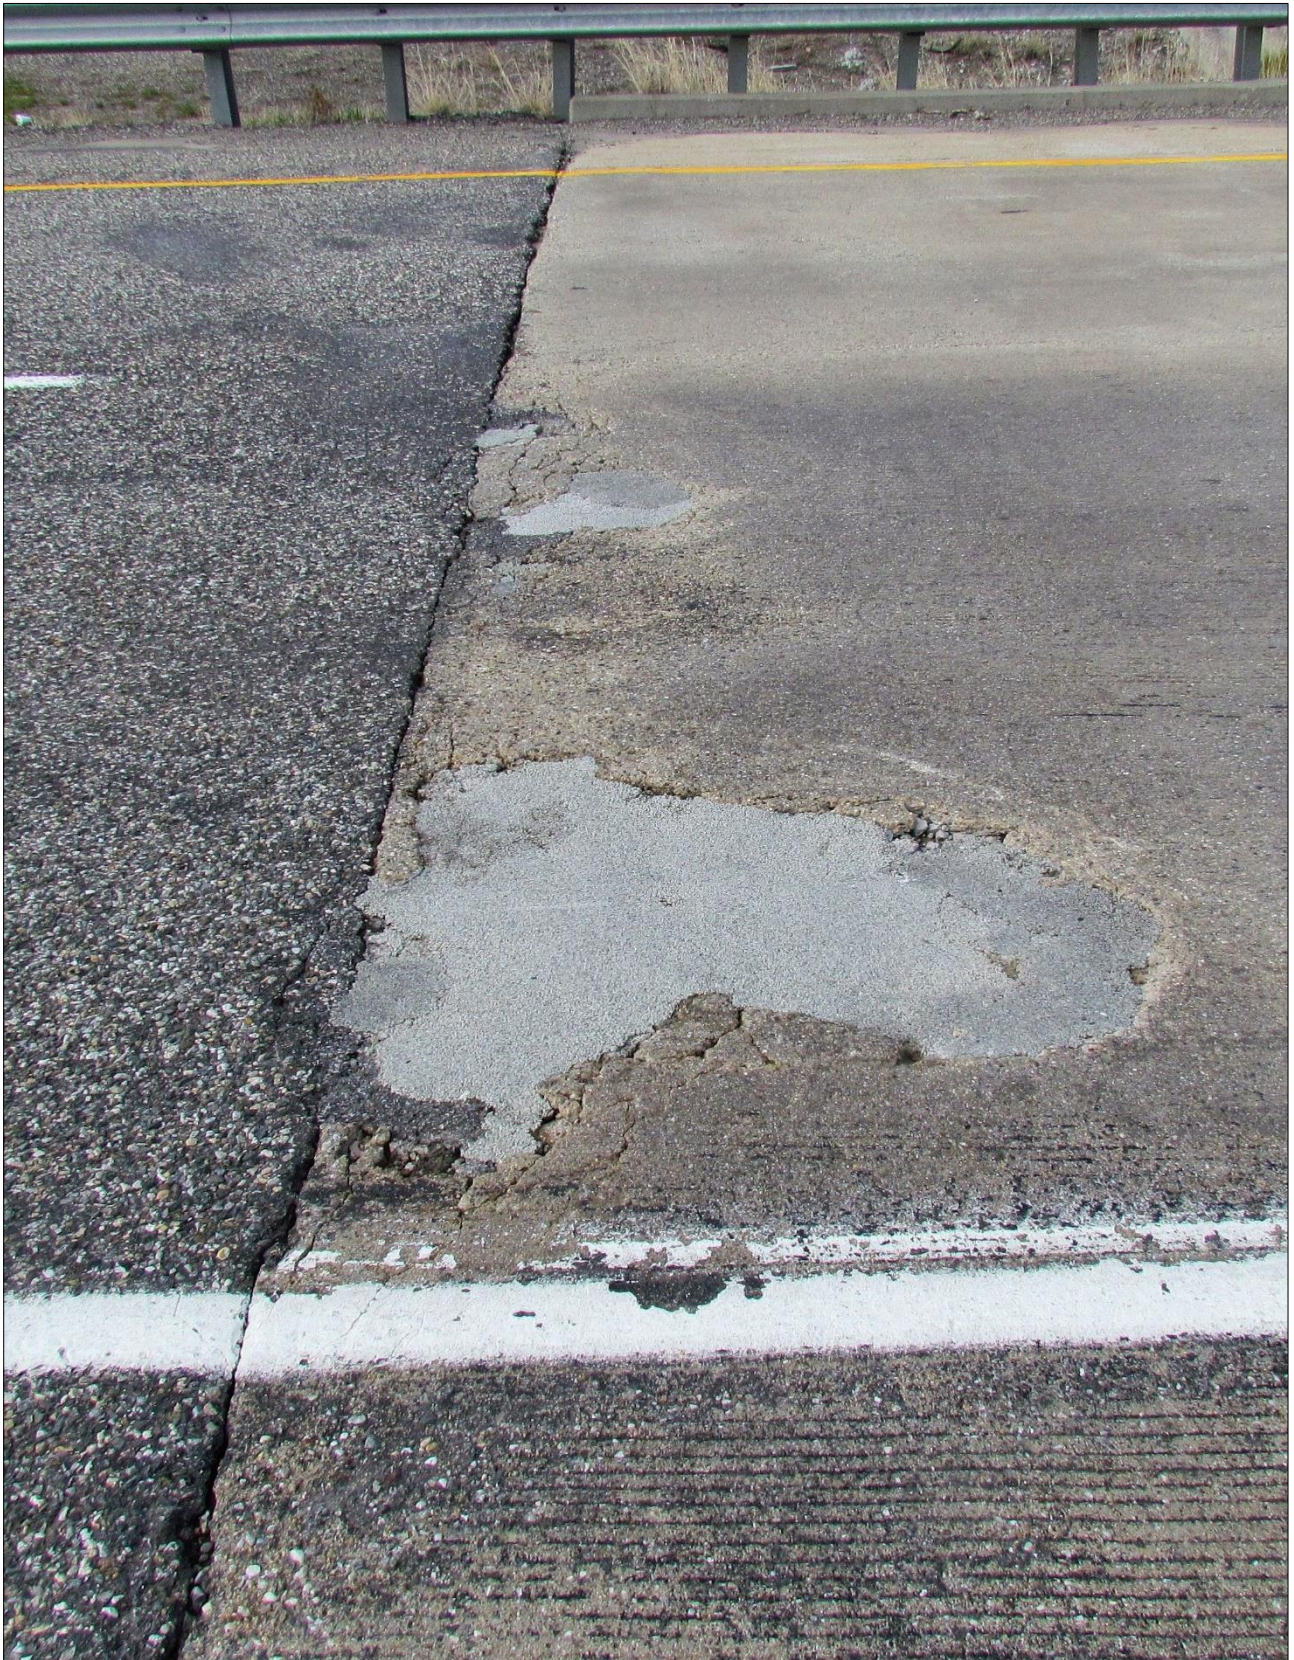
↑ Additional view of deck patching at east end of westbound deck; continued spalling is apparent.

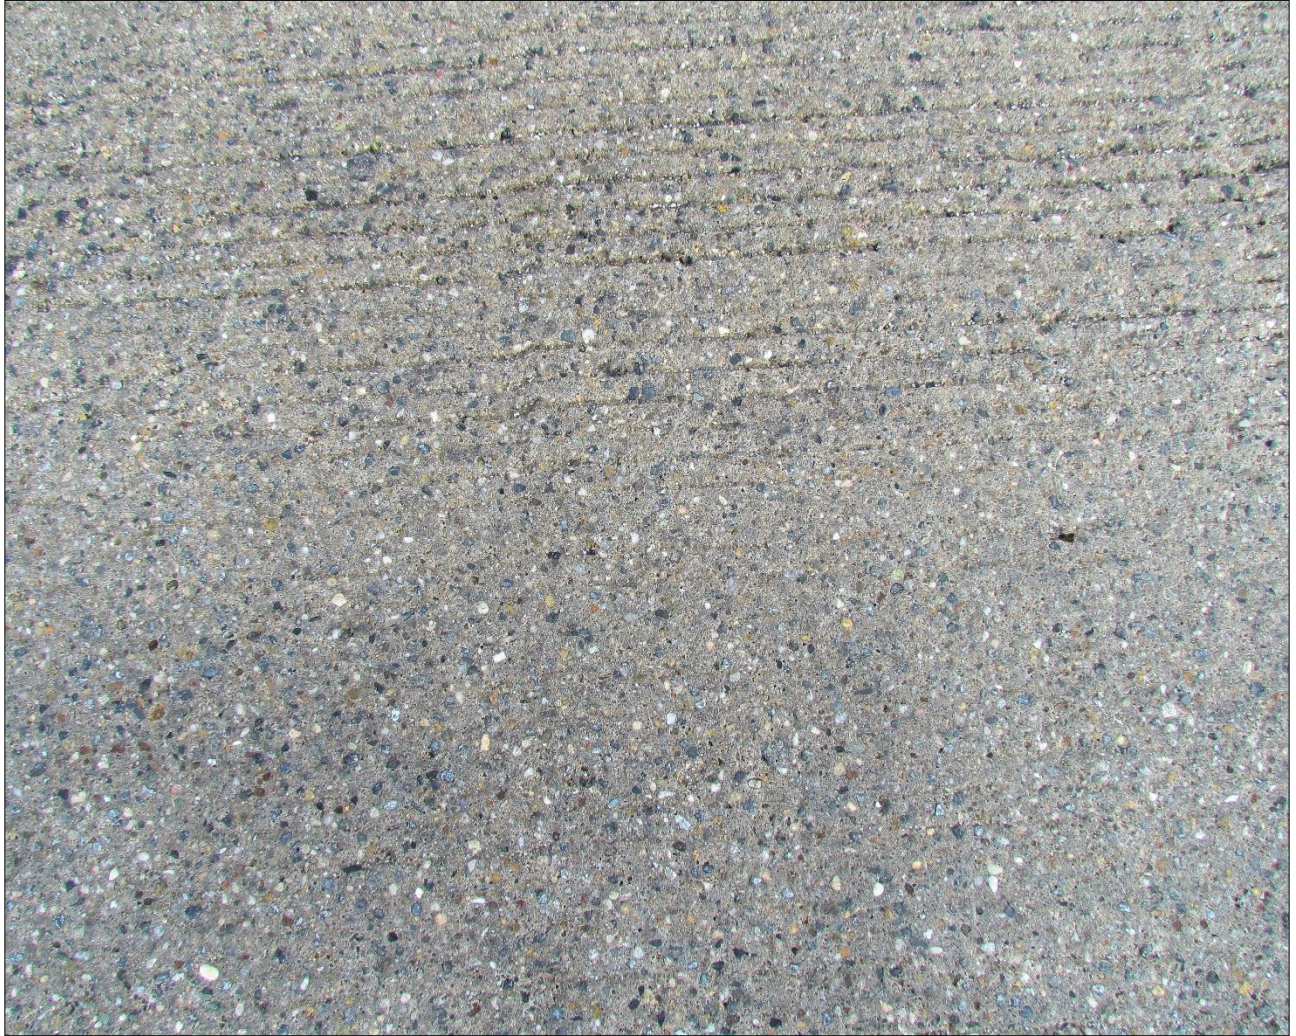
The three PPC structures wheel paths are exhibiting a more polished appearance not seen in past inspections. The Department may want to perform skid testing to determine if skid resistance is within a reasonable parameter (page 29).

↑ General representation of the texture difference within and outside the wheel path on all three PPC decks.

The upper half of the image shows some of the initial tining applied during construction in 2014 (see page 9); the lower half of the image is the texture within the wheel paths with a more polished appearance.
