## EVALUATION REPORT

### FIBER-REINFORCED POLYMER (FRP) PULTRUDED DECKING MATERIAL AND HELICAL ANCHORING SYSTEM FOR USE IN SNOW FENCE APPLICATIONS

Project No.: IM90-7(63)331

Description: Fifth semi-annual evaluation of remaining test section of snow fence using proprietary EZ-Deck Fiber-Reinforced Polymer (FRP).

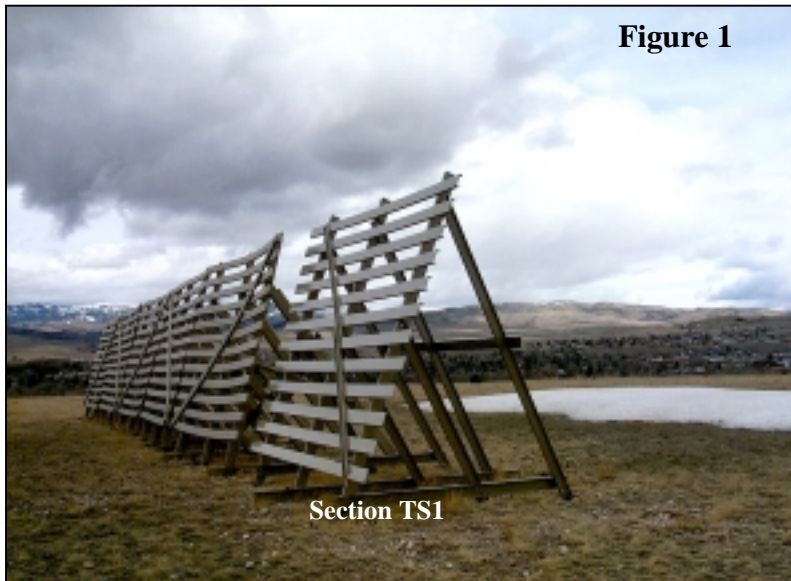
**Figure 1**

Inspections are held in early spring and late fall to document the environmental effects of seasonal extremes of the FRP material as well as stability of design. Figure 1 shows the remaining section TS1 as seen on April 10.

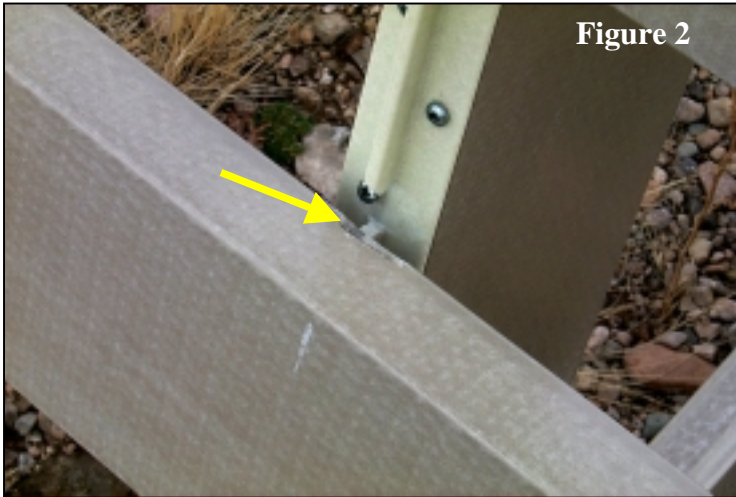
As detailed in the October 2001 inspection, the FRP plank, at the top of the center clip attachment, seems to have broken or sheared off. Figure two shows a close-up of the broken clip. The screw used to help secure the plank to clip remains. The plank shows the damage from the screw head as it (apparently) was pulled away. We

can assume stress on the front panel from wind turbulence could have caused the separation. This occurrence is just on one clip attachment. The damage was not noticed on any other areas of the test section during this inspection. No additional movement was noticed during this evaluation, all other connections used to attach the FRP planking to the frames are intact with no evidence of loose screws or chipping of the FRP rail attachments. Visual appearance of all the FRP material and plank connections shows no signs of deterioration or sun or wind degradation.

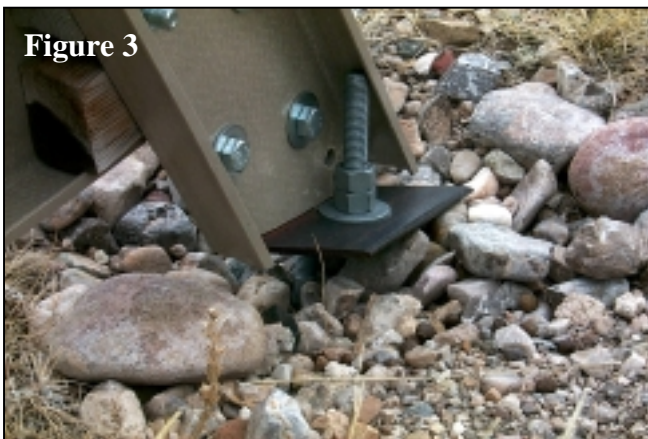
As noted in the October 2000 Report. The right, rear bolt attachment to the frame sill has broken (Figure 3). During this investigation, it was observed the sill had jumped once more to cover the broken bolt of the rear ground support. This broken sill support has, up to this time, not caused a catastrophic failure of section TS1. Nor is there any evidence that this loose rear sill attachment may have caused stress that allowed the center clip bracket to shear off. It was also observed the front frame to bolt attachment has bent slightly. This may be the result of the freedom of the rear connection, which is allowing the stress from wind turbulence to deflect the bolt. The sill frame will be closely monitored in future evaluations.
