**Experimental Feature Evaluation
 December 2022**

Experimental Feature:	Sprayroq – SprayWall Polyurethane Applied Culvert Lining
Location:	Missoula District, Mineral County, Interstate 90, RP 59.0, Nemote Creek
MDT Project Name:	I-90 Nemote Creek Culvert
MDT Project Number:	IM 90-1(205)59
Experimental Project Number:	MT-13-14
Principle Investigator:	Chad DeAustin, Experimental Project Manager (ExPM)
Construction Date:	February 2017
Date of Inspections:	April 2017, April 2018, March 2020, September 2021, July 2022

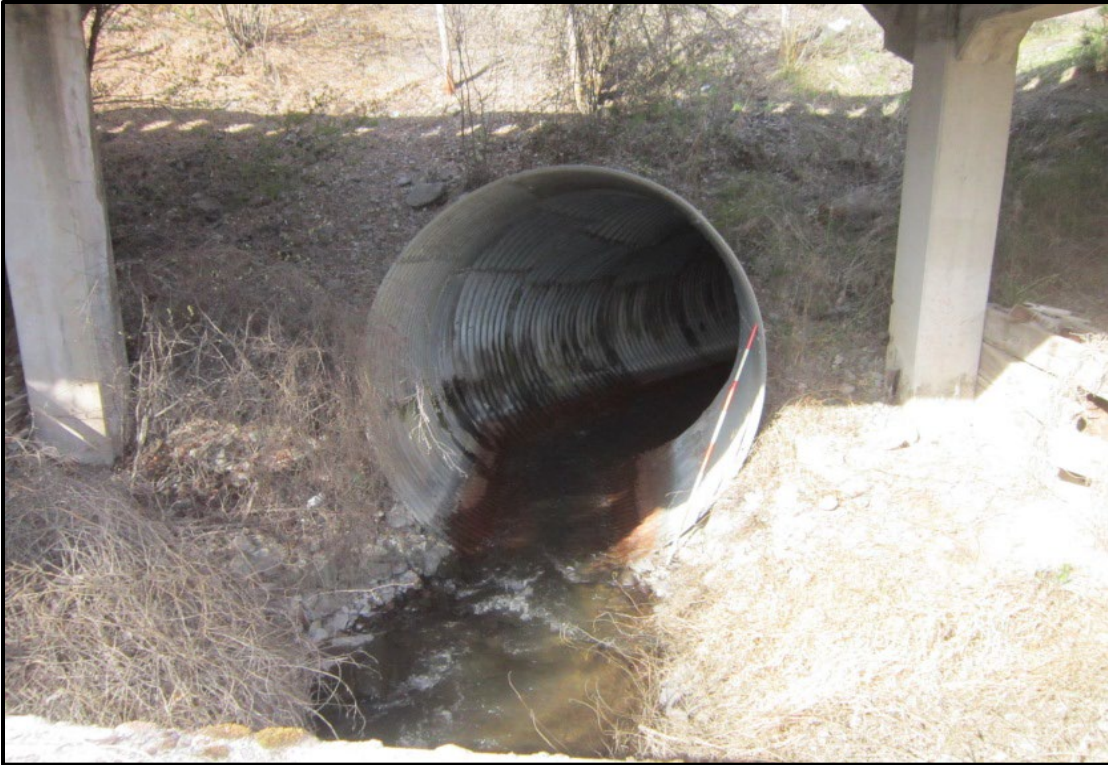
↑ Upstream culvert inlet view, east end.

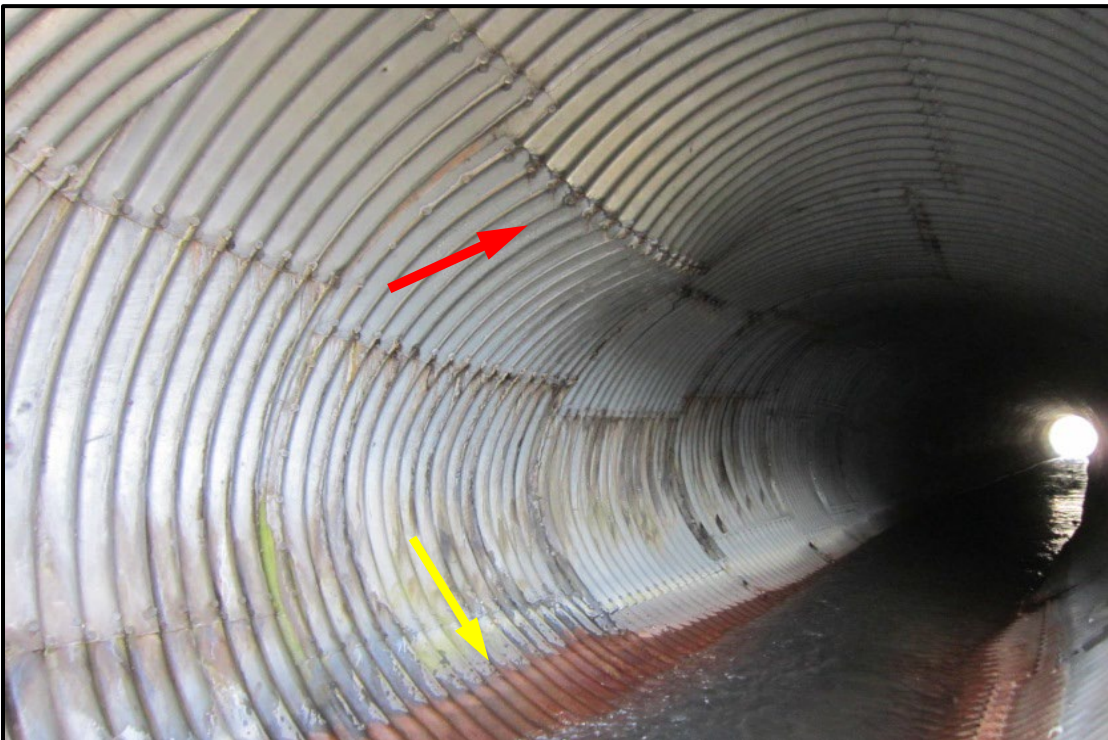
↑ Representative image of the observed sagging in the top panels of the steel plate arch culvert. Deflection estimated at six inches inspected in 2014 (red). Corrosion also apparent at the base of the culvert (yellow).

During project development, Sprayroq representatives inspected the culvert and provided SprayWall application recommendations based on repairing the deflection of the culvert. After discussions with the contractor, it was decided to not repair the deflection. Sprayroq engineers recalculated the application of the SprayWall for the new site parameters.

The original calculation, with the ovality of 9%, was an application rate of 412 mil thickness. With the change in parameters, a new ovality was used of 19.2% resulting in a new mil thickness of 555. For safety purposes, Sprayroq recommended 750 mils for the deflection and area within two feet then tapering to the original design thickness over the remaining area.

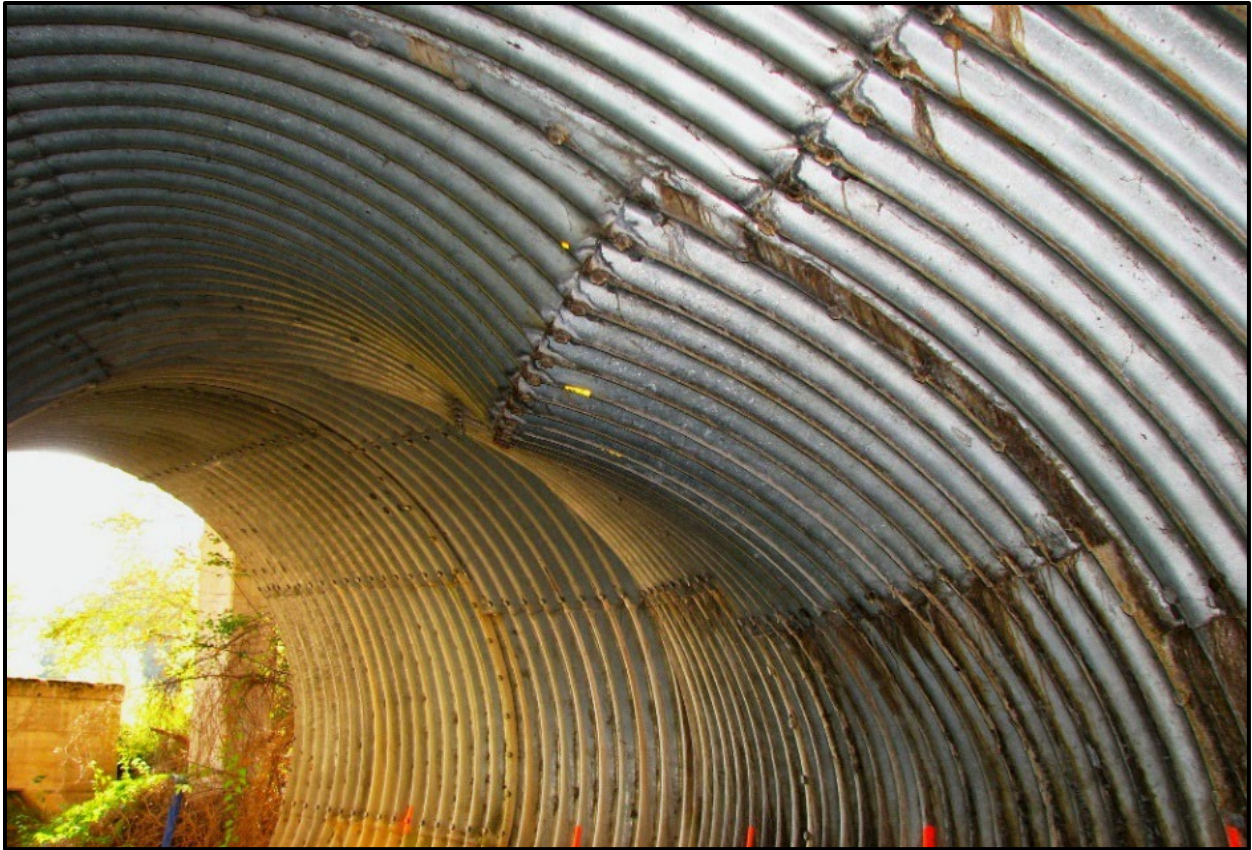
↑ Interior view of extent of steel plate deflection.

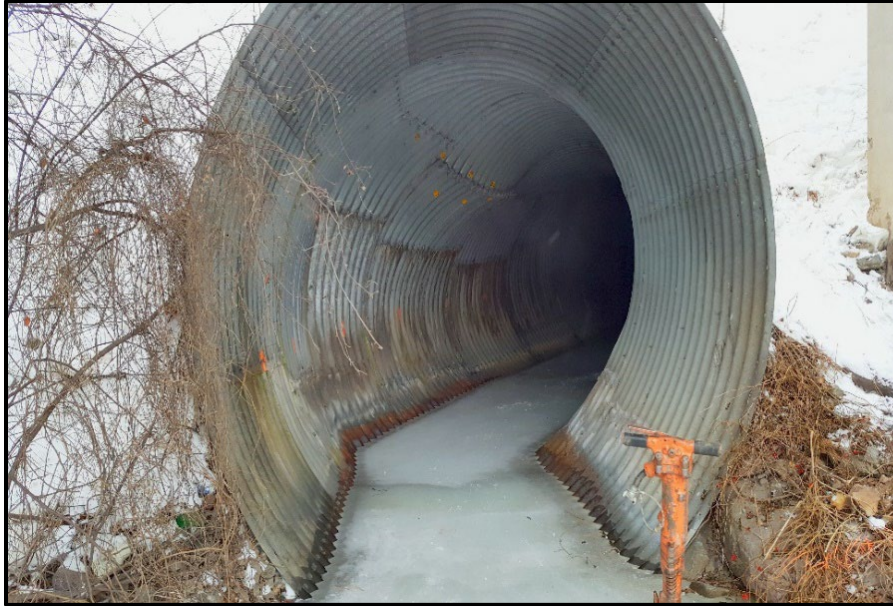
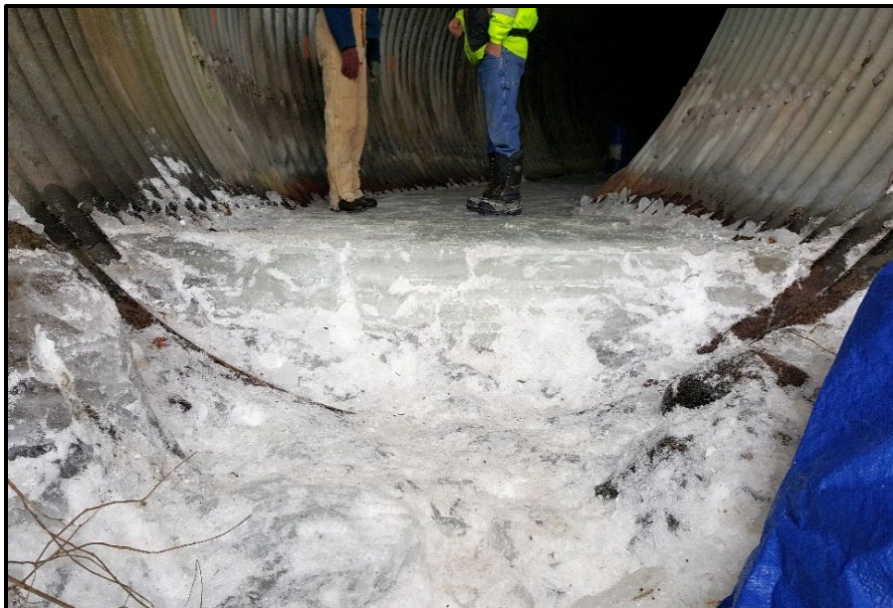
↑↓ The contractor elected to perform the work during the coldest month of winter when the stream was fully frozen. With the intent to remove the ice, then to dry the culvert with high heat to allow the preparation work required prior to the SprayWall application. Shown are representative images of the progress of removing ice from the culvert. Jackhammers, shovels, and picks were used to break up nearly two feet thick ice.

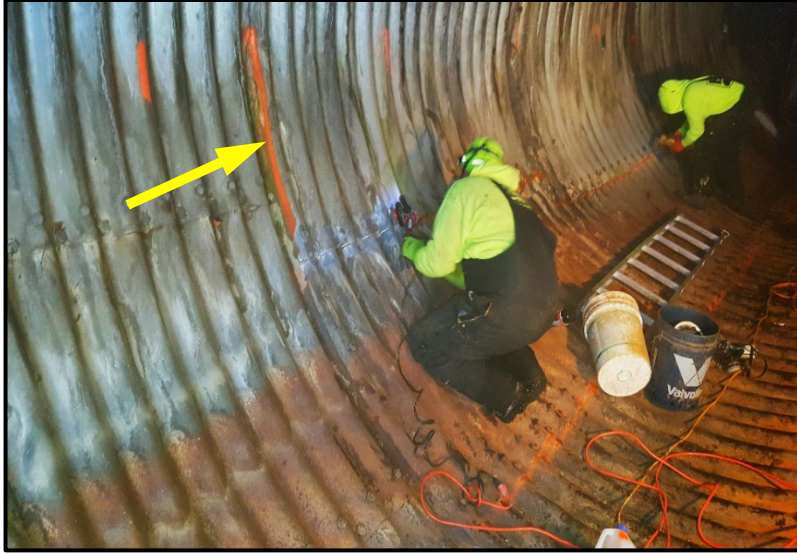
← Surface prep is the key to successful polymer application. For maximum adhesion of the SprayWall liner, the interior surface of the culvert needs to be free of debris, rust, scale, moisture, etc. As seen here, areas of the pipe, mostly seam connections, needing grinding to remove deteriorated material were spray painted orange.

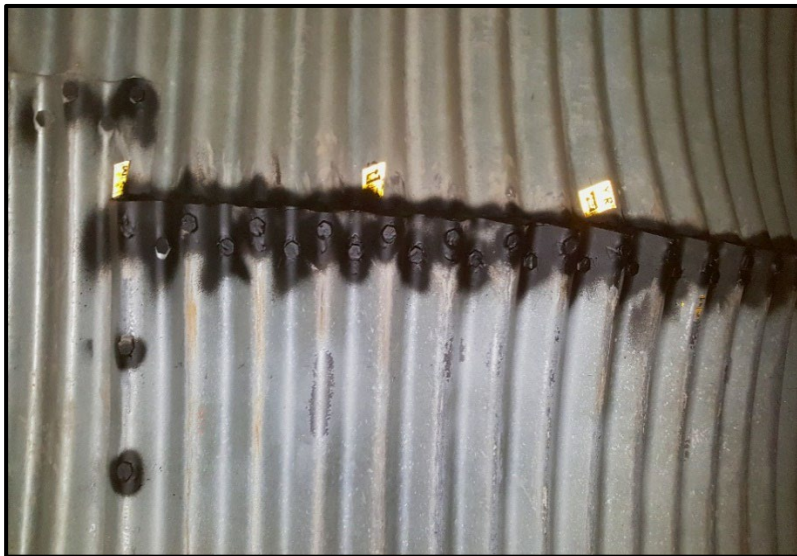
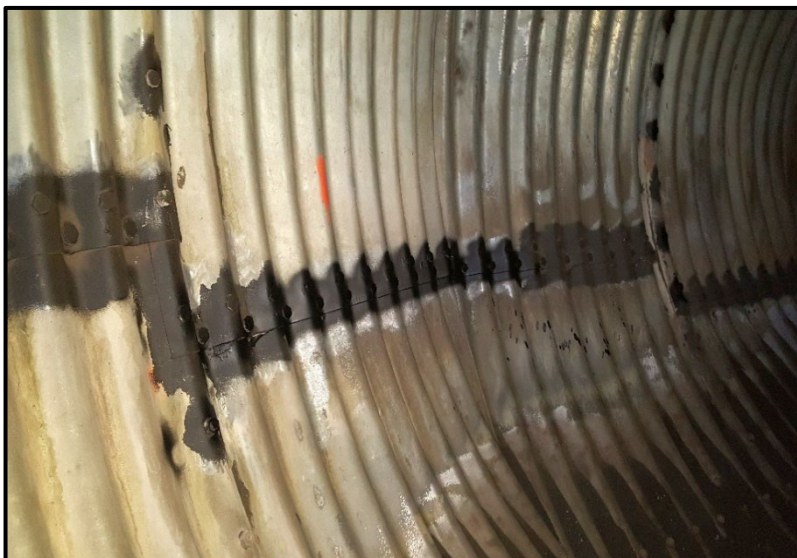
←↓ To prevent oxidation and moisture seepage, Flex Seal is applied to all plate seams and bolts. In areas where moisture still permeated the sealant, a product called Speed Dry was also used to minimize moisture infiltration.

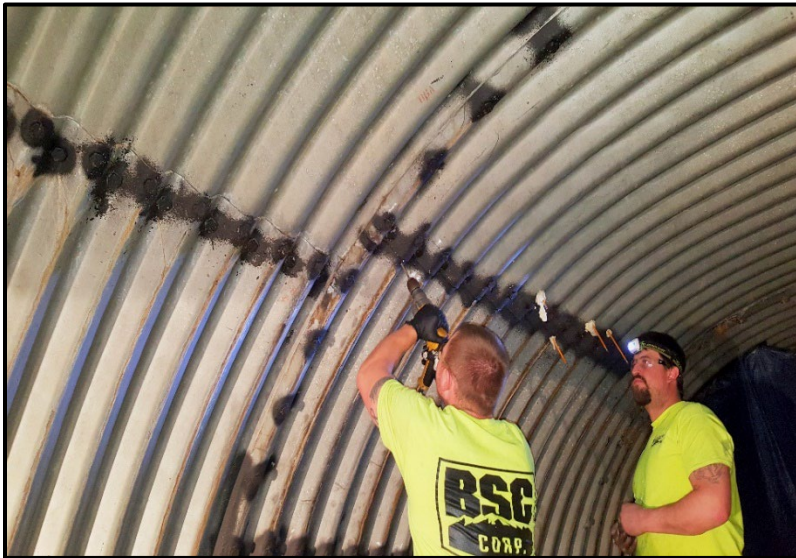
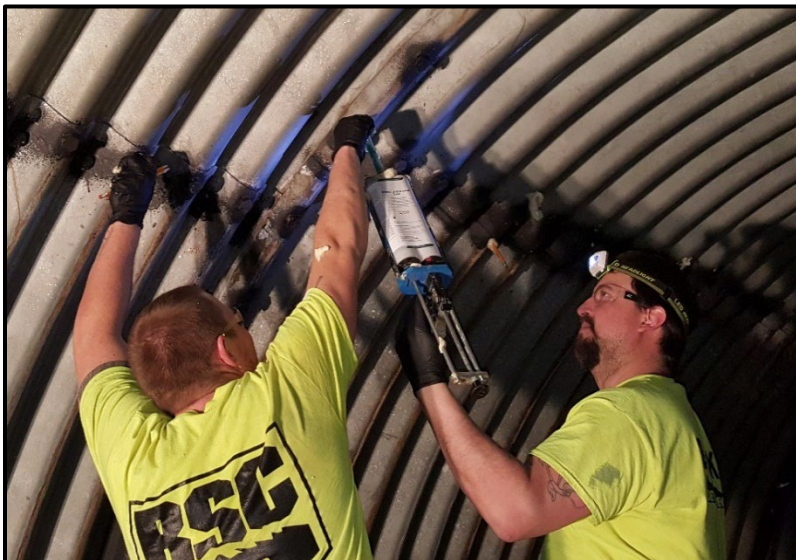
←↓ Although the application of the rubber sealant did mitigate moisture intrusion, the internal heating of the culvert caused moisture, that was inherently frozen around the pipe, to begin to melt and seep through at various plate joint connections. To mitigate this, the contractor would drill near the seam and inject a two-part hydroscopic polyurethane (Dural Aqua-Dam 200F) which expands to create a waterproof seal.

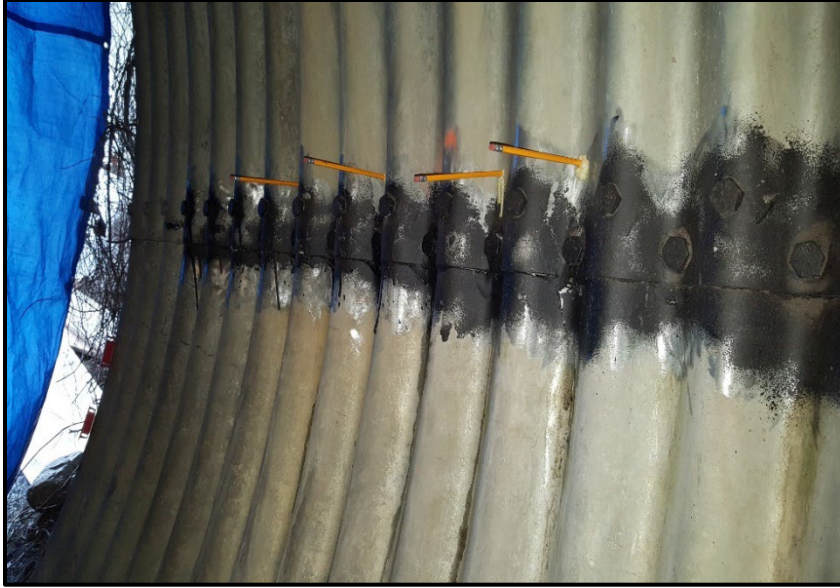
← Once the Aqua-Dam is injected, pencils were used to plug the holes to prevent seepage and allow curing. Once it sets the pencils are cut flush to the surface and excess sealant is removed prior to SprayWall application. MDT inspectors stated the applied sealants were not 100% effective in mitigating the moisture intrusion.

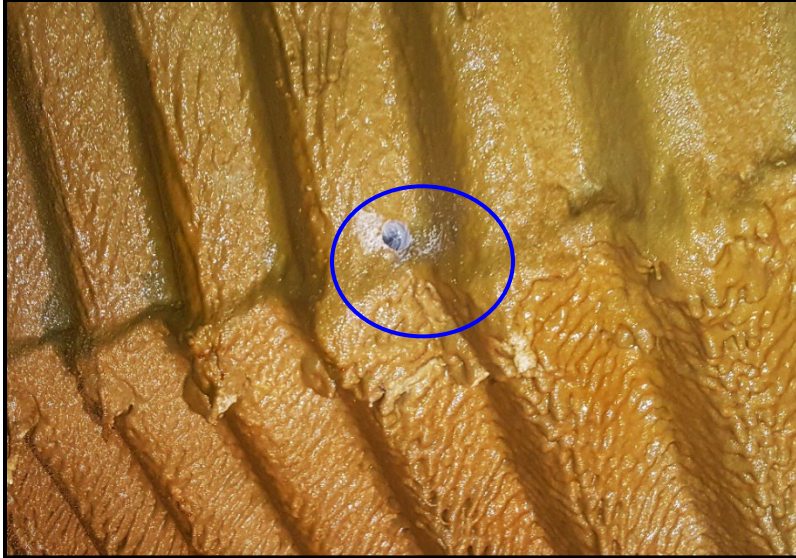
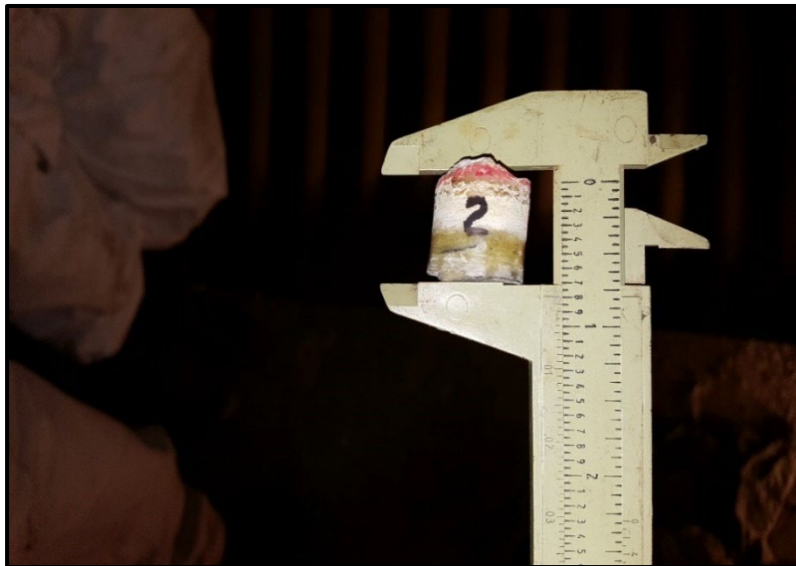
← Several quality controls tests were performed; as seen here, a coring was performed to measure product thickness. The image below shows a core sample taken near the pipe deflection seam at approximately 3/4". Other inspections such as pull testing and spark testing were performed with satisfactory results.

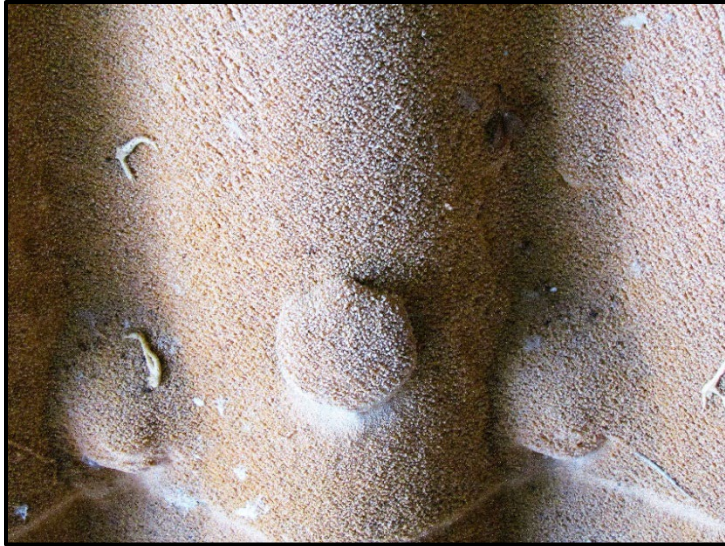
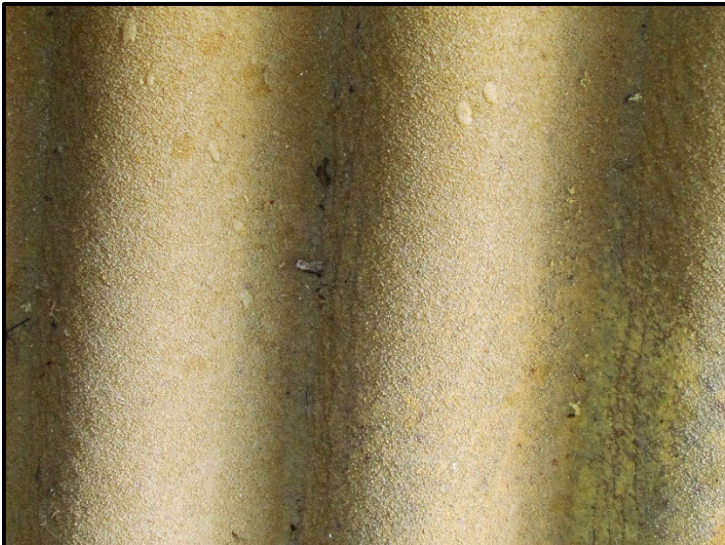
↩️⬇️ During the January 2019 site inspection, it was noticed that approximately the lower quarter section of the culvert had developed a grainy, sandpaper like texture (top and center image). In contrast as compared to the lower image which represents the texture further up the culvert lining.

A Sprayroq representative states this may be an issue of overspray during initial application.

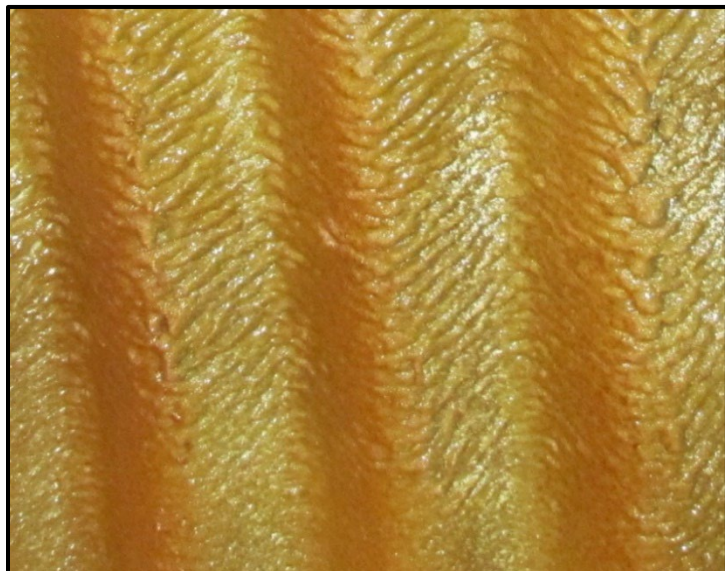
↩️ SprayWall texture noticed in much of the treated area.

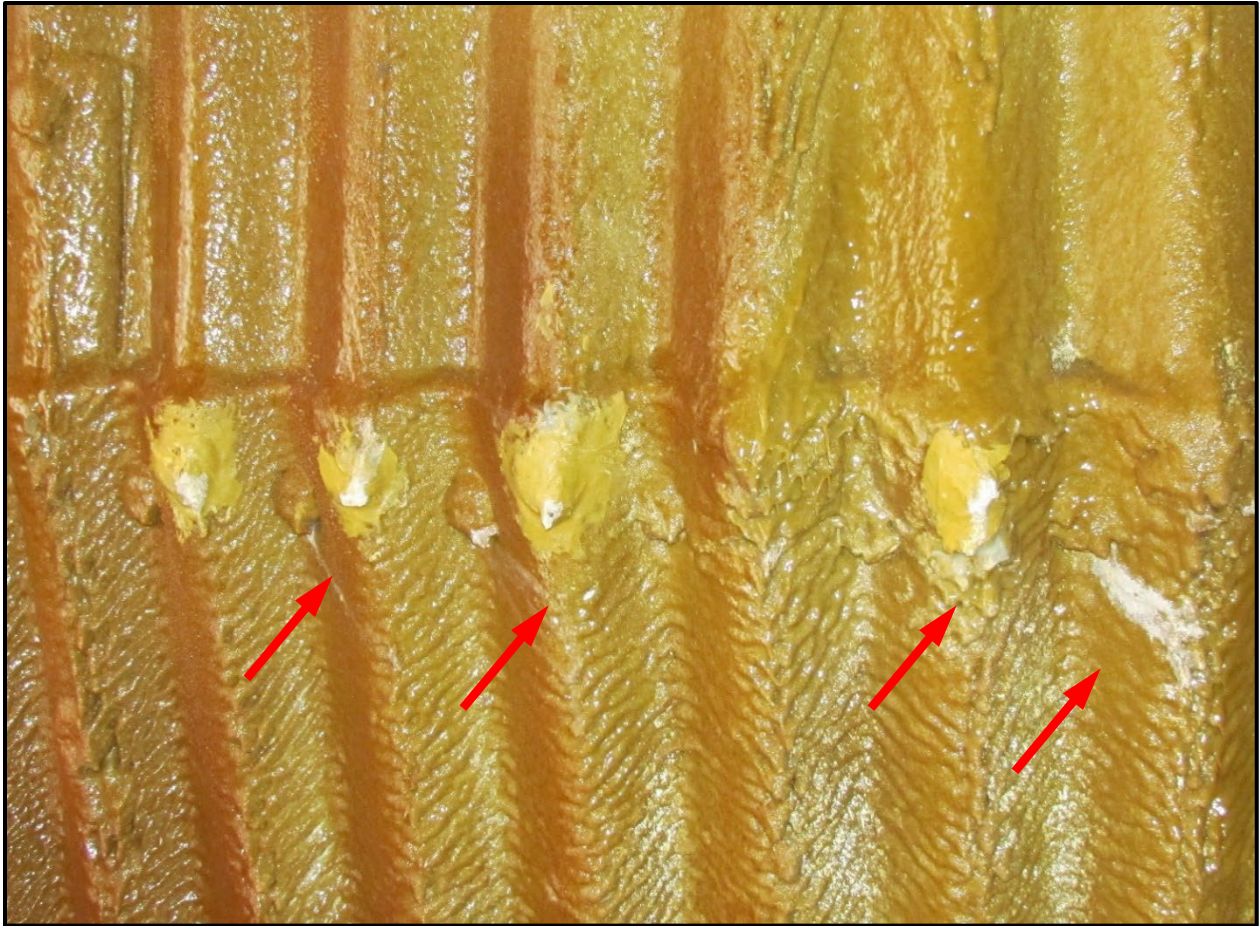
↑ The above image is the apex of the deflected steel plate panel. It appears that precipitates, possibly from mineralized water, may be forming through small holes or cracks near the bolt plate connections.

The moisture issues noticed during the 2019 and 2020 inspections at some seams and near the deflection were corrected with patch work that was done in February of 2021. This mitigated the mineral and water seepage.

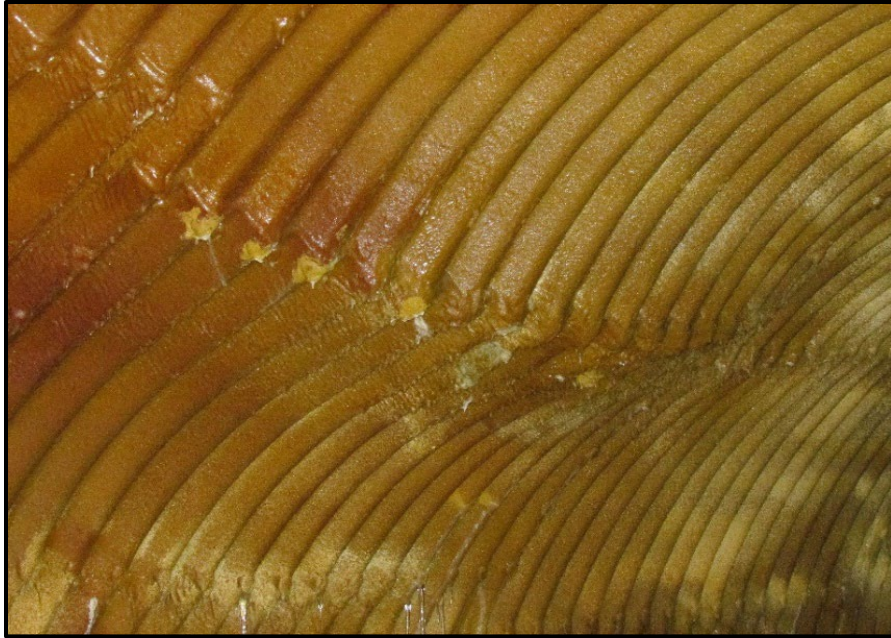
↑ Area of culvert deflection. Although difficult to see in this image, there was some ice coating the culvert seams.

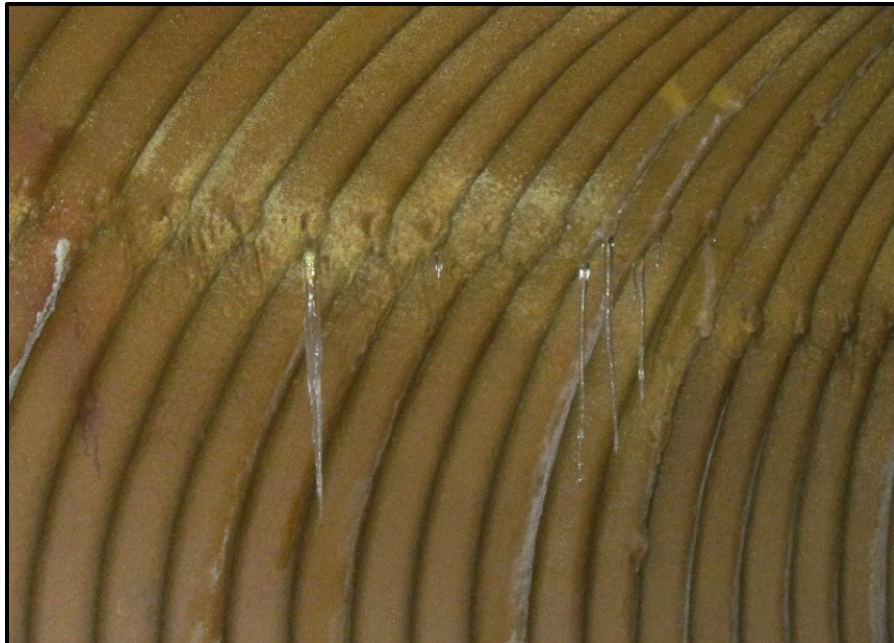
↑ This is the steel plate seam just below the area of deflection. Noticeable icicles are extruding from the plate bolt connections.

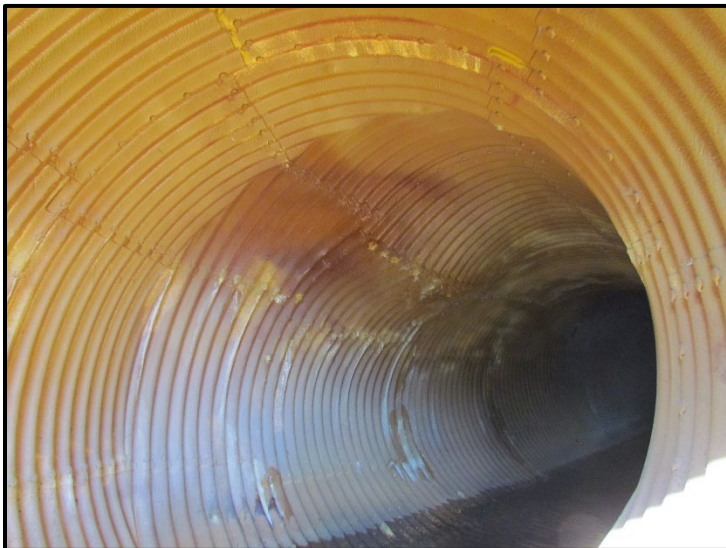
← View highlighting the original deflected section of the culvert. There's no sign of failed adhesion or SprayWall liner separation from the culvert.

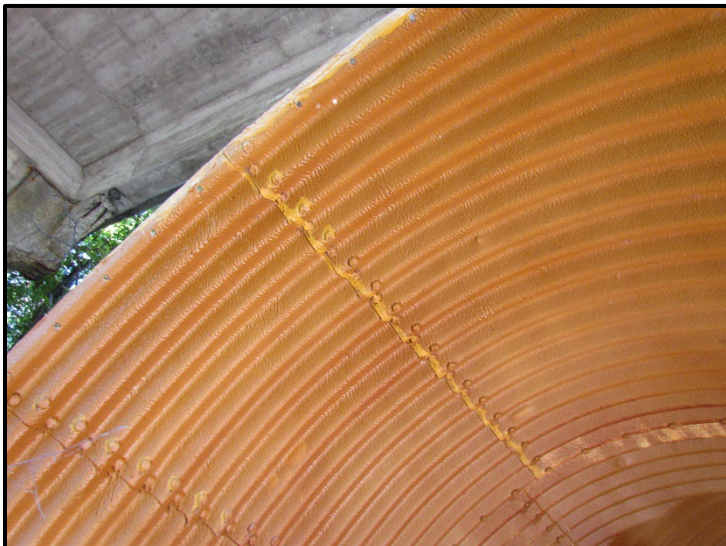
← View of some of the hand patch work done during the 2021 repair work. It shows no sign of degradation or water seepage.
