STRUCTURE INSPECTION REPORT

MDT ID - 02939
 NBI ID - L15672000+02001
 Feature Intersected - SWAN RIVER 110
 Facility - BRIDGE ST

Inspector - Edward Cinadr
 Inspection Type - Fracture Critical
 Inspection Date - 06/21/2023
 Inventory Direction - West to East

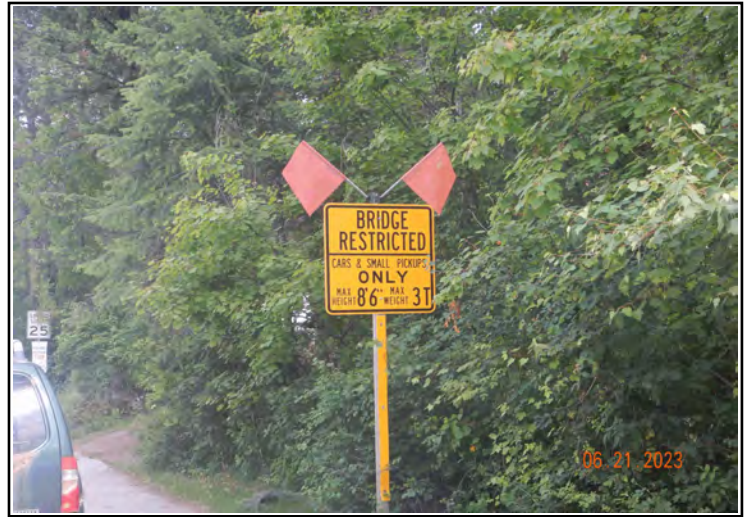
Looking east at "Bridge Restricted" sign on west approach near Hwy 35 intersection.

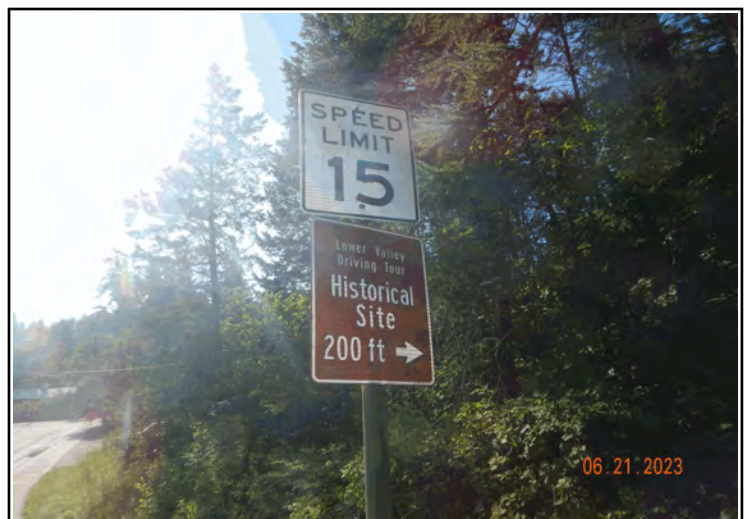
Looking east at 15 mph advance warning sign at the west approach.

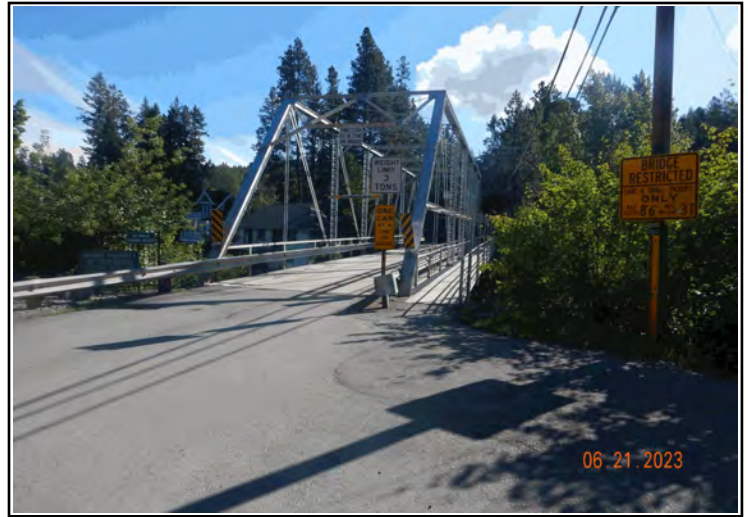
Looking northeast at west bridge end view AOL. Note: load posting sign and multiple warning signs.

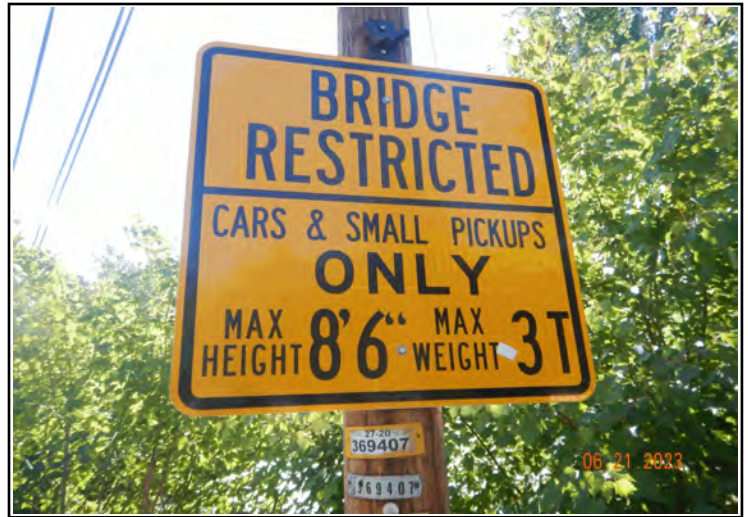
Looking northeast at the 8'6" vertical clearance sign at the west approach.

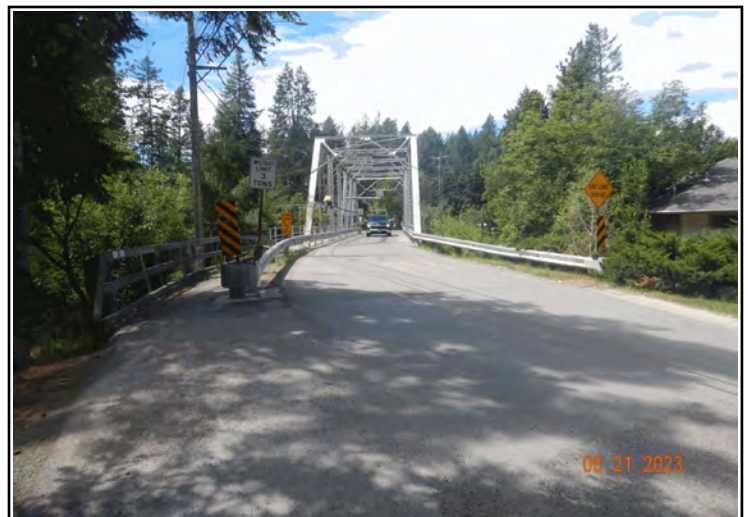
Looking west at end view from east approach. Note: 3-ton posting sign, 8'-6" vertical clearance sign and headache bar, "One Car at a Time" signs, and end markers in place.

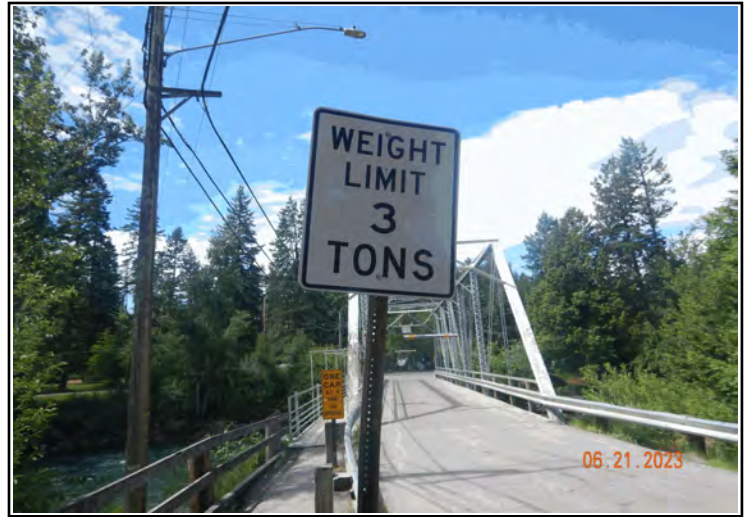
Comments:
Looking west at the east approach 3-ton load posting sign.

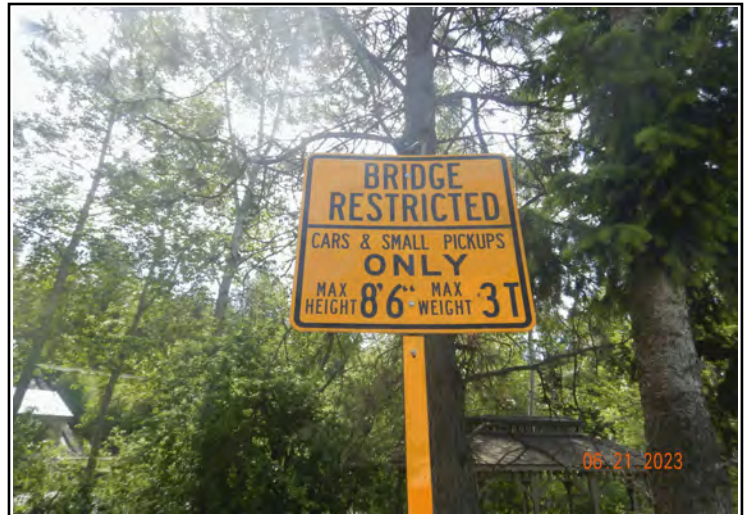
Comments:
Looking south at "Bridge Restricted" sign on east approach.

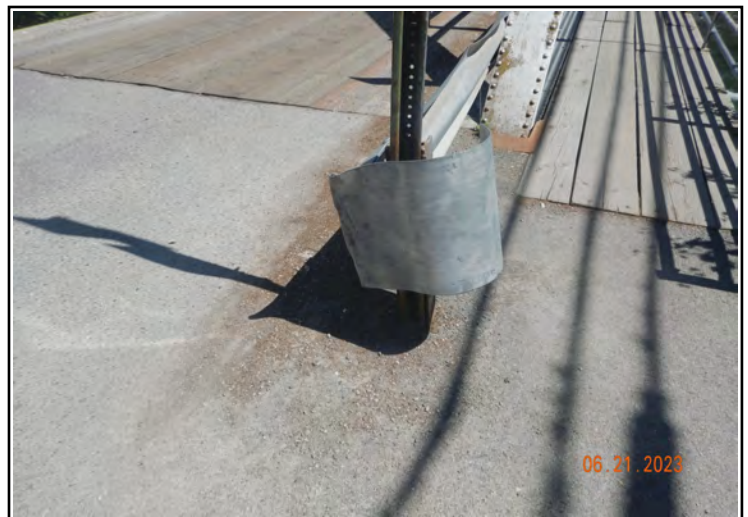
Comments:
Looking east at RT guardrail end on west approach. Note: moderate impact damage/deformation.

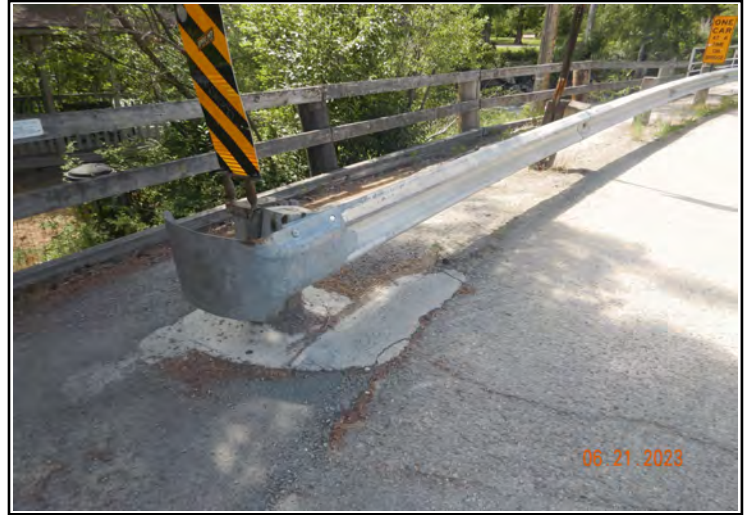
Looking southwest at RT guardrail on east approach. Note: moderate impact damage.

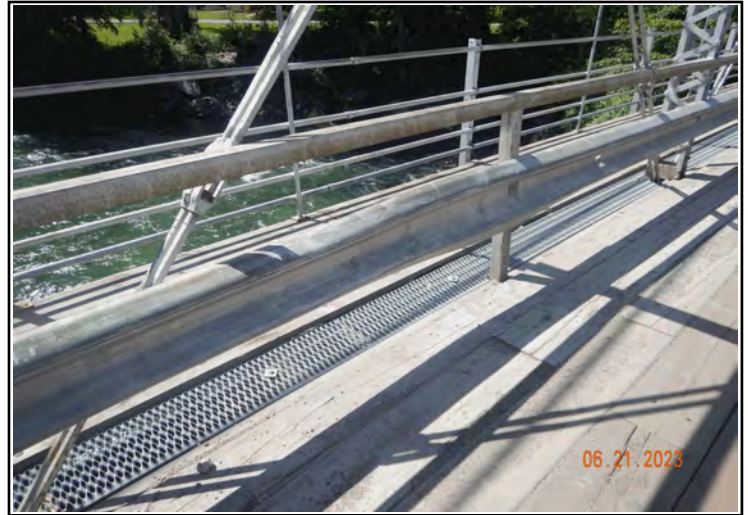
Looking southwest at RT w-beam bridge rail near midspan. Note: moderate impact damage, still functional.

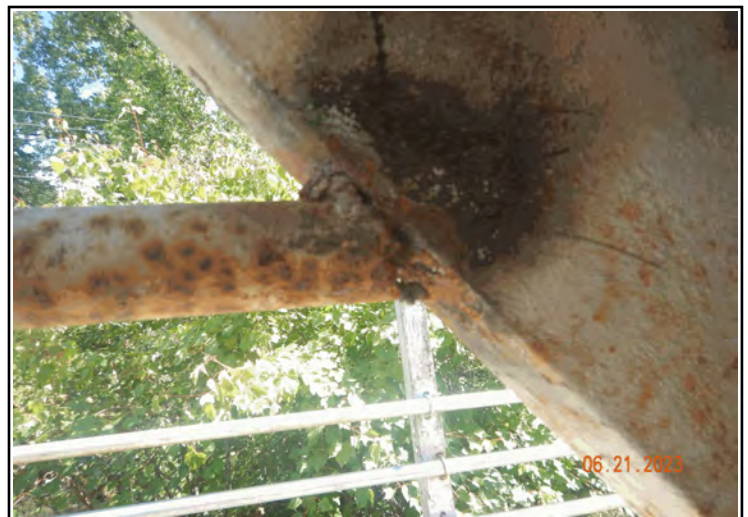
Looking south at pipe rail weld to underside of end post L0-U1 south. Note: previously noted cracked weld has been rewelded.

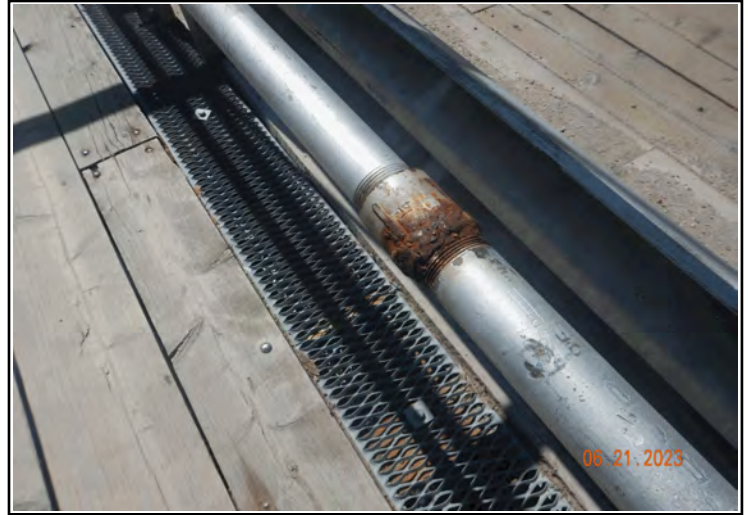
Looking northwest at mid-rail between L0'-L1' south. Note: previously noted crack has been rewelded.

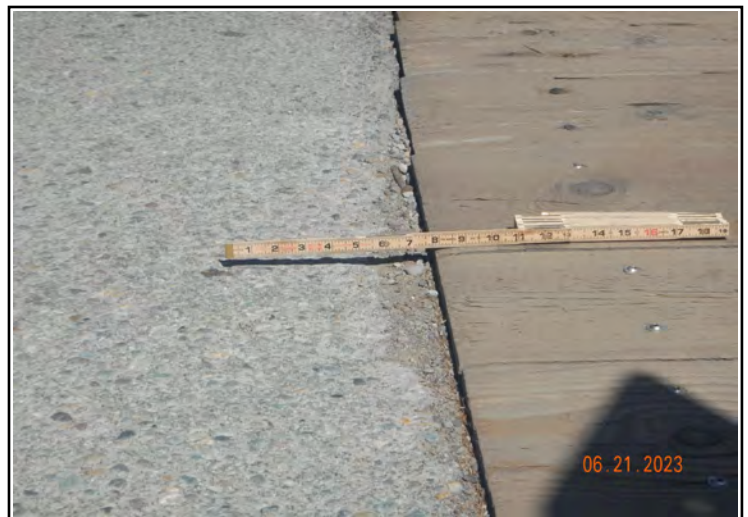
Looking north at transition over abutment 1. Note: up to 3/4" settlement in asphalt pavement.

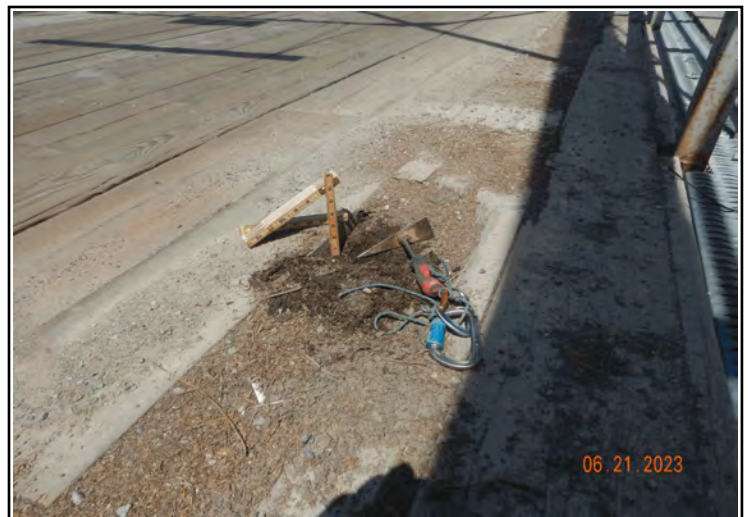
Timber runner near south rail and panel point 1 exhibits 10-inch-wide by 3-foot-long by up to 2 1/2-inch deep severe deterioration with fibrous remains of runner.

Looking east at severely deteriorating timber runner near south rail and panel point 1. Note: 10-inch-wide by 3-foot-long by up to 2 1/2-inch deep fibrous remains of runner.

Recommended By:	Date Recommended	Type	Status	Suggested Priority
	11/07/2017	Repair Suggestion	Repair Suggestion	Low
Comments				
Replace deteriorated wearing surface and sidewalk timber boards, secure loose timber boards, and level 2-inch settlement at abutment 2 sidewalk approach.

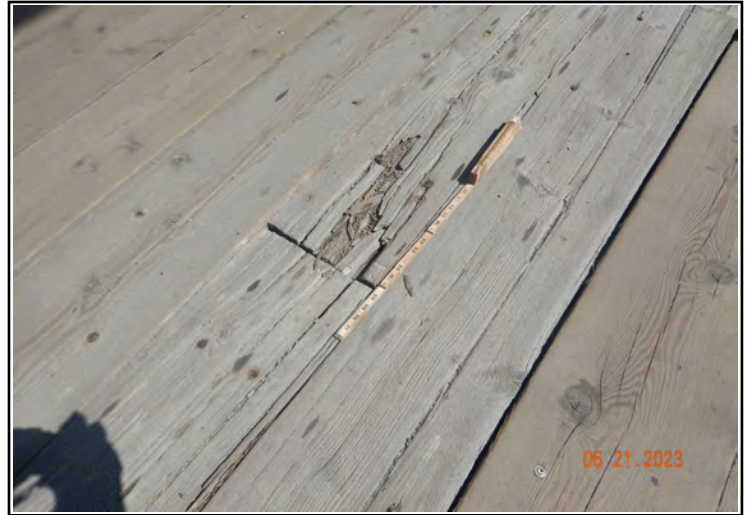
Timber runner board ends exhibit random crushing and rot throughout.

Looking northeast at timber runner near centerline and midspan. Note: crushing and rot at end of runner, typical but isolated throughout.

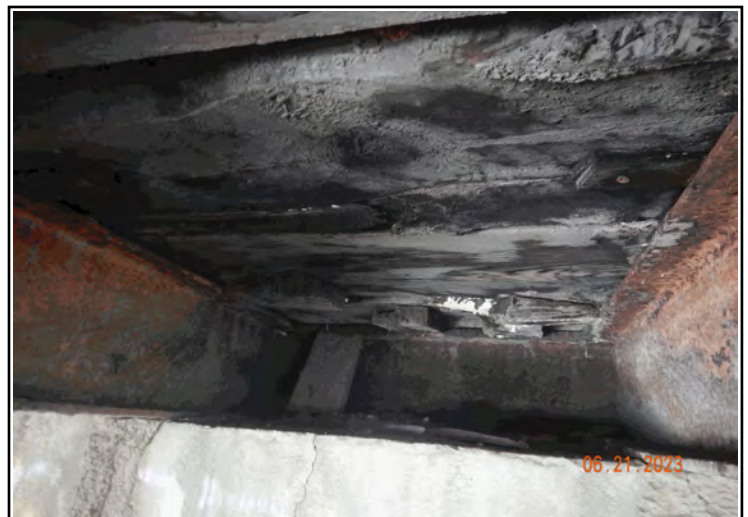
Timber deck at west end over abutment 1 exhibits multiple timber wedge shims that are working loose.

Looking west at west end underside of deck over Abutment 1. Note: deck has been shimmed with multiple timber wedges, some shims are working loose.

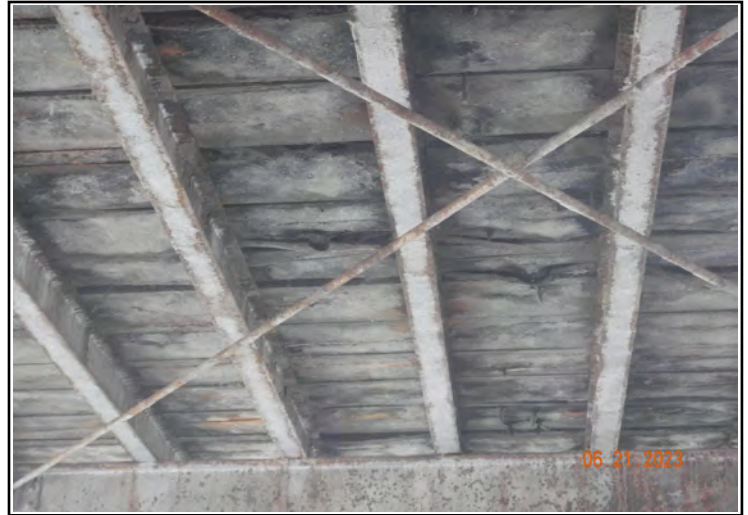
Timber deck soffit exhibits multiple partially failed planks that deflect under live load.

Looking west at underside in bay 1'-2' between stringers 4 and 6. Note: planks deflect under live load and are partially damaged.

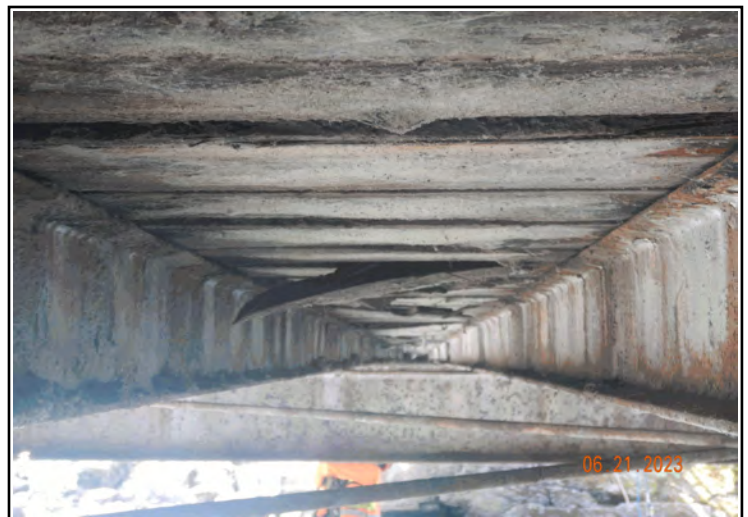
Timber deck soffit exhibits multiple partially damaged planks.

Looking west at deck underside between stringers 5 and 6 bay 2'-1'. Note: partial failed timber planks. Deck pumps under live load.

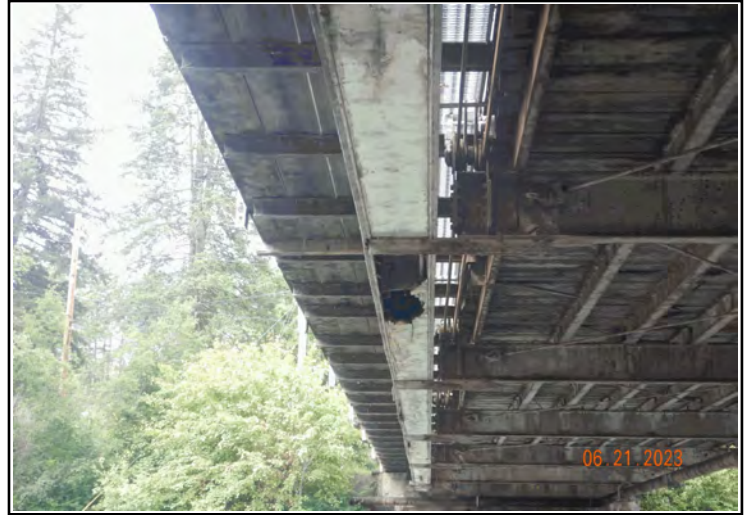
Looking west at the timber conduit box. Note: timber components are heavily rotten and decayed. Approximately 6-foot long failed section adjacent to panel point 2' south.

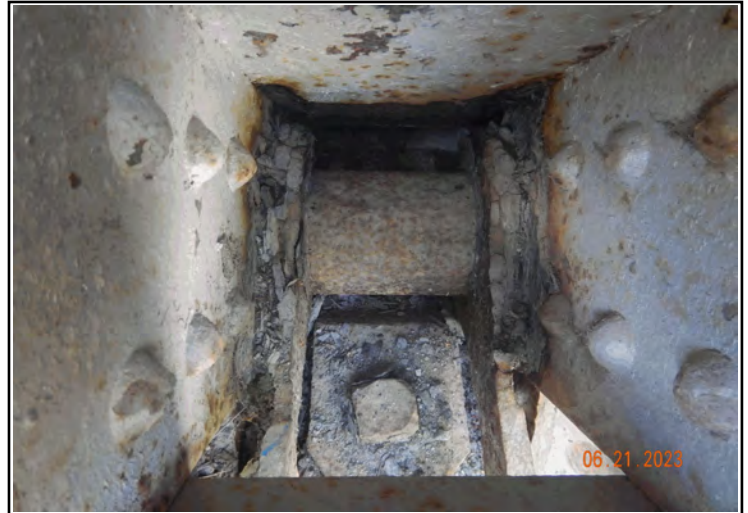
Looking west at L0-L1 at L0 north truss. Note 3/16-inch average (1/4 max) loss on outside face of outboard eyebar and 1/8-inch average (3/16 max) loss on inside face of inboard eyebar. Also note heavy laminating corrosion and pack rust around full perimeter of heads, estimate 1/16-inch loss both faces.

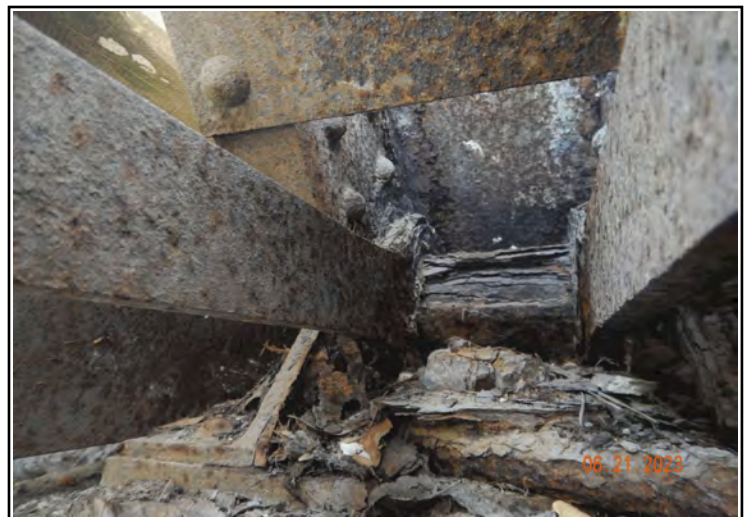
Looking southwest at L0-L1 at L0 south truss. Note: 1/16-inch average loss on one face of both eyebars.

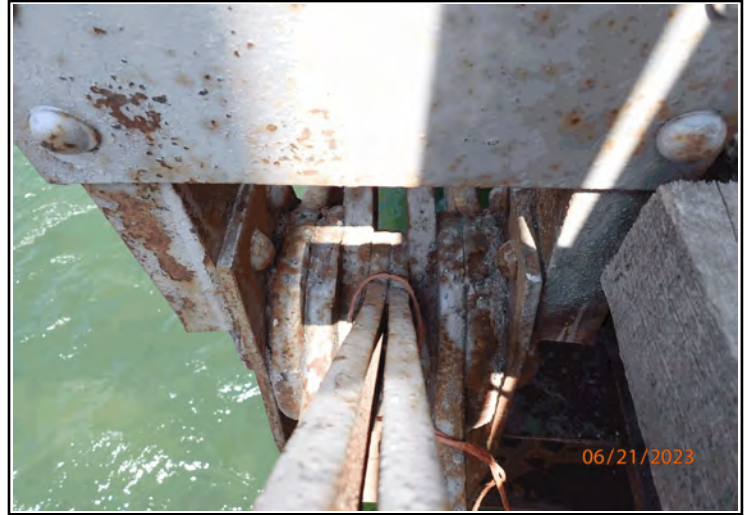
Looking east at north truss panel point L2 bottom chord and eyebars connection. Note: up to 3/16-inch pack rust.

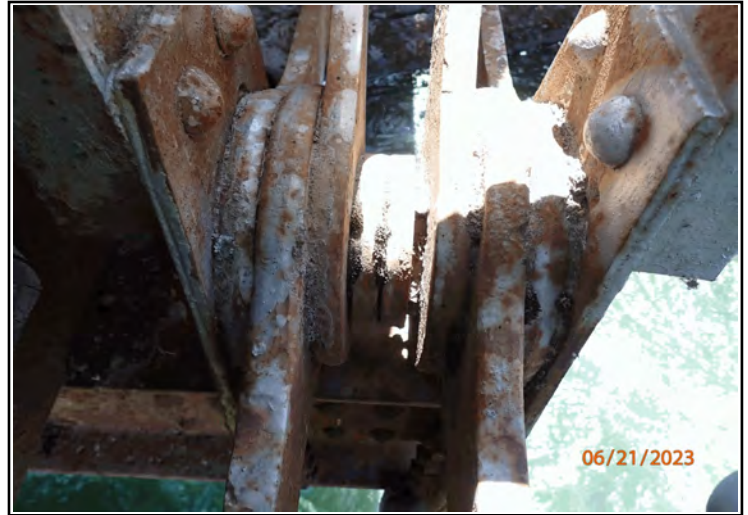
Looking west at north truss panel point L3 bottom chord and eyebars connection. Note: up to 1/4-inch pack rust.

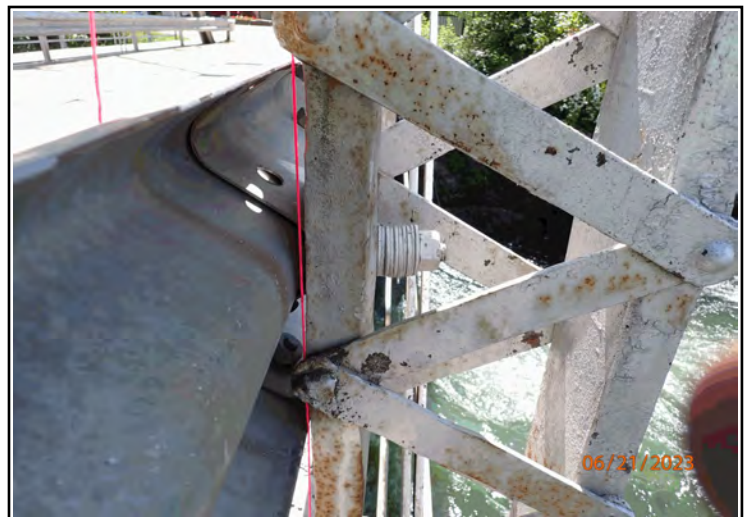
Looking west at north truss L3-U3 inboard channel lower 3 feet above deck. Note: up to 1/2-inch out-of-plane distortion.

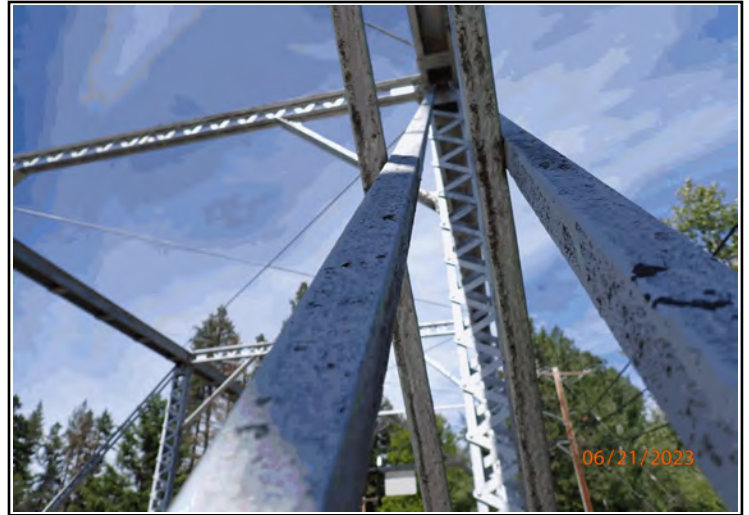
Looking east at south truss L3-U3' and L3'-U3. Note: eyebars are rubbing together with minor wear at point of contact.

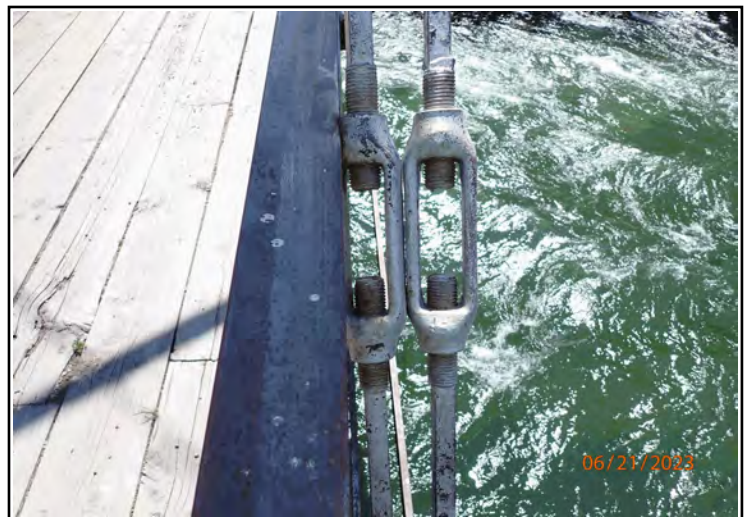
Looking west at south truss L3'-U3 eyebar at the top of the bridge rail. Note: eyebar is rubbing on the rail with minor wear at point of contact.

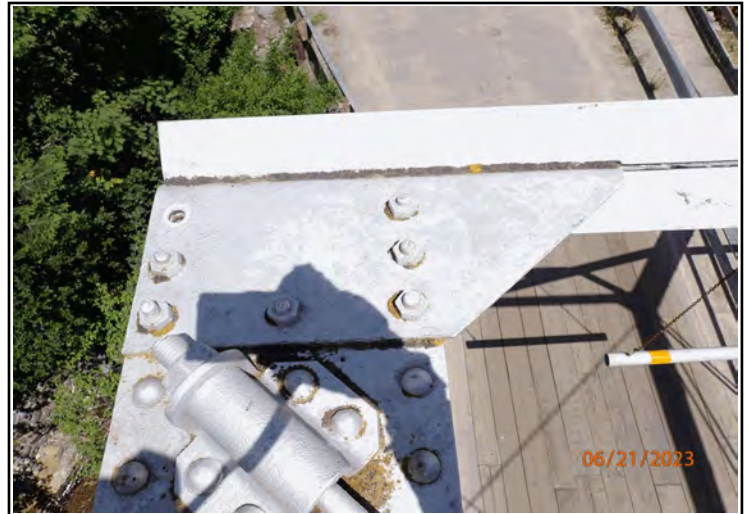
Looking east at north truss U2'-U1' connection to end post at U1'. Note: one missing bolt.

Recommended By:	Date Recommended	Type	Status	Suggested Priority
	11/07/2017	Repair Suggestion	Repair Suggestion	Low
Comments				
Replace missing truss connection hardware.

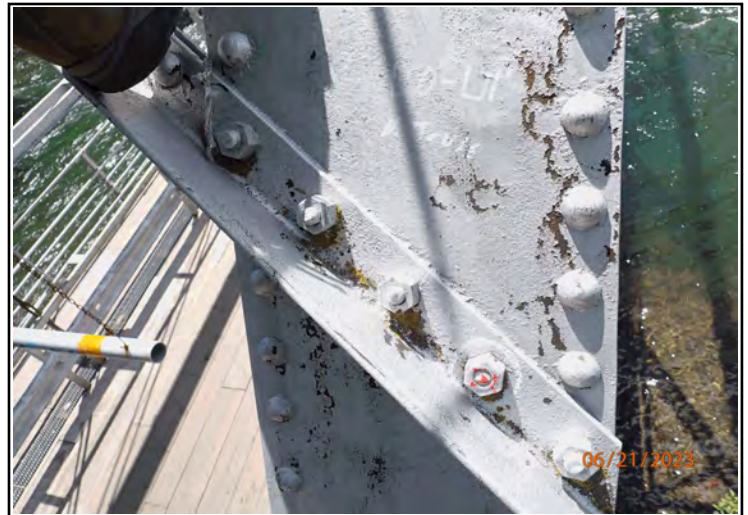
Looking west at north truss L0'-U1' east portal sway bracing kicker to end post connection. Note: one loose bolt.

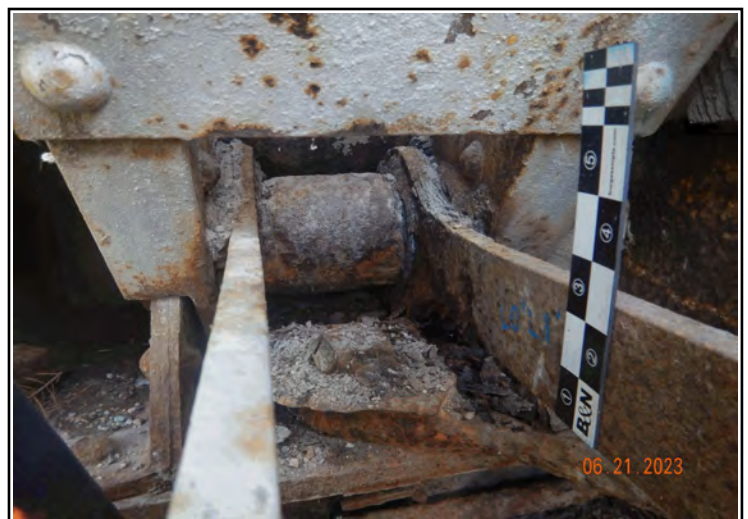
Looking east at north truss L1'-L0' inboard at L0'. Note: heavy section loss, pitting, and pack rust on eyebar head and end of member. Approximately 1/8-inch section loss around the full perimeter of the eyebar head due to heavy pack rust and laminating corrosion. On the main eyebar, heavy section loss includes 1/4-inch remaining over the lower height and 7/16-inch remaining over the upper height.

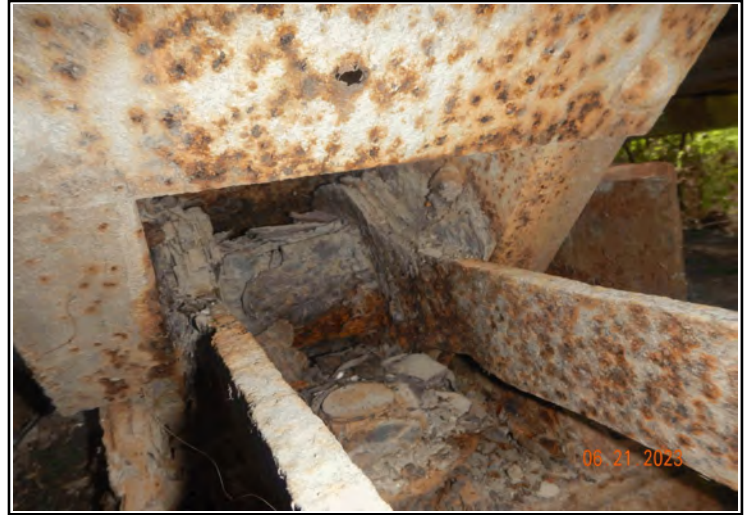
Looking southeast at south truss L1'-L0' inboard at L0'. Note: 1/4-inch average remaining thickness full height of the eyebar. Also note, severe pack rust and laminating corrosion around perimeters of eyebar heads with approximate 1/8-inch loss on faces.

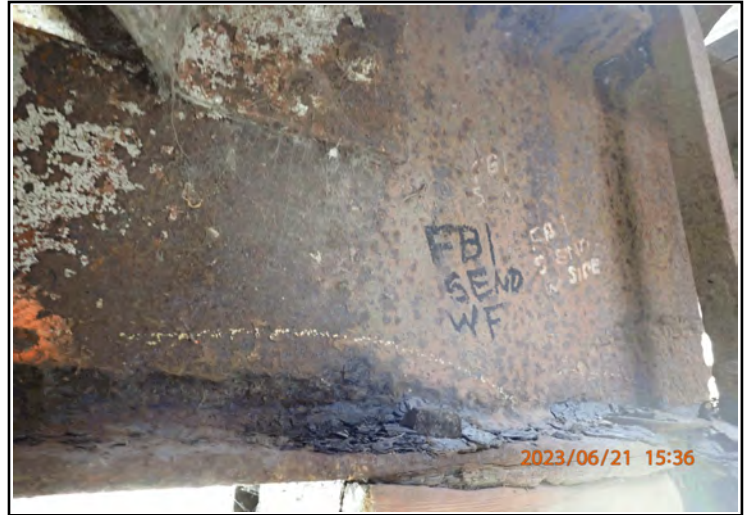
Looking southeast at FB1 west face south end. Note: corrosion at web to lower flange interface measuring 3-foot-long by 2-inch-high by up to 1/8-inch deep.

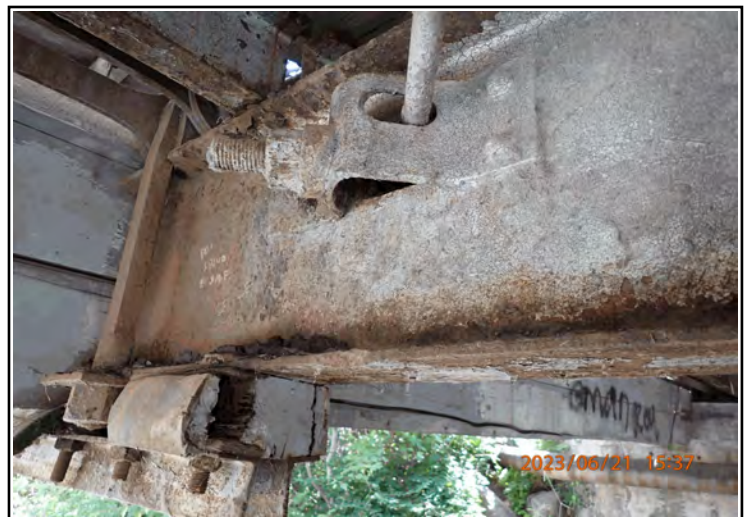
Looking southwest at FB1 east face south end. Note: corrosion at web to lower flange interface measuring 3-foot-long by 2-inch-high by up to 1/8-inch deep.

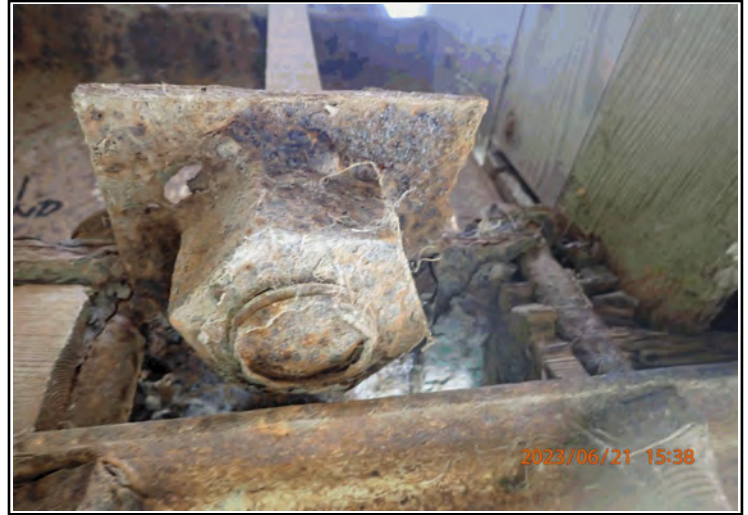
Looking east at FB 1 south end U-bolt and plate. Note: Corrosion with 1-inch hole in U-bolt plate

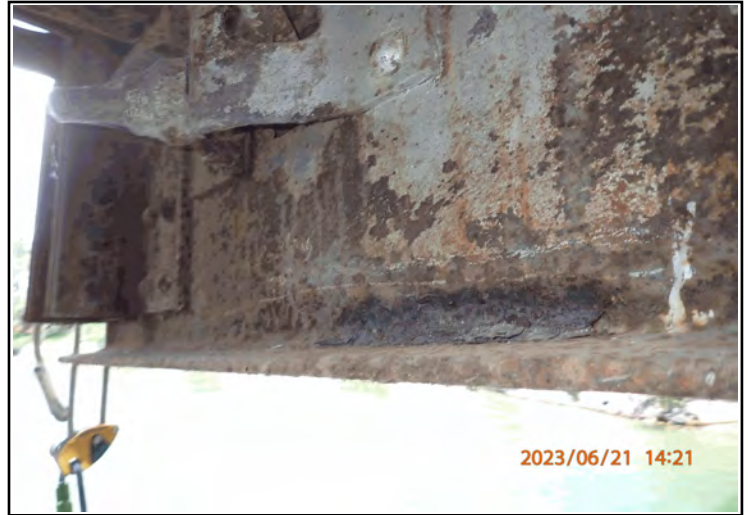
Looking northeast at FB2 west face north end 12 inches from beam end. Note: corrosion at web to bottom flange interface measuring 20-inch-long by 2-inch-high by up to 1/8-inch deep.

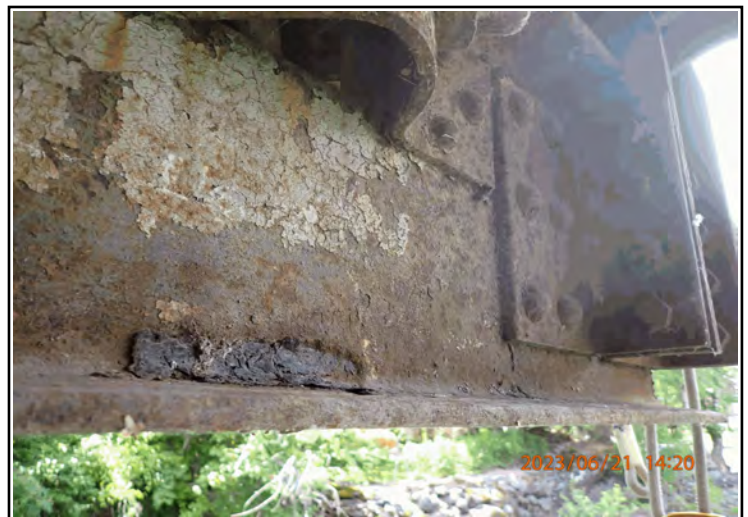
Looking northwest at FB2 east face north end 12 inches from beam end. Note: corrosion at web to bottom flange interface measuring 10-inch-long by 2-inch-high by up to 1/8-inch deep.

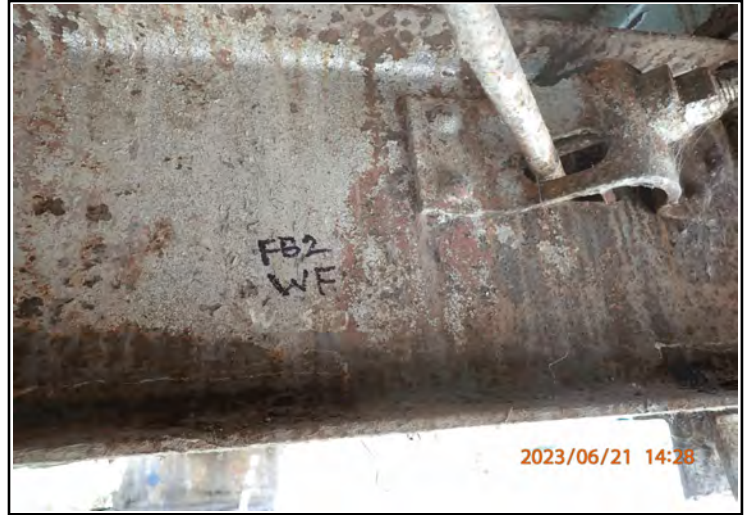
Looking southeast at FB2 web to bottom flange interface west face south end. Note: corrosion measuring up to 3-foot long by 2-inch high by 1/8 inch deep.

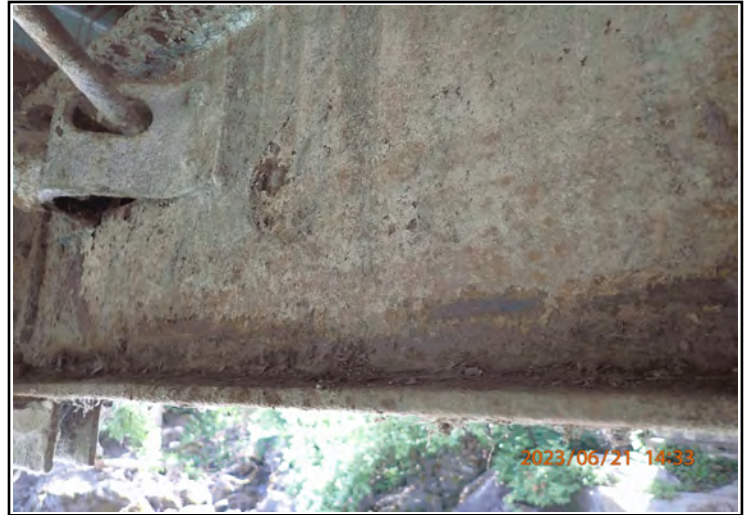
Looking southwest at FB2 web to bottom flange interface east face south end. Note: corrosion measuring up to 3-foot long by 2-inch high by 1/8-inch deep.

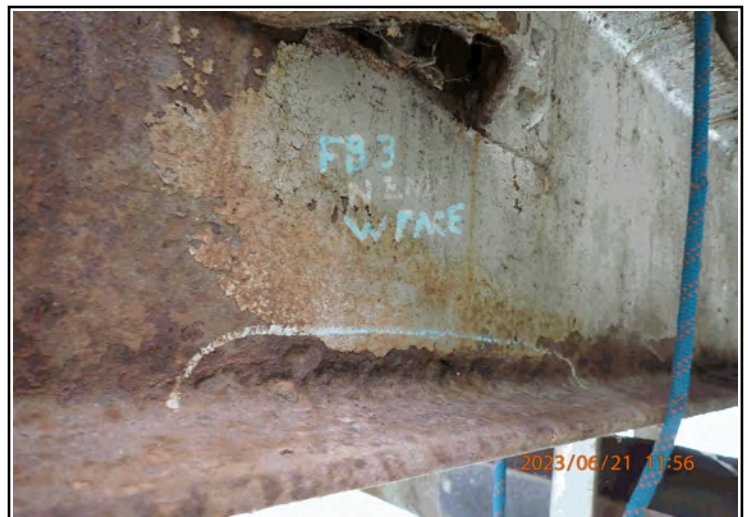
Looking southeast at FB3 web to bottom flange interface west face north end. Note: corrosion measuring up to 28-inch long by 2-inch high by 3/16-inch deep on both faces.

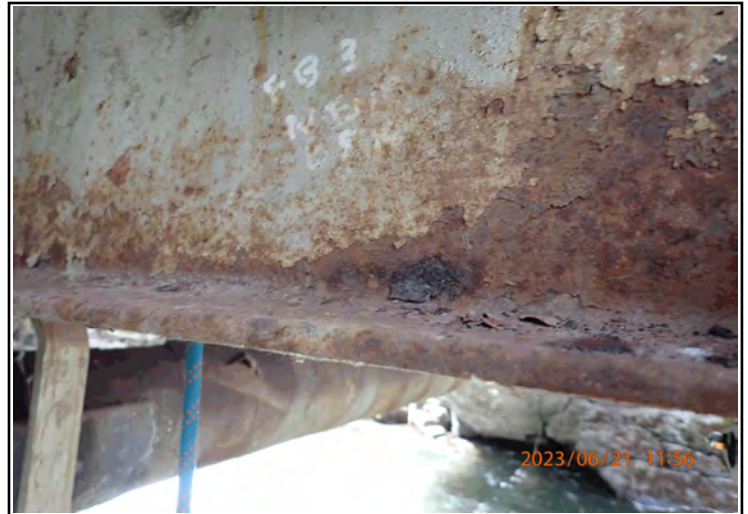
Looking southwest at FB3 web to bottom flange interface east face north end. Note: corrosion measuring up to 28-inch long by 2-inch high by 3/16-inch deep on both faces.

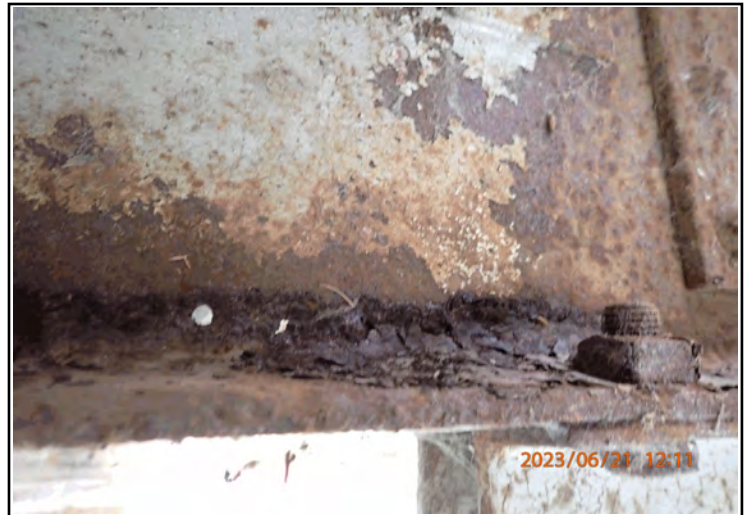
Looking southeast at FB3 web to bottom flange interface west face 12 inches from south end. Note: corrosion measuring up to 34-inch long by 2-inch high by 3/16-inch deep with two through holes up to 1/2-inch diameter on each face.

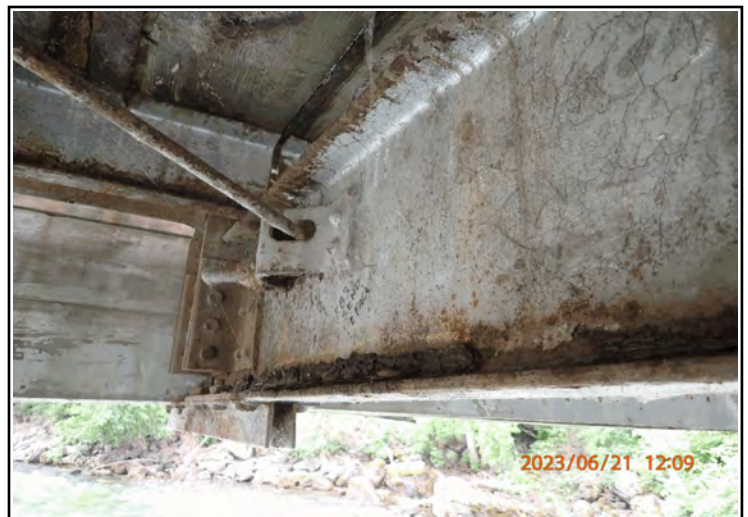
Looking southwest at FB3 web to bottom flange interface 12 inches from south end. Note: corrosion measuring up to 34-inch long by 2-inch high by 3/16-inch deep on both faces.

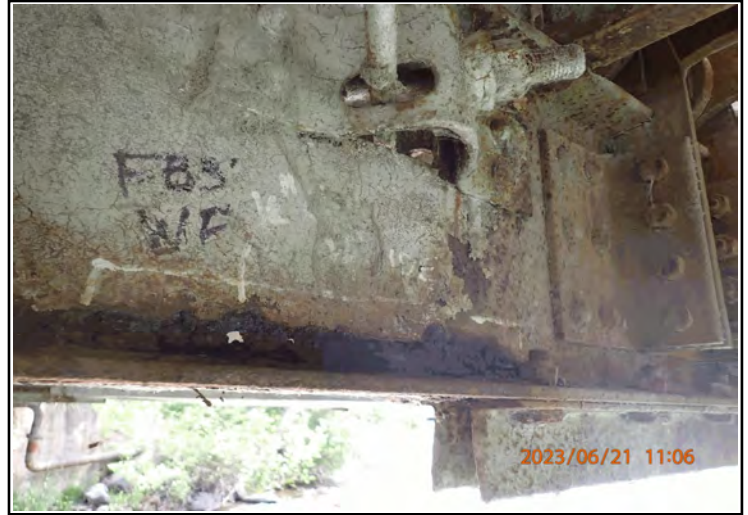
Looking southeast at FB3' web to bottom flange interface west face south end. Note: corrosion measuring up to 36-inch long by 2-inch high with 1/2-inch diameter through holes.

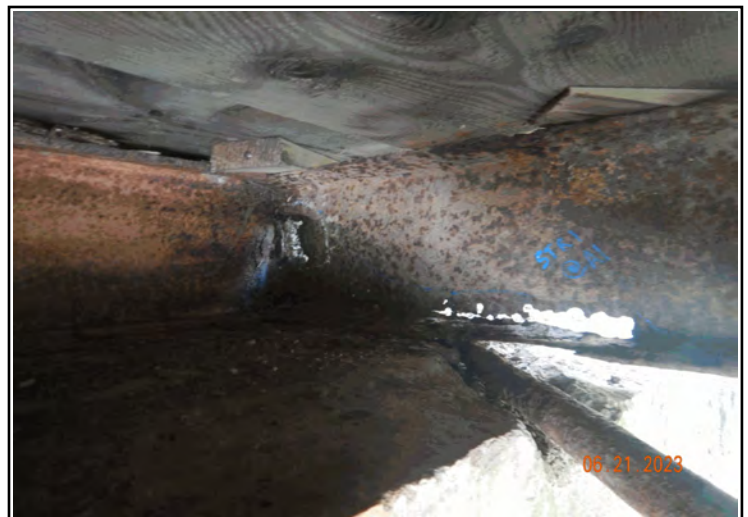
Looking northwest at stringer 1 at Abutment 1. Note: 18-inch-long area of through holes in lower web up to 1 1/2-inch height and a 3-inch diameter hole in the web end.

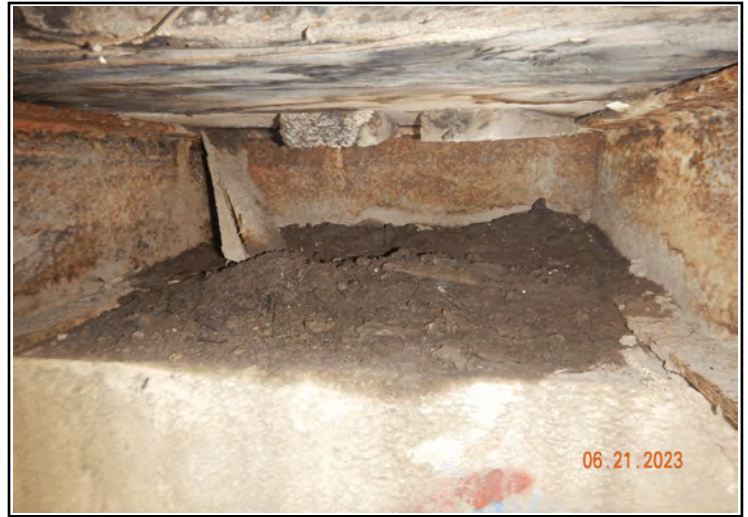
Looking west at Abutment 1 bearing seat between stringers 6 and 7. Note: up to 2 inches of soil buildup retaining moisture and promoting corrosion on stringer ends, typical full width.

Recommended By:	Date Recommended	Type	Status	Suggested Priority
Drew Urban	06/21/2023	UBIV Access/Other DeRepair Suggestion		Medium
Comments				
Clear soil and debris off abutment bearing seats and truss bearings.

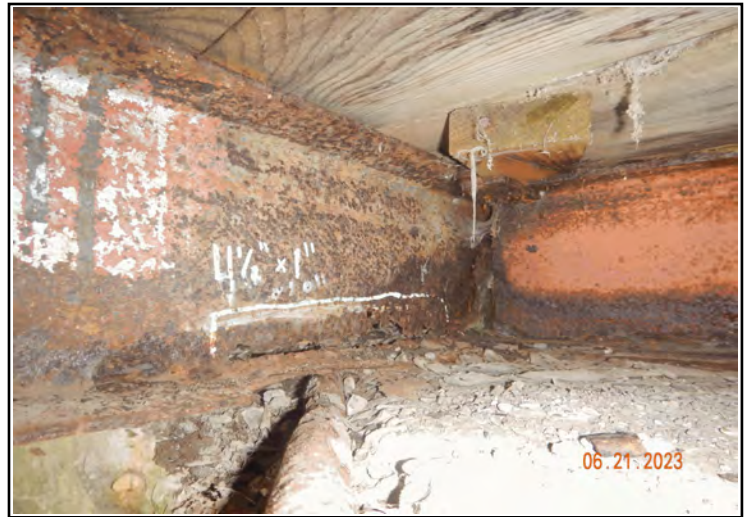
Looking southwest at stringer 8 at Abutment 1. Note: no change in previously documented 11 1/2-inch-long by 1-inch-high hole in web adjacent to bottom flange at end with up to 50% section loss to the end 2 feet of the stringer and knife edged bottom flange.

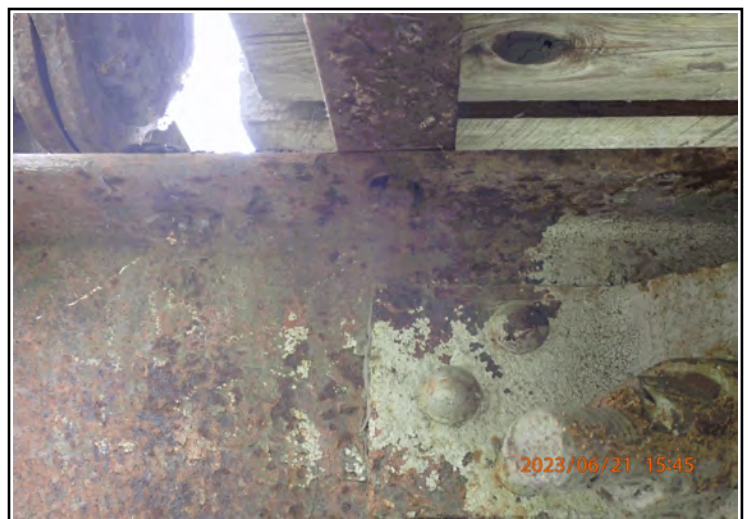
Bay 0-1, stringer 1 to FB1 connection west face exhibits a loose bolt.

Looking east at stringer 1 to FB1 connection west face. Note: one loose connection bolt.

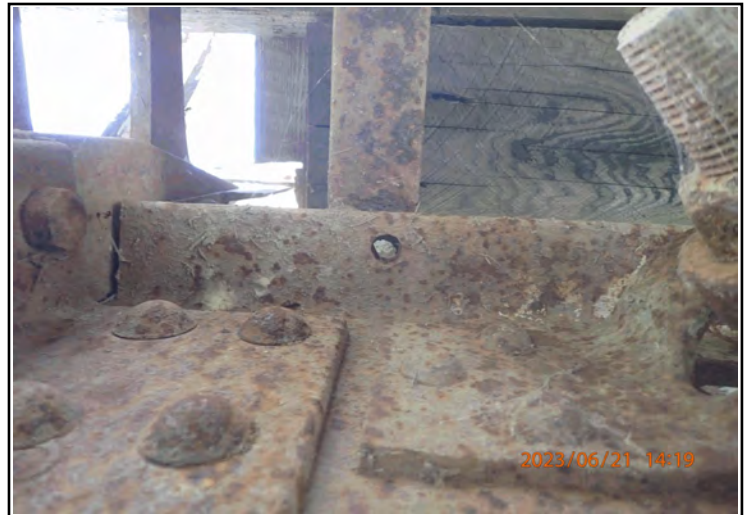
Bay 1-2, stringer 1 to FB2 connection west face exhibits a missing bolt.

Looking east at stringer 1 at FB2 west face. Note: one missing connection bolt.

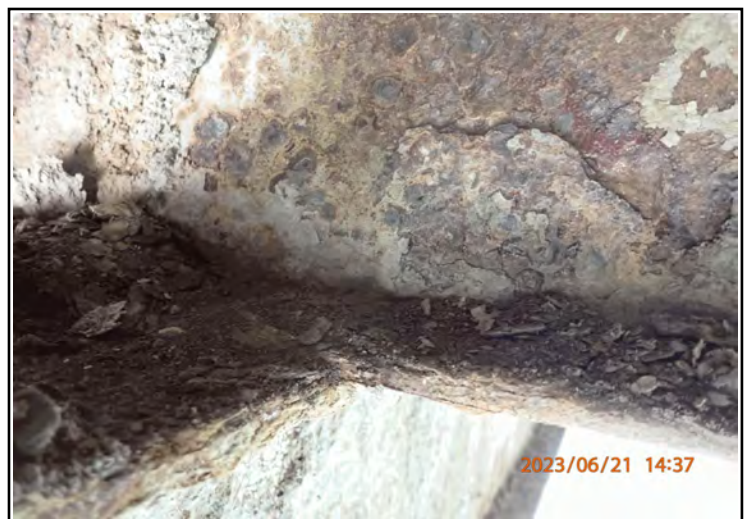
Stringer 6 at FB2 bottom flange exhibits pitting and laminating corrosion up to 1/16-inch deep.

Looking northwest at stringer 6 bottom flange at FB2. Note: pitting and laminating corrosion up to 1/16-inch deep.

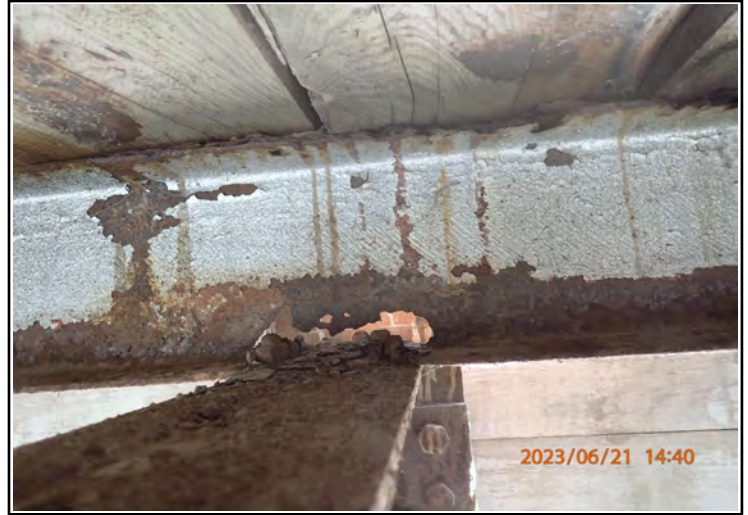
Stringer 8 at FB2 lower channel web exhibits up to 3-inch high by 3-foot long area of corrosion with section loss and a 8-inch-long by up to 3-inch tall through hole.

Looking south at stringer 8 bottom flange to web interface at FB2. Note: corrosion up to 3-foot long by 3-inch high with through holes up to 8-inch long by 3-inch tall.

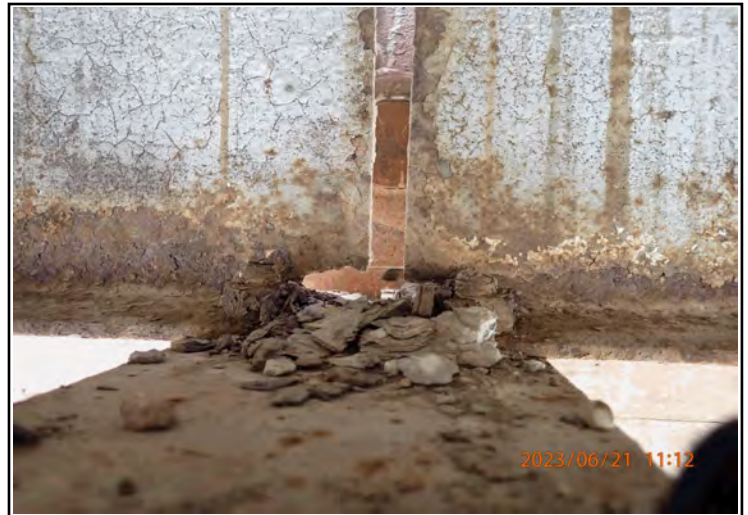
Stringer 8 at FB3' lower channel web exhibits up to 2-inch high by 3-foot long area of corrosion with section loss and a 2-inch-long by up to 1 1/2-inch tall through hole.

Looking south at stringer 8 web to bottom flange interface at FB3' south end. Note: corrosion measuring up to 36-inch long by 2-inch high with 2-inch long by up to 1 1/2-inch tall through holes.

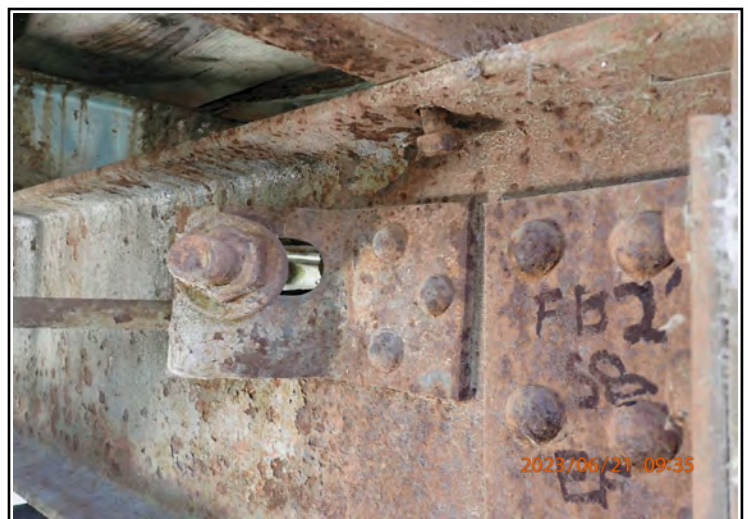
Bay 2'-1', stringer 1 to FB2' connection east face exhibits a loose bolt.

Looking southwest at stringer 1 to FB2' connection east face. Note: one loose connection bolt.

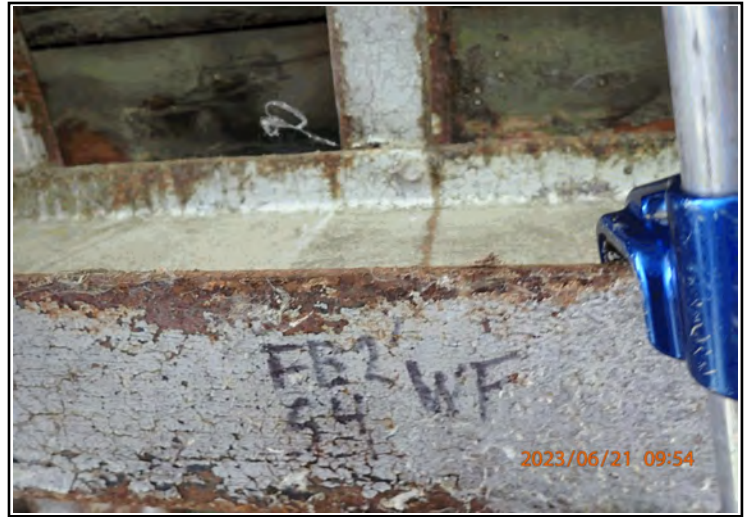
Looking east at end of stringer 4 top flange at FB2' west face.
Note: approximately 1/2-inch torsional displacement of top flange.
