STRUCTURE INSPECTION REPORT

MDT ID - 02939
 NBI ID - L15672000+02001
 Feature Intersected - SWAN RIVER 110
 Facility - BRIDGE ST

Inspector - Edward Cinadr
 Inspection Type - Fracture Critical
 Inspection Date - 06/21/2023
 Inventory Direction - West to East

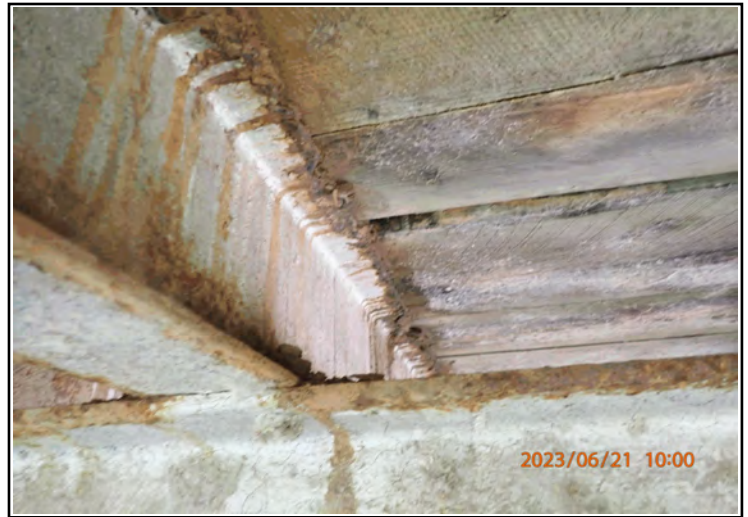
Looking east at stringer 7 top flange over FB2'. Note: up to full depth by 2-inch-wide section loss full length of the stringer.

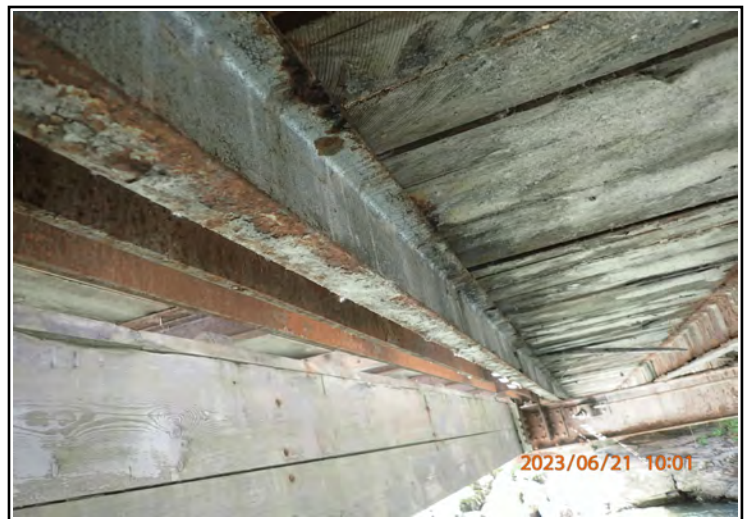
Looking west at stringer 8 top flange near FB2'. Note: corrosion with section loss and through holes up to 2-inch long by 2-inch high full length of the stringer.

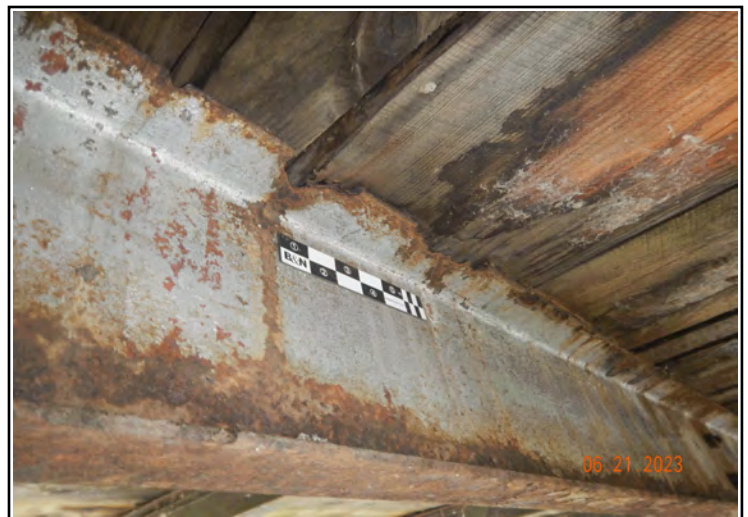
Looking southwest at stringer 8 top flange between FB1' and FB0'. Note: heavy section loss with through holes up to 1 1/4-inch wide and 1/8-inch remaining along top flange over the east end 6 feet.

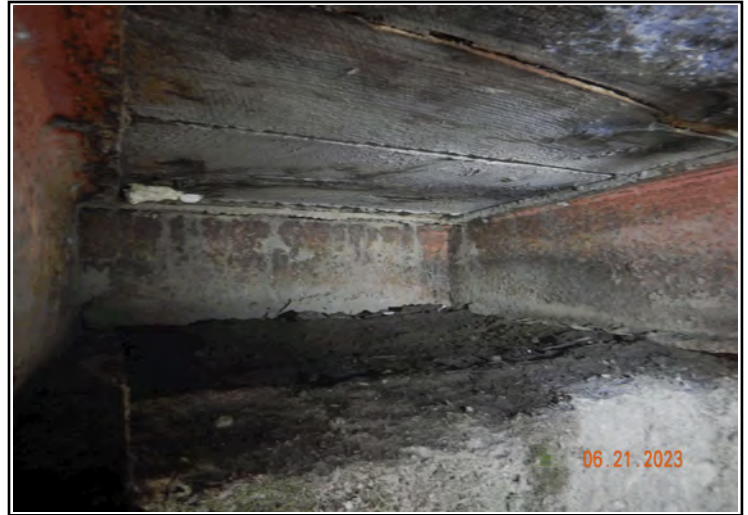
Looking southeast at stringer 6 at abutment 2. Note: typical up to 2-inch soil accumulation and surface corrosion with negligible pitting on all interior stringers.

Recommended By:	Date Recommended	Type	Status	Suggested Priority
Drew Urban	06/21/2023	UBIV Access/Other DeRepair Suggestion		Medium
Comments				
Clear soil and debris off abutment bearing seats and truss bearings.

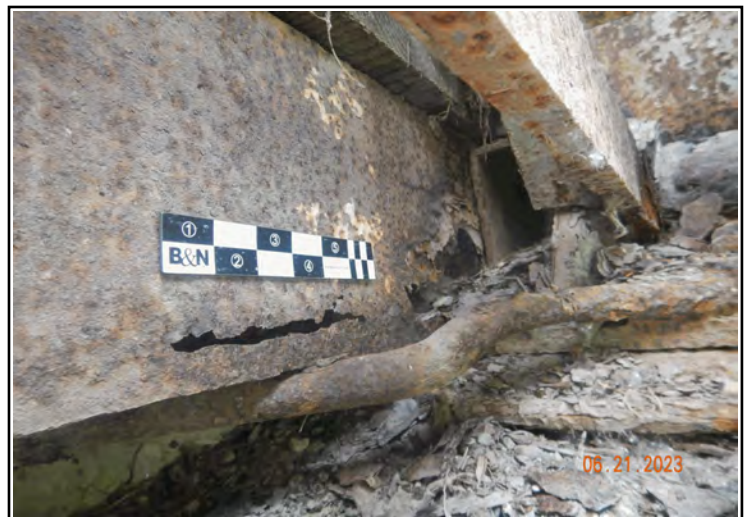
Looking northeast at stringer 8 at abutment 2. Note: 14-inch-long by up to 3 1/2-inch-high through hole in lower channel web.

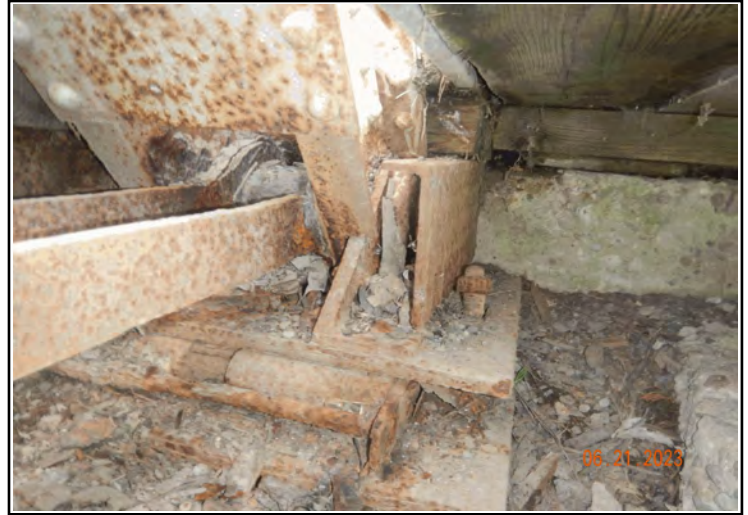
Looking east at L0' south roller nest bearing at abutment 2.
 Note: the roller nest is slightly racked out of alignment. Heavy to severe laminating corrosion and pitting on roller nest components. North anchor bolt is missing (never installed) and the south anchor bolt is heavily bent towards the approach. Bearing is at limits of expansion at 52 degree F.

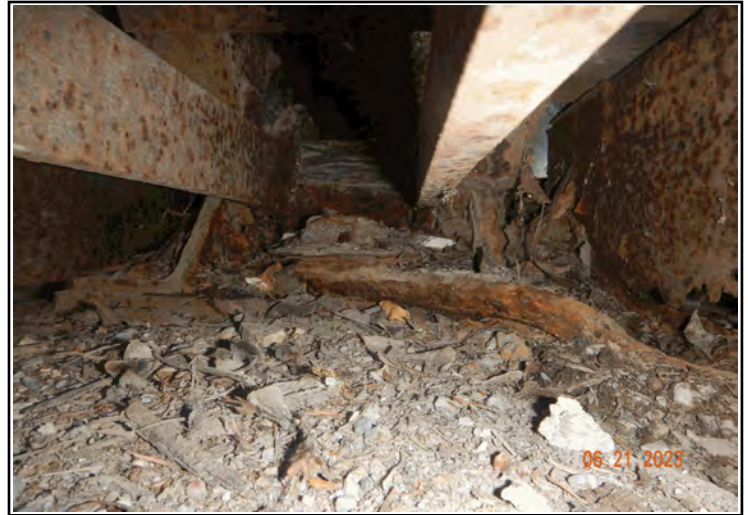
Looking southwest at south truss fixed bearing at Abutment 1.
 Note: heavy laminating corrosion and pack rust with 1/8-inch max pitting on bearing components.

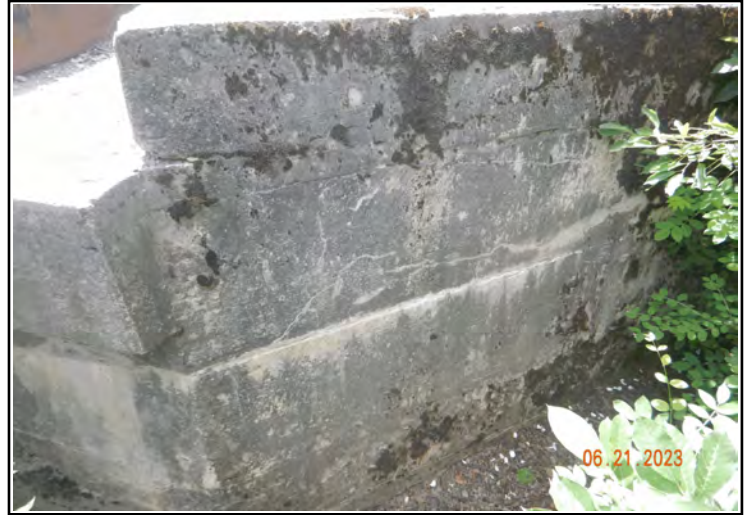
Looking southwest at abutment 1 north wingwall. Note: moderate efflorescence in construction joint and 0.026-inch-wide transverse crack.
