Existing and Projected Conditions Report

Swan River - Bridge St (Bigfork)

STPB 9015 (126)

July, 2016

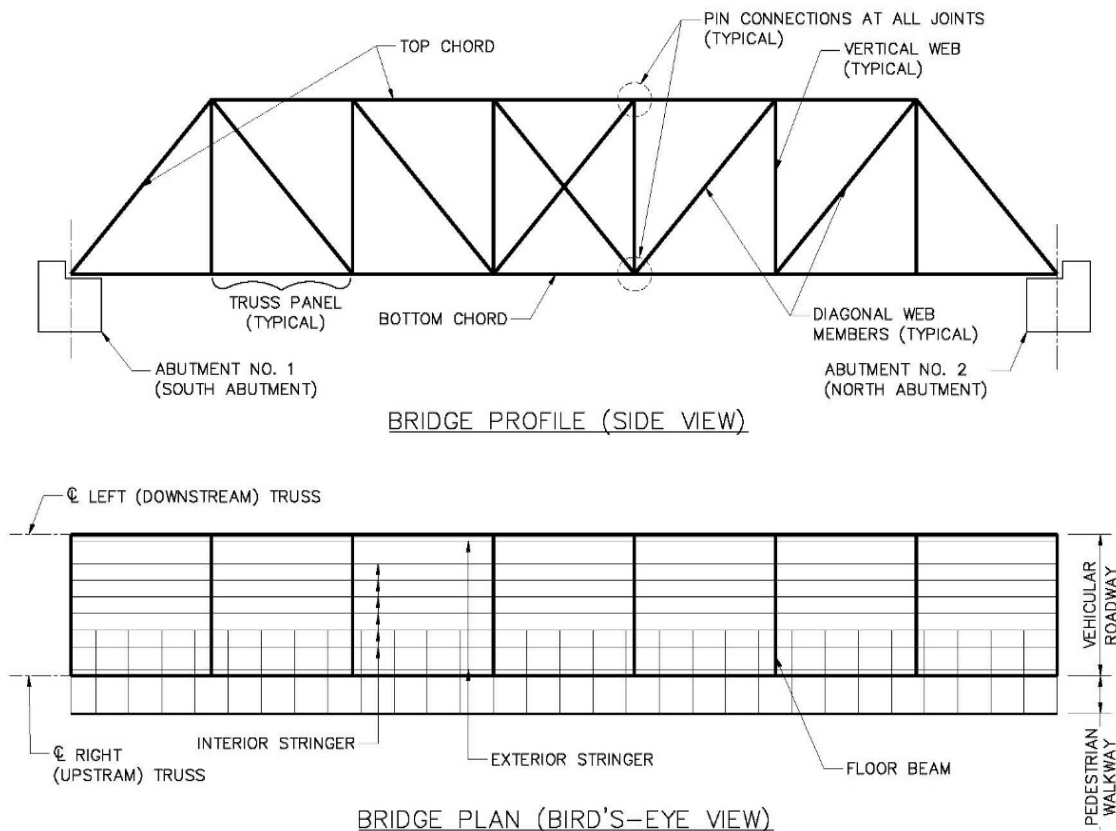
Figure 3: Bridge Plan and Profile

The existing 119-foot, steel truss is a pin connected Pratt through truss. Shown in Figure 3, a pedestrian walkway was attached onto the bridge at an unknown date after the original construction. Wooden planks serve as both the driving and walking surfaces.

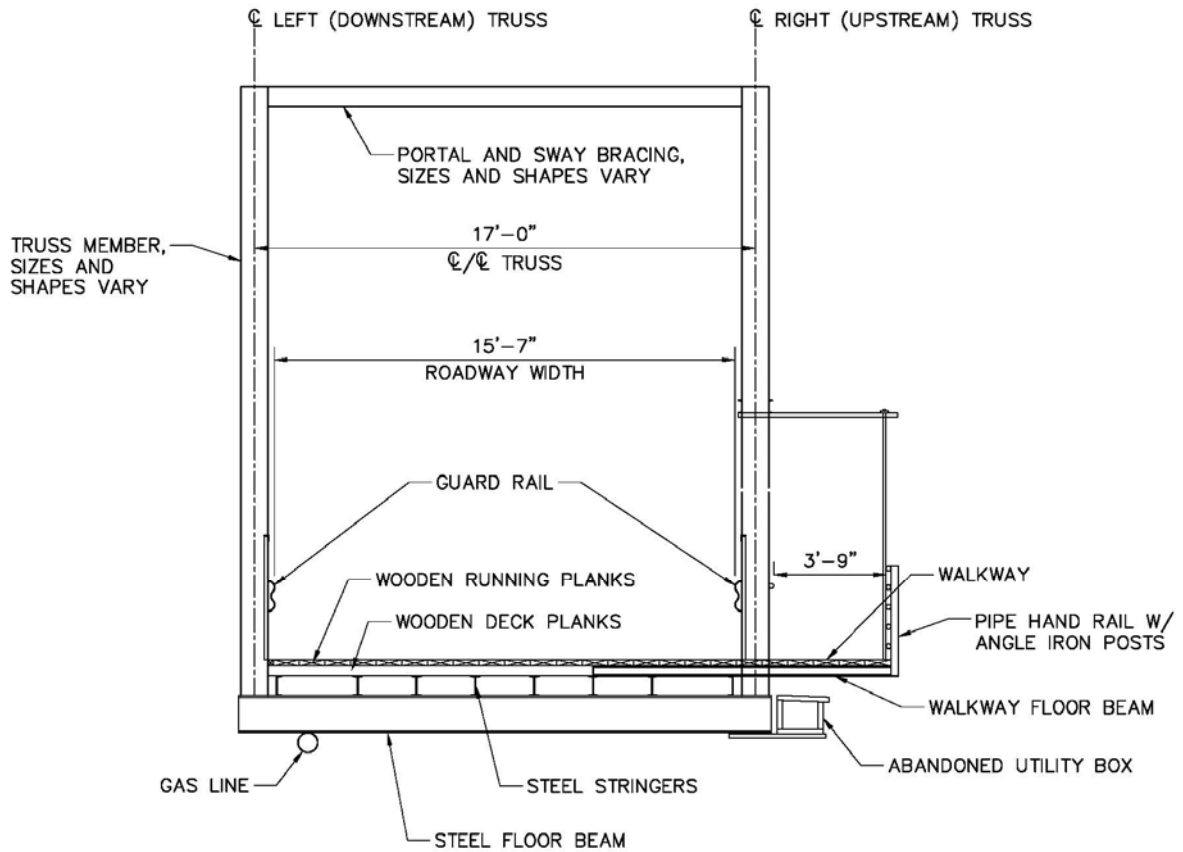
Figure 4: Bridge Cross Section

Figure 4 shows the existing bridge cross-section which provides a single 15'-7" vehicle lane with a 16'-2" vertical clearance to the overhead truss and an 8'-6" clearance to a rub-bar installed by the County. The pedestrian walkway provides a 3'-9" width for travel on the upstream side of the bridge. Guardrail (steel W-beam) is installed on both trusses to channel errant vehicles and provides modest protection for the truss members. A detailed description of the individual truss elements is included in Appendix 2.

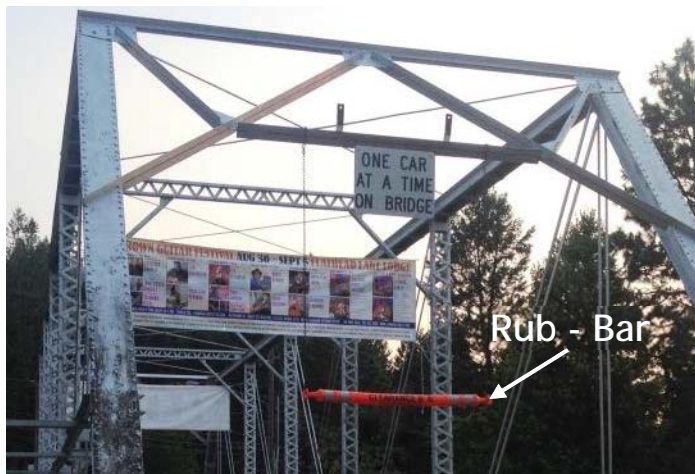
County staff have installed hanging rub-bars at both ends of the bridge (shown right) to provide a visual deterrent to drivers of large vehicles. The 8'-6" rub-bar height is well below the clearance of the truss. The structure itself provides adequate clearance for most vehicles, although the rub-bar does not provide vertical clearance for taller vehicles. Observations indicate the rub-bar is impacted regularly; but due to its swinging nature no bridge or vehicular damage is typically incurred.

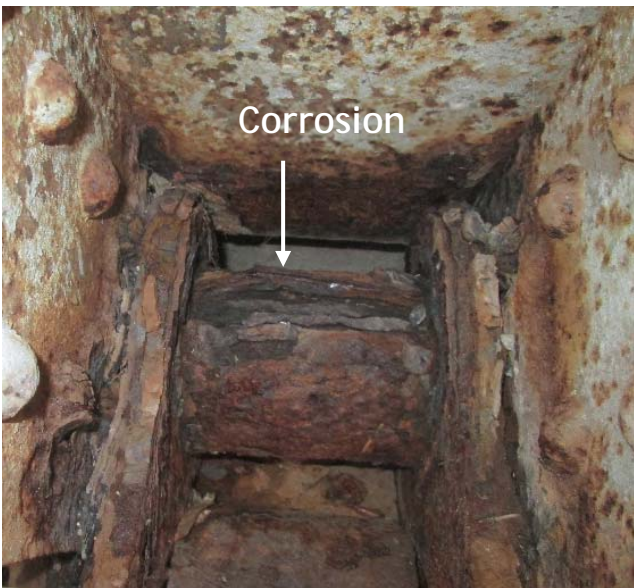
The steel truss members all have varying degrees of corrosion which reduces their effective size, thus reducing their ability to carry loads. The most severely corroded components of the bridge are the steel stringers, floorbeams, and pins at the bearings (shown left).

At some point during the life of the truss, an errant vehicle struck the left side of the truss causing substantial damage to the vertical web member VW3-L and minor damage to the diagonal web member DW4-L. The vehicular damage was repaired by welding.

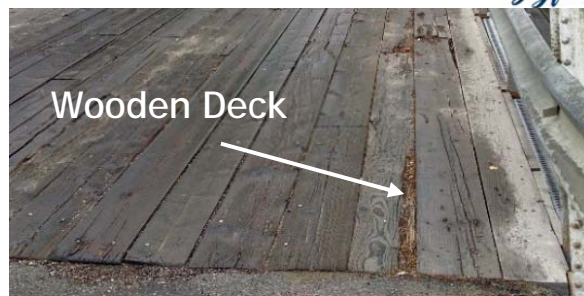
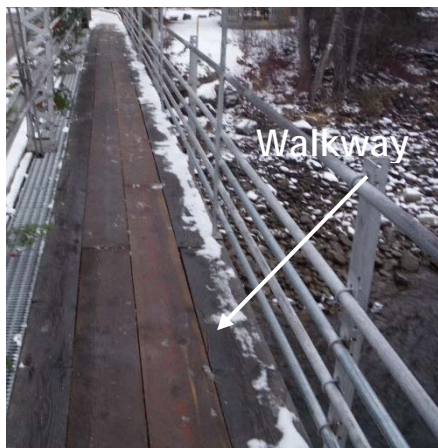
The capacity of the wood deck planks is reduced due to the presence of moisture, substantiated by observations of fungal growth.

The pedestrian walkway is narrow and does not meet Americans with Disability Act (ADA) requirements for accessibility. The wooden surface and the pipe hand rail also do not meet current design standards.
