June 28, 2023

RE: Asset 03719, L32101000+01001 Fracture Critical Inspection

The above summarizes our inspection findings from the 2023 Maclay Bridge Fracture Critical Inspection. Per FHWA requirements, the Maclay Bridge should be inspected at intervals not to exceed 24 months. If you have any questions regarding the report or our fracture critical inspection, please do not hesitate to contact me at 608.831.3238.

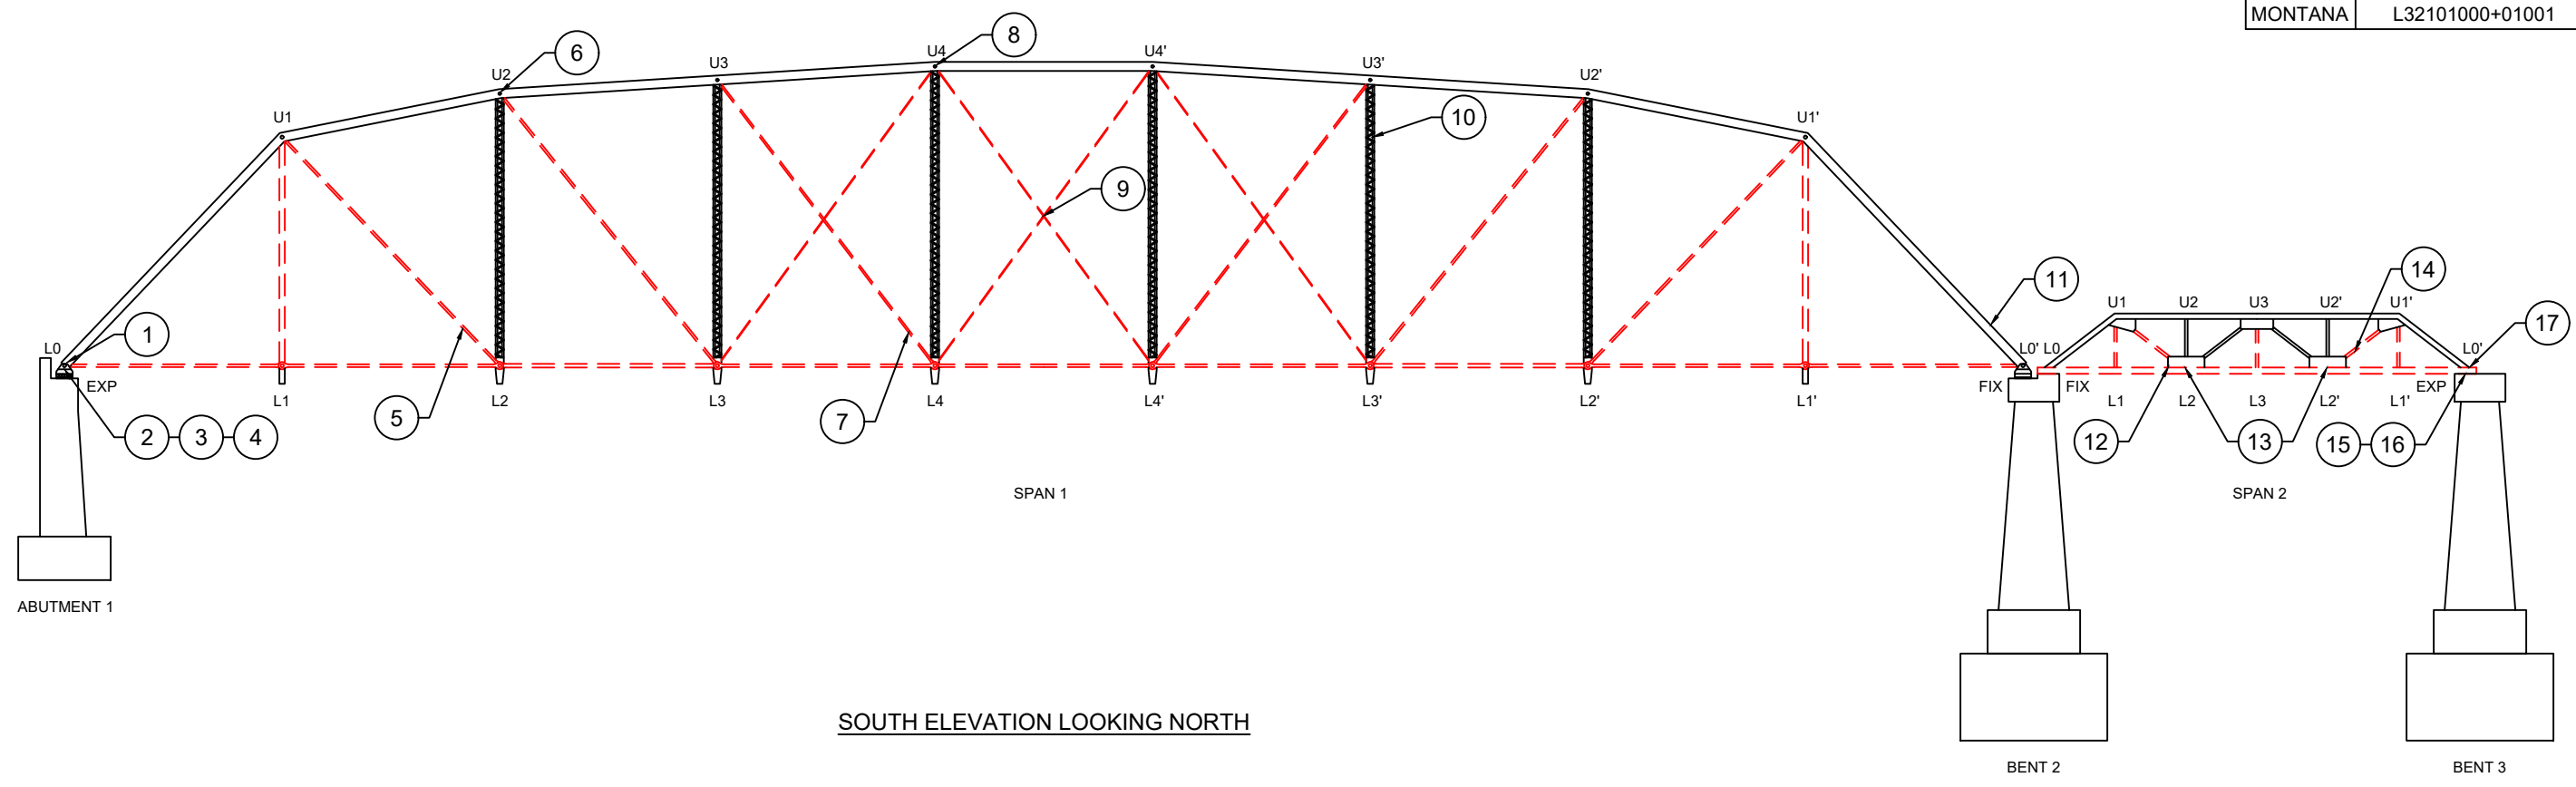
SOUTH ELEVATION LOOKING NORTH

- THE PIN AT L0 HAD PACK RUST UP TO 1 IN. THICK.
- MOVEABLE BEARING HAD HEAVY CORROSION WITH UP TO 50% SECTION LOSS TO THE ANCHOR RODS.
- MOVEABLE BEARING SOLE PLATE WAS DISPLACED 1-7/8 IN. TO THE WEST, IN EXPANSION, IN RELATION TO THE MASONRY PLATE ON A 65°F DAY.

- THE ROLLERS HAD WORKED OUT FROM UNDERNEATH THE BEARING AND WERE PUSHING AGAINST THE ABUTMENT BACKWALL. TWO ROLLERS WERE NO LONGER UNDER THE SOLE PLATE.

- INBOARD DIAGONAL EYEBAR WAS BENT 3 IN. UPWARDS OVER A 3 FT. LENGTH.
- ONE BOLT WAS LOOSE AT UPPER HORIZONTAL STRUT TO TOP CHORD CONNECTION PLATE.
- INBOARD DIAGONAL EYEBAR WAS BENT 1 IN. TO THE NORTH OVER A 2 FT. LENGTH.

- ONE BOLT WAS SHEARED OFF AT UPPER HORIZONTAL STRUT TO TOP CHORD CONNECTION PLATE.
- MINOR ABRASION AT THE INTERSECTION BETWEEN L4-U4' AND U4-L4' WITH NEGLIGIBLE SECTION LOSS.

- LOWER HORIZONTAL SWAY BRACING AT U3' WAS BENT 2 IN. TO THE EAST, AND UPWARD AND DOWNWARD 1 IN. DUE TO IMPACT DAMAGE.
- ONE BOLT WAS MISSING AT TOP FLANGE PLATE TO RAIL POST ANGLE CONNECTION.

- BOTTOM CHORD INBOARD WEB HAD PITTING UP TO 1/8 IN. DEEP AROUND GUSSET PLATE.
- PACK RUST UP TO 1/4 IN. THICK BETWEEN BOTTOM CHORD AND BOTH INTERIOR AND EXTERIOR GUSSET PLATES. PACK RUST UP TO 3/4 IN. THICK BETWEEN LOWER STRUT ANGLES OF EXTERIOR SWAY BRACE FRAMES.

- DIAGONAL WAS BENT 3/4 IN. OUT-OF-PLANE OVER A 12 IN. LENGTH.
- MOVEABLE BEARING WAS LEFT UNPAINTED AND HAD MODERATE CORROSION WITH PITTING UP TO 1/16 IN. DEEP.

- MOVEABLE BEARING SOLE PLATE WAS DISPLACED 1-7/8 IN. TO THE EAST, IN EXPANSION, IN RELATION TO THE UPPER FLANGE OF THE BEARING ON A 65°F DAY. THE ELASTOMERIC BEARING PAD WAS CRACKED.

- LOWER CHORD CHANNEL MEMBERS WERE DEFLECTED UP TO 1-1/2 IN. OUT-OF-PLANE OVER THE MOVEABLE BEARING. PACK RUST UP TO 3/16 IN. THICK BETWEEN OUTBOARD CHANNEL AND GUSSET PLATE.

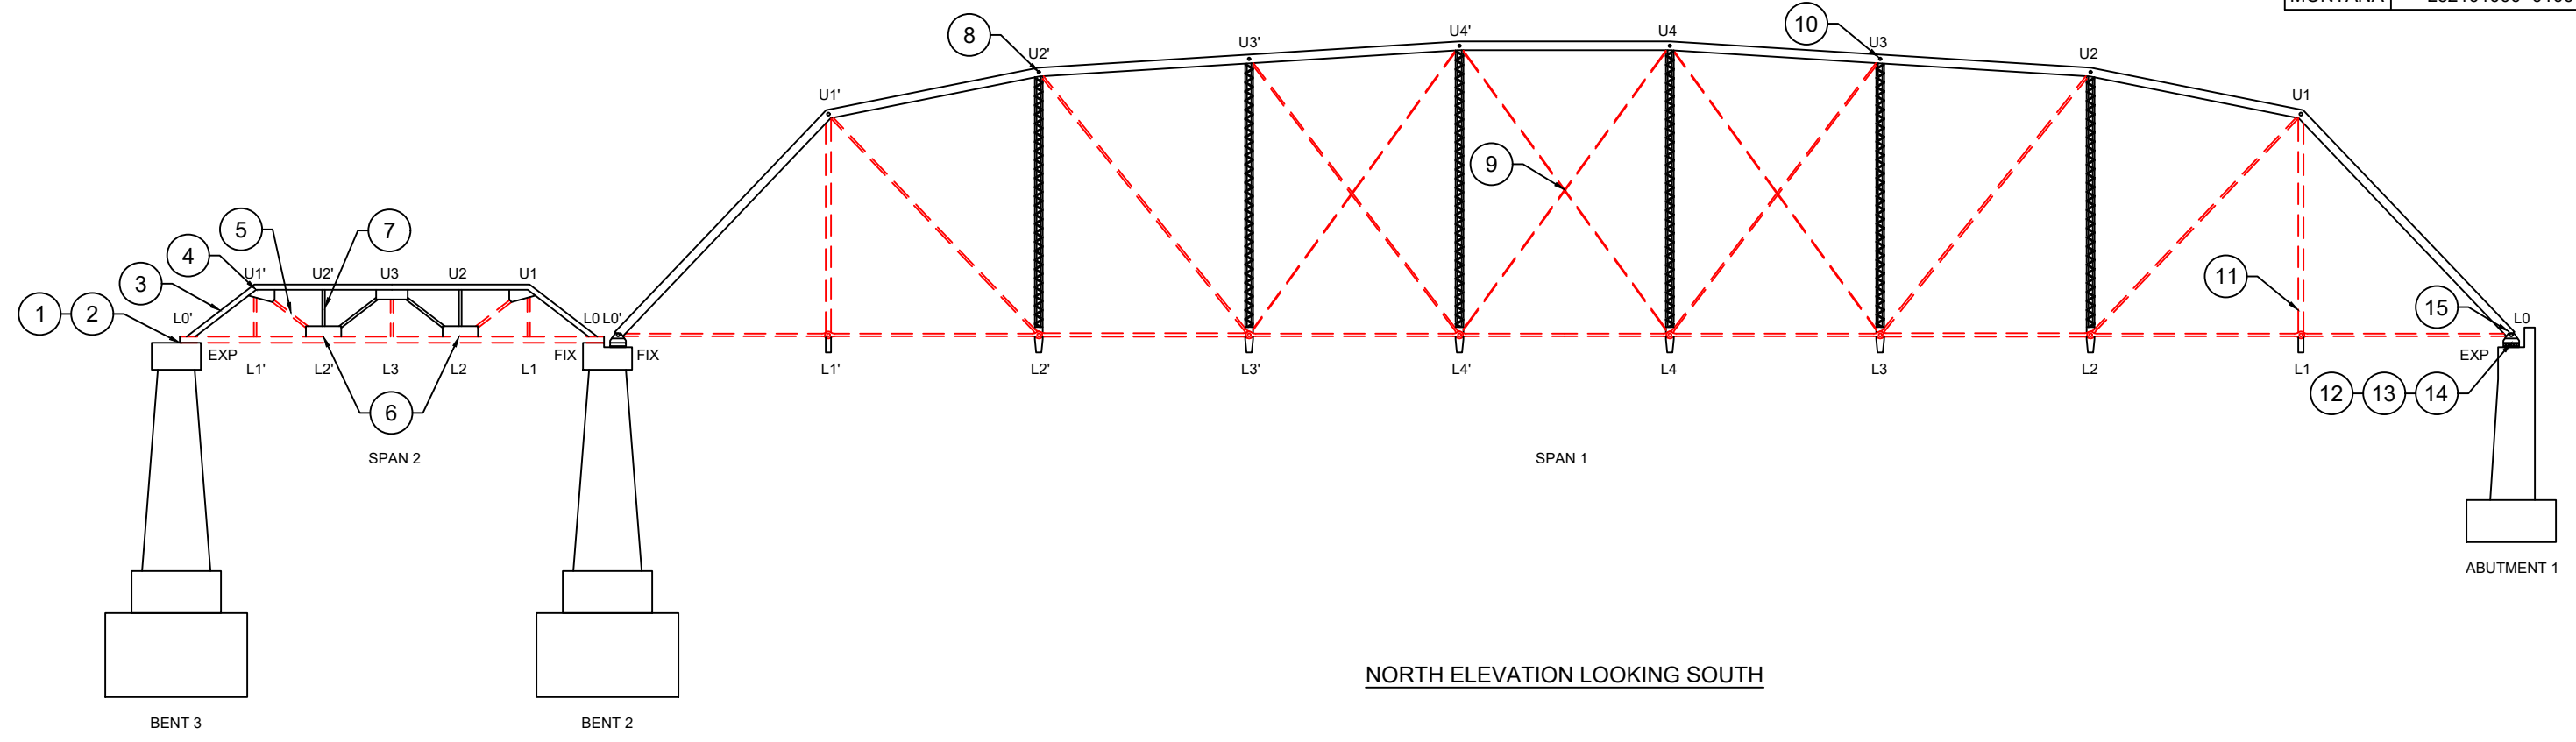
NORTH ELEVATION LOOKING SOUTH

- MOVEABLE BEARING WAS LEFT UNPAINTED AND HAD MODERATE CORROSION WITH PITTING UP TO 1/16 IN. DEEP.
- MOVEABLE BEARING TOP PLATE WAS DISPLACED 1-1/2 IN. TO THE EAST, IN EXPANSION, IN RELATION TO THE UPPER FLANGE OF THE BEARING ON A 65°F DAY. THE ELASTOMERIC BEARING PAD WAS CRACKED/TORN.

- END POST HAD SEVEN AREAS OF IMPACT DAMAGE UP TO 3/4 IN. LONG WITH UP TO 1/4 IN. OF DEFLECTION SPACED OVER A 15 IN. LENGTH.
- EXTERIOR GUSSET PLATE HAD TWO MISDRILLED 3/4 IN. DIAMETER HOLES.

- DIAGONAL INTERIOR FLANGE WAS BENT 1-3/8 IN. OUT-OF-PLANE OVER A 24 IN. LENGTH DUE TO IMPACT DAMAGE.
- PACK RUST UP TO 3/8 IN. THICK BETWEEN LOWER CHORD AND BOTH INTERIOR AND EXTERIOR GUSSET PLATES. PACK RUST UP TO 3/4 IN. THICK BETWEEN LOWER STRUT ANGLES OF EXTERIOR SWAY BRACE FRAMES.

- VERTICAL INTERIOR FLANGE WAS BENT 1 IN. OUT-OF-PLANE OVER A 6 IN. HEIGHT DUE TO IMPACT DAMAGE.
- TWO LOOSE BOLTS AT UPPER HORIZONTAL STRUT TO TOP CHORD CONNECTION PLATE.

- MINOR ABRASION AT THE INTERSECTION BETWEEN L4-U4' AND U4-L4' WITH NEGLIGIBLE SECTION LOSS.
- OUTBOARD PIN NUT HAD A 3/8 IN. GAP BETWEEN NUT AND CHORD WEB.

- EAST INTERIOR AND EXTERIOR FLANGES OF VERTICAL WERE BENT 1 IN. TO THE NORTH DUE TO IMPACT DAMAGE APPROXIMATELY 5 FT. ABOVE THE BRIDGE DECK.
- MOVEABLE BEARING HAD HEAVY CORROSION WITH UP TO 50% SECTION LOSS TO THE ANCHOR RODS.

- MOVEABLE BEARING SOLE PLATE WAS DISPLACED 2 IN. TO THE WEST, IN EXPANSION, IN RELATION TO THE MASONRY PLATE ON A 65°F DAY.
- THE NESTED ROLLER KEEPER HAD FAILED. TWO ROLLERS HAD WORKED OUT FROM UNDERNEATH THE BEARING AND WERE PUSHED AGAINST THE ABUTMENT BACKWALL. ONE ROLLER WAS STICKING OUT ON THE EAST SIDE OF THE BEARING.

- THE PIN AT L0 HAD PACK RUST UP TO 2.25 IN. THICK.

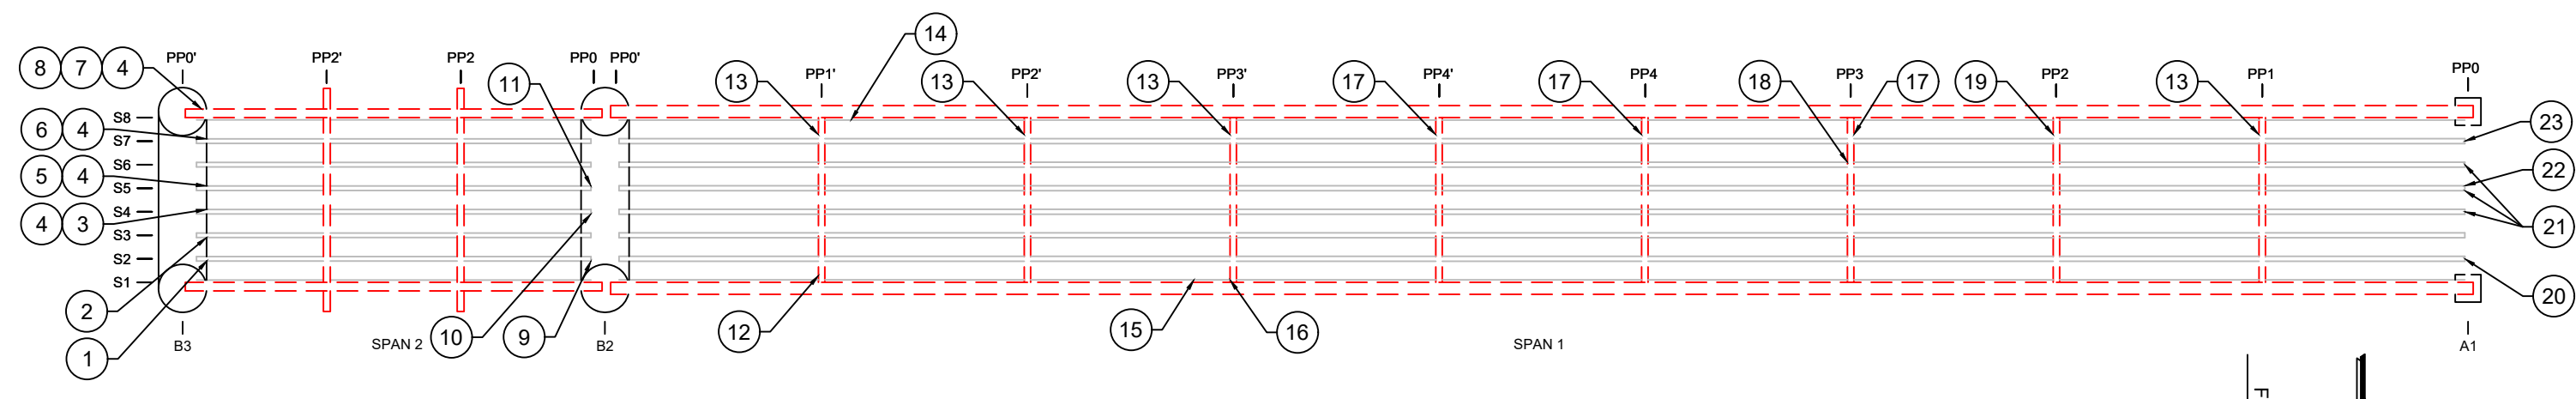
FLOOR BEAM PLAN VIEW

- STRINGER 2, AT BENT 3, HAD HEAVY CORROSION WITH A 4 IN. LONG BY 1 IN. HIGH THROUGH HOLE AT THE WEB TO BOTTOM FLANGE INTERFACE.
- STRINGER 3, AT BENT 3, HAD HEAVY CORROSION AND UP TO 1/8 IN. THICK RUST SCALE ON BOTH SIDES OF WEB AT WEB TO BOTTOM FLANGE INTERFACE ADJACENT TO STRINGER END.

- THE EAST ANCHOR ROD OF THE BEARING PIPE AT STRINGER 4 WAS SHEARED OFF. THE WEST ANCHOR ROD AT STRINGER 4 HAD UP TO 50% SECTION LOSS AND WAS LOOSE ON CONCRETE. THE BEARING PIPE MOVED UP TO 1/2 IN. VERTICALLY UNDER LIVE LOAD.

- STRINGERS 4, 5, 7, AND 8 HAD A GAP BETWEEN THE BOTTOM FLANGE AND THE HOLLOW BEARING PIPE AT BENT 3. MOVEMENT OF THE STRINGERS WAS OBSERVED UNDER LIVE LOAD.

- STRINGER 5, AT BENT 3, HAD HEAVY CORROSION AND SECTION LOSS IN THE WEB WITH AN 8 IN. LONG BY 1 IN. HIGH THROUGH HOLE NEAR STRINGER END. BOTTOM FLANGE WAS KNIFE-EDGED IN THIS AREA.

- STRINGER 7, AT BENT 3, HAD HEAVY CORROSION WITH UP TO 50% SECTION LOSS OVER A 10 IN. LONG BY 2 IN. HIGH AREA ADJACENT TO THE STRINGER END THAT HAD A 5 IN. LONG BY 1 IN. HIGH THROUGH HOLE AT THE WEB TO LOWER FLANGE INTERFACE.

- STRINGER 8, AT BENT 3, HAD HEAVY CORROSION AND SECTION LOSS IN THE WEB FOR THE END 14 IN. WITH A 7 IN. LONG BY 1 IN. HIGH THROUGH HOLE AT WEB TO BOTTOM FLANGE INTERFACE AT THE STRINGER END.

- BOTH ANCHOR RODS OF THE BEARING PIPE AT STRINGER 8 WERE SHEARED OFF. THE BEARING PIPE MOVED UP TO 1/2 IN. VERTICALLY UNDER LIVE LOAD. IMPRINTS IN DEBRIS ON TOP OF BENT SHOWED UP TO 2 IN. OF LATERAL MOVEMENT.

- STRINGER 2, AT BENT 2, HAD HEAVY CORROSION AND SECTION LOSS IN THE WEB WITH A 22 IN. LONG BY 2 IN. HIGH THROUGH HOLE AND KNIFE EDGING TO THE BOTTOM, NORTH FLANGE.

- STRINGER 4, AT BENT 2, HAD AN 18 IN. LONG BY 2 IN. HIGH AREA OF LAMELLAR CORROSION UP TO 1/4 IN. THICK ON THE BOTTOM OF THE NORTH FACE AT THE WEST END OF THE STRINGER.

- STRINGER 5, AT BENT 2, HAD A 16 IN. LONG BY 2 IN. HIGH AREA OF LAMELLAR CORROSION UP TO 1/4 IN. THICK ON THE BOTTOM OF THE WEB LOCATED 12 IN. FROM THE END OF THE STRINGER ON THE SOUTH FACE.

- FLOOR BEAM 1' BOTTOM WEST FLANGE WAS BENT UPWARDS 1/2 IN. OVER A 6 IN. LENGTH APPROXIMATELY 16 IN. FROM THE NORTH END.
- FLOOR BEAM HAD LAMELLAR CORROSION WITH PITTING UP TO 1/64 IN. DEEP UNDERNEATH FOR APPROXIMATELY 25% OF LENGTH. REMAINING LENGTH HAD MODERATE CORROSION WITH NEGLIGIBLE SECTION LOSS.

- STRINGER 8 TOP FLANGE WAS ROTATED 2 IN. TOWARDS THE NORTH FOR END 3 FT. AT FLOOR BEAM 1'.
- STRINGER 1, BETWEEN FLOOR BEAMS 3' AND 2', HAD LAMELLAR CORROSION UP TO 1/4 IN. THICK WITH 1/8 IN. SECTION LOSS UNDERNEATH.

- TWO OF TWO BOLTS LOOSE AT STRINGER 1 TO FLOOR BEAM 3' CONNECTION.
- FLOOR BEAM HAD LAMELLAR CORROSION WITH PITTING UP TO 1/64 IN. DEEP FOR APPROXIMATELY 75% OF LENGTH. END 2 FT. ON BOTH ENDS HAD AREAS WITH LESS THAN 0.470 IN. REMAINING (APPROXIMATELY 7% SECTION LOSS).

- TWO OF TWO BOLTS LOOSE AT STRINGER 6 TO FLOOR BEAM 3 CONNECTION.
- FLOOR BEAM 2, NORTH 8 FT. OF EAST WEB FACE HAD LAMELLAR CORROSION UP TO 1/4 IN. THICK WITH SECTION LOSS WHEN REMOVED. HEAVIEST CORROSION UNDER STRINGER 3 WITH 0.430 IN. REMAINING (APPROXIMATELY 14% SECTION LOSS). FLOOR BEAM HAD LAMELLAR CORROSION ALONG TOP AND BOTTOM FLANGES BUT SECTION LOSS COULD NOT BE ACCURATELY MEASURED DUE TO TAPERED MEMBER.

- STRINGER 2, AT ABUTMENT 1, HAD HEAVY CORROSION AND SECTION LOSS OVER A 14 IN. LONG BY 2 IN. HIGH AREA WITH A 2-1/2 IN. LONG BY 3/4 IN. HIGH HOLE CENTERED 2 IN. FROM THE STRINGER END.

- STRINGERS 4, 5, AND 6, AT ABUTMENT 1, HAD HEAVY CORROSION AND DELAMINATION ON WEB AND FLANGES UP TO 1/8 IN. THICK FROM THE WEST END FOR UP TO HALF OF THE SPAN LENGTH.

- STRINGER 5, AT ABUTMENT 1, HAD A 1/4 IN. GAP BETWEEN THE BOTTOM FLANGE AND THE ABUTMENT 1 BEAM SEAT AND DEFLECTED UNDER LIVE LOAD.
- STRINGER 7, AT ABUTMENT 1, HAD HEAVY CORROSION AND SECTION LOSS IN THE WEB OVER A 17 IN. LONG BY 2 IN. HIGH AREA WITH A 10 IN. LONG BY 1 IN. HIGH HOLE CENTERED 10 IN. FROM THE STRINGER END. ELASTOMERIC PAD WAS WORKING ITSELF OUT TO THE SOUTH AND WAS UNSUPPORTED FOR 1/2 IN. ALONG NORTH EDGE OF STRINGER.

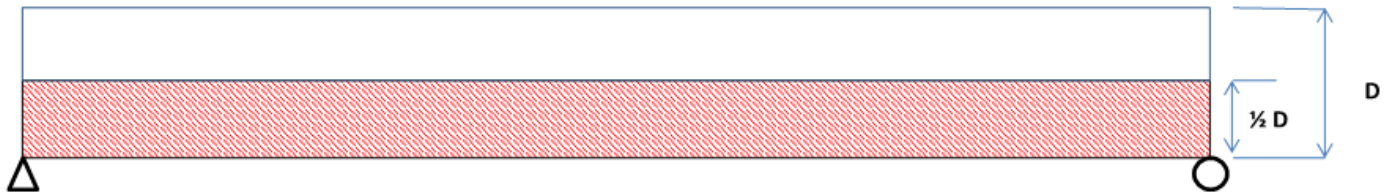
Solid Floor Beams:

Seepage through deck at seams and weld burn through locations was accelerating corrosion to floor beams. Pony Truss floor beams had minor surface corrosion with negligible section loss in areas of failed paint.

Span	Panel Point	Inspection Comment	Photos
1	1	Floor Beam 1 had lamellar corrosion with pitting up to 1/64 in. deep underneath for approximately 25% of length. Remaining length had moderate corrosion with negligible section loss.	See BrM
1	2	Floor Beam 2, north 8 ft. of east web face had lamellar corrosion up to 1/4 in. thick with section loss when removed. Heaviest corrosion under Stringer 3 with 0.430 in. remaining (approximately 14% section loss). Floor beam had lamellar corrosion along top and bottom flanges but section loss could not be accurately measured due to tapered member.	See BrM
1	3	Floor Beam 3 had lamellar corrosion with pitting up to 1/64 in. deep for approximately 75% of length. End 2 ft. on both ends had areas with 0.470 in. remaining (approximately 7% section loss).	See BrM
1	4	Floor Beam 4 had lamellar corrosion with pitting up to 1/64 in. deep for approximately 75% of length. End 2 ft. on both ends had areas with 0.470 in. remaining (approximately 7% section loss).	See BrM

1	4'	Floor Beam 4' had lamellar corrosion with pitting up to 1/64 in. deep for approximately 75% of length. End 2 ft. on both ends had areas with 0.470 in. remaining (approximately 7% section loss).	See BrM
1	3'	Floor Beam 3' had lamellar corrosion with pitting up to 1/64 in. deep underneath for approximately 25% of length. Remaining length had moderate corrosion with negligible section loss.	See BrM
1	2'	Floor Beam 2' had lamellar corrosion with pitting up to 1/64 in. deep underneath for approximately 25% of length. Remaining length had moderate corrosion with negligible section loss.	See BrM
1	1'	Floor Beam 1' had lamellar corrosion with pitting up to 1/64 in. deep underneath for approximately 25% of length. Remaining length had moderate corrosion with negligible section loss. Bottom west flange was bent upwards 1/2 in. over a 6 in. length approximately 16 in. from the north end.	See BrM
2	2	Typical condition	N/A

2	2'	Typical condition	N/A
