Rope Access Climbing Bridge Inspection Report

Asset #: 03719

Location: Maclay Truss Bridge over Bitterroot River

Inspected: June 21st, 2021

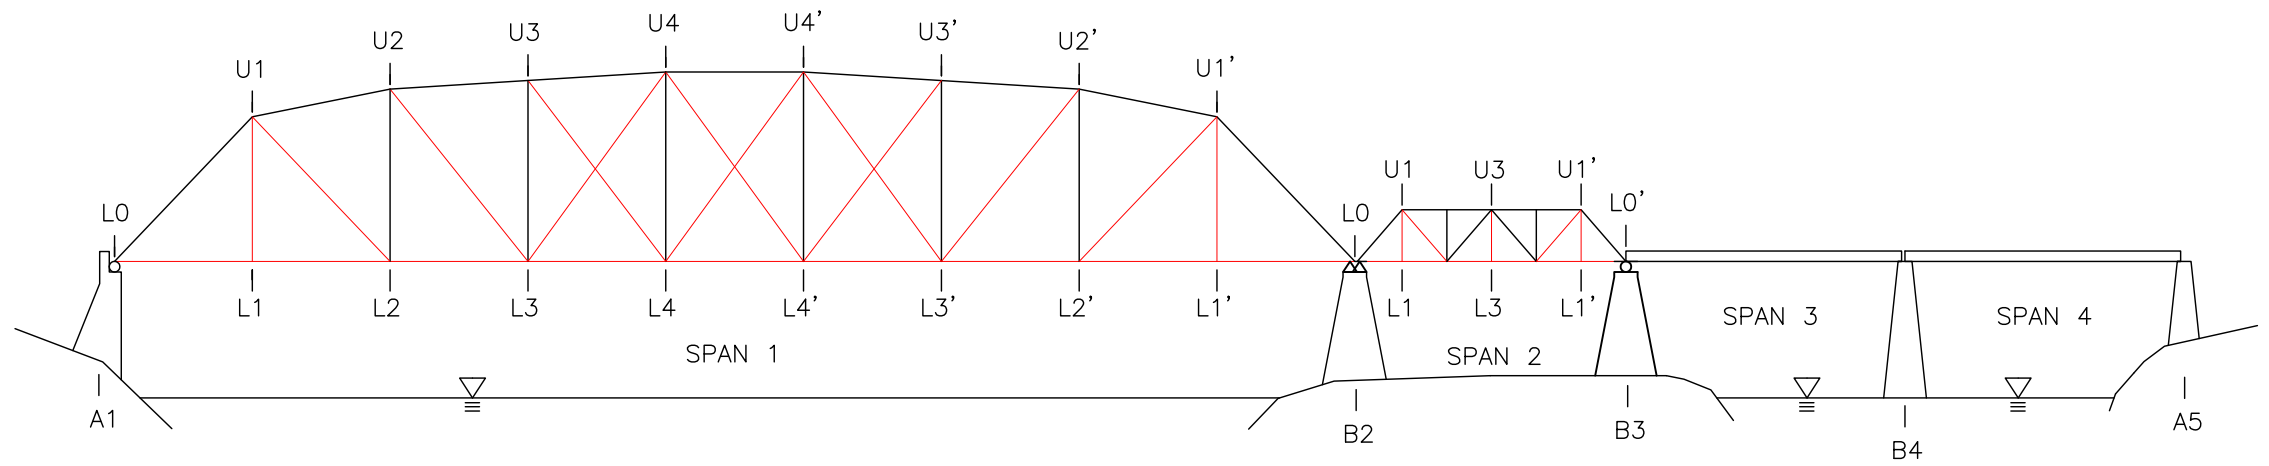
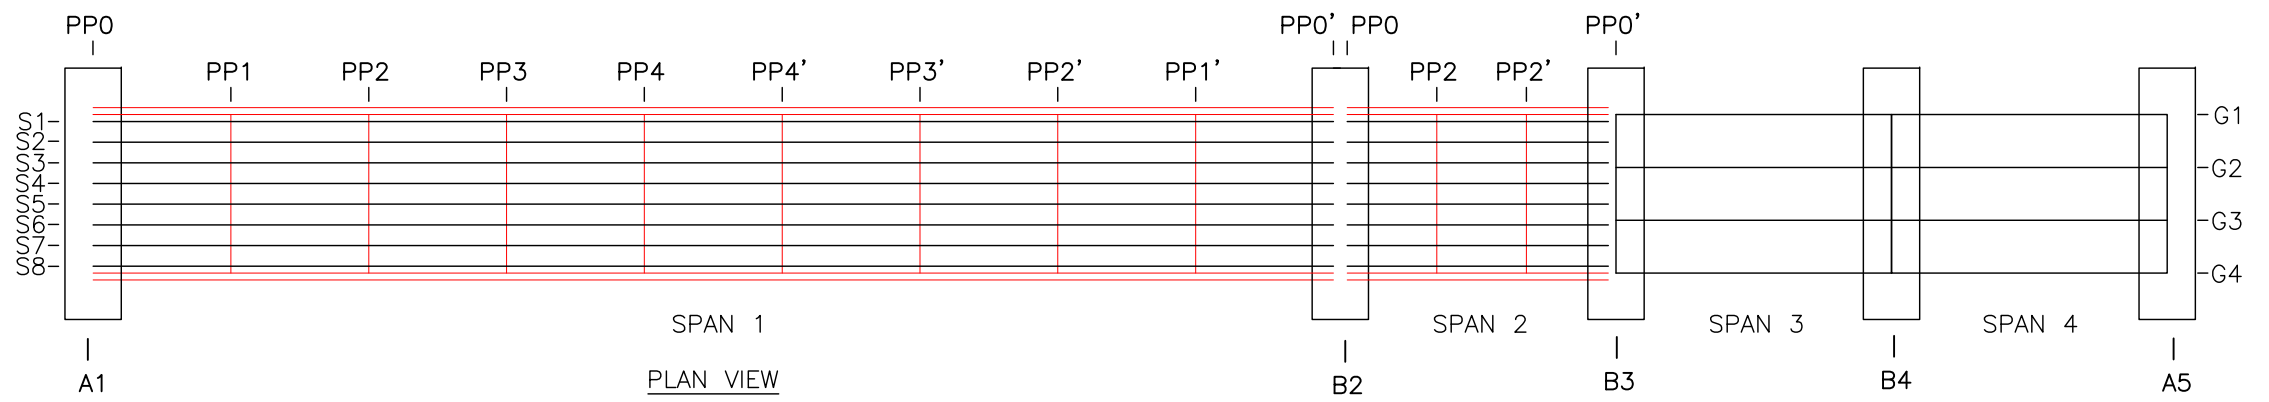
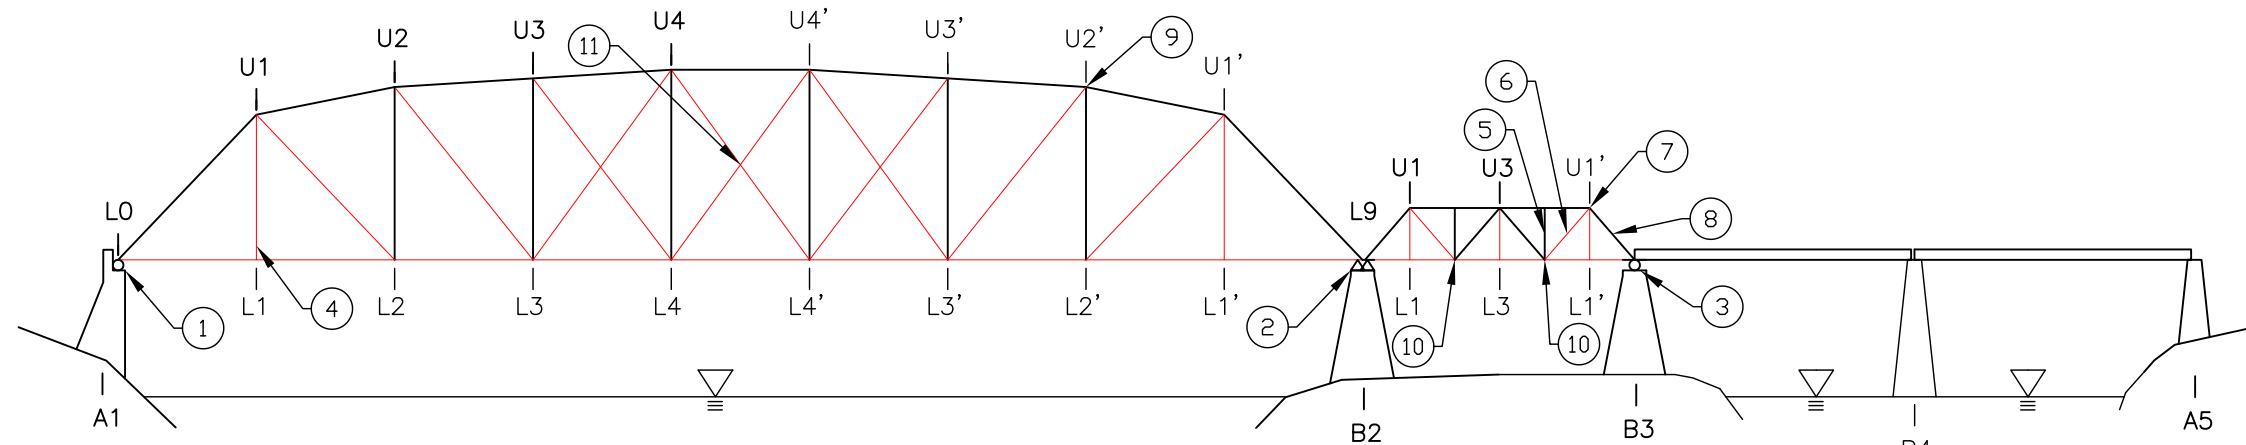
Fracture Critical Member Diagram
Maclay Bridge
Asset # 03719, Bridge # L32101000+01001
 Missoula, MT

1. ROLLER BEARING AT ABUTMENT 1 HAD FAILED PAINTED COATING ON APPROXIMATELY 25 PERCENT OF THE SURFACE AREA WITH MODERATE CORROSION AND PITTING UP TO $\frac{1}{16}$ IN. HEAVY CORROSION UNDER THE ROLLERS AND ROLLER KEEPER RESULTED IN THE ROLLER KEEPER SPLITTING. THE NESTED ROLLER KEEPER HAD FAILED. TWO OF THE ROLLERS WENT OUT FROM UNDERNEATH THE TRUSS. THE ANCHOR RODS HAD UP TO 50 PERCENT SECTION LOSS AT THE CONCRETE INTERFACE DUE TO HEAVY CORROSION. THE PIN AND PIN SLEEVE WERE SEPARATED BY 2.25 IN. DUE TO PACK RUST.
2. THE SPAN 1 FIXED BEARINGS HAD A FAILED PAINTED COATING ON APPROXIMATELY 5 PERCENT OF THE SURFACE AREA WITH MINOR SURFACE CORROSION.

3. THE SPAN 2 SLIDING BEARINGS AT BENT 3 WAS UNPAINTED AND HAD MODERATE CORROSION WITH PITTING UP TO $\frac{1}{16}$ IN. DEEP. THE TOP PLATE WAS DISPLACED $1-\frac{1}{2}$ IN. TO THE EAST (IN EXPANSION) IN RELATION TO THE UPPER FLANGE OF THE BEARING. THE ELASTOMERIC BEARING PAD WAS CRACKED/TORN.

4. THE EAST INTERIOR AND EXTERIOR FLANGES OF VERTICAL L1-U1 WERE BENT 1 IN. TO THE NORTH DUE TO IMPACT DAMAGE APPROXIMATELY 5 FT. ABOVE THE BRIDGE DECK.

5. THE INTERIOR FLANGE OF VERTICAL L2'-U2' WAS BENT 1 IN. OVER A 6 IN. HEIGHT DUE TO IMPACT DAMAGE.
6. THE INTERIOR FLANGE OF DIAGONAL L2'-U1' WAS BENT $1-\frac{3}{8}$ IN. OVER A 24 IN. LENGTH DUE TO IMPACT DAMAGE.

7. THE EXTERIOR GUSSET PLATE AT U1'N HAD TWO MISDRILLED $\frac{3}{4}$ IN. DIAMETER HOLES.
8. END POST U1'-L0' HAD (7) AREAS OF IMPACT DAMAGE UP TO $\frac{3}{4}$ IN. LONG AND $\frac{1}{4}$ IN. OF DEFLECTION SPACED OVER A 15 IN. LENGTH.

9. 2 LOOSE BOLTS AT UPPER HORIZONTAL STRUT CONNECTION U2'N.
10. UP TO $\frac{1}{4}$ IN. THICK PACK RUST BETWEEN LOWER CHORD AND BOTH INTERIOR AND EXTERIOR GUSSET PLATES AT L2 AND L2'. PACK RUST UP TO $\frac{3}{4}$ IN. THICK BETWEEN LOWER STRUT ANGLES OF EXTERIOR SWAY BRACE FRAMES AT L2 AND L2'.

11. THERE WAS MINOR ABRASION AT THE INTERSECTION BETWEEN L4-U4' and U4-L4' WITH NEGLIGIBLE LOSS OF SECTION

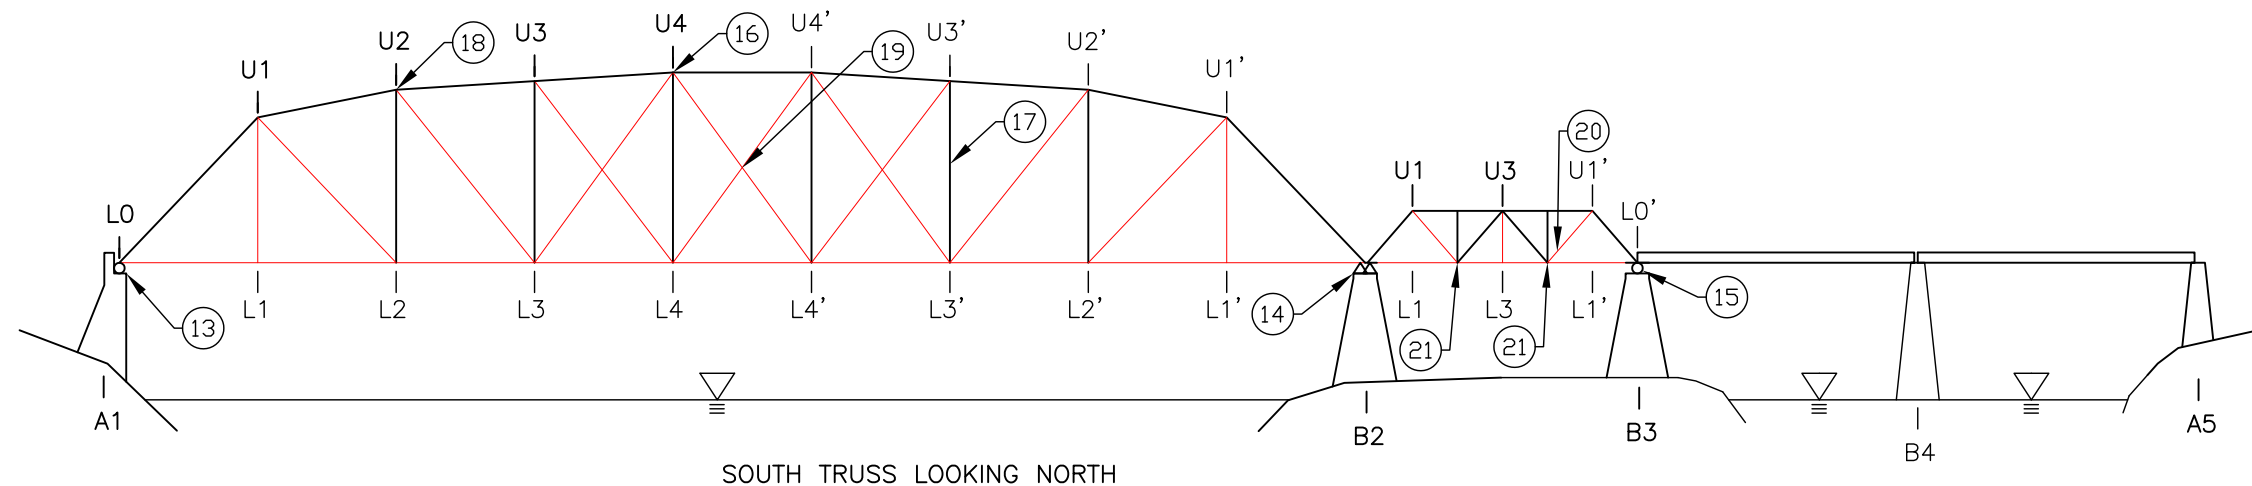
Defect Sketch
Maclay Bridge
Asset # 03719, Bridge # L32101000+01001
 Missoula, MT

- 13. ROLLER BEARING AT ABUTMENT 1 HAD FAILED PAINTED COATING ON APPROXIMATELY 25 PERCENT OF THE SURFACE AREA WITH MODERATE CORROSION AND PITTING UP TO $\frac{1}{16}$ IN. HEAVY CORROSION UNDER THE ROLLERS AND ROLLER KEEPER RESULTED IN THE ROLL TWO OF THE ORIGINAL SOUTH ROLLERS WERE STILL IN BEARING. THE ANCHOR RODS HAD UP TO 50 PERCENT SECTION LOSS AT THE CONCRETE INTERFACE DUE TO HEAVY CORROSION. THE PIN AND PIN SLEEVE WERE SEPARATED BY 1 IN. DUE TO PACK RUST.

- 14. THE SPAN 1 FIXED BEARINGS HAD A FAILED PAINTED COATING ON APPROXIMATELY 5 PERCENT OF THE SURFACE AREA WITH MINOR SURFACE CORROSION.
- 15. THE SPAN 2 SLIDING BEARINGS AT BENT 3 WAS UNPAINTED WITH MODERATE CORROSION AND PITTING UP TO $\frac{1}{16}$ IN. DEEP. THE TOP PLATE WAS DISPLACED $1-\frac{3}{4}$ IN. TO THE EAST (IN EXPANSION) IN RELATION TO THE UPPER FLANGE OF THE BEARING.

- 16. ONE BOLT WAS SHEARED OFF AND ONE BOLT WAS LOOSE AT UPPER HORIZONTAL STRUT TO TOP CHORD U4S CONNECTION PLATE.
- 17. THE LOWER HORIZONTAL SWAY BRACING AT U3' WAS BENT 2 IN. TO THE EAST, AND UPWARD AND DOWNWARD 1 IN. DUE TO IMPACT DAMAGE.

- 18. ONE BOLT WAS LOOSE AT UPPER HORIZONTAL STRUT TO TOP CHORD U2S CONNECTION PLATE.
- 19. THERE WAS MINOR ABRASION AT THE INTERSECTION BETWEEN L4-U4' and U4-L4' WITH NEGLIGIBLE LOSS OF SECTION

- 20. DIAGONAL L2'-U1' WAS BENT $\frac{3}{4}$ IN. OVER 12 IN. AT L2'.
- 21. UP TO $\frac{1}{4}$ IN. THICK PACK RUST BETWEEN LOWER CHORD AND BOTH INTERIOR AND EXTERIOR GUSSET PLATES AT L2 AND L2'. PACK RUST UP TO $\frac{3}{4}$ IN. THICK BETWEEN LOWER STRUT ANGLES OF EXTERIOR SWAY BRACE FRAMES AT L2 AND L2'.

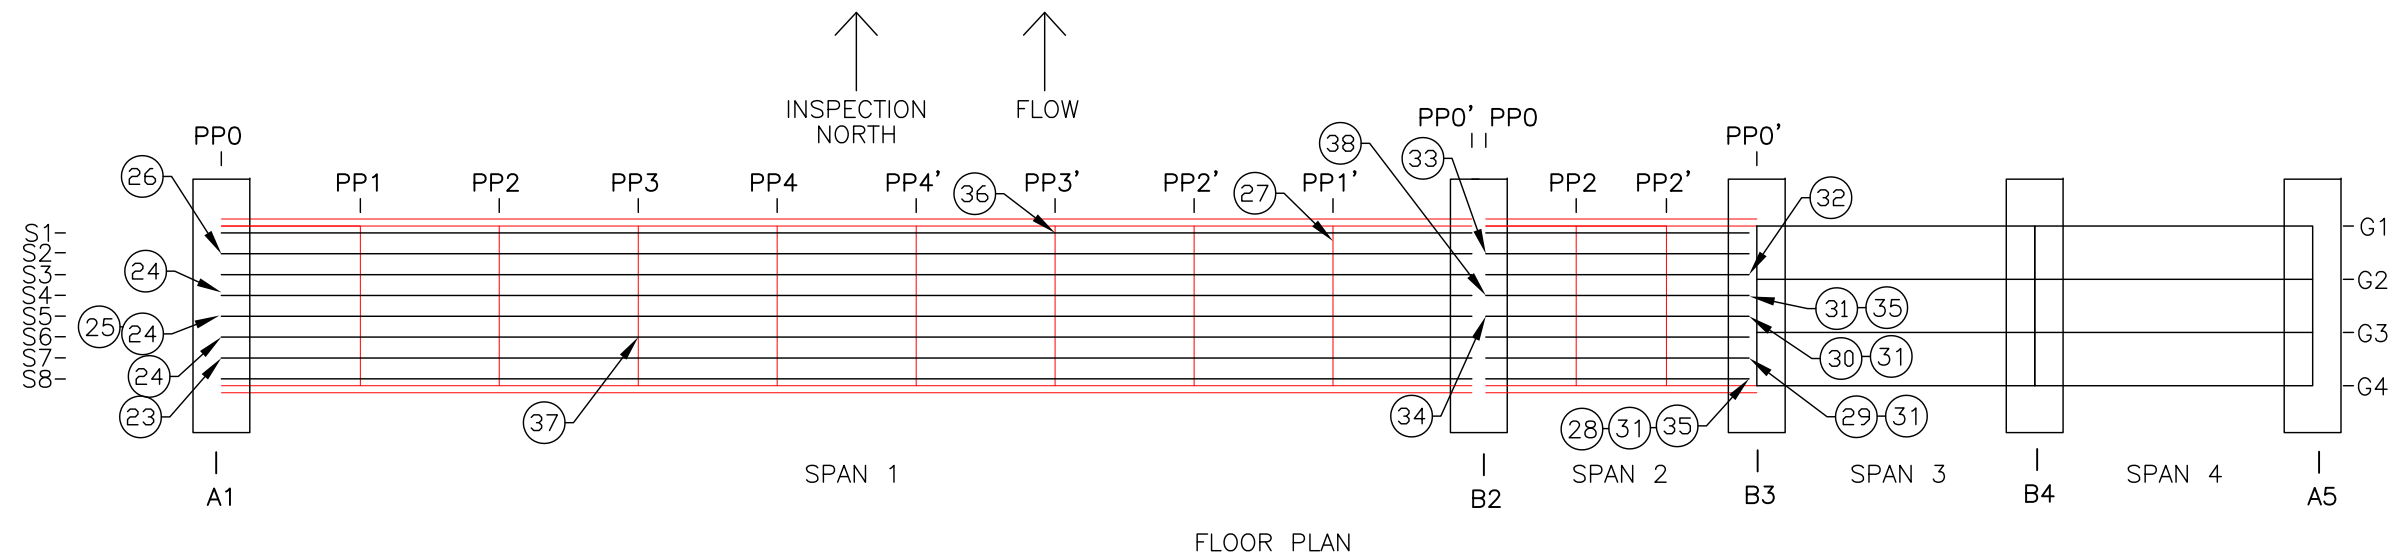
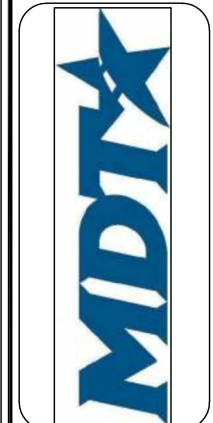
Defect Sketch
Maclay Bridge
Asset # 03719, Bridge # L32101000+01001
 Missoula, MT

- 23. STRINGER 7, ABUTMENT 1, HEAVY CORROSION AND SECTION LOSS IN THE WEB 17 IN. LONG BY 2 IN. HIGH WITH A 1 IN. HIGH BY 10 IN. LONG HOLE CENTERED 10 IN. FROM THE STRINGER END.

- 24. STRINGERS 4, 5, AND 6, ABUTMENT 1, HEAVY CORROSION AND DELAMINATION ON WEB AND FLANGES UP TO $\frac{1}{8}$ IN. DEEP FROM WEST END UP TO $\frac{1}{2}$ LENGTH OF SPAN.

- 25. STRINGER 5, ABUTMENT 1, $\frac{1}{4}$ IN. GAP BETWEEN BOTTOM FLANGE AND ABUTMENT BEAM SEAT WHICH DEFLECTED UNDER LOAD.
- 26. STRINGER 2, ABUTMENT 1, HEAVY CORROSION AND SECTION LOSS IN THE WEB 14 IN. LONG BY 2 IN. HIGH WITH A 2.5 IN. LONG BY $\frac{3}{4}$ IN. HIGH HOLE CENTERED 2 IN. FROM THE STRINGER END.

- 27. FB1', SPAN 1, BOTTOM WEST FLANGE BENT UPWARDS $\frac{1}{2}$ IN. OVER A 6 IN. LENGTH APPROXIMATELY 16 IN. FROM THE NORTH END.
- 28. STRINGER 8, BENT 3, HEAVY CORROSION AND SECTION LOSS IN THE WEB WITH (3) HOLES RANGING IN SIZE FROM $\frac{1}{4}$ - $\frac{1}{2}$ IN. IN DIAMETER LOCATED AT WEB TO LOWER FLANGE INTERFACE AT THE STRINGER END.

- 29. STRINGER 7, BENT 3, HEAVY CORROSION AND UP TO 50 PERCENT SECTION LOSS IN WEB 10 IN. LONG BY 2 IN. HIGH ADJACENT TO THE STRINGER END AND $\frac{1}{2}$ IN. DIAMETER HOLE LOCATED 6 IN. FROM THE STRINGER END.

- 30. STRINGER 5, BENT 3, HEAVY CORROSION AND SECTION LOSS IN THE WEB WITH A 6 IN. LONG BY 1 IN. HIGH HOLE NEAR STRINGER END. BOTTOM FLANGE WAS KNIFE-EDGED IN THIS AREA.

- 31. STRINGERS 4, 5, 7, AND 8, BENT 3, GAP BETWEEN THE BOTTOM FLANGE AND THE SUPPORTING BEARING SEAT OF THE BENT. MOVEMENT OBSERVED WHEN TRAFFIC PASSED OVER (GAP CLOSED).

- 32. STRINGER 3, BENT 3, HEAVY CORROSION AND UP TO $\frac{1}{8}$ IN. THICK RUST SCALE ON BOTH SIDES OF WEB AT WEB TO BOTTOM FLANGE INTERFACE ADJACENT TO STRINGER END.

- 33. STRINGER 2, BENT 2 (PONY TRUSS), HEAVY CORROSION AND SECTION LOSS IN WEB WITH (2) HOLES: 10 IN. LONG BY 1.5 IN. HIGH HOLE AND A 6 IN. LONG BY 1 IN. HIGH HOLE CENTERED 16 IN. FROM THE STRINGER END.

- 34. STRINGER 5, BENT 2 (PONY TRUSS), 16 IN. LONG BY 2 IN. HIGH AREA OF DELAMINATION UP TO $\frac{1}{4}$ IN. THICK ON BOTTOM OF WEB LOCATED 12 IN. FROM END OF STRINGER ON SOUTH FACE.

- 35. SPAN 2 BEARING PIPE AT BENT 3: EAST ANCHOR ROD OF BEARING PIPE AT STRINGER 4 AND WEST ANCHOR ROD OF BEARING PIPE AT STRINGER 8 BROKEN. WEST ANCHOR ROD AT STRINGER 4 HAD 50% LOSS OF SECTION. EDGE OF PIPE TYPICALLY MOVED UP TO $\frac{1}{2}$ IN. UNDER LIVE LOAD.

- 36. 2 OF 2 BOLTS LOOSE AT STRINGER 1 TO FB3' CONNECTION.
- 37. 2 OF 2 BOLTS LOOSE AT STRINGER 6 TO FB3 CONNECTION.
- 38. STRINGER 4, BENT 2, 18 IN. LONG BY 2 IN. HIGH BY UP TO $\frac{1}{4}$ IN. THICK AREA OF DELAMINATION ON THE BOTTOM OF THE NORTH FACE AT THE WEST END.
