Bridge No. L32101000+01001
Missoula, Montana
Condition Evaluation Report:
Routine and Fracture Critical Inspection
Inspection Date: August 8 and 10, 2017

Prepared By:

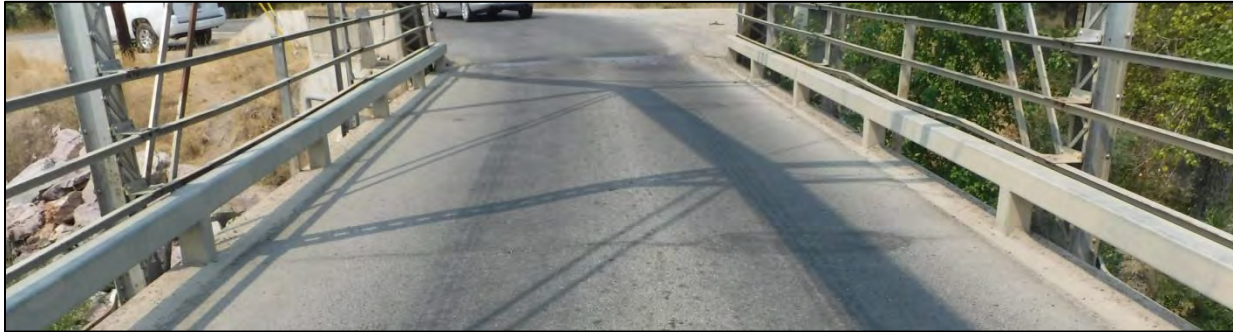
Both the East and West Approaches consisted of asphalt pavement with minor wear over the entire surface area of the approaches (**Photo 18**). The West Approach had a 5 ft. long by bridge width area of cold patch which was sound with no noted cracking (**Photo 19**). A 1/4 in. wide by full width transverse crack was noted approximately 18 ft. from the west transition (**Photo 20**). A 1/2 in. wide by full width transverse crack was noted approximately 4 ft. from the east transition (**Photo 21**).

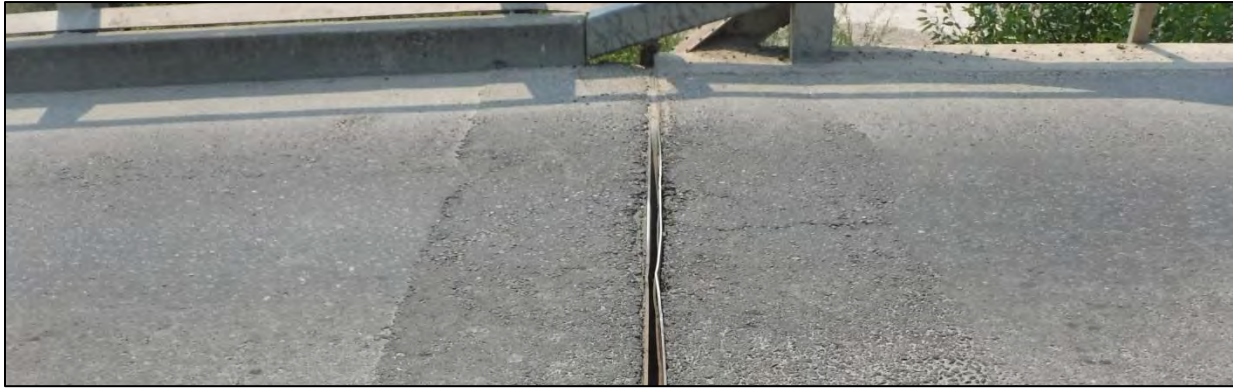
Joint 1 over Abutment 1 was a 11 ft. long by 30 in. wide metal plate bolted to the bridge deck on the east side of the joint (**Photo 38**).

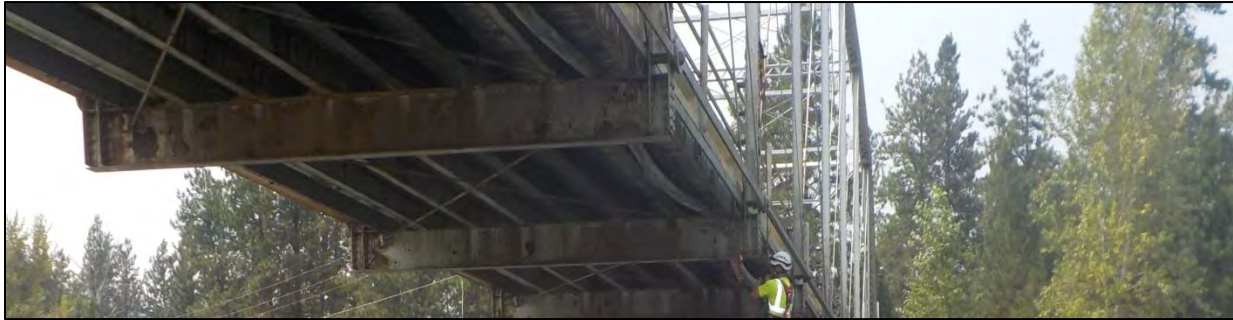
The floor beams were steel rolled beam sections connected to the lower chord by a pinned connection. Approximately 40 percent of the painted coating on the floor beams had failed with minor surface corrosion and negligible section loss, 40 percent had failed with exposed primer underneath, and the remaining painted coating was bubbling and peeling. The bottom west flange of Floor Beam 1' on Span 1 had bent upwards 1/2 in. over a 6 in. length approximately 16 in. from the north end (**Photo 43**).

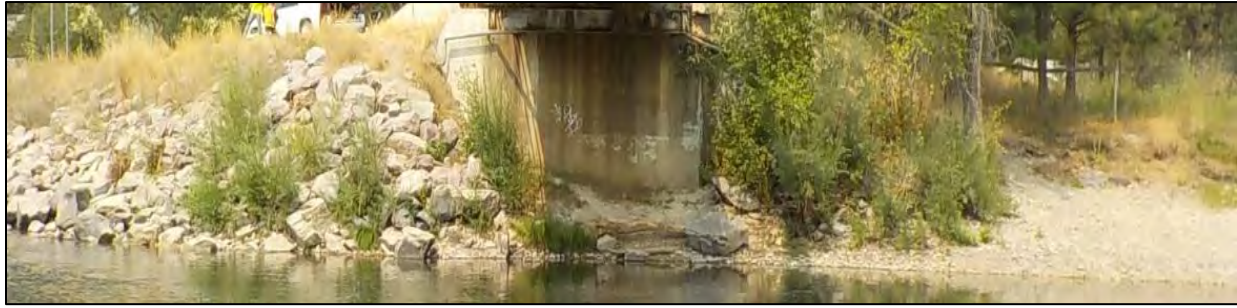
Abutment 1 (**Photo 13**) was constructed of reinforced concrete. The abutment had one full height, vertical crack up to 1/8 in. wide in the middle of the abutment (**Photo 55**). The abutment had rust staining under the truss due to corrosion from the steel members above the abutment.

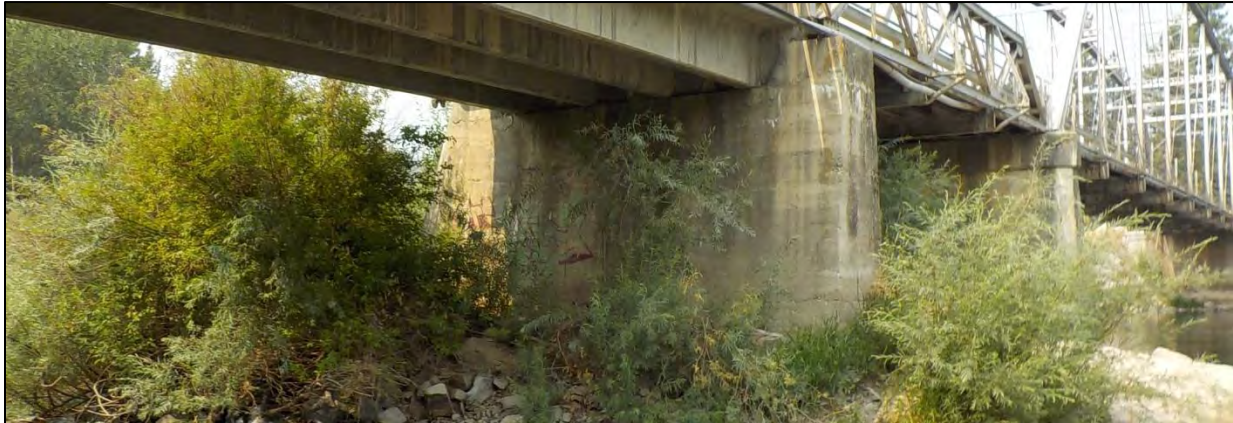
The bents were constructed of reinforced concrete. At the time of inspection, the bents were located on dry land and could be fully inspected.

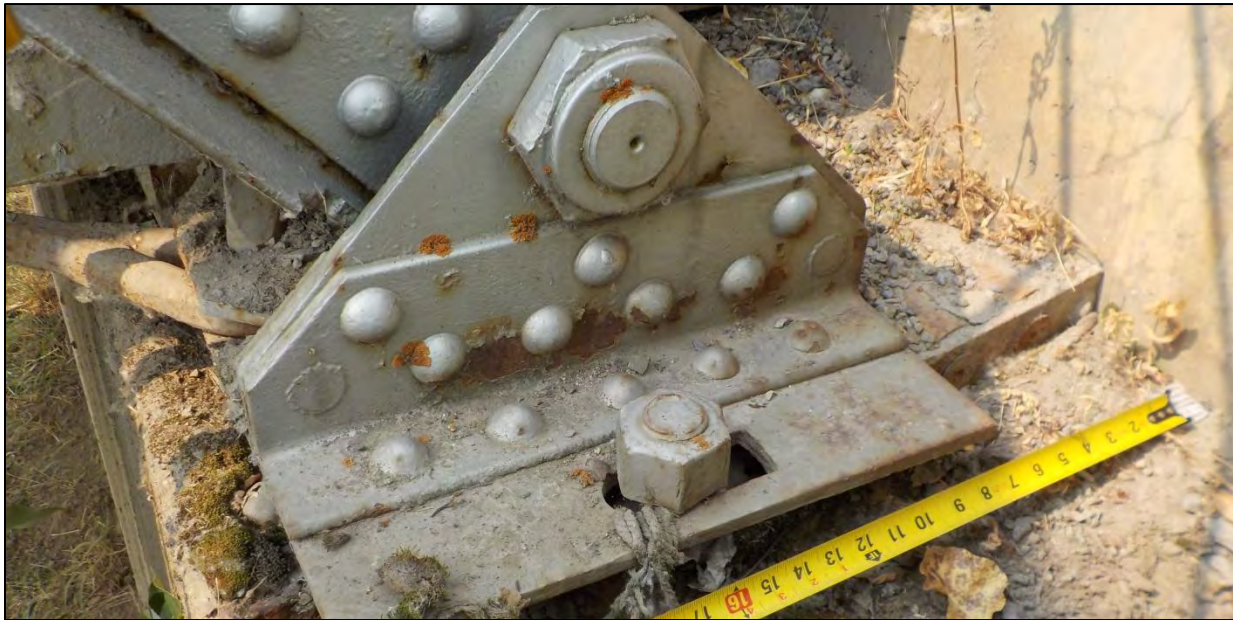
Abutment 1, North Truss roller bearing (**Photo 60**) had a failed painted coating on approximately 25 percent of the surface area with moderate corrosion and pitting up to 1/16 in. to the steel underneath, 10 percent had failed with exposed primer underneath, and the remaining paint was chalking. The heavy corrosion was under the rollers and roller keeper (**Photo 61**). The roller keeper had split due to heavy corrosion and the nested roller assembly had failed. Two of the rollers along with a portion of the keeper were out from underneath the truss to the west of the bearing and one roller was sticking out from underneath the bearing to the east of the bearing (**Photo 62**). The anchor rods had up to 25 percent section loss at the concrete interface due to heavy corrosion. The top plate was displaced 1-7/8 in. to the west (in expansion) in relation to the bottom plate.

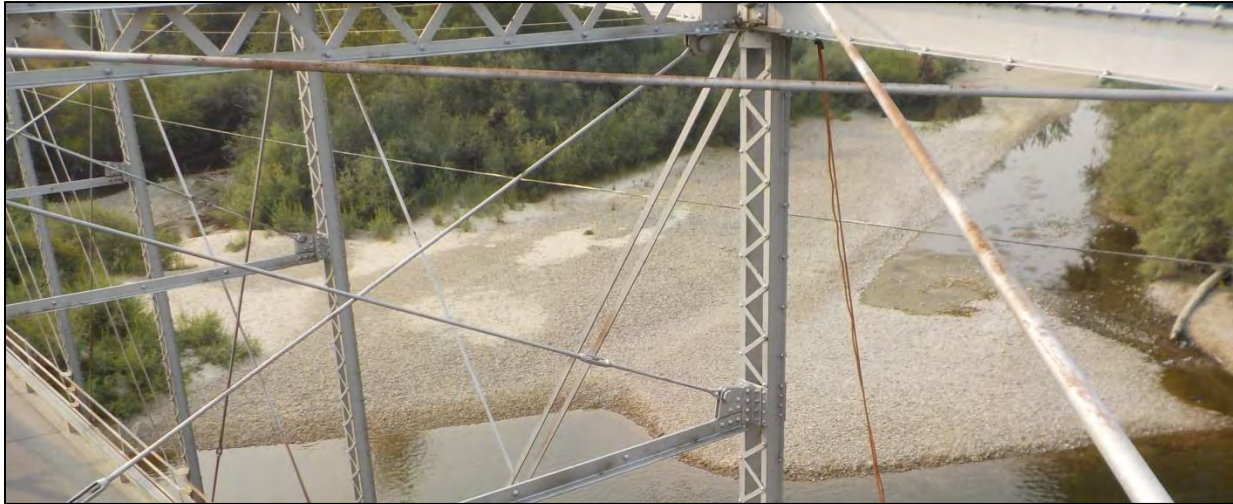
The verticals and upper chords were built up steel members consisting of C-channels with supporting lacing bars, batten plates, rolled beams. The diagonals consisted of eyebars connected at either end by a pinned connection. The pony truss consisted of built up steel members consisting of rolled members with supporting lacing bars and batten plates. Approximately 5 percent of the painted coating had failed on the truss members with minor surface corrosion and negligible section loss, 5 percent had failed with exposed primer underneath, 5 percent was chalking, and the remaining painted coating was in good condition.

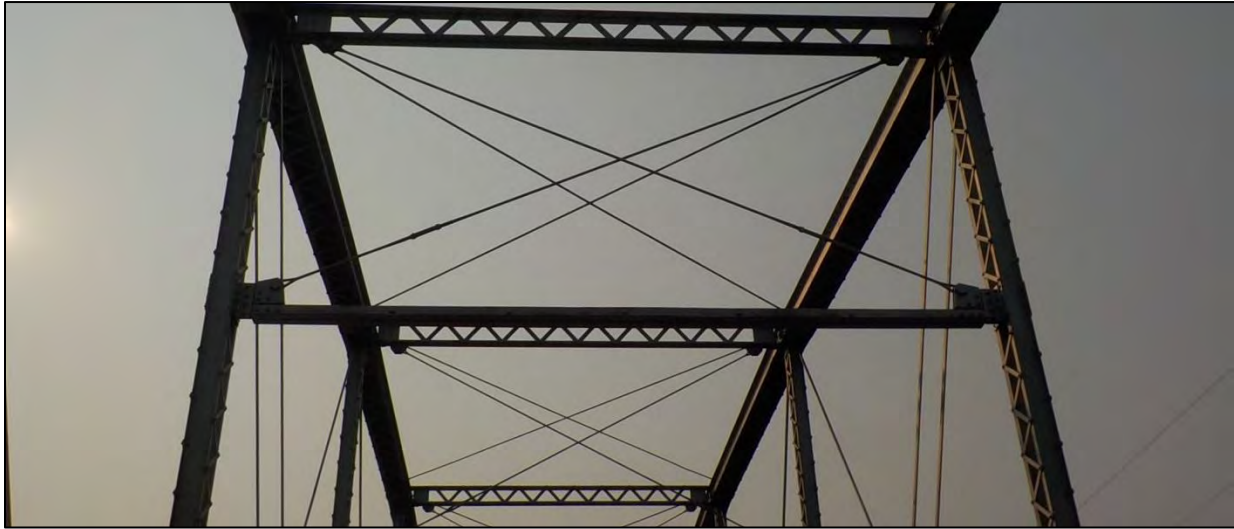
Approximately 40 percent of the painted coating on the bracing had failed with minor surface corrosion and negligible section loss, 40 percent had failed with exposed primer underneath, and the remaining painted coating was bubbling and peeling.

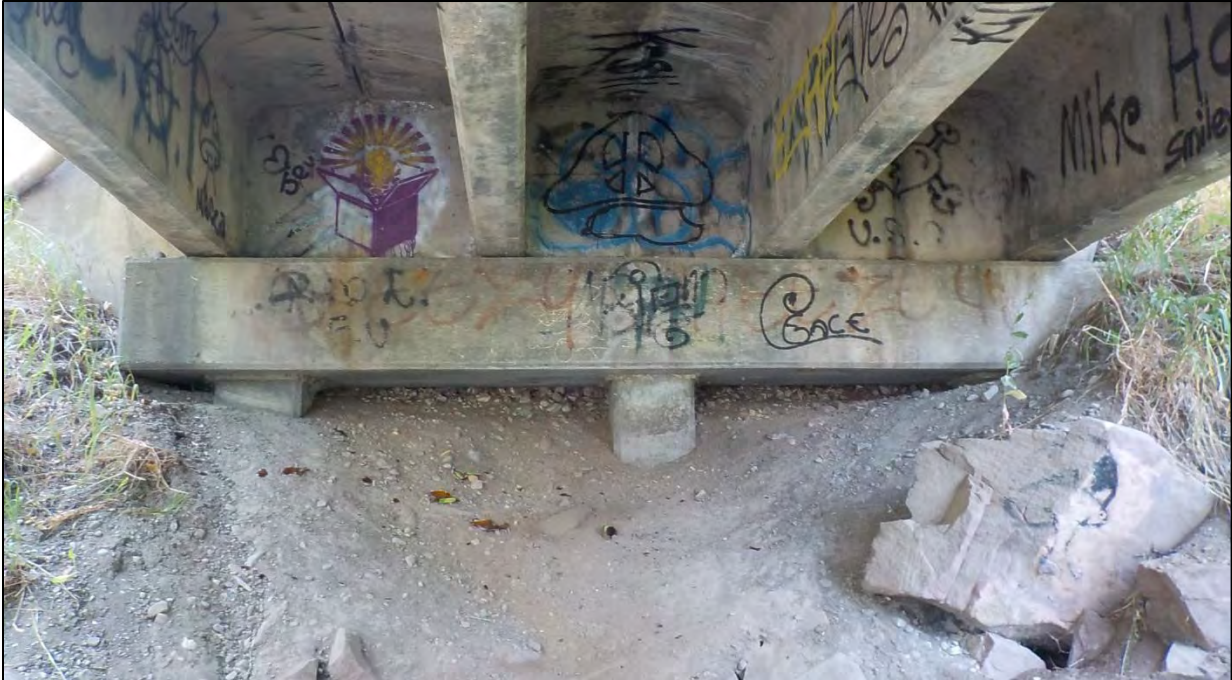
Photo 17: Abutment 5 West Elevation looking east

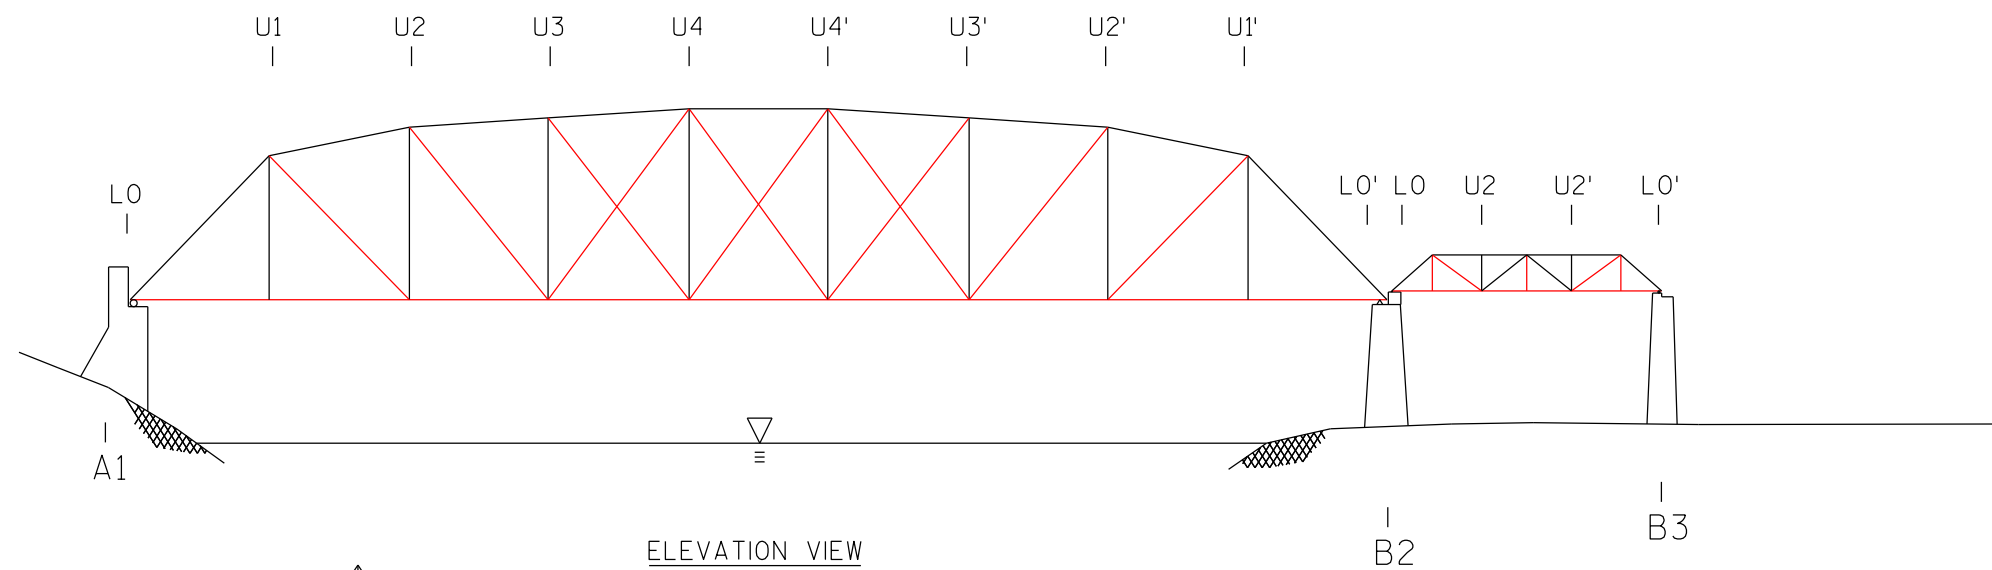
The following drawing shows the members in red that were considered fracture critical during inspection. Fracture critical inspection requires visual inspection from no further away than arm's length, which was achieved via rope access methods.

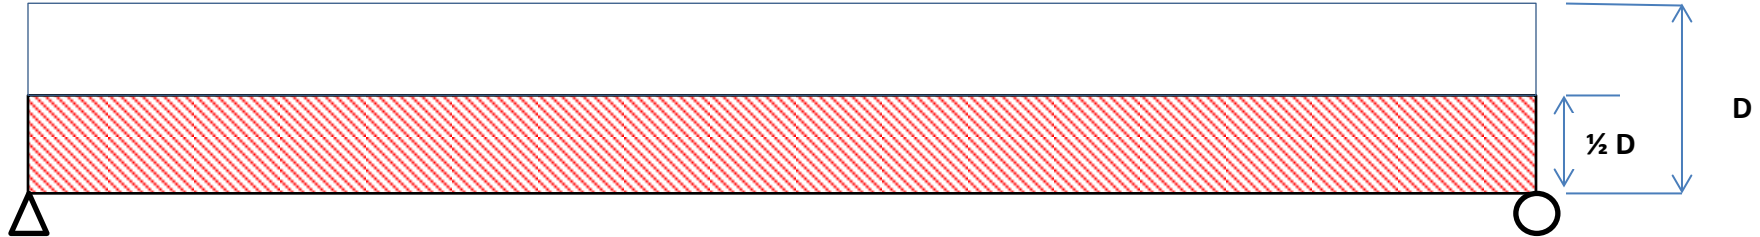
Consider the fracture critical portion of the floor beam as the lower half of the beam depth, the portion below the neutral axis that is in tension. Use separate forms for each member. Note any defects and label the defect accordingly. Make sure and note that a defect is Near Face (NF), Far Face (FF) or Both Faces (BF). All notations will be recorded looking ahead on line. Use this drawing for trusses or two girders system bridges with solid rolled or built up section floor beams.

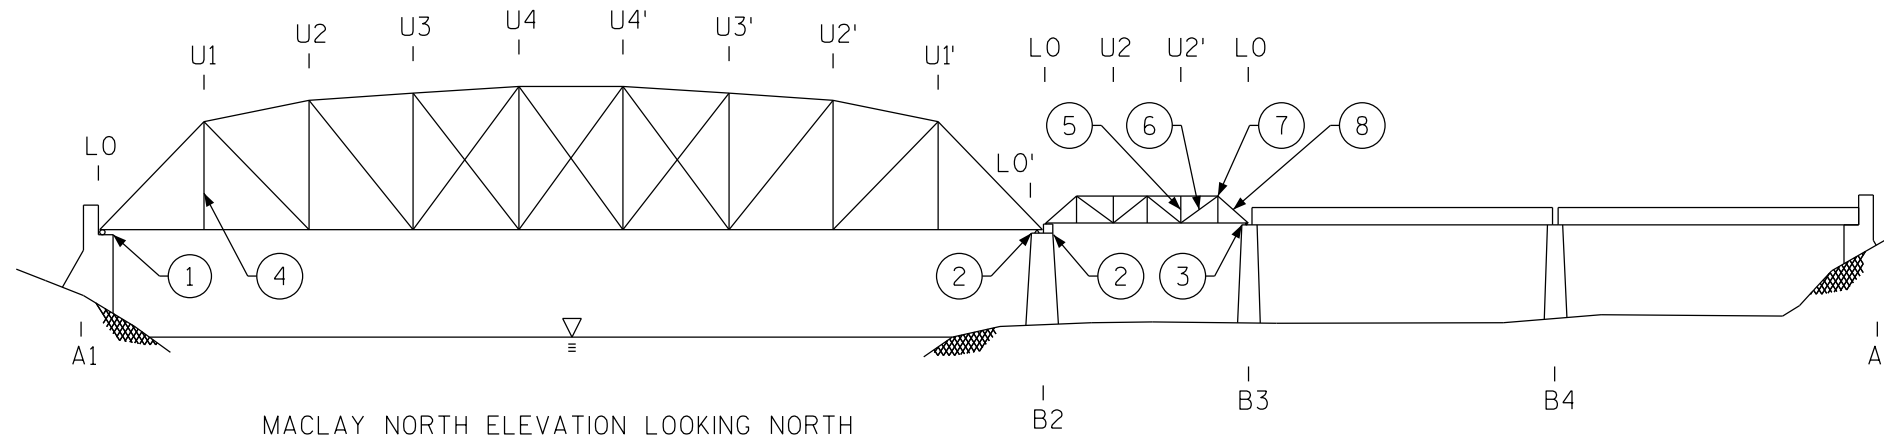
MACLAY NORTH ELEVATION LOOKING NORTH

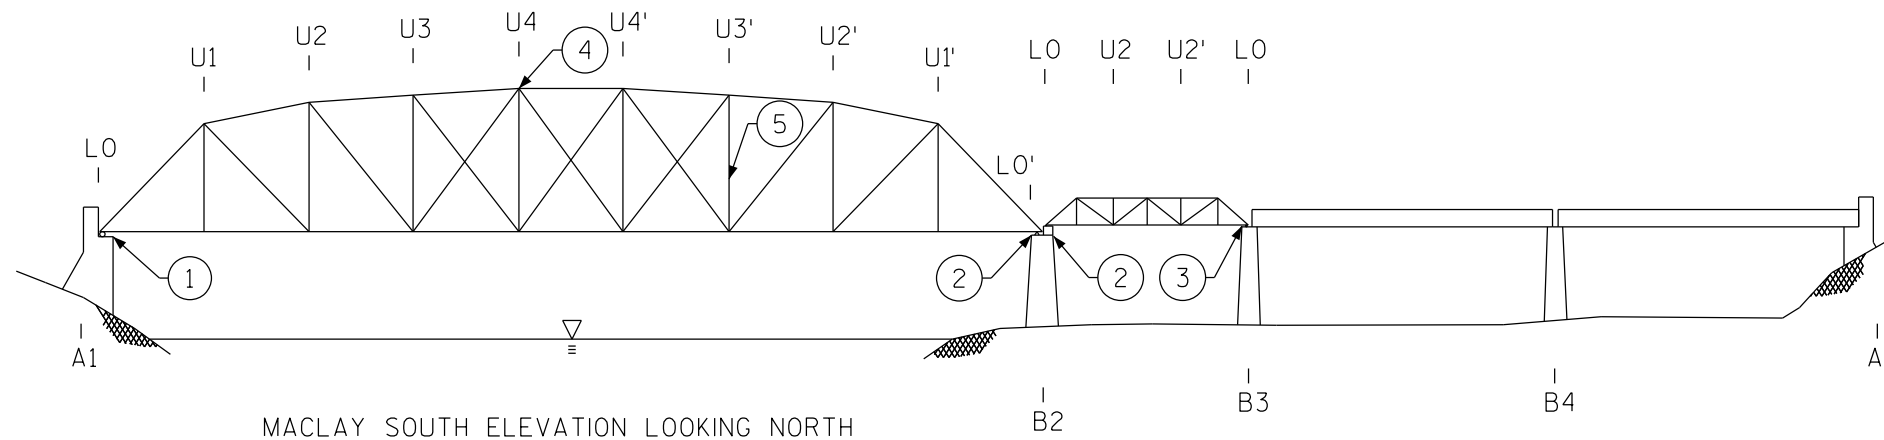
DRAWN BY	RYAN A SIEVERS				
	REVIEWED BY	TODD DEMSKI

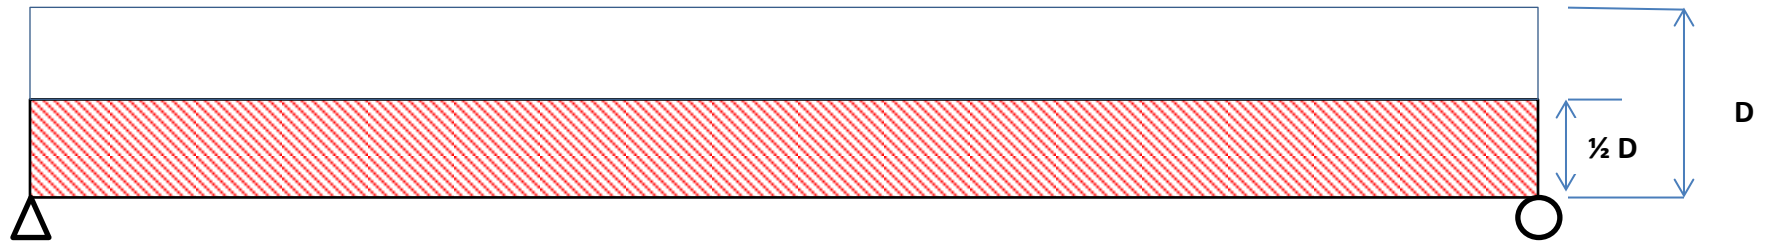
Consider the fracture critical portion of the floor beam as the lower half of the beam depth, the portion below the neutral axis that is in tension. Use separate forms for each member. Note any defects and label the defect accordingly. Make sure and note that a defect is Near Face (NF), Far Face (FF) or Both Faces (BF). All notations will be recorded looking ahead on line. Use this drawing for trusses or two girders system bridges with solid rolled or built up section floor beams.

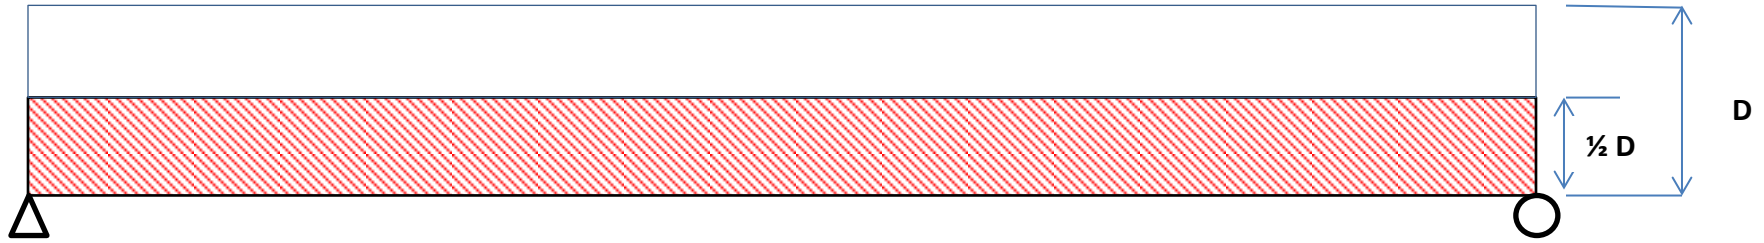
Consider the fracture critical portion of the floor beam as the lower half of the beam depth, the portion below the neutral axis that is in tension. Use separate forms for each member. Note any defects and label the defect accordingly. Make sure and note that a defect is Near Face (NF), Far Face (FF) or Both Faces (BF). All notations will be recorded looking ahead on line. Use this drawing for trusses or two girders system bridges with solid rolled or built up section floor beams.

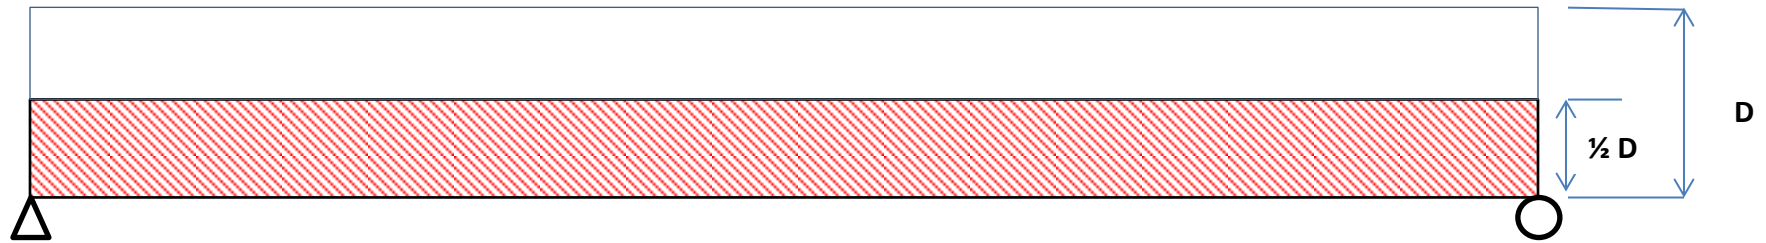
Consider the fracture critical portion of the floor beam as the lower half of the beam depth, the portion below the neutral axis that is in tension. Use separate forms for each member. Note any defects and label the defect accordingly. Make sure and note that a defect is Near Face (NF), Far Face (FF) or Both Faces (BF). All notations will be recorded looking ahead on line. Use this drawing for trusses or two girders system bridges with solid rolled or built up section floor beams.

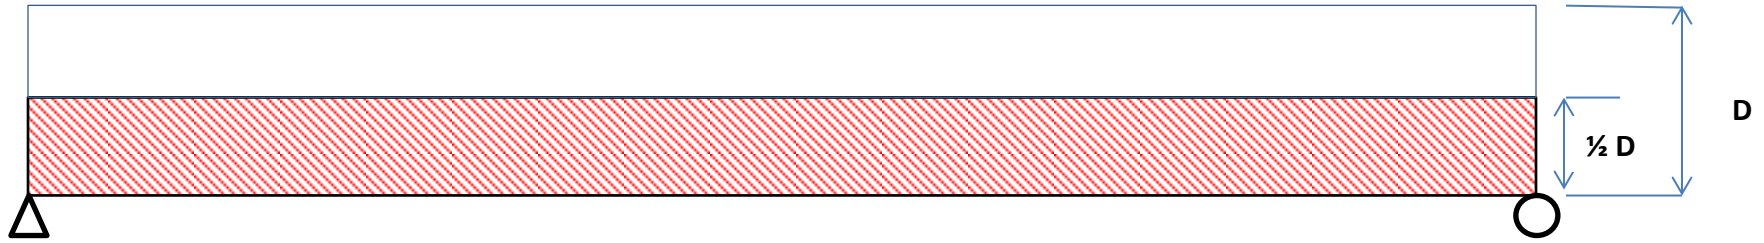
Consider the fracture critical portion of the floor beam as the lower half of the beam depth, the portion below the neutral axis that is in tension. Use separate forms for each member. Note any defects and label the defect accordingly. Make sure and note that a defect is Near Face (NF), Far Face (FF) or Both Faces (BF). All notations will be recorded looking ahead on line. Use this drawing for trusses or two girders system bridges with solid rolled or built up section floor beams.

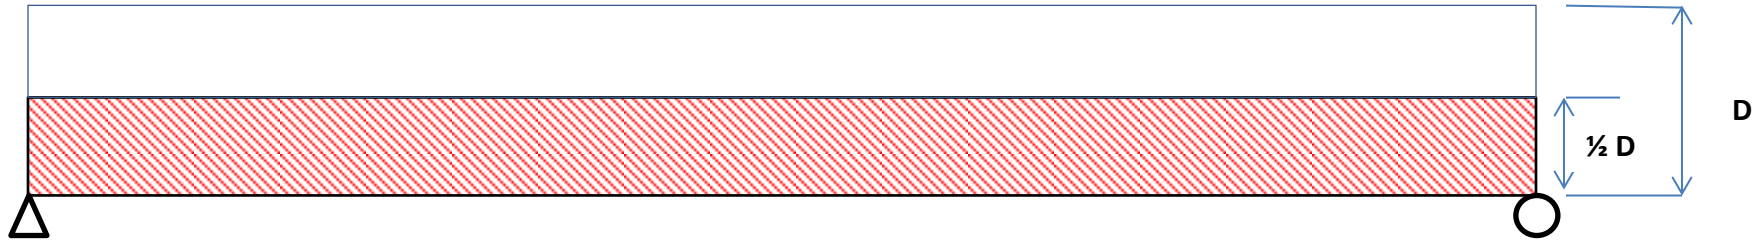
Consider the fracture critical portion of the floor beam as the lower half of the beam depth, the portion below the neutral axis that is in tension. Use separate forms for each member. Note any defects and label the defect accordingly. Make sure and note that a defect is Near Face (NF), Far Face (FF) or Both Faces (BF). All notations will be recorded looking ahead on line. Use this drawing for trusses or two girders system bridges with solid rolled or built up section floor beams.

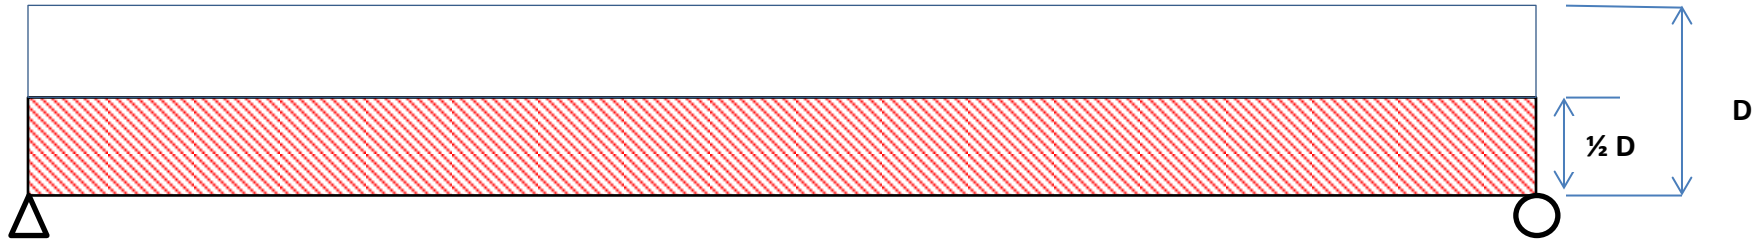
Consider the fracture critical portion of the floor beam as the lower half of the beam depth, the portion below the neutral axis that is in tension. Use separate forms for each member. Note any defects and label the defect accordingly. Make sure and note that a defect is Near Face (NF), Far Face (FF) or Both Faces (BF). All notations will be recorded looking ahead on line. Use this drawing for trusses or two girders system bridges with solid rolled or built up section floor beams.

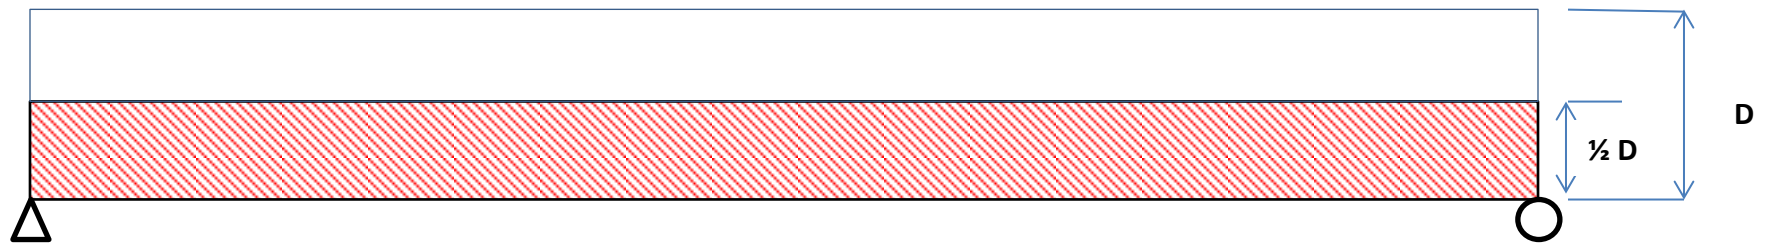
Consider the fracture critical portion of the floor beam as the lower half of the beam depth, the portion below the neutral axis that is in tension. Use separate forms for each member. Note any defects and label the defect accordingly. Make sure and note that a defect is Near Face (NF), Far Face (FF) or Both Faces (BF). All notations will be recorded looking ahead on line. Use this drawing for trusses or two girders system bridges with solid rolled or built up section floor beams.

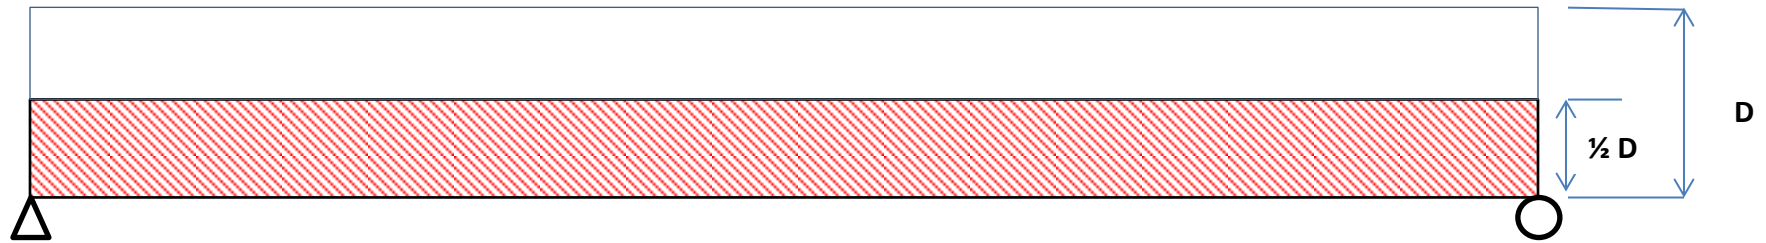
Consider the fracture critical portion of the floor beam as the lower half of the beam depth, the portion below the neutral axis that is in tension. Use separate forms for each member. Note any defects and label the defect accordingly. Make sure and note that a defect is Near Face (NF), Far Face (FF) or Both Faces (BF). All notations will be recorded looking ahead on line. Use this drawing for trusses or two girders system bridges with solid rolled or built up section floor beams.

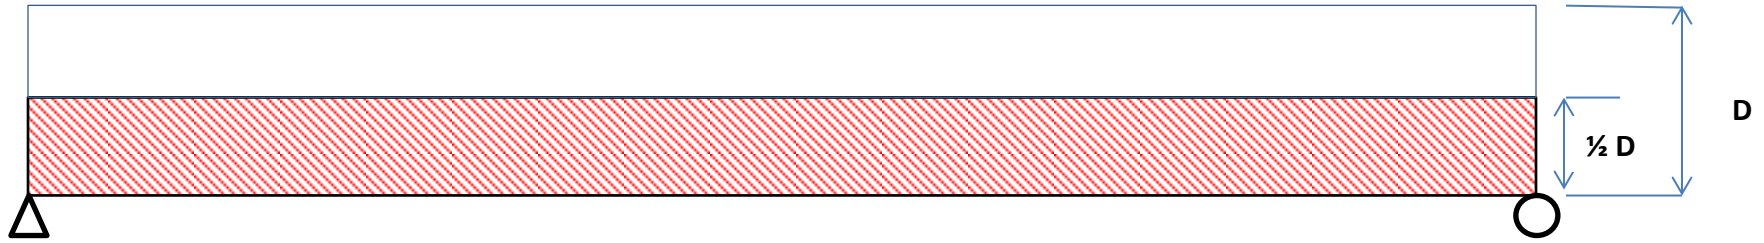
Consider the fracture critical portion of the floor beam as the lower half of the beam depth, the portion below the neutral axis that is in tension. Use separate forms for each member. Note any defects and label the defect accordingly. Make sure and note that a defect is Near Face (NF), Far Face (FF) or Both Faces (BF). All notations will be recorded looking ahead on line. Use this drawing for trusses or two girders system bridges with solid rolled or built up section floor beams.

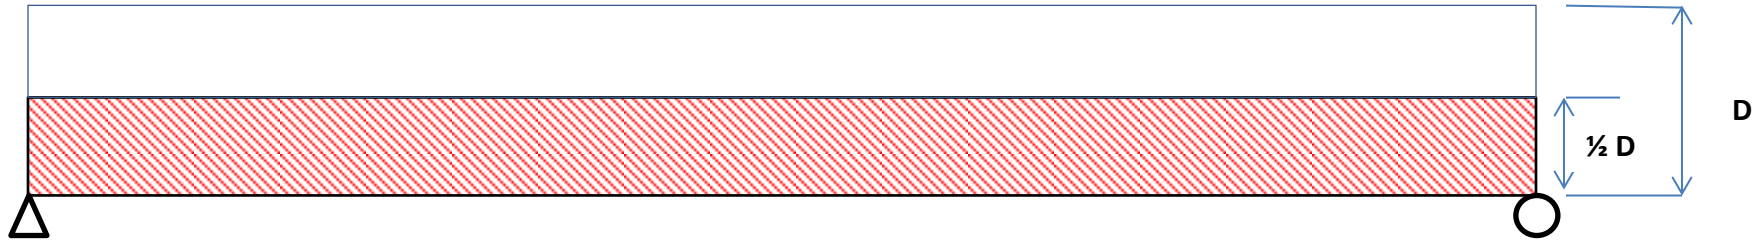
Consider the fracture critical portion of the floor beam as the lower half of the beam depth, the portion below the neutral axis that is in tension. Use separate forms for each member. Note any defects and label the defect accordingly. Make sure and note that a defect is Near Face (NF), Far Face (FF) or Both Faces (BF). All notations will be recorded looking ahead on line. Use this drawing for trusses or two girders system bridges with solid rolled or built up section floor beams.

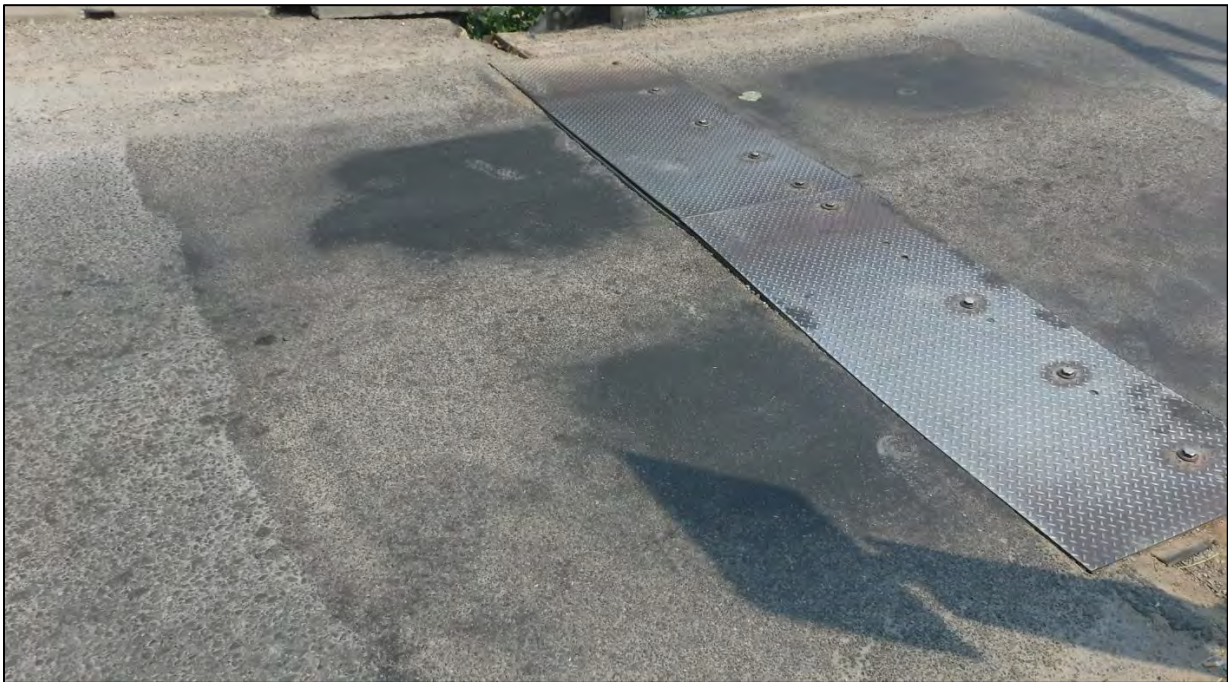
Photo 19: West Approach within 5 ft. of bridge deck had section of cold patch in good condition

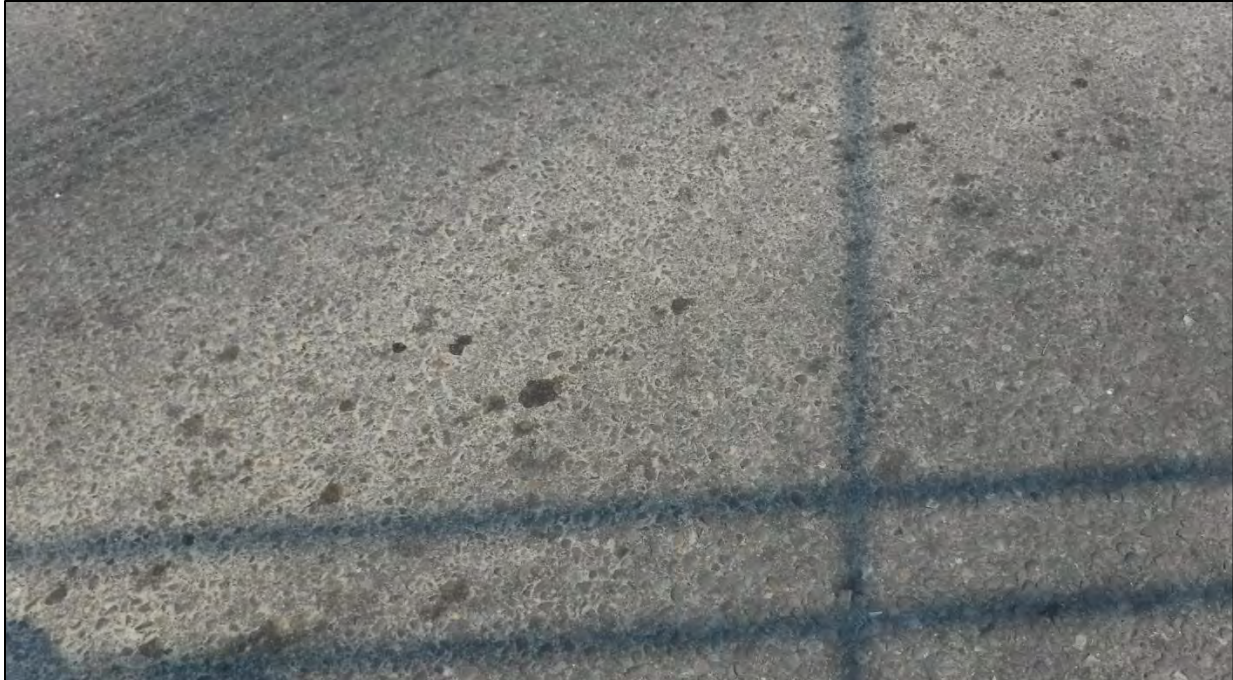
Photo 22: Typical minor wear on Span 1 bituminous overlay

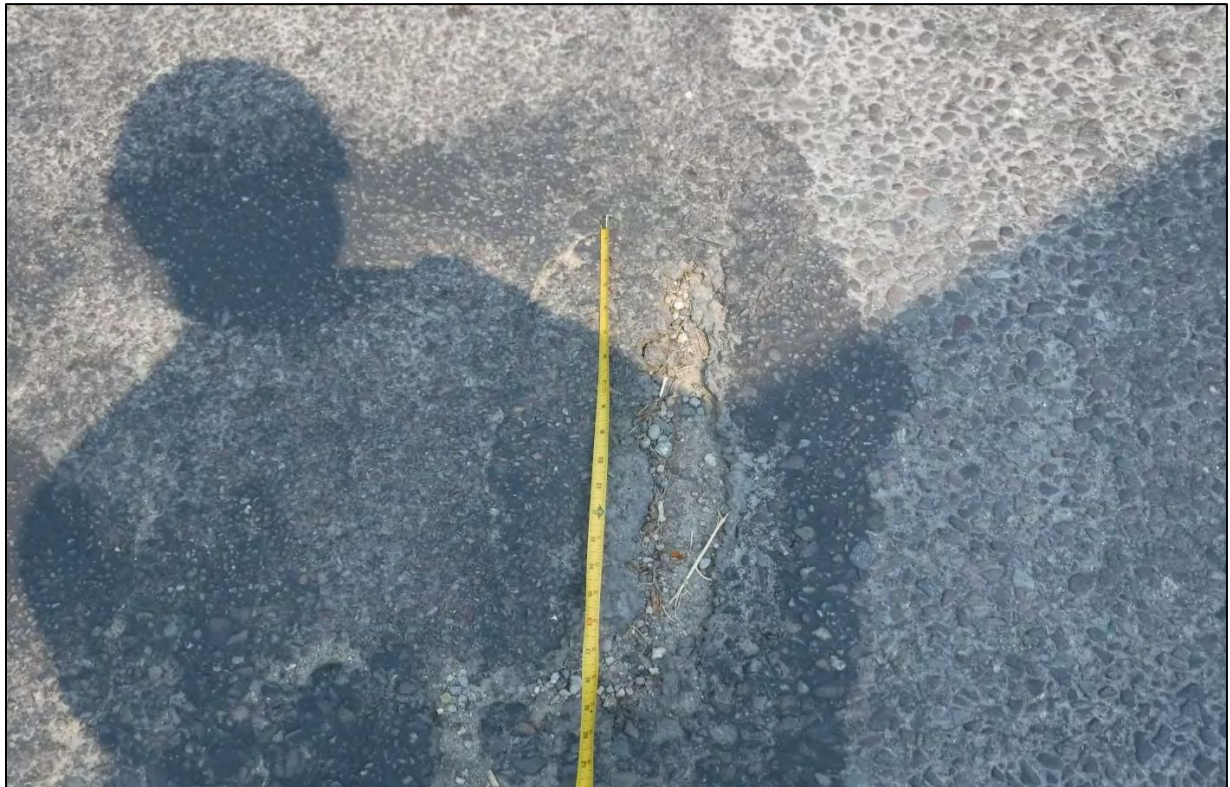
Photo 23: Typical minor wear on Span 1 bituminous overlay

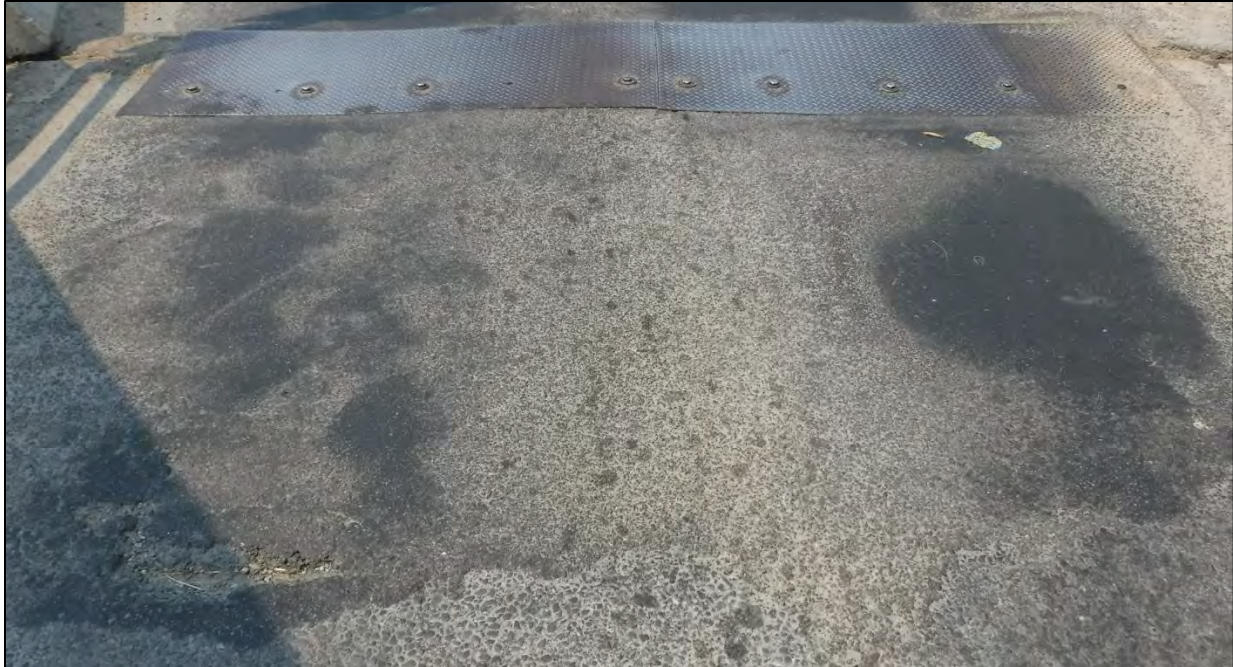
Photo 24: End 6 ft. at the West Transition had cold patch with minor wear and hairline map cracking

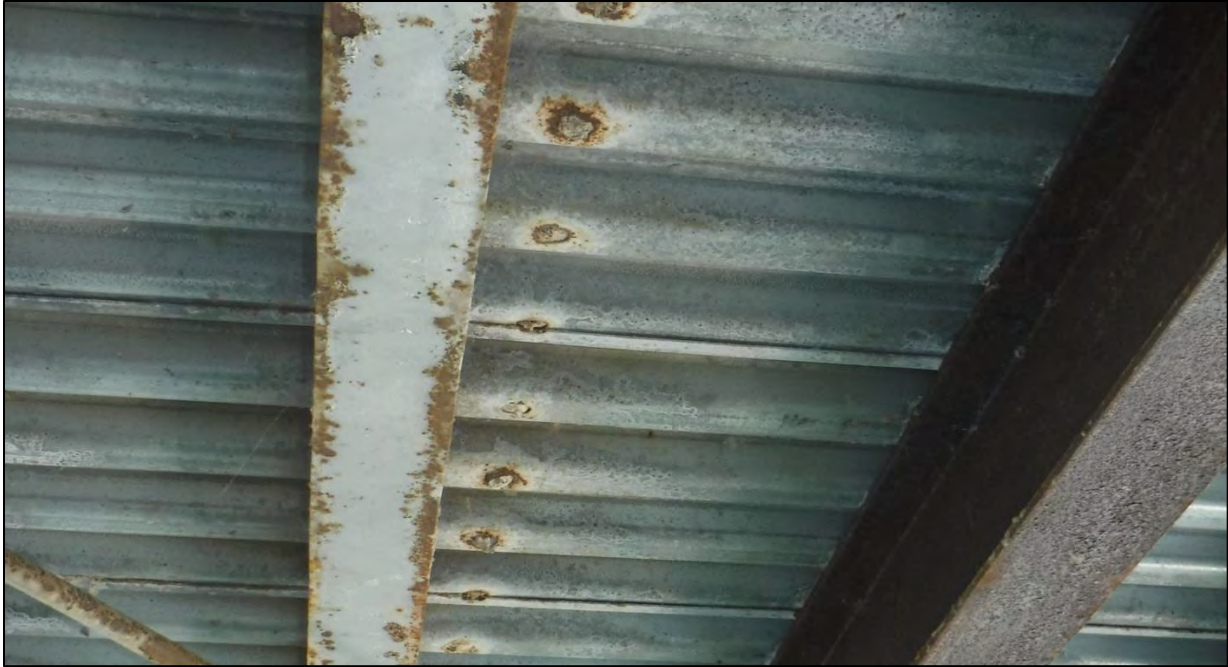
Photo 28: Typical underside of Span 1 deck; Note burn through holes in corrugated steel

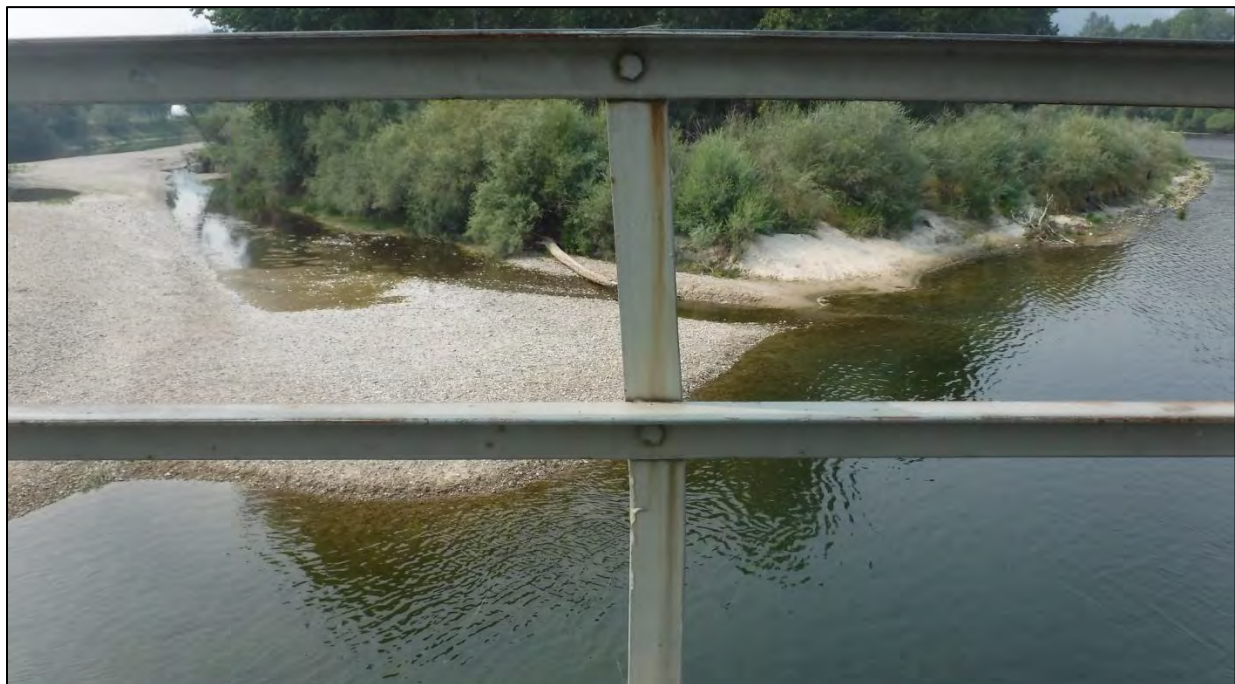
Photo 33: The vertical angle on the South Rail between Panel Point 4' and 3' was bent 1-1/2 in. over a 2 ft. length due to impact damage

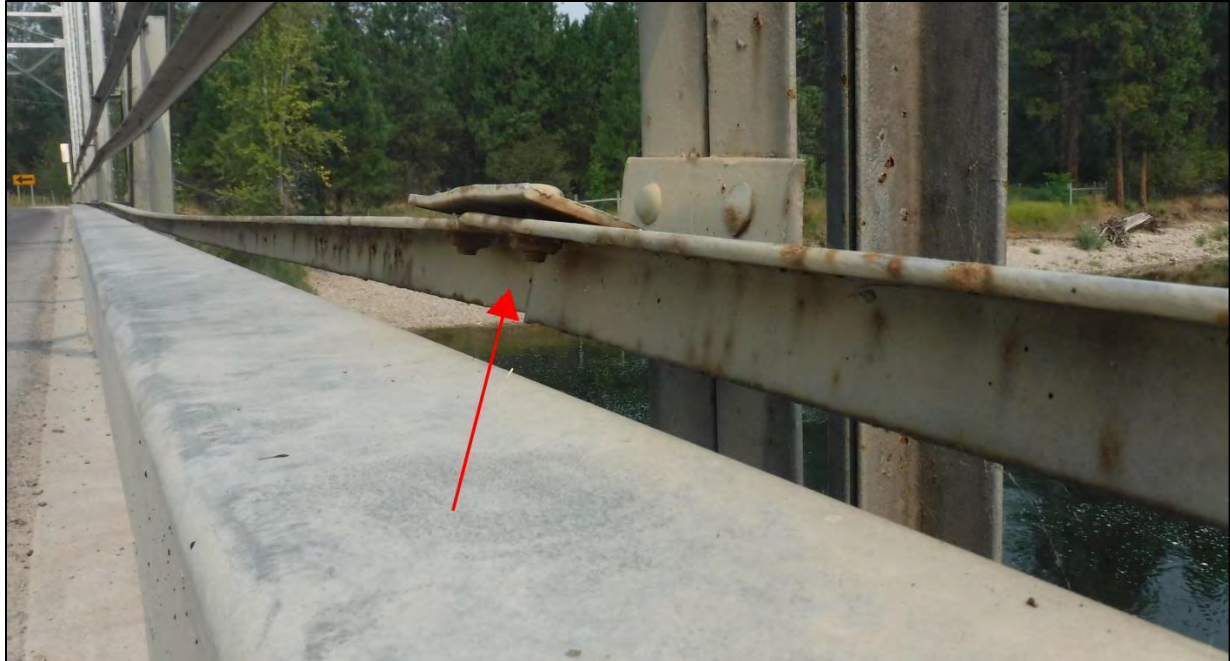
Photo 34: North Rail, Panel Point 1': The bottom angle was bent 3/4 in. upwards

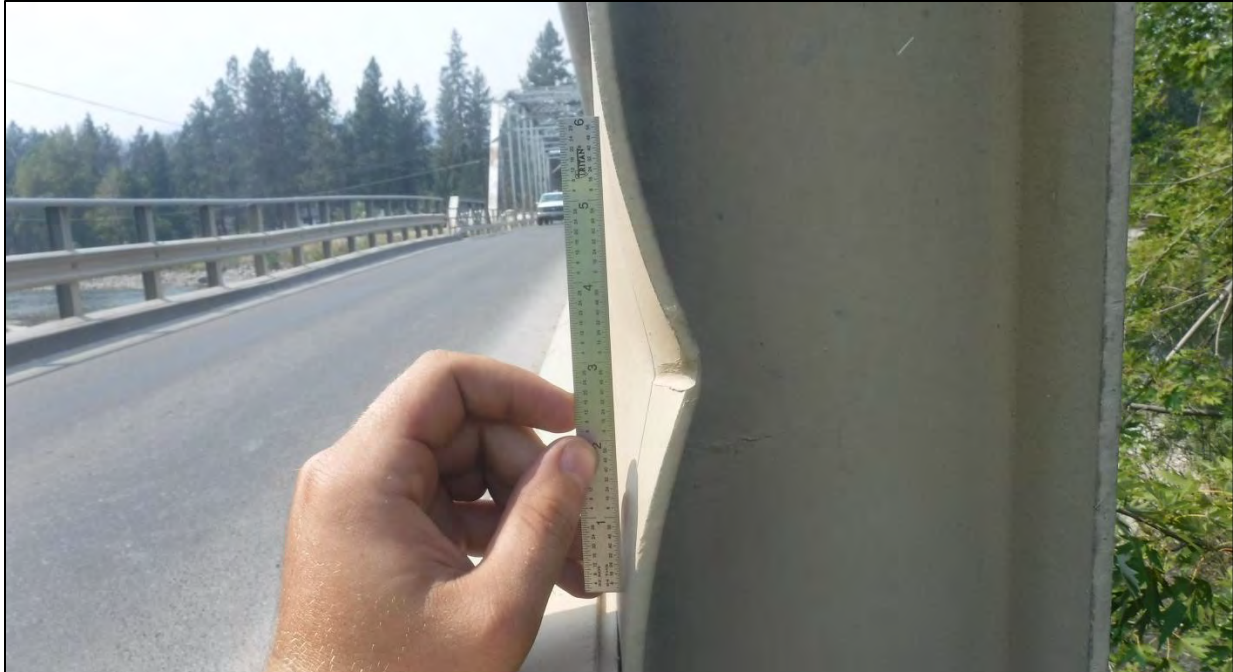
Photo 36: Three vertical members had impact damage that bent the interior flange 3/4 in. over a 6 in. length on the North Rail near the East Approach

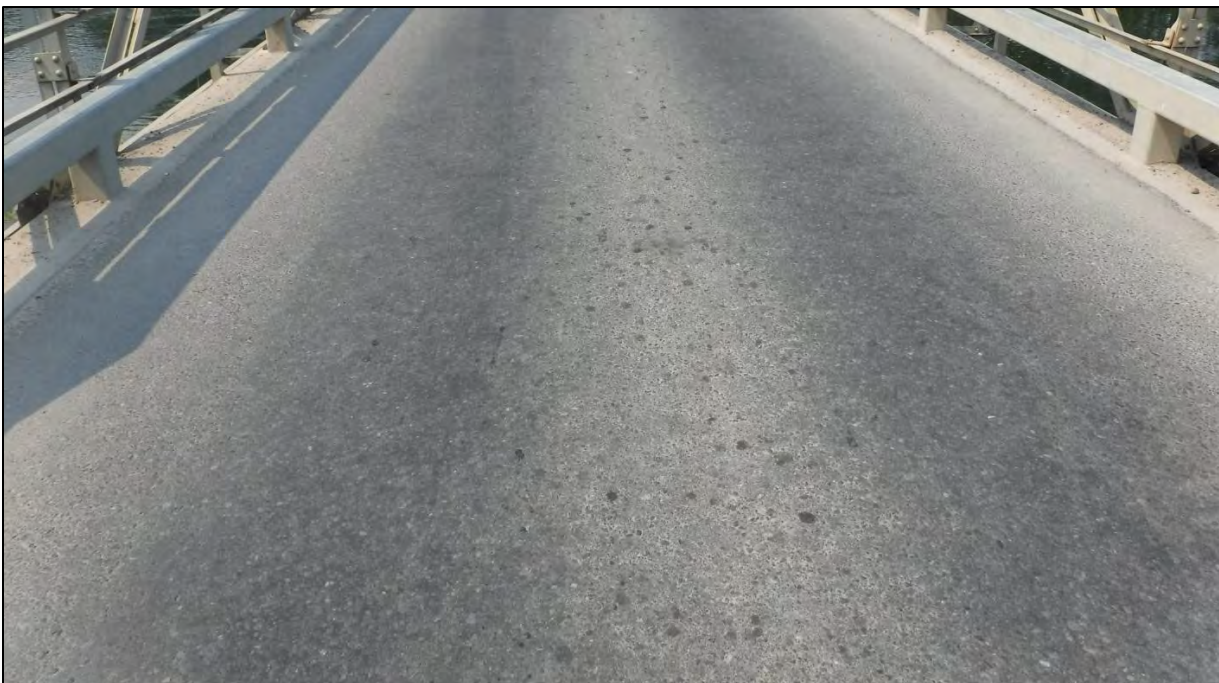
Photo 37: Typical minor wear on Span 2 bituminous overlay
