Bridge No. L32101000+01001
Missoula, Montana
Condition Evaluation Report:
Routine and Fracture Critical Inspection
Inspection Date: August 8 and 10, 2017

Prepared By:

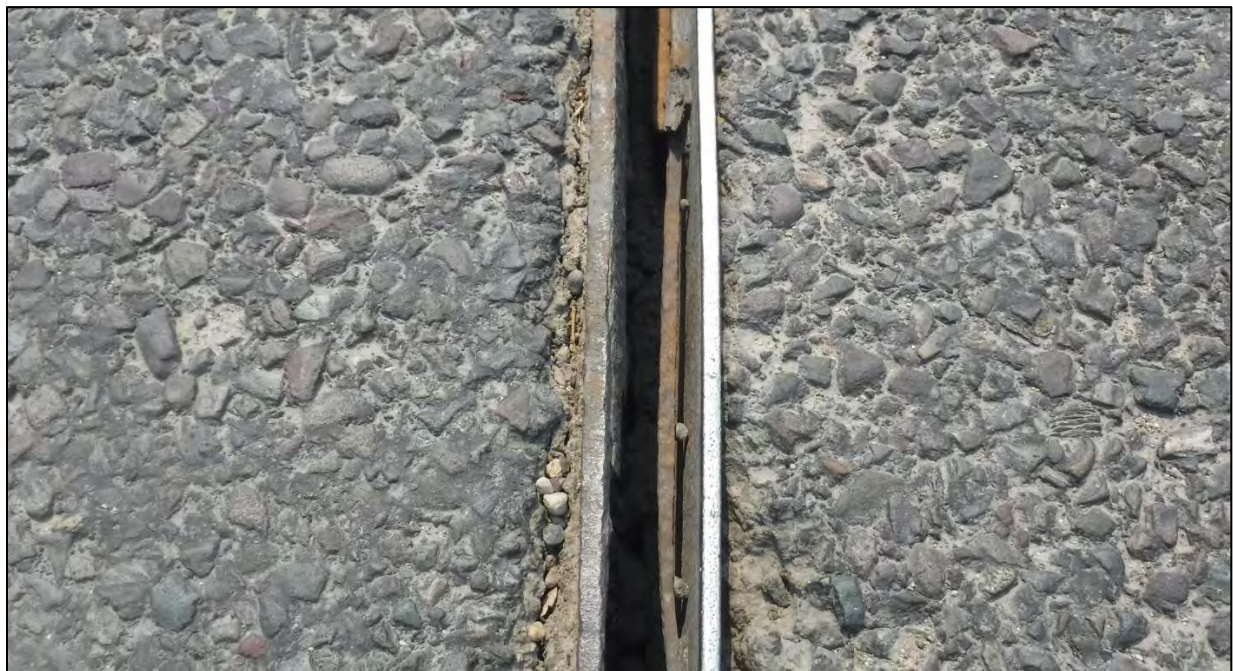
Photo 41: Joint 3 over Bent 3 with seal deterioration which was typical over 90 percent of the length

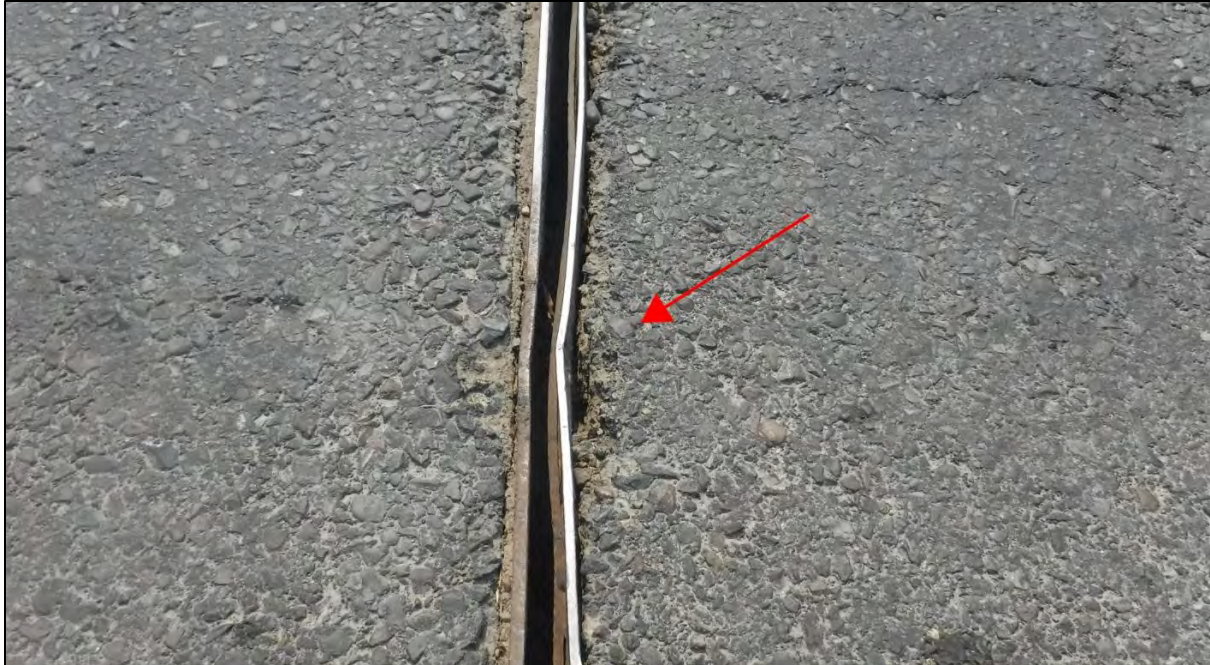
Photo 42: Joint 3 over Bent 3 with separation from the Span 2 deck over a 4 ft. length

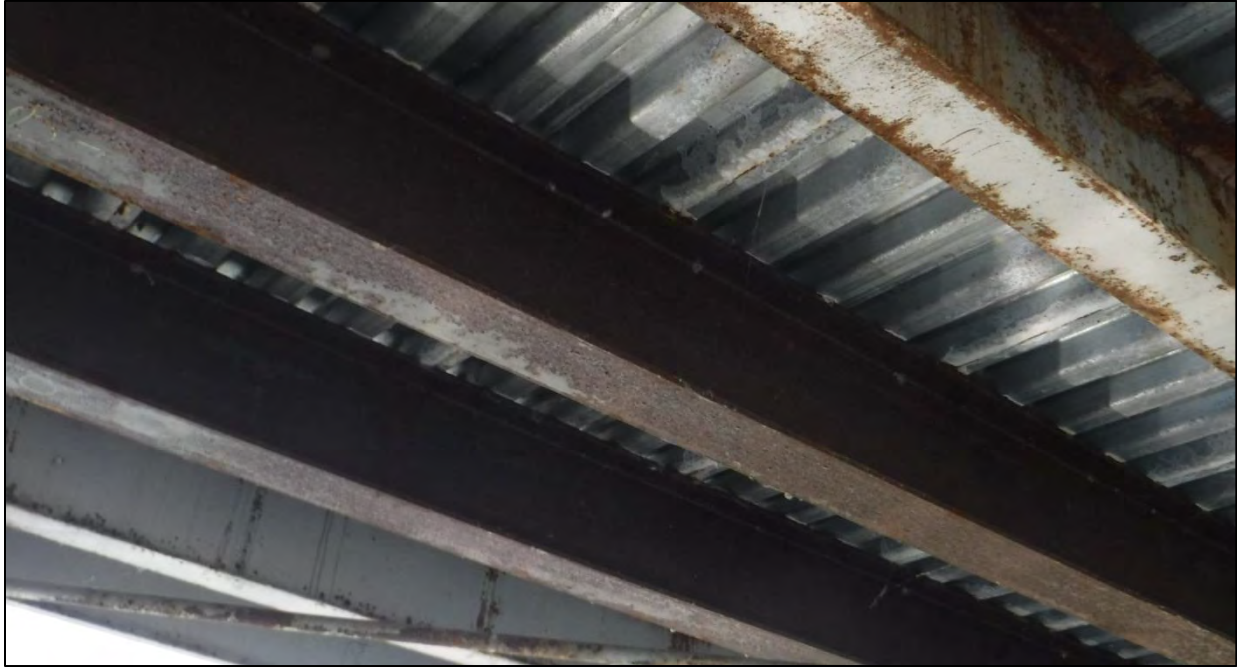
Photo 44: Typical unpainted stringers with minor to moderate corrosion and negligible section loss

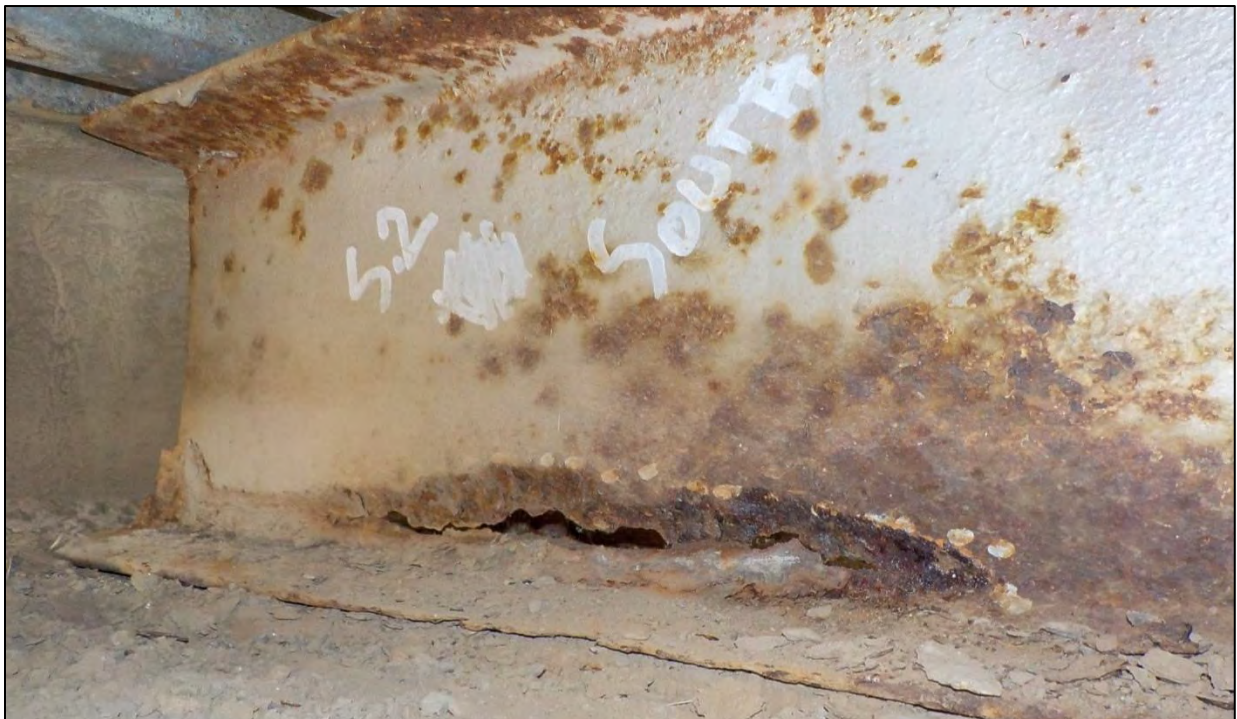
Photo 45: Span 1, Abutment 1, Stringer 2: the stringer web had heavy corrosion and section loss over a 17 in. long by 2 in. high area with a 1 in. diameter hole center 10 in. from the stringer end

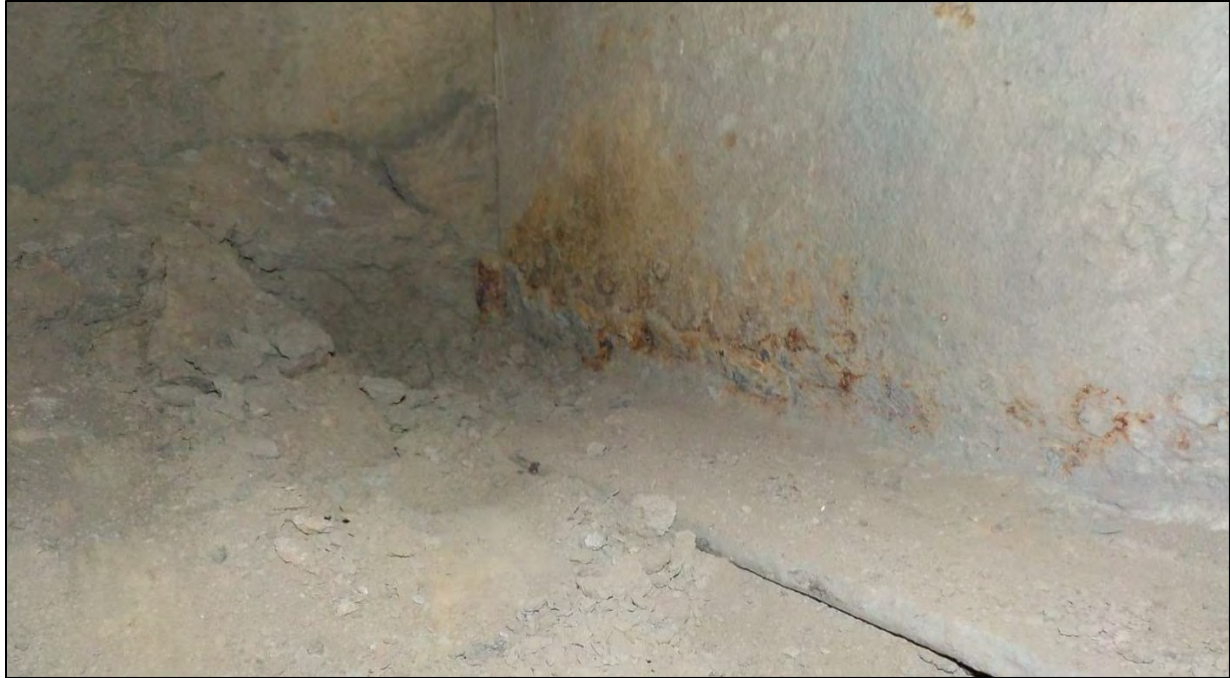
Photo 46: Span 1, Abutment 1, Stringer 5: the stringer web had heavy corrosion and up to 50 percent section loss over a 10 in. long by 1 in. high hole adjacent to the stringer end

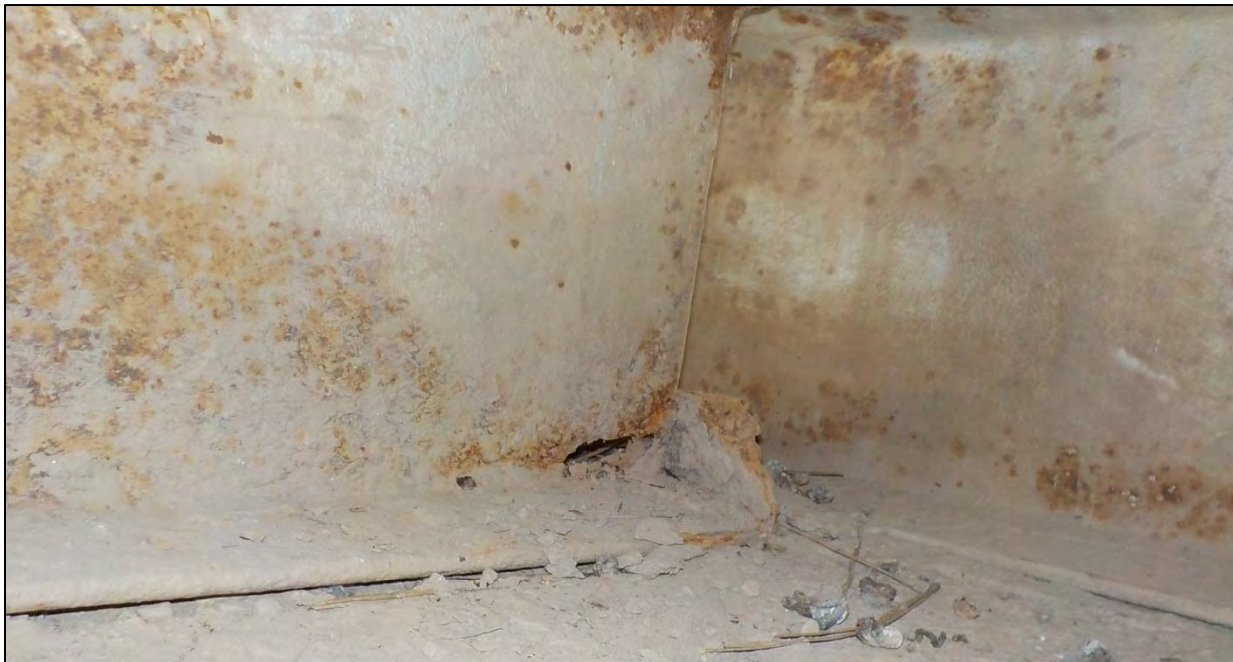
Photo 47: Span 1, Abutment 1, Stringer 7: the stringer web had heavy corrosion and section loss over a 14 in. long by 2 in. high area with a 2 in. long by 1/2 in. high hole center 2 in. from the stringer end

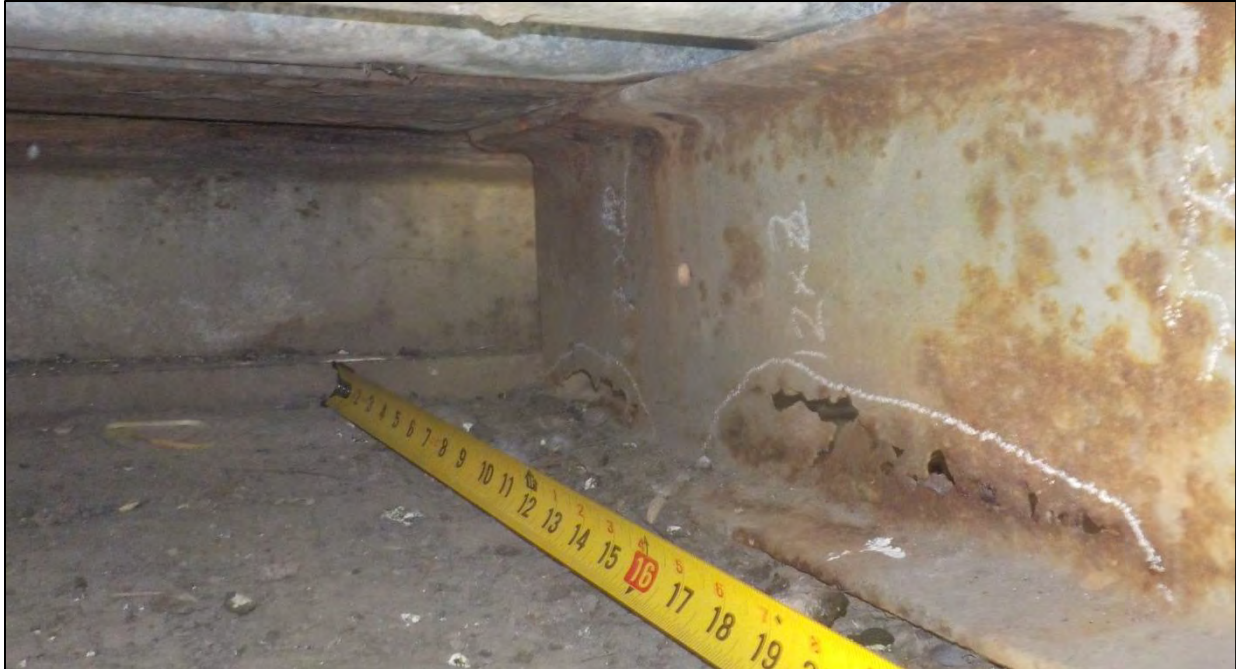
Photo 48: Span 2, Bent 2, Stringer 2: the stringer web had heavy corrosion and section loss with two holes; 7 in. long by 1 in. high and 6 in. long by 2 in. high centered 16 in. from the stringer end

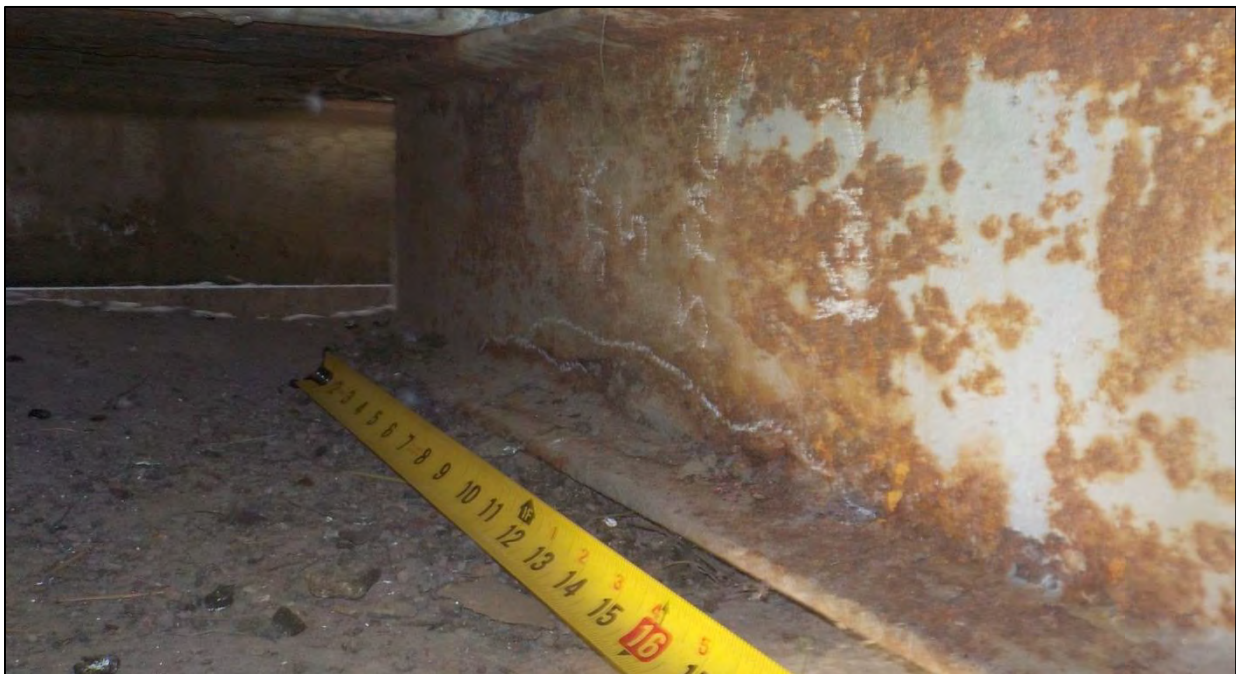
Photo 49: Span 2, Bent 2, Stringer 5: the south face had a 16 in. long by 2 in. tall area of pack rust up to 1/4 in. thick on the bottom of the web located 12 in. from the end of the stringer

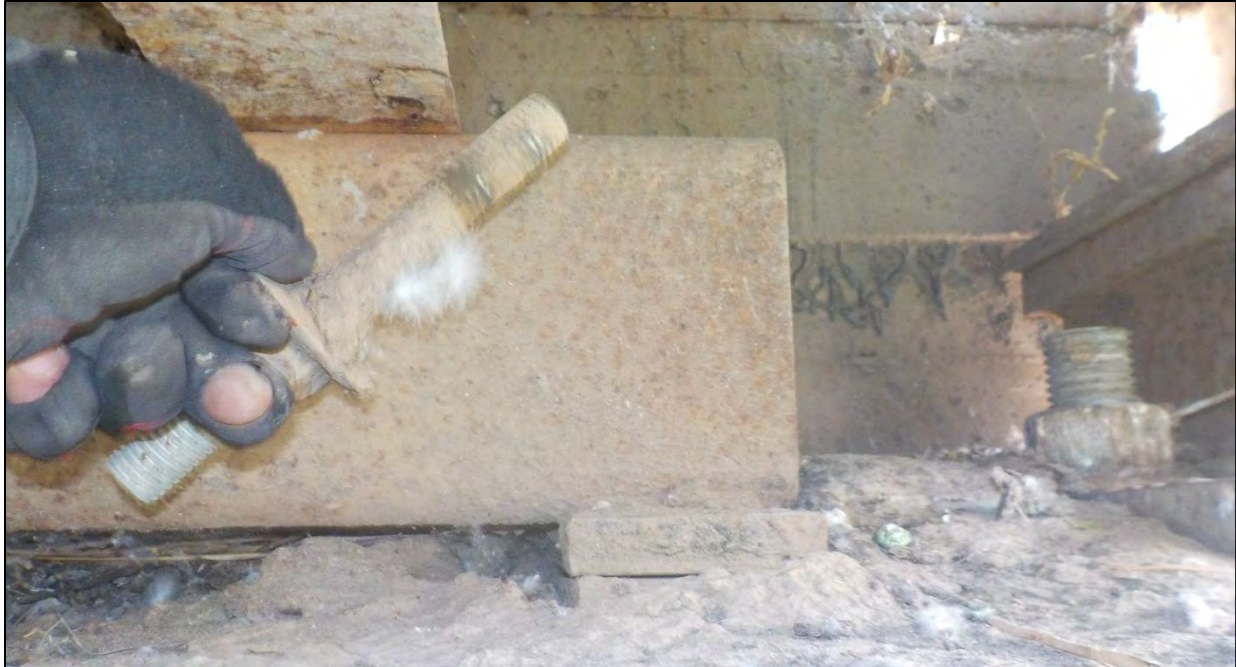
Photo 50: Span 2, Bent 3, All Stringers: the hollow pipe that the stringers were bearing on had vertical movement up to 1/4 in. when vehicles passed. The south anchor rod for the south pipe had failed and this edge of the pipe had movement up to 1/2 in. when vehicles passed

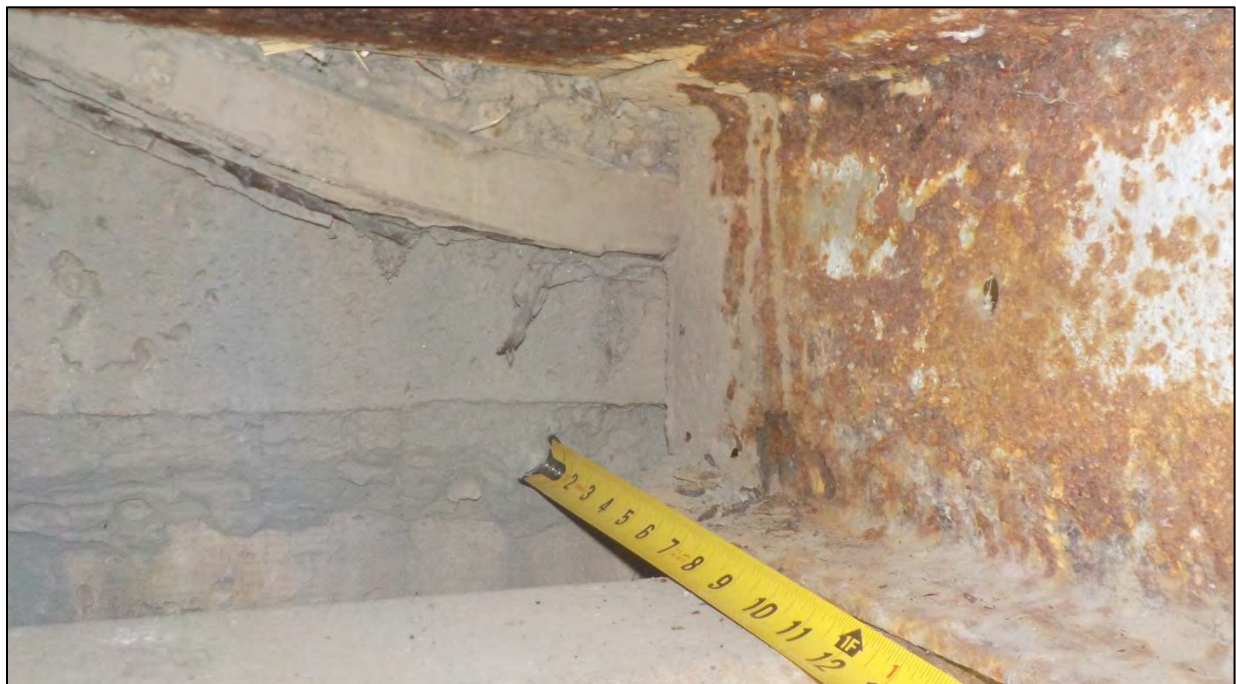
Photo 51: Span 2, Bent 3, Stringer 2: the stringer web had heavy corrosion with up to 1/8 in. thick rust scale on both sides of the stringer web at the web to lower flange interface adjacent to the stringer end

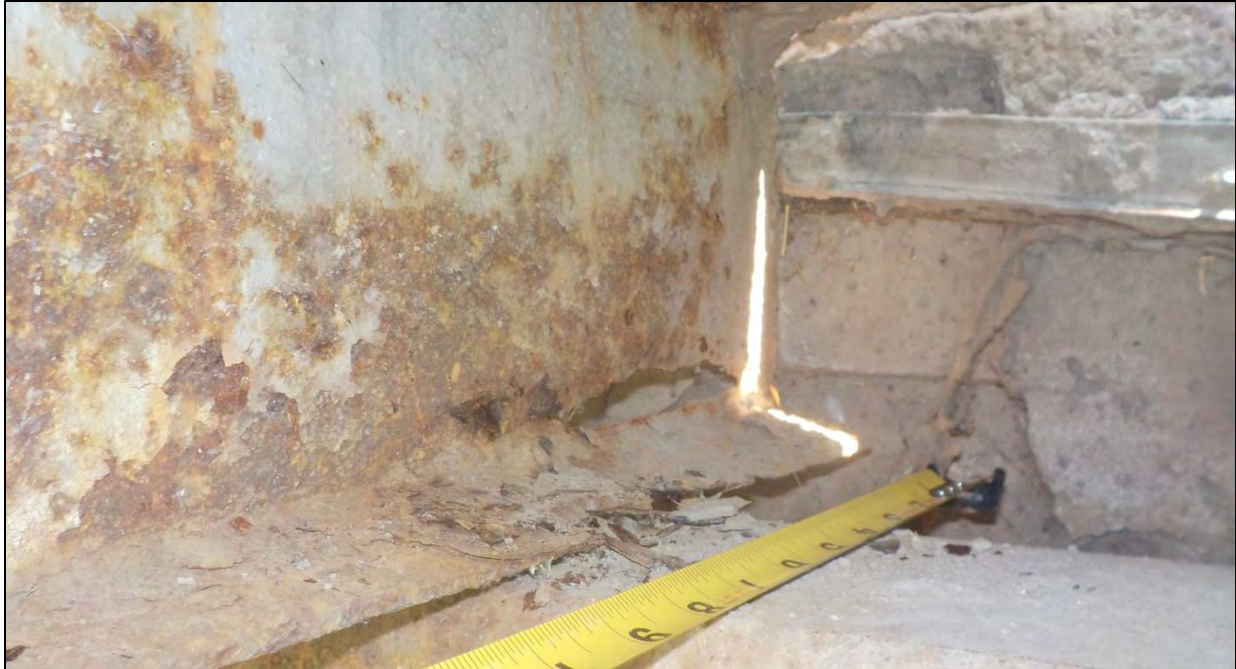
Photo 52: Span 2, Bent 3, Stringer 4: the stringer web had heavy corrosion and section loss with a 5 in. long by 1 in. high through hole near the stringer end. The bottom flange was knife edges in this area

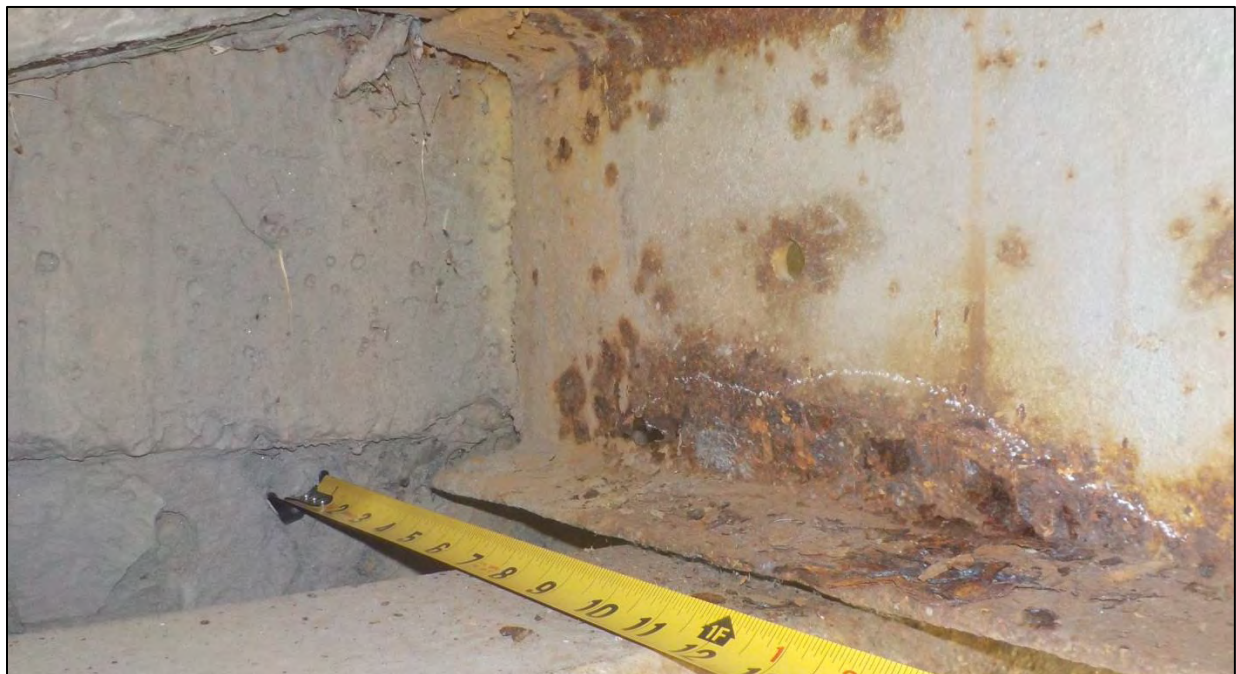
Photo 53: Span 2, Bent 3, Stringer 7: the stringer web had heavy corrosion with up to 50 percent section loss over a 6 in. long by 2 in. high adjacent to the stringer end that had a 1/2 in. diameter hole 6 in. from the stringer end at the web to lower flange interface

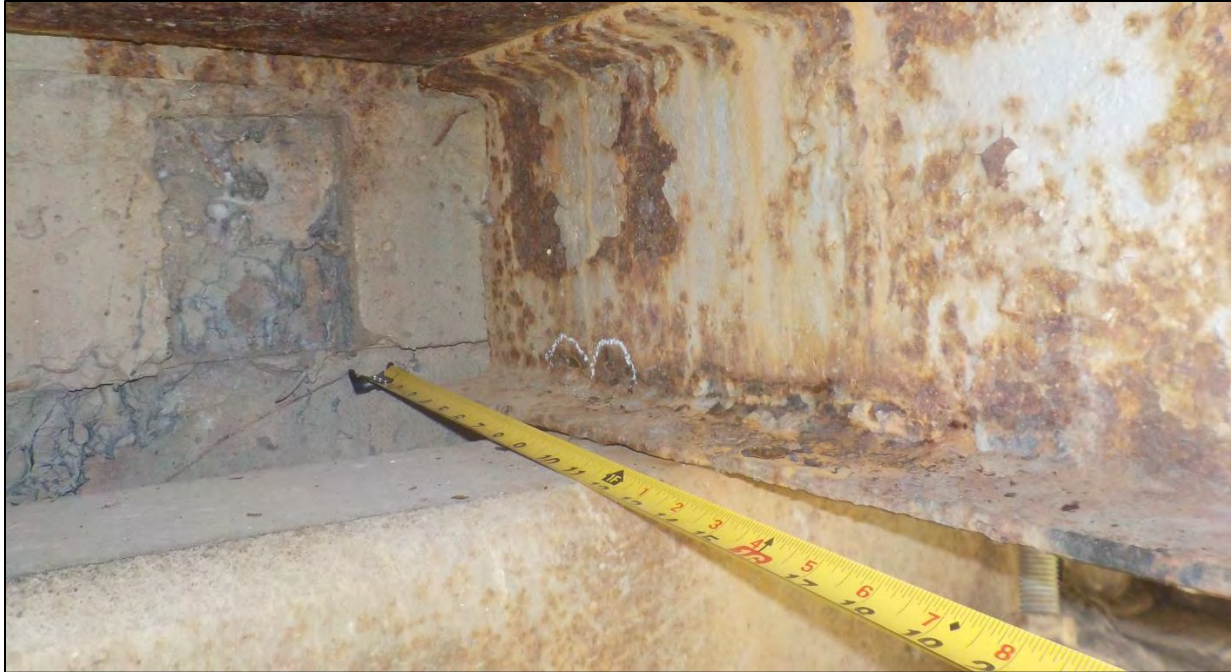
Photo 54: Span 2, Bent 3, Stringer 8: the stringer web had heavy corrosion and section loss with three through holes ranging in size from 1/4 in. to 1/2 in. in diameter located at the web to lower flange interface at the stringer end

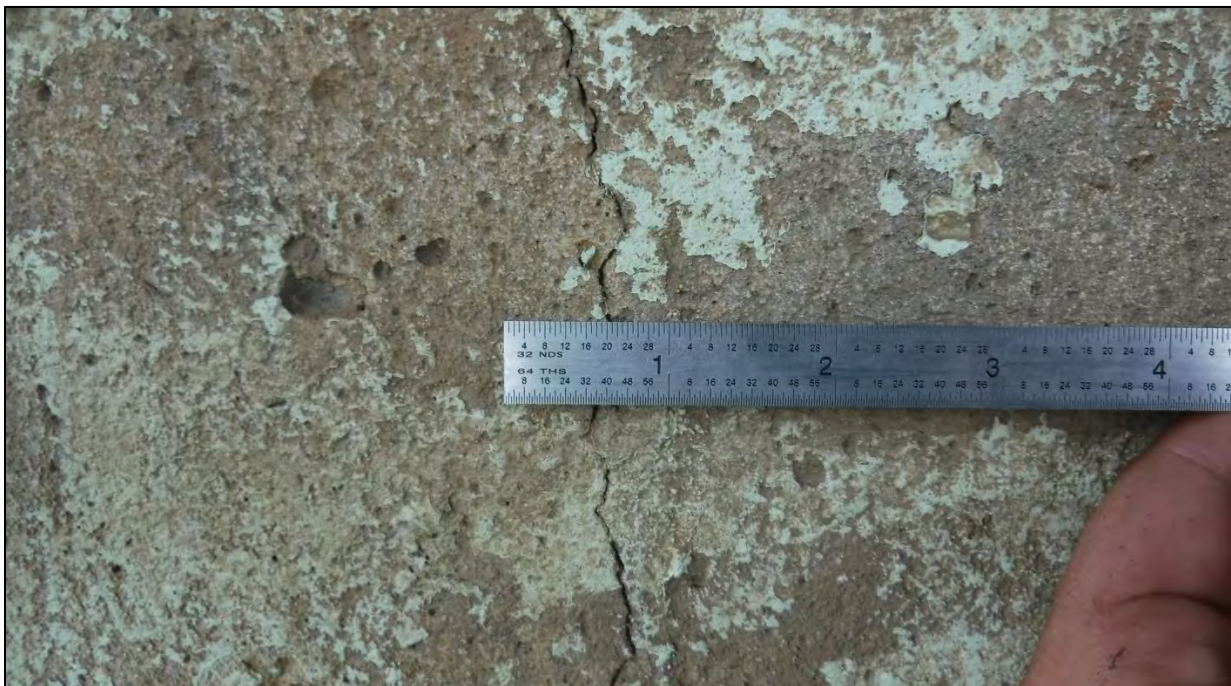
Photo 55: Abutment 1 had one full height, vertical up to 1/8 in. wide in the middle of the abutment

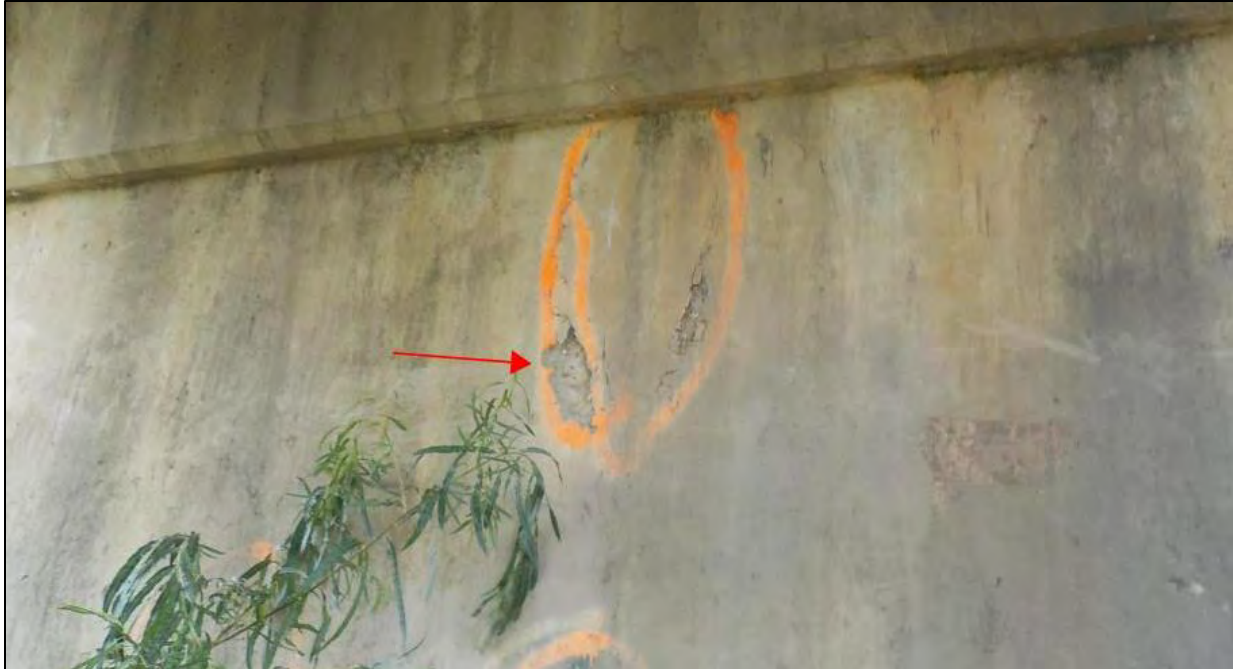
Photo 56: Bent 2 with areas of spalling on the edge of a delamination with 1 in. of penetration and no exposed reinforcing steel

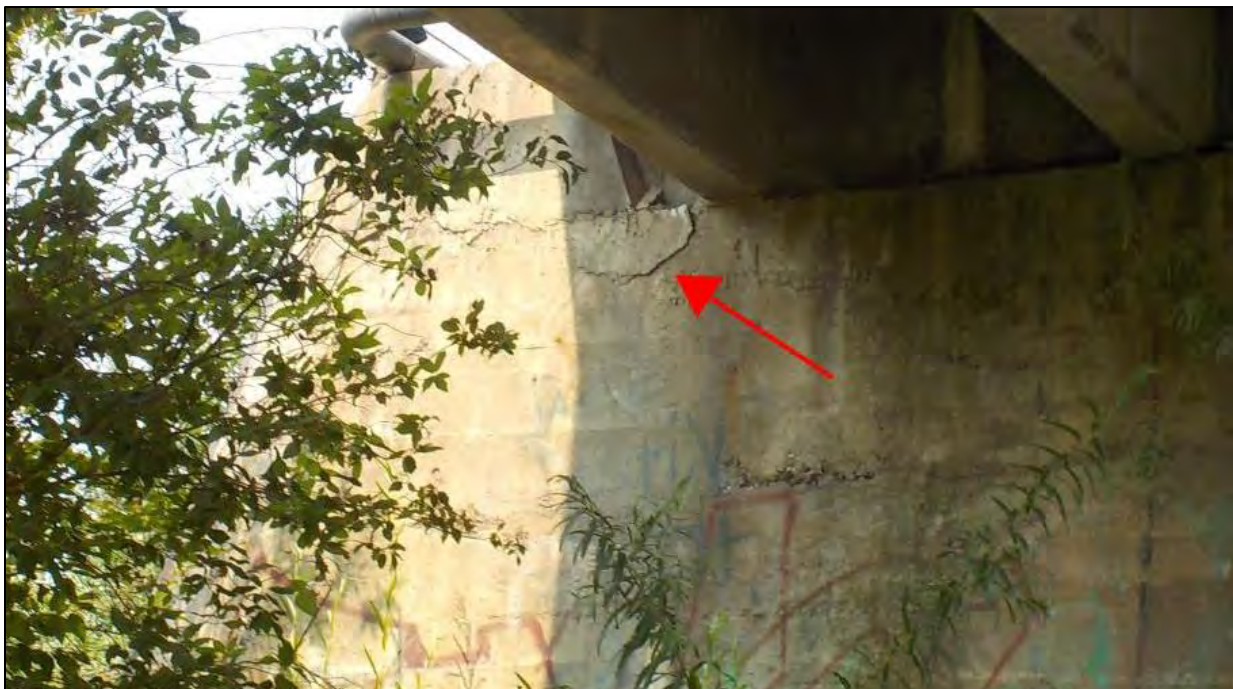
Photo 57: Bent 3 had a 12 in. wide by 10 in. high area of delamination on the top, southeast corner of the bent

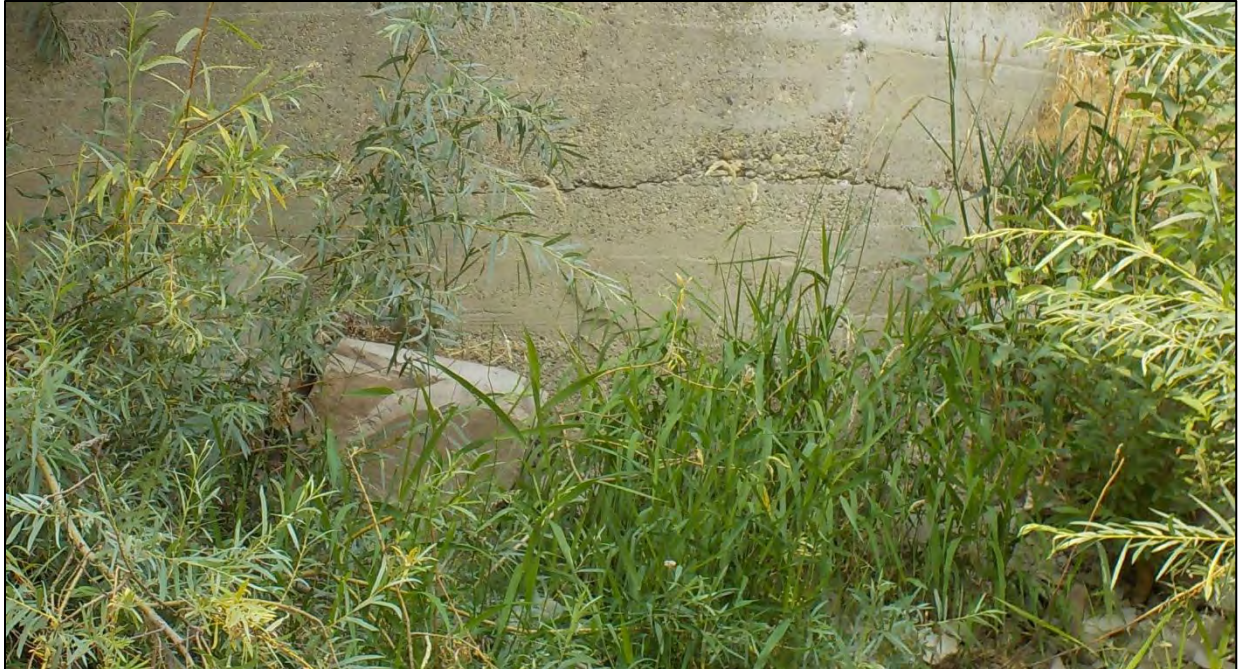
Photo 58: Bent 3 had a 5 ft. long horizontal crack up to 1/16 in. wide was located near the bottom, northeast corner

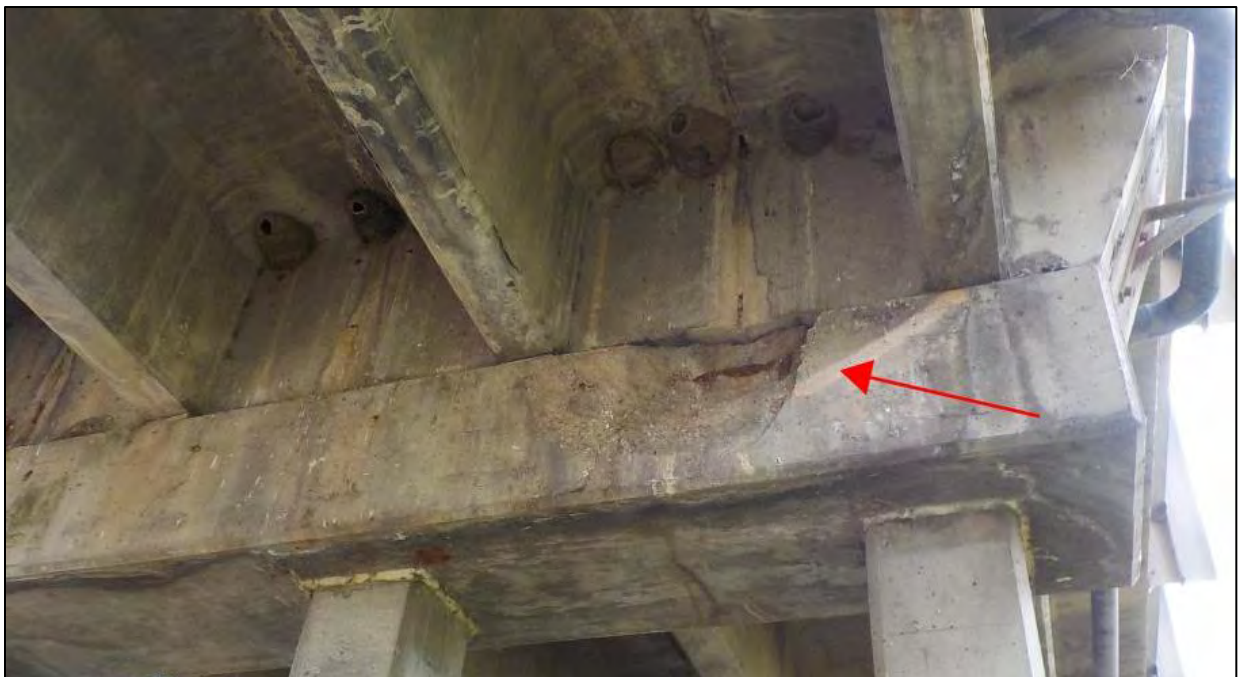
Photo 59: Bent 4 had a 3 ft. wide by 2 ft. high spall with exposed reinforcing steel on the west face of the bent cap. The exposed reinforcing steel had moderate corrosion with negligible section loss

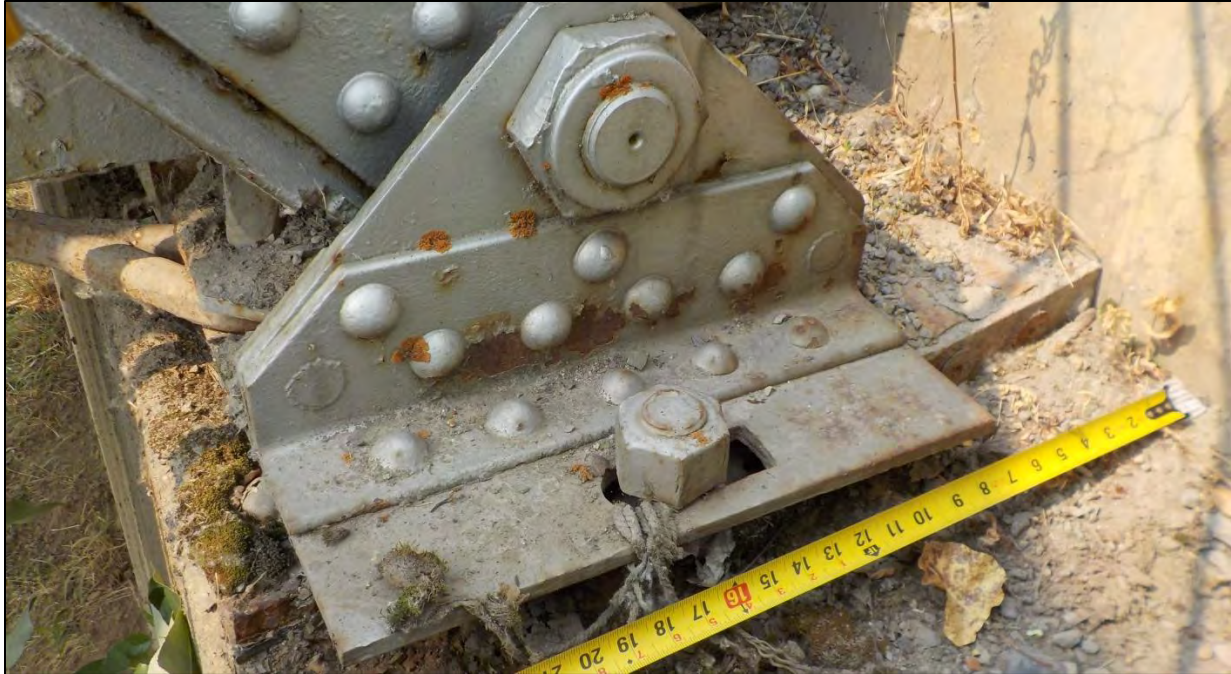
Photo 60: Abutment 1, North Truss roller bearing

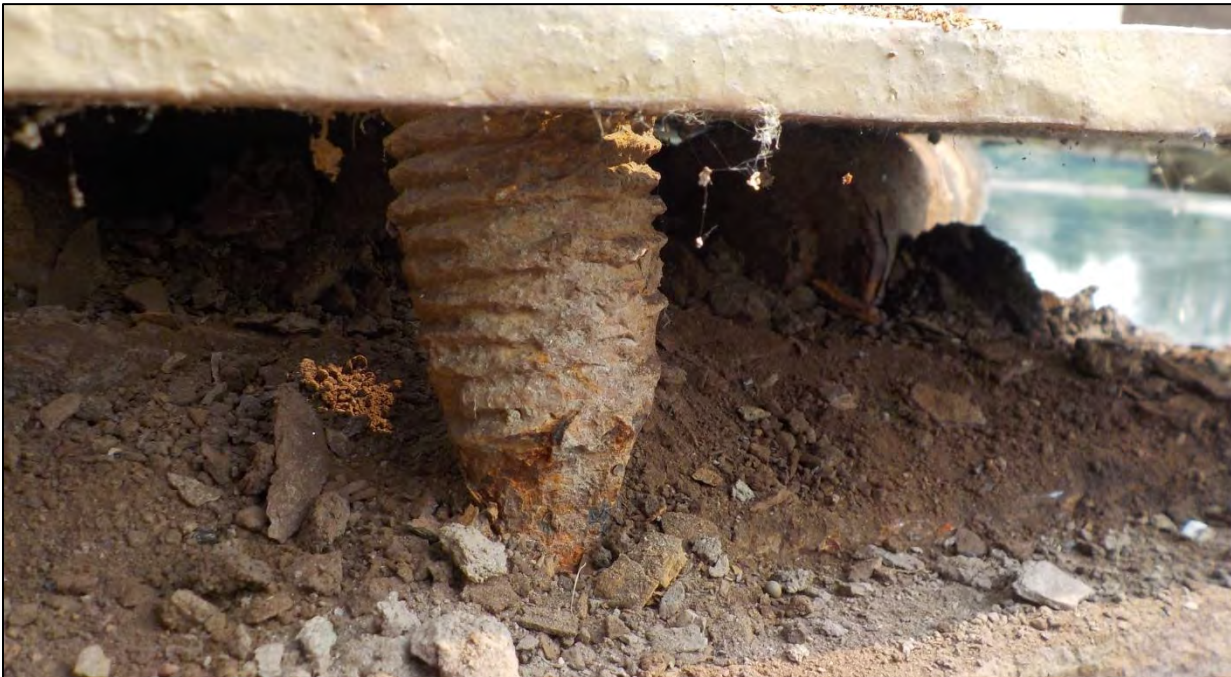
Photo 61: Abutment 1, North Truss roller bearing with heavy corrosion and section loss to the anchor rods

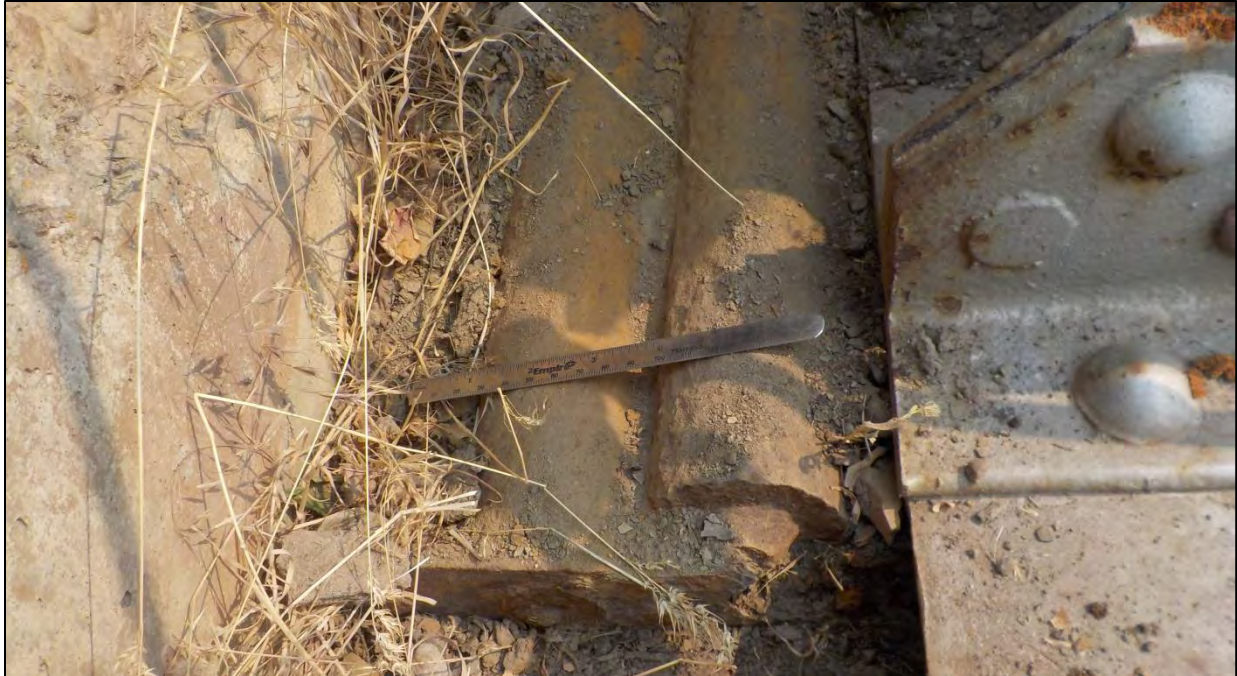
Photo 62: Abutment 1, North Truss roller bearing with two of the rollers severed and displaced from underneath the roller keepers

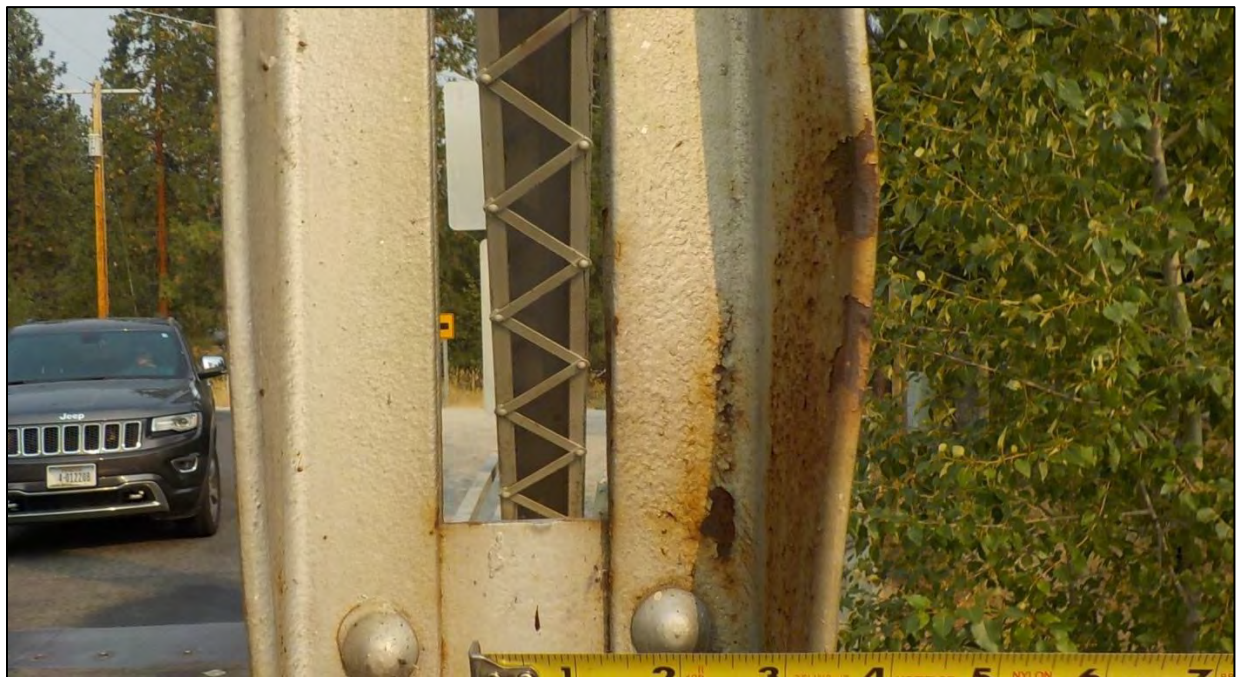
Photo 71: Span 1, North Truss, Vertical U1-L1: the exterior flange of the vertical was bent 1 in. to the north due to impact damage approximately 5 ft. above the bridge deck

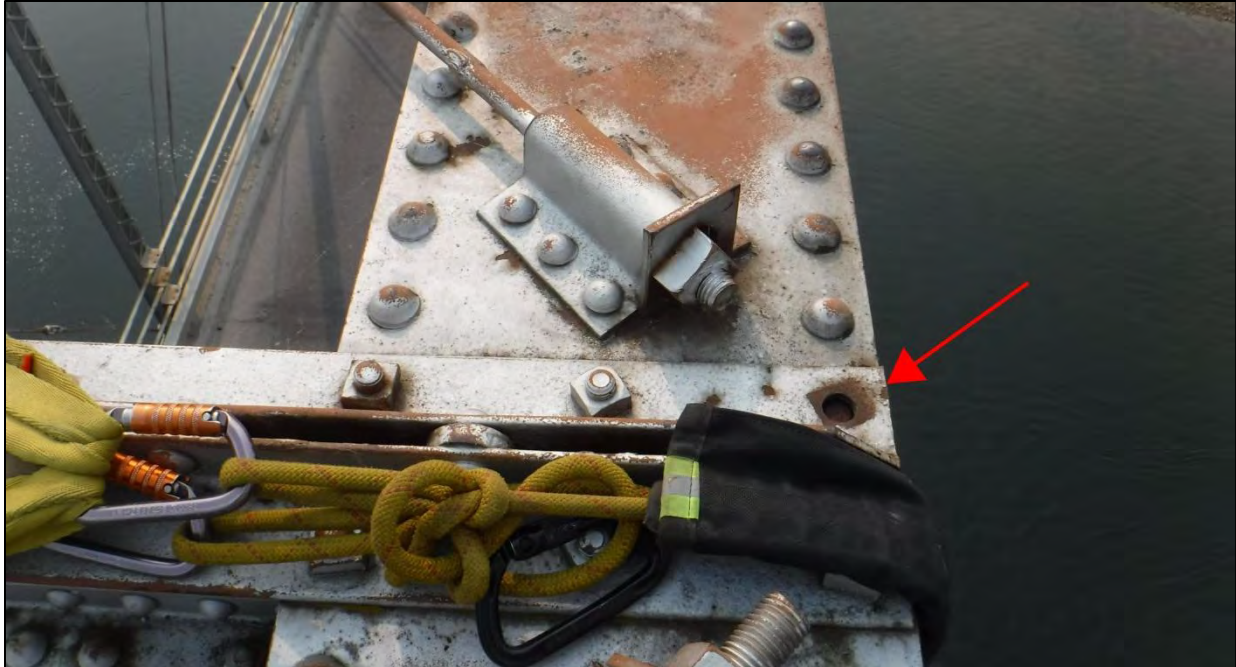
Photo 72: Span 1, South Truss, Top Chord at U4: one bolt was sheared off on the horizontal brace to top chord connection plate

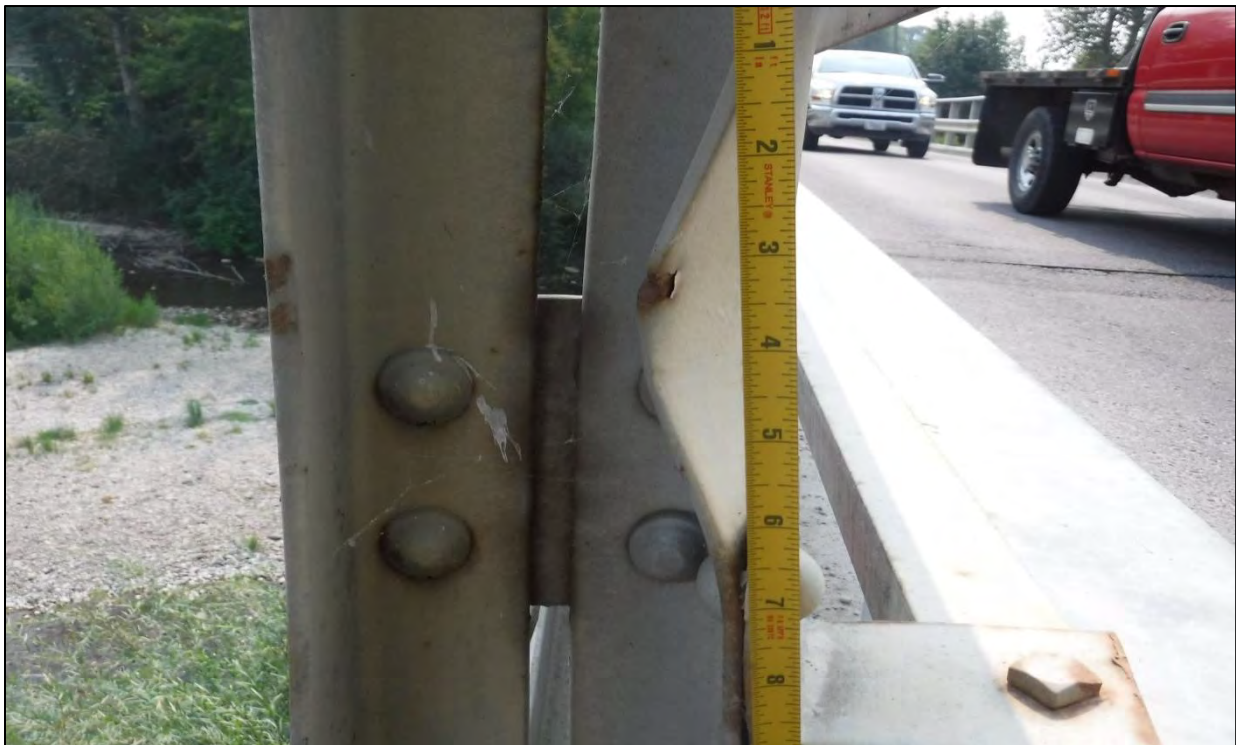
Photo 73: Span 2, North Truss, Vertical L2'-U2': the interior flange of the vertical was bent 1 in. over a 6 in. length due to impact damage

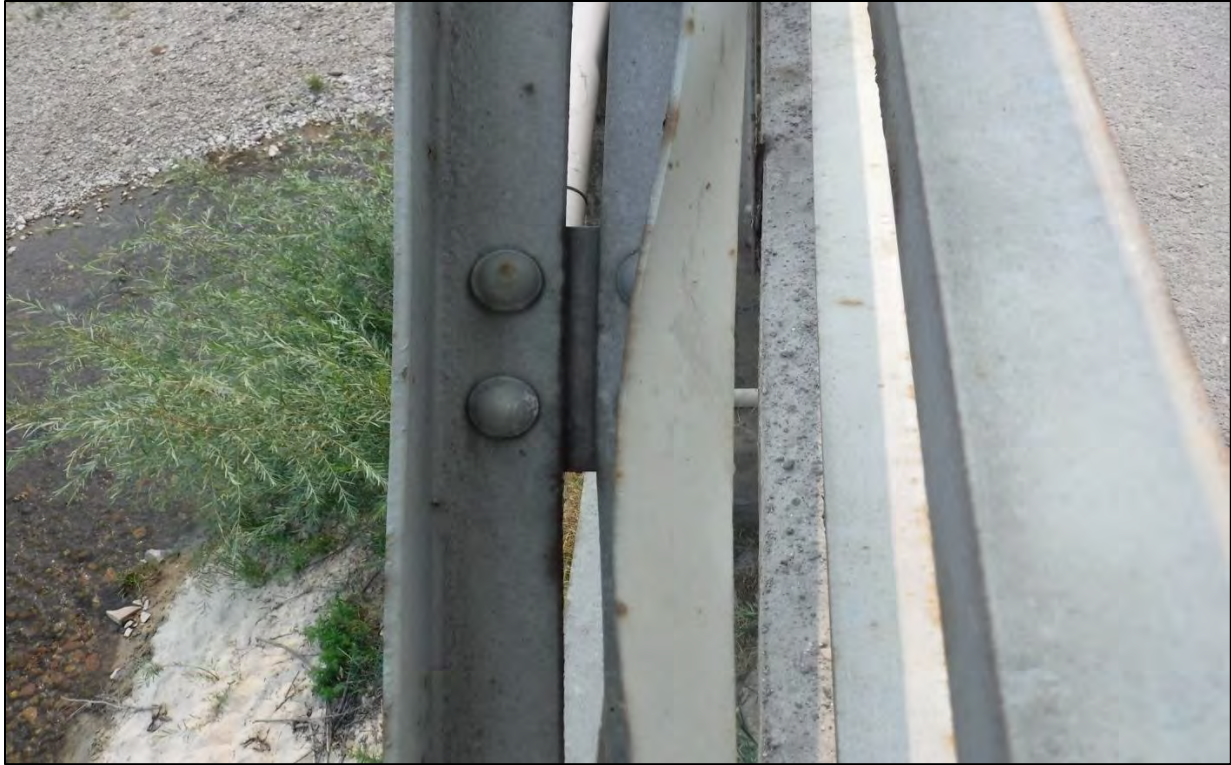
Photo 74: Span 2, North Truss, Diagonal L2'-U1': the interior flange was bent 1-3/8 in. over a 24 in. length due to impact damage

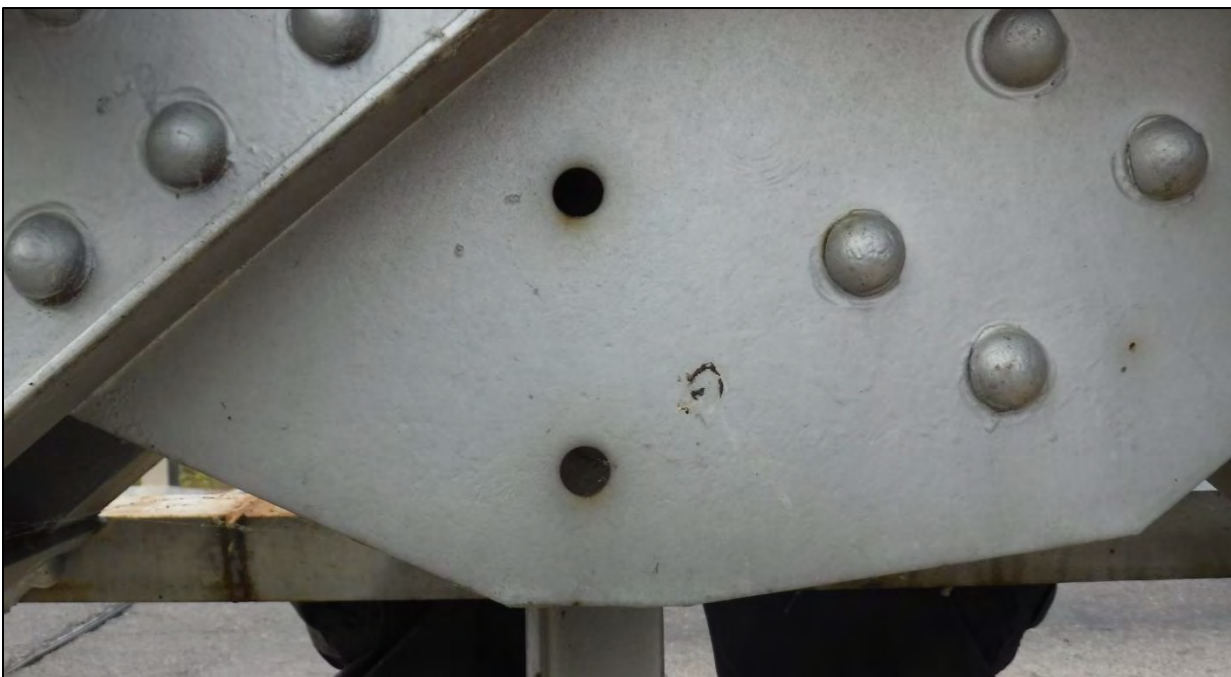
Photo 75: Span 2, North Truss, Gusset Plate U1': the exterior gusset plate had two misdrilled 3/4 in. diameter holes
