Bridge No. L32101000+01001
Missoula, Montana
Condition Evaluation Report:
Routine and Fracture Critical Inspection
Inspection Date: August 8 and 10, 2017

Prepared By:

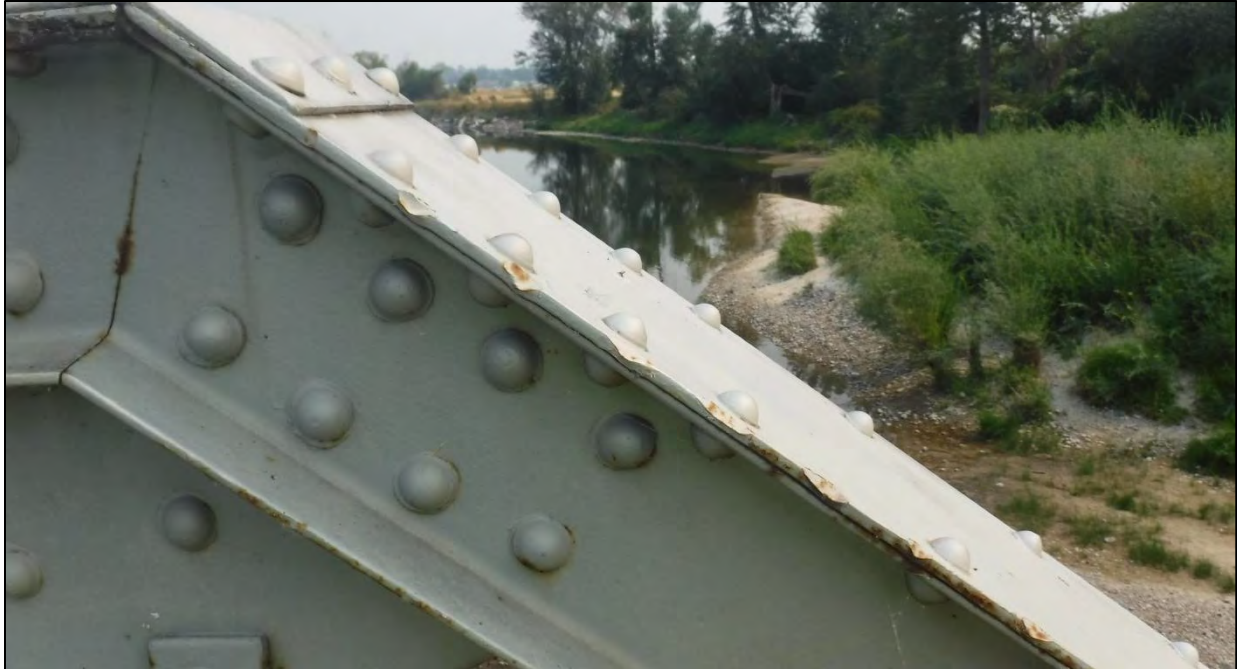
Photo 76: Span 2, North Truss, Diagonal L0'-U1': the diagonal had seven areas of impact damage up to 3/4 in. long and 1/4 in. of deflection spaced over a 15 in. length

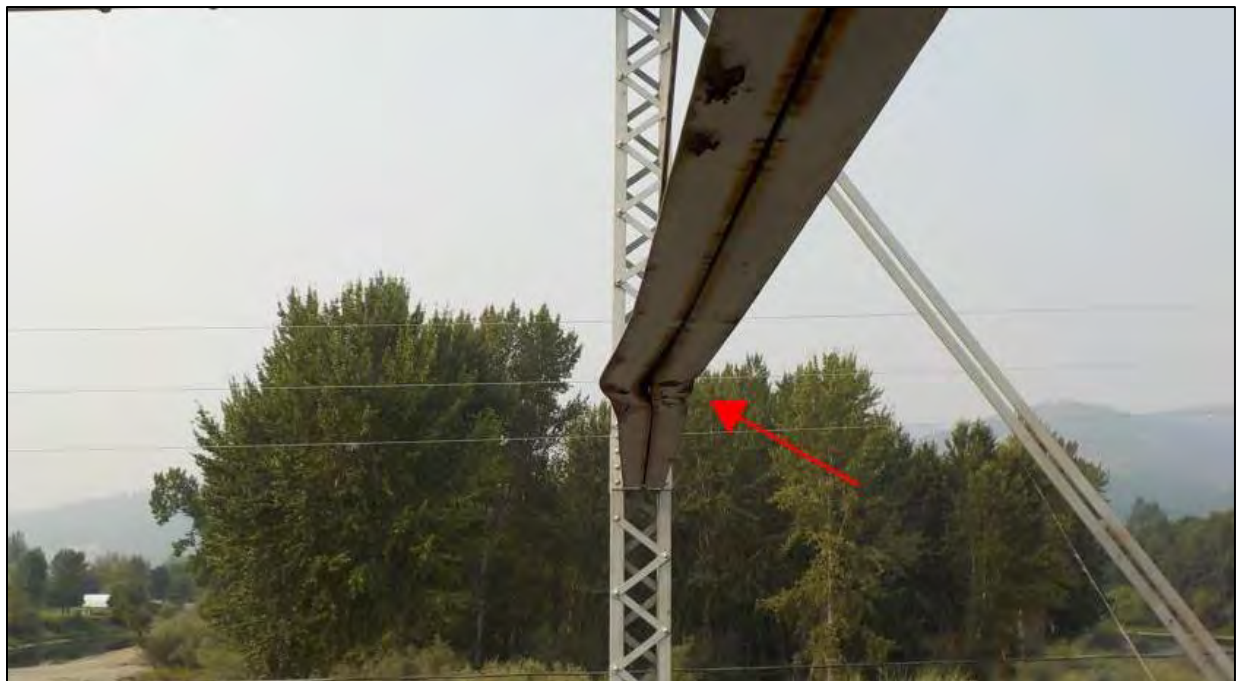
Photo 77: Panel Point 3': the lower, horizontal bracing member was bent 2 in. to the east, and bent upward and downward 1 in. due to impact damage
