APPENDIX B

Photographs of Elements Needing Repair or Replacement

Site Visits Conducted
January 19 – January 21, 2009

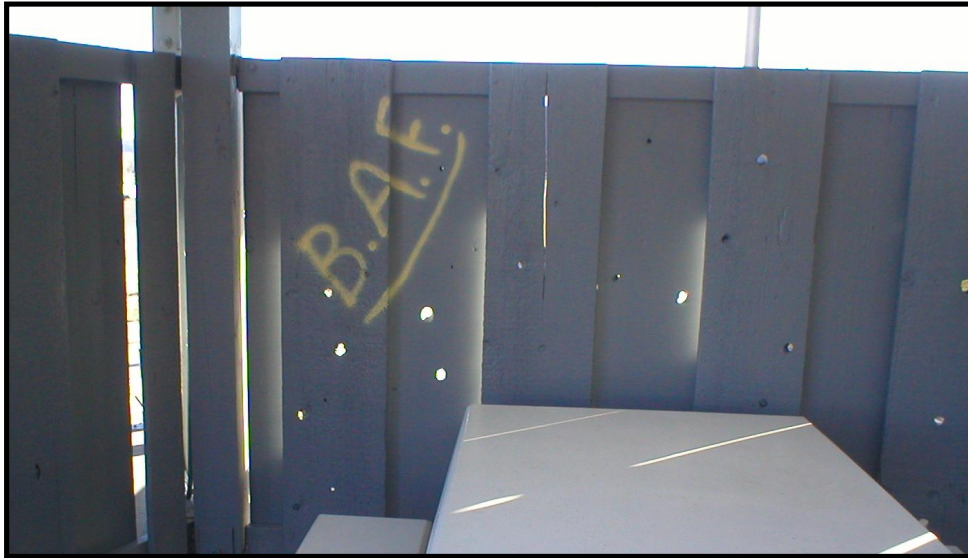
Photo 1. Graffiti near Greycliff EB picnic table.

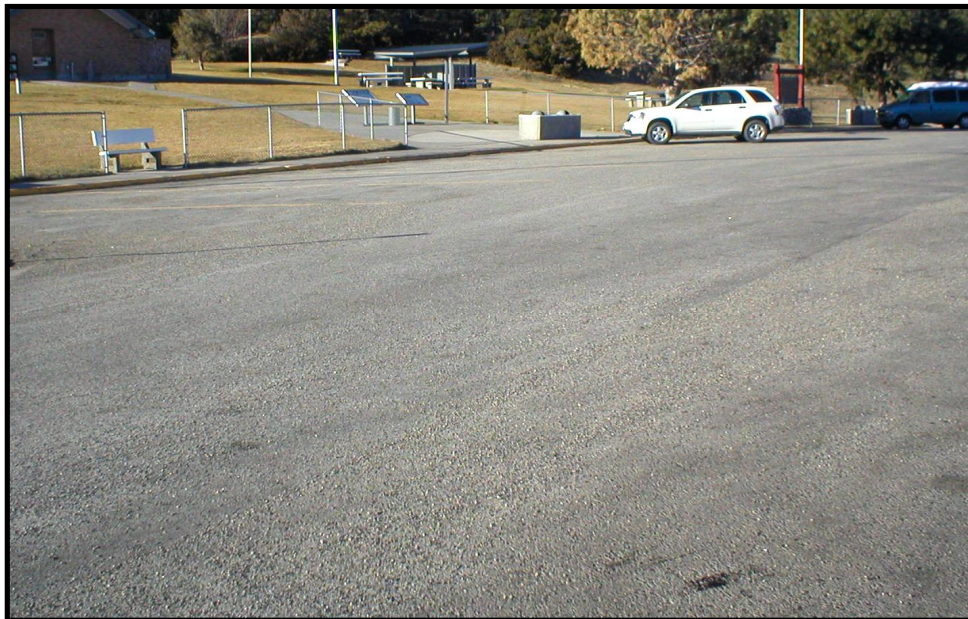
Photo 2. Truck parking at Greycliff EB site in need of striping.

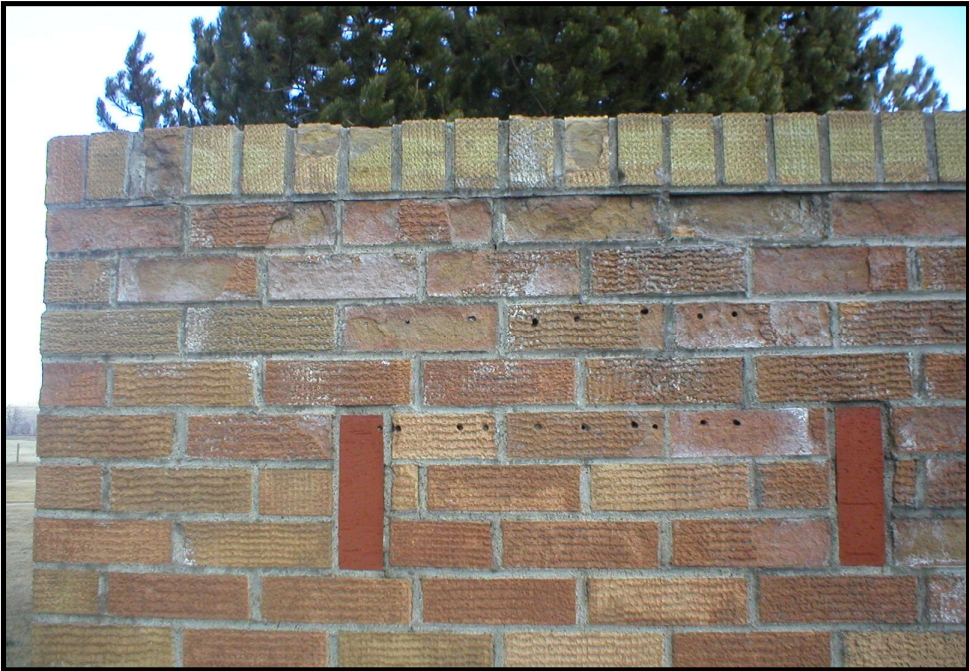
Photo 3. Crumbling brick at Greycliff WB site.

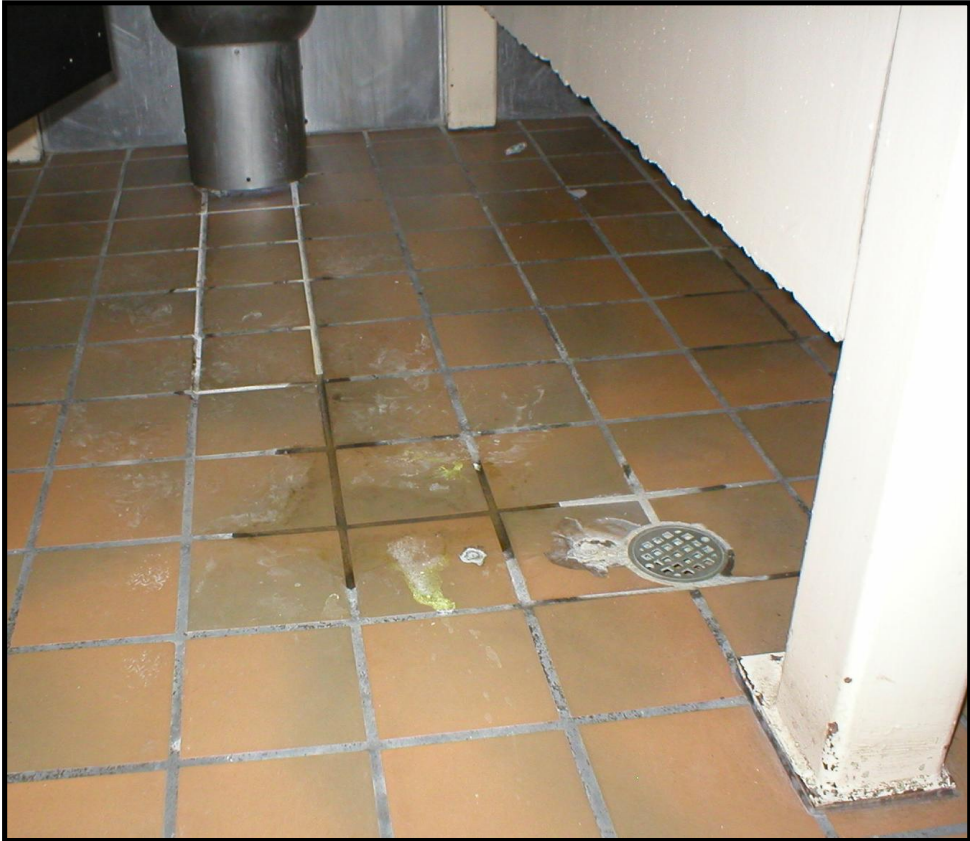
Photo 4. Crumbling floor tile in women's restroom at Greycliff WB site.

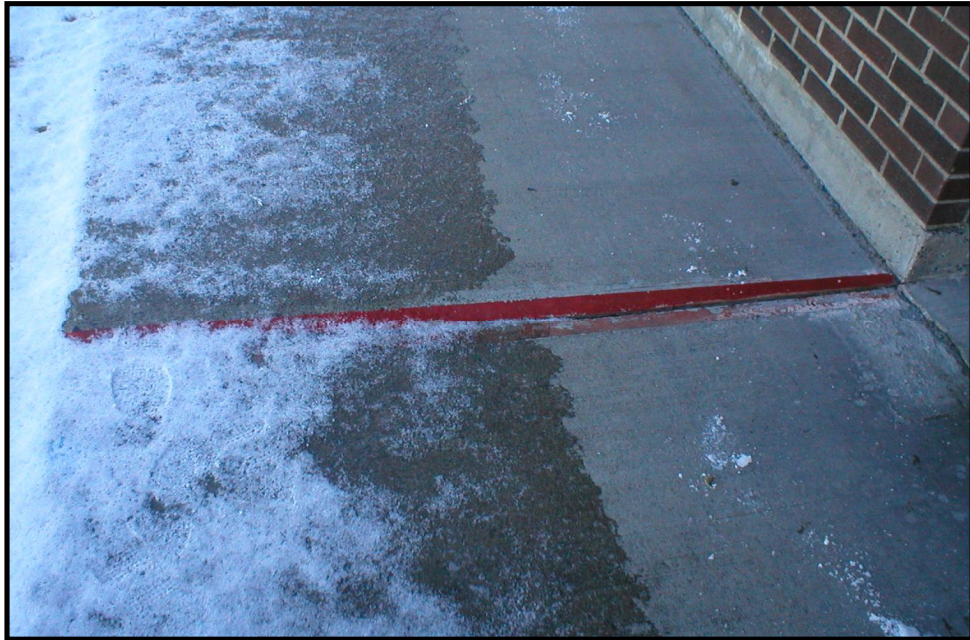
Photo 5. Uneven sidewalk at Custer EB site.

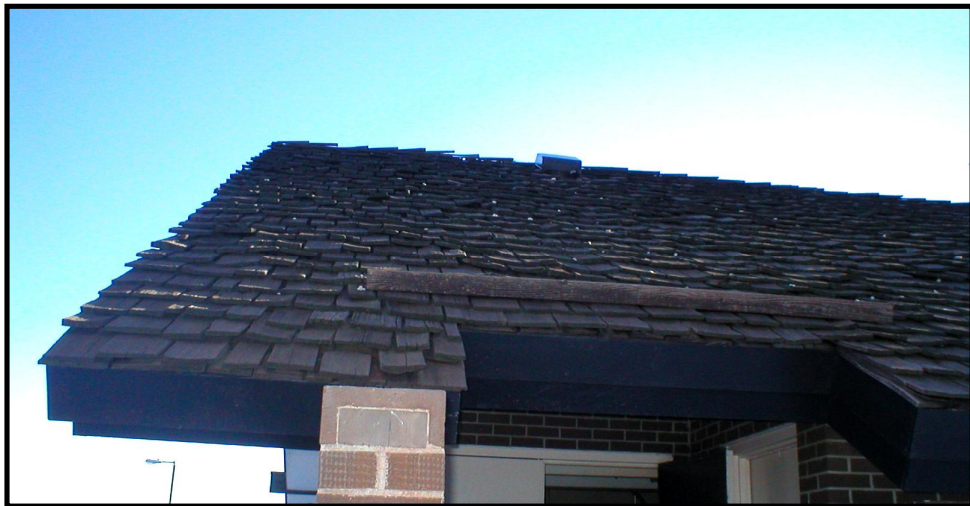
Photo 6. Cedar shake roof at Custer EB site in need of repair / replacement.

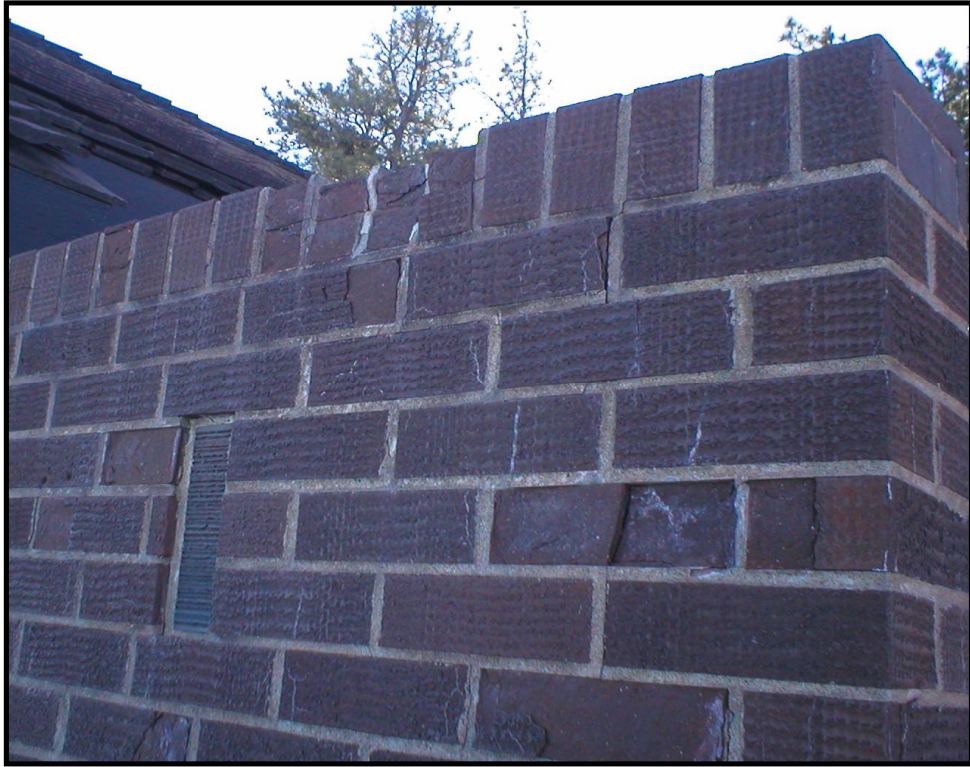
Photo 7. Crumbling brick at Custer EB site.

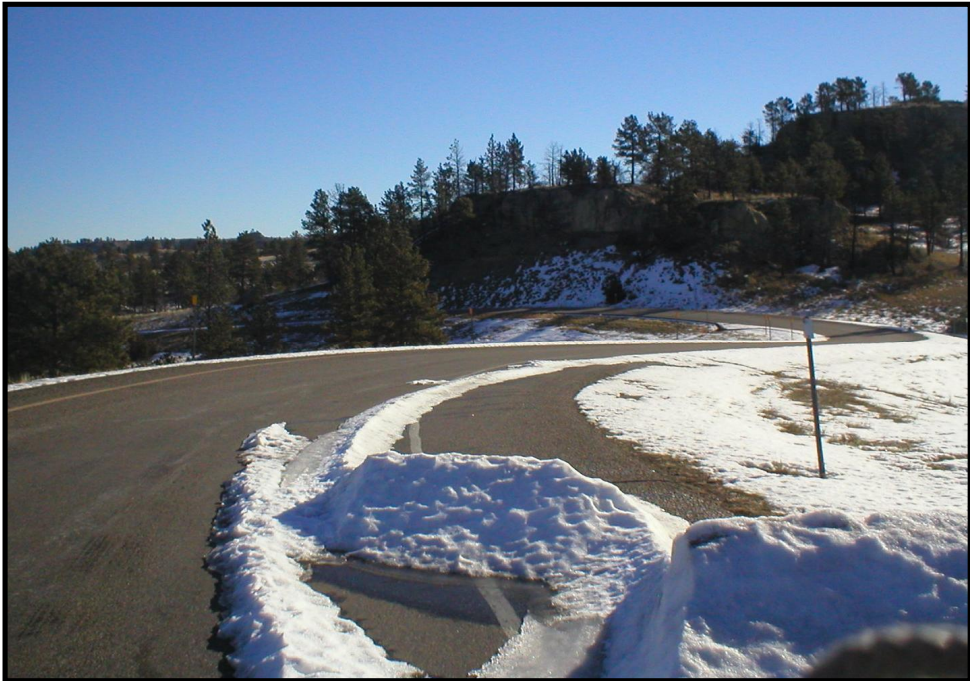
Photo 8. Acceleration ramp at Custer EB site.

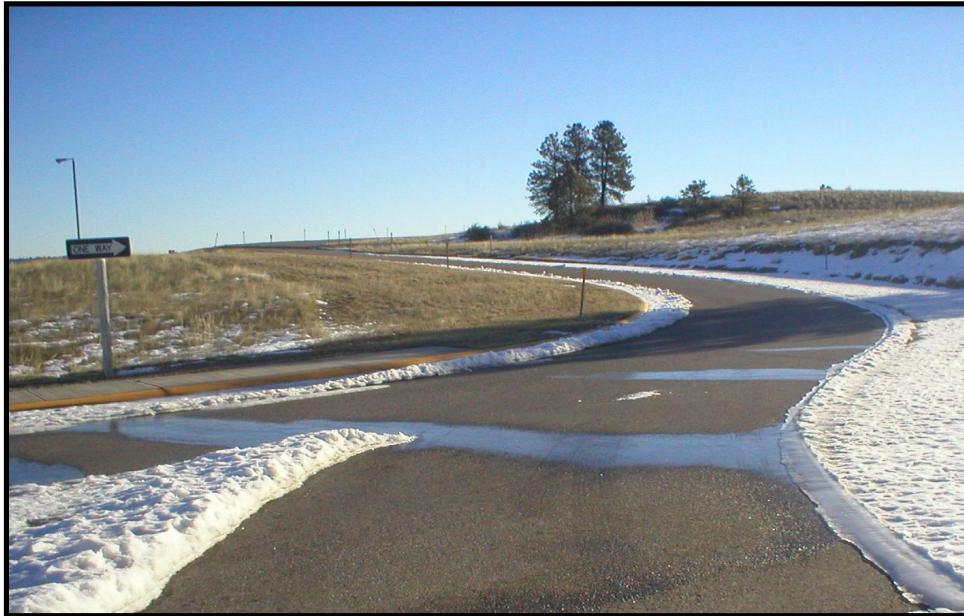
Photo 9. Acceleration ramp at Custer WB site.

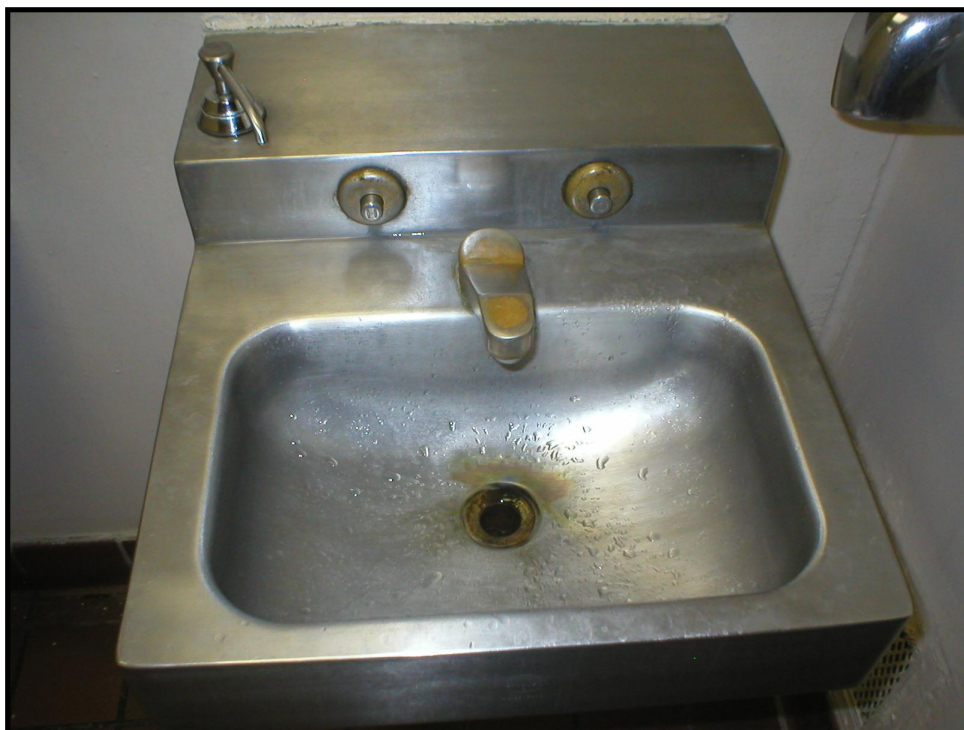
Photo 10. Rusted sink at Hysham EB site.

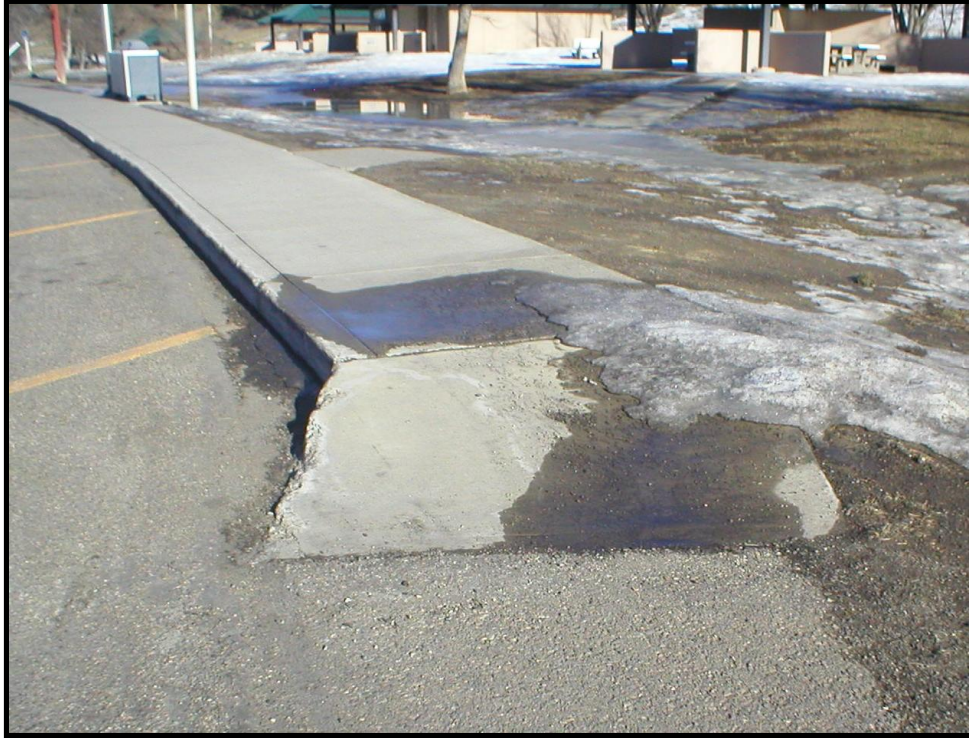
Photo 11. Crumbling ramp at Hysham EB site.

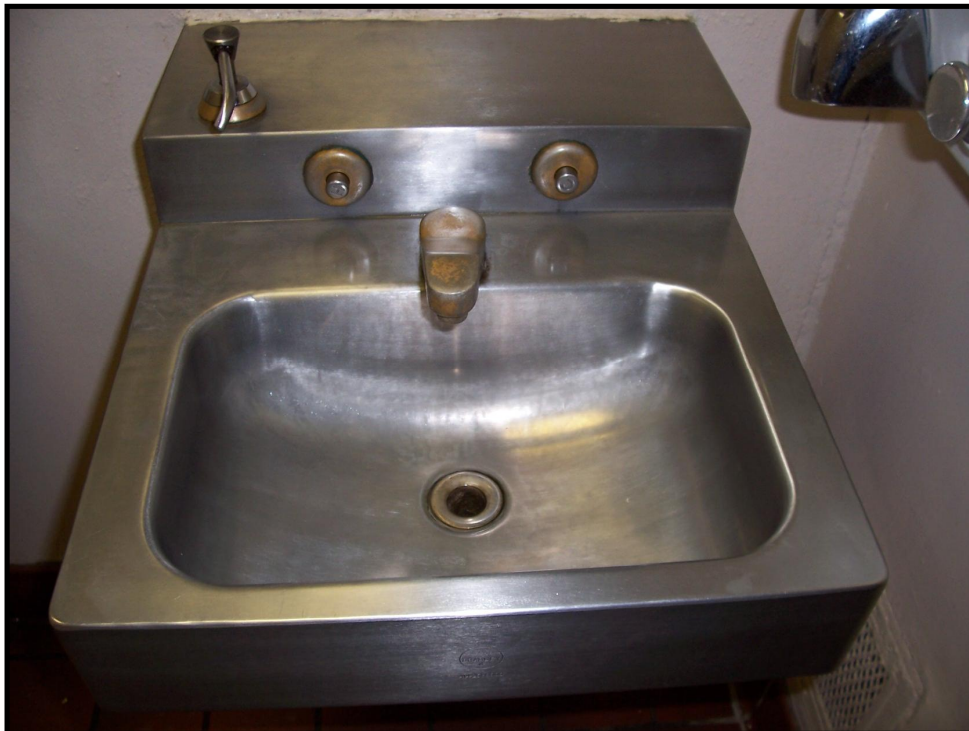
Photo 12. Rusted sink at Hysham WB site.

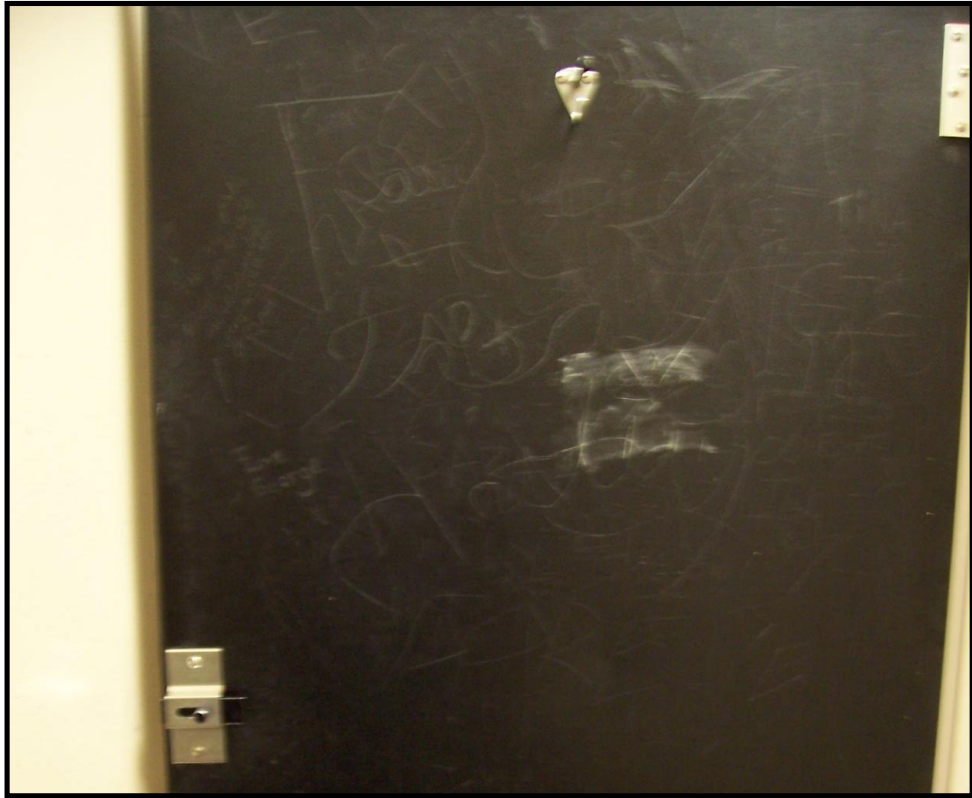
Photo 13. Graffiti on door of women's stall at Hysham WB site.

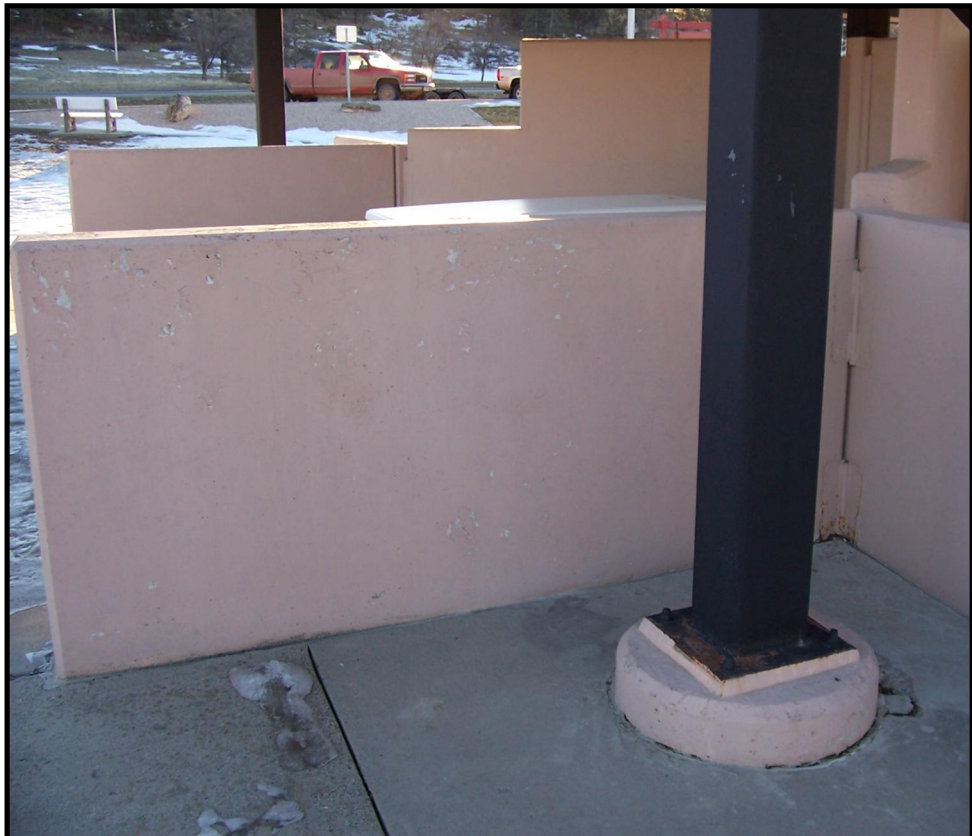
Photo 14. Chipped paint near picnic tables at Hysham WB site.

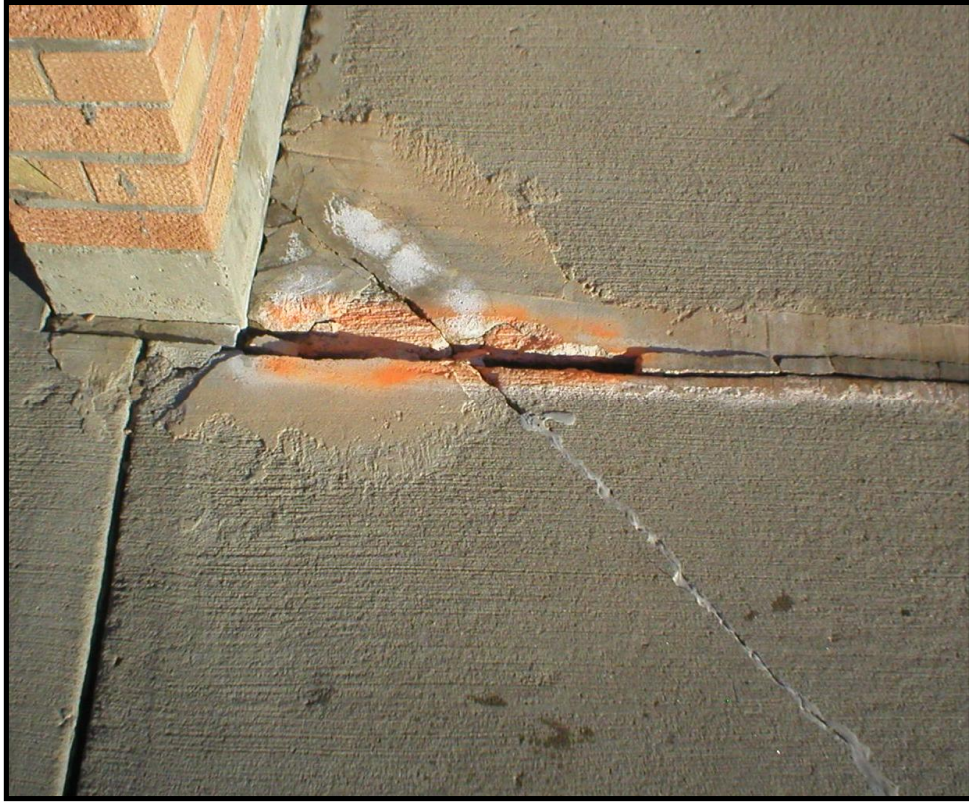
Photo 15. Cracked sidewalk at Hathaway EB site.

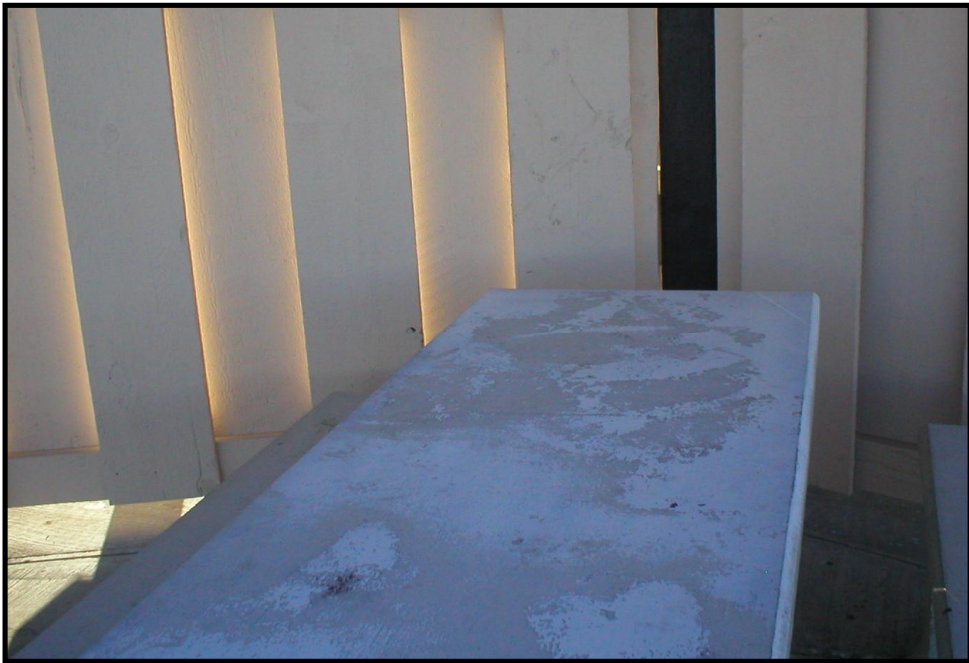
Photo 16. Chipping paint on picnic table at Hathaway EB site.

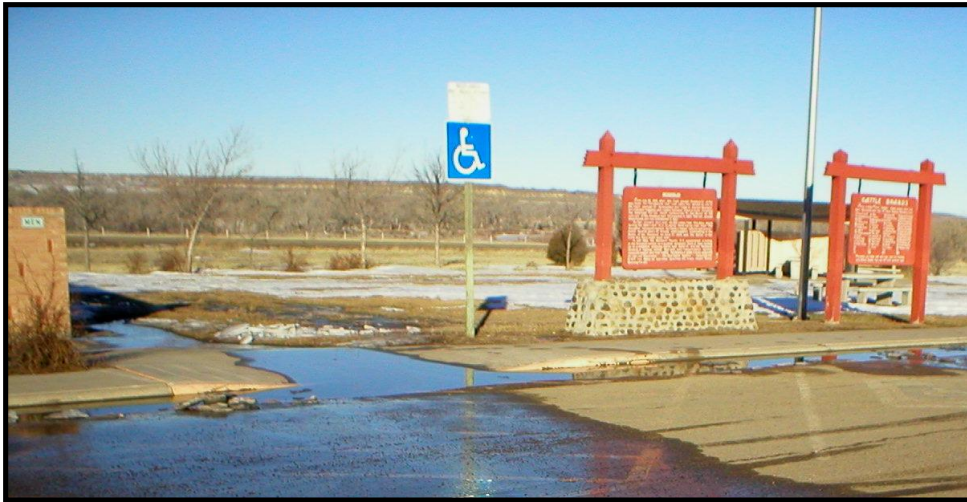
Photo 17. Drainage issues at Hathaway EB site. Melting snow is flooding sidewalk area.

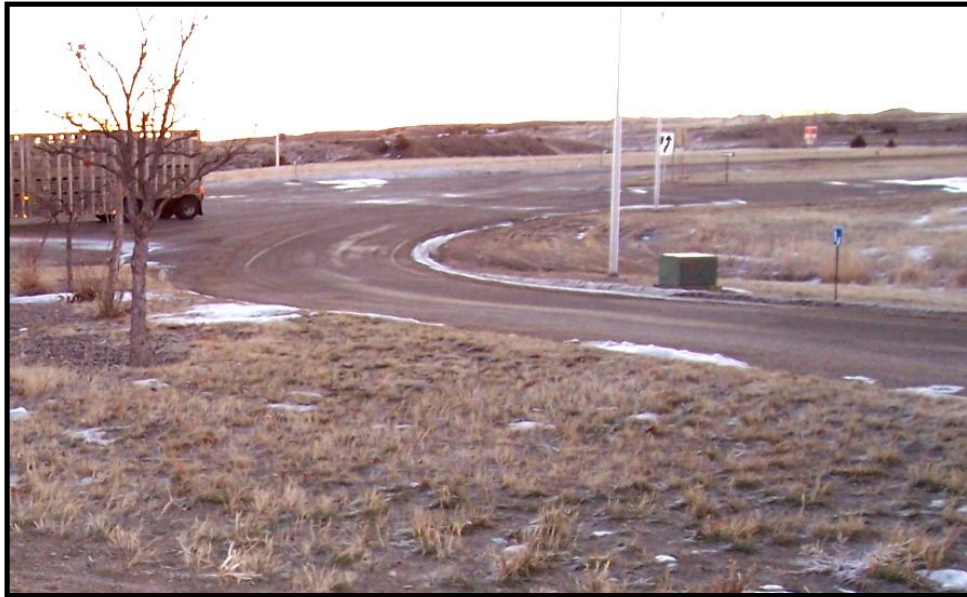
Photo 18. Acceleration ramp at Hathaway WB site.
