# **EXISTING AND PROJECTED CONDITIONS**

Maclay Bridge Planning Study

Prepared for: Montana Department of Transportation Helena, Montana

Prepared by: **Robert Peccia & Associates** Helena, Montana November 1, 2012

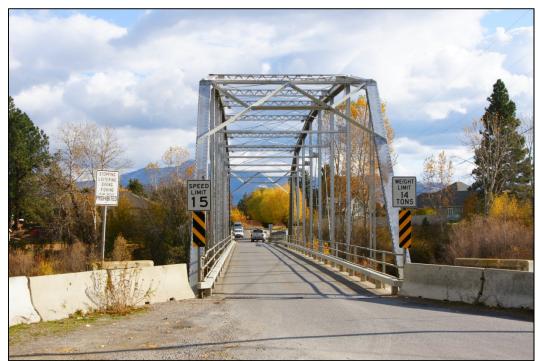
PHOTO 3: LOOKING SOUTHEAST ON ALIGNMENT – 14 TON POSTED WEIGHT LIMIT WAS REDUCED TO 11 TONS AFTER THIS IMAGE WAS TAKEN

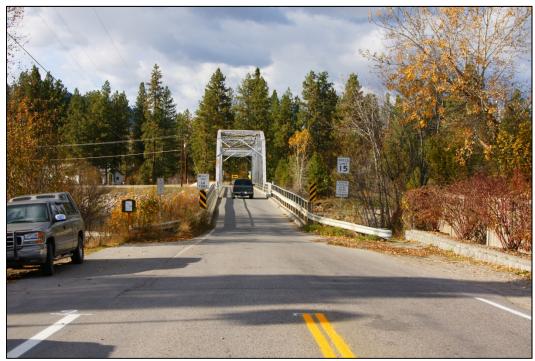
PHOTO 6: LOOKING NORTHWEST ON ALIGNMENT – 14 TON POSTED WEIGHT LIMIT WAS REDUCED TO 11 TONS AFTER THIS IMAGE WAS TAKEN

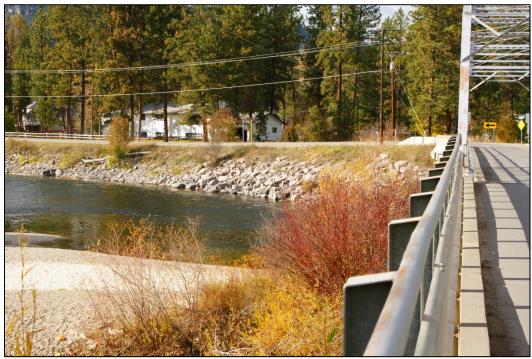
PHOTO 7: LOOKING WEST - NOTE RIPRAP ARMORED FILL SLOPE ON RIVER PINES ROAD

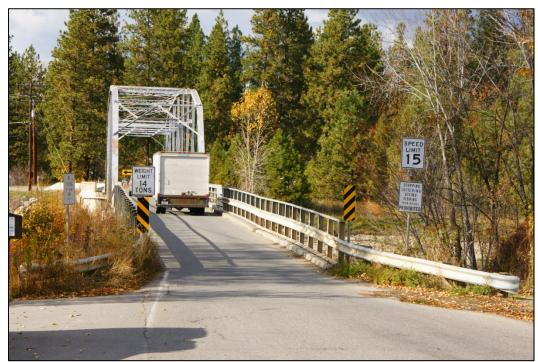
PHOTO 11: LOOKING NORTHWEST ON ALIGNMENT AS TRUCK TRAVERSES EXISTING BRIDGE – 14 TON POSTED WEIGHT LIMIT WAS REDUCED TO 11 TONS AFTER THIS IMAGE WAS TAKEN

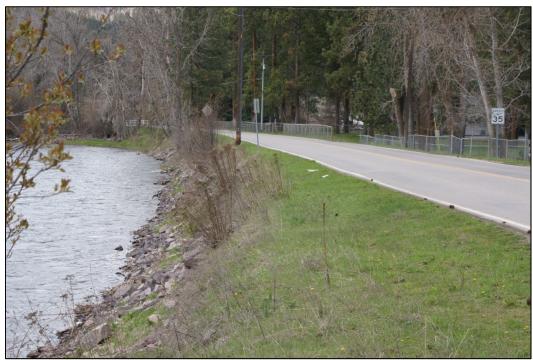
PHOTO 13: LOOKING SOUTHWEST ALONG RIVER PINES ROAD – NOTE RIPRAP ARMORING ALONG FILL SLOPE AND POWER POLE NEXT TO ROADWAY

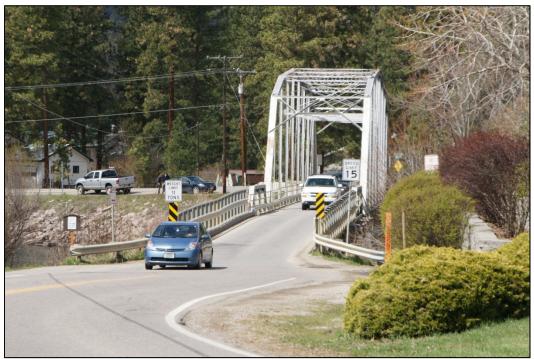
PHOTO 14: LOOKING WEST FROM NORTH AVENUE - NOTE 11 TON POSTED WEIGHT LIMIT

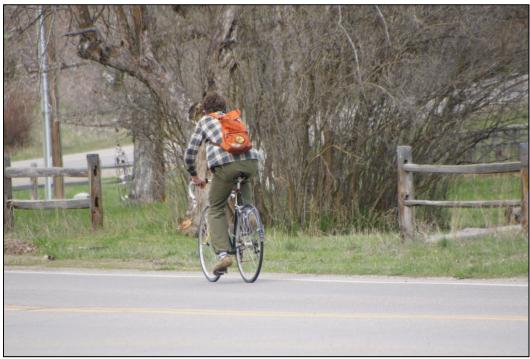
PHOTO 17: BICYCLIST ON RIVER PINES ROAD TRAVELLING SOUTHWEST IN DRIVING LANE

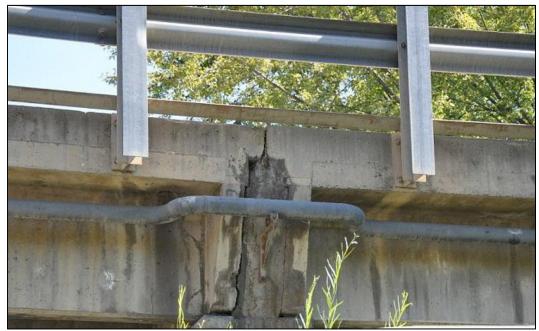
PHOTO 20: DEGRADED JOINT BETWEEN TWO CONCRETE SPANS (NOTE HIGH PRESSURE NATURAL GAS LINE)

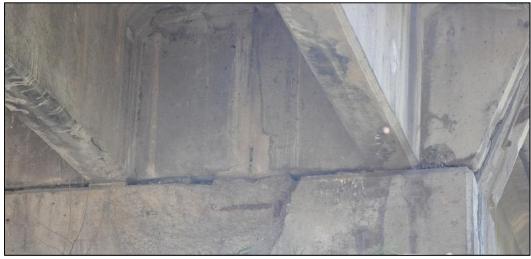
PHOTO 21: EXPOSED RUSTED REBAR AND CONCRETE SPALLING (ON EAST BRIDGE ABUTMENT)

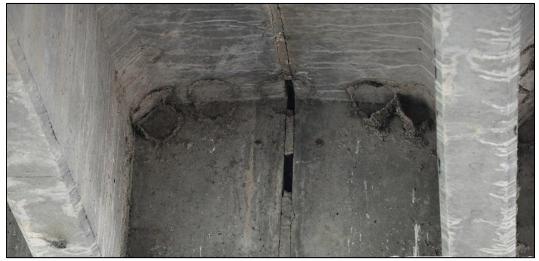
PHOTO 22: MISSING GROUT AND SKEWED JOINT (EAST BRIDGE SPAN)

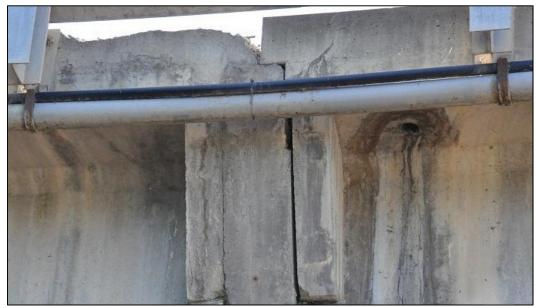
PHOTO 23: BROKEN CONCRETE, EXPOSED RUSTING REBAR, AND WOODEN SHIM (UNDER EAST SPAN)

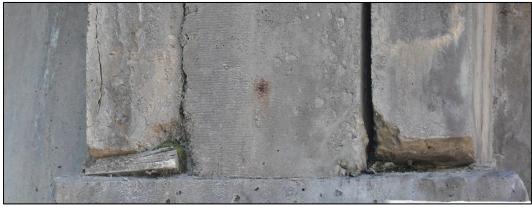
PHOTO 24: WOODEN SHIM UNDER CONCRETE SPAN

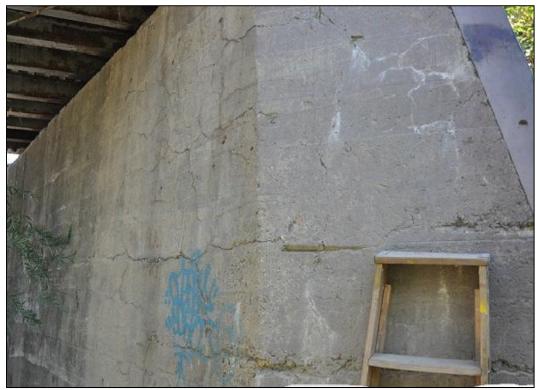
**PHOTO 25: CRACKS IN CONCRETE PIER**

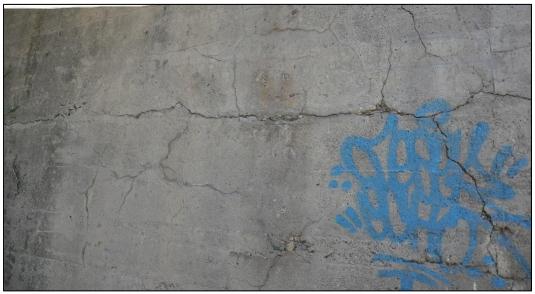
PHOTO 26: CLOSE UP OF CRACKS IN CONCRETE PIER

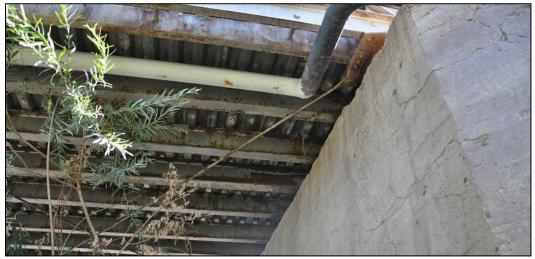
PHOTO 27: RUST ON STEEL MEMBERS (UNDER THE BRIDGE)

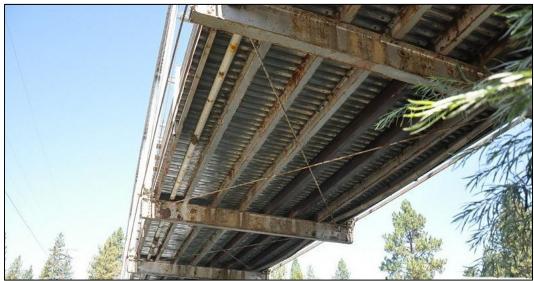
PHOTO 28: STEEL MEMBERS OF VARYING AGES AND CONDITION
