# Montana Department of Transportation

## 2008 Seal Coat Warranty Administration Guide

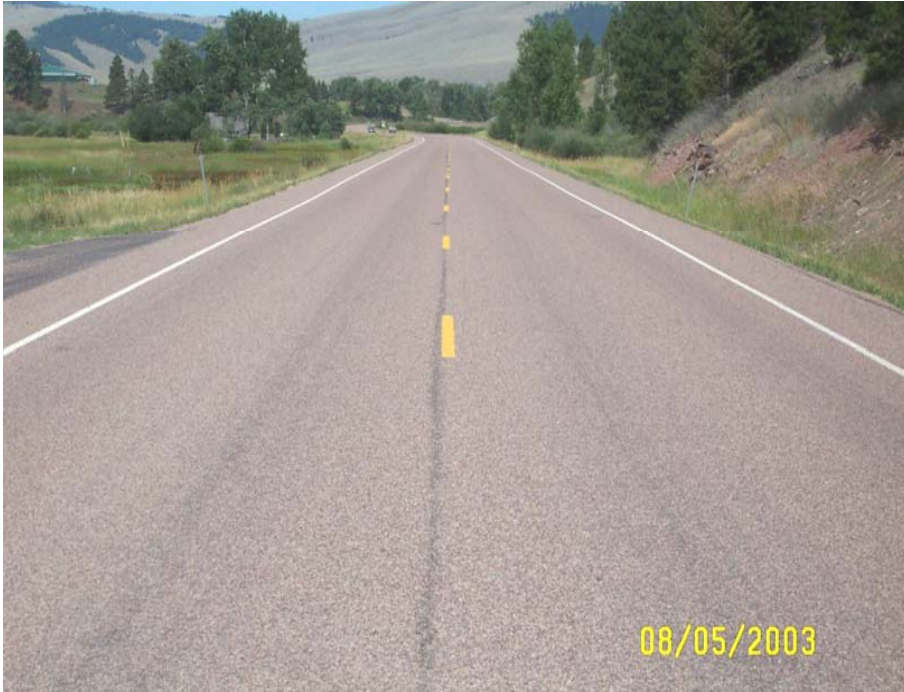
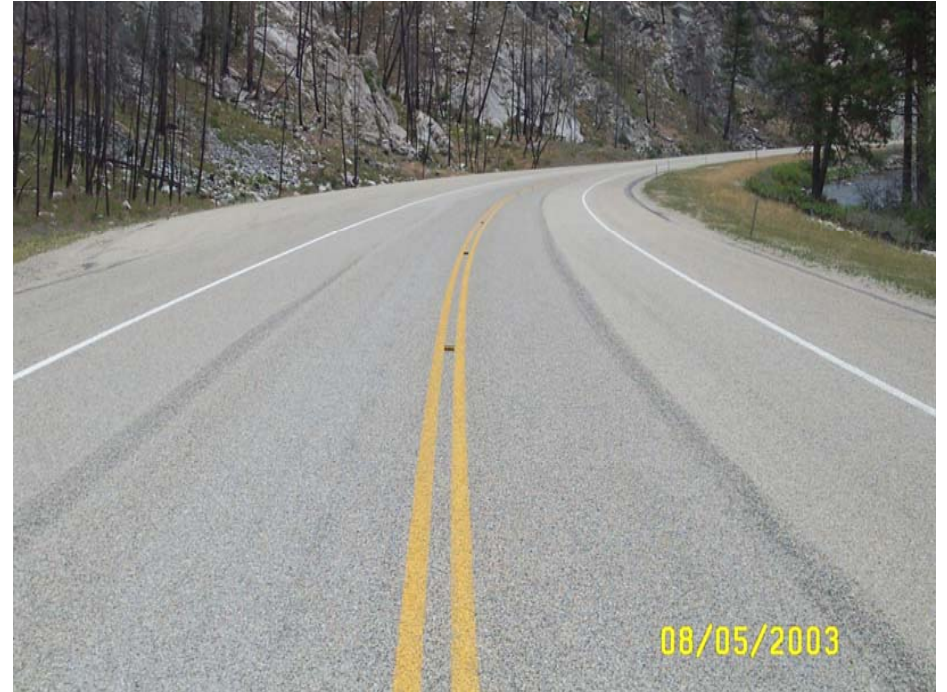
Condition: Longitudinal Joint Location

- Per Subsection 409.03.7, Locate Longitudinal Joints at The Centerline or Lane Line.

- Obtain Approval From The Project Manager to Construct The Joint at Any Other Location.

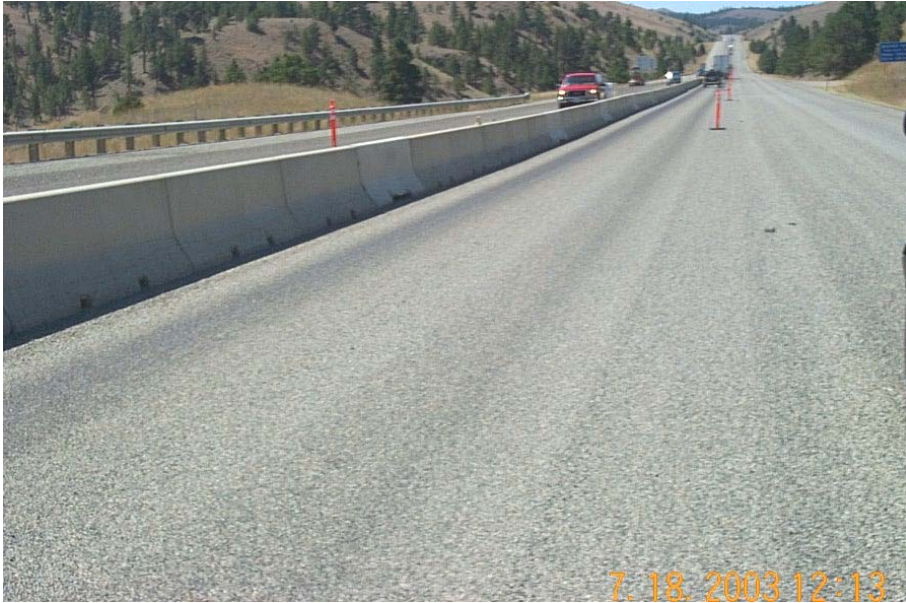
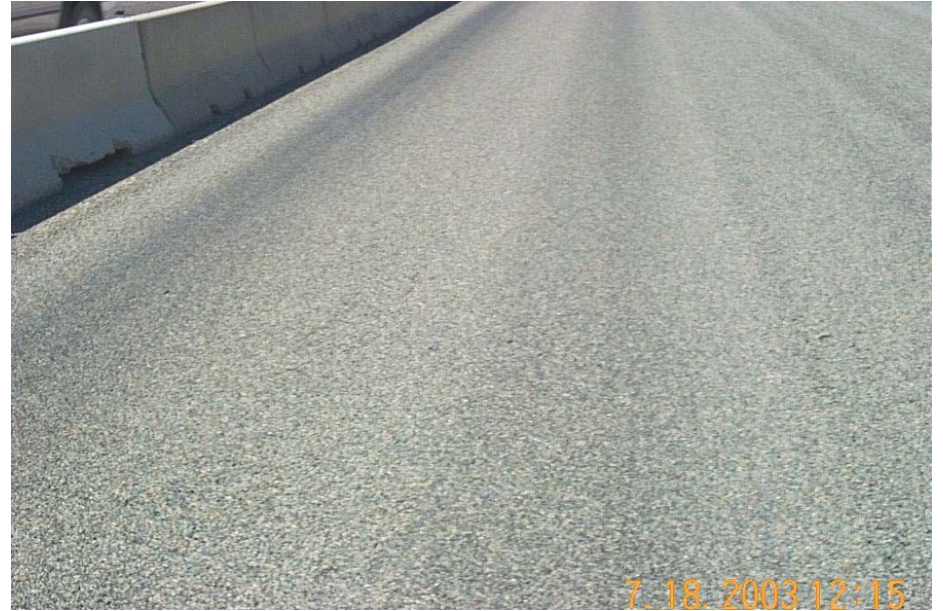
Condition: Light Tracking

- Move Traffic Control Devices as Needed; Keep Vehicle Tires Off of Oil Tracking Areas.
- Apply Blotter Material on Live Oil Areas For Duration of Warranty Period. Refer to Subsection 409.03.9. Application of Blotter Material.

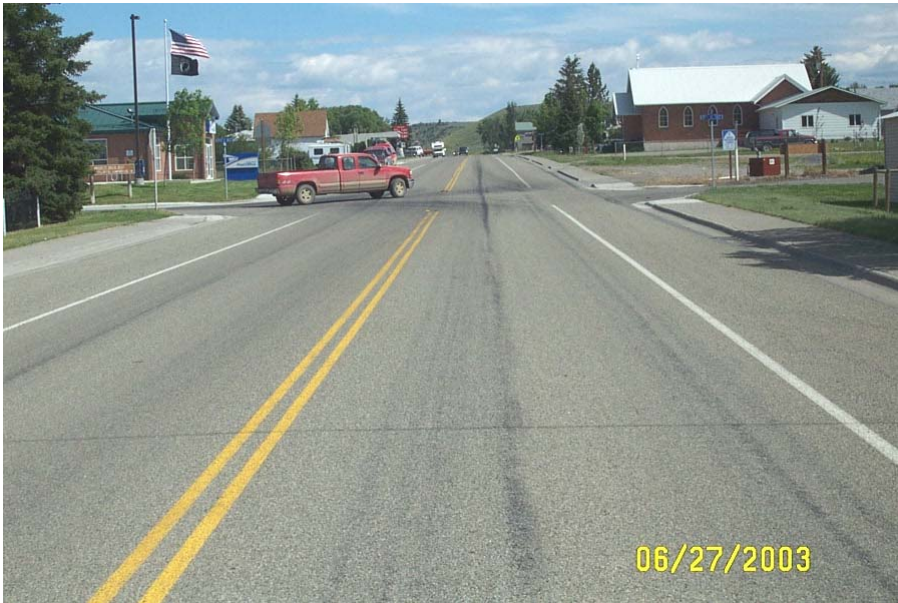
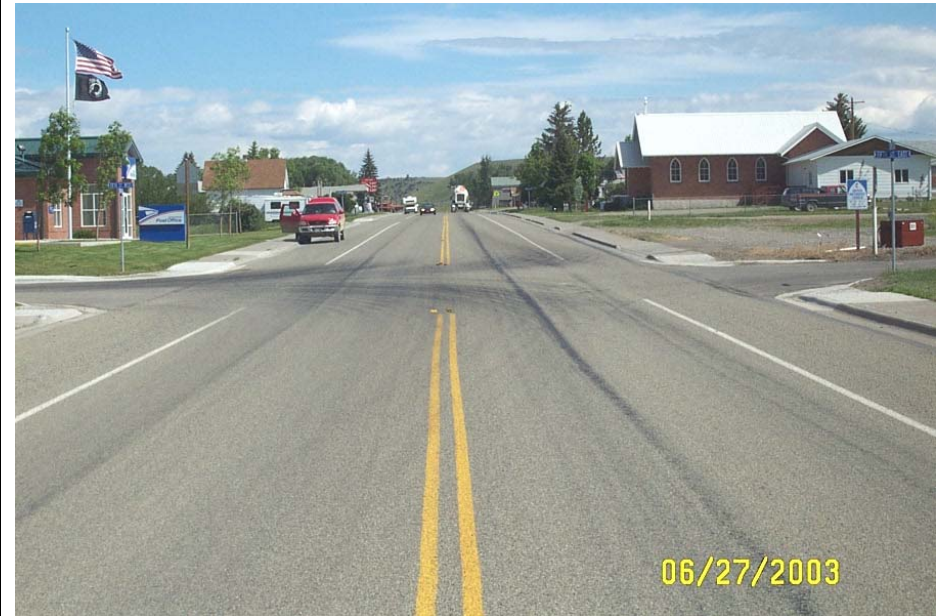
Condition: Light Tracking at Intersection

- Blot Live Oil Areas Throughout Warranty Period. Refer to Subsection 409.03.9. Application of Blotter Material.
- This Level of Tracking is Considered Acceptable And is Expected to Diminish With Cooler Temperatures.

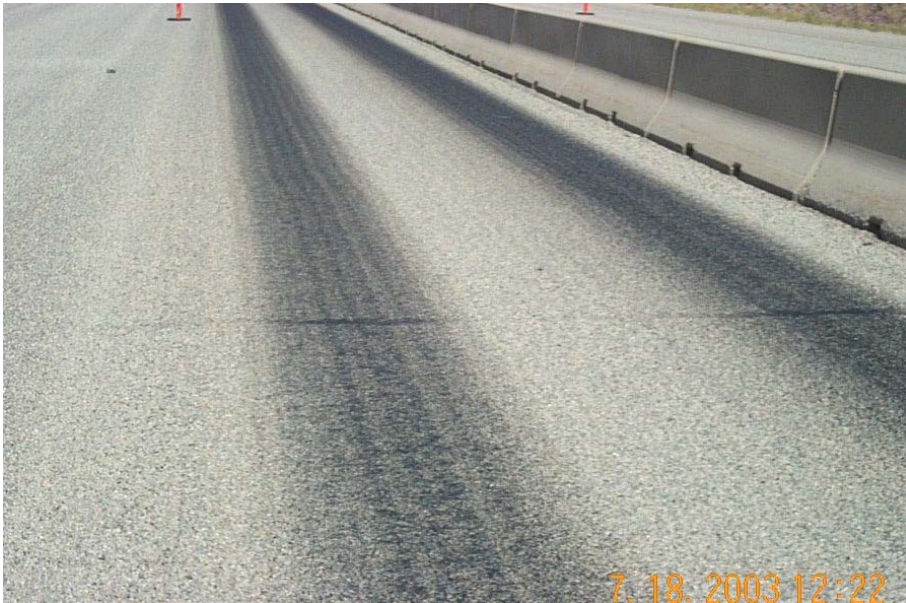
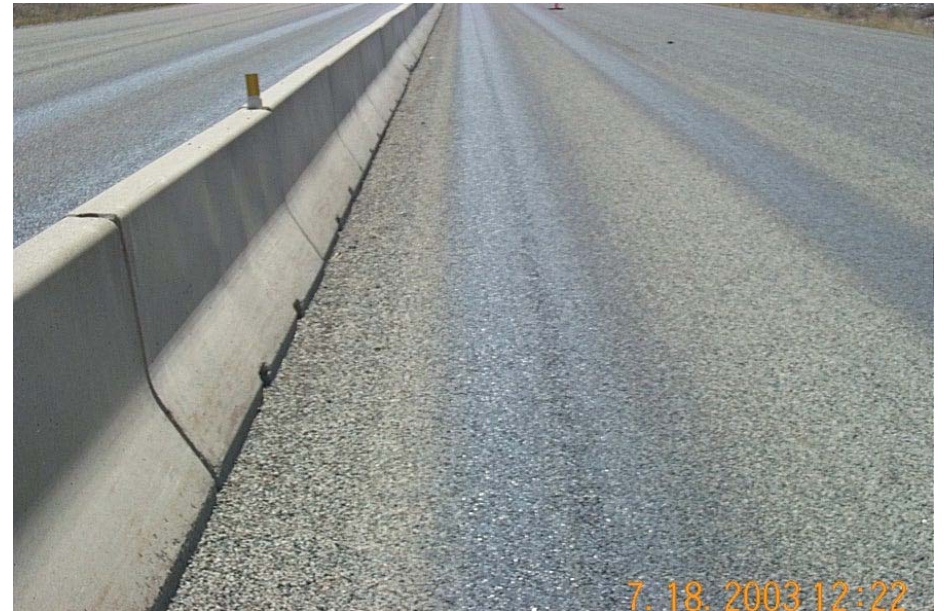
Condition: Moderate Tracking

- Move Traffic Control Devices as Needed; Keep Vehicle Tires Off of Oil Tracking Areas.
- Apply Blotter Material on Live Oil Areas For Duration of Warranty Period. Refer to Subsection 409.03.9. Application of Blotter Material.

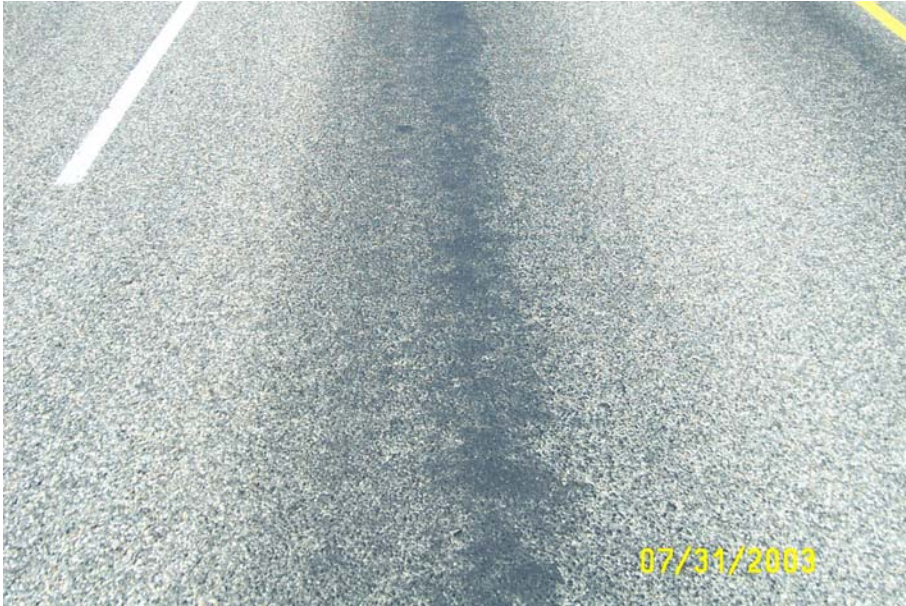
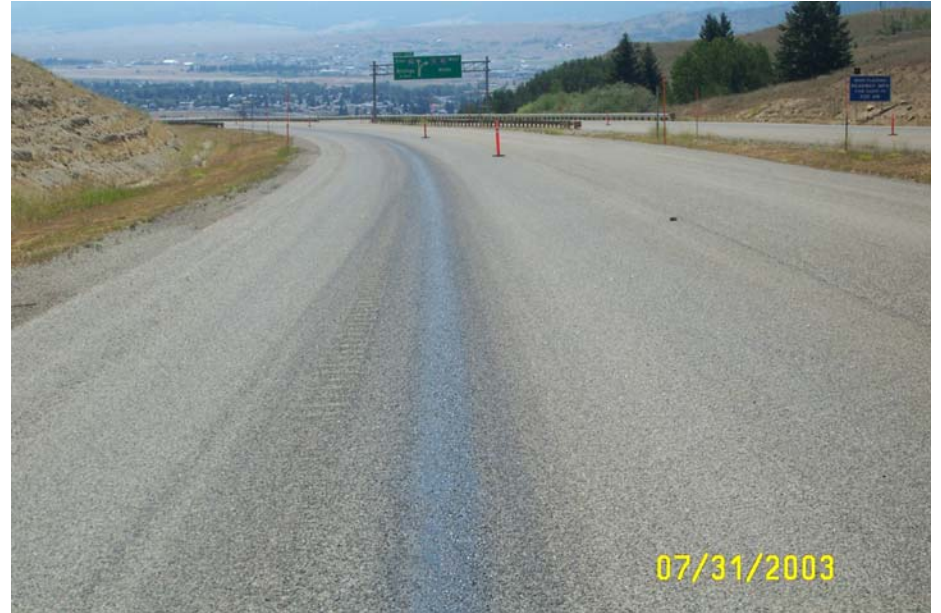
Condition: Moderate Tracking

- Move Traffic Control Devices as Needed to Keep Vehicle Tires Off of Oil Tracking Areas.
- Apply Blotter Material on Live Oil Areas For Duration of Warranty Period. Refer to Subsection 409.03.9. Application of Blotter Material.

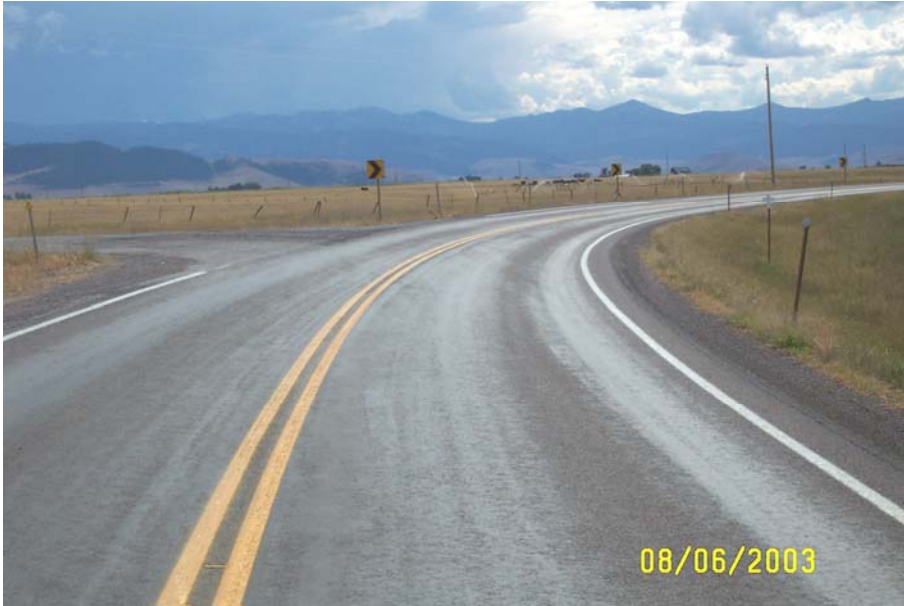
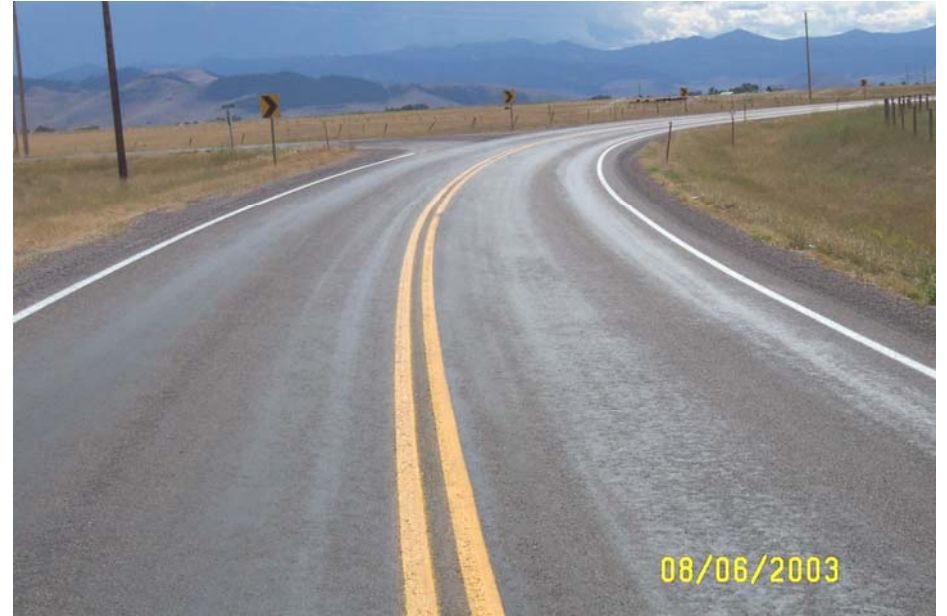
Condition: Heavy Tracking in Curve Section

- Blot Live Oil Areas Throughout Warranty Period. Refer to Subsection 409.03.9. Application of Blotter Material.
- In Cases Where This Condition Persists at The End of The Warranty Period, Acceptance is Made Under Subsection 105.03.1.
- Due to The Loss of Service Life, Skid Resistance and Headlight Reflectivity, a 50% Price Reduction is Recommended for Affected Area.

- During Seal Coat Placement in High ADT And/or Turning Movement Areas, Consider Reducing Traffic Speeds And Continually Monitor Device Placement (i.e. Flagging Station Locations), to Avoid Aggregate Rollover During Curing Period.

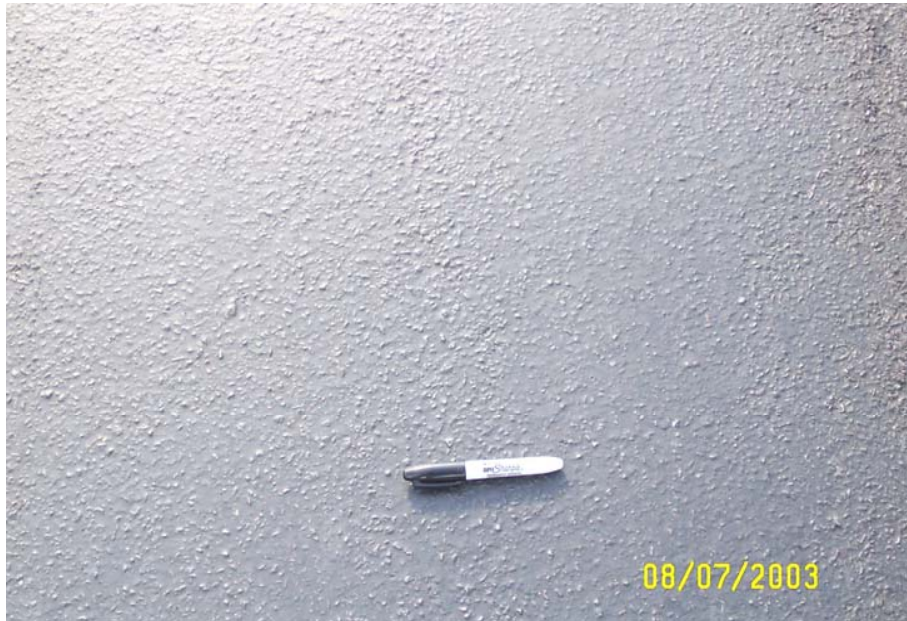
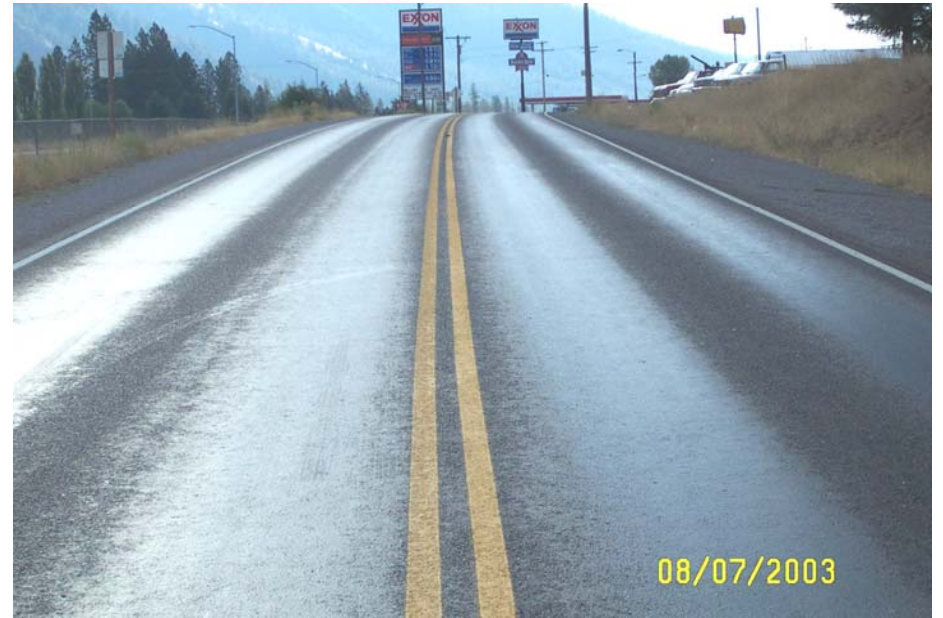
Condition: Heavy Tracking, Bleeding

- Blot Live Oil Areas Throughout Warranty Period. Refer to Subsection 409.03.9. Application of Blotter Material.
- In Cases Where This Condition Persists at The End of The Warranty Period, Acceptance is Made Under Subsection 105.03.1.
- Due to The Loss of Service Life, Skid Resistance and Headlight Reflectivity, a 50% Price Reduction is Recommended for Affected Area.

- During Seal Coat Placement in High ADT And/or Turning Movement Areas, Consider Reducing Traffic Speeds And Continually Monitor Device Placement (i.e. Flagging Station Locations) to Avoid Aggregate Rollover During Curing Period

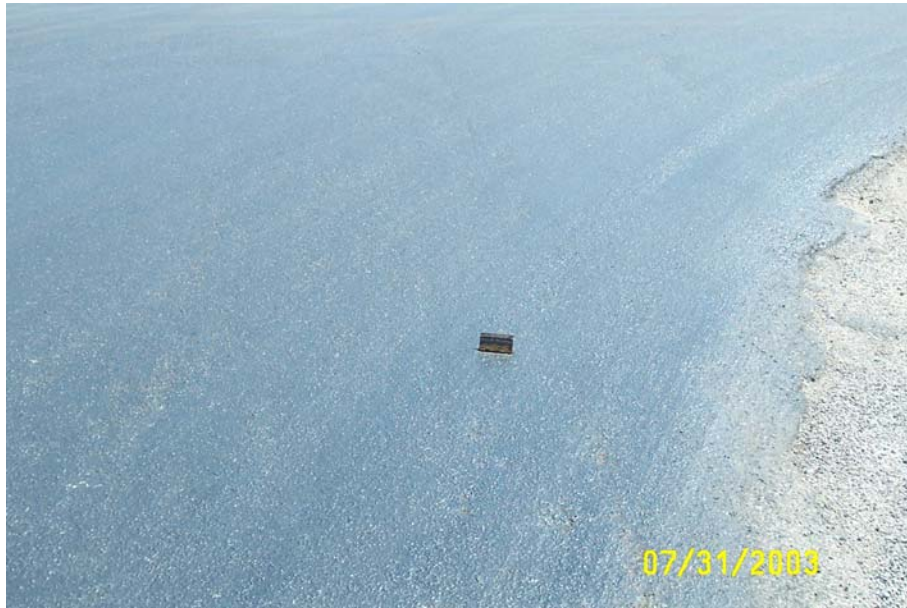
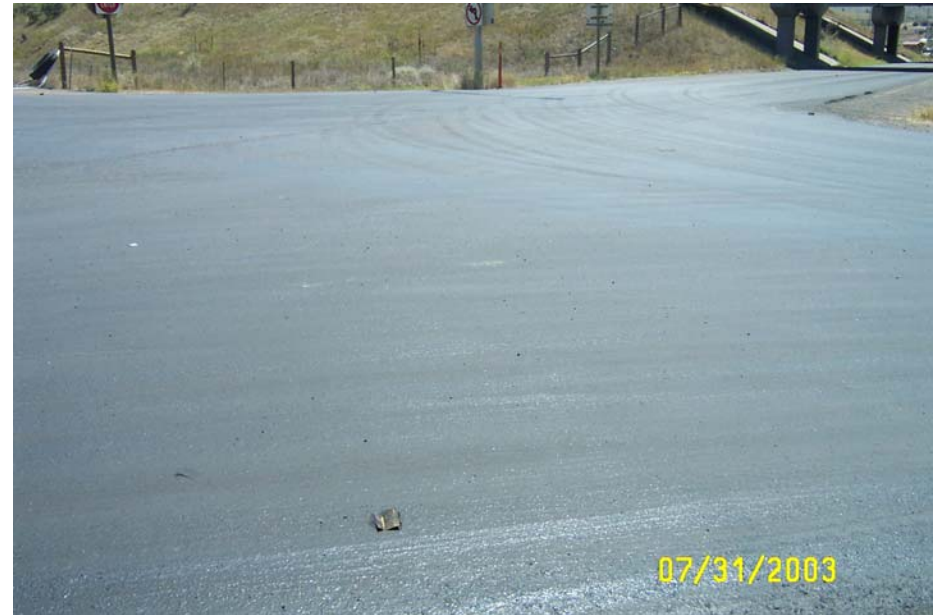
Condition: Heavy Tracking, Bleeding

- Blot Live Oil Areas Throughout Warranty Period. Refer to Subsection 409.03.9. Application of Blotter Material.
- In Cases Where This Condition Persists at The End of The Warranty Period, Acceptance is Made Under Subsection 105.03.1.
- Due to The Loss of Service Life, Skid Resistance and Headlight Reflectivity, a 50% Price Reduction is Recommended for Affected Area.

- During Seal Coat Placement in High ADT And/or Turning Movement Areas, Consider Reducing Traffic Speeds And Continually Monitor Device Placement (i.e. Flagging Station Locations) to Avoid Aggregate Rollover During Curing Period.

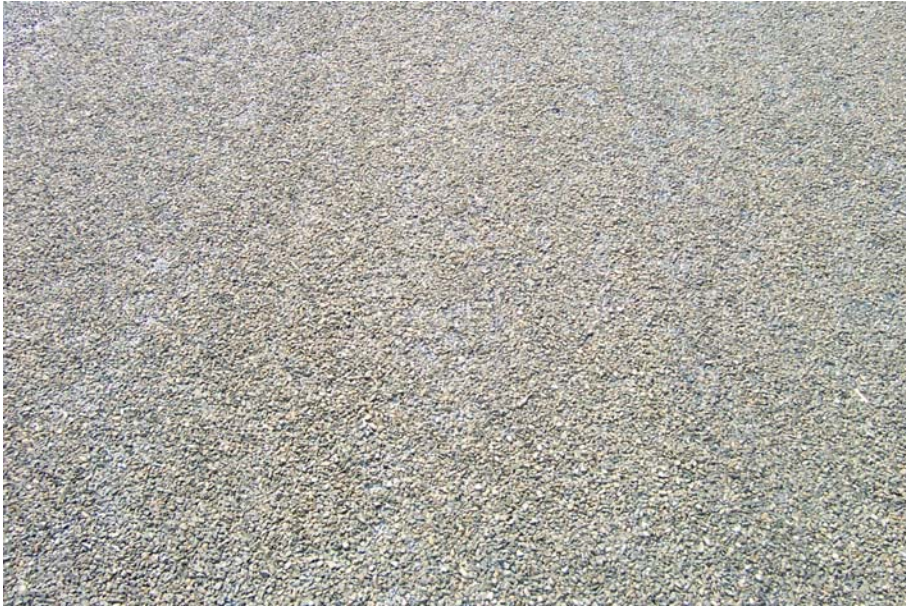
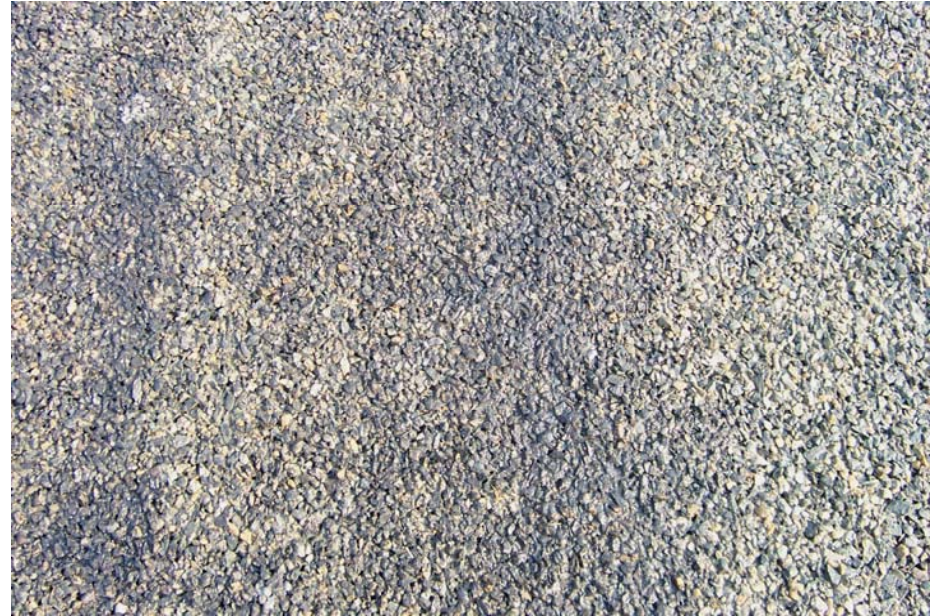
Condition: Flushing, Excess Bituminous Material

- \* This Condition Typically Occurs When Cover Material is Saturated to The Point Where Free Water Runs From The Bed of The End Dump at The Chip Spreader. Bituminous Materials Are Then Drawn to The Surface by Seal Coat Equipment Tires.

- Decrease Bituminous Material Application Rate.
- Increase Cover Material Application Rate.
- \* Reduce The Amount of Water Applied to Cover Material.
- Modify Aggregate Wetting Method to More Uniformly Distribute Water.
- Blot Live Oil Areas Throughout Warranty Period. Refer to Subsection 409.03.9. Application of Blotter Material.

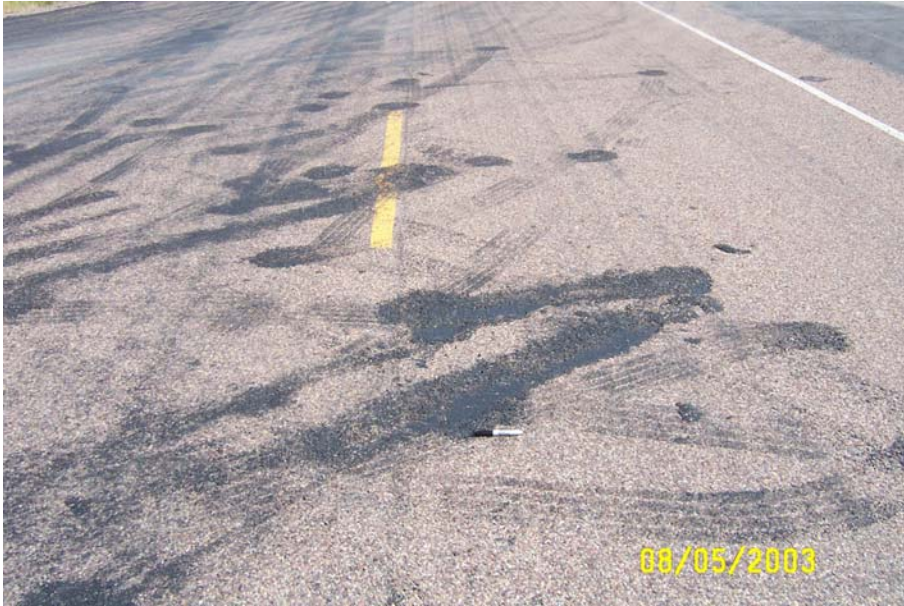
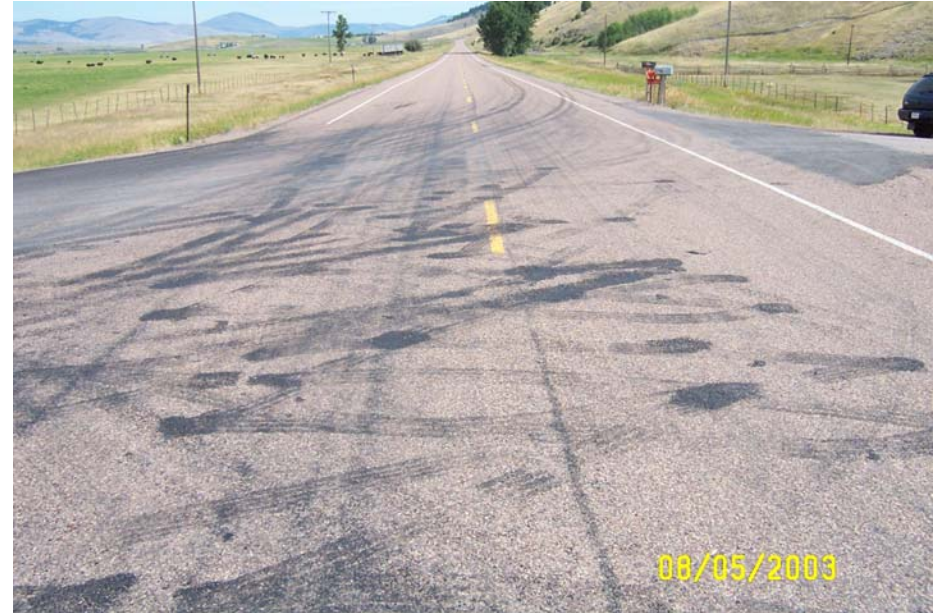
Condition: Equipment Damage During Seal Coat Cure

- Clean Surface, Patch Bare Areas With Additional Bituminous Material And Cover Aggregate.
- Per Subsection 409.03.8 Warranty, Submit a Detailed Repair Plan to The Project Manager For Approval Within 14 Calendar Days of Notification of Required Repairs.
- Turning Movements Resulting in Damage of This Severity Should Not Occur at Any Time During The Curing Period.

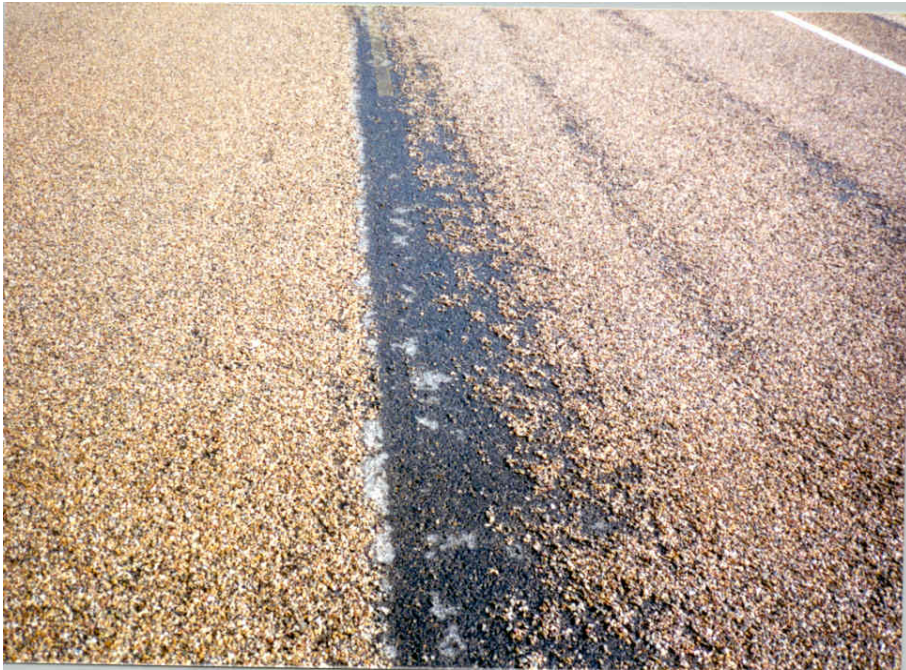
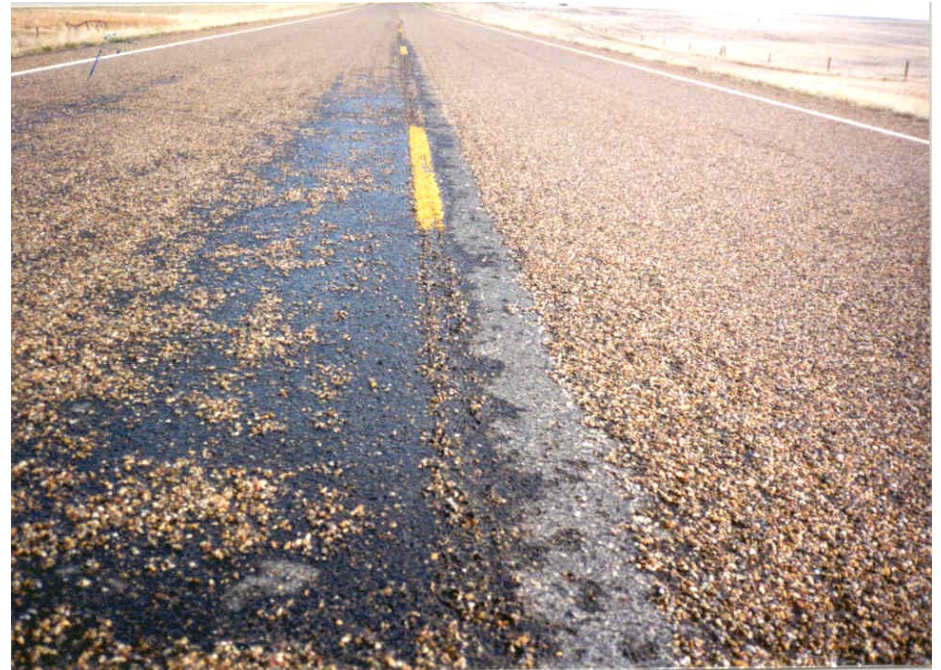
Condition: Cover Material Loss Attributed to Insufficient Embedment.

- Per Subsection 409.03.8 Warranty, Submit a Detailed Repair Plan to The Project Manager For Approval Within 14 Calendar Days of Notification of Required Repairs.
- This Condition is Unacceptable And Must be Repaired Prior to Final Acceptance.

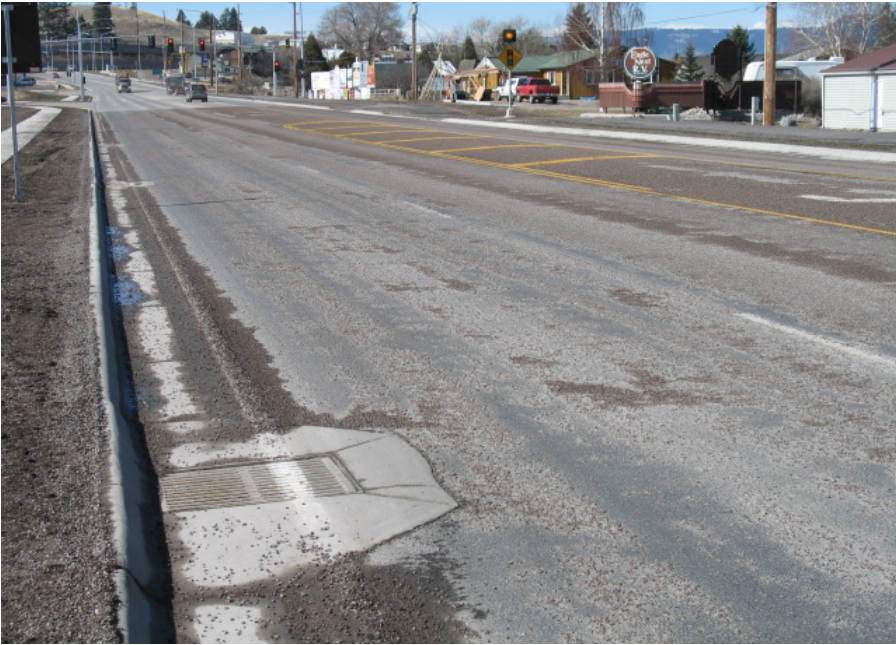
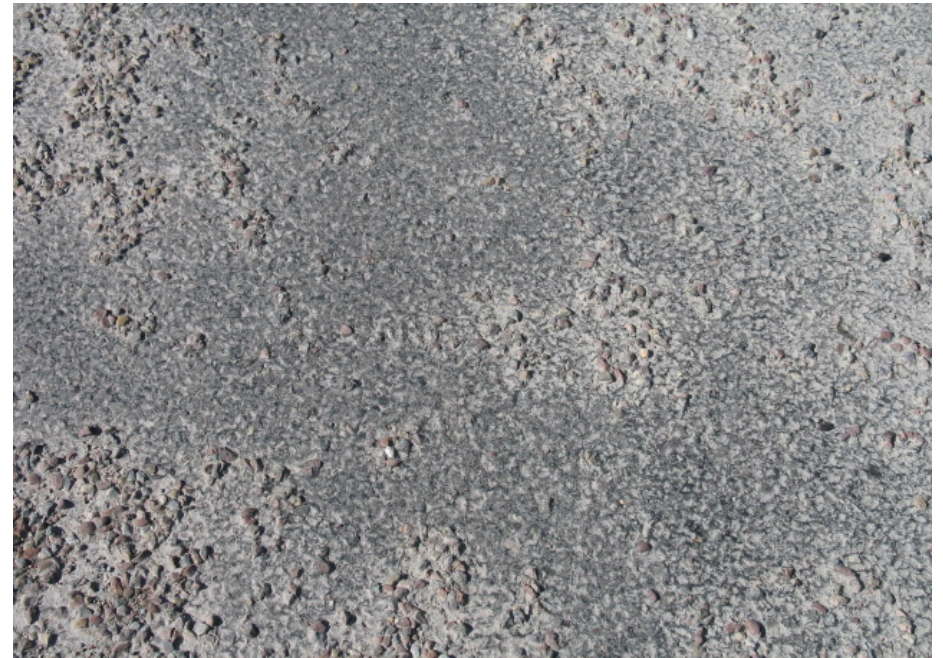
Condition: Cover Material Loss Attributed to Insufficient Embedment.

- Cover Material Removed From Roadway Found to Have Less Than 20% Embedment.
- Condition Attributed to a Distributor Calibration Issue.
- Project Was Sealed in Late August; Weather Conditions Included High Humidity and Heavy Fog.
- Cover Material Loss Began to Occur Within Days of Application.

- Per Subsection 409.03.8 Warranty, Submit a Detailed Repair Plan to The Project Manager For Approval Within 14 Calendar Days of Notification of Required Repairs.
- This Condition is Unacceptable And Must be Repaired Prior to Final Acceptance.

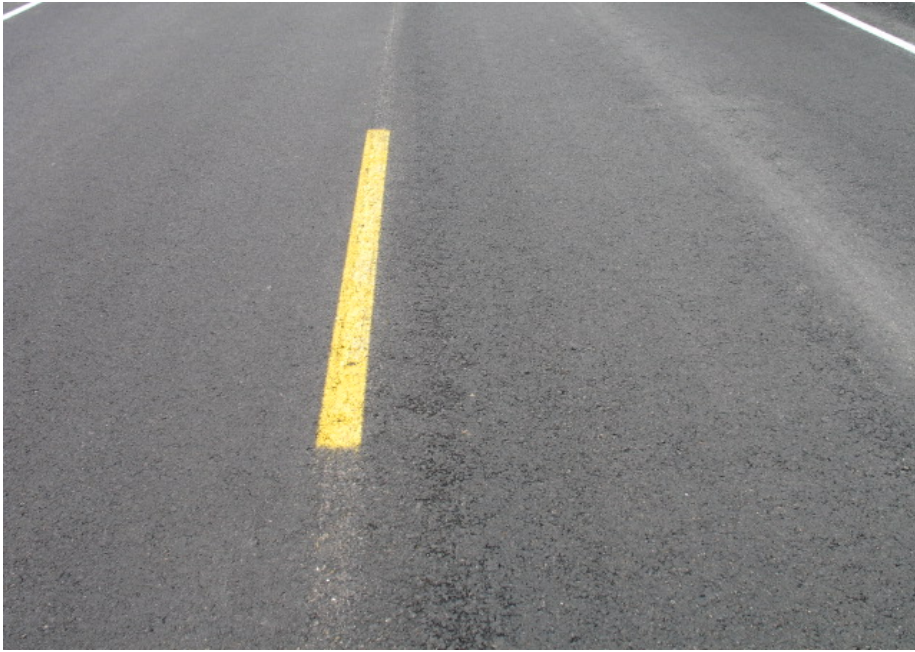
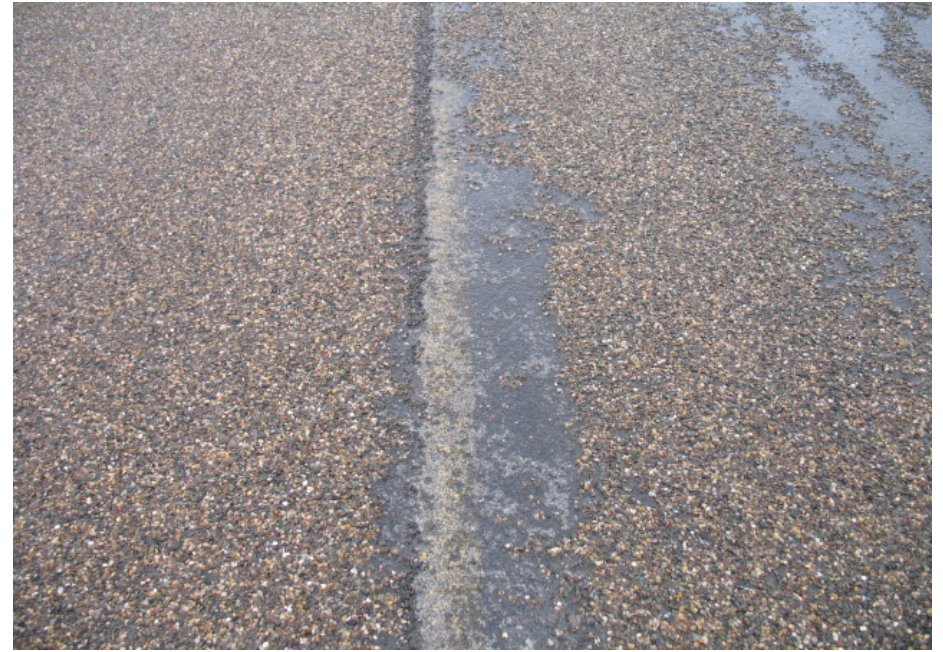
Condition: Cover Material Loss Attributed to Insufficient Embedment Caused From Plant Mix Surfacing Segregation.

- Condition Attributed to Plant Mix Surfacing Segregation.
- Per Subsection 409.03.8 Warranty, Submit a Detailed Repair Plan to The Project Manager For Approval Within 14 Calendar Days of Notification of Required Repairs.
- This Condition is Unacceptable And Must be Repaired Prior to Final Acceptance.

- Segregated Plant Mix Surfacing Sections Should be Identified And Addressed Prior to Seal Coat Application.

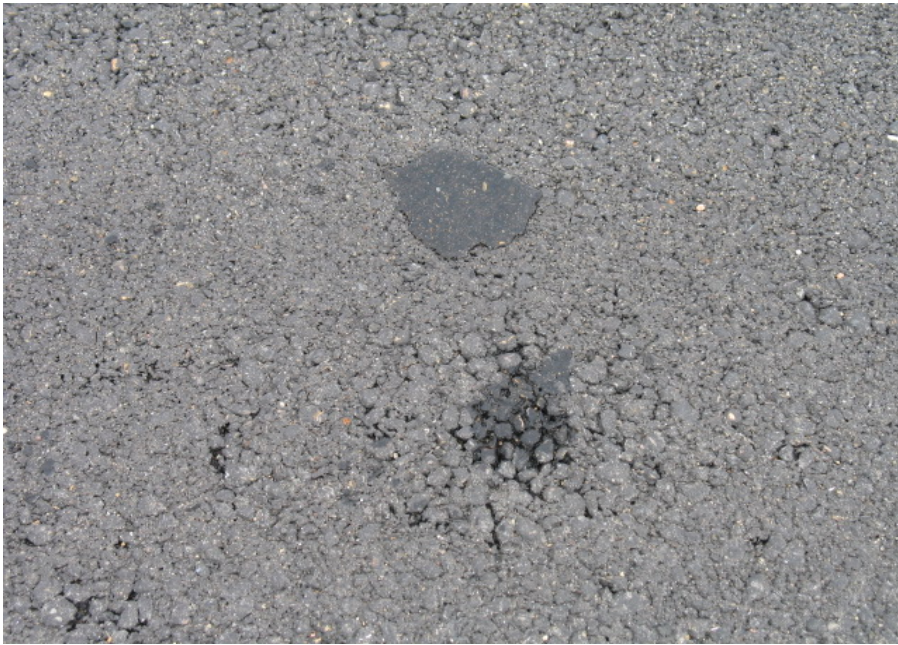
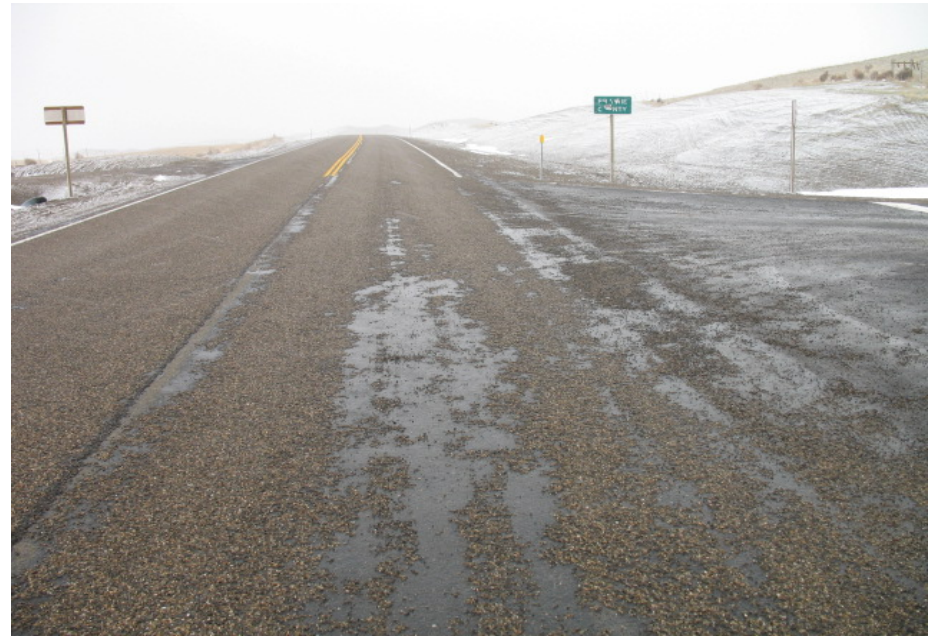
Condition: Cover Material Loss Attributed to Insufficient Embedment Caused From Plant Mix Surfacing Segregation.

- Water Poured on Plant Mix Surface Illustrates Effects of Segregation. Bituminous Materials Will Behave Similarly, Resulting in Insufficient Quantities Remaining on the Plant Mix Surface to Embed Cover Material.
- Segregated Plant Mix Surfacing Sections Should be Identified And Addressed Prior to Seal Coat Application.

- Cover Material Loss Attributed to Plant Mix Surfacing Segregation.
- Per Subsection 409.03.8 Warranty, Submit a Detailed Repair Plan to The Project Manager For Approval Within 14 Calendar Days of Notification of Required Repairs.
- This Condition is Unacceptable And Must be Repaired Prior to Final Acceptance.

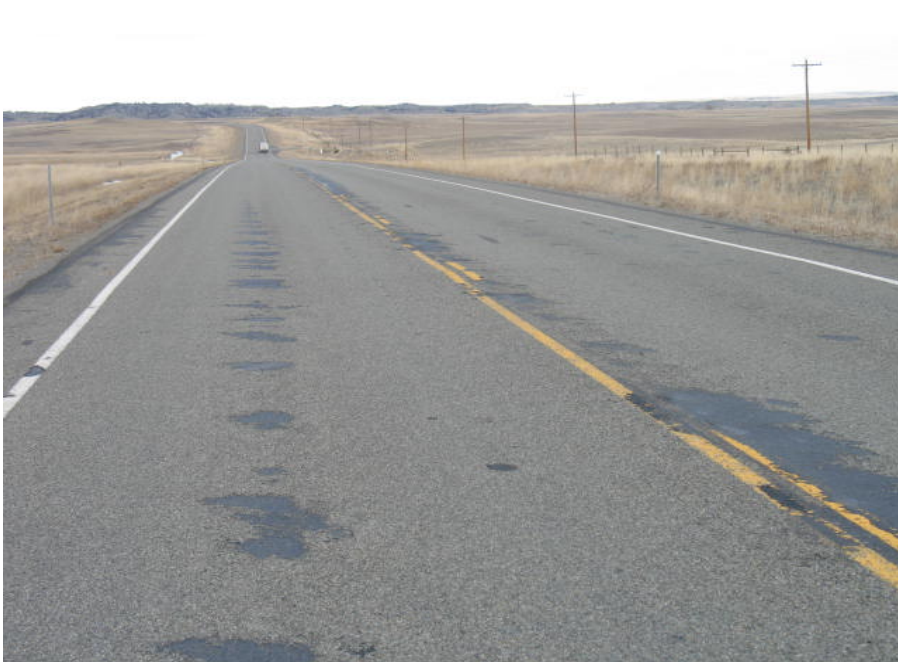
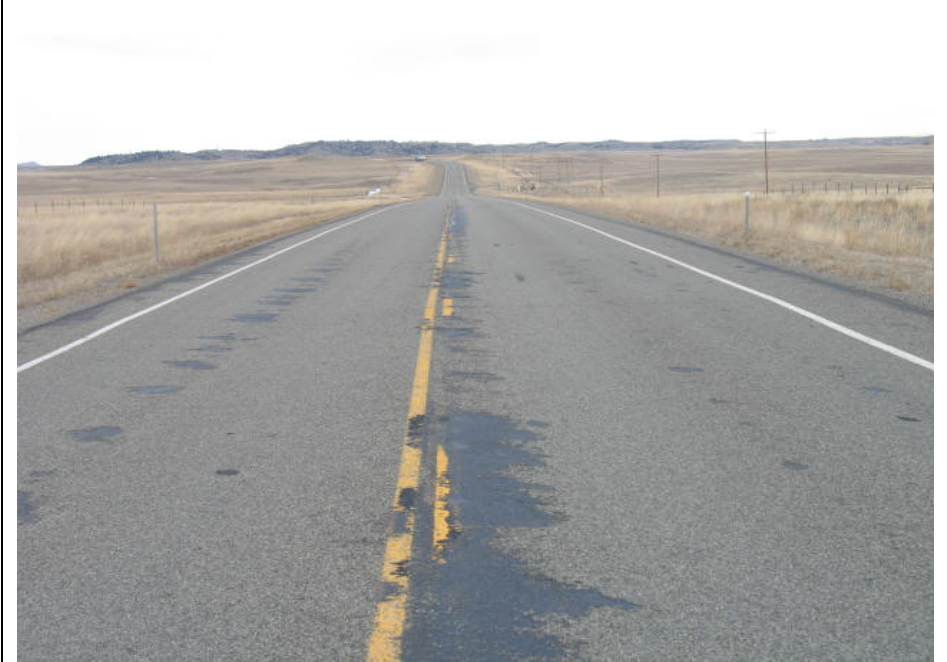
Condition: Cover Material Loss- Snow Plow Damage

- Condition Typically Presents Itself in a Transverse Fashion.
- Accompanied by Tell Tale “Chatter Mark” Effect.
- Damage Typically Located at, or Near, Roadway Crown, Quarter Line, And Shoulder.

- Contributing Factors Include Plant Mix Surfacing Smoothness & Snow Plow Speed.
- Areas Determined as Having Damage Resulting From Snow Plow Activities Are Not Subject to Seal Coat Warranty Provisions.

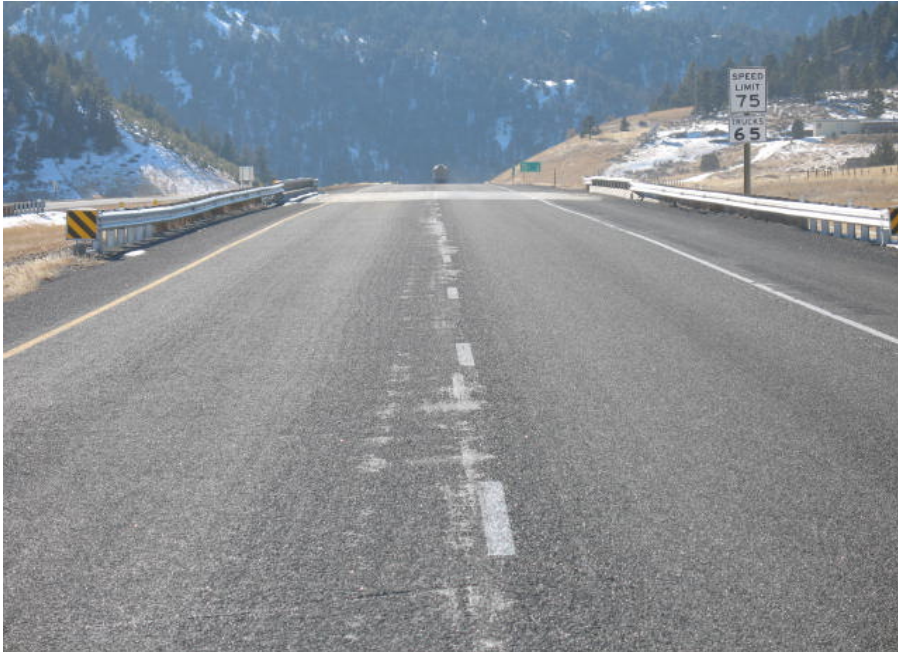
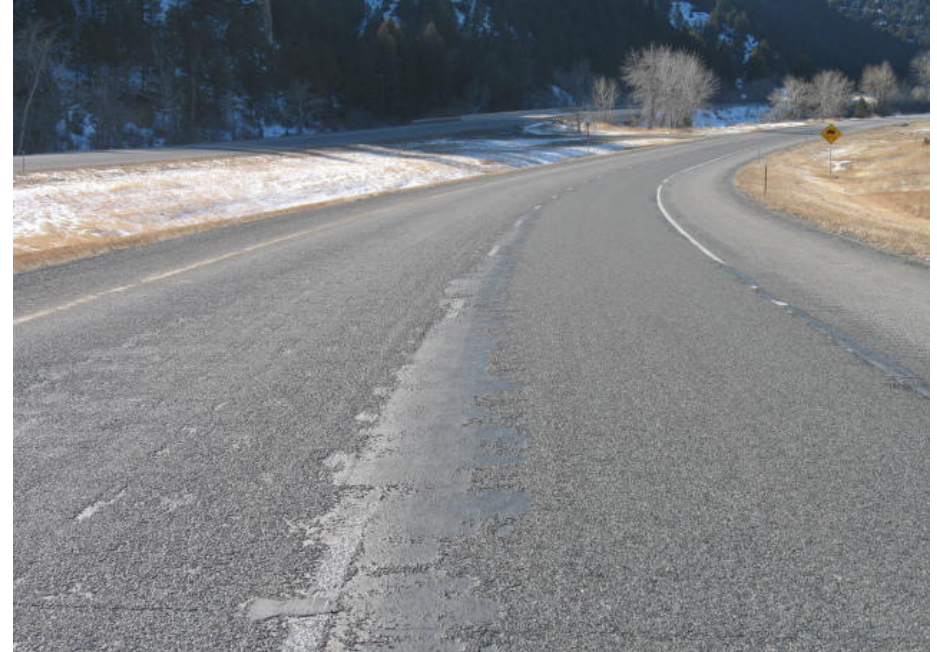
Condition: Cover Material Loss- Snow Plow Damage

- Condition Typically Presents Itself in a Transverse Fashion.
- Accompanied by Tell Tale “Chatter Mark” Effect.
- Damage Typically Located at, or Near, Roadway Crown, Quarter Line, And Shoulder.

- Contributing Factors Include Plant Mix Surfacing Smoothness & Snow Plow Speed.
- Areas Determined as Having Damage Resulting From Snow Plow Activities Are Not Subject to Seal Coat Warranty Provisions.

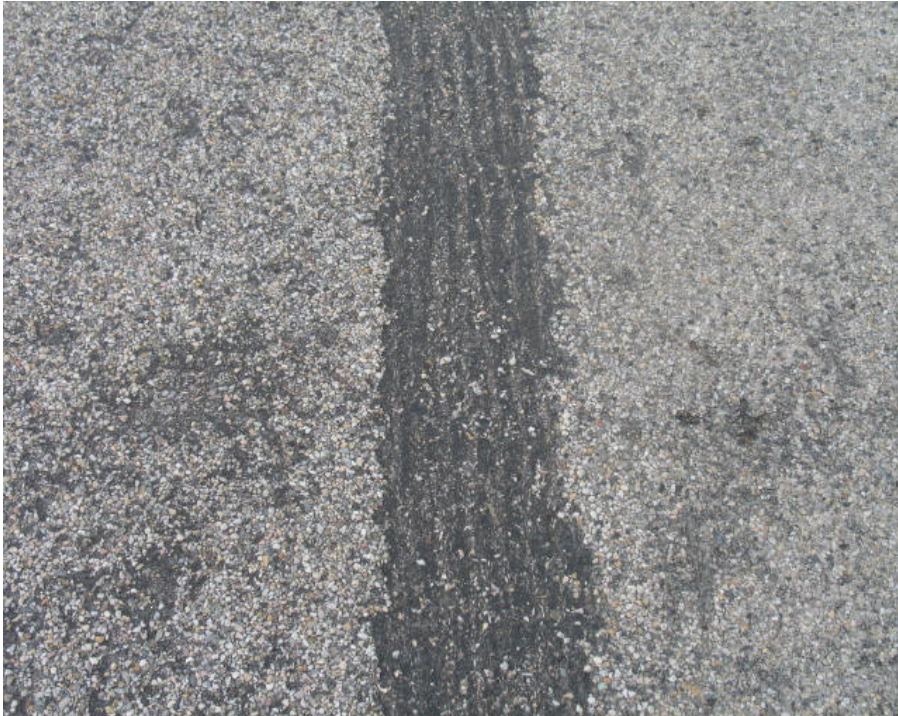
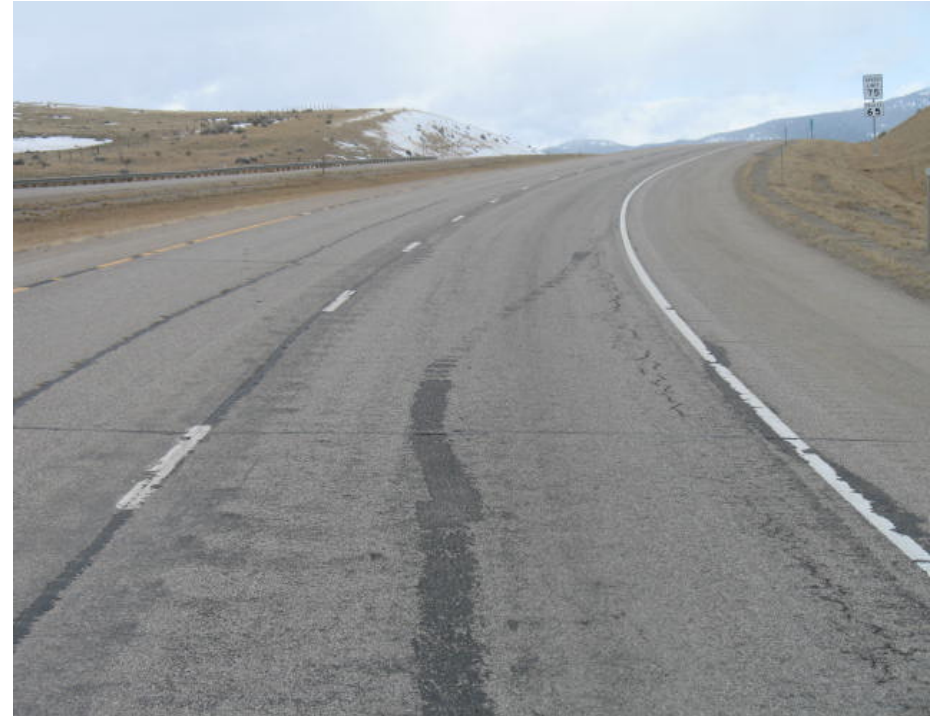
Condition: Cover Material Loss- Tire Chain Damage

- Condition Typically Present in Steep Grade Sections.
- Grooved Surface Texture Shown Indicates Damage Induced by “V Bar” Style Tire Chain.

- Areas Determined as Having Damage Resulting From Tire Chains Are Not Subject to Seal Coat Warranty Provisions.
