#### Montana Department of Transportation Research Programs November 2013

#### **EXPERIMENTAL PROJECTS INSTALLATION REPORT**

### TAPCO (BLINKERBEAM/BLINKSYNC) BLINKERCHEVRON TRAFFIC CONTROL SIGNAGE

| Location: | MT Highway 41 (P-49) Reference Point 14.3; Madison<br>County: Butte District |
|---|--|
| Project Name: | Curve Near Beaverhead Rock |

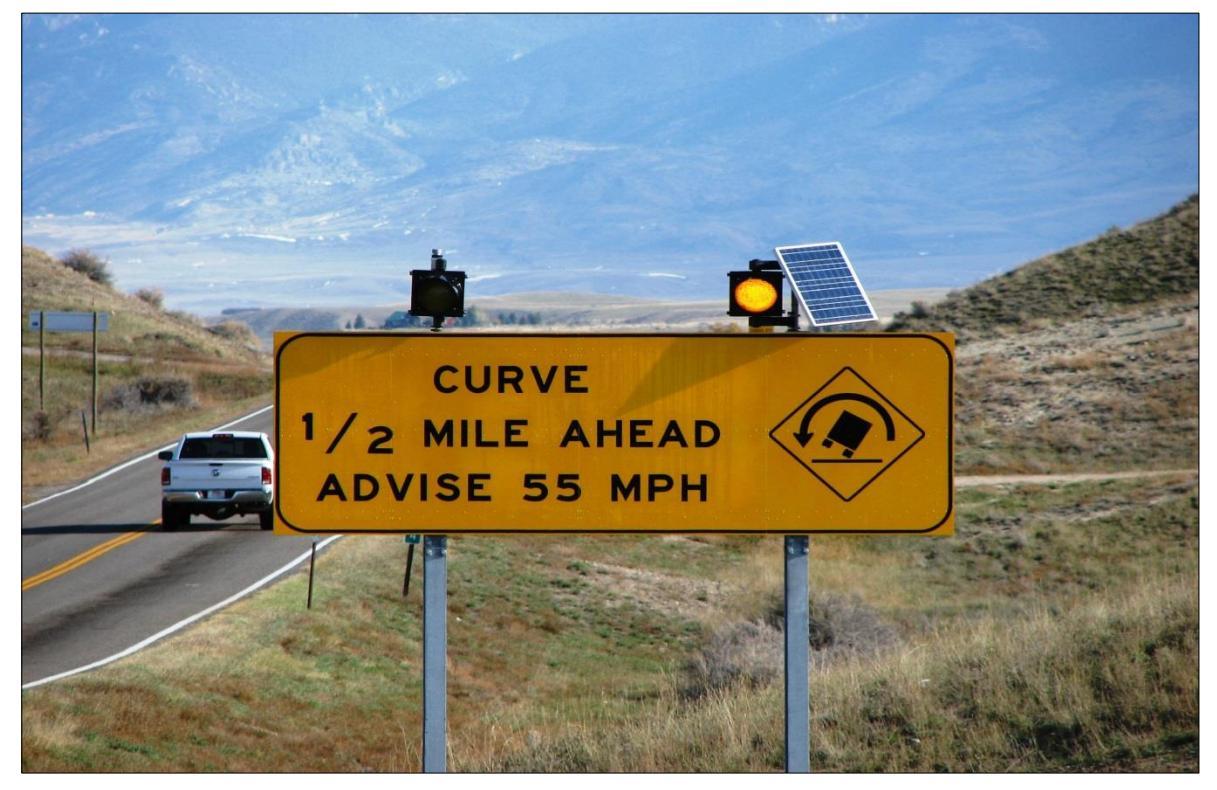
The issue with the LED chevron appears to have been a defective battery which had to be replaced twice within a period of 1 month. The solar panel used in the approach warning signs were low-wattage models and were not adequately charging the batteries which supply power to the dual LED units. Subsequently larger solar capacity panels were installed and (to date) have corrected the problem.

✤ Northbound (identical to the southbound approach) completed dual flasher warning sign with the larger wattage solar panel replaced in October.

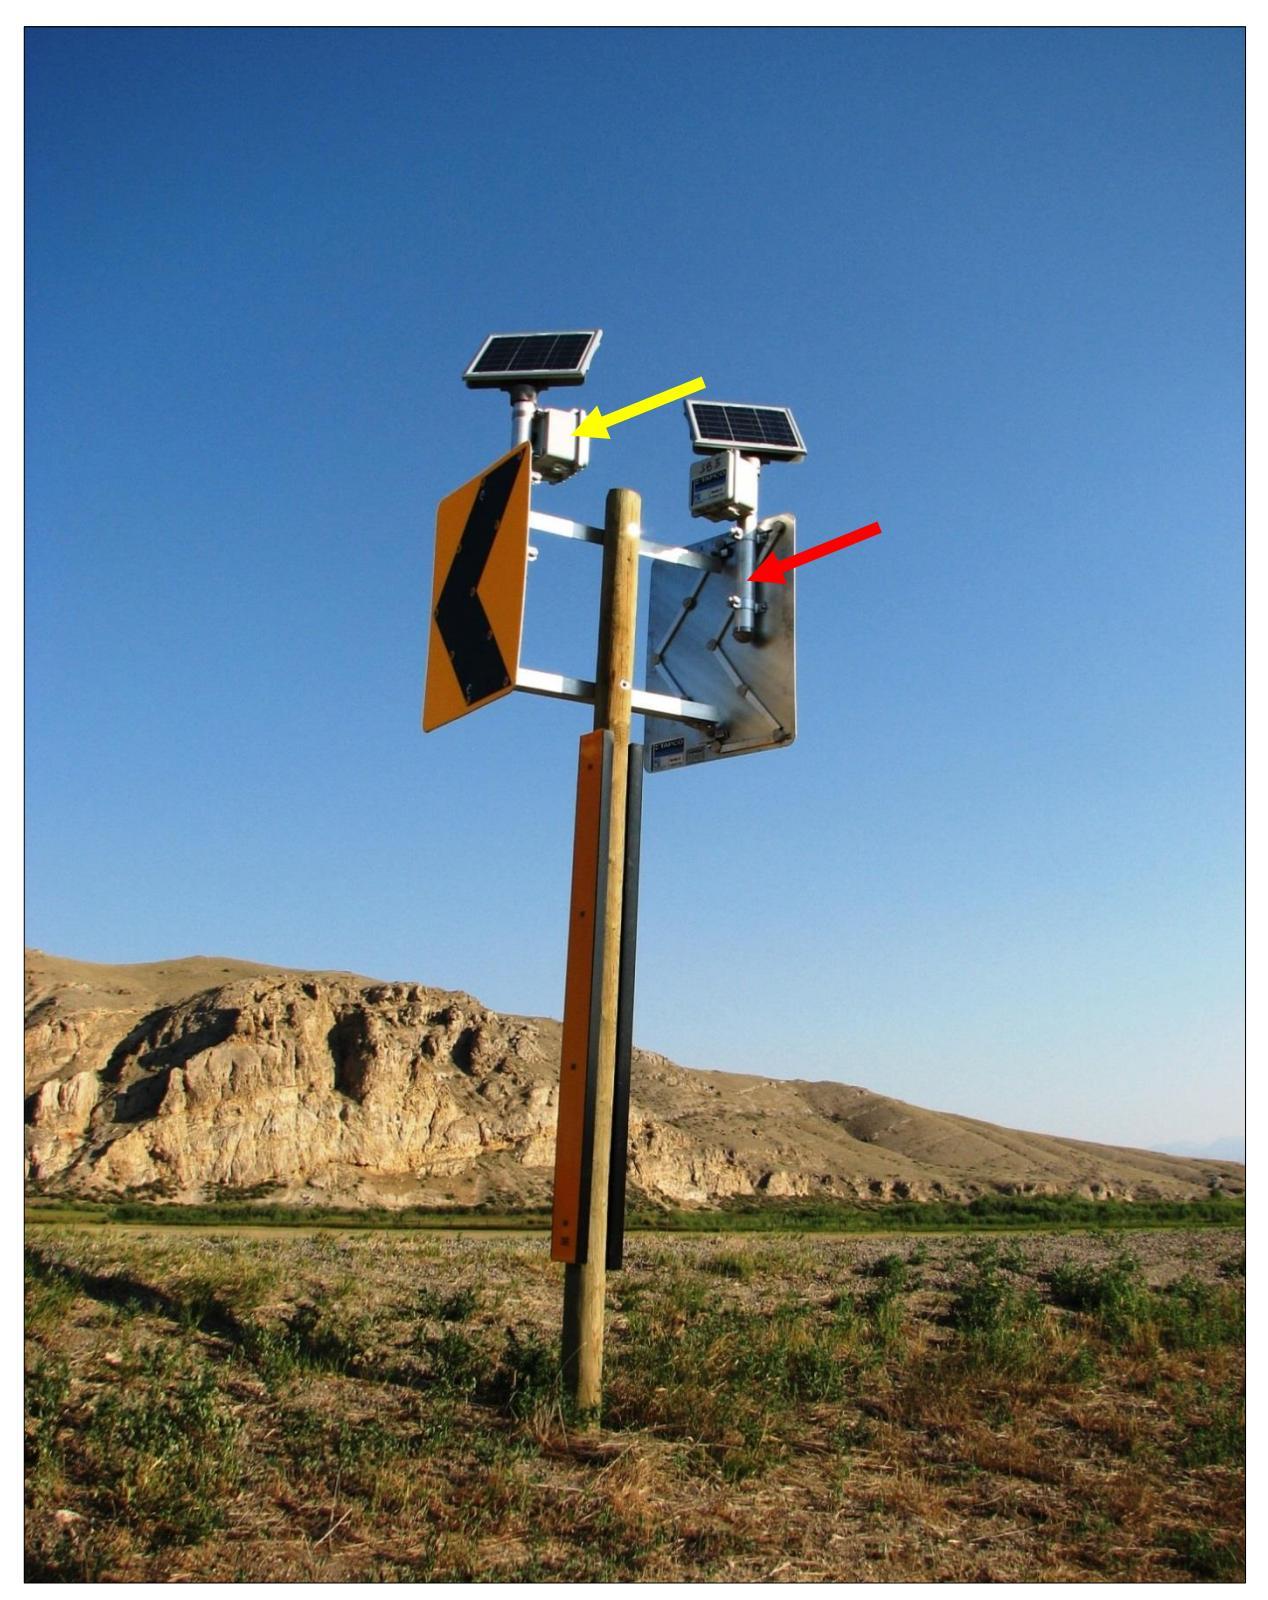
In a minor issue the dual chevron slave units (per post) are presently using one solar panel per individual chevron (refer to page 9); manufacturer specifications were to only have one (larger-wattage panel) to provide battery charge and power to both chevron units. Per consultation with District personnel and the vendor it was determined the currently installed panels will be adequate to supply sufficient charge to maintain functioning NiHM battery power.

↑ One of the six dual BlinkerChevron's installed on site. The chevron components are fixed on a four (4) inch post with added reflector panels. Each individual LED chevron has its own solar panel and slave radio control unit (yellow arrow). As in the advance signal master control, the NiMH battery is located in the tube bracket (red arrow).

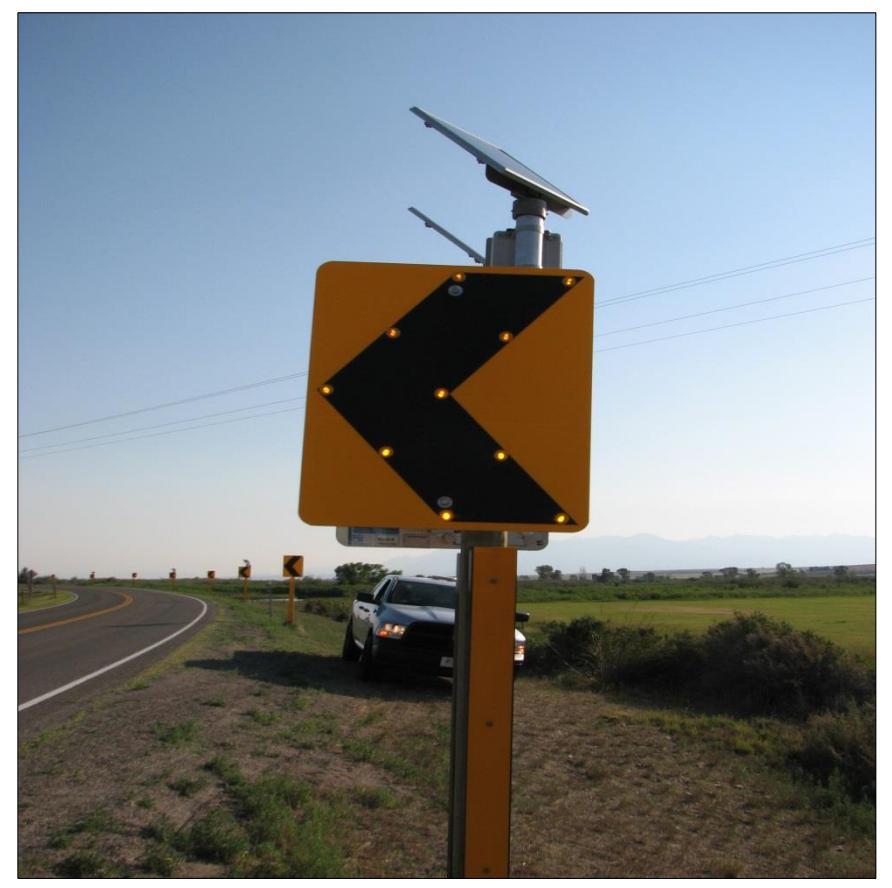
← Side view of the BlinkerChevron unit under activation. There are ten (10) high-intensity LED's per each panel.

The LED panels (upon inspection during activation) required to be angled correctly for maximum visual illumination to oncoming traffic.

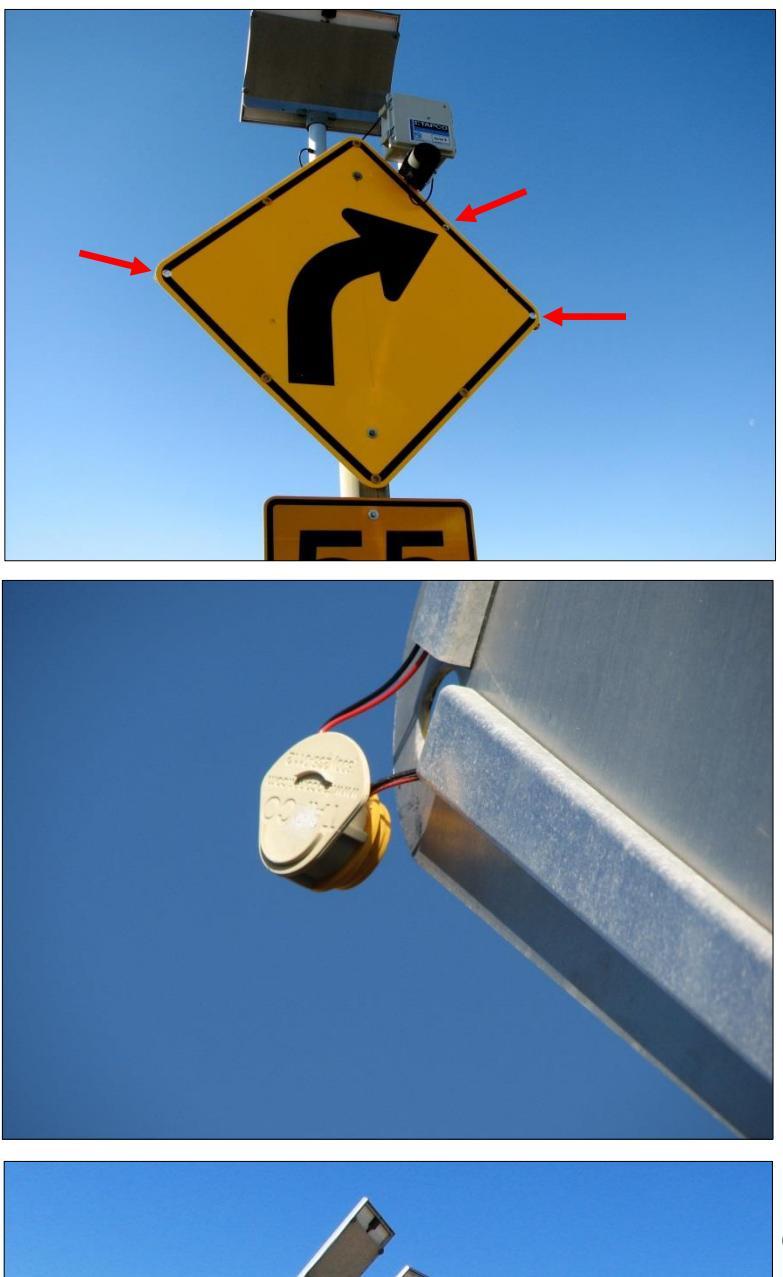
# June 2016 Site Inspection

In addition, it has been documented that several of the LED units have become loose in their brackets and pulled away from the chevron sheet attached only by wires (see page 11); it is unsure if this is from vibration by wind or environmental factors such as freeze thaw or weakening of bracket material.

← ♥ Representative images of the LED lamps that have pulled away from the chevron sheet bracket (red arrows).

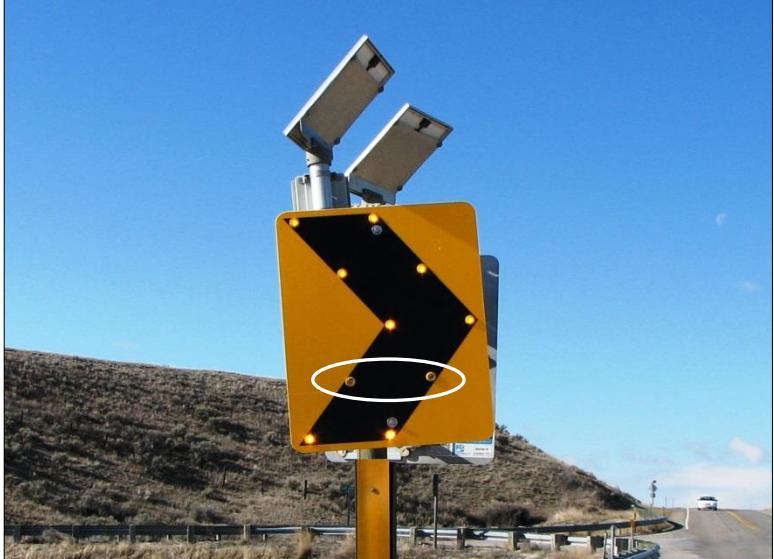
In addition, several of the individual LED elements are no longer working. Currently, these operating issues are small in number at this time. Additional monitoring will determine if this trend continues.

← It was noticed that several of the LED lamps were no longer activating (white circle).
