Montana Department of Transportation Wetland Mitigation Monitoring Report

SCHRIEBER MEADOWS MITIGATION SITE

Monitoring Year: 2023

Years Monitored: 13th year of monitoring.

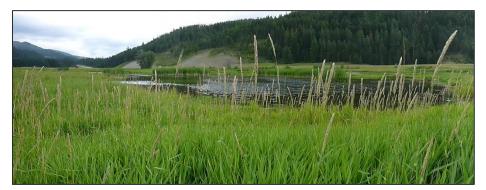
Photo Point 10; Location: Cell 3; Bearing 0 degrees; Year 2023

Many fish observed in Cell 3.

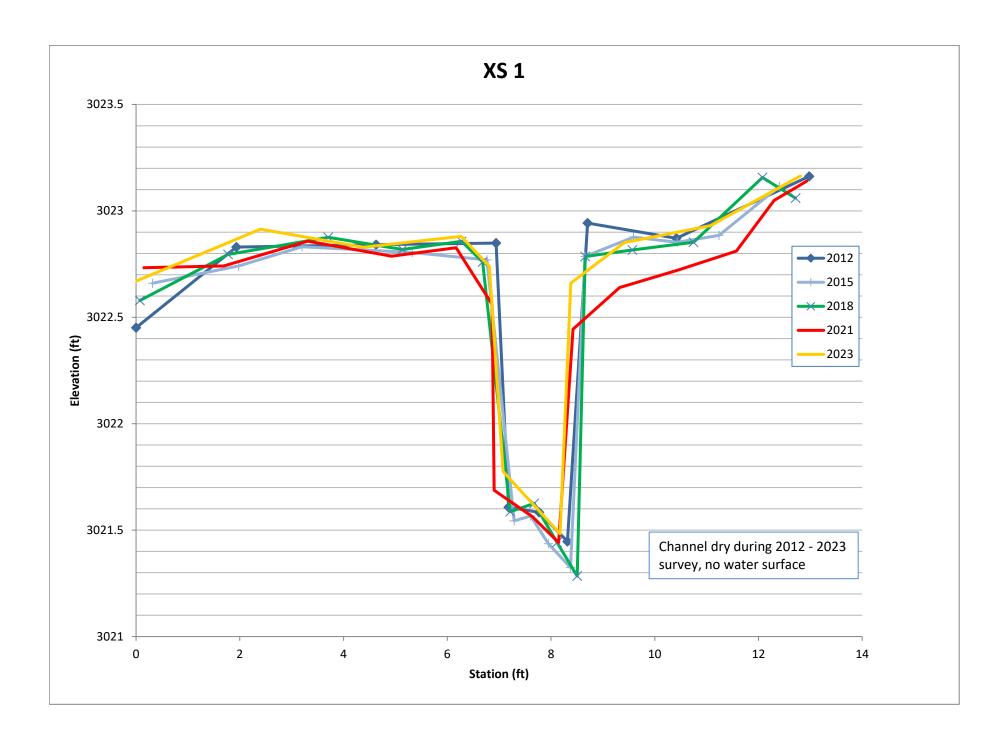
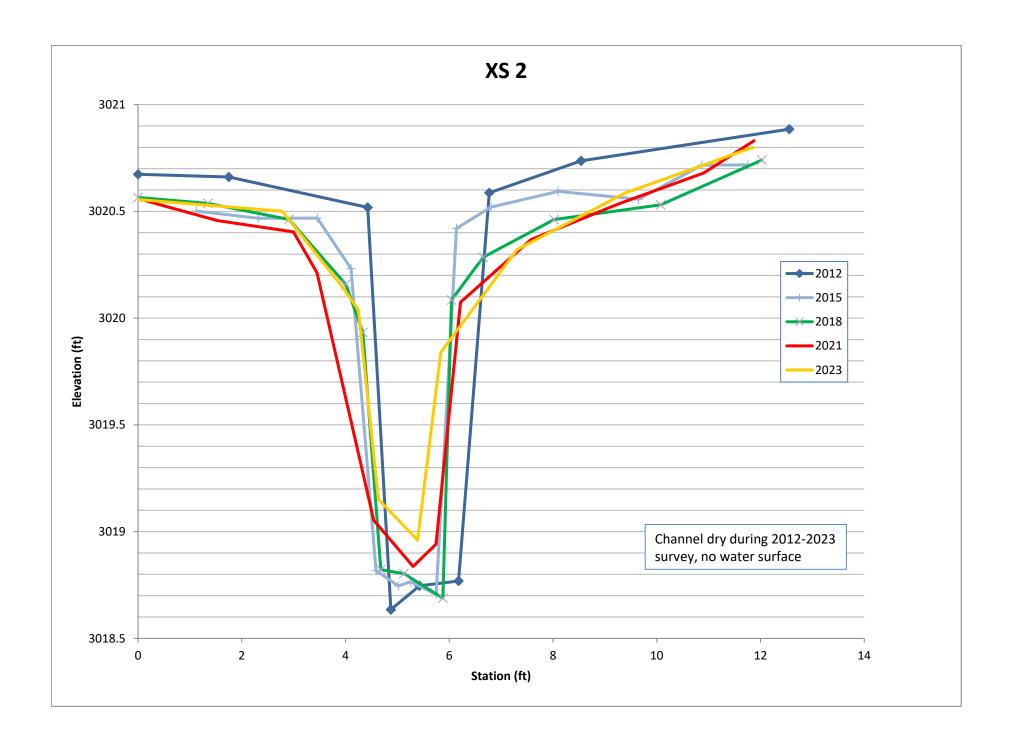
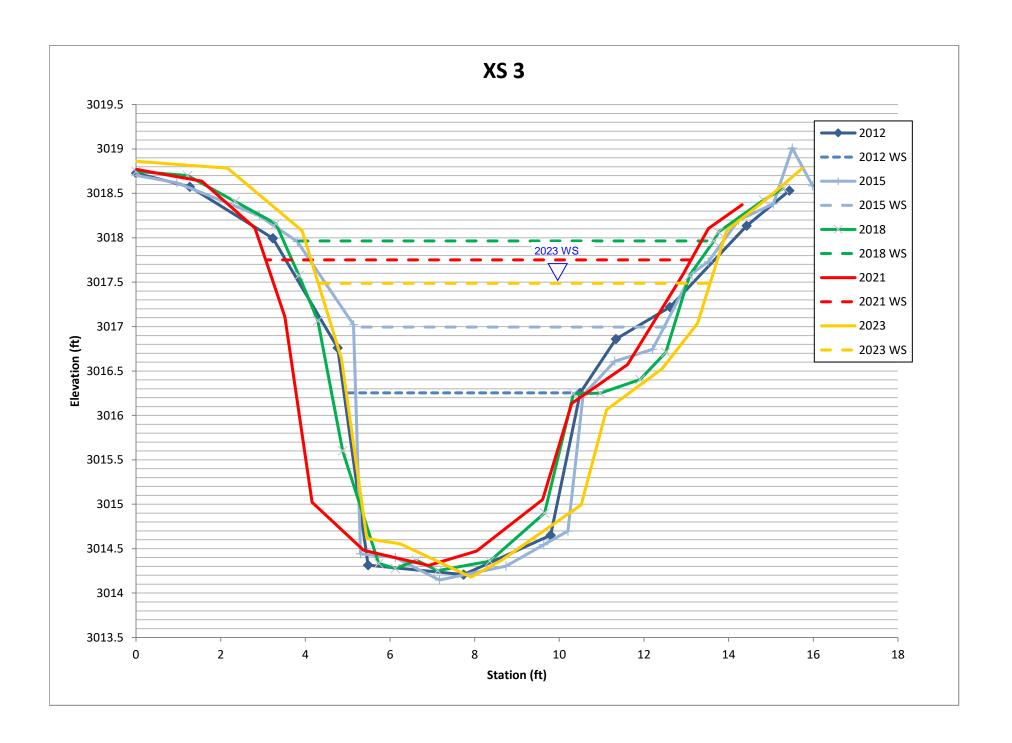
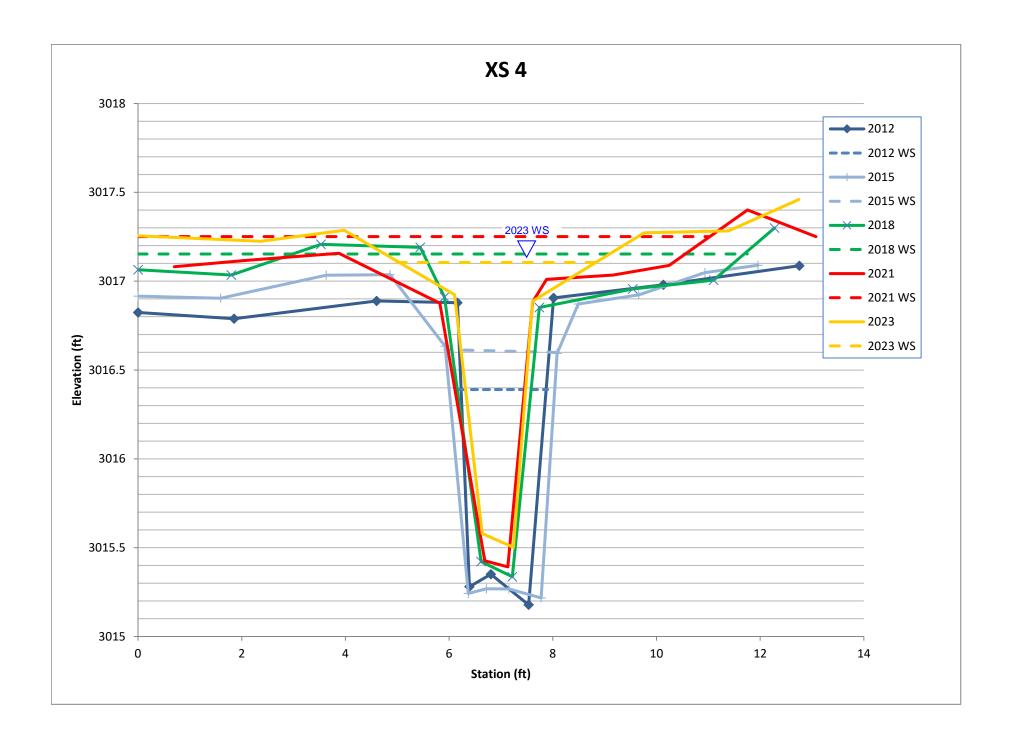
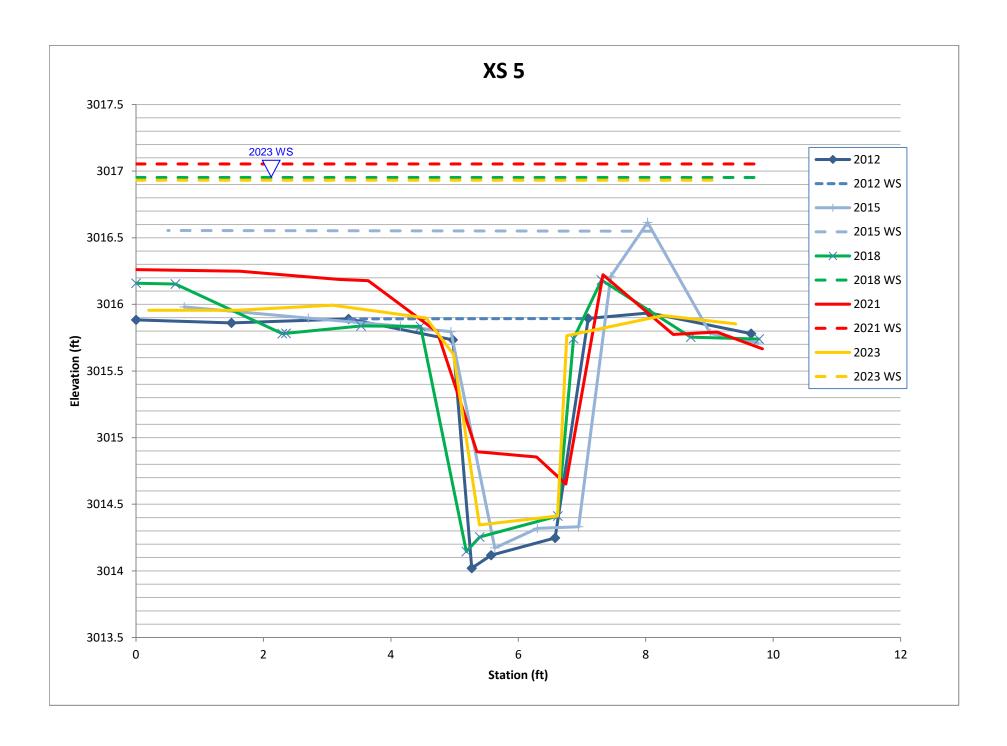
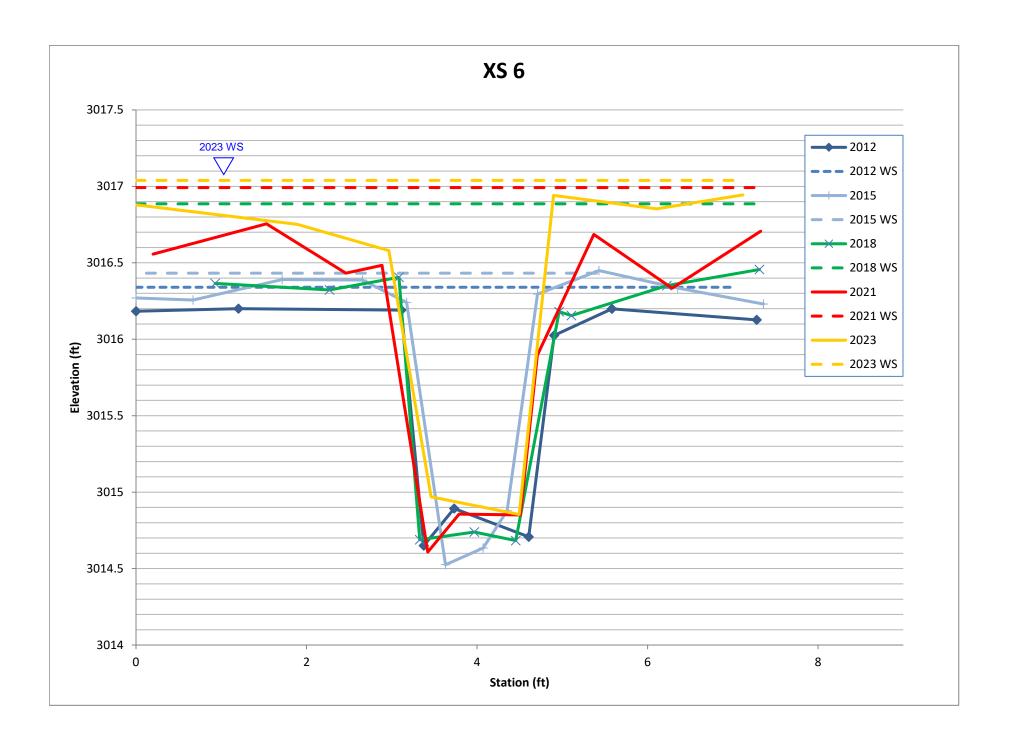
APPENDIX D Surveyed Stream Cross Sections

compared to the previous surveys and discussions to assess stream channel stability. Generally, the constructed channel's banks were well-vegetated and exhibited stable conditions. Consequently, no major channel morphological changes have been observed throughout the monitoring years.
