**Experimental Feature Evaluation  
December 2022**

<b>Experimental Feature:</b>	Zapcrete Electrified Wildlife Deterrent Mat
<b>Location:</b>	Missoula District, Sanders County, MT Hwy 200, RP 56.4 – 59.1
<b>MDT Project Name:</b>	East of Thompson River – East
<b>MDT Project Number:</b>	STPP 6-1(123)57[4039]
<b>Experimental Project Number:</b>	MT-20-01
<b>Principle Investigator:</b>	Chad DeAustin, Experimental Project Manager, (ExPM)
<b>Technical Contact:</b>	Aaron Mason, Bill Semmens, Deb Wambach
<b>Construction Date:</b>	October 2019
<b>Date of Inspections:</b>	May 2020, September 2021, July 2022

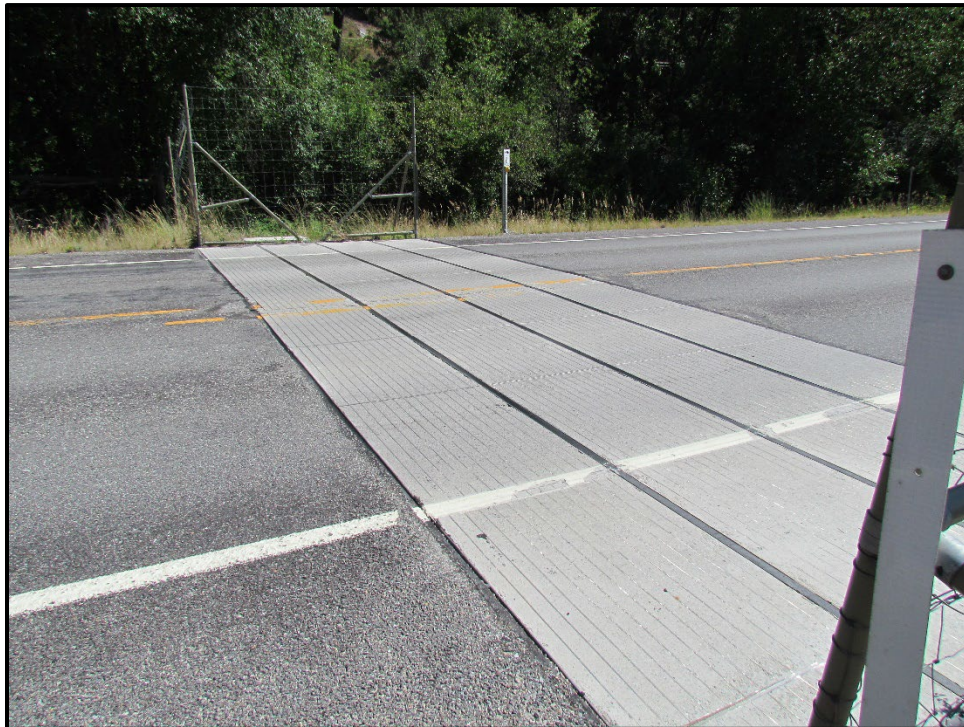
↑ East EWDM, transverse view. The EWDM in this location remains in good condition and operational.

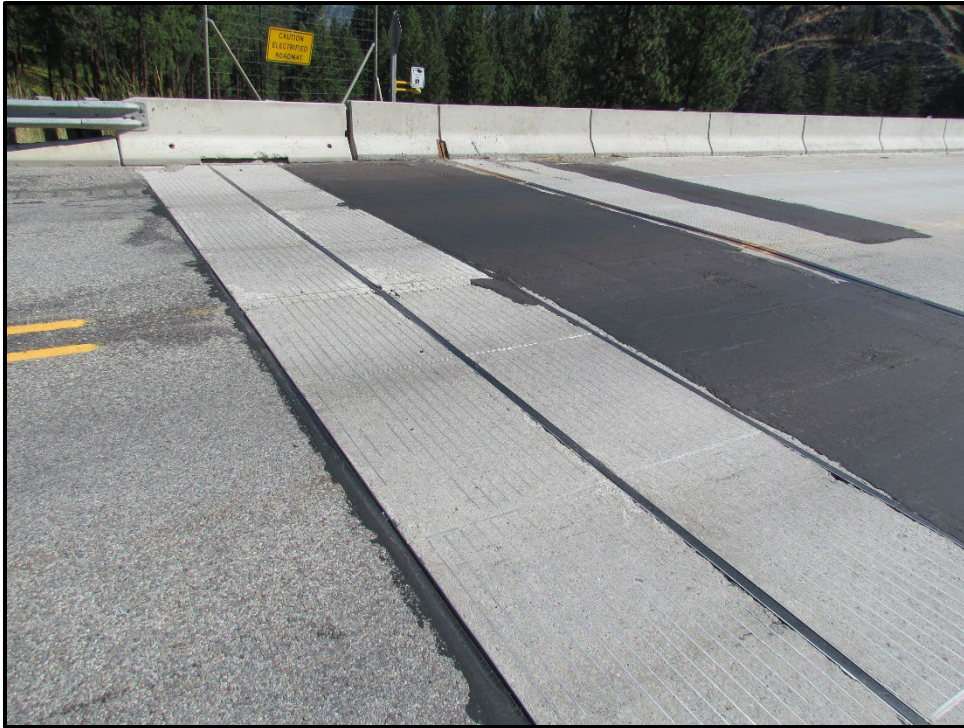
In 2021, damage was observed by MDT maintenance to the west EWDM at the Thompson River bridge. MDT maintenance placed mastic over approximately half of the mat. This also helped mitigate the transition from the bridge to pavement. The east EWDM is still in good condition and operating correctly.

↑ West EWDM, transverse view. After the 2021 site visit, discussions were had about what to do with the damaged EWDM. Ultimately it was decided to replace the EWDM in a location approximately 50' west of the bridge end. To mitigate issues until replacement MDT Maintenance placed mastic over the damage to maintain safe crossing for vehicles.

After the 2021 site visit, the damage to the west EWDM was discussed at great lengths by MDT staff and it was determined that the mat needed replacement. The investment and importance of an operational EWDM were crucial evidence in deciding to replace the mat. MDT Missoula Maintenance staff was aware of the damage and as soon as Missoula Administration and Engineering staff were notified, plans were put into progress to begin design of a replacement mat. MDT determined that the mat would be more resistant to similar damage if it was moved away from the bridge end a minimum of 50'. Currently MDT Missoula District staff is working to coordinate plans to complete the needed repair work.

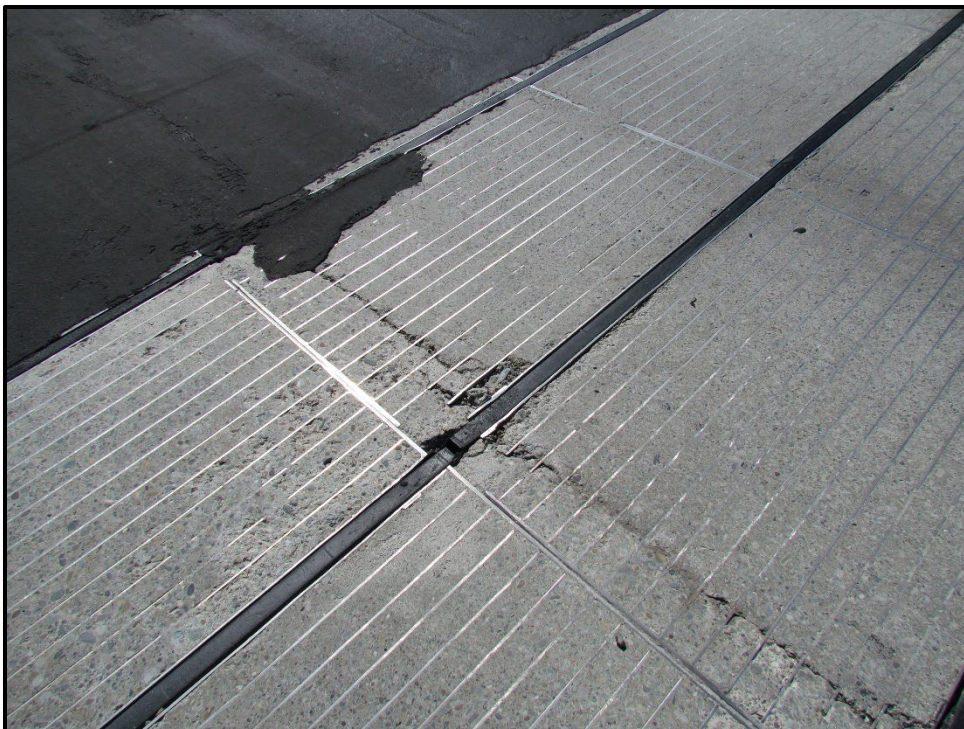
↑ West EWDM, close-up view. Damage at the concrete seam continues to worsen.

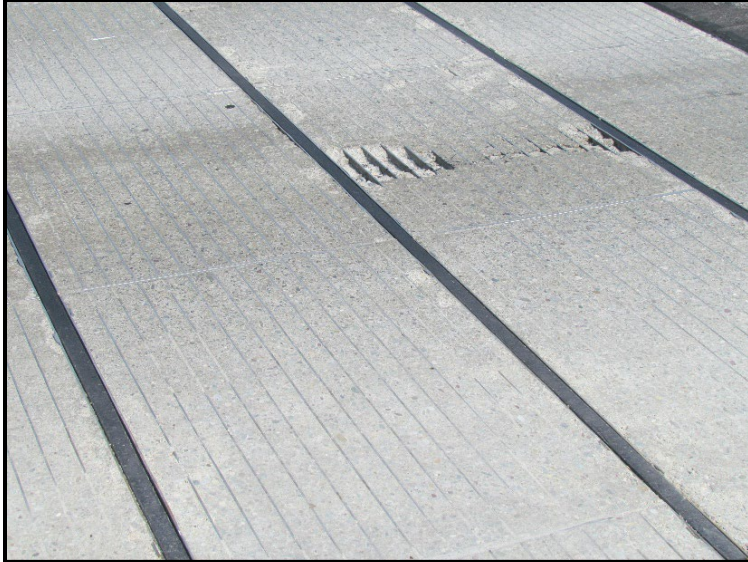
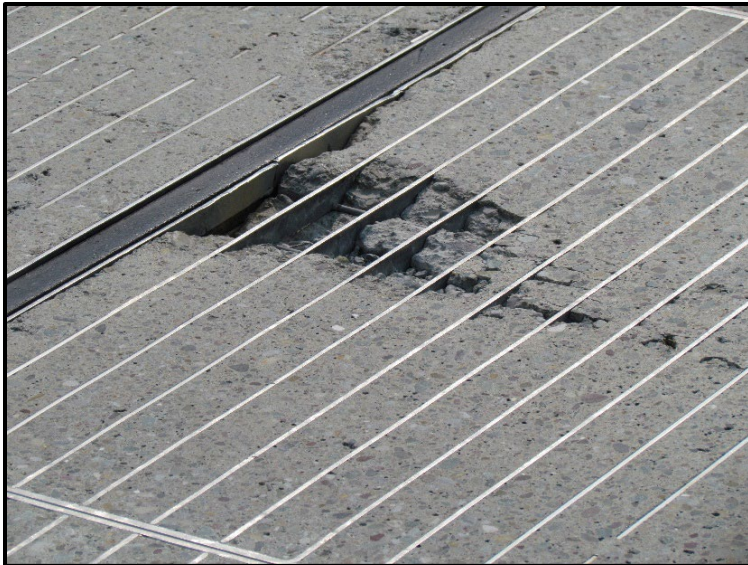
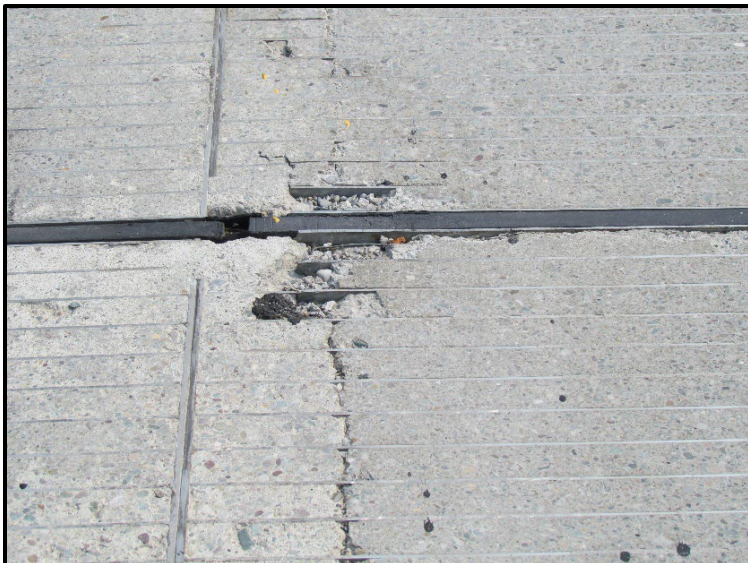
↙↓ West EWDM, close-ups prior to mastic application of the damage to the concrete. These issues were escalated to concerned parties.

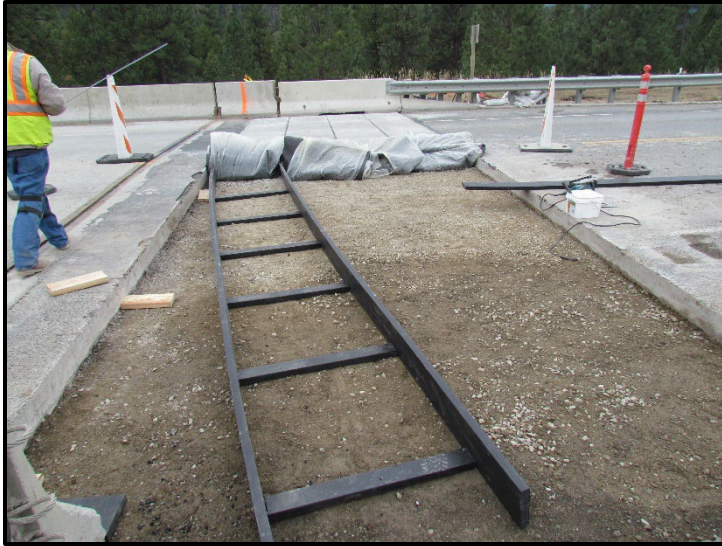
◀ West EWDM installation at the Thompson River bridge end. The plant mix was saw cut and removed for EWDM work. Seen here the metal grid is being placed with the insulation material to follow.

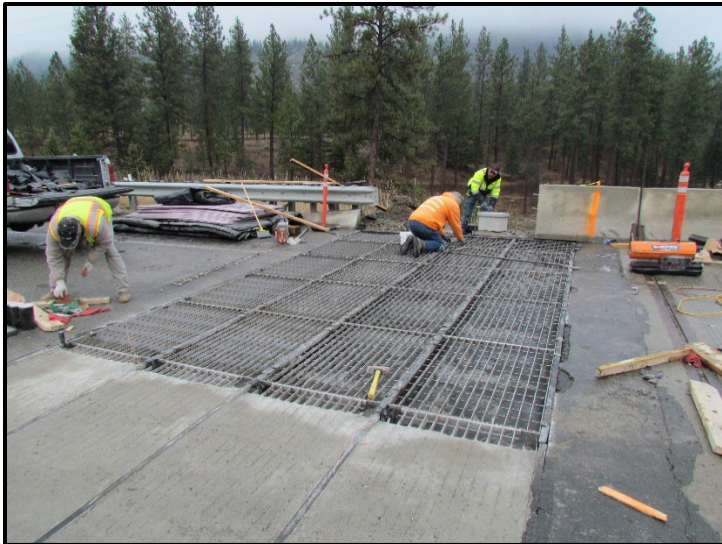
◀ CrossTek laborers are installing the grid and wiring between the panels. After all the wiring is completed, the mat is ready for concrete.

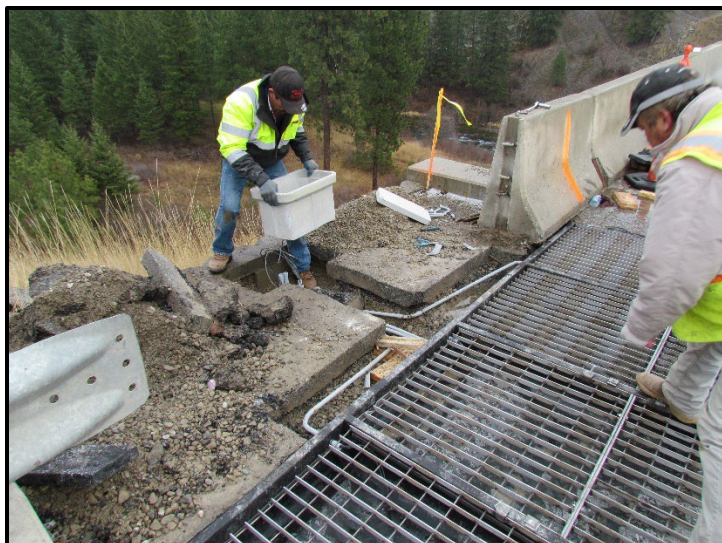
◀ The junction box installation is seen here. The box is in the wing wall and is easily accessible if there are repairs needed.

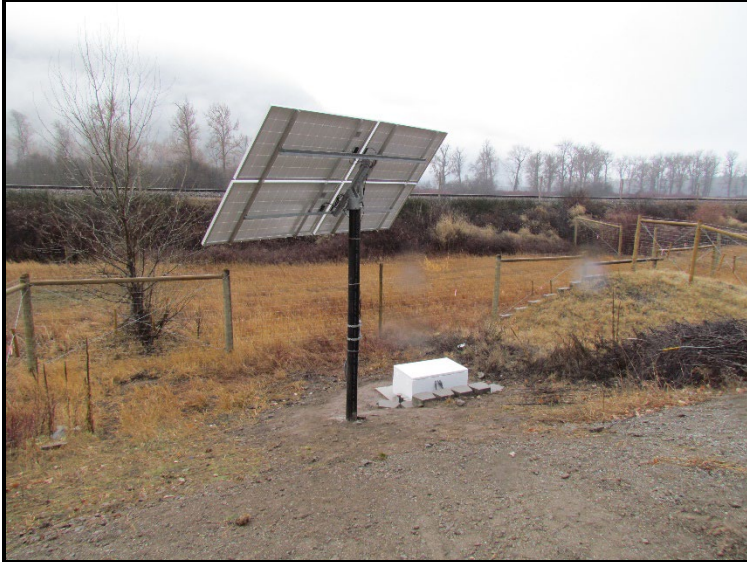
← The EWDMs are solar powered and there are batteries stored in the control box for supplying the electric current.

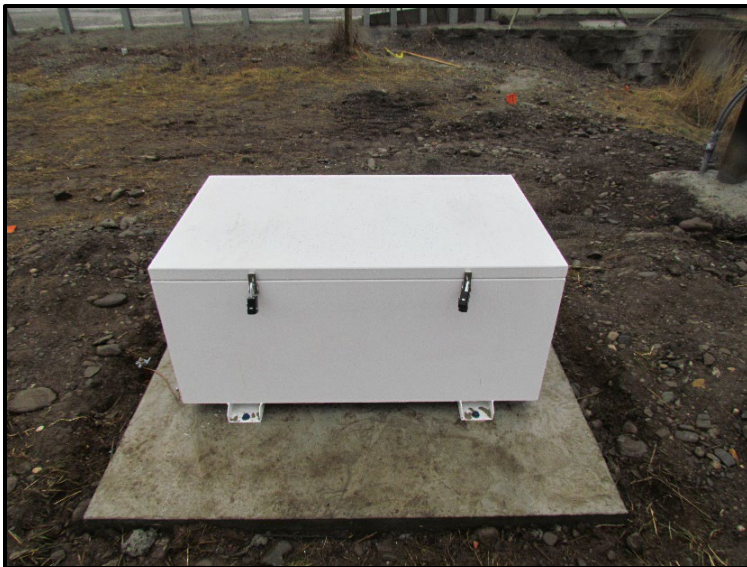
← Close-up view of the control box. Both are locked to prevent tampering or injury.

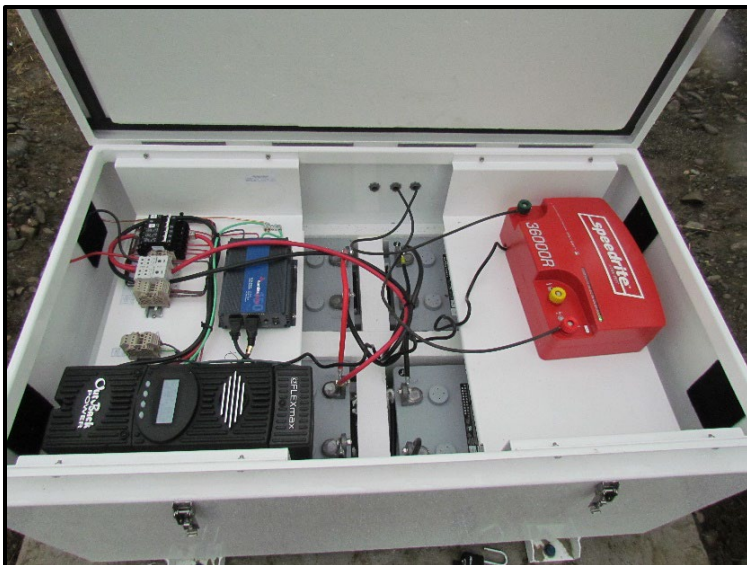
← View of the interior of the control box. There is a meter reading device that is used to monitor and adjust the electric current running through the EWDM.

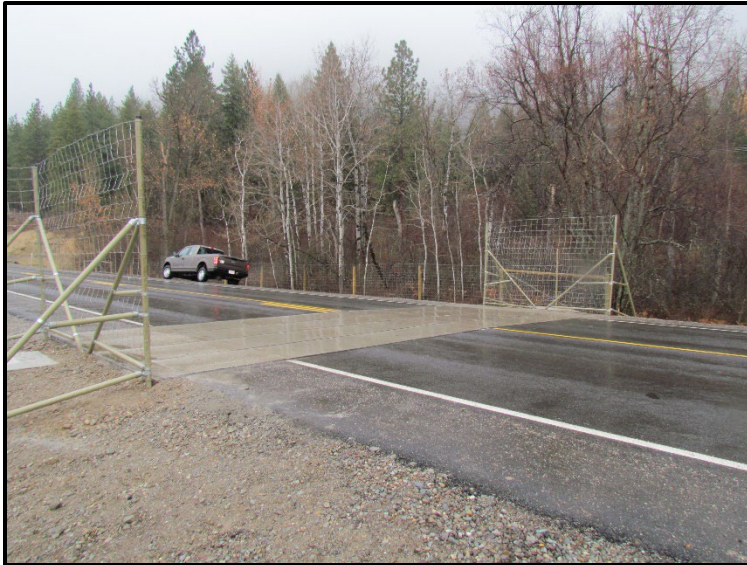
← View of the east EWDM that highlights how the wildlife fencing is used to fully restrict animal access to the wildlife free zone.

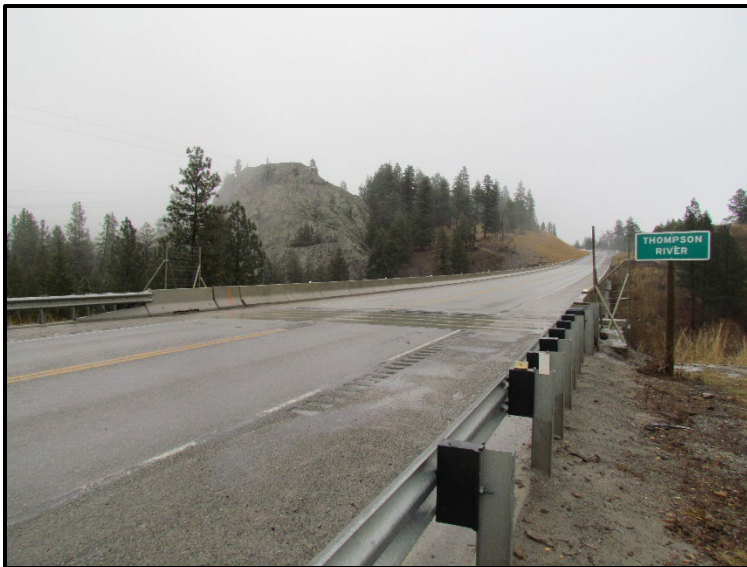
← View of fencing set up at the west EWDM. The main difference here is the use of the bridge as another form of deterrent. Because of this there only needed to be fencing panels on the wing walls.

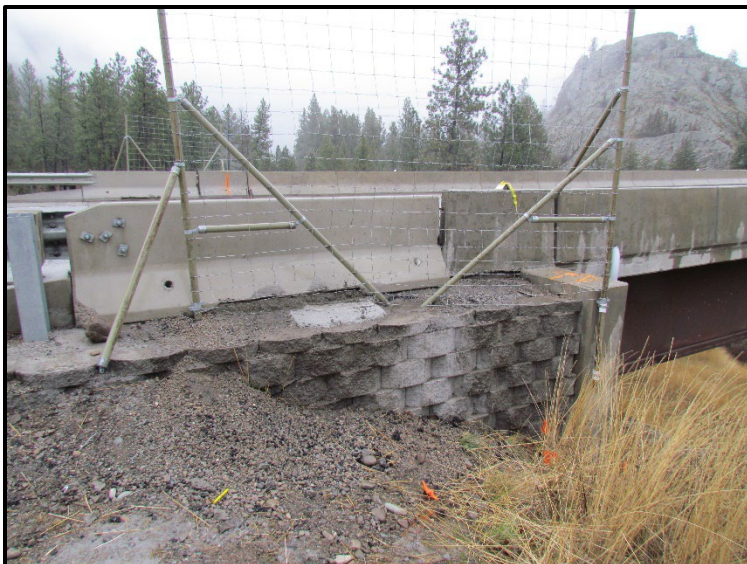
← View of the fencing anchored to the wing wall which in tandem with the west EWDM restricts animals from accessing the wildlife free zone by using the wing walls to bypass the EWDM.

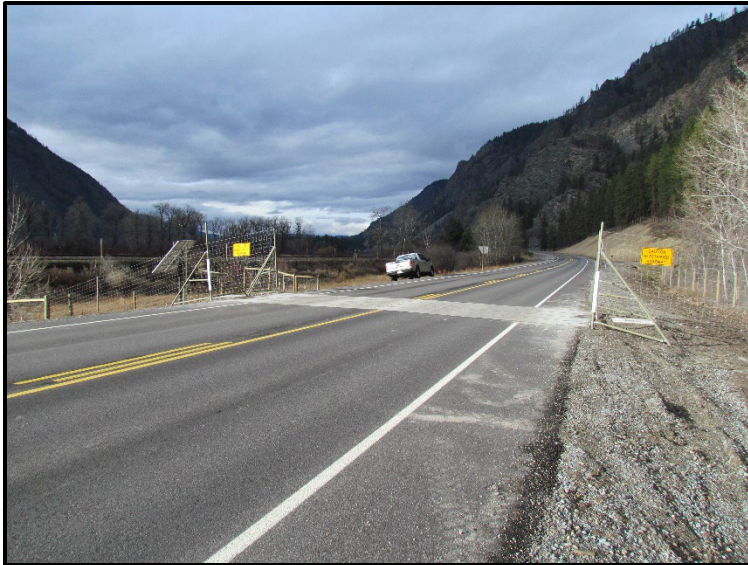
← View west of the east EWDM with fencing installed.

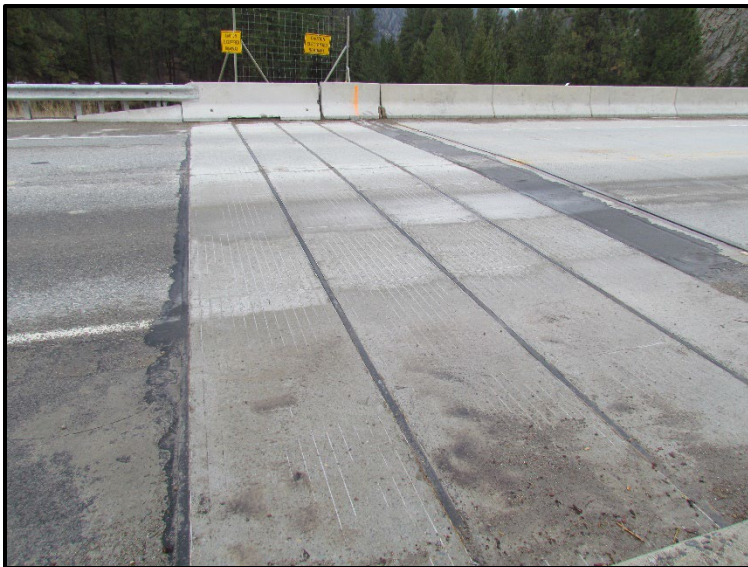
← Transverse view of the west EWDM at the end of Thompson River bridge.

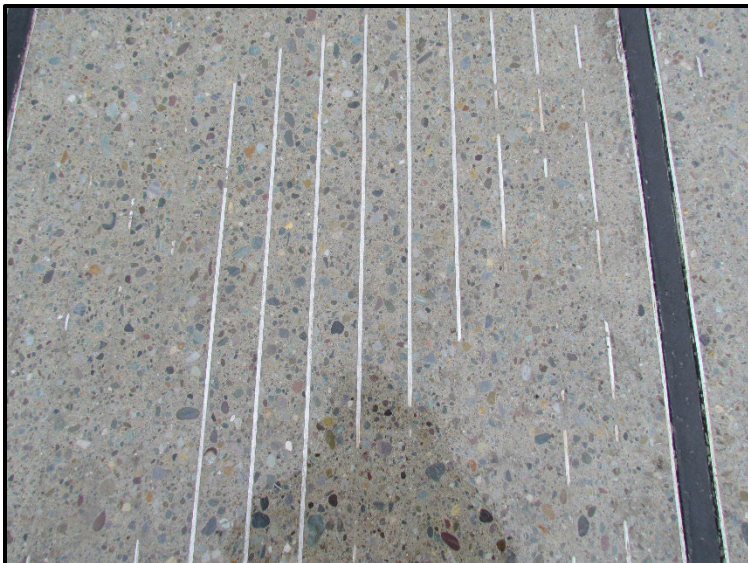
← Close up of the surface of the EWDM showing the exposed electrical grid after concrete grinding.
