EVALUATION OF GEORIDGE PERMEABLE PLASTIC BERM FOR EROSION AND SEDIMENT CONTROL (INFORMAL)

Evaluation Report

Project name: Epsie-East & West

Project Number: NH 37-3(11)85

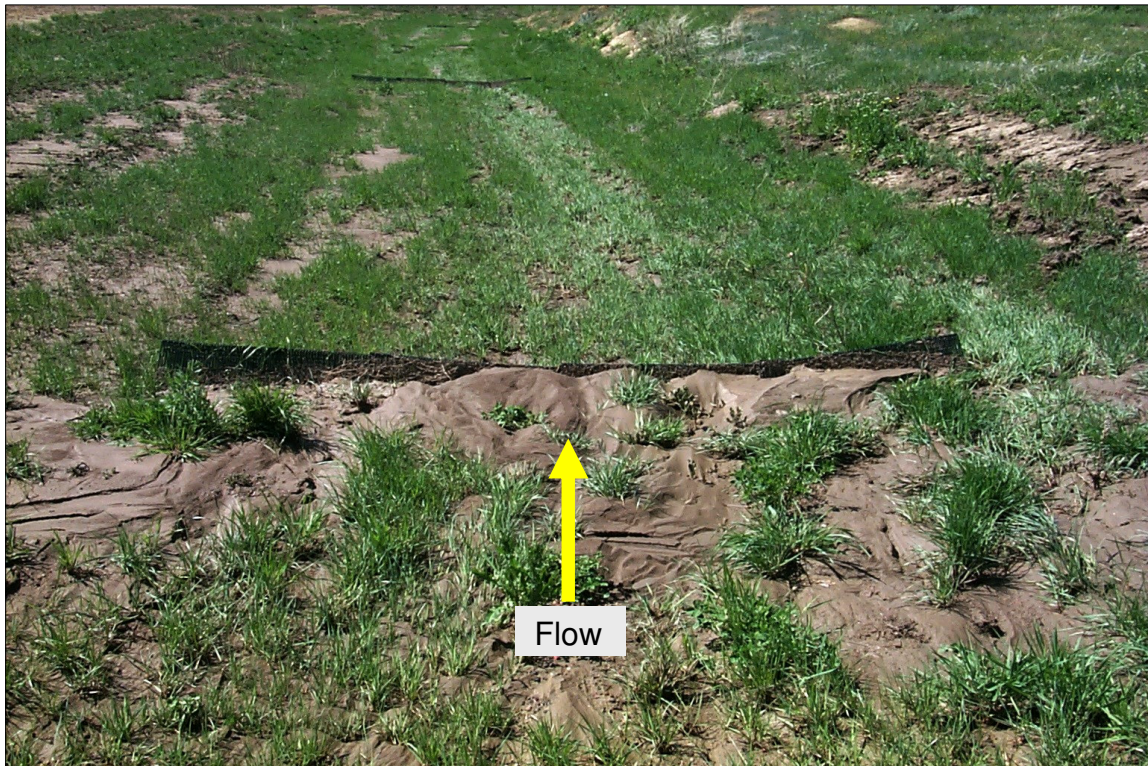
June 2007: A good example of the effectiveness of the durable PPB. Note how the sediment is deposited on the upstream side of the berm allowing vegetation to establish on the downstream side.

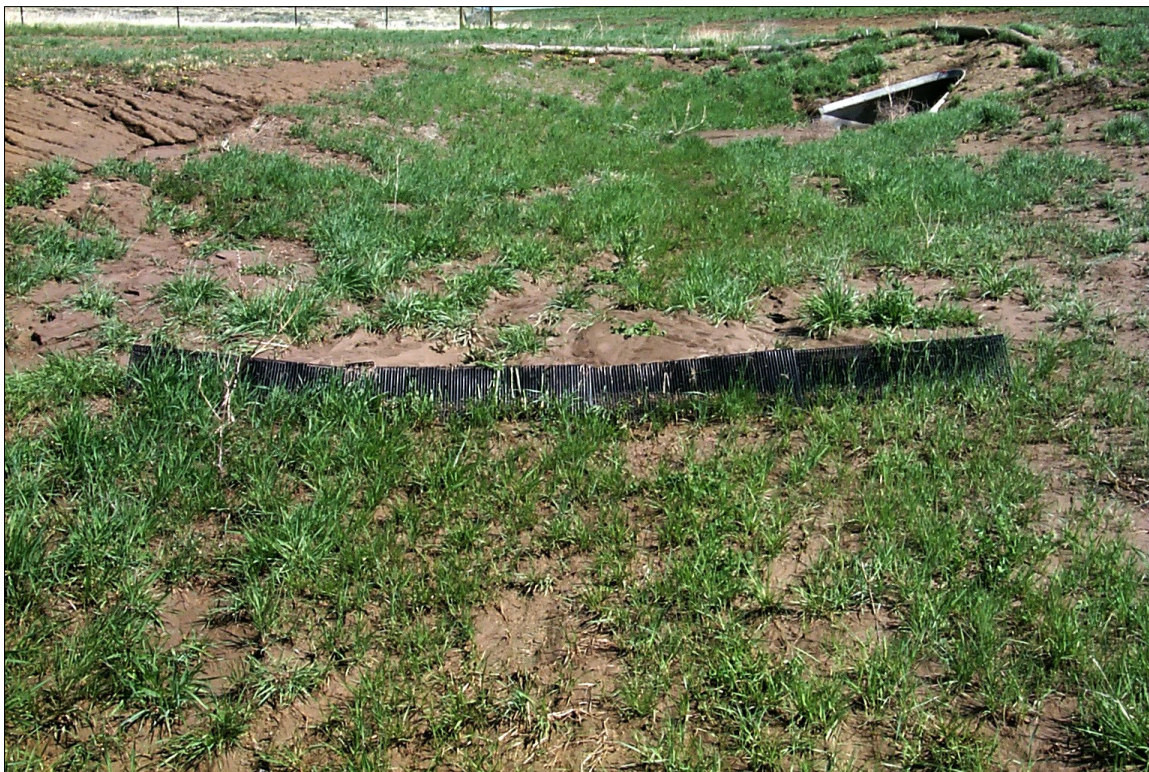
June 2007: Same image as previous with the view of the PPB from the downstream side.

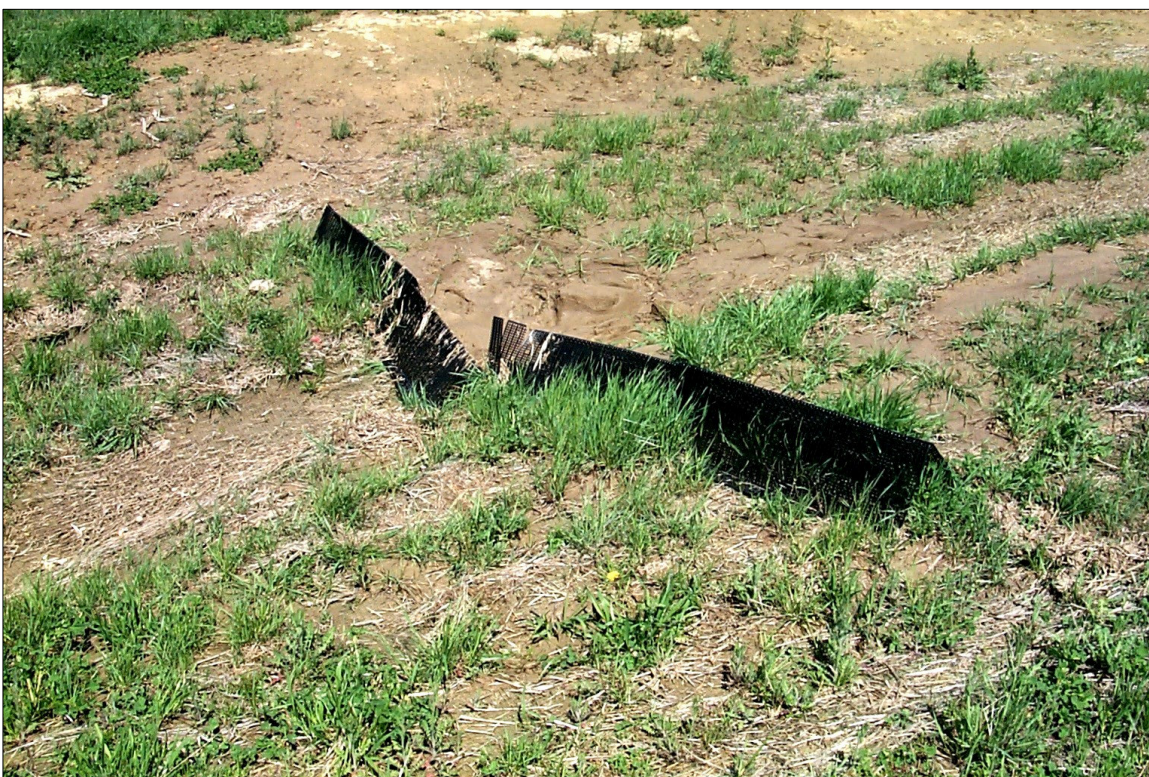
June 2007: Above image shows break in the PPB section either due to improper installation or a significant hydraulic event. However the device appears to be functioning nominally.

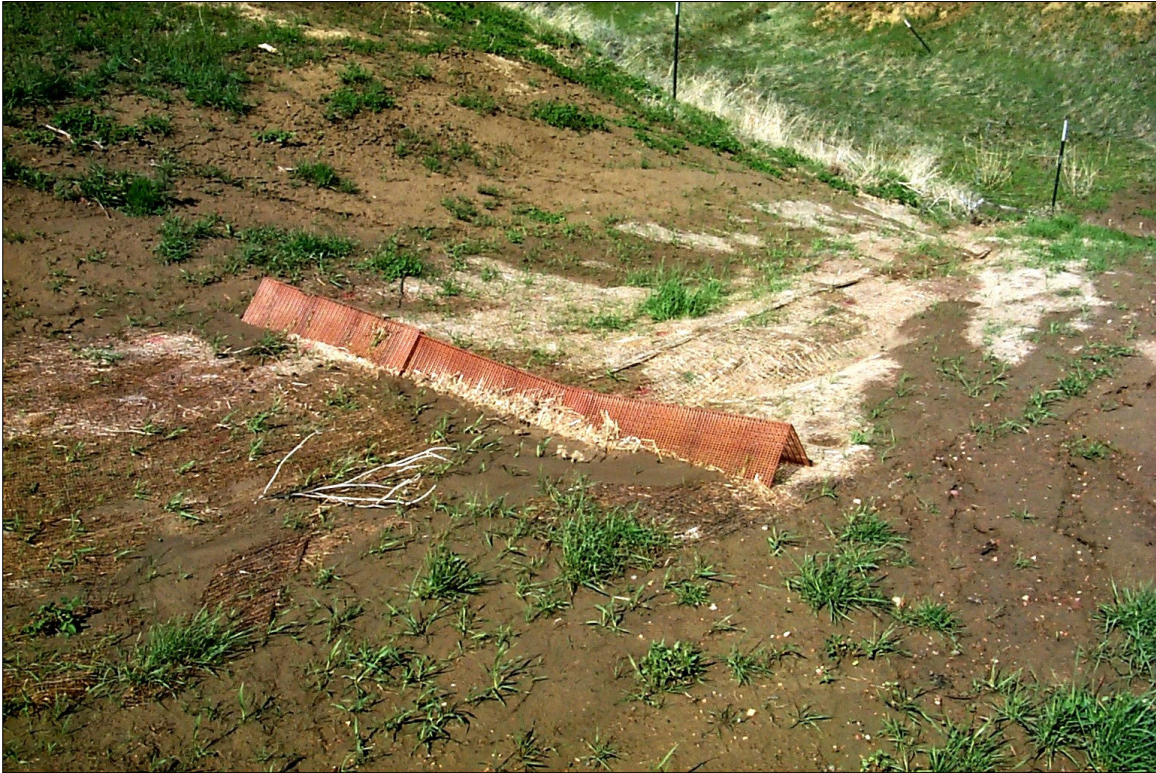
June 2007: Image representing the biodegradable PPB use in conjunction with an erosion mat.

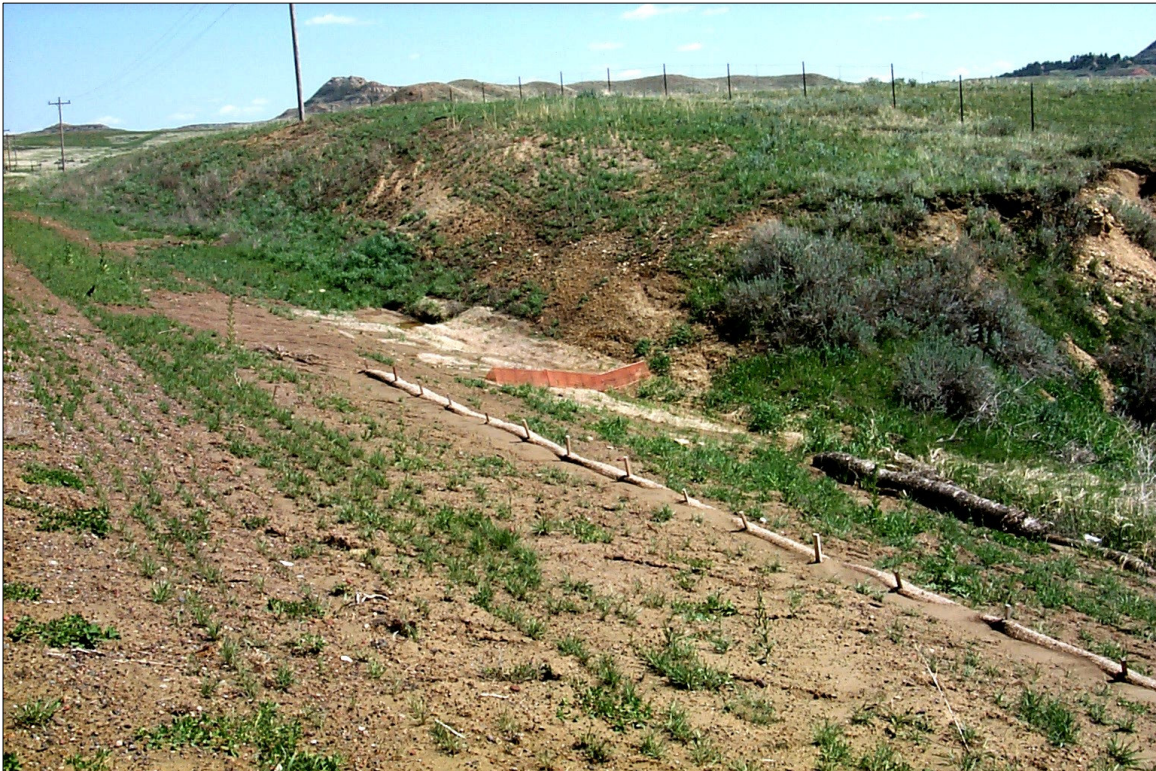
June 2007: This image shows the biodegradable PPB used conjunction with conventional wattles and erosion blankets.

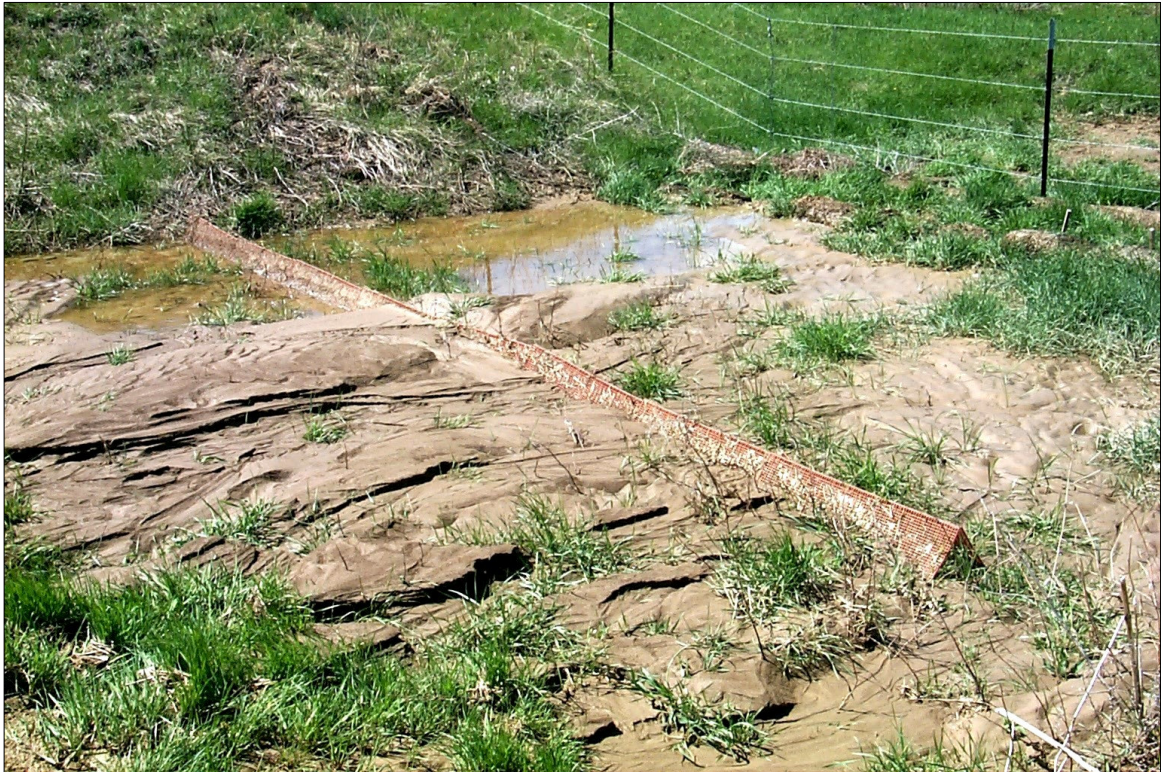
June 2007: Image of biodegradable PPB which has exceeded capacity to retain sediment. Silt deposited on the upstream side of the PPB must be removed periodically to maintain the permeability and, therefore, the optimum performance of the PPB. Allowing excessive sediment to accumulate on the upstream side of the berm will create a non-porous structure. As water flows over the plugged berm, the impact of the water on the downstream side of the terrace will promote the dislodgment and transportation of sediment, leading to failure of the system.

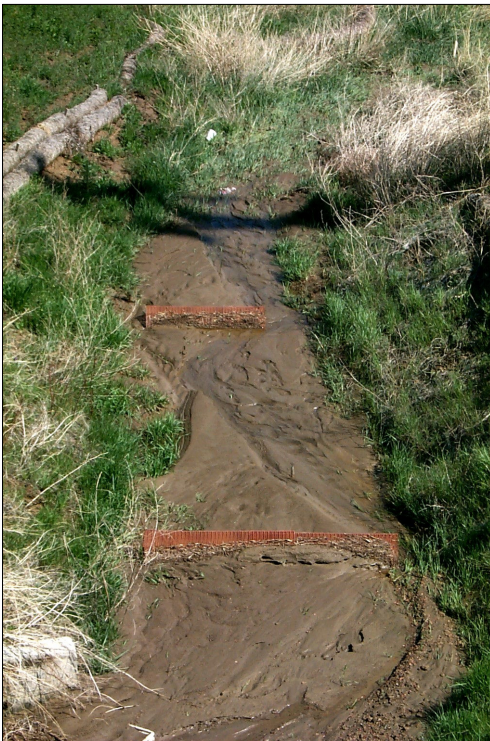
June 2007: Image at left; two sections of PPB are placed at discharge of the culvert outlet. Outlet is out of view the image which would be located off to the lower left of the picture. The flow of sediment and debris has circumvented the PPB as seen on the right side of the channel, most likely caused by a significant hydraulic event. The PPB's have accumulated a large amount of silt upstream of the devices.

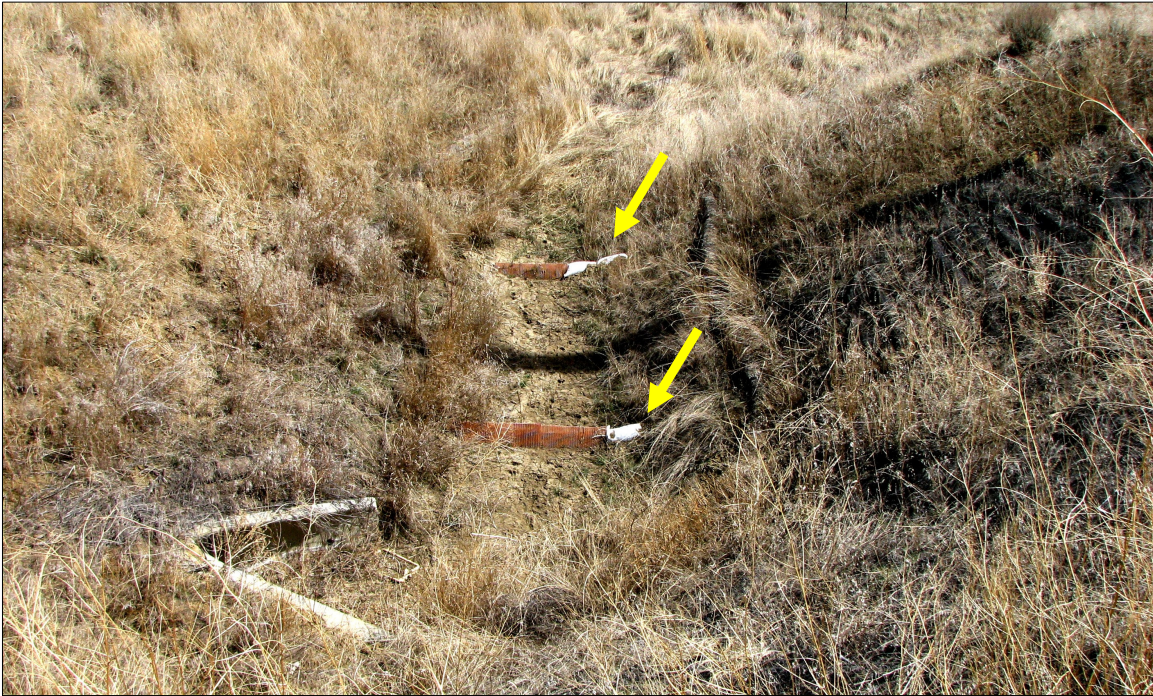
May 2008: Same site depicted in the previous image. Sand bags were placed to supplement the gaps in the berm sections (yellow arrows). It also appears that some of the accumulated sediment may have been removed and the PPB's cleaned and reset. Revegetation below the PPB's was well established.

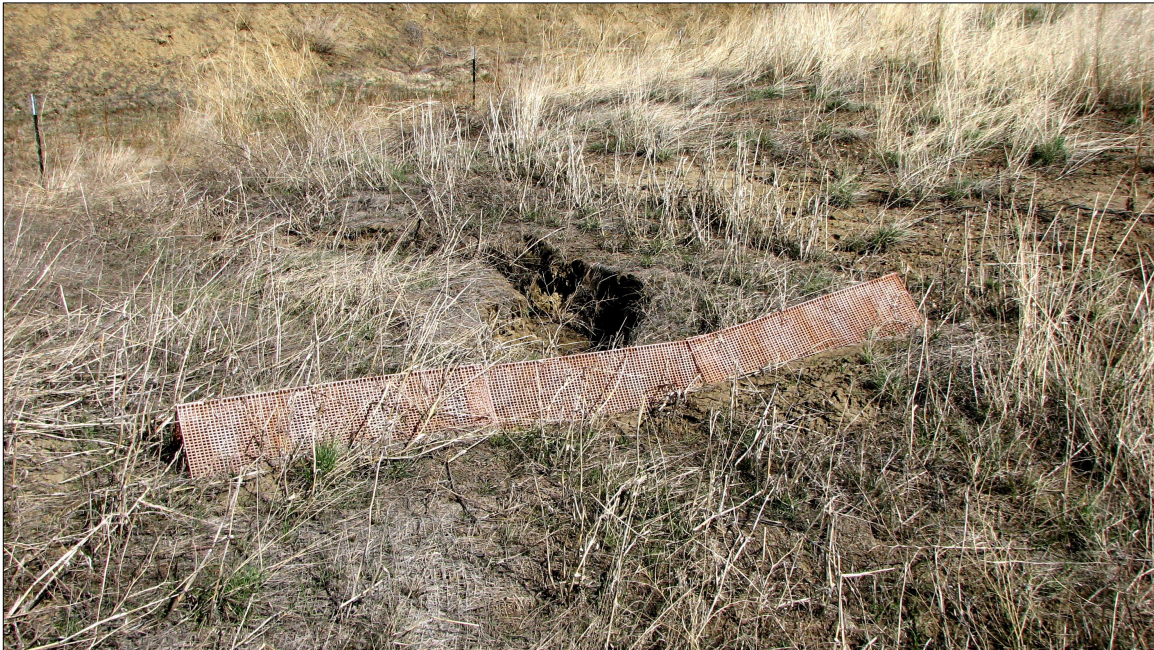
May 2008: PPB used to mitigate further erosion of slope. An erosion blanket was placed directly upstream of the device; however it is difficult to see in this image.

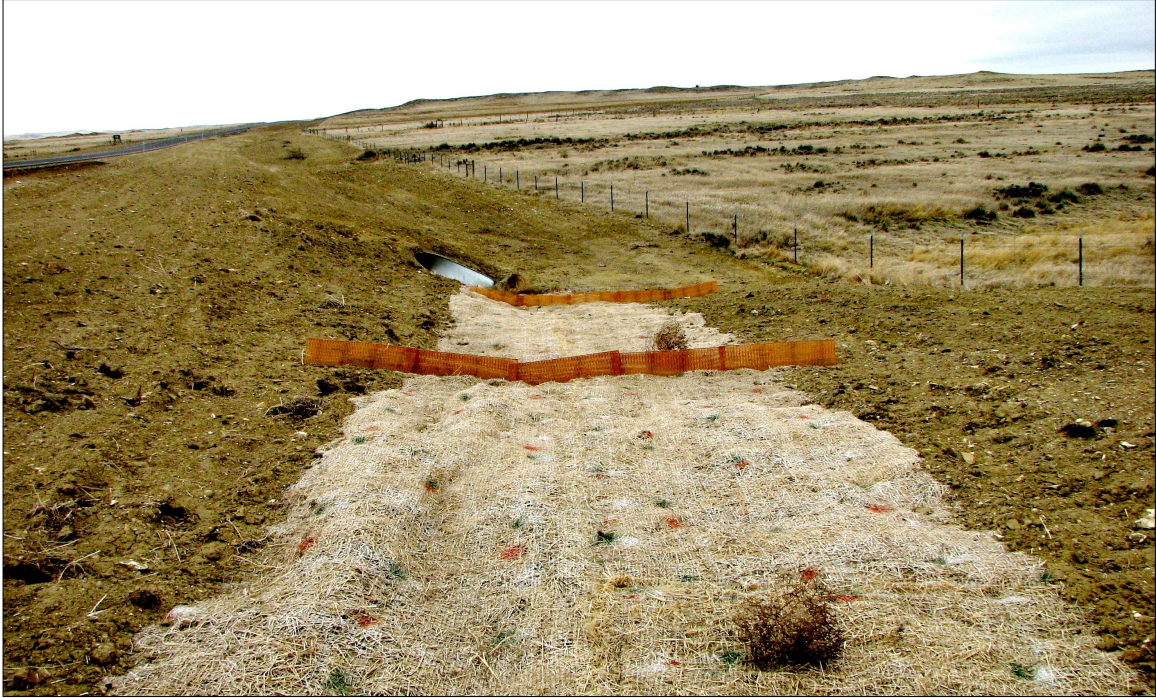
May 2008: Example of GeoRidge and erosion blanket lay-out on the Angela N & S project located in the Glendive District, highway 59 (P-18) approximate mile point 24; north of Miles City.
