Alkali-Silica Reactivity in the State of Montana

Authors: Ashton Siegner
Michael Berry
Kirsten Matteson

Research completed for: The State of Montana Department of Transportation - FHWA/MT-21-006/9577-607
In cooperation with: The U.S. Department of Transportation Federal Highway Administration and the Montana Contractors Association
https://www.mdt.mt.gov/research/projects/mat/alkali_silica.aspx

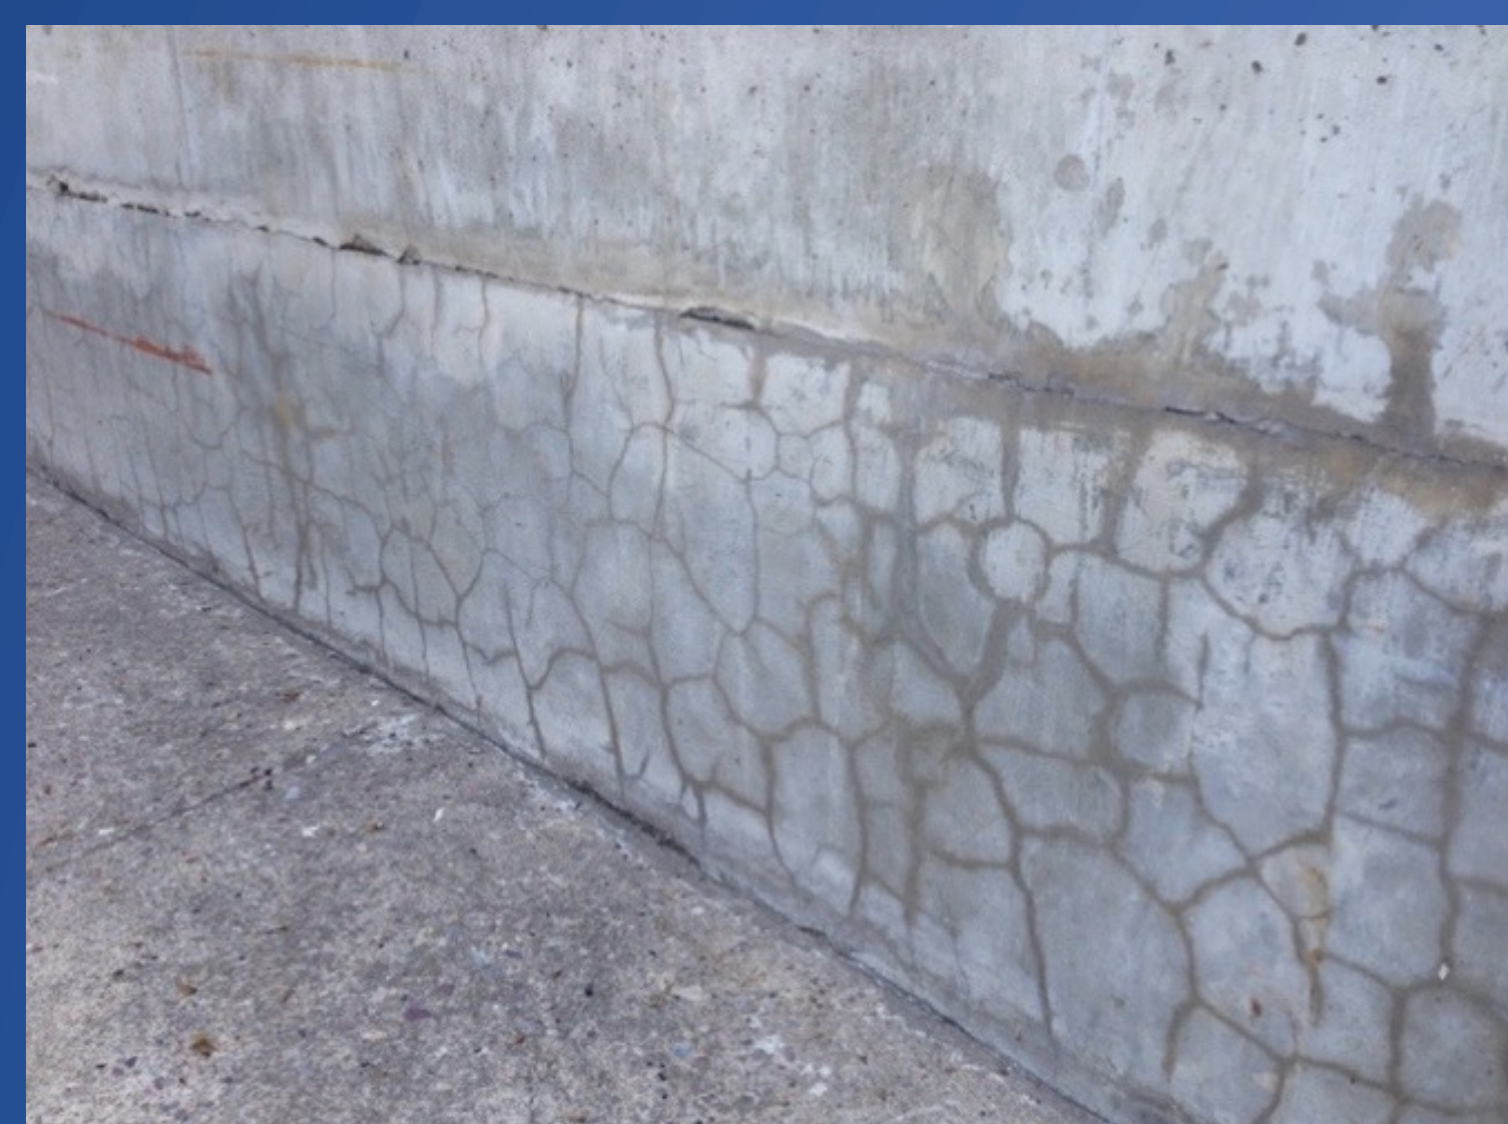
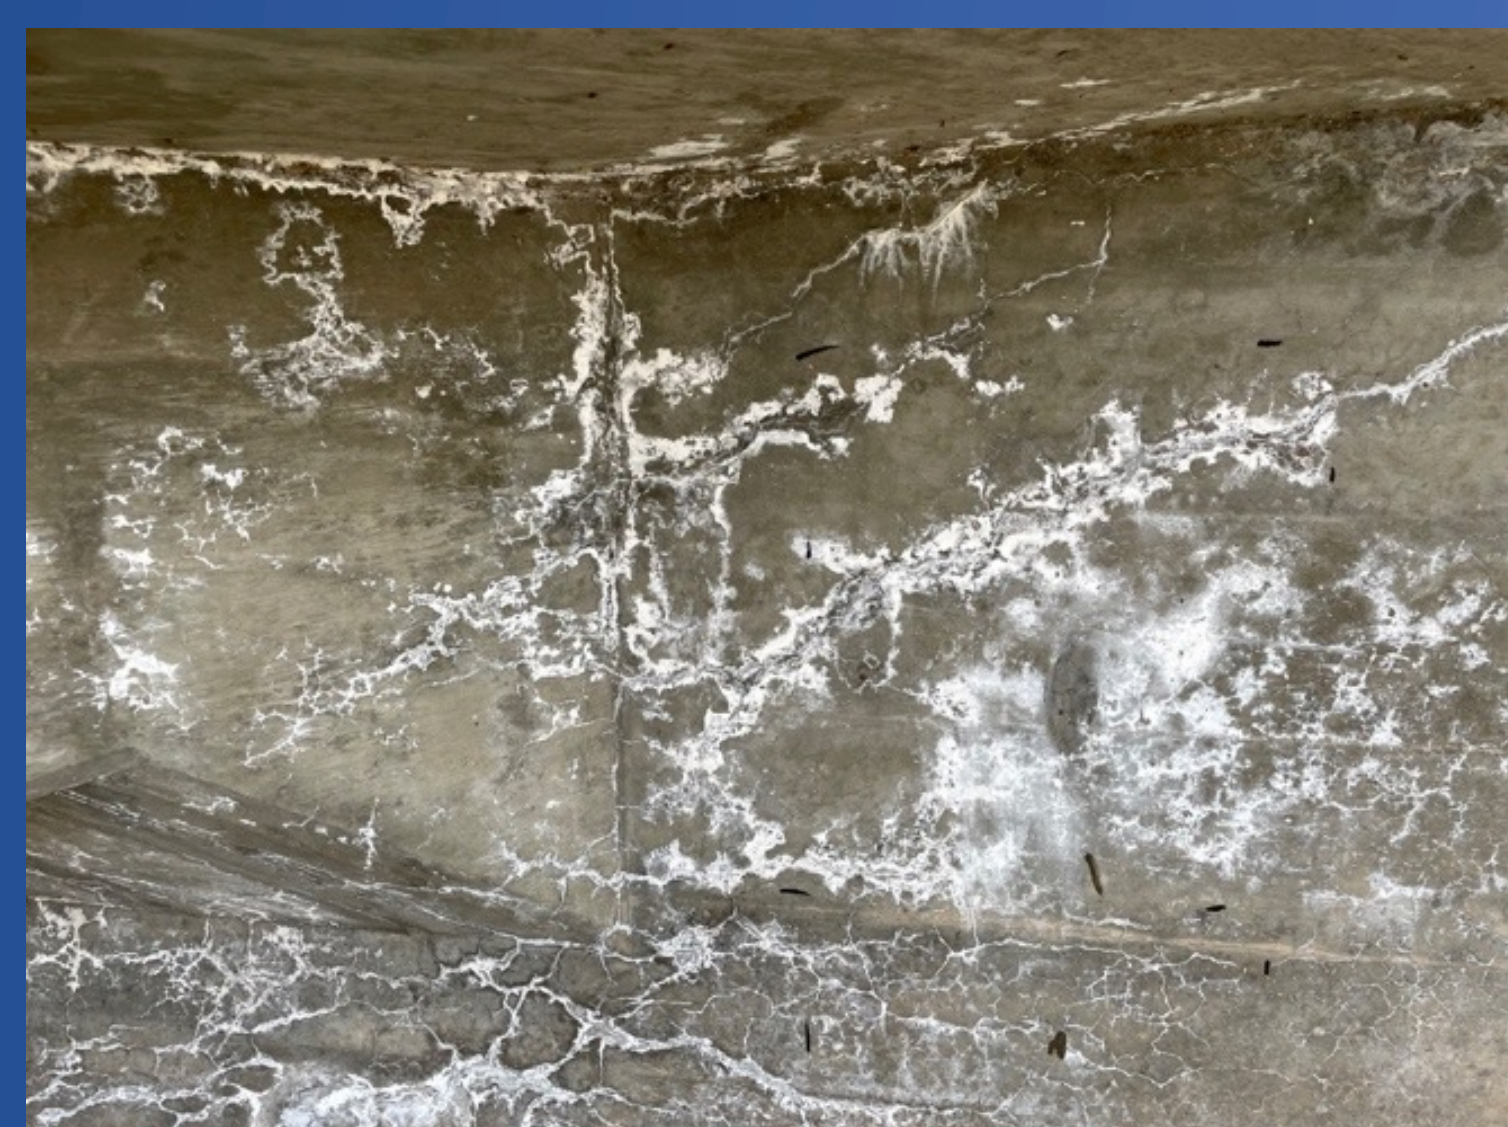
Typical ASR Crack Patterns

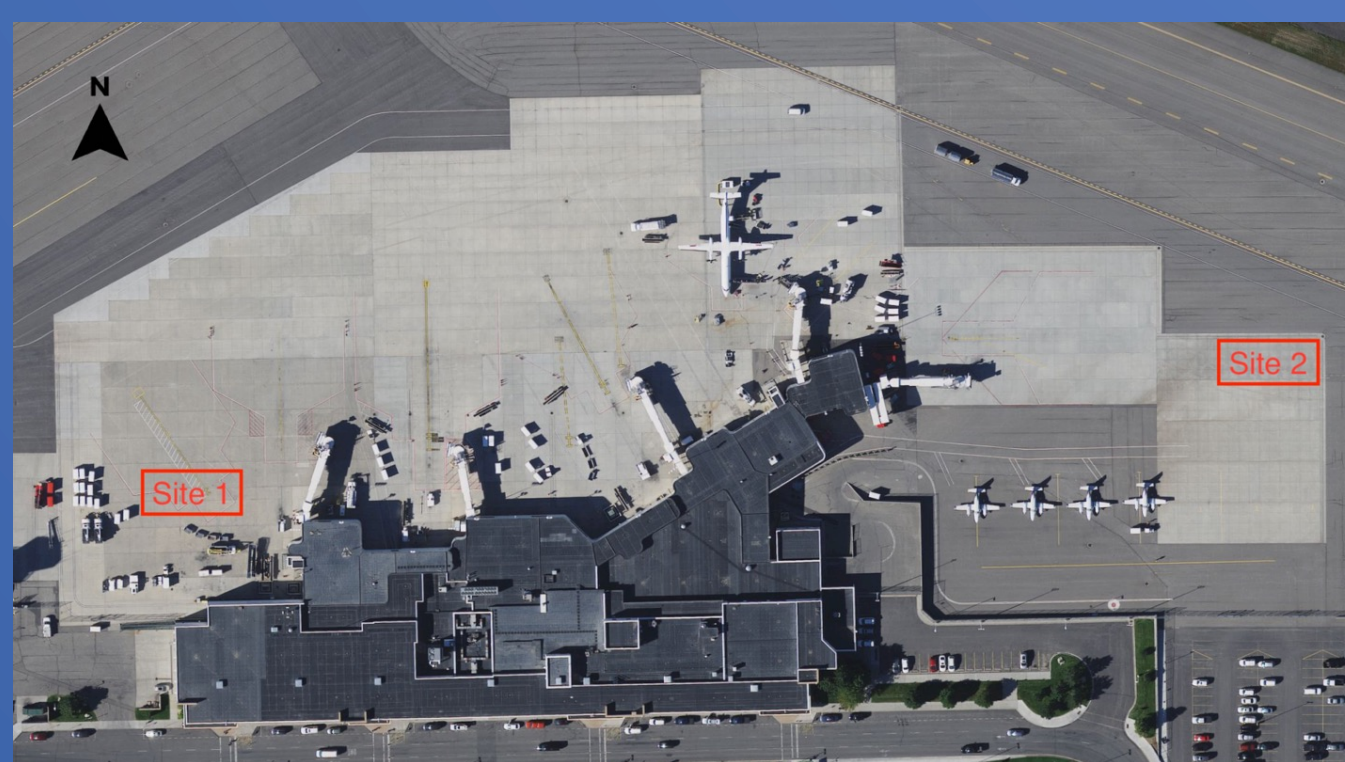
Site Locations at Airport

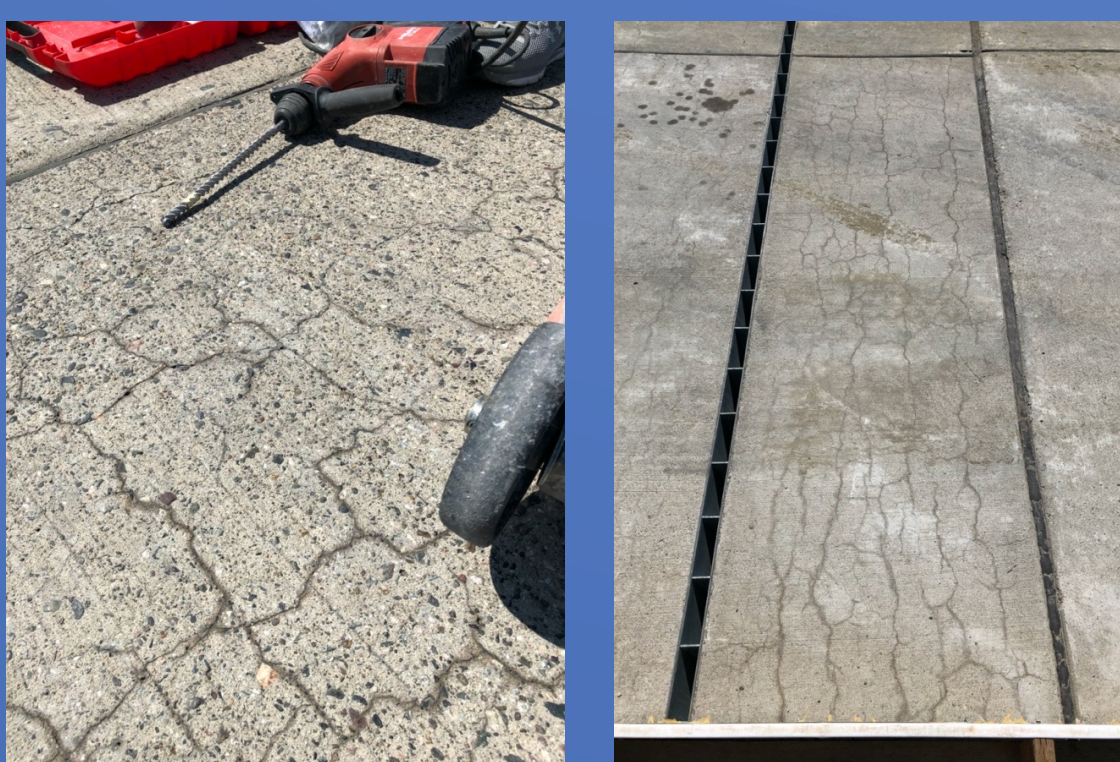
Site 1

Site 2

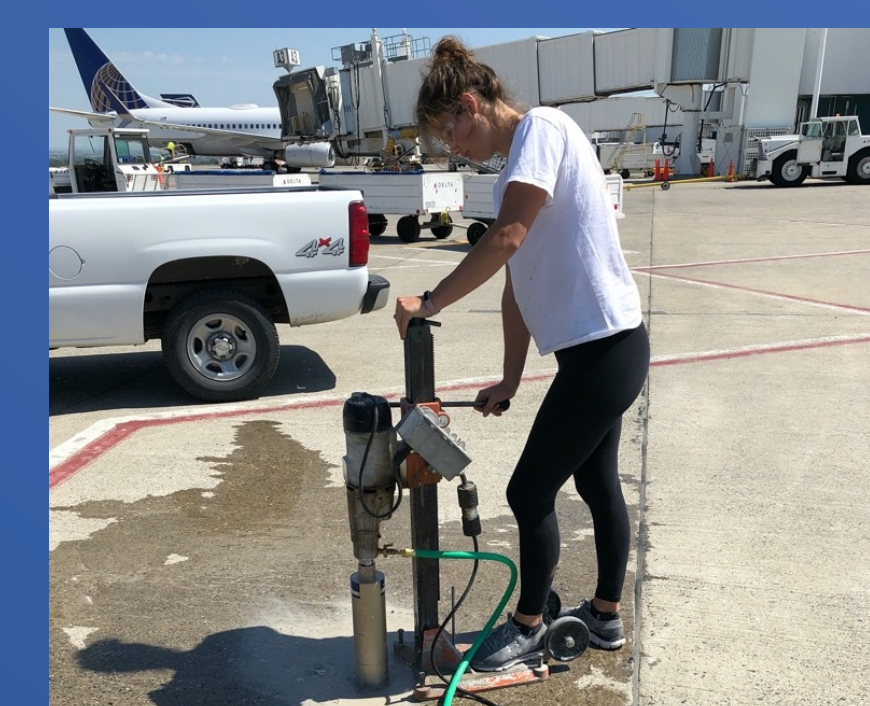
Coring of Site 1

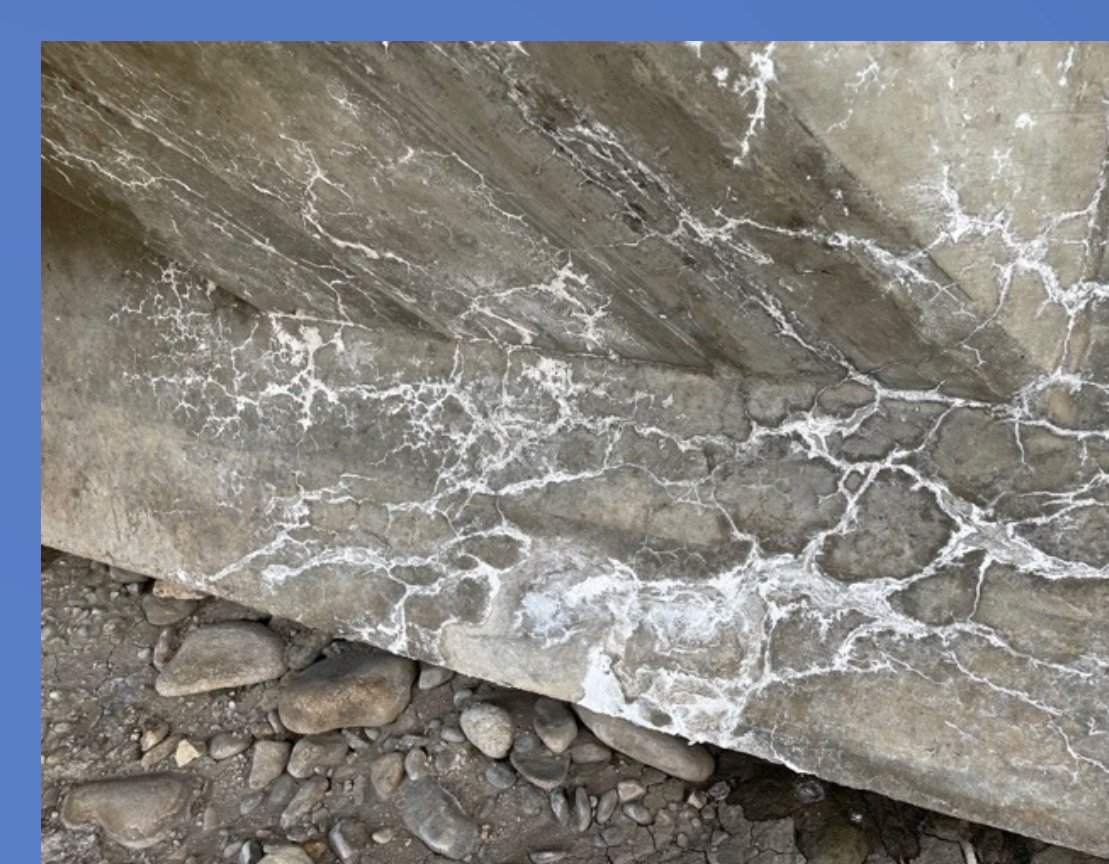
Backwall and Beam Showing Signs of Distress

- Bridge Backwall and Beam Showing Signs of Distress
- Cores evaluated via Petrographic Analysis
- Core determined to have significant damage associated with ASR

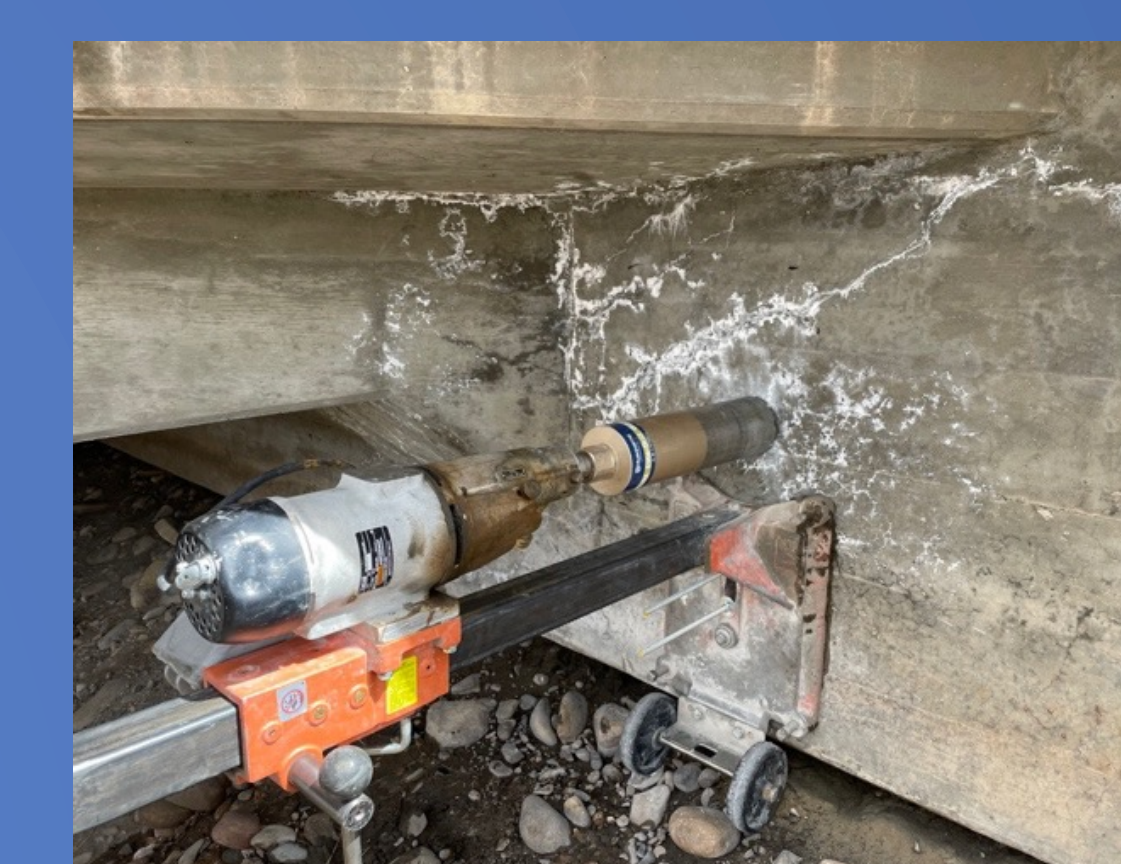
Backwall Being Cored

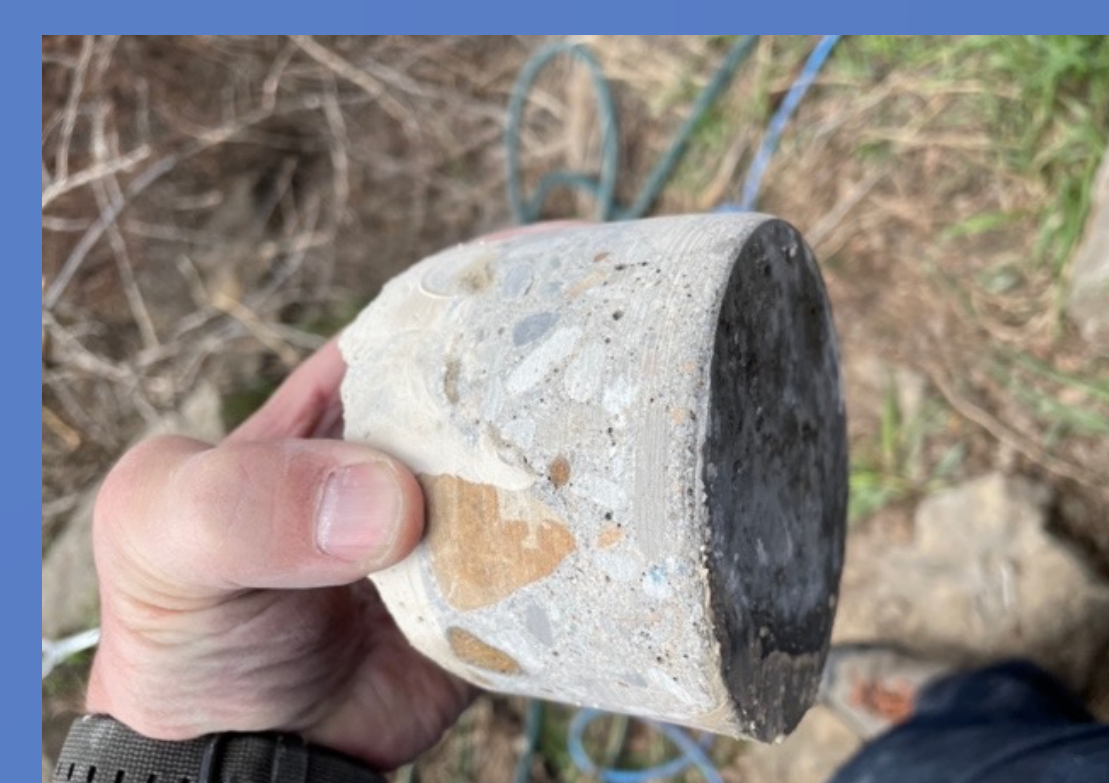
Extracted Core

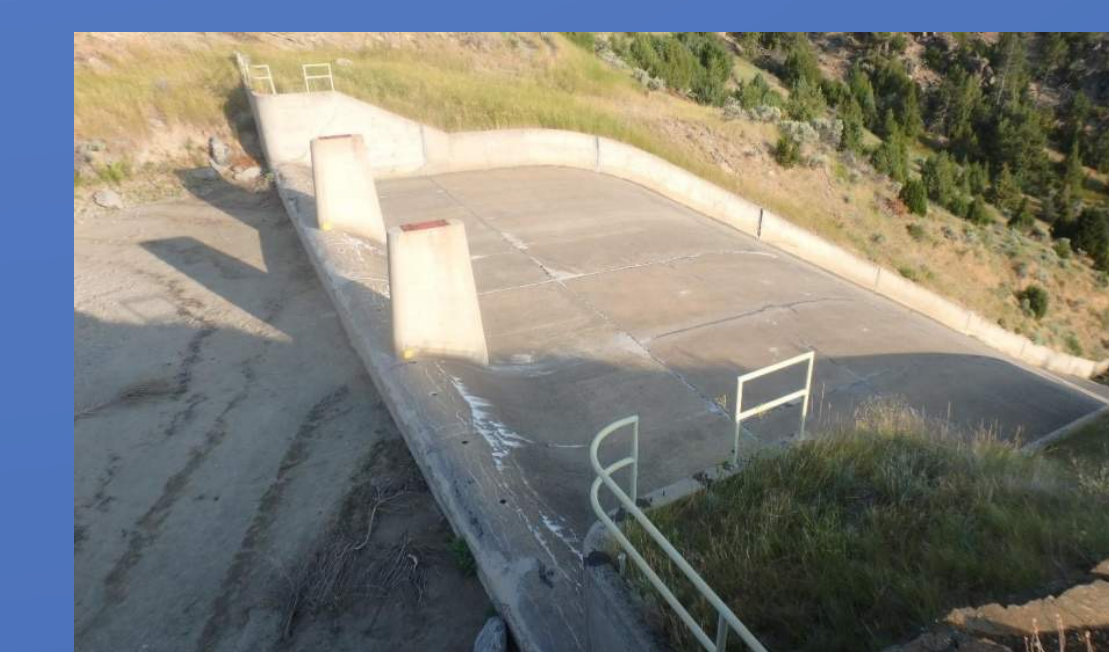
Ogee of Dam

- Spillway showed signs of distress
- Cores evaluated via Petrographic Analysis
- Cores determined to have varying degrees of damage associated with ASR

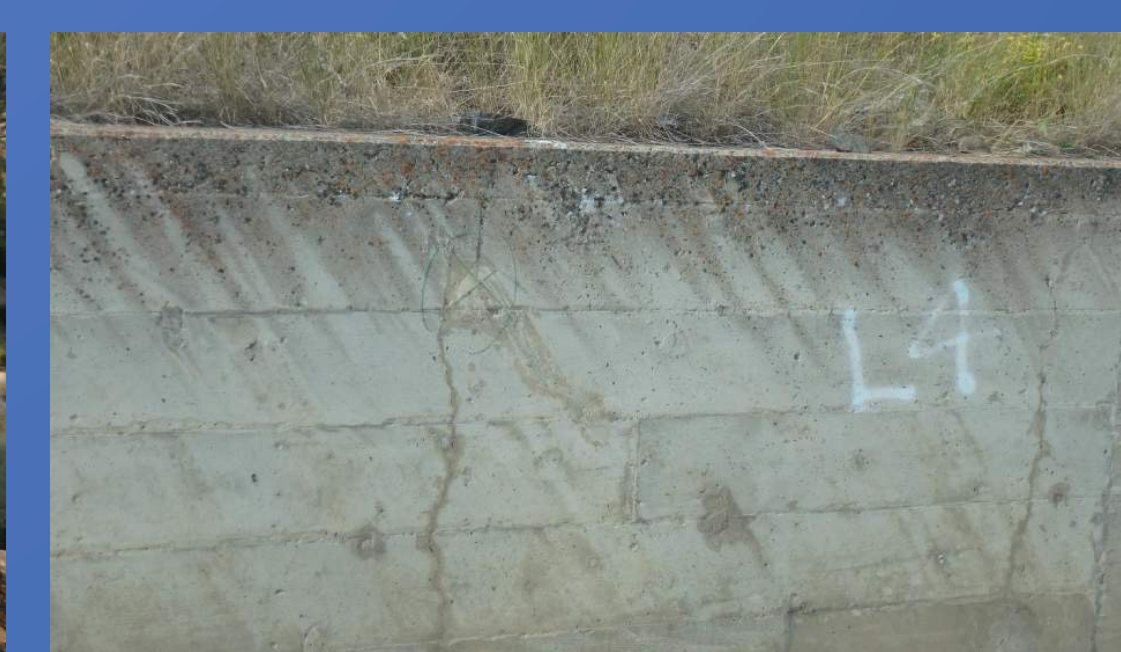
Sidewall

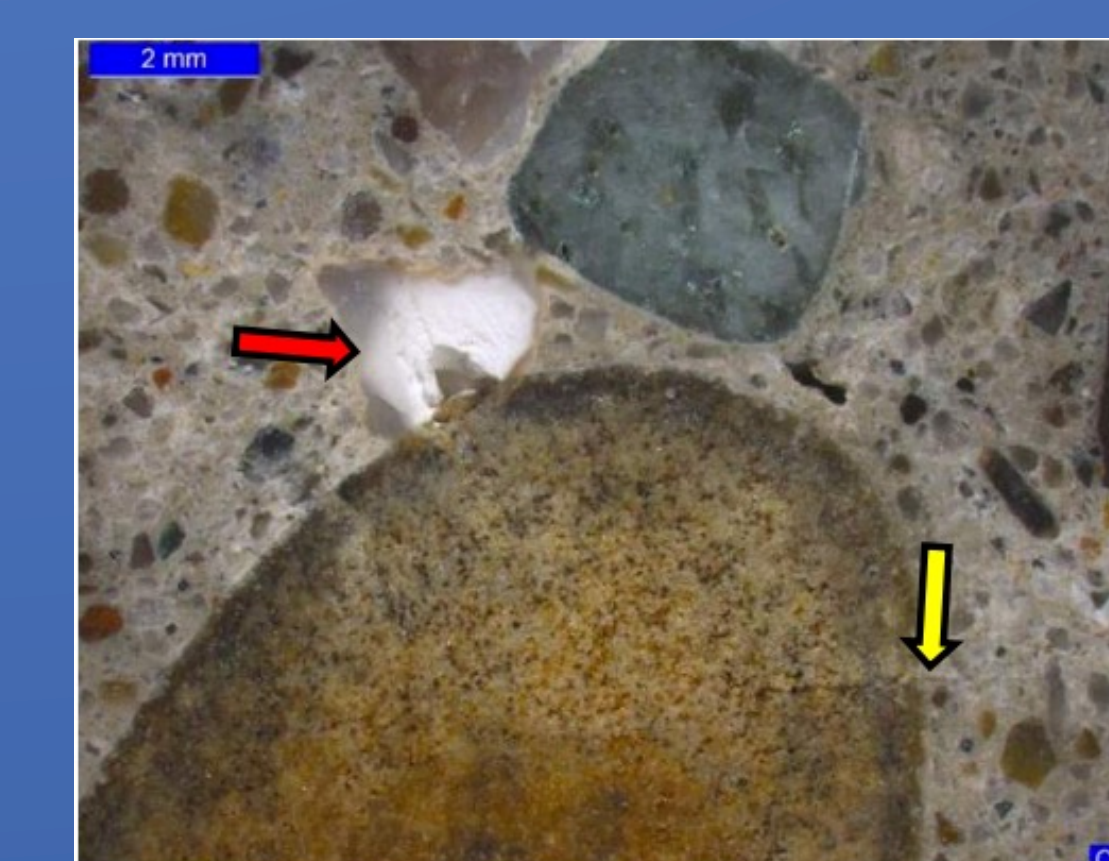
Core from Chute Showing ASR Gel Deposits

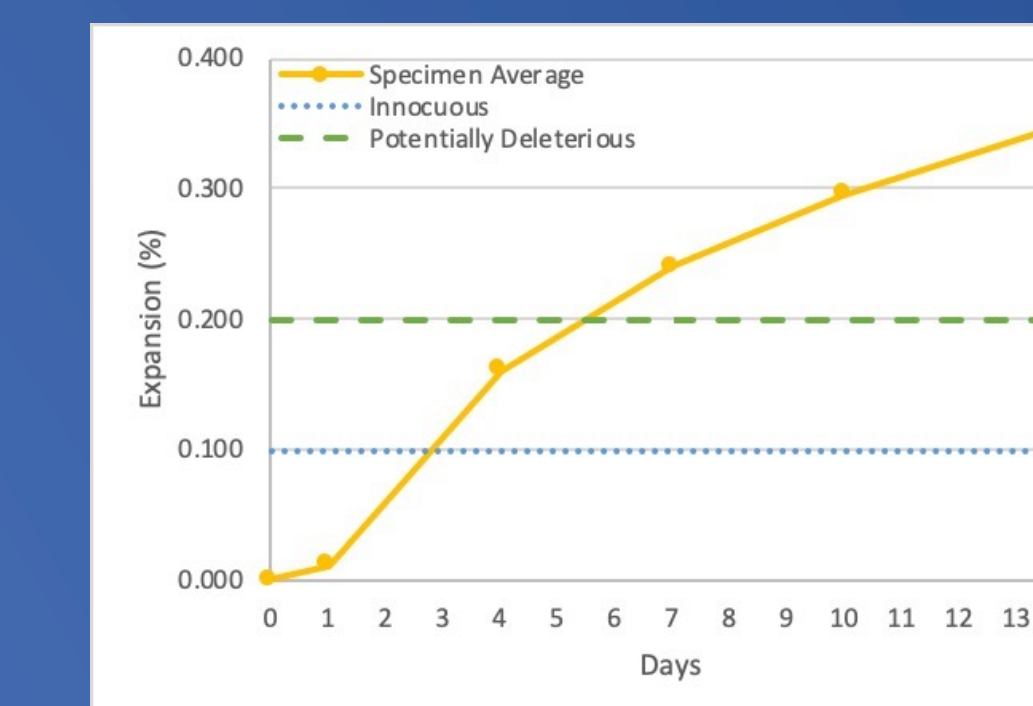
Mix F-1: ASTM C1260 Average

Mix ID	Location	ASTM C1260, 14 Days		AASHTO T380, 56 Days	
		Expansion (%)	Degree of Reactivity	Expansion (%)	Degree of Reactivity
F-1	Helena Sand & Gravel - Lake Helena Drive Pit	0.351	Reactive	0.352	Very Highly Reactive
F-2	Knife River Billings - Sindelar Pit	0.529	Reactive	0.376	Very Highly Reactive
F-3	Knife River Billings - Sindelar Pit	0.568	Reactive	0.419	Very Highly Reactive
F-4	Knife River Missoula - Allen Pit	0.347	Reactive	0.364	Very Highly Reactive
C-1	Helena Sand & Gravel - Lake Helena Drive Pit	0.036	Innocuous	0.056	Moderate Reactive
C-2	Knife River Billings - Sindelar Pit	0.333	Reactive	0.143	Highly Reactive
C-3	Knife River Billings - Sindelar Pit	0.324	Reactive	0.147	Highly Reactive
C-4	Knife River Missoula - Allen Pit	0.076	Innocuous	0.157	Highly Reactive

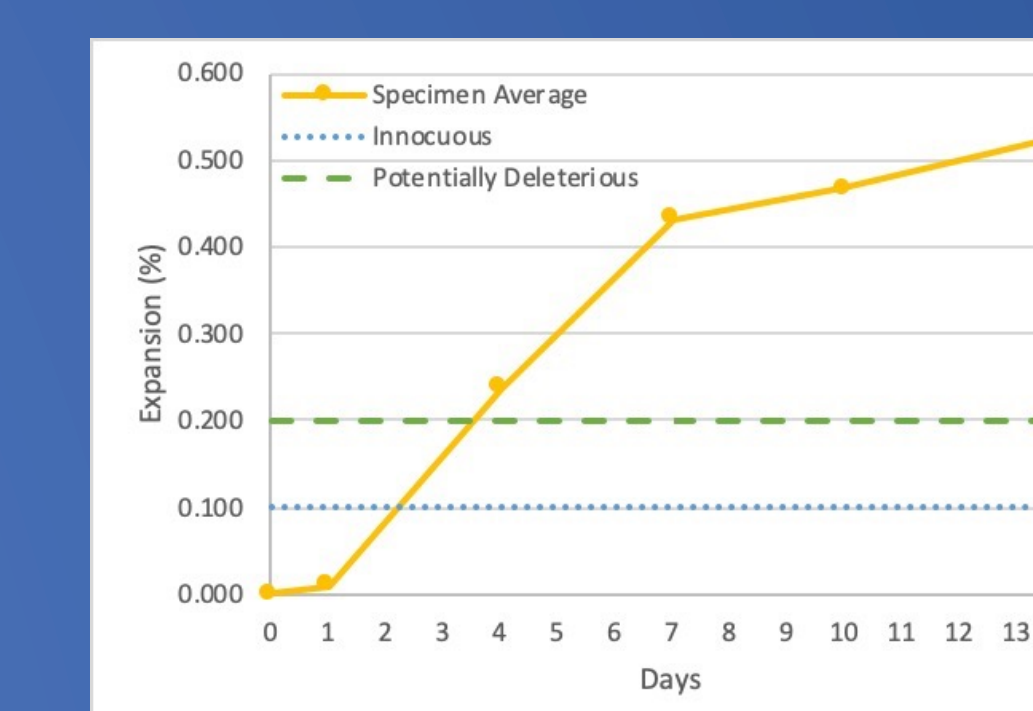
Mix F-2: ASTM C1260 Average
