APPENDIX A

Bridge Inspection Reports

I-15 Corridor Study

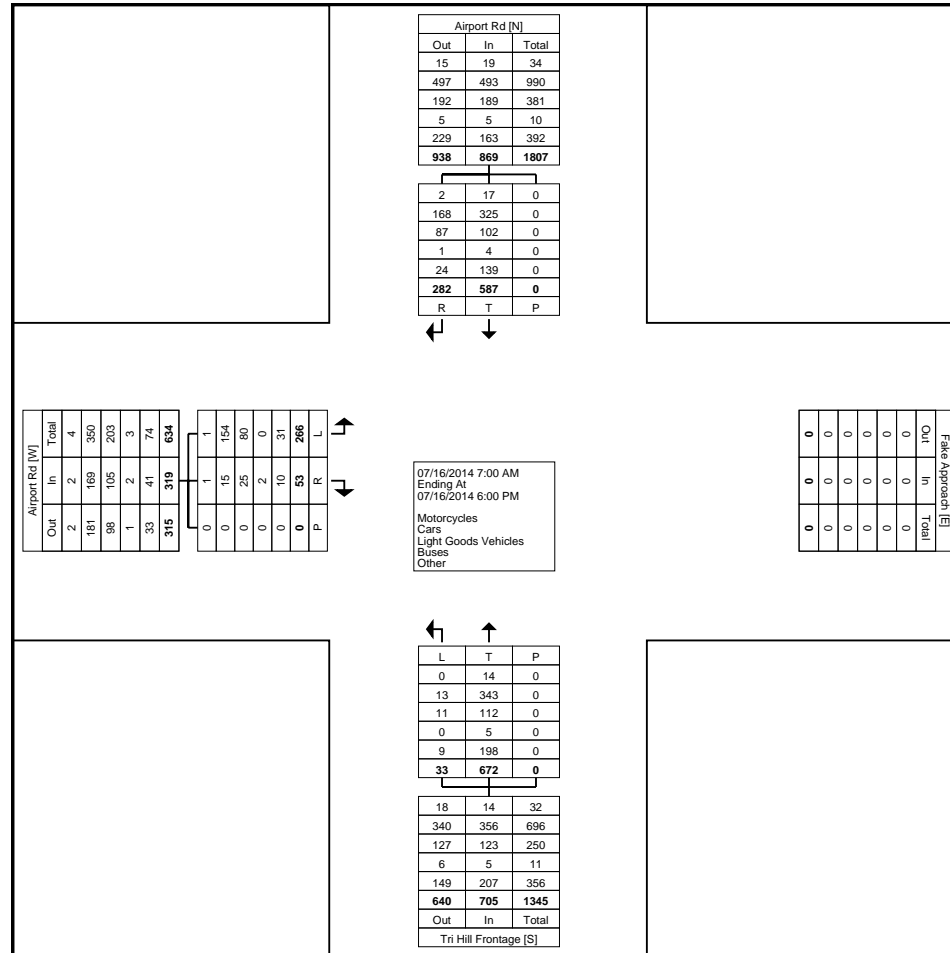
Count Name: 01-TriHillFrontage_AirportRd TMC
Site Code: TMC-01
Start Date: 07/16/2014
Page No: 3

Turning Movement Data Plot

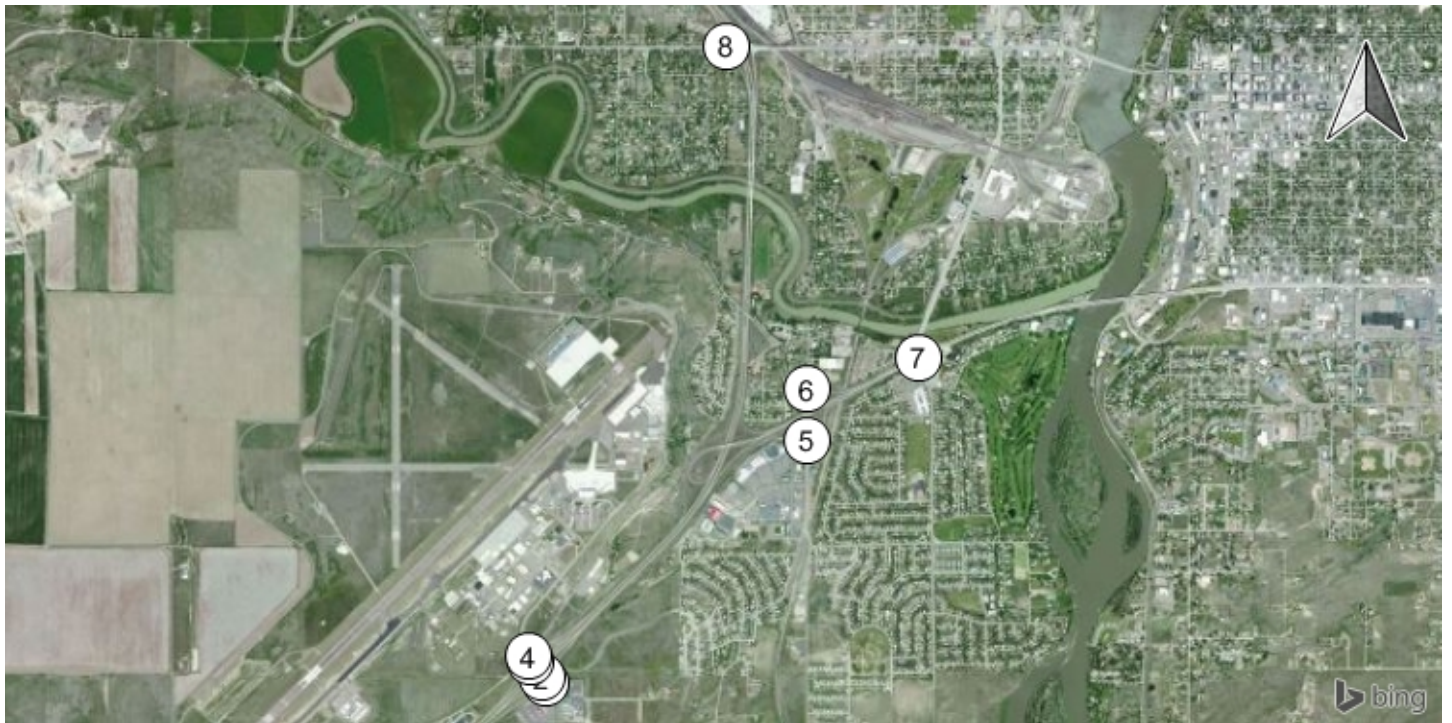
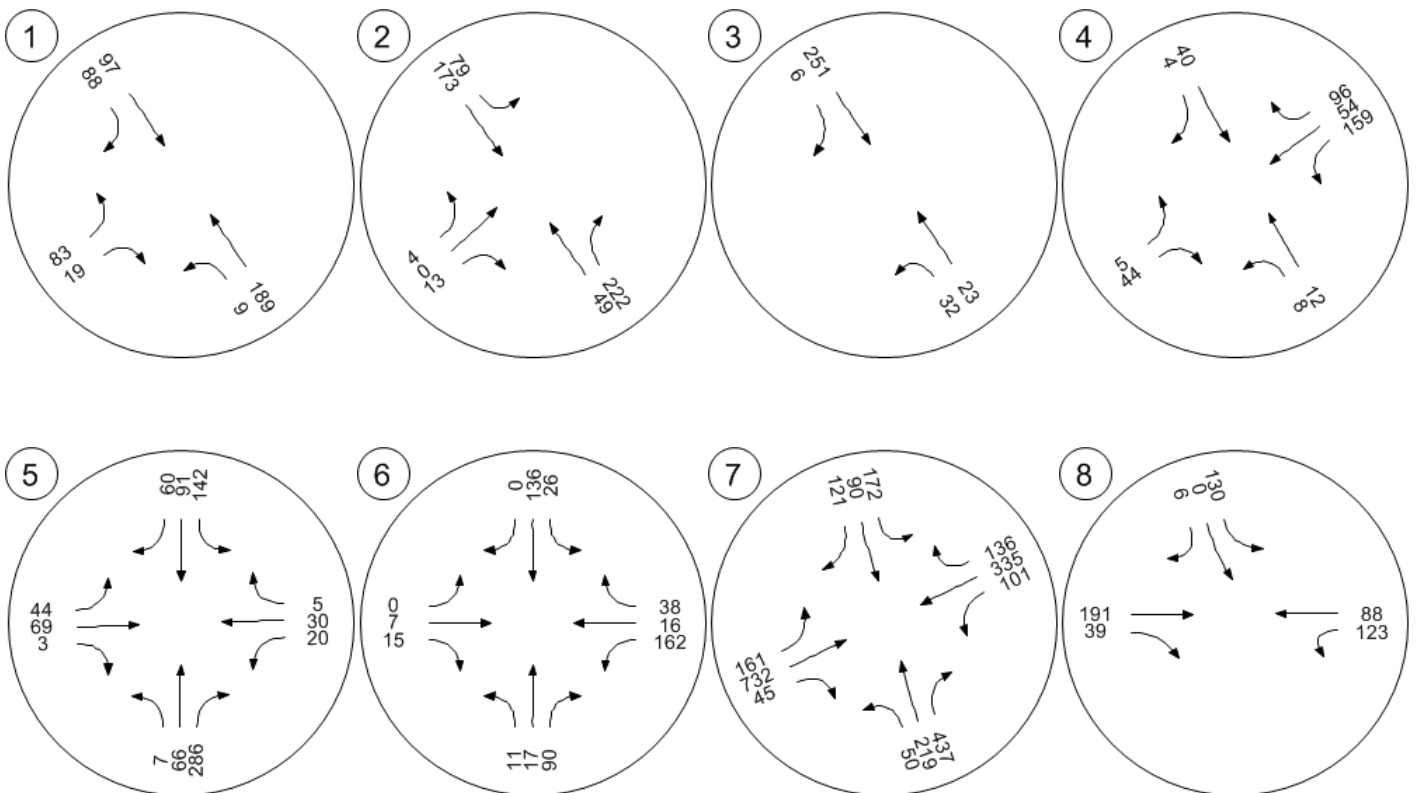
Traffic Volume - Base Volume

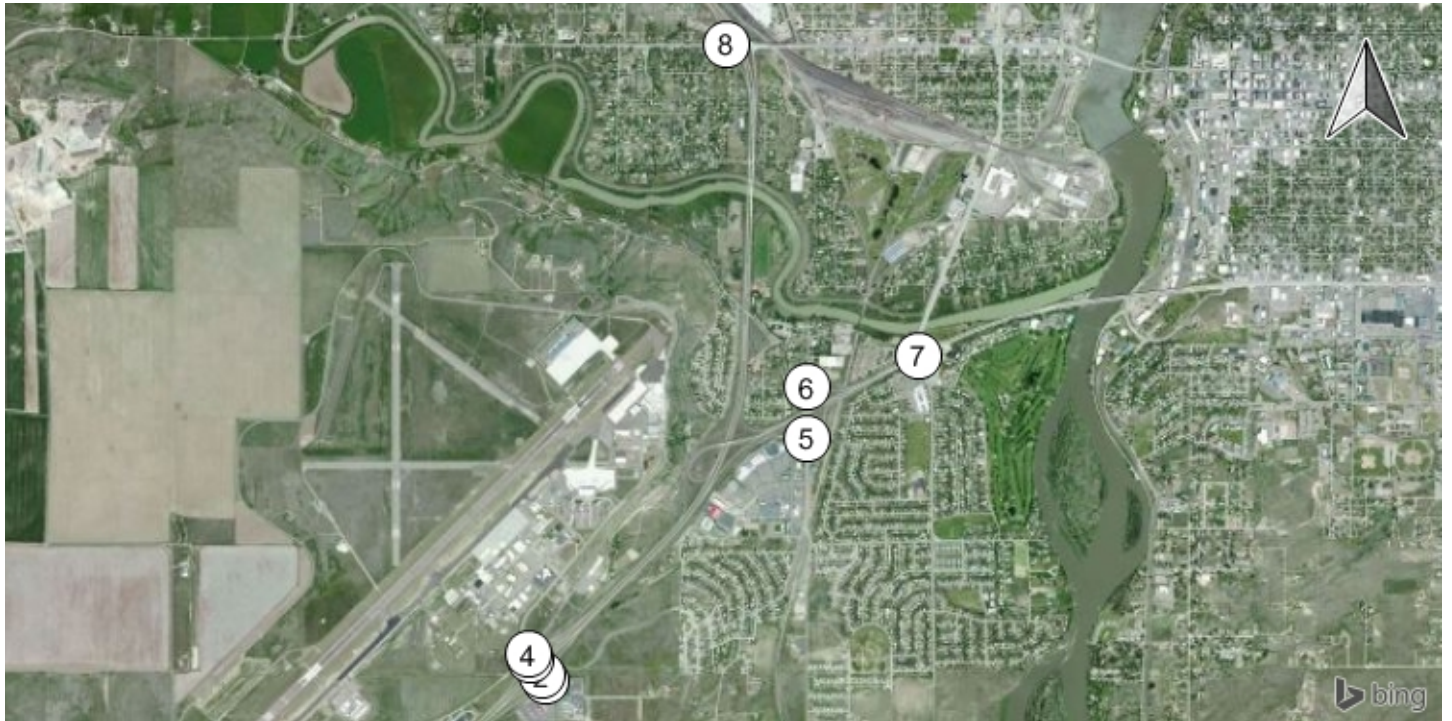
Traffic Conditions

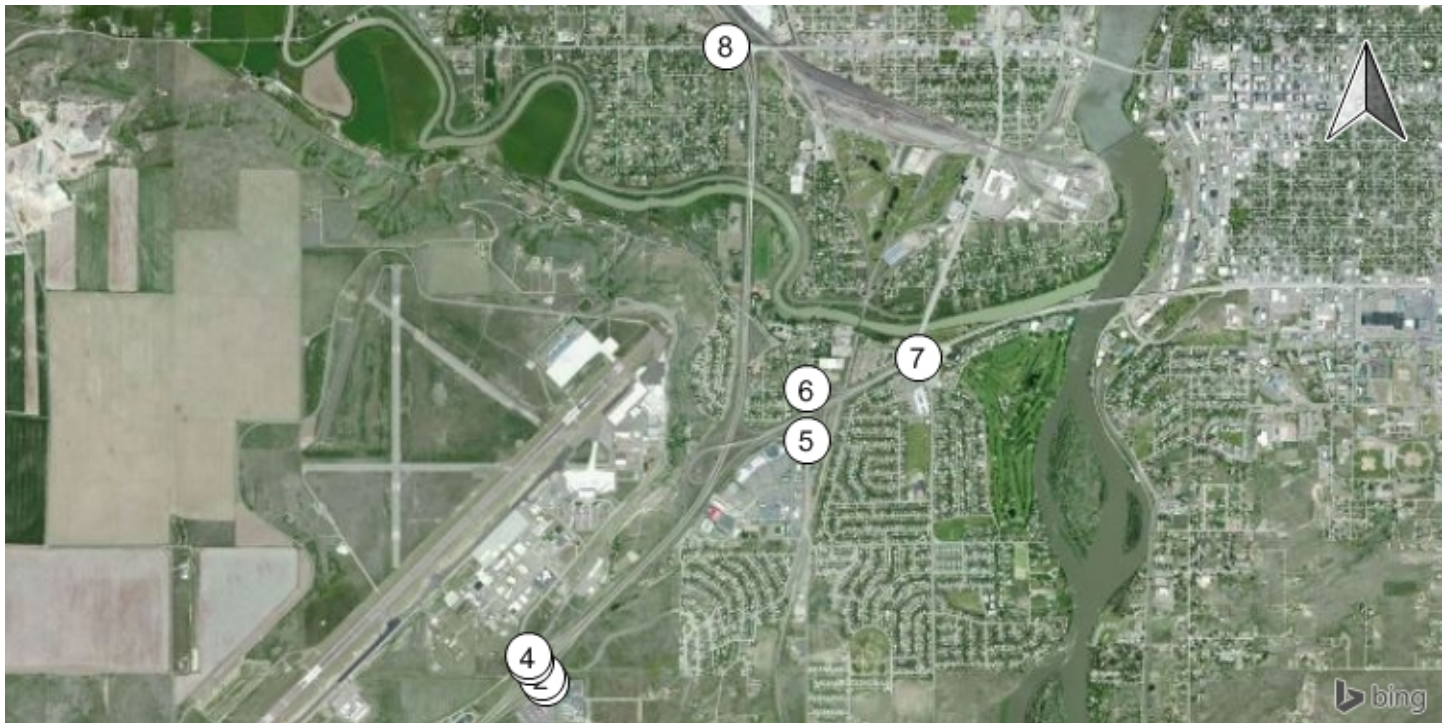
Traffic Volume - Future Total Volume

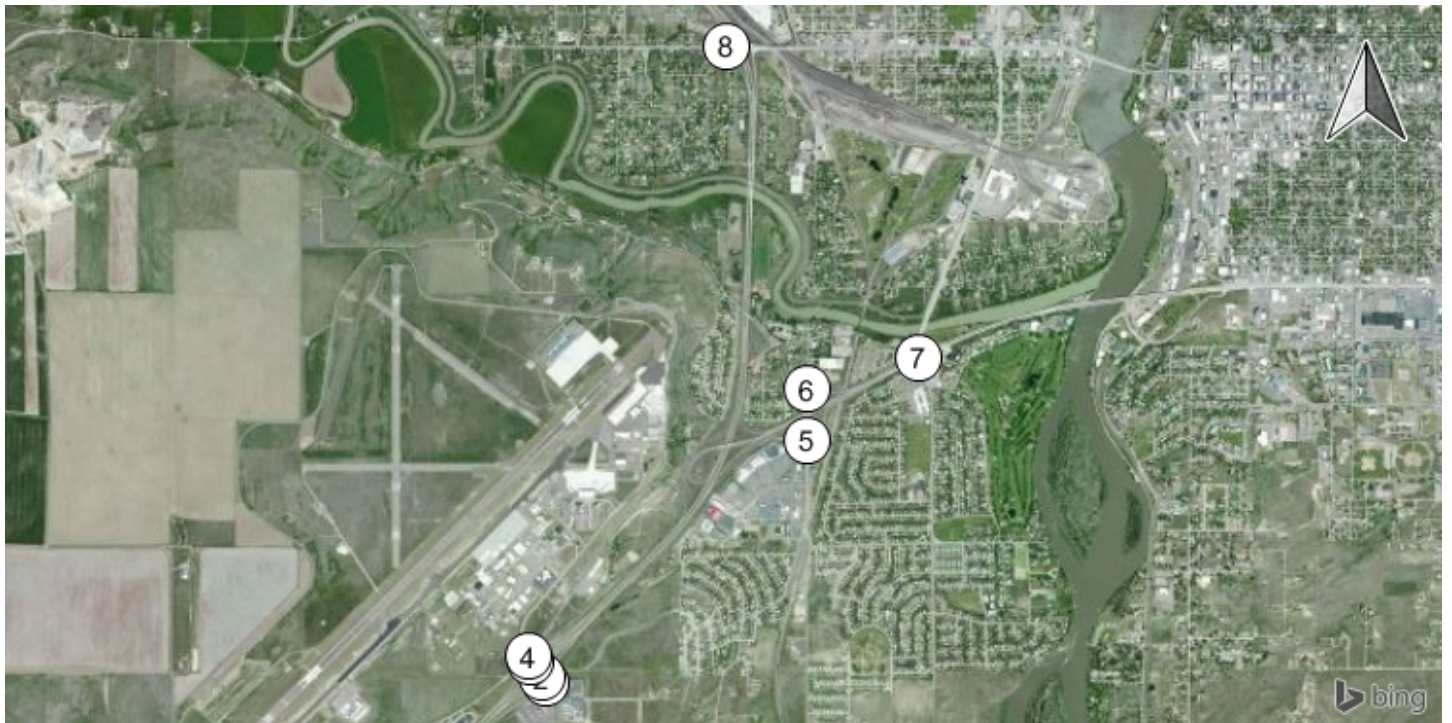
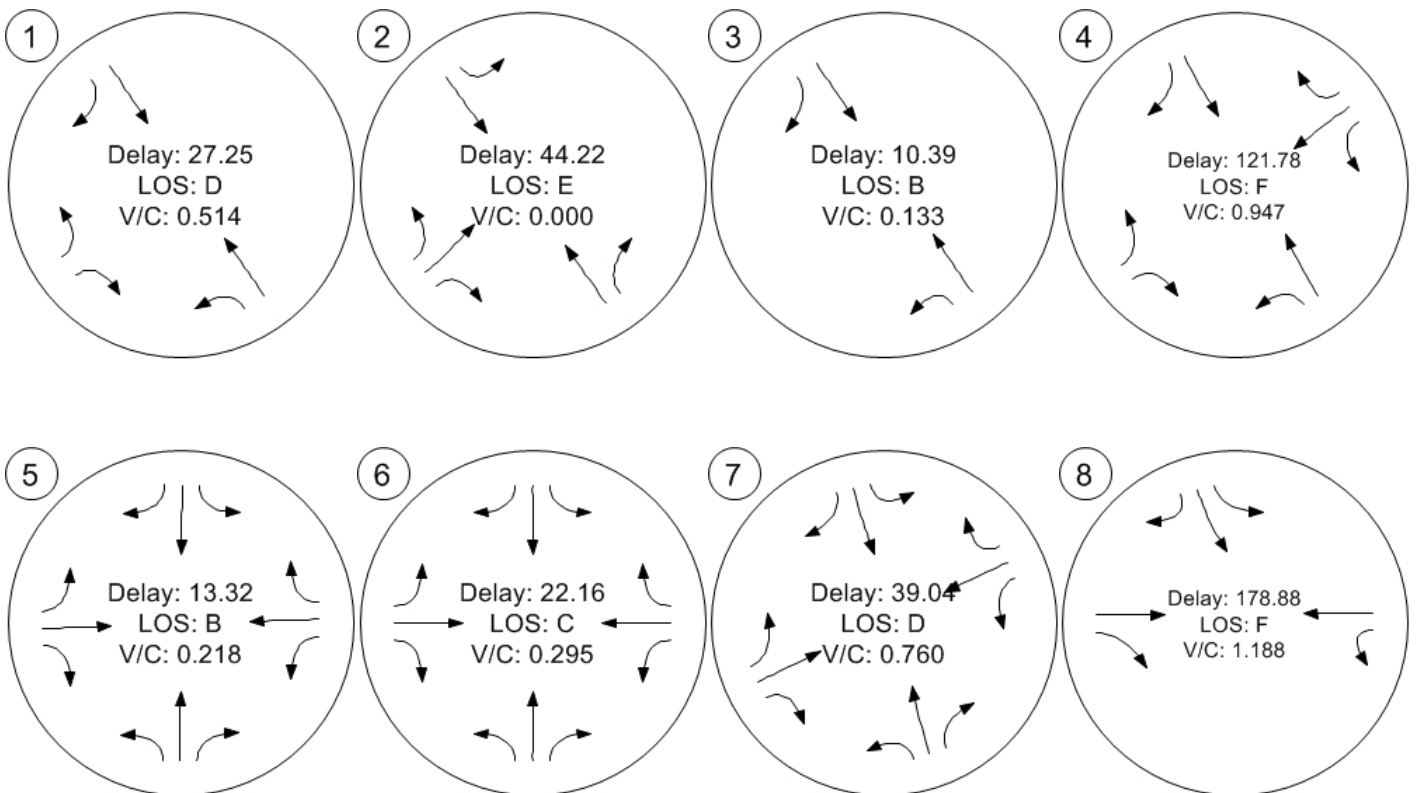
Traffic Conditions
