Informational Meeting #1

Wednesday, June 12, 2013

The Missoula Bridges Planning Study IS:

- A **planning-level evaluation** of the Higgins Avenue and Madison Street Bridges

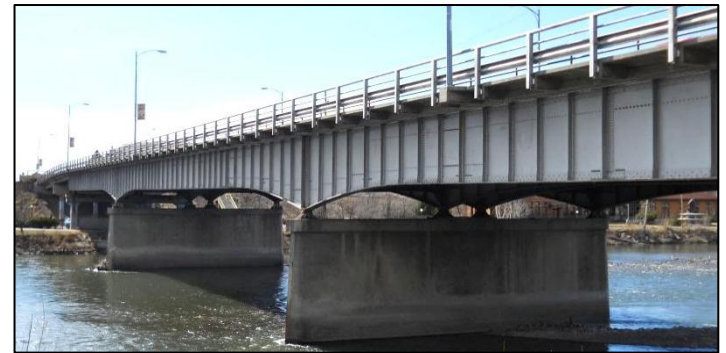
● Higgins Avenue Bridge (MDT Route U-8113 at RP 0.23)

- ⦿ Urban minor arterial
- ⦿ Constructed in 1962
- ⦿ Approximately 972 feet long

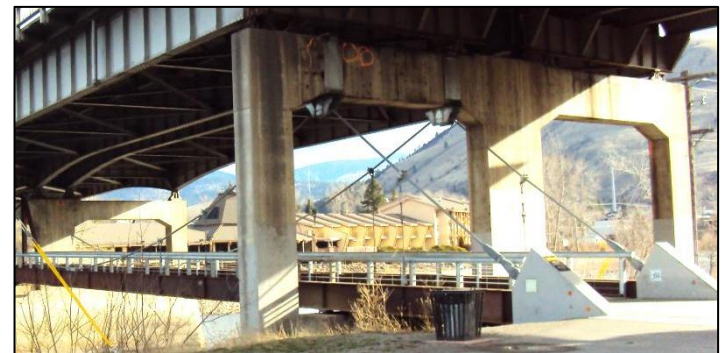
● Madison Street Bridge (MDT Route P-7 at RP 95.05)

- ⦿ Urban principal arterial
- ⦿ Constructed in 1958
- ⦿ Approximately 552 feet long

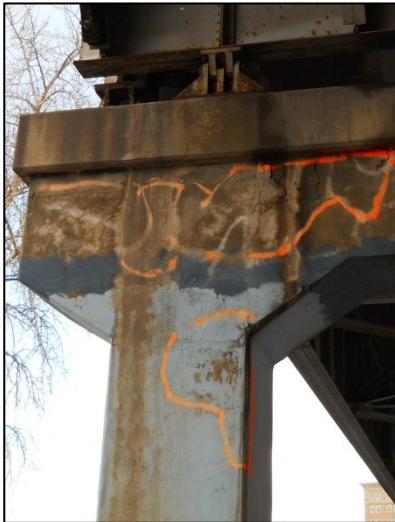
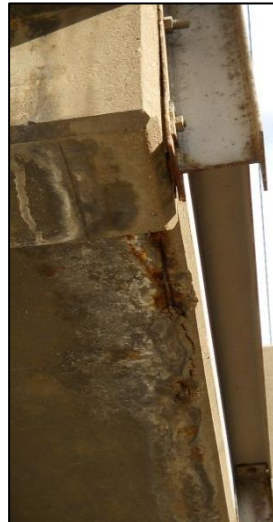
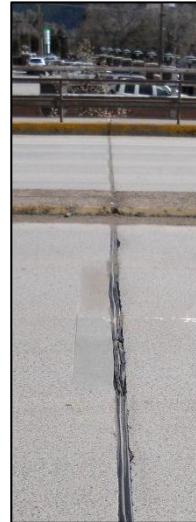
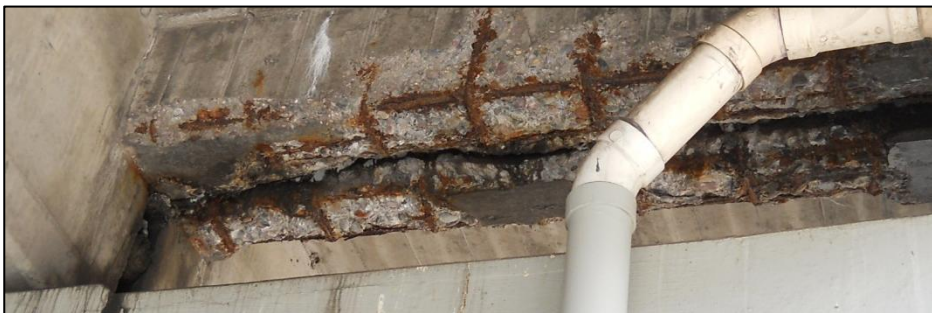
Field Review – Structural Elements

Confirmed MDT Inspection Reports

- Concrete deterioration
- Corroding steel
- Leaking joints

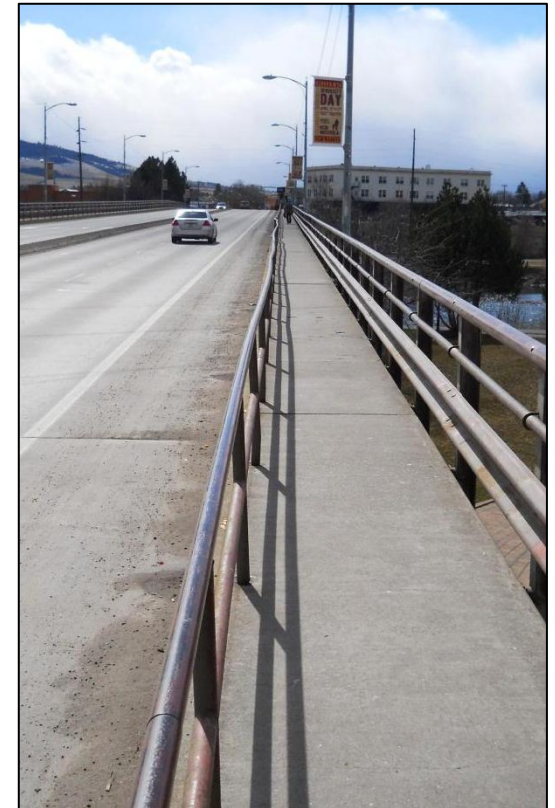
● Madison Street Bridge

- ⊙ Dedicated 4-foot bicycle lanes
- ⊙ 4-foot sidewalks
- ⊙ Bridge railings on outside edges of sidewalks
- ⊙ Separate bicycle/pedestrian bridge underneath the main roadway bridge

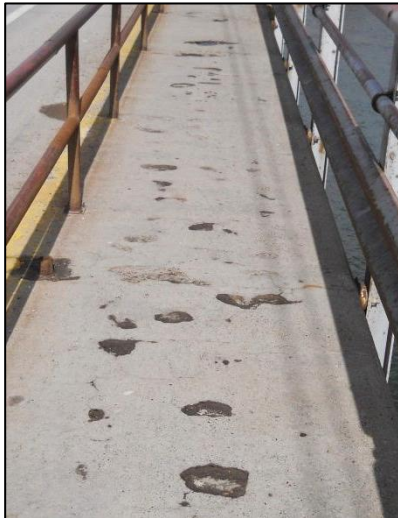
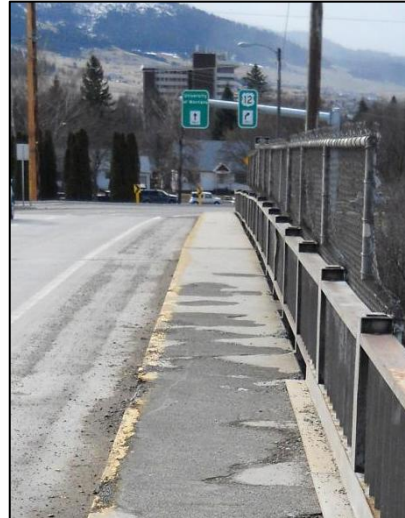
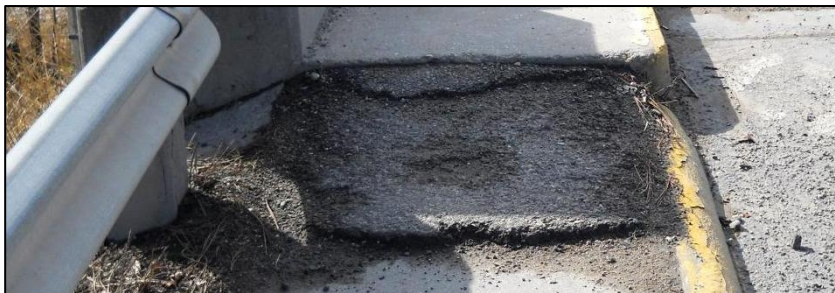
Field Review – Bicycle/Pedestrian Elements

- Concrete deterioration
- Ramp discontinuities
(i.e., trip hazards)
- Railing type and height
 - ⊙ Crashworthy barrier required
 - ⊙ Minimum height of 43 inches
- Usable width

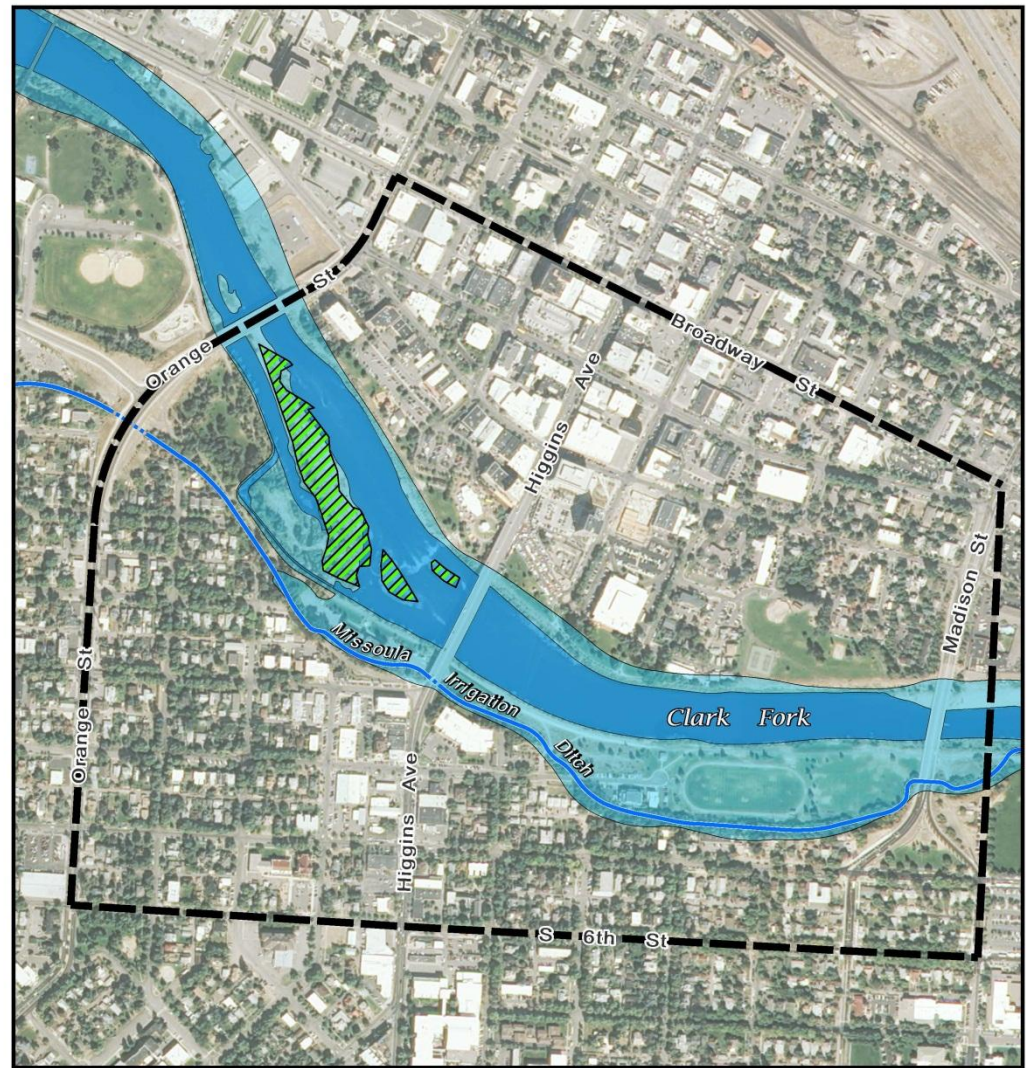
Surface Waters, Wetlands, and Floodplain

- Clark Fork River
 - Impaired under Section 303(d) of the Clean Water Act
 - Considered navigable by the state
- Freshwater forested/shrub wetlands
- Within 100-year floodplain of the Clark Fork River

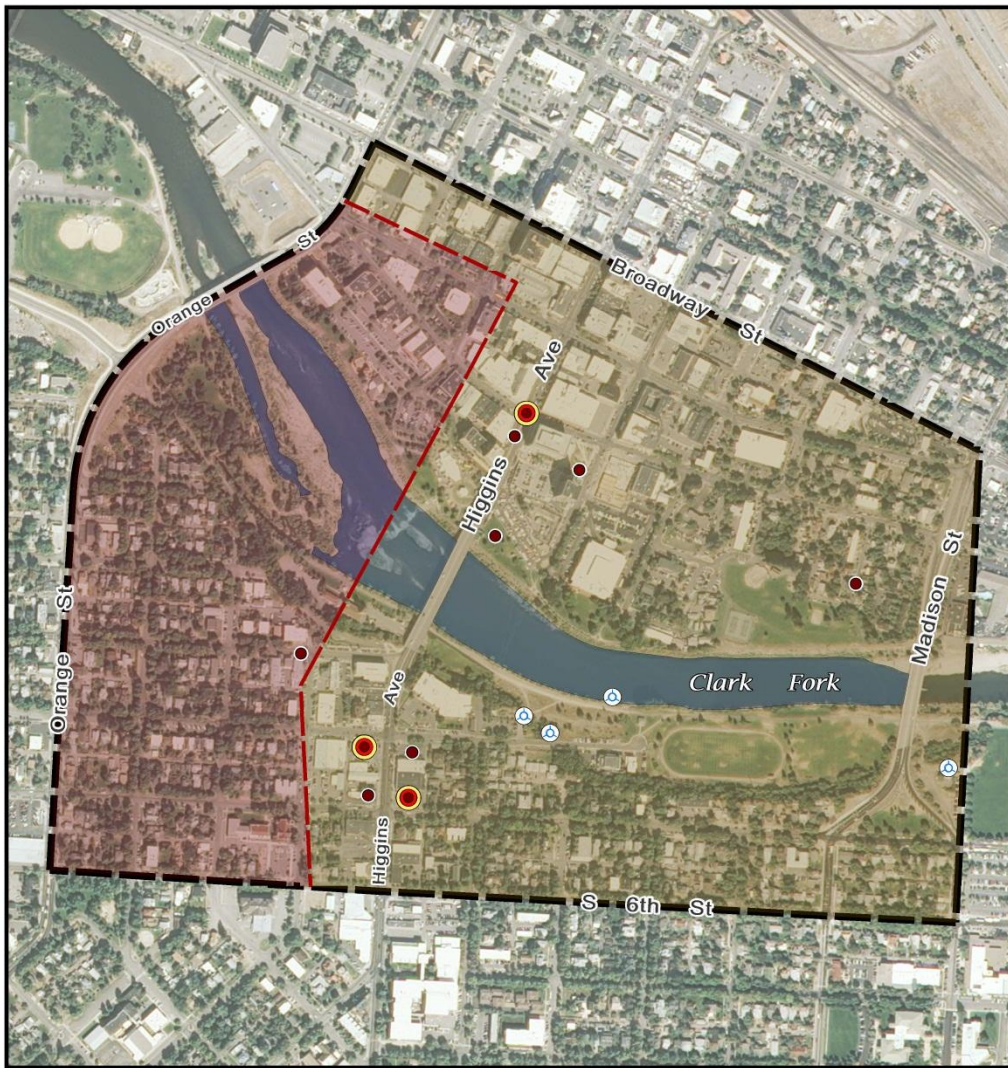
Hazardous Materials and Public Water Supplies

- Ten UST sites in proximity to bridges
- Three of the ten sites are reported as leaking
- Four public water supply locations in proximity to bridges
