EXISTING AND PROJECTED CONDITIONS

TONGUE RIVER ROAD (S-332) – Corridor Planning Study

Montana Department of Transportation

Robert Peccia & Associates

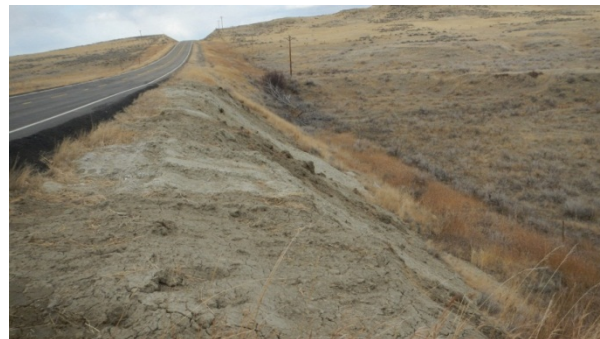
Example of slide area - note abrupt pavement edge

2011 was a historic year for flooding in eastern Montana. Due to severe flooding, a number of slides occurred along S-332. Evidence of recent slides was noted at the following approximate locations along S-332 during the field review:

The majority of the identified slide locations received minor repair work intended as temporary mitigation. Evidence of continued subsurface failure was noted at some of these locations.

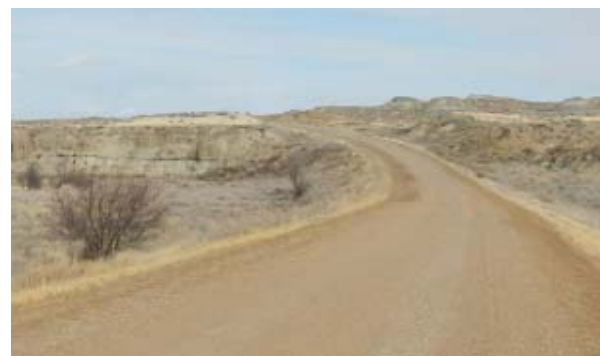
Example of steep fill slope

A list of roadside clear zone areas of concern was developed based on information obtained during field reviews. Features looked at during the field reviews were sight distances, side slopes, and roadside hazards. A table of roadside clear zone observations is presented in **Table 12**.

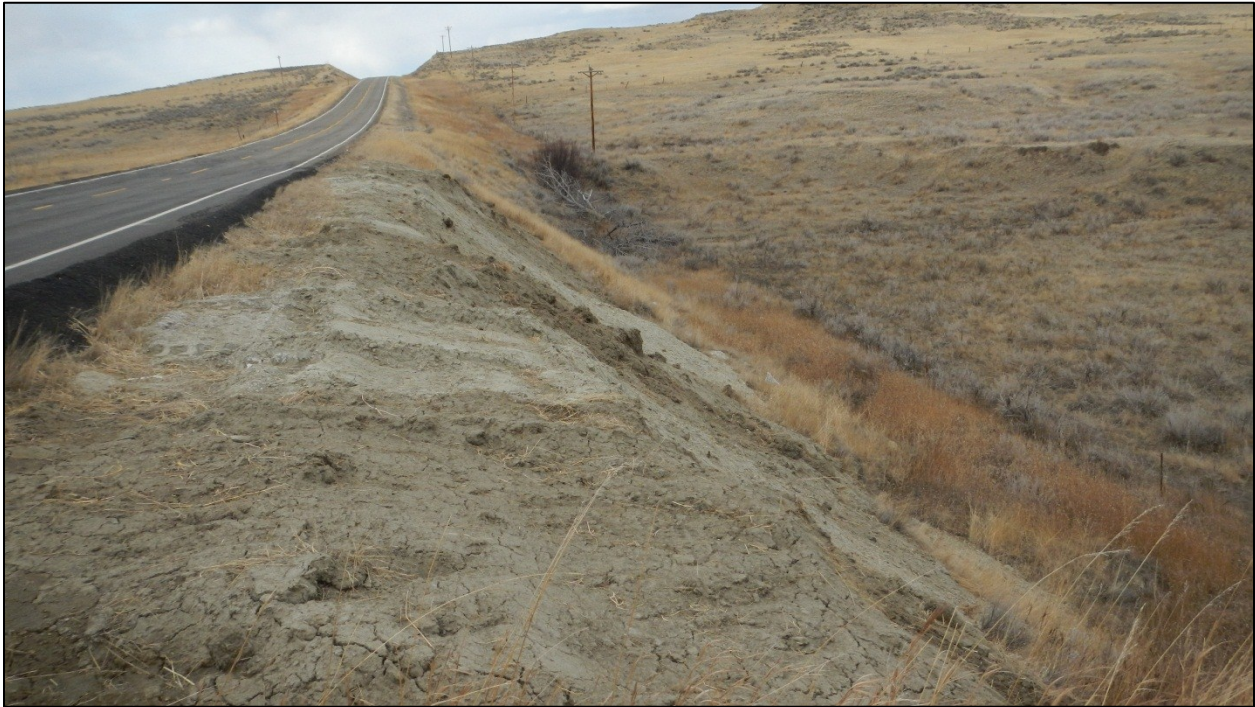
PHOTO 6: RP 3.7 LOOKING NORTH – RECENT SLIDE AREA

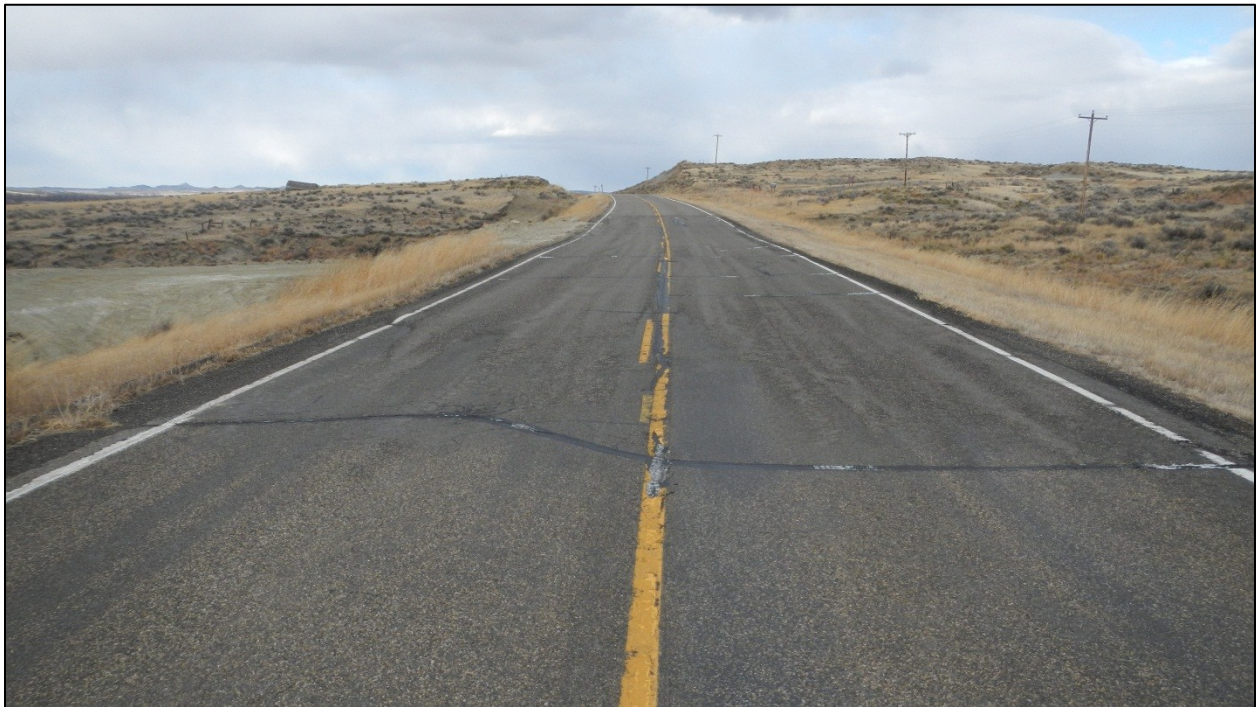
PHOTO 8: RP 4.2 LOOKING NORTH – RECENT SLIDE AREA

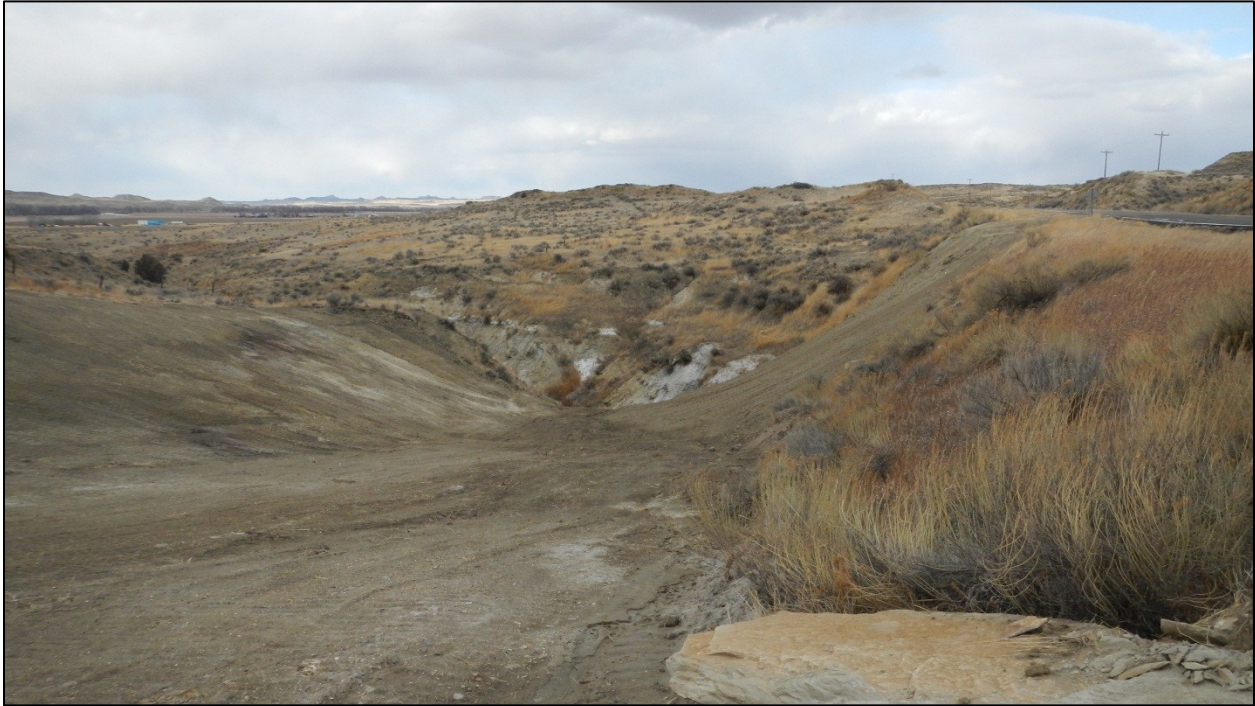
PHOTO 9: RP 4.5 LOOKING NORTH – RECENT SLIDE AREA

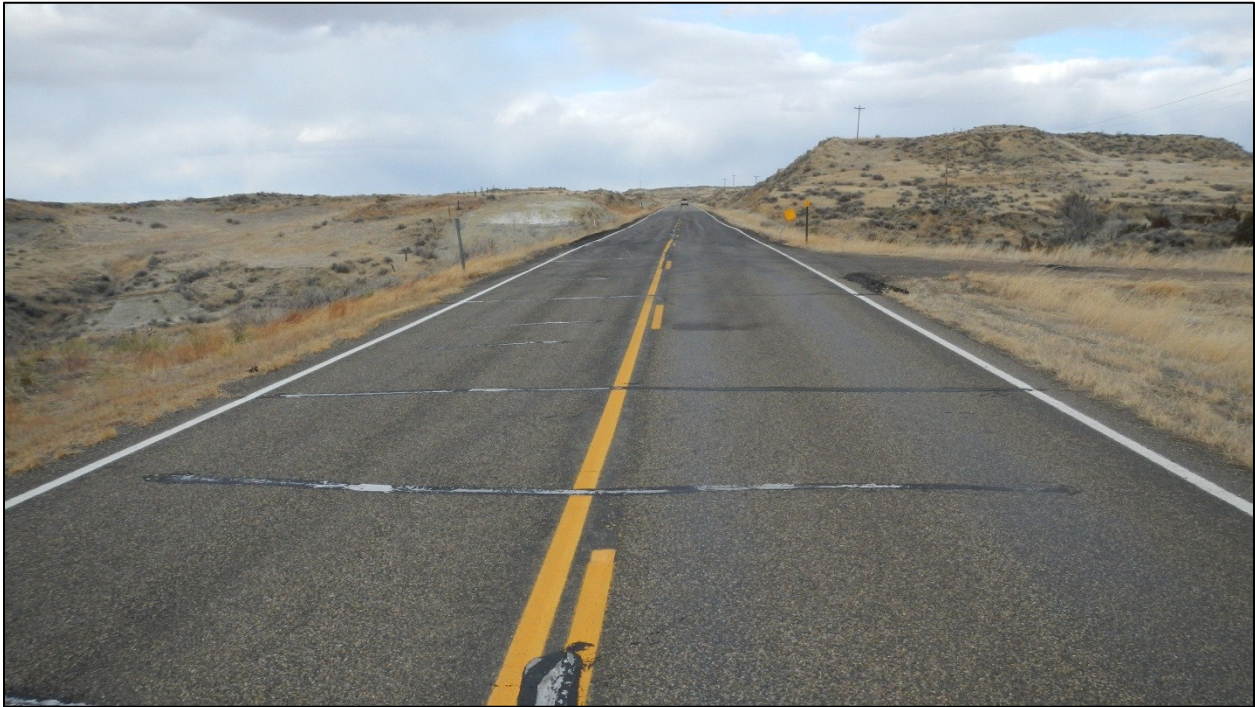
PHOTO 10: RP 4.7 LOOKING NORTH – RECENT SLIDE AREA

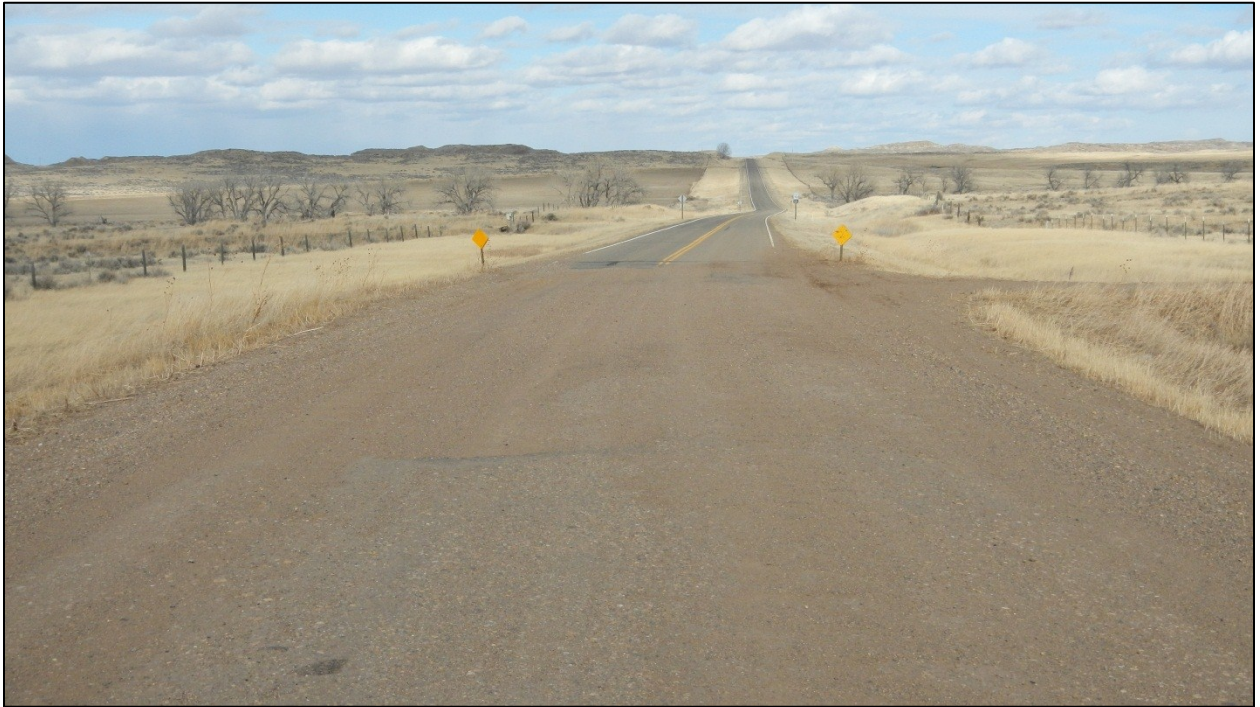
PHOTO 24: RP 17.7 LOOKING NORTH - END OF PAVEMENT

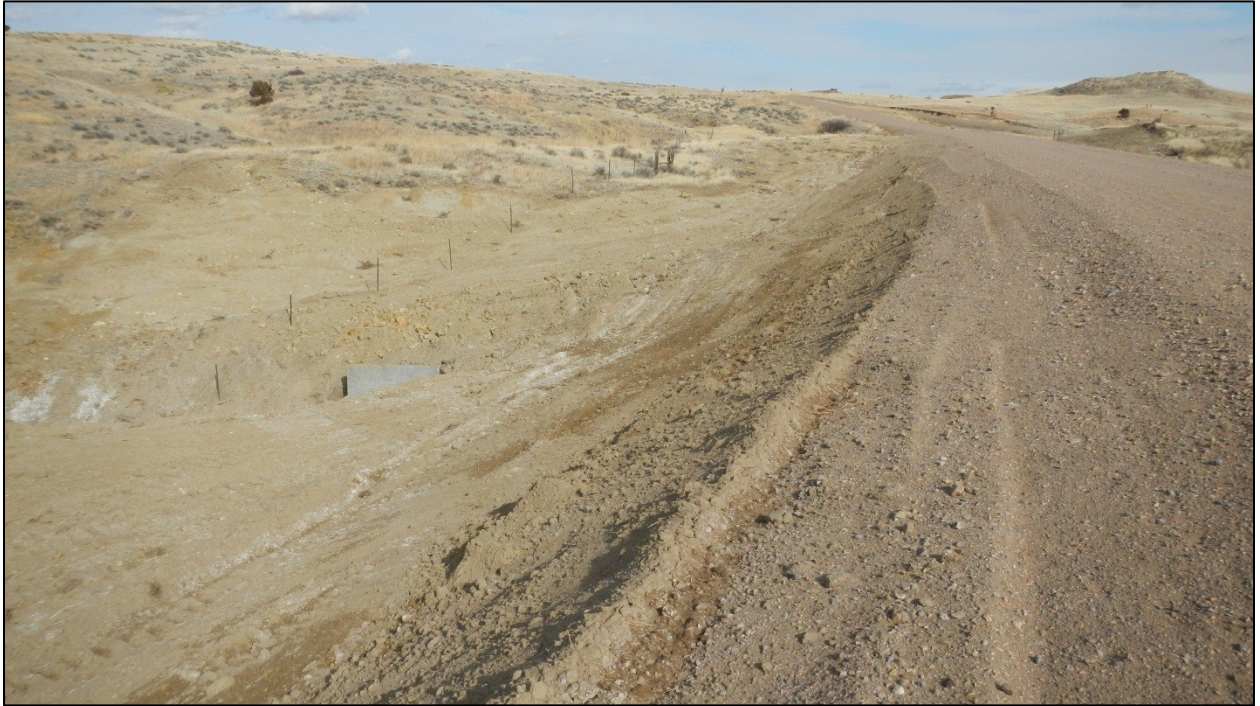
PHOTO 35: RP 26.2 LOOKING EAST - RECENT SLIDE AREA

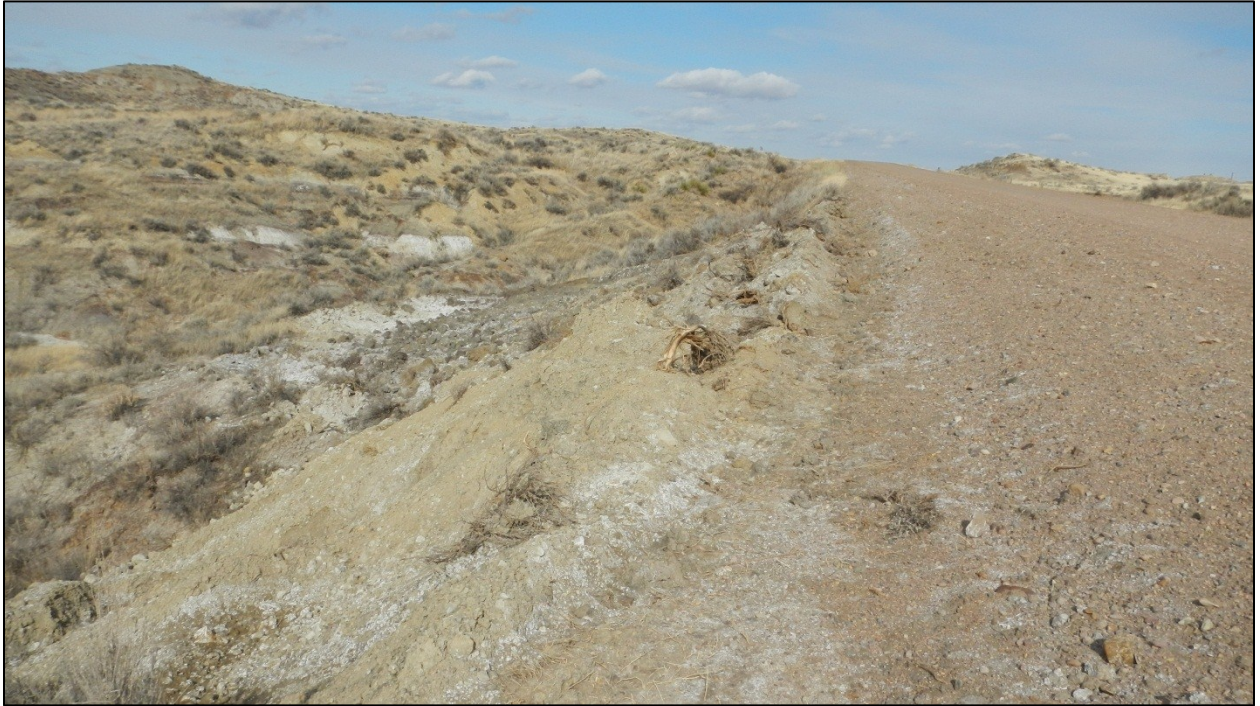
PHOTO 37: RP 27.9 LOOKING NORTHEAST - RECENT SLIDE AREA

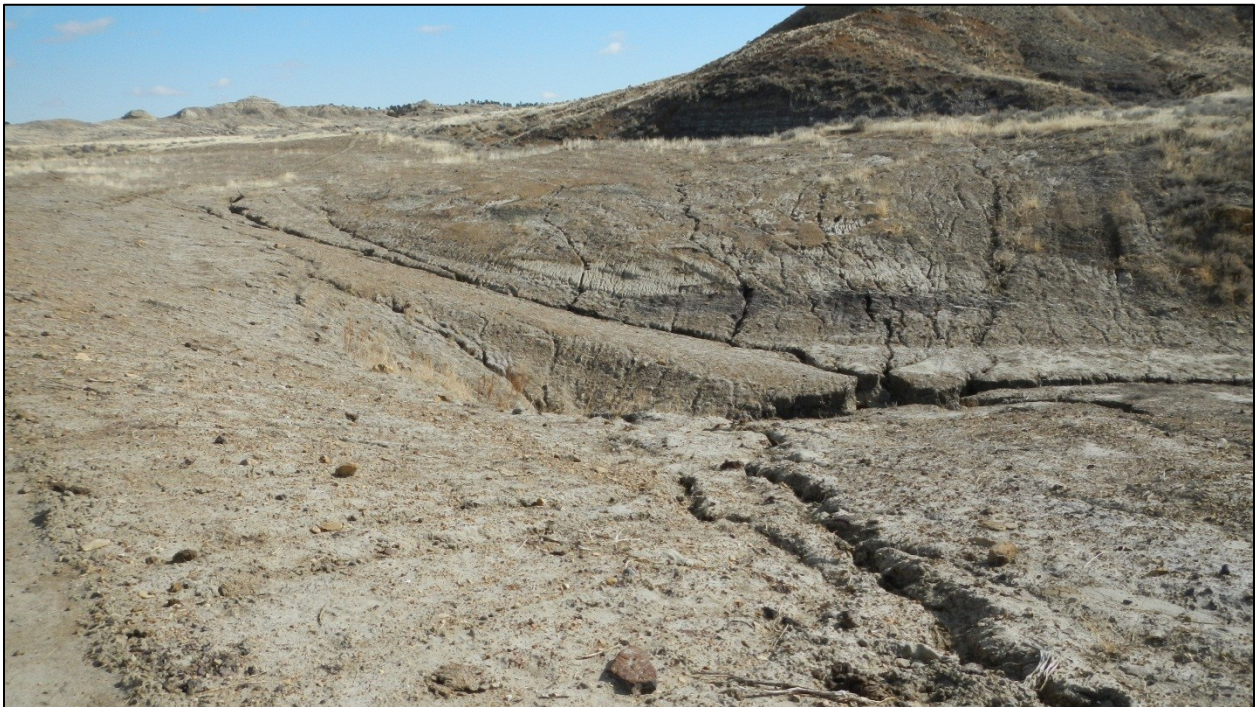
PHOTO 48: RP 36.3 LOOKING NORTHEAST - RECENT SLIDE AREA

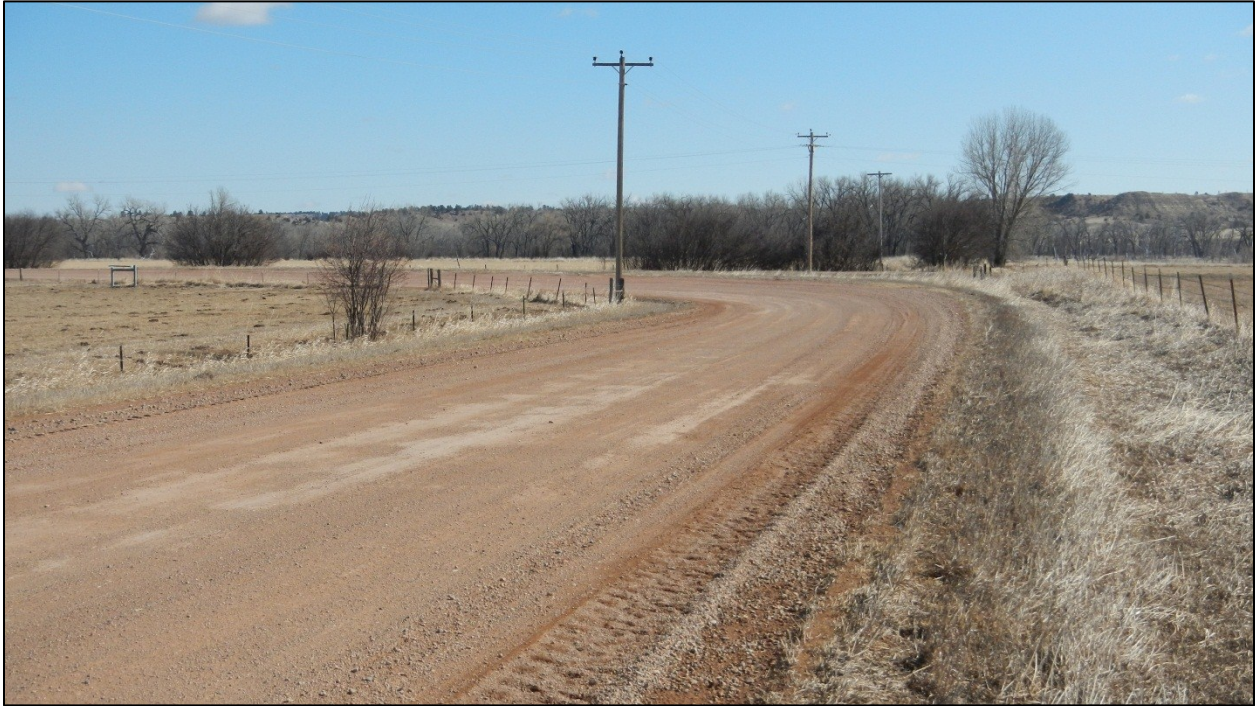
PHOTO 53: RP 40.7 LOOKING EAST - SUBSTANDARD HORIZONTAL CURVE

Elements comprising horizontal alignment include curvature, superelevation (i.e. the “bank” on the road), and sight distance. These horizontal alignment elements influence traffic operation and safety and are directly related to the design speed of the corridor. MDT’s standards for horizontal curves are defined in terms of curve radius and vary based on design speed. For a 60 mph design speed (level terrain) the maximum recommended radius is 1,200 feet. The maximum recommended radius for a 50 mph design speed (rolling terrain) is 760 feet.
