BIG TIMBER AIRPORT

Branch: 25A **APRON**

Branch: 25R RUNWAY

PAVEMENT STRENGTH SURVEY/PAVEMENT CONDITION SURVEY

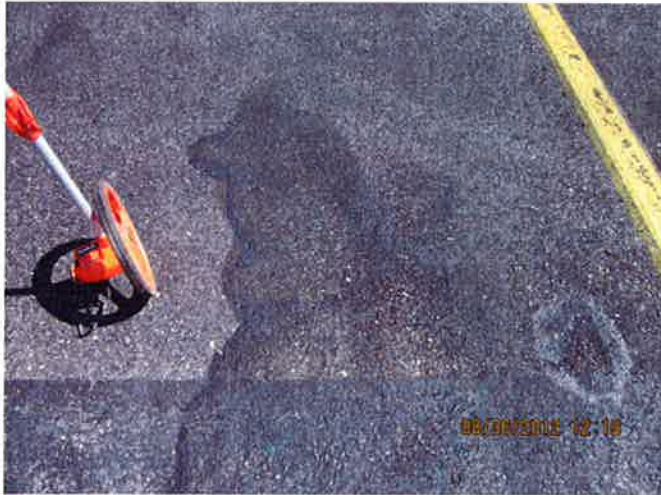
Distress Description	Severity	Quantity
DEPRESSION	L	30 SF
DEPRESSION	M	10 SF
LONGITUDINAL/TRANSVERSE CRACKING	L	77 LF
WEATHERING	L	2,457 SF

A-2, Surface detail with depression

Section	Distress Description	Severity	Quantity	Work Description	Quantity	Cost	Policy
A-1	L & T CR	M	242 LF	Crack Sealing - AC	242 LF	\$605 PREV.	
A-1	OIL SPILLAGE	N	14 SF	Patching - AC Shallow	33 SF	\$661 PREV.	
A-2	DEPRESSION	M	16 SF	Patching - AC Deep	36 SF	\$1,427 PREV.	
A-2	OIL SPILLAGE	N	17 SF	Patching - AC Shallow	38 SF	\$760 PREV.	
R-1	L & T CR	M	235 LF	Crack Sealing - AC	235 LF	\$588 PREV.	
R-2	L & T CR	M	10 LF	Crack Sealing - AC	10 LF	\$24 PREV.	
T-1	ALLIGATOR CR	M	20 SF	Patching - AC Deep	42 SF	\$1,680 PREV.	
T-1	L & T CR	M	34 LF	Crack Sealing - AC	34 LF	\$85 PREV.	
T-2	L & T CR	M	690 LF	Crack Sealing - AC	690 LF	\$1,726 PREV.	
T-3	L & T CR	M	122 LF	Crack Sealing - AC	122 LF	\$305 PREV.	
T-5	OIL SPILLAGE	N	14 SF	Patching - AC Shallow	33 SF	\$651 PREV.

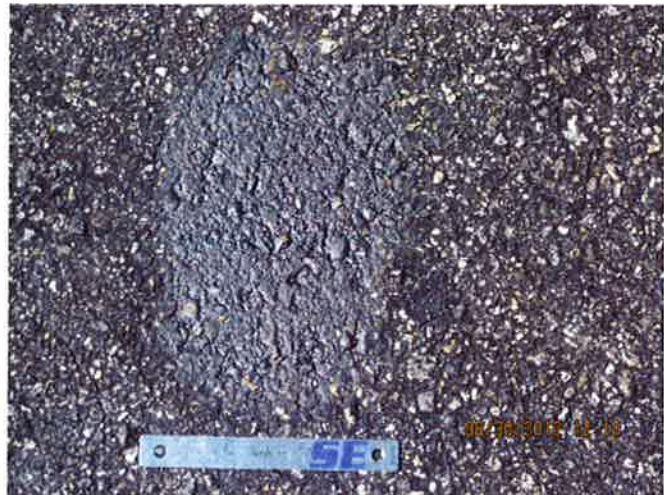
Distress Description	Severity	Quantity
BLEEDING	N	60 SF
OIL SPILLAGE	N	11 SF
WEATHERING	L	4,080 SF

A-2, Surface detail with oil spillage

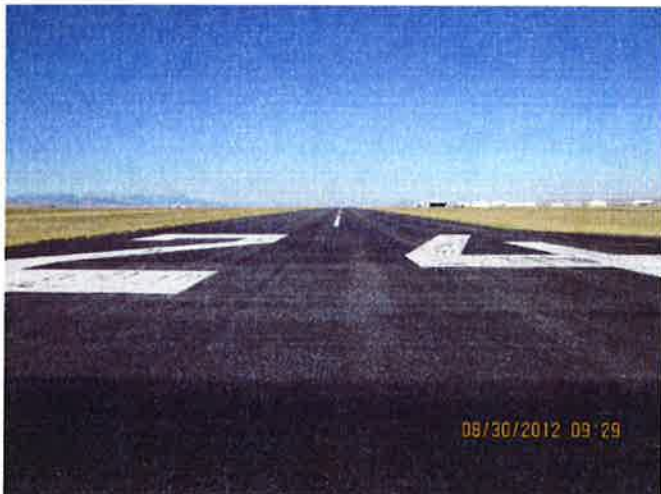
R-1, Overview

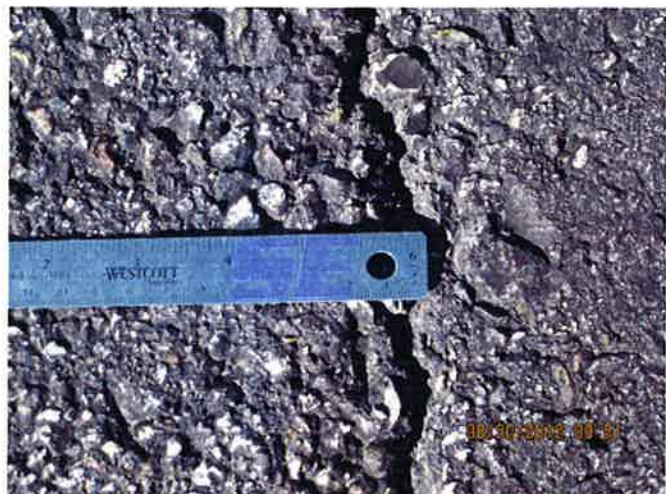
Distress Description	Severity	Quantity	Density	Deduct
ALLIGATOR CRACKING	L	8,508 SqFt	2.44%	29.04
LONGITUDINAL/TRANSVERSE CRACKING	L	5,309 Ft	1.52%	6.17
LONGITUDINAL/TRANSVERSE CRACKING	M	118 Ft	0.03%	4.00
WEATHERING	L	34,875 SqFt	10.00%	1.72

R-1, Surface detail with crack

Plan Year: 2013				Estimated Cost: \$1,524,423		PCI		
Section	Maintenance	Local	Global	Major<Crit	Major>Crit	Total	Before	After
A-1	Preventive	\$981	\$0	\$0	\$0	\$981	76	77
A-2	Preventive	\$187	\$0	\$0	\$0	\$187	82	82
R-1	Major Above Critical	\$0	\$0	\$0	\$1,383,843	\$1,383,843	57	100
R-2	Major Above Critical	\$0	\$0	\$0	\$66,103	\$66,103	78	100
T-1	Major Above Critical	\$0	\$0	\$0	\$22,092	\$22,092	52	100
T-2	Global MR + Preventive	\$3,144	\$9,900	\$0	\$0	\$13,044	67	70
T-3	Global MR + Preventive	\$528	\$3,438	\$0	\$0	\$3,966	73	77
T-4	Global MR + Preventive	\$2,629	\$21,341	\$0	\$0	\$23,970	75	79
T-5	Global MR + Preventive	\$1,481	\$8,755	\$0	\$0	\$10,236	72	76

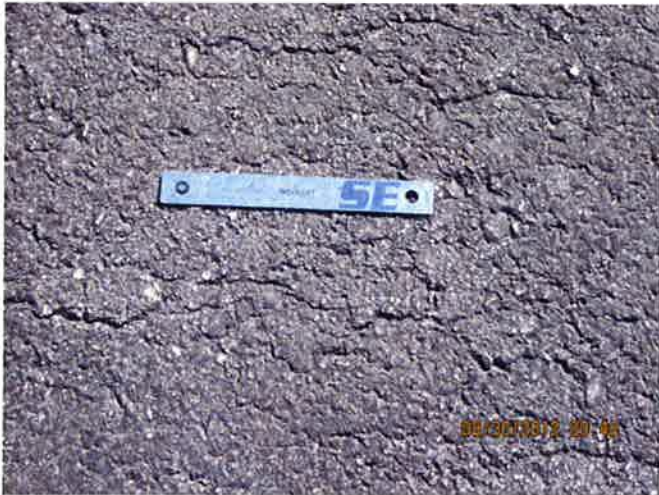
R-1, Surface detail with cracking

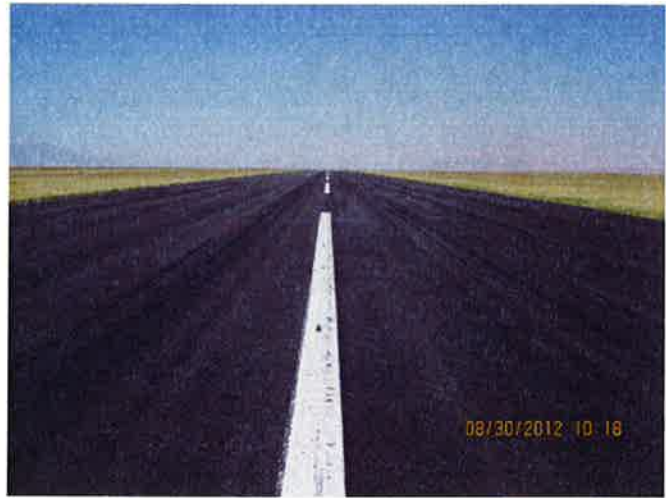
R-2, Overview

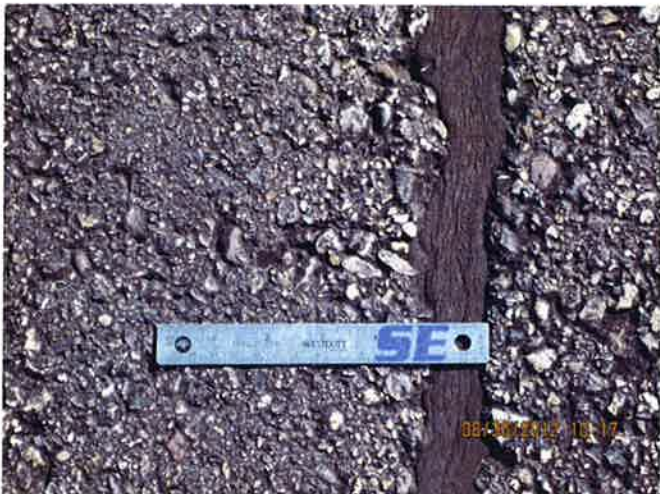
Distress Description	Severity	Quantity	Density	Deduct
LONGITUDINAL/TRANSVERSE CRACKING	M	10 Ft	0.02%	4.00
LONGITUDINAL/TRANSVERSE CRACKING	L	1,780 Ft	3.74%	11.89
WEATHERING	L	9,525 SqFt	20.00%	2.81
ALLIGATOR CRACKING	L	356 SqFt	0.75%	17.84

R-2, Surface detail with crack

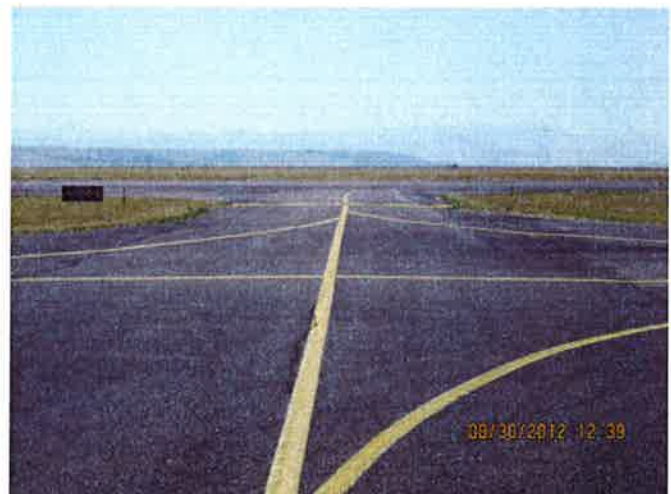
T-1, Overview

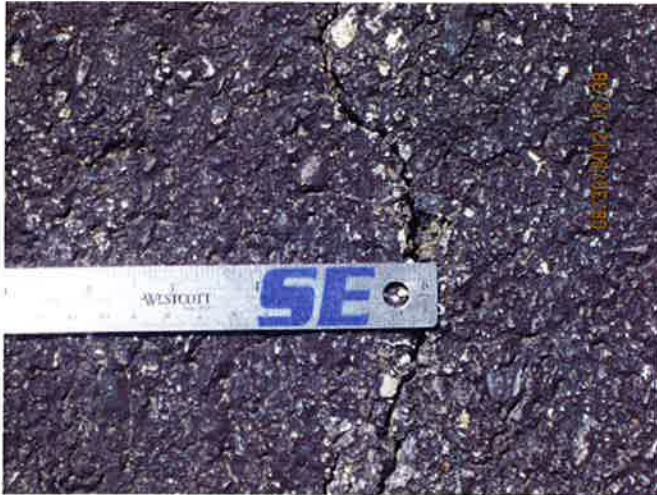
Distress Description	Severity	Quantity	Density	Deduct
ALLIGATOR CRACKING	L	13 SF	0.28%	10.36
LONGITUDINAL/TRANSVERSE CRACKING	M	34 LF	0.73%	9.79
WEATHERING	M	930 SF	20.00%	8.76
LONGITUDINAL/TRANSVERSE CRACKING	L	85 LF	1.83%	6.96
WEATHERING	L	3,720 SF	80.00%	5.71

T-1, Surface detail with crack

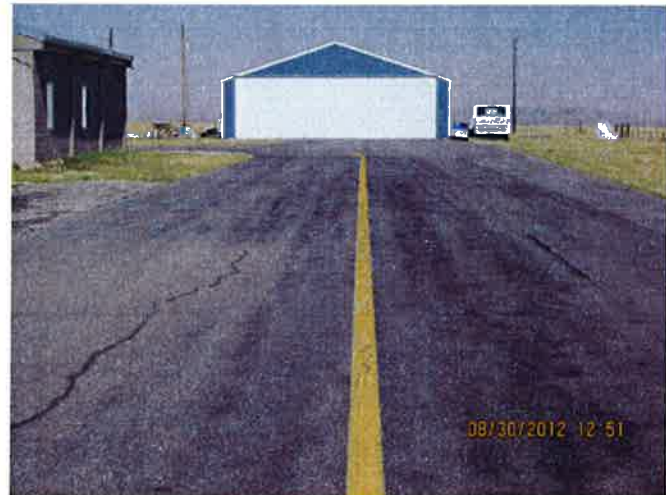
T-2, Overview

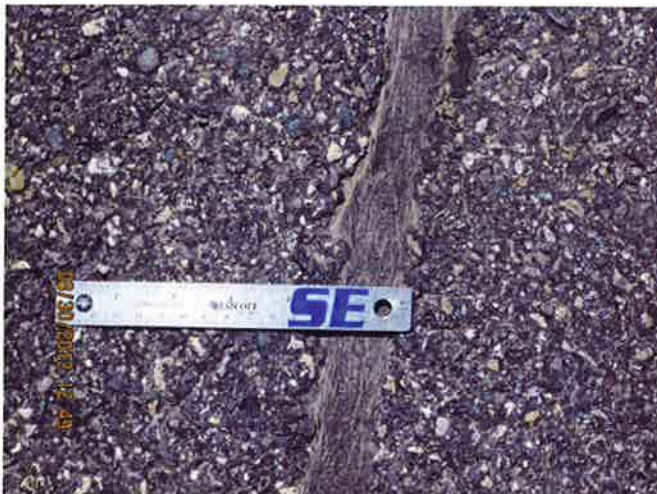
Distress Description	Severity	Quantity	Density	Deduct
WEATHERING	M	27,720 SF	70.00%	17.87
LONGITUDINAL/TRANSVERSE CRACKING	M	690 LF	1.74%	14.64
LONGITUDINAL/TRANSVERSE CRACKING	L	843 LF	2.13%	7.75
WEATHERING	L	11,880 SF	30.00%	3.65

T-2, Surface detail with crack

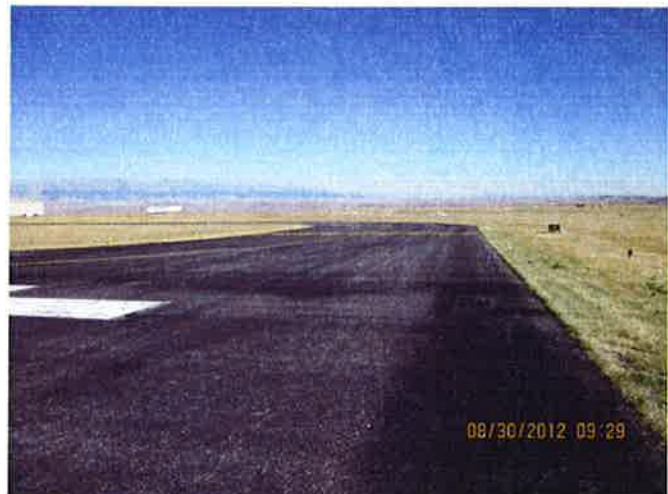
T-3, Overview

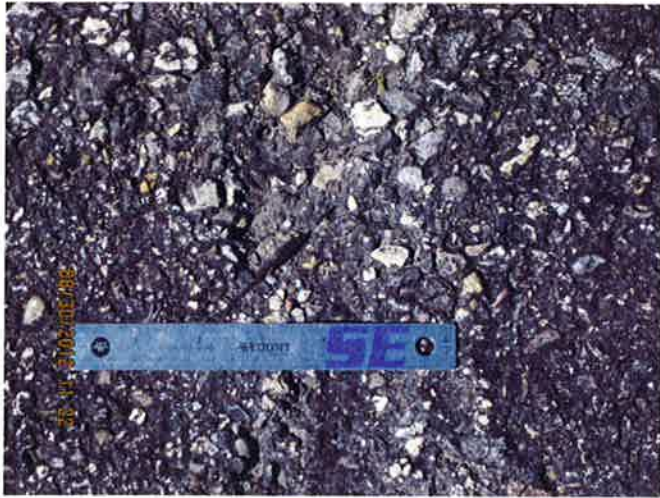
Distress Description	Severity	Quantity	Density	Deduct
LONGITUDINAL/TRANSVERSE CRACKING	M	122 LF	0.89%	10.66
WEATHERING	M	2,961 SF	21.53%	9.2
RAVELING	H	1 SF	0.01%	6
WEATHERING	L	10,790 SF	78.48%	5.68
LONGITUDINAL/TRANSVERSE CRACKING	L	175 LF	1.27%	5.55

T-3, Surface detail with raveling

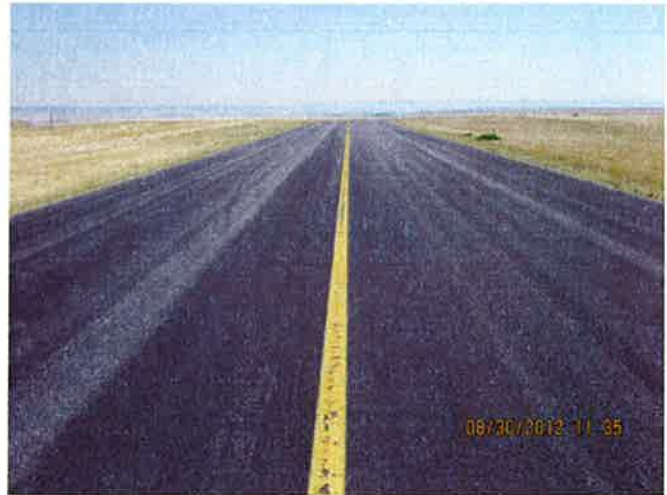
T-4, Overview

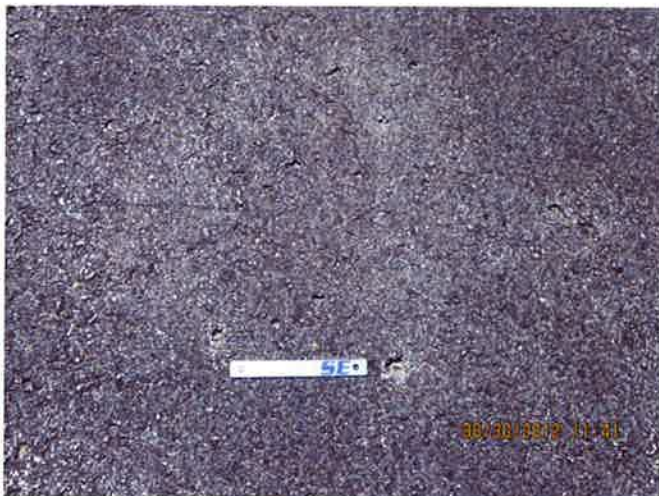
Distress Description	Severity	Quantity	Density	Deduct
RAVELING	L	13,658 SF	16.00%	12.36
WEATHERING	M	27,317 SF	32.00%	11.86
RAVELING	M	384 SF	0.45%	5.93
WEATHERING	L	44,390 SF	52.00%	4.89

T-4, Surface detail with raveling

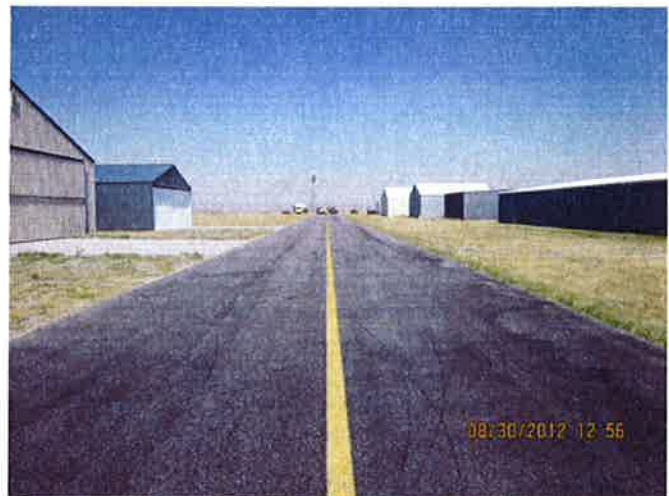
T-5, Overview

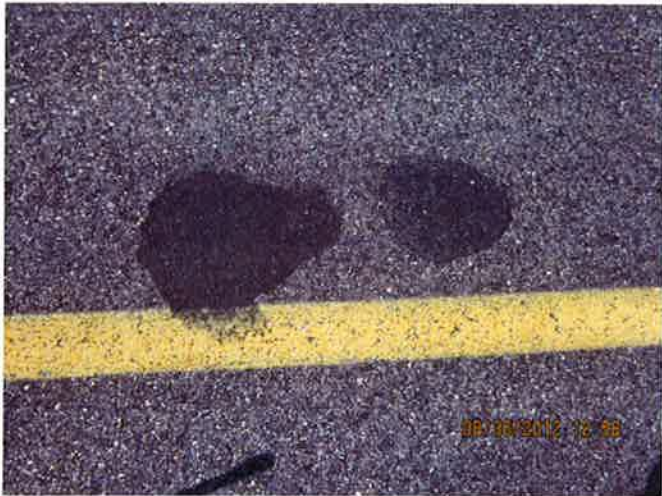
Distress Description	Severity	Quantity	Density	Deduct
WEATHERING	M	31,518 SF	90.00%	19.66
RAVELING	M	178 SF	0.51%	6.18
OIL SPILLAGE	N	14 SF	0.04%	2
WEATHERING	L	3,499 SF	9.99%	1.72

T-5, Surface detail with oil spillage
